Rhayader Castle, Rhayader (RD132)

Damage Assessment Report

By:
Ian Halfpenney
BA (Hons), MIFA

Date: **August 2007**

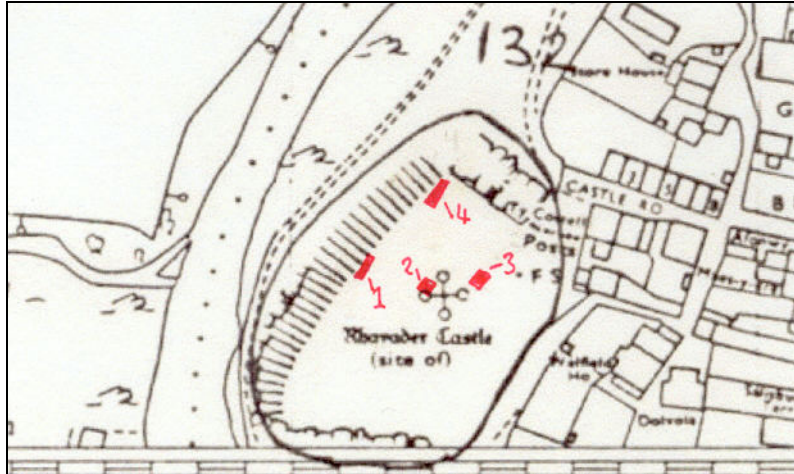
Figure 02: Showing location of excavated areas within Rhayader Castle

As mentioned four areas had been excavated within the interior of the Castle. The contractor informed me that the plan had been to excavate out a base for each picnic table and bench and then to infill the excavated areas with concrete so that they could be used as bases for the tables and benches:

Following consultation (via telephone) with the Cadw Inspector of Ancient Monuments (Dr. Rees) I asked Mr. Lloyd to cease work on site and for the contractors to infill the excavated areas and that SMC would need to be applied for and granted before any work could resume on site. Mr. Lloyd agreed to this and I said that the relevant SMC forms would be forwarded to the Town Council Clerk (Mr. Barker).

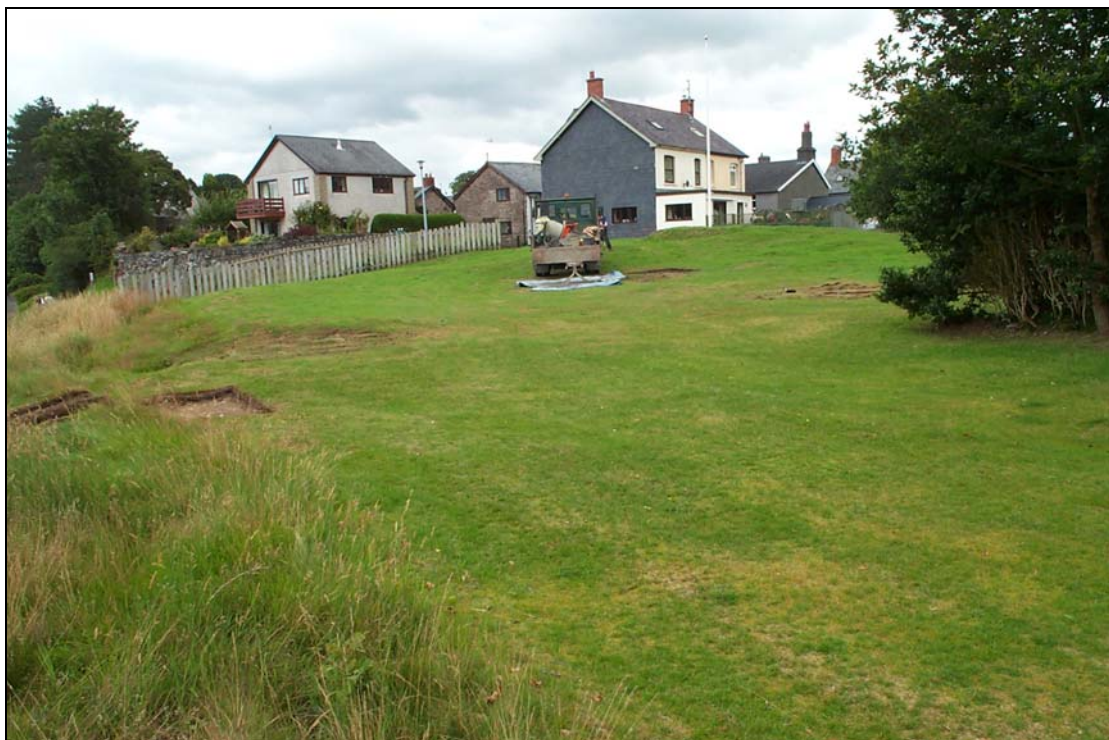
Photo 01: General view of Castle interior, looking NE

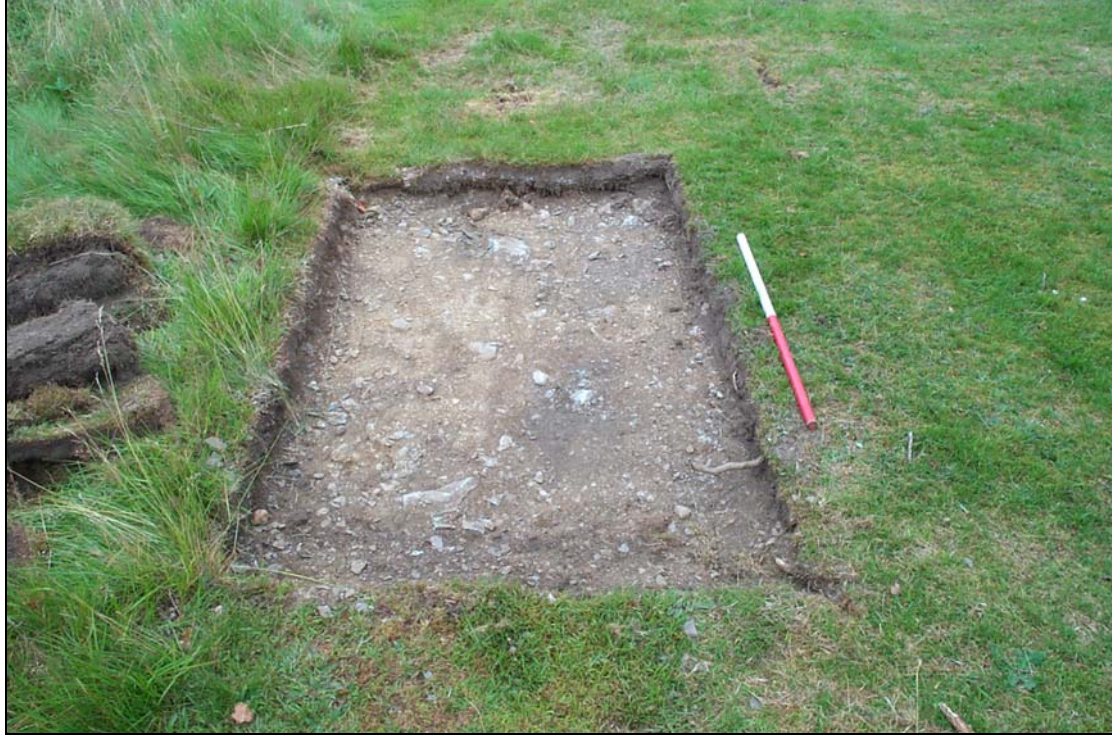
Area 1 – located at SN96819/68041 and measuring 2.2m (N/S) x 1.3m (E/W). Depth of excavation was 0.1m, which had removed the turf layer and topsoil. The underlying deposit was composed of a light brown silty clay containing a large amount of fractured shale inclusions. This excavation area had been dug through a previously undisturbed area of the site.

Photo 02: View of excavation area 1, looking NE

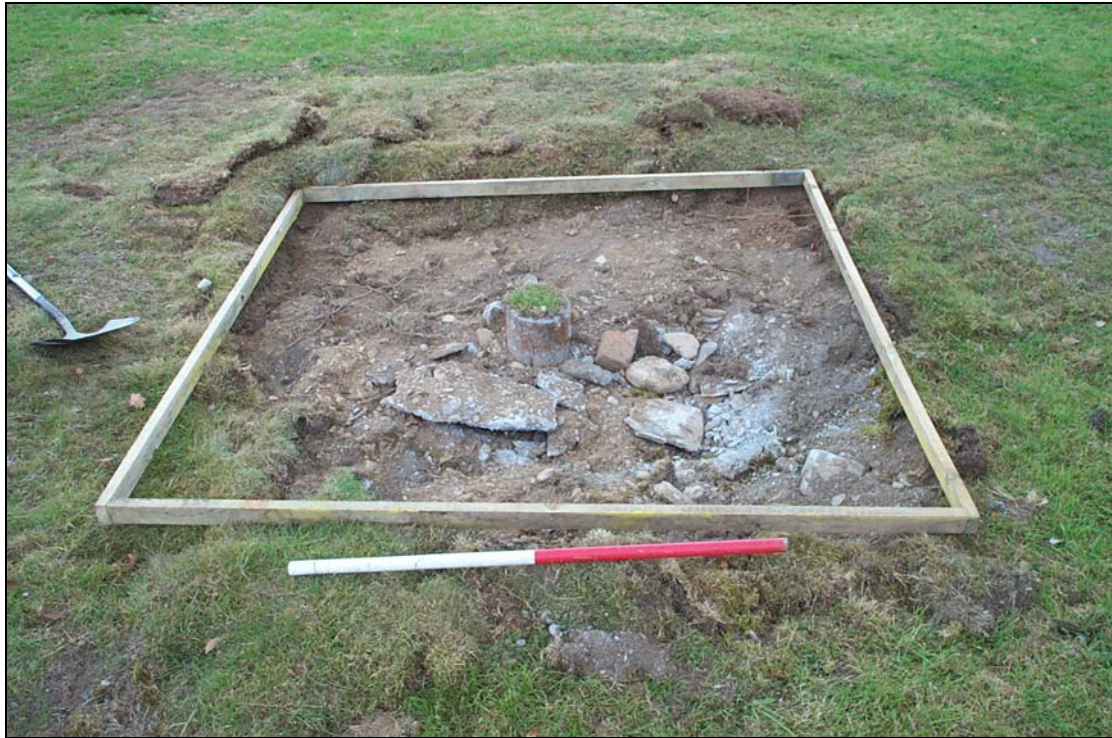
Area 2 – located at SN96838/68038 and measuring 1.9 x 1.9m. Depth of excavation was 0.15m which had removed the turf and topsoil and had exposed a mid brown silty loam with frequent shale inclusions. At the centre of this trench was an area of disturbance that according to the contractor had once been a child's play area. The disturbance consisted of modern rubble.

Photo 03: View of excavation area 2, looking ESE

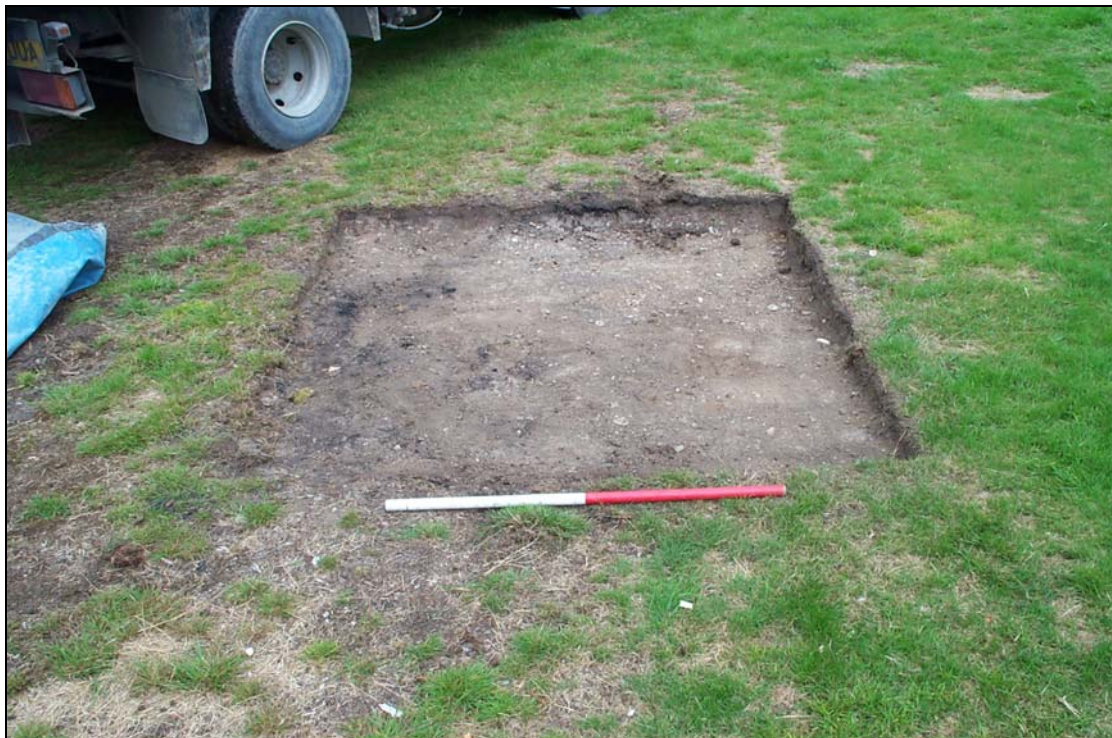
Area 3 – located at SN96838/68045 and measuring 1.9 x 1.9m. Depth of excavation was 0.15m which had removed the turf and topsoil and had exposed a mid brown silty loam with frequent shale inclusions. There were also a number of late 19th/20th Century pottery sherds evident on the exposed surface. According to the contractor a concrete slab had covered this area and this is all that they had removed.

Photo 04: View of excavation area 3, looking NNE

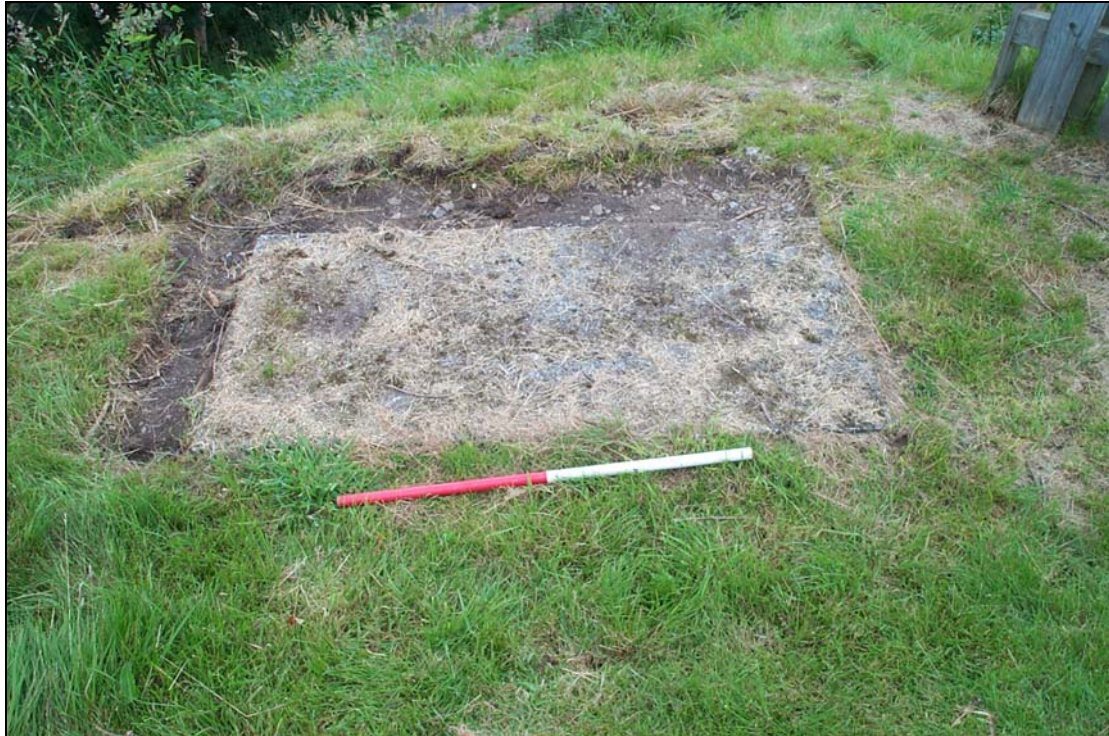
Area 4 – located at SN96835/68060 and measuring 1.22m (N/S) x 2.1m (E/W). Depth of excavation was 0.1m which had removed the turf and topsoil and had exposed a mid brown silty loam with frequent shale inclusions. A pre-existing concrete slab that had been used as the base for a bench covered the majority of the exposed area. The only excavation that had taken place was around the north and west sides of the slab. The contractor said that the plan was to locate another bench on top of the slab but as the new bench was slightly larger than the previous one it had been necessary to excavate the ground surface so that additional concrete could be used.

Photo 05: View of excavation area 4, looking N
