An Interim Report on Phase 1 Archaeological Evaluation at Hay Castle

Oxford Road, Hay-on-Wye, Powys

March 2016

Report prepared for Hay Castle Trust by Peter Dorling, BSc MCIfA
April 2016

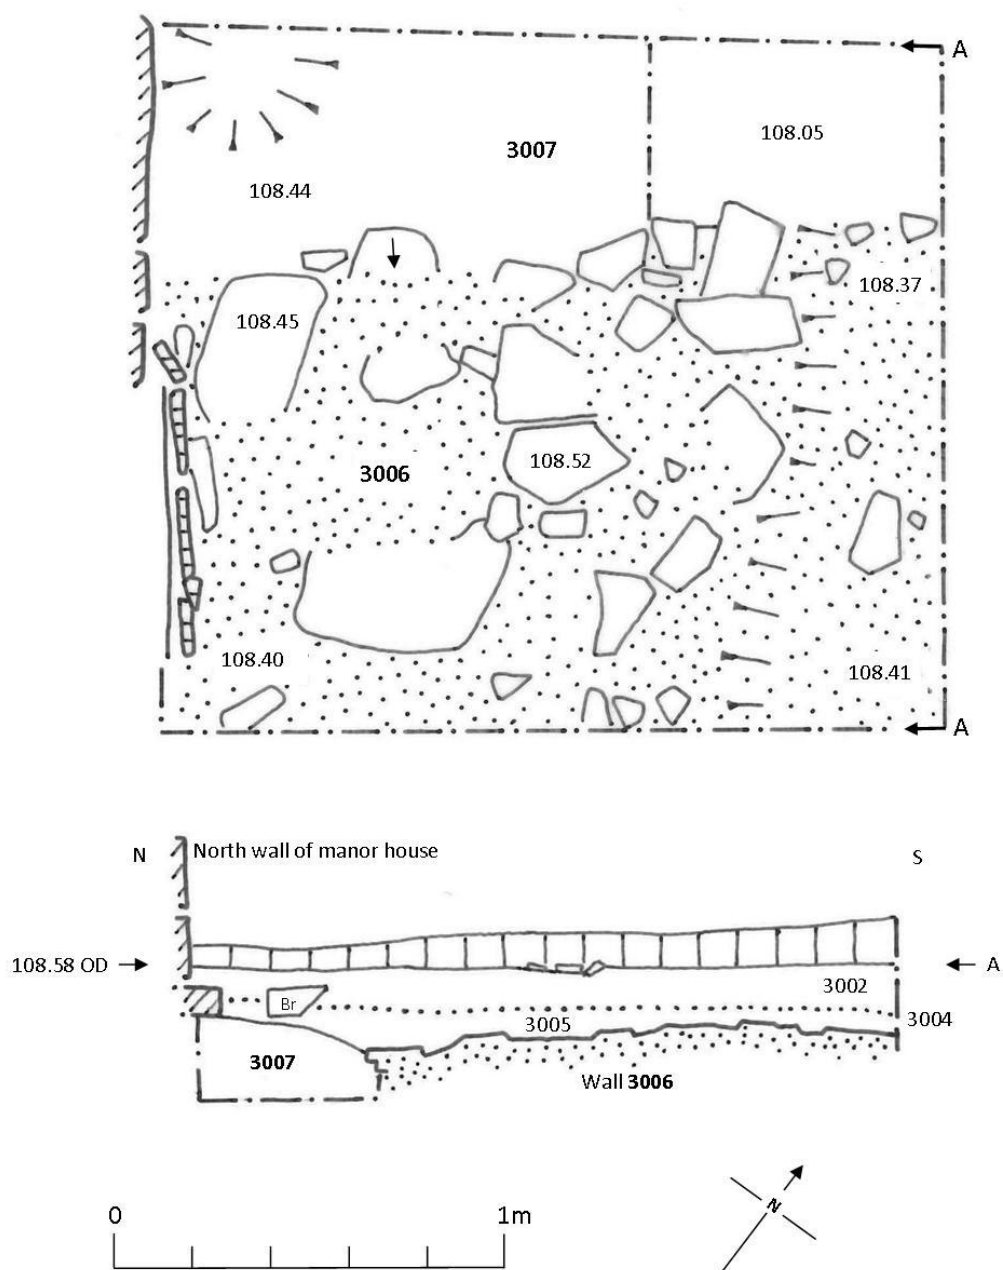
- 7.1.3 Excavation of this test pit was prevented from proceeding below a depth of about 0.30m by a mass of masonry and solid lime mortar, clearly the top of a substantial wall or other structure (3006, figures 2 and 3). This was present in around two thirds of the area of the trench and extended beyond the southern, eastern and western sides of the trench. In the northern third of the trench there was a consistent deposit of dark red (2.5YR 3/6) silty clay marl. This clay continued under the transverse north-south wall (3010) to the west of TP3 and to the north under the main northern wall (3009). The former appears to have no foundations at all whilst the latter has a one course foundation recorded in section (figure 2).

Figure 2: TP3 plan and section, heights are in metres above OD. Br = Brick.

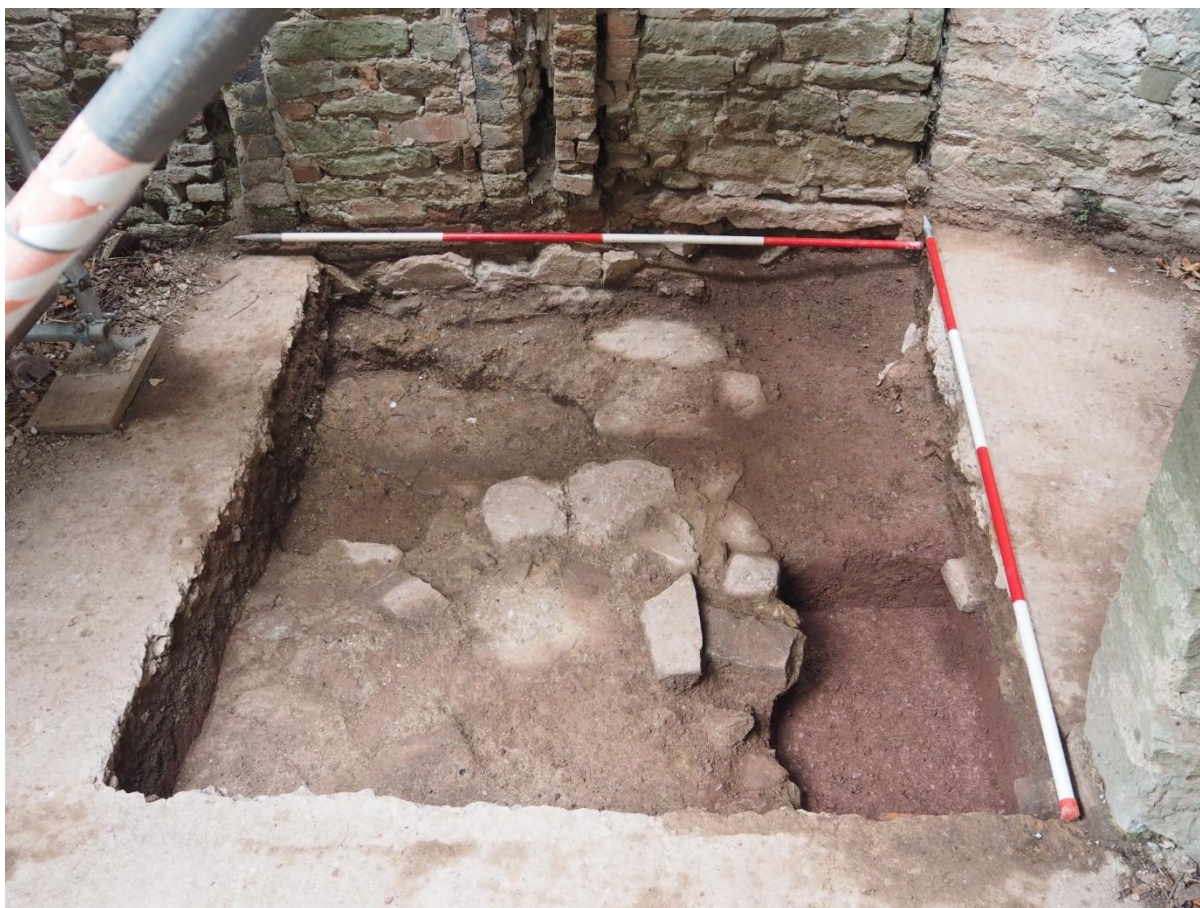
- 7.1.4 The north side of the wall 3006 has an unfaced ragged-edge finish suggesting that it was built against the already in-situ clay marl. Excavation of a shallow slot through the clay to a depth of 0.40m confirmed that the top courses of the wall overlie the clay deposit which may be the natural subsoil or redeposited subsoil within an earthwork such as the early defensive rampart. Further work would be needed to clarify this. For further discussion of the wall see 7.2.4 below.

Figure 3: TP3, wall 3006 on the left (south) and the clay deposit 3007 to the right, the scales are 2 metres

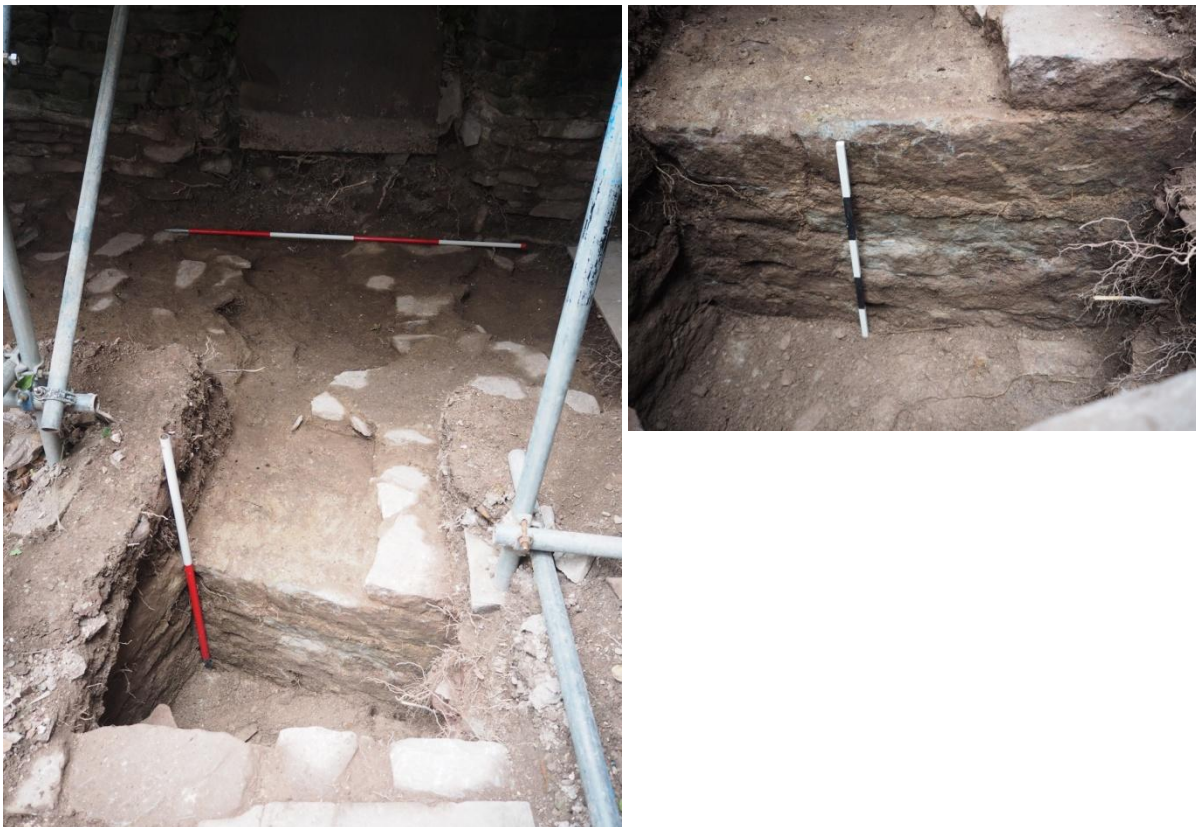
7.2.3 A small extension to the south exposed four to five courses of the face of the wall to a depth of about 0.60m (figure 5), further facing was buried below building collapse /

demolition rubble (4004). The wall face at this point was well constructed of large dressed sandstone blocks up to 0.60m by 0.15m set in lime mortar. An extension to the east and the subsequent removal of the chimney stack (4007) confirmed that this wall was built butting up to the gatehouse / keep tower.

Figures 4 and 5: TP4/11, Wall 4002 from the south and detail of the wall face, the scales are 2m, 1m and 0.5m (black and white)

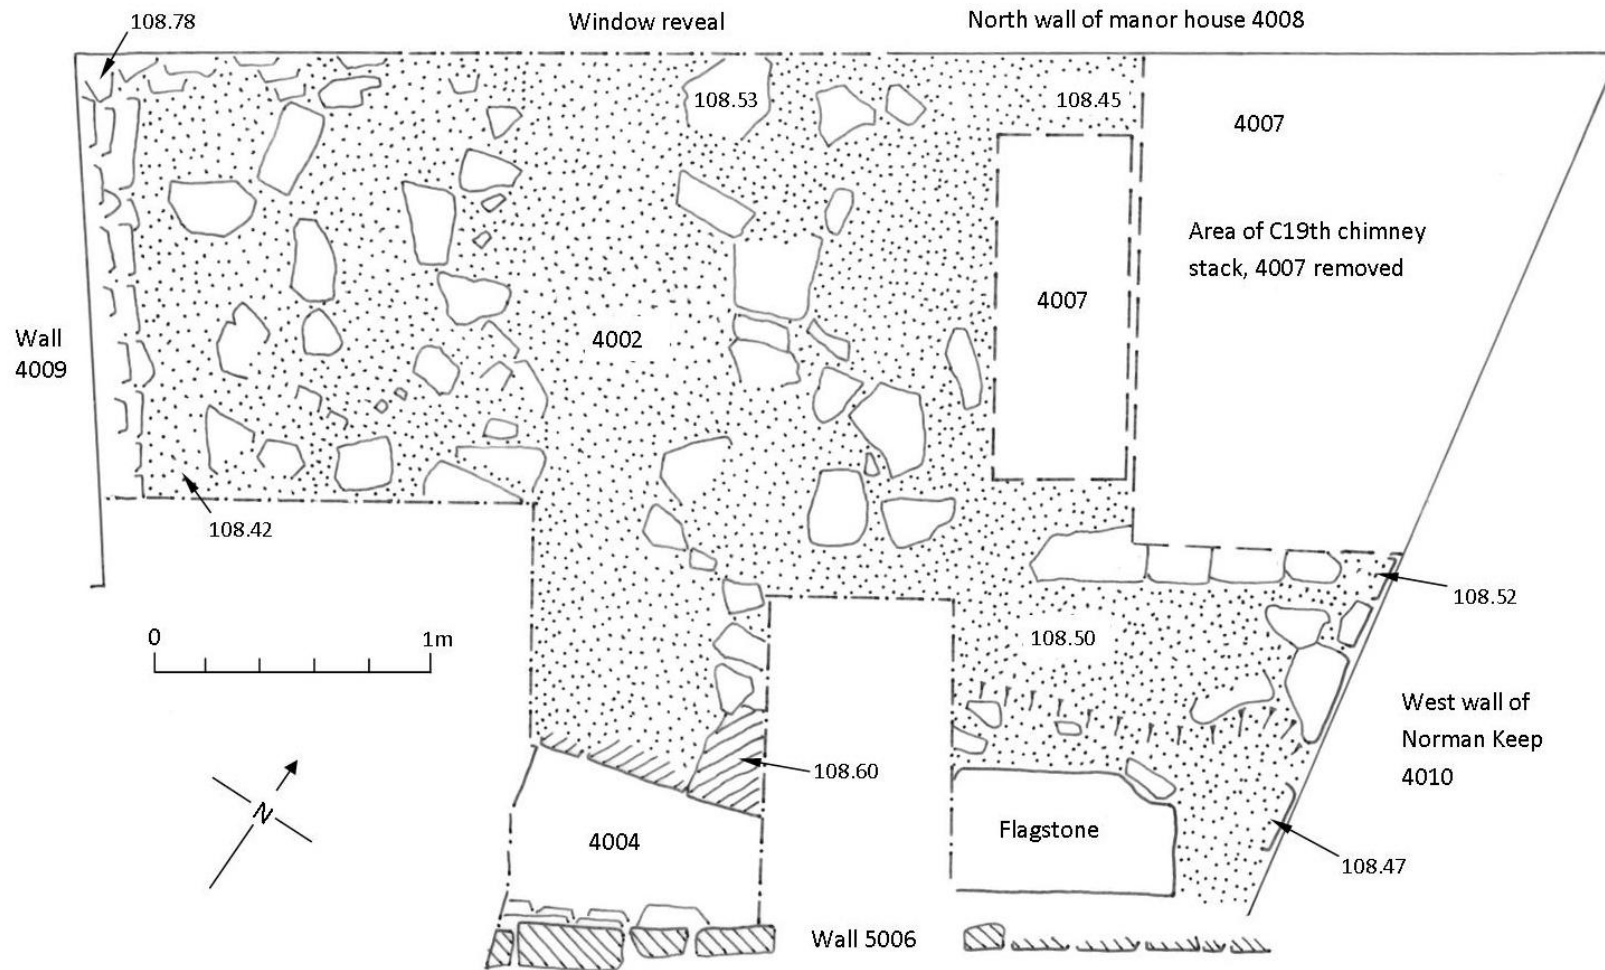
7.2.2 Modern debris and post 1939 fire material (4001) was removed to reveal that the whole of the original excavation area was occupied by a mass of masonry and solid lime mortar similar to the masonry in TP3 (4002, figures 4 and 6). It continued under the north wall of the manor house (4008) and under the transverse north-south wall to the west (4009), in both cases serving as a foundation for those walls. The top of wall 4002, where it acted as a foundation below wall 4009, was between 0.36m and 0.27m above the general level of the surviving wall top elsewhere (figure 6).

7.2.4 Given the size of the wall, at least 3.50m wide, and the angle and relationship with the gatehouse / keep this must be the 13th century castle curtain wall. It is interesting that there is a low plinth on the outside of the north wall of this bay of the manor house, the only place where this occurs, and this may be a remodelling of the underlying curtain wall.

Figure 6: TP4/11, curtain wall 4002.

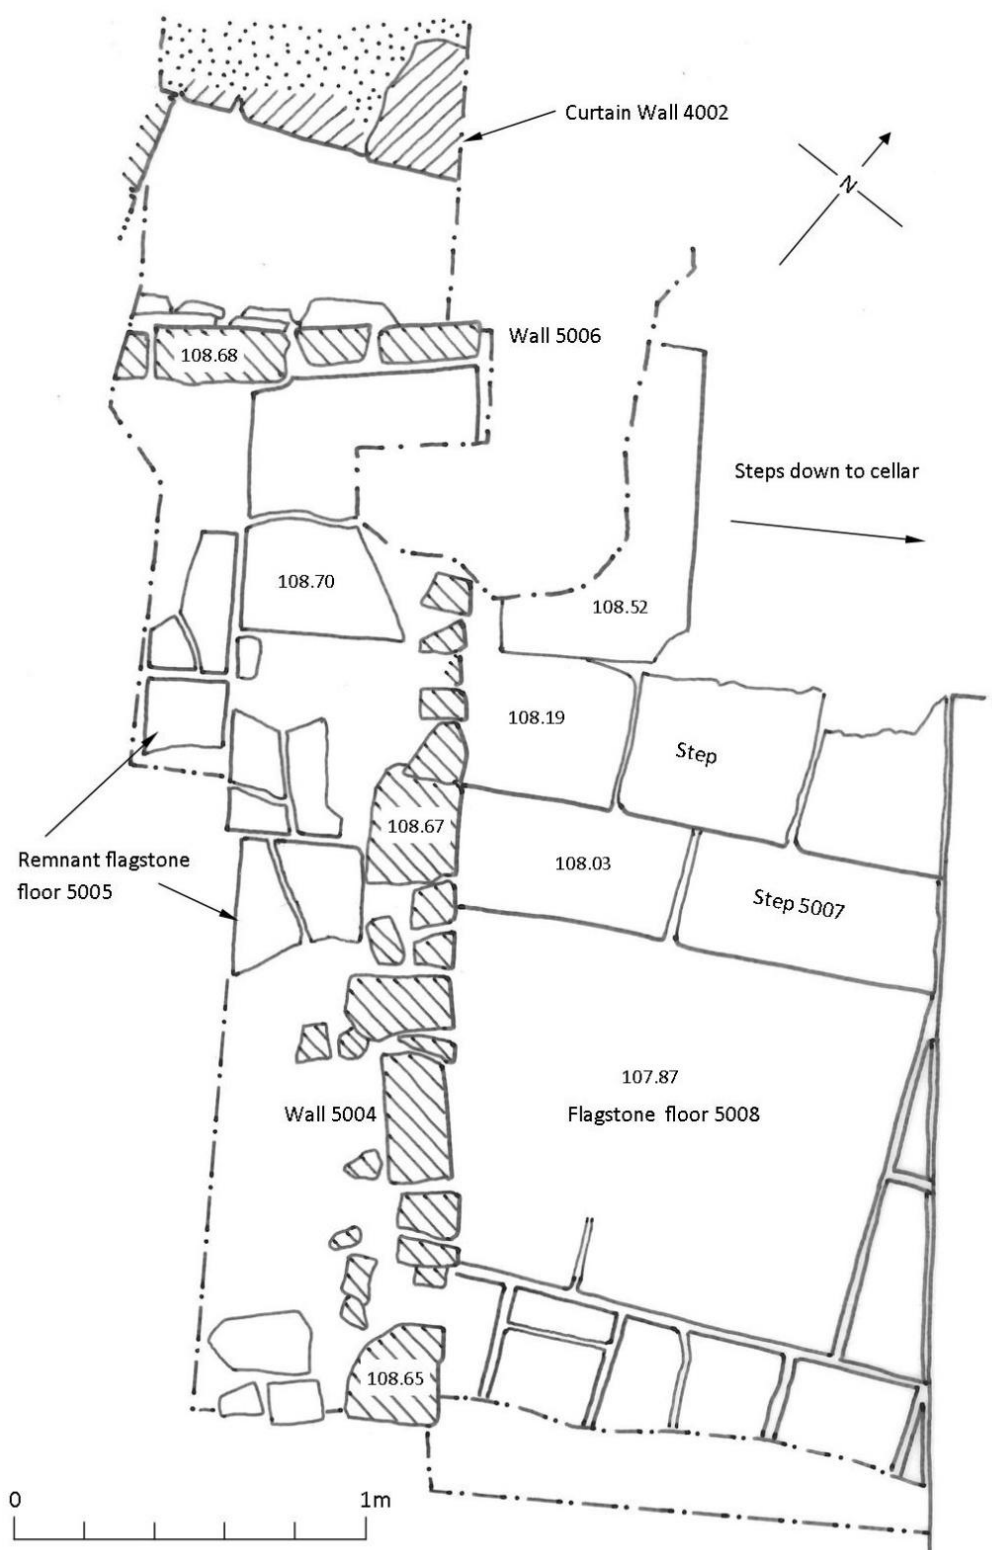
Figure 7: TP5 plan.

- 7.3.3 Removal of recent debris / overburden and deliberate backfilling revealed a number of different masonry and structural elements (Figure 7). The earliest of these may be the substantial flagstone floor (5008) associated with a set of two stone steps (5007) rising to the north of the floor. The upper (most northern) of these has been cut through on the north by later steps descending into the cellar (5009).

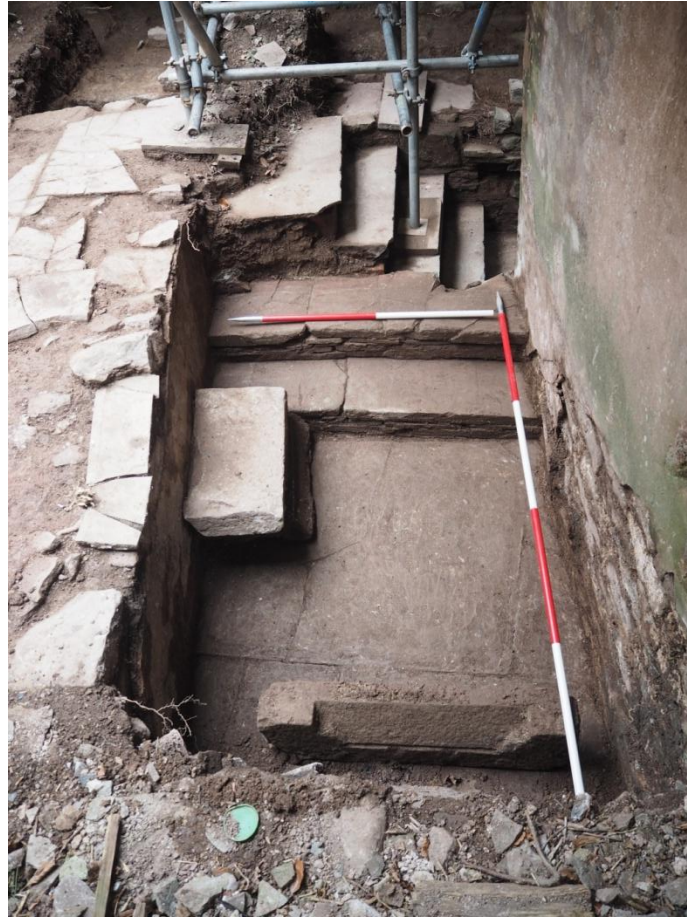
- 7.3.4 The sunken lower area, “cupboard under the stairs”, is defined on the west side by a low wall (5004) which is plastered on the eastern internal side. It stands a maximum of 0.78m high above the flag stone floor level. A wall of similar construction, a possible return of 5004, was revealed to the north running east to west (5006) this consists of only three courses of regular walling set on three or four courses of foundations which in turn sit on earlier demolition / collapse rubble (4004). These are likely to be sleeper walls for the former staircase and partitions separating the cellar access and the “Study” in the north-east corner from the main hall area, these are shown in the 1914 Country Life photograph (figure 8).

Figure 8: TP5 showing wall 5005 on the left, flagstone floor and steps 5008 and 5007, the scales are 2m and 1m

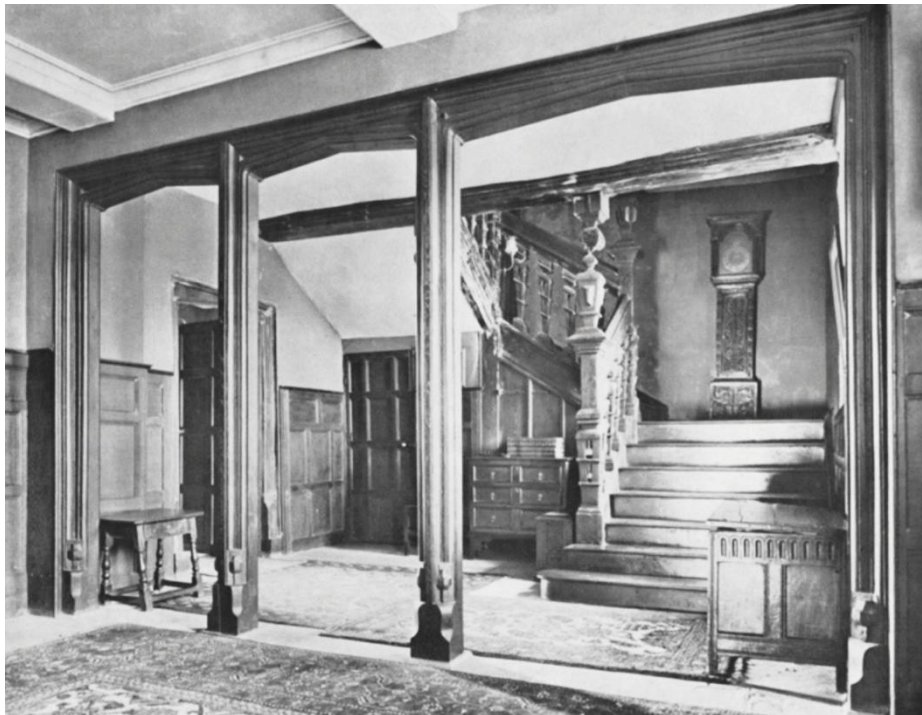
Figure 9: Jacobean staircase and adjacent partitions, these are probably supported by the walls in TP5

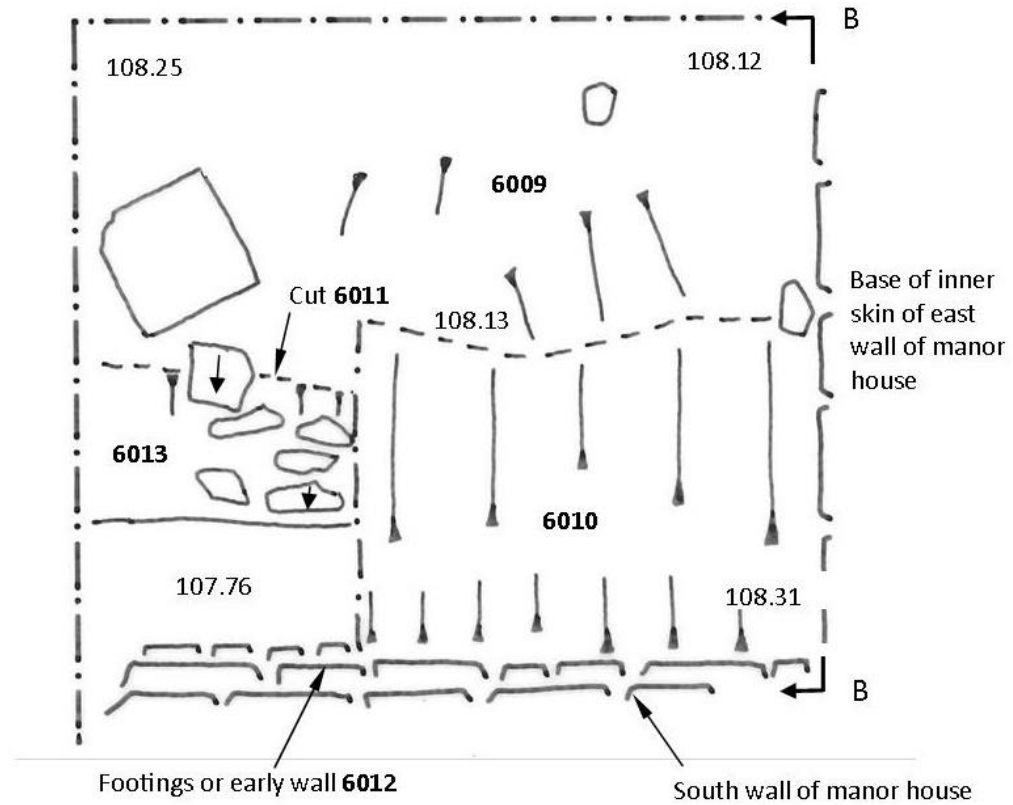
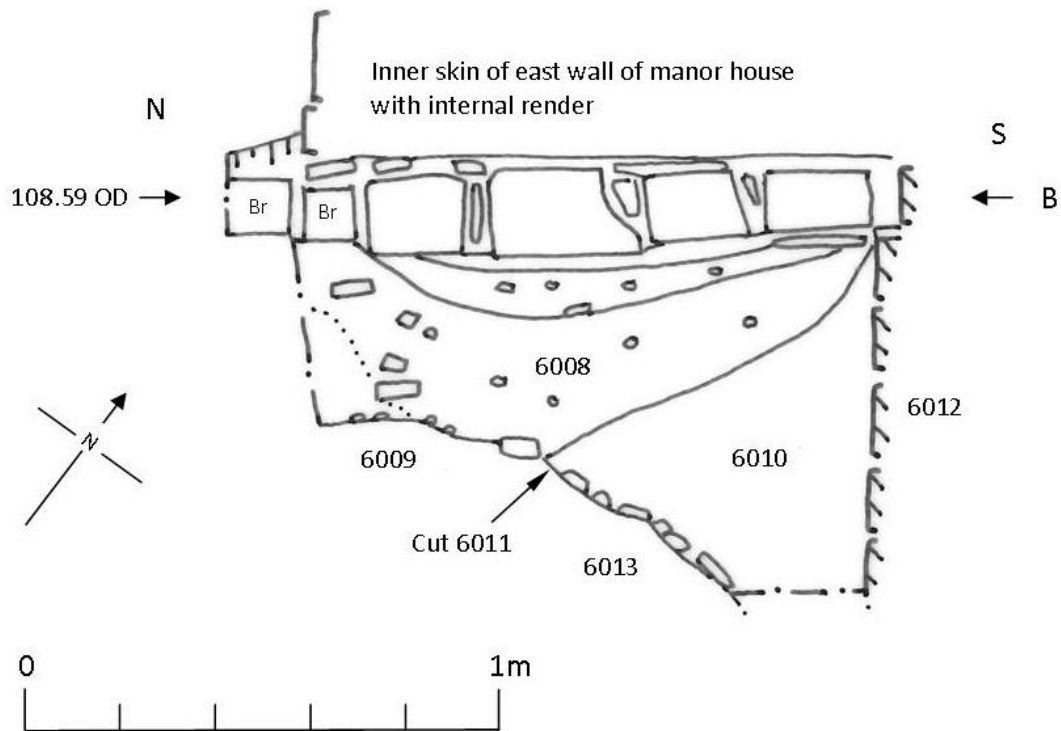
- 7.4.2 The earliest deposit recorded, some 0.50m below current floor levels, was a densely packed layer of sub-angular sandstone rubble in a matrix of firm clay (6013). This was overlain by a semi cemented compact layer of fine gravel and sand (6009). Context 6013 was cut into by the foundation trench for the southern wall of the manor house however it is not clear if 6009 was also cut by the trench or simply faded out (the relationship was only investigated in the small slot shown in figure 10).

- 7.4.6 The inner side of the east wall at this point is clearly an addition to an existing wall. Its foundations are minimal, consisting of one course of squared sandstone blocks (figure 10, section).

Figure 10: TP6 plan and section, Br = Brick.

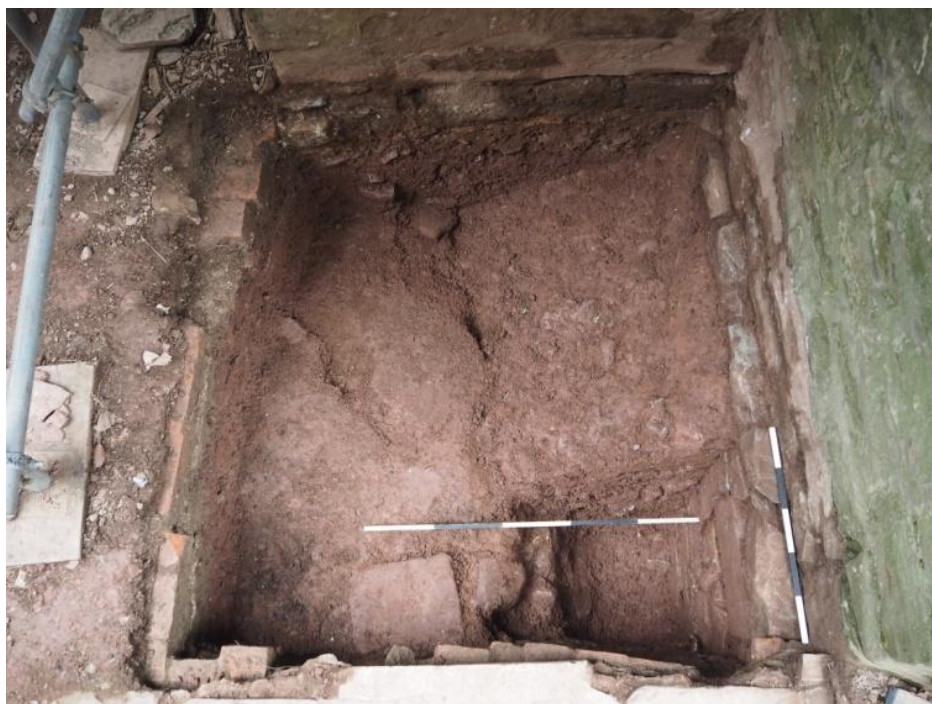
- 7.4.3 There is a possibility that this deposit might represent a construction level or surface and be associated with the erection of the wall 6012. The surface of the deposit sloped significantly towards the trench, suggesting that the trench may have been open at the time of deposition. The character of the foundation wall was good quality faced clay bonded sandstone blocks (figure 12). The quality is better than might be expected for foundations and it is possible that this might be an earlier wall later utilised as a foundation for the southern wall of the Jacobean mansion.

Figure 11: TP6 from the west, context 6009 on the left, the clay fill of the foundation trench 6010 and the underlying rubble deposit 6013 can be seen. Scales are 1m and 0.5m

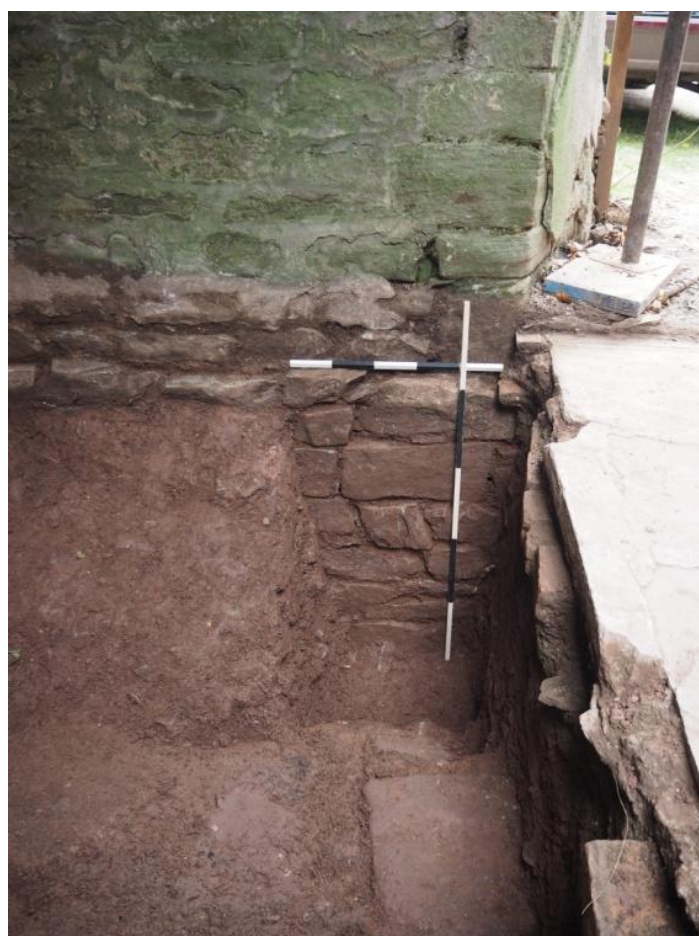
Figure 12: TP6 from the north showing detail of the wall build and the offset wall above. The brick floor can be seen on the right underlying surviving flagstones. Scales are 1m and 0.5m
