# Historic Environment Feature Management Report

## **Clwyd-Powys Archaeological Trust**

**Site name: Nantiago Mine**

**UID: 106946**

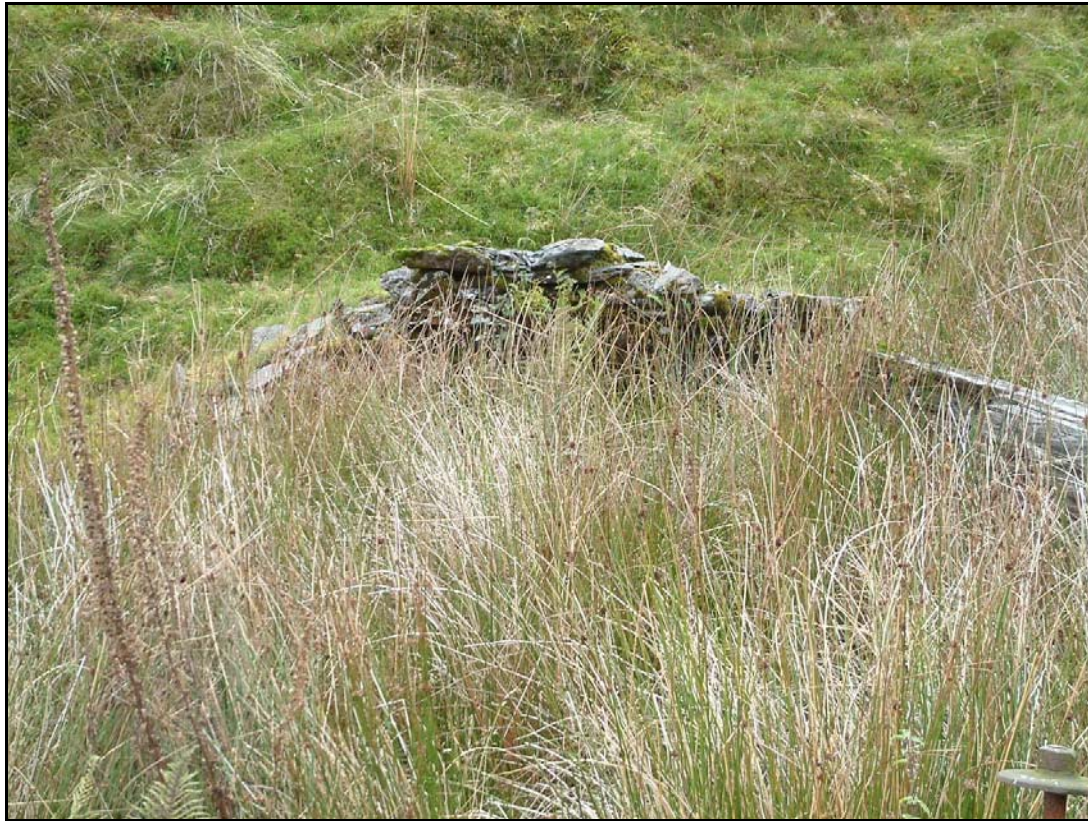
Furthermore, some of the buildings are visibly overgrown with vegetation which can be damaging to both upstanding structural remains and below ground archaeological deposits. The roots of trees and scrub can cause damage to below ground remains, and climbing vegetation can prise apart masonry bonds and dislodge upstanding structures. Unstable or dead trees can be at danger of wind throw or falling limbs, both of which can cause

### **Examples of sites requiring vegetation management**

*Nantiago Mine, concrete structure (NGR SN82498639) © CPAT Image 1519-0045*

1. In the case of buildings where there has been partial collapse - such as at the Nantiago Mine crusher above (NGR SN82678608), consolidate the standing remains by removing any unstable materials away from the upstanding walling. Consult with the Clwyd Powys Archaeological Trust in advance of any consolidation work.
2. Remove any scrub, saplings and intrusive vegetation that is growing directly on, in or immediately surrounding any of the mining remains in order to retain the visibility of the building ruins and earthwork remains. Remove by hand cutting to ground level, allowing the roots to rot in situ, managing any subsequent woody growth if required.
3. Remove any young trees or vegetation growing directly out of, or close to the walls by cutting by hand

4. Remove any overhanging branches and dead or unstable trees that may cause damage to historic features by falling limbs or wind throw. Remove by hand cutting to ground level, allowing the roots to rot in situ.

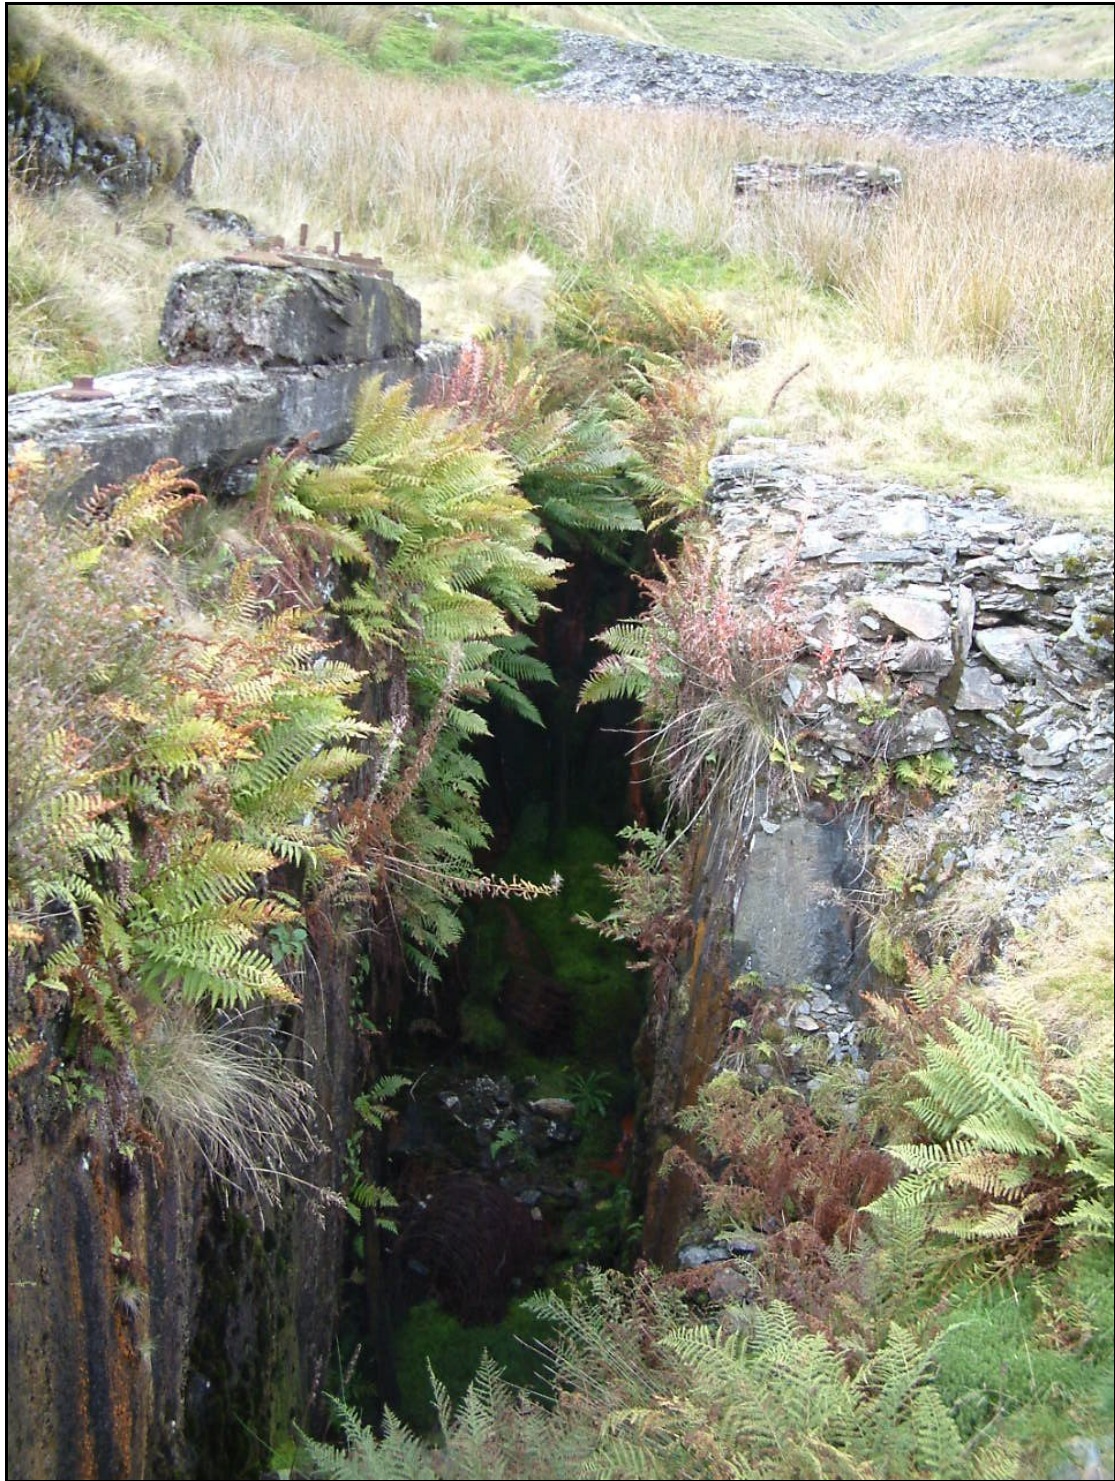
*Nantiago Mine, wheel pit (NGR SN8256286281) © CPAT Image 1519-0058*

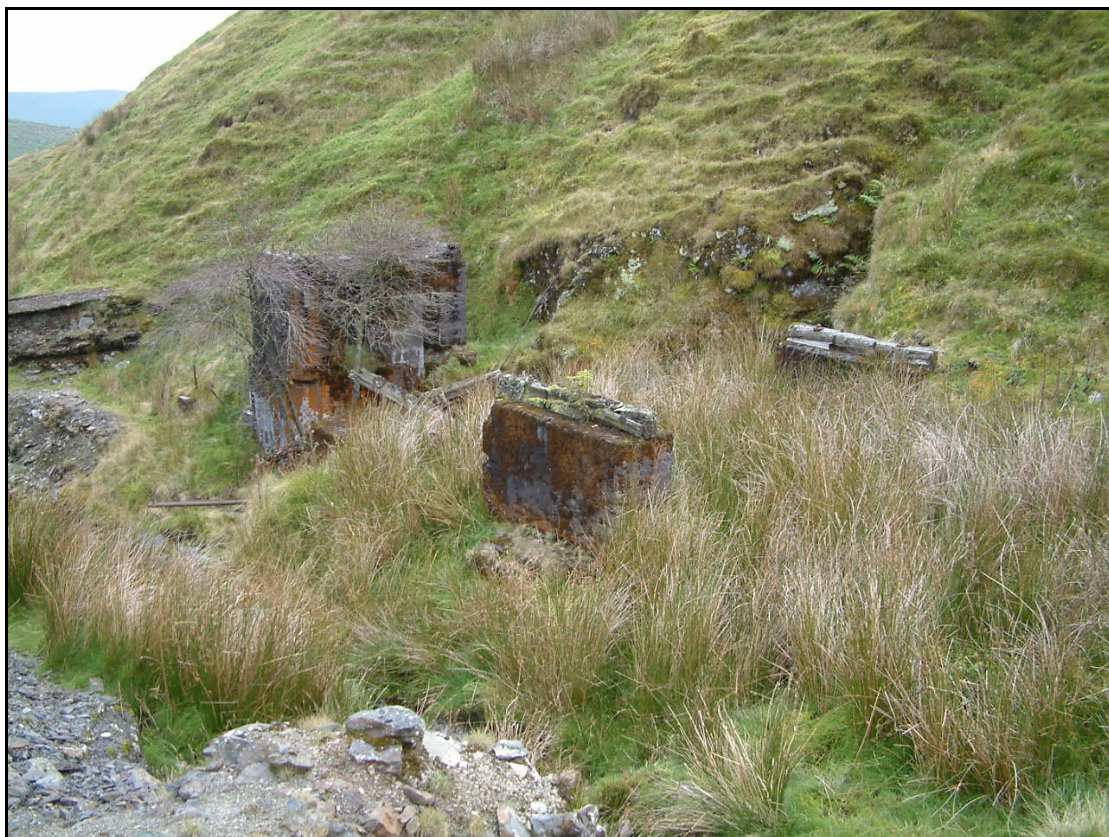
*Nantiago Mine, winding house (NGR SN82488639) © CPAT Image 1519-0046*

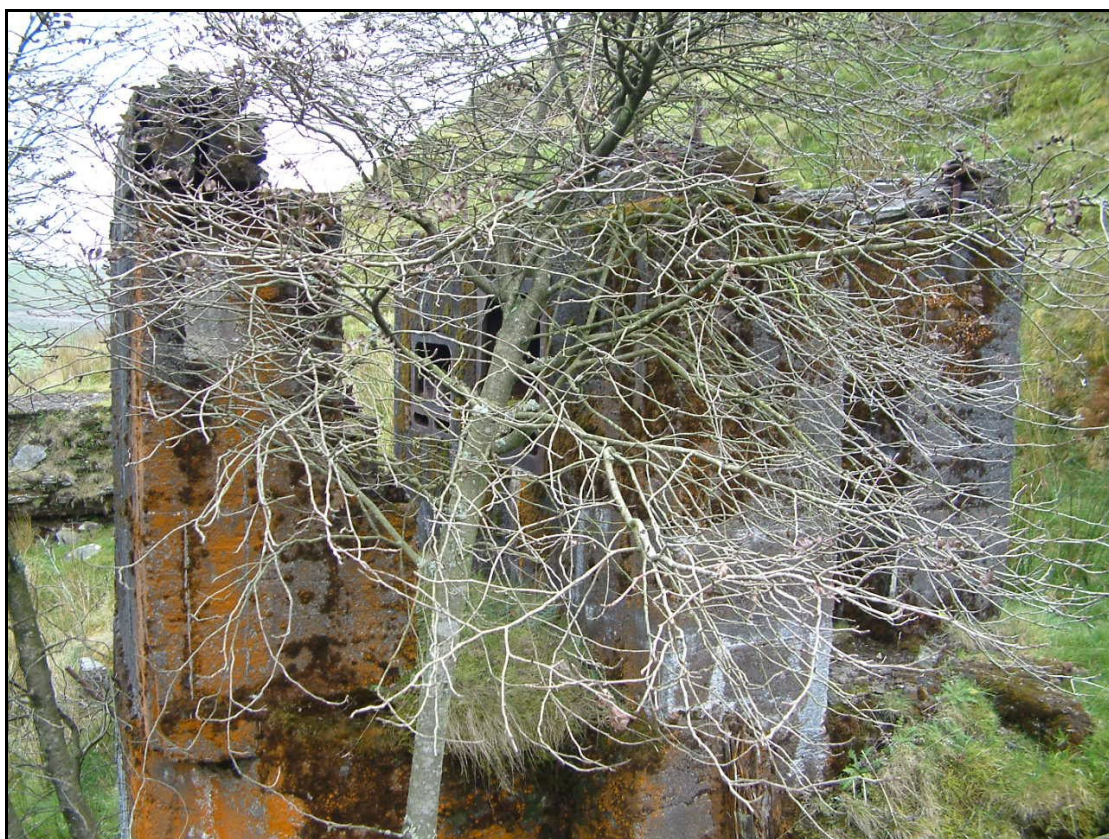
*Nantiago Mine, winding house (NGR SN82488639) © CPAT Image 1519-0051*

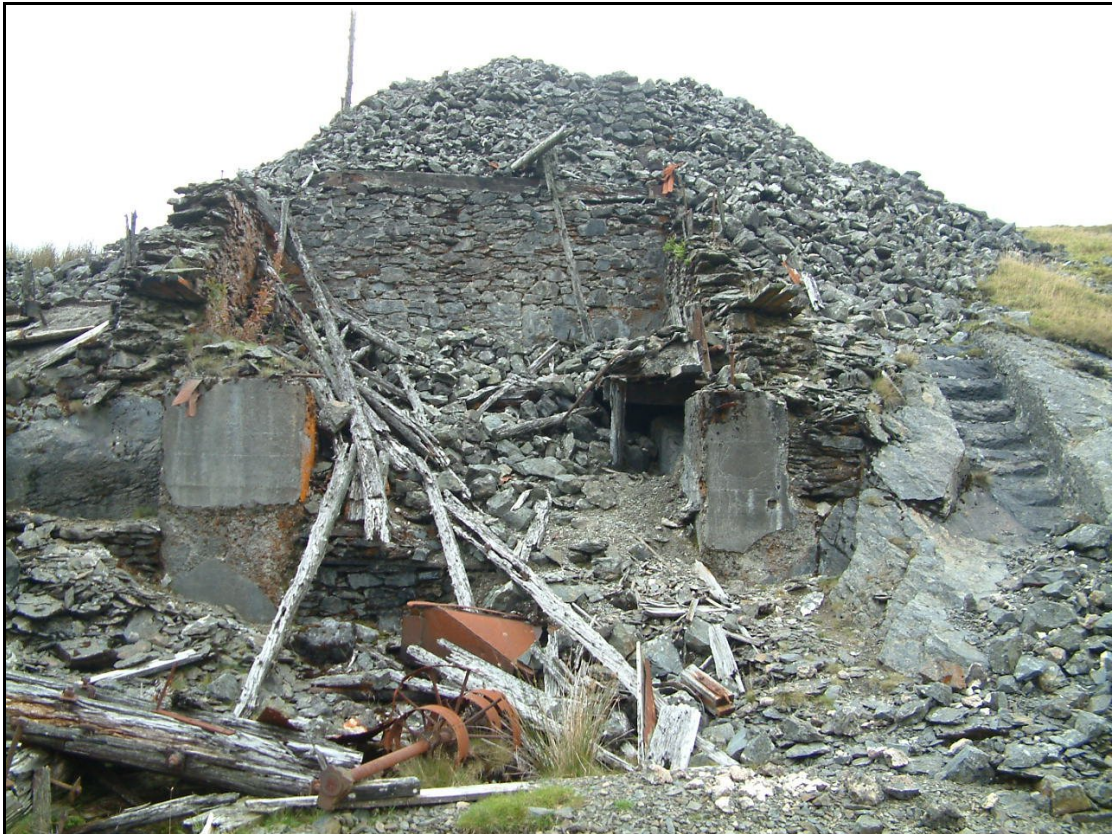
Photographs taken during a site visit in 2003 show that some of the buildings are in need of consolidation - particularly where buildings have partially collapsed. These structures stand a better chance of long term survival if any unstable material is moved away from the upstanding structural remains.

## Examples of sites requiring consolidation

*Nantiago Mine, crusher (NGR SN82678608) © CPAT Image 1519-0080*
