**THE OLD LIFEBOAT STATION  
ANGLE, PEMBS  
PRN 33850**

**AN HISTORICAL SUMMARY AND  
STRUCTURAL DESCRIPTION**

**AUGUST 1997**

Report prepared for Pembrokeshire County Council  
by  
Neil Ludlow

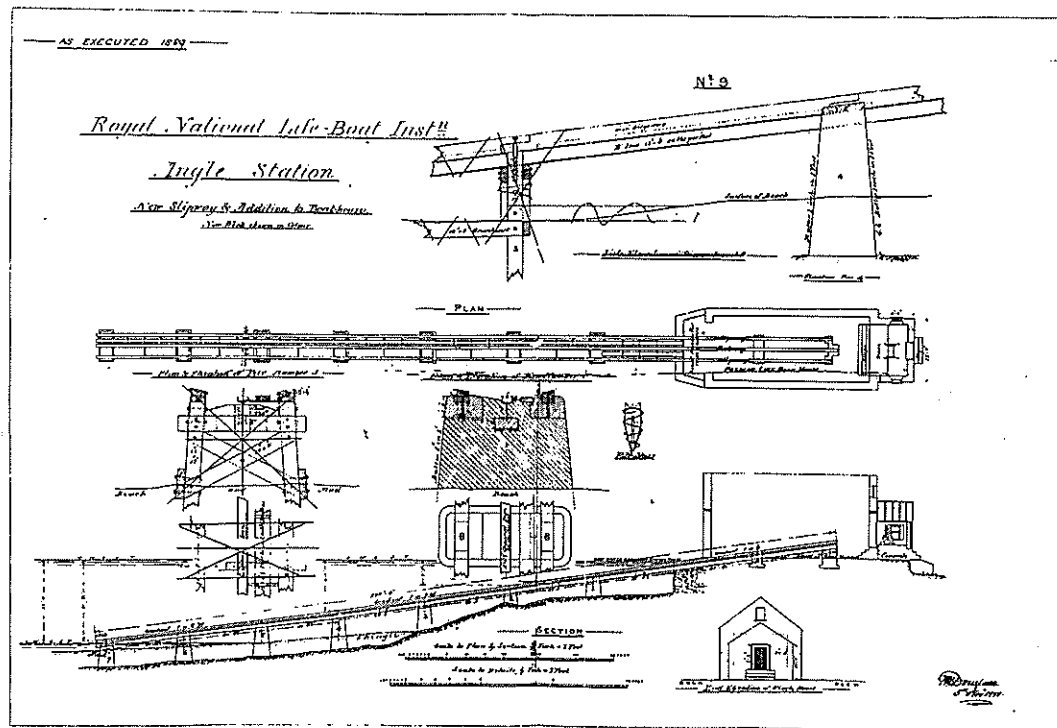
Angle Old Lifeboat Station showing 1889 alterations  
(J Morris, 1889 plan)

The building was, from at least 1889, entered through the south (end) wall and thus via the winch-house annexe (Illus. 1).. Its low gable survives but has been slightly truncated - it never rose much higher than today but the gable of the main body beyond was pierced by a simple square light (Morris, 1889 plan). The wall is fronted by a concrete plinth, 1.94m wide and secondary as it exists today, retained - where the ground surface is uneven - by a wall of large Old Red Sandstone rubble which is probably primary. Part of the plinth has been washed away. The concrete sill of the entry, 1.6m wide, lies 1.1m above plinth level and was reached up a flight of three concrete steps of the same width; both sill and steps are secondary as they exist, and the steps have become detached from the wall. The entry is 2.15m tall with freestone quoins, lying beneath an almost flat-headed outer arch of freestone with a large central voussoir. Beneath the end voussoirs are the sockets for a former external timber lintel. The depressed, segmental rear-arch is of brick. The internal face, and reveals, are rendered as the east and west walls; a large area of render has fallen away from above the door. Horizontal impressions and shallow sockets west of the door, 1.7m up from internal floor level, may represent housings for the runners of a sliding door; there is no evidence, otherwise, as to how the entry was closed.

The centre of the building is occupied by piers for the slipway, both of roughly squared and coursed local Carboniferous Limestone. Both were newly built in 1889 (J Morris, 1889 plan - Illus. 1). The southern of the two measures 1.38m from north-south and 2.5m from east-west and, in plan, forms an 'E' with an offset central bar. It survives to a height of 1m but the masonry blocks for the slipway channels are missing. The northern pier is of similar dimensions but is a plain rectangle in plan. The eastern masonry block for the slipway channel survives, as does a section of the slipway runner itself, a timber 0.28m square. The pier lies 6m north of its partner, with a 0.8m drop.

To the north are two piers, 5.56m apart in a north-south line, newly built in 1889 (J Morris, 1889 plan - Illus. 1). Each is rectangular, measuring 1.34m north-south and 2.58m east-west. Neither stands taller than 0.2m but as built they averaged 1.3m in height, with battered sides (J Morris, 1889 plan). 0.36m to the west of the piers is a channel in the rock shelf, rectangular in section and 0.33m square. It contains iron bolts and may represent a channel for subsidiary runners. A number of further retaining bolts and rings occur in the rock shelf, but follow no discernible pattern.

A further five piers extended northwards, at similar and regular intervals, for a further 60m (J Morris, 1889 plan - Illus. 1). None of these now survive in any form and indeed it appears from the contemporary plan, drawn up for their construction in 1889, that they were all entirely of timber.

The 1889 slipway apparently followed an average gradient of 1 in 7 (J Morris, 1889 plan - Illus. 1) which is consistent with the sill-level on the north wall compared with the summit-level of the surviving southern pier. The slipway comprised a central keelway and two flanking bilgeways, supported on 12" x 6" 'H'-irons (J Morris, 1889 plan - Illus. 1). The bases of two masonry piers survive, but the remaining five piers to seaward appear to have been entirely of timber without masonry plinths. The channel scored into the rock shelf adjacent to the former slipway is regular in profile and appears to have been deliberately excavated as opposed to worn; it may represent a channel for subsidiary slipway runners (not shown on J Morris, 1889 plan).
