ST. BRYNACH'S CHURCH, LLANFYRNACH, PEMBROKESHIRE: ARCHAEOLOGICAL WATCHING BRIEF

RHIF YR ADRODDIAD / REPORT NO 2013/30.
RHIF Y DIGWILLIAD / EVENT RECORD NO. 105558

Ebrill 2013
April 2013

Andrew Shobbrook

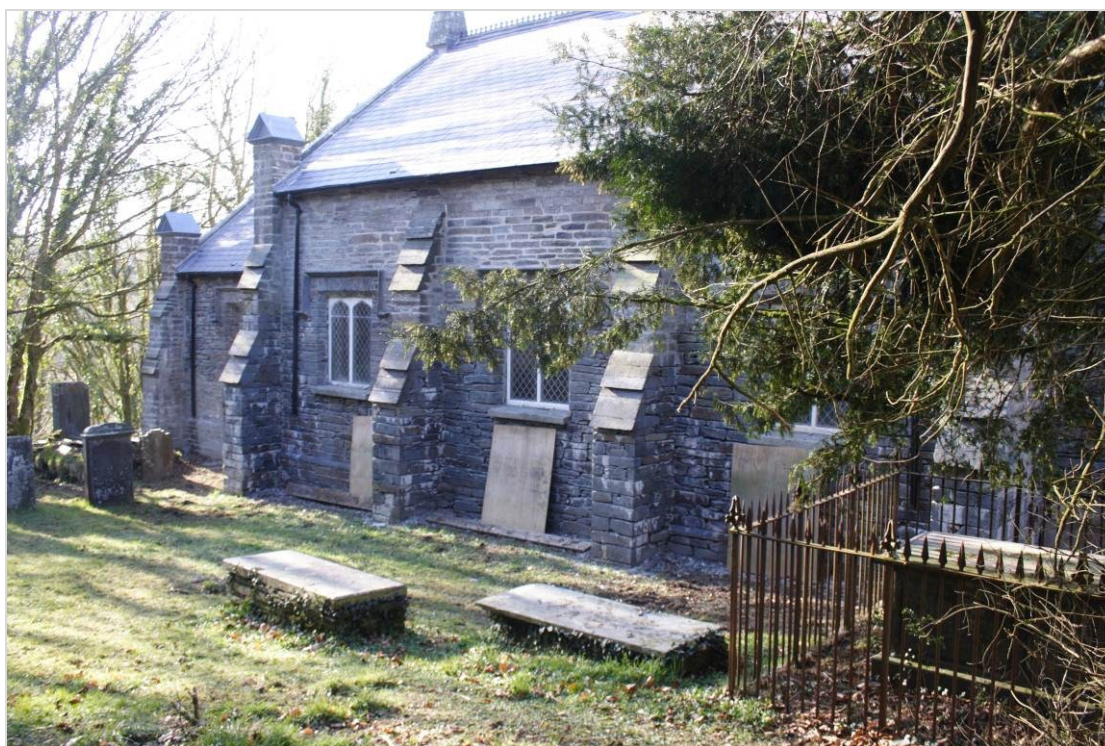
Photo 1: A view of the north facing side of the church before the excavation of the trench for Drain 1

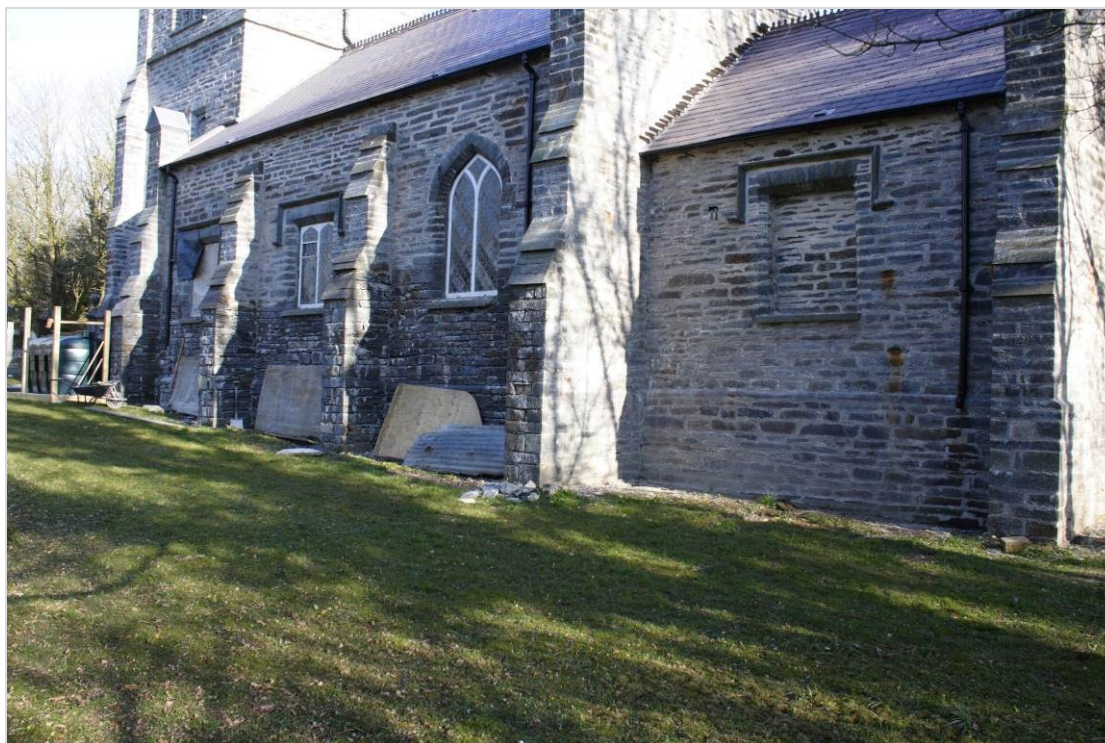
Photo 2: A view of the south facing side of the church before the excavation of the trench for Drain 2

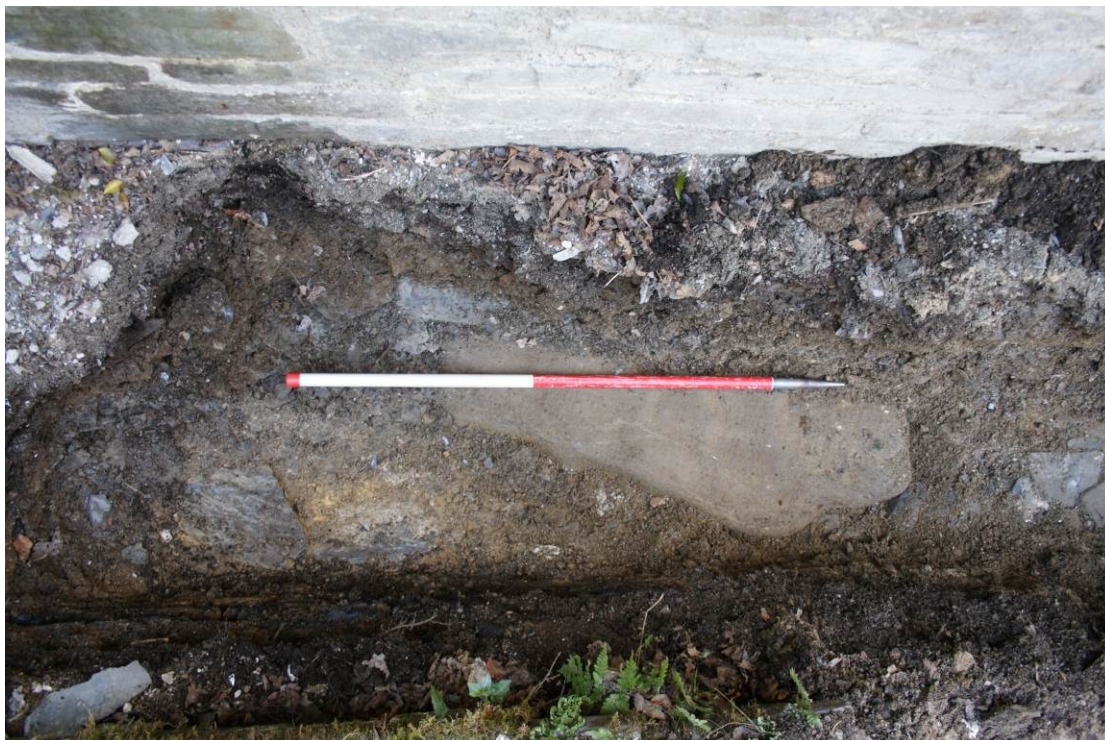
- 3.8 Near the north-eastern buttress of the church chancel (Figure 3, Photos 3-6) a large stone slab was uncovered. Initially it was thought that it might indicate a burial as the slab was lying on an east-west alignment; the alignment along which early Christian burials were normally placed and the stone slab could have been the capstone covering a grave beneath. Almost certainly it forms part of the mixed deposits together with the deposit of broken slate that lies below it [1008] that lie either side of the chancel building; a result of the rebuilding of the church in 1842.

Photo 3: Vertical view of stone slab [1007] in the trench for Drain 1

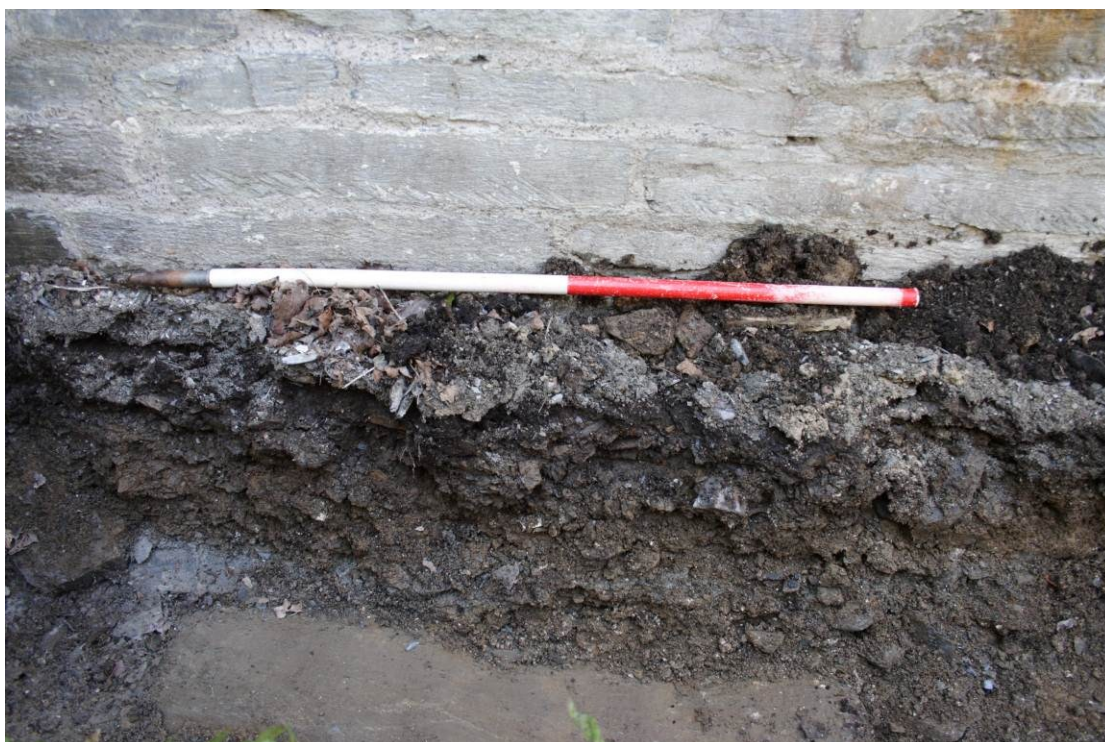
Photo 4: North facing section view of deposits [1006] overlying stone slab[1007]

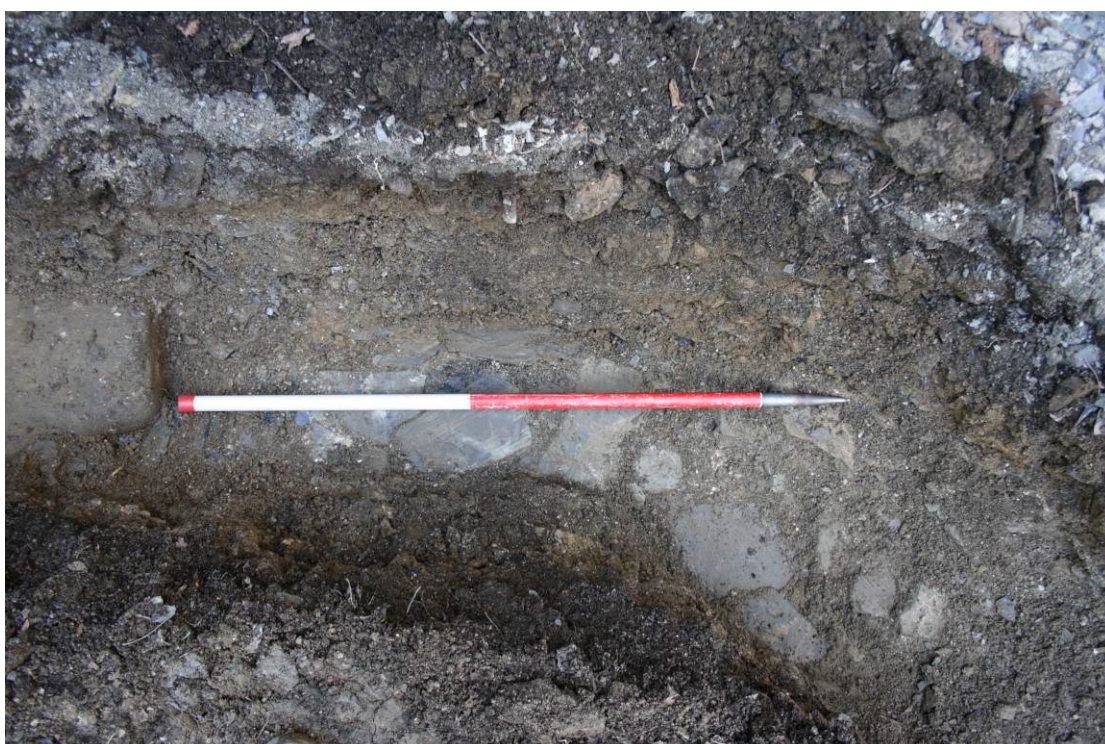
Photo 5: View of western end of stone slab[1007] and the fragmented slate deposit [1008] that appears to lie underneath it

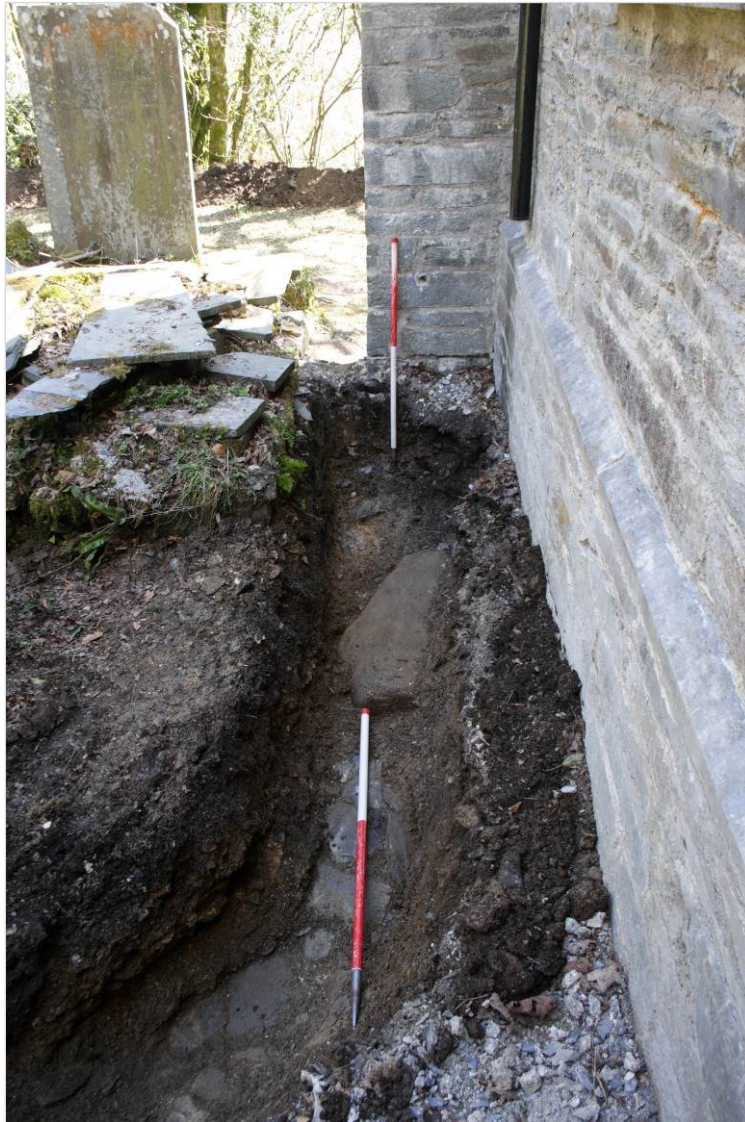
Photo 6: View looking east of stone slab [1007] and fragmented slate deposit [1008] in foreground

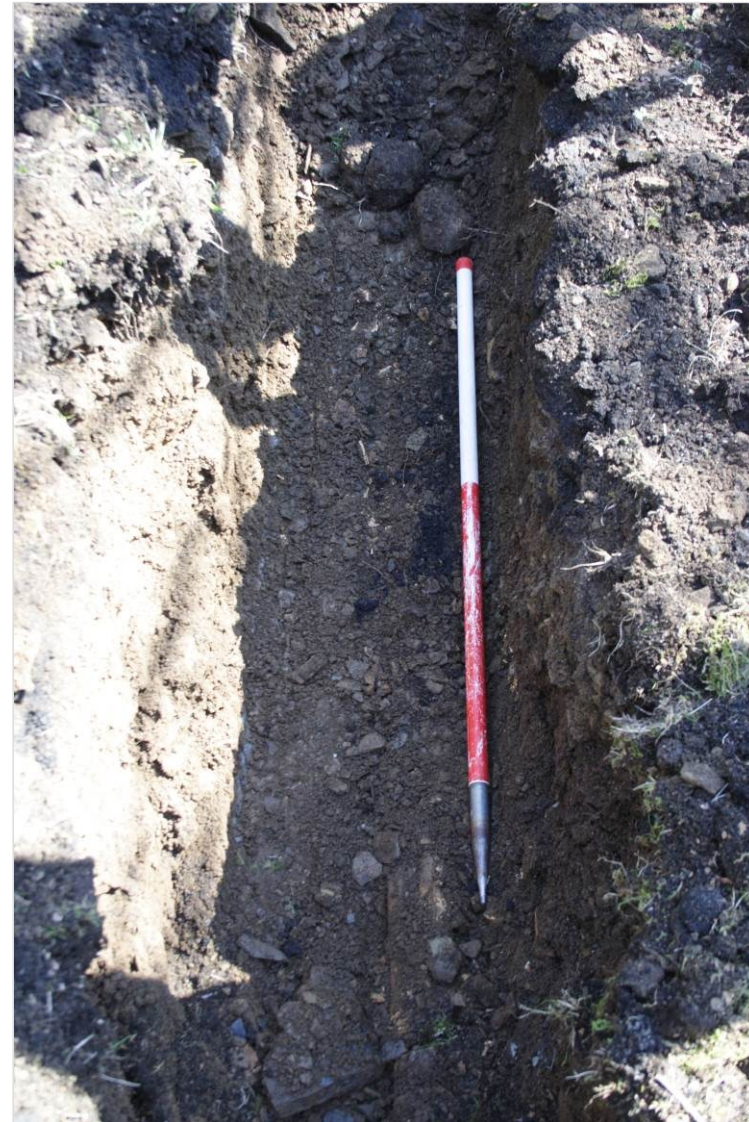
Photo 7: View looking east of inhumation burial [1002] found at the eastern end of Drain 1. The exposed bones are visible as lighter flecks within the surrounding soil

- 3.9 The inhumation burial [1002] was found during the excavation at the eastern end of the trench for Drain 1 (Figure 3, Photos 7-8). The top of the burial was first observed at 0.48m below present ground level and appeared to be placed on an east-west alignment.
- 3.10 No grave cut for this burial was evident within the sections of the trench or in plan. Once the grave was identified as an *in situ* burial the depth of the trench was reduced thereby preserving the remains contained within the grave and not disturbing the grave any further. The date of the burial is unknown as no dateable artefacts were visible within the exposed grave. The skeletons mid-section appeared to be located at right angles to the present line of the north-south aligned upstanding headstones suggesting that this unmarked burial [1002] is older than the marked graves visible today above ground.

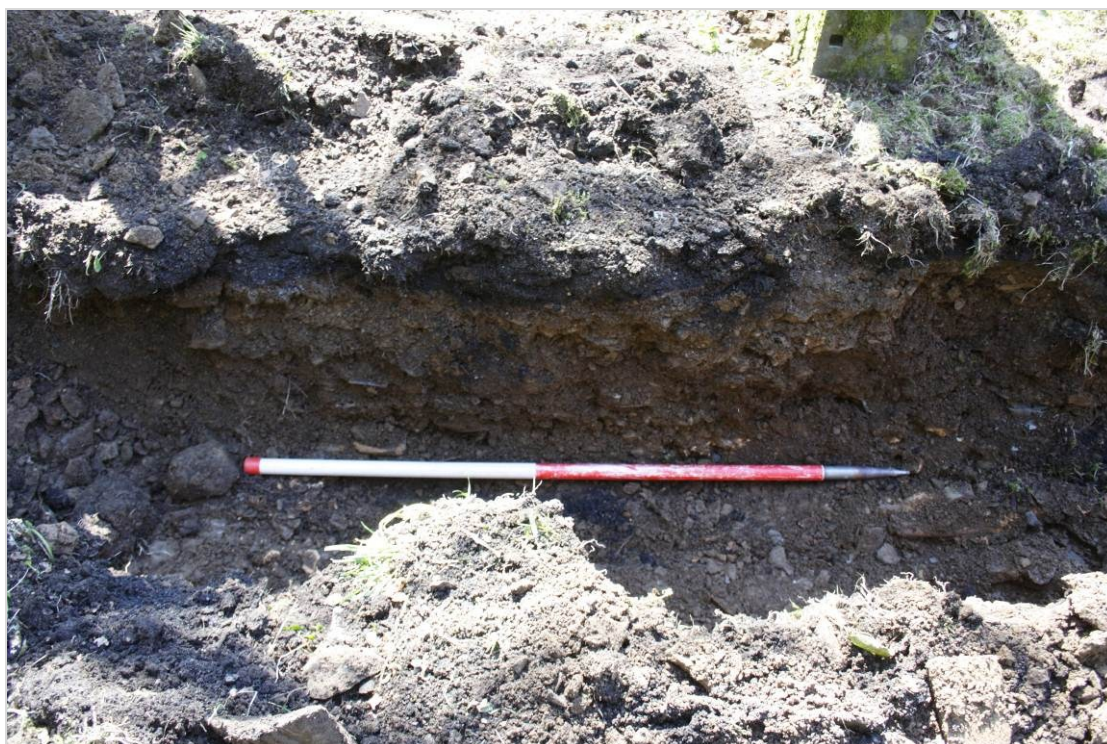
Photo 8: View looking south of burial [1002] found at the eastern end of the trench for Drain 1

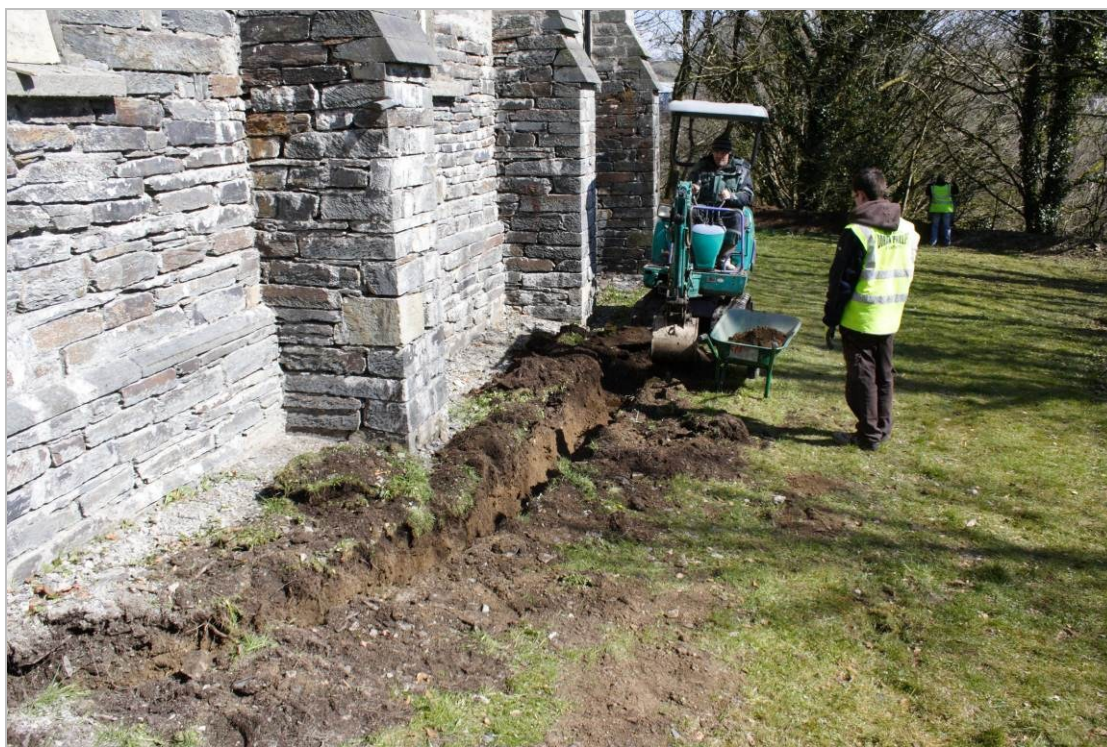
Photo 9: Working shot of the excavation for Drain 2 on the southern side of the church

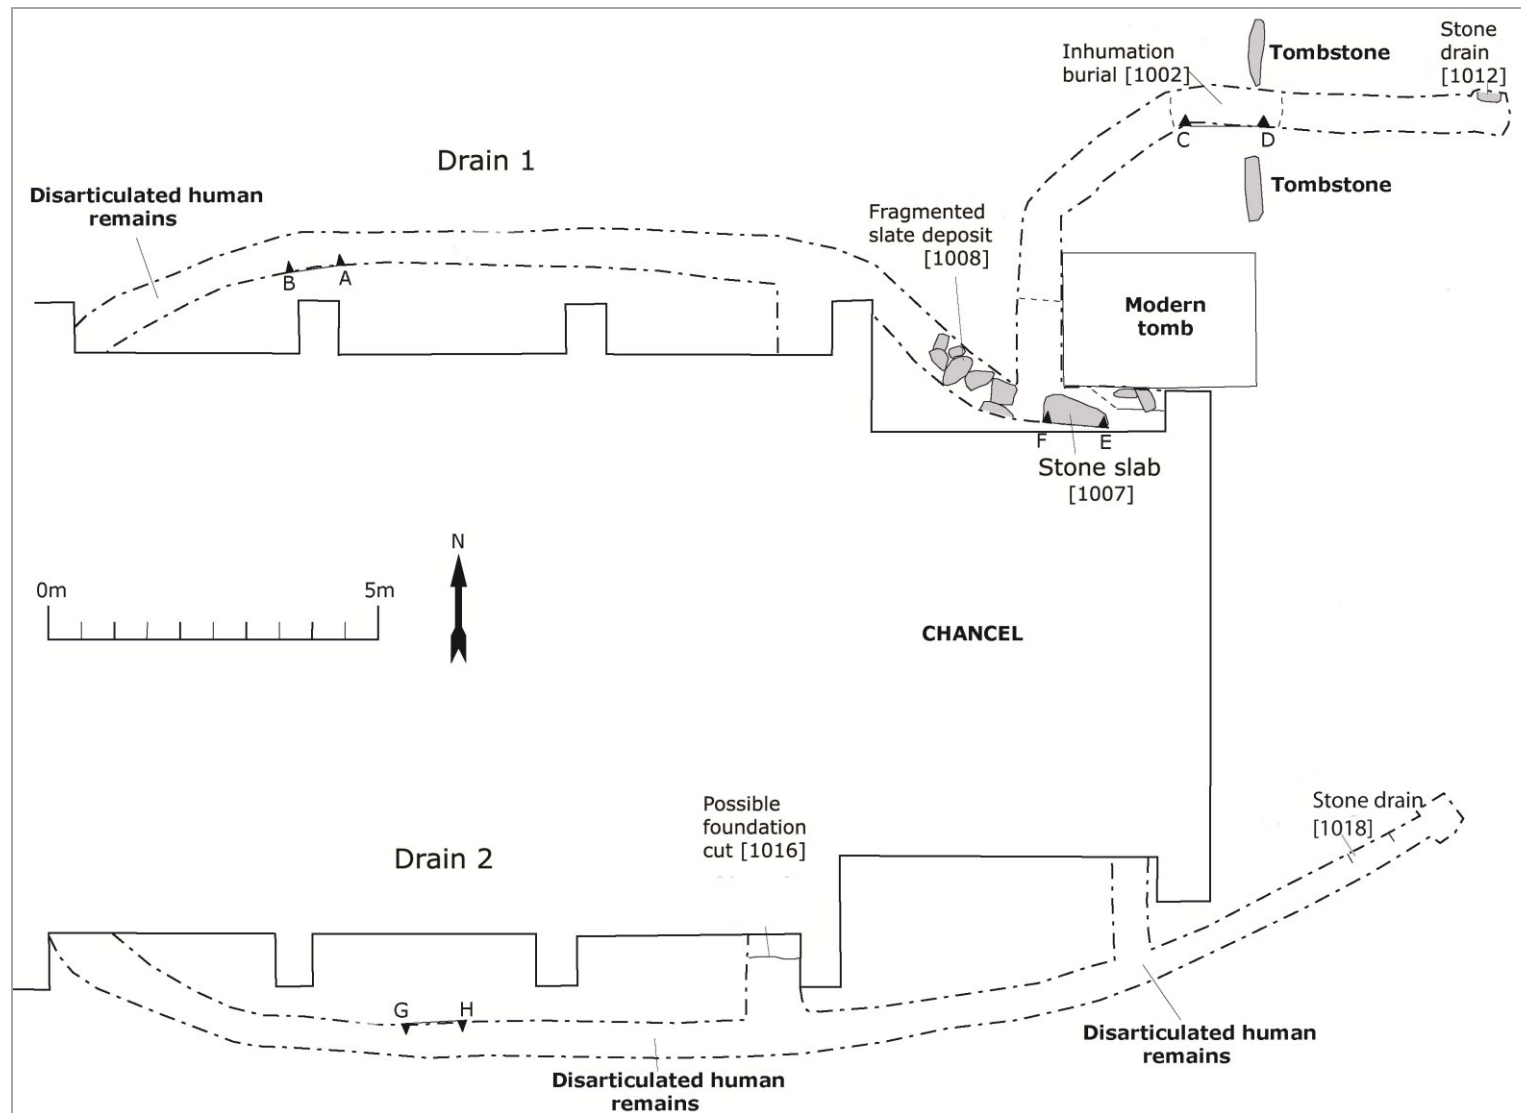
Figure 3: Plan of the two trenches excavated for Drains 1 & 2 and the location of archaeological features described in the text

- 3.11 During the excavation of the soak away located at the eastern end of Drain 1 evidence of a stone drain was observed [1012] (Figure 3). The stones appeared to be randomly positioned and upon further investigation it was concluded that the feature was probably part of a stone drain of unknown date.

- 3.13 A possible foundation cut [1016] associated with the present Victorian church building was observed near the south-eastern facing buttress of the chancel (Figure 3). The foundation cut had a width of 0.38m and contained one visible fill [1017]; a blackish grey clay containing frequent small sub angular slates.

- 3.14 Whilst excavating the soak away for Drain 2 a second stone drain [1018] was encountered at the eastern end of the trench which was similar in construction to that discovered at the eastern end of Drain 1 (Figure 3).

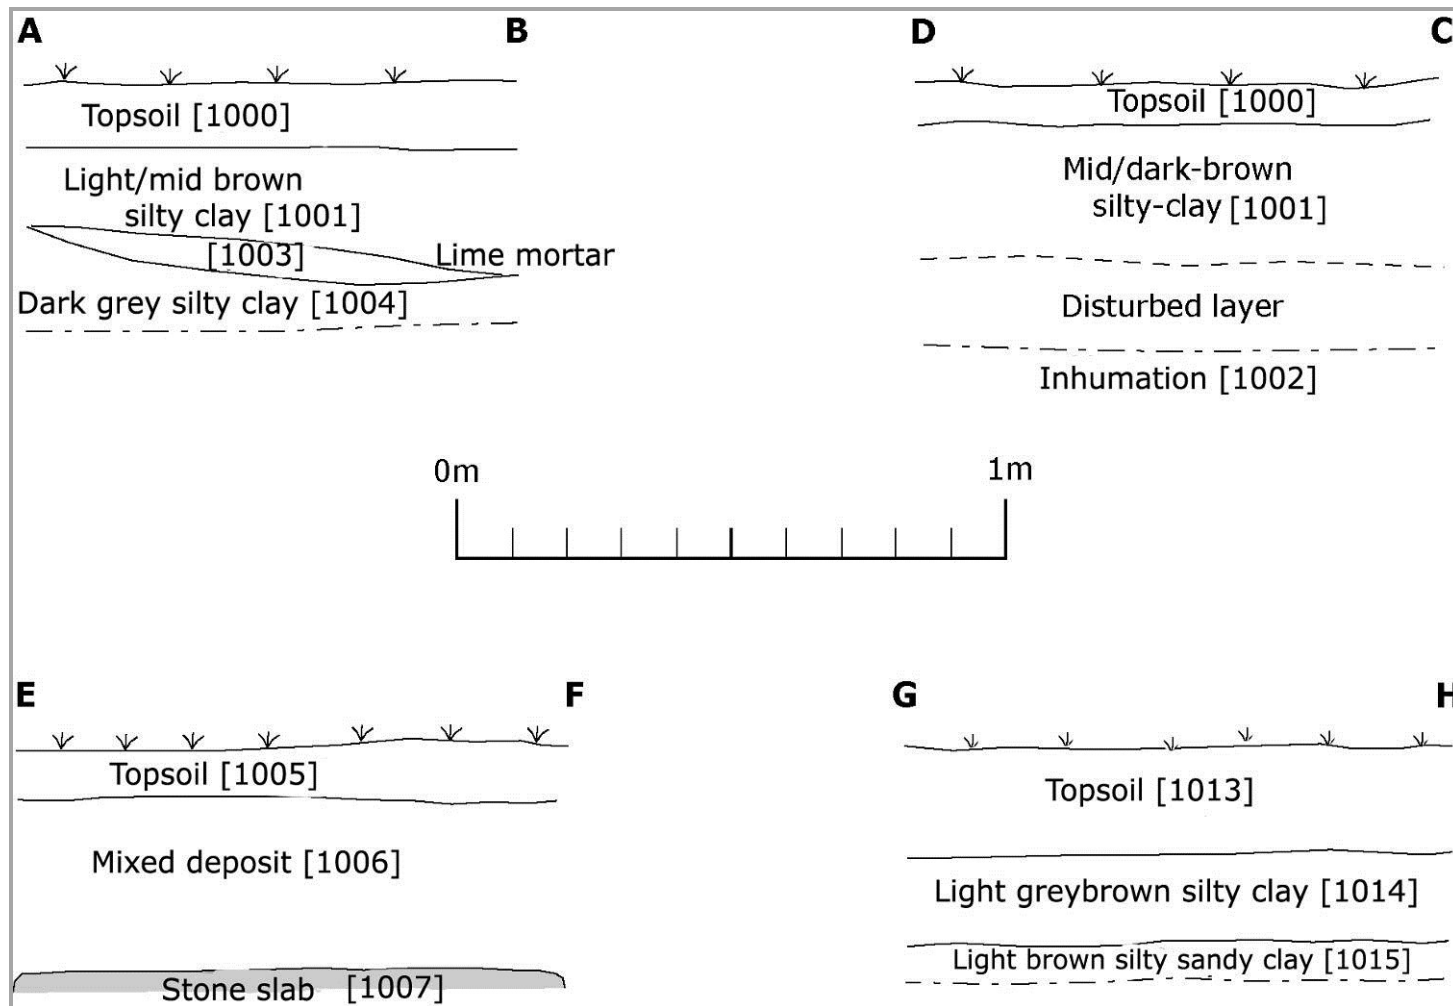
Figure 4: Sections recorded in the trenches excavated for Drains 1 & 2. Their locations are marked on Figure 3

- 3.6 The remains of a white mortar mixing pad [1003] were observed within the north facing section of Drain 1 at its western end (Figure 4) between the mixed deposits [1001] and [1004]. The plinth measured roughly 1.0m wide by 0.07m deep and was almost entirely composed of lime mortar. This feature probably relates to a renovation phase undertaken during the church history.
