ST. CYNLLO'S CHURCH, CEREDIGION: ARCHAEOLOGICAL WATCHING BRIEF (NGR SN 35218 43940)

Prepared by Dyfed Archaeological Trust
For: Ceredigion County Council

RHIF YR ADRODDIAD / REPORT NO 2013/63
RHIF Y DIGWILLIAD / EVENT RECORD NO 105808

ST. CYNLLO'S CHURCH, LLANGYNLLO, CEREDIGION DRAINAGE IMPROVEMENT WORKS: ARCHAEOLOGICAL WATCHING BRIEF

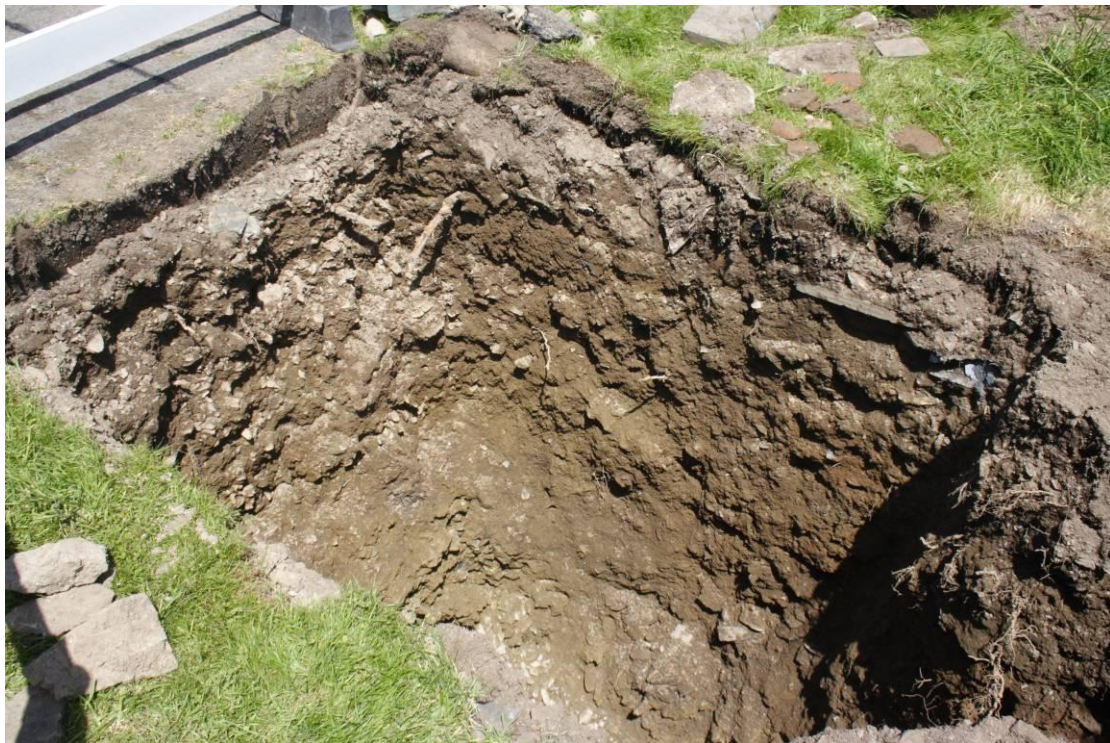
- 3.2.1 A pit measuring 2.5m in depth, 2.3m in length by 1.8m wide was excavated to accommodate an inspection chamber forming part of the new drainage system. The inspection chamber was located within the boundary of the churchyard and was excavated to the south of the path running through the churchyard. Due to the depth of the excavation access to the confines of the trench was limited to the first 1.2m after which no further access could be gained on health and safety grounds.

- 3.2.2 Observation of the sections of the inspection chamber pit indicated that the main deposit present comprised a dark brown silty clay (1001) which contained frequent fragments of mortar along with fragmentary clay fired roofing tile and discarded building stone. A single piece of probable human pelvis was seen from (1001). A natural soil consisting of consist of a light yellowish silty clay which contained inclusions of frequent small sub angular stone (1002) was encountered at a depth of 1.4m below present ground level. This suggests that this area of the churchyard had been potentially landscaped, and that the discarded building stone within (1001) probably represents debris associated with the rebuilding of the church between 1868-70.

Photo 1: Northwest view of excavated inspection chamber.

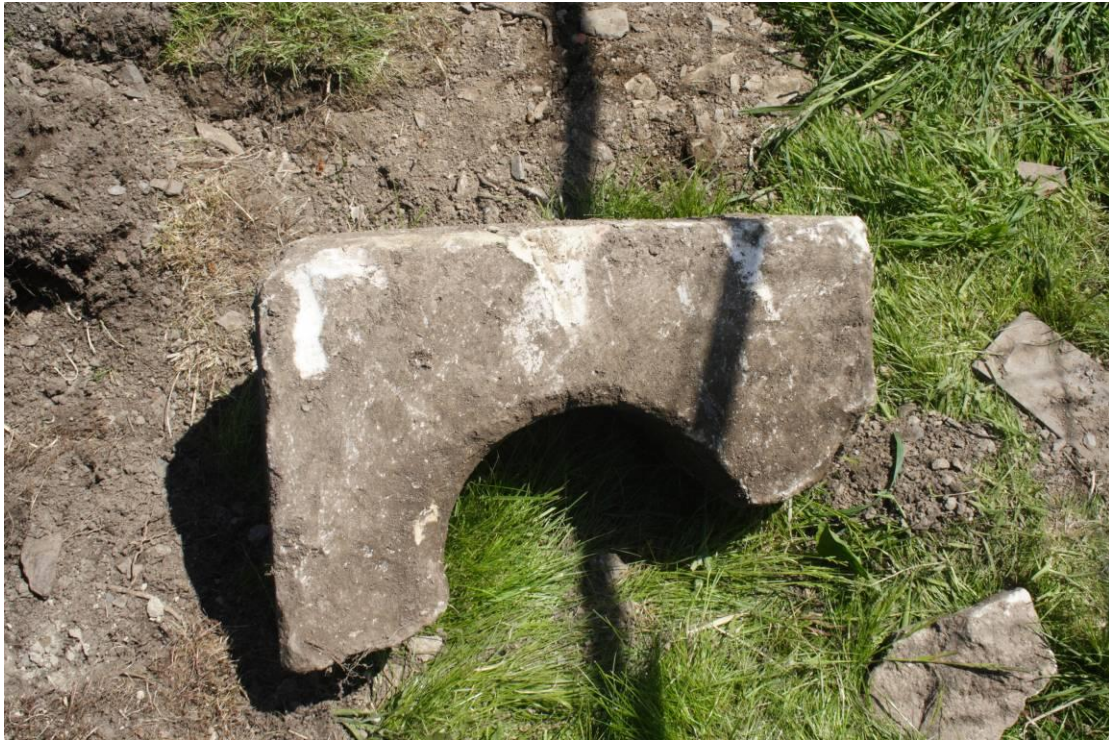
Photo 2: Semi circular chamfered window head recovered from (1001)

- 3.2.3 A single piece of dressed stonework was also recovered from (1001). This was a semi-circular chamfered window head (0.56m x 0.36m) (Photo 2).

- 4.1.2 A sandstone window head which was discovered during the excavation of the inspection chamber pit. From its shape and style it is likely that it dates to the 12th century or earlier. As stone buildings would have only been present Such windows would have and would have belonged to a church building which would pre-date the present standing building. Due to the condition of the sandstone showing little or no erosion caused by weathering it is possible that the block may have been used as an internal feature within the fabric of an earlier church (Richard Suggett, pers. comm.). It is likely that this window was removed during 19th century rebuilding of the church.

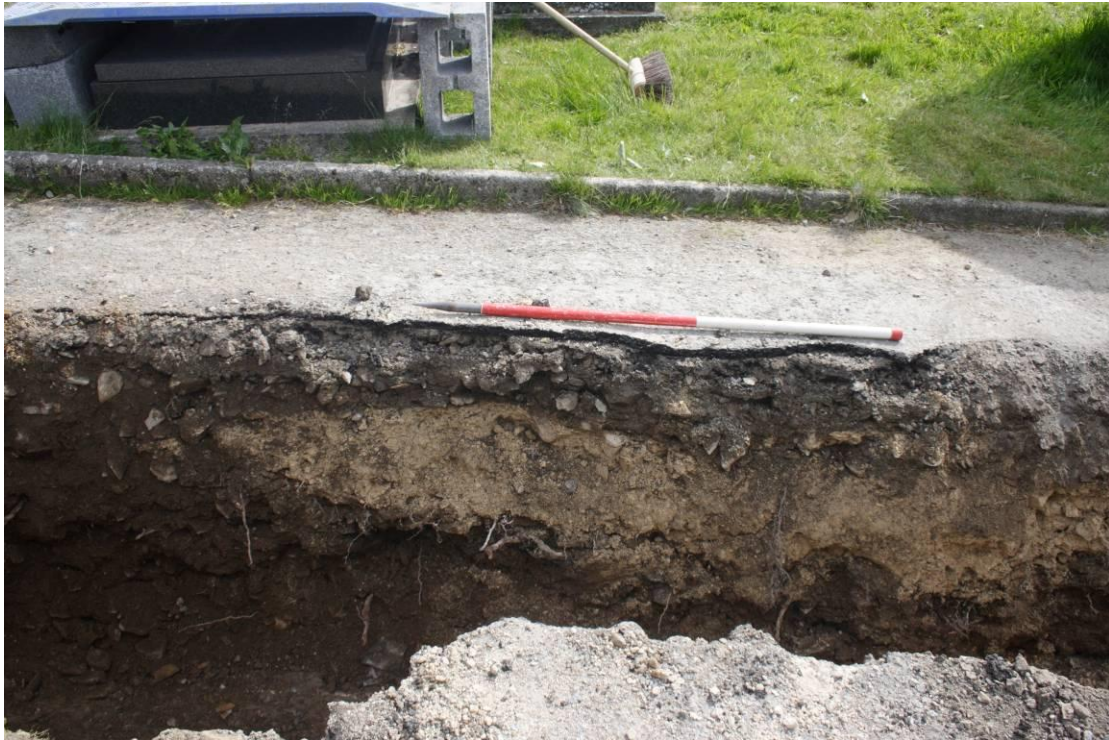
- 3.3.1 The new drainage pipe trench was designed to connect to an existing drain located within the northern gateway of the churchyard. The excavation of the trench commenced within the southern area of the scheme next to the inspection chamber (see above). The trench measured a total length of 47m by 0.8m in width and was excavated to a maximum depth of 1.20m.
- 3.3.2 The current churchyard path consisted of a 0.04m thick layer of tarmacadam. Underlying the tarmacadam a 0.10m thick gravel formation layer was revealed (1004).
- 3.3.3 During initial machining at the southern end of the trench a spread of fine lime mortar (1005) was revealed, which was a maximum of 0.38m in depth. This spread continued beyond both sides of the trench. The mortar spread continued for 4.7m northwards and lay immediately below gravel layer (1004) (photo 3).

Photo 3: Mortar spread (1005) within west facing section of pipe trench.

- 4.1.3 The mortar spread recorded around the church within the excavated areas is likely to be associated with the 1868-70 church rebuilding. It would appear to represent waste or unused lime mortar used as levelling after the rebuild.

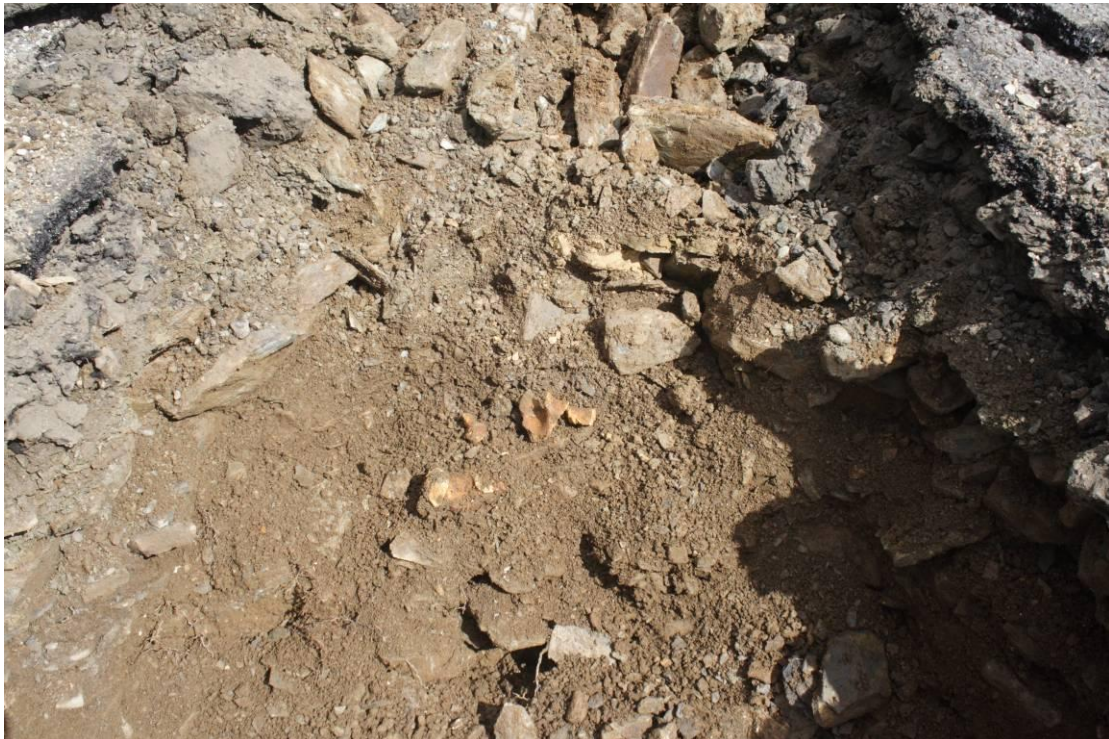
- 3.3.4 Lime mortar layer (1005) overlay a dark brown silty clay layer (1006), 0.22m in depth at its thickest part, tapering to the north. This was a made ground layer containing frequent inclusions of small flecks of mortar and building demolition. Disarticulated human remains were present within this layer, recorded at around 11m from the southern end of the trench. One vertebrae was identifiable along with part of a fibula, as well as other unidentified fragments (Photo 4).

Photo 4: Disarticulated human remains revealed in pipe trench.

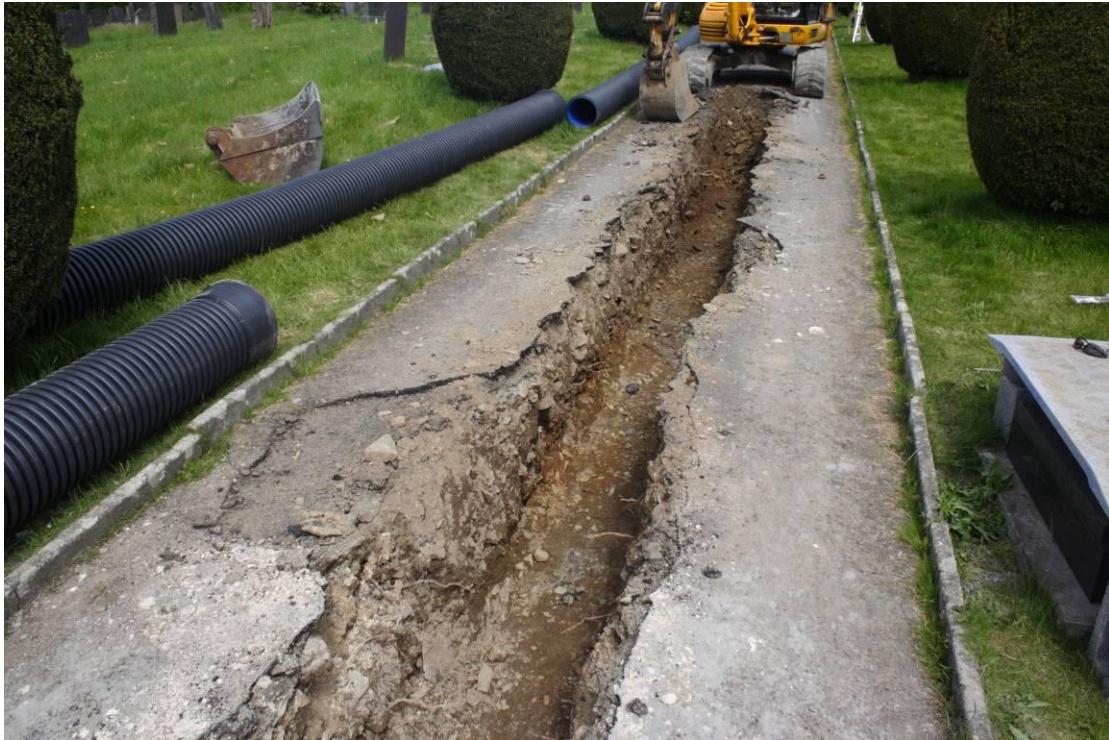
Photo 5: North view along pipe trench showing natural subsoil (1002)/(1007)

- 3.3.5 At 7.4m from the southern end of the trench the natural subsoil (1002)/(1007) was revealed at the base of the trench, 0.60m below the ground surface (Photo 5). This comprised a light orangey brown silty clay containing frequent inclusions of small sub angular stone. The natural was the same as that seen within the inspection chamber area.

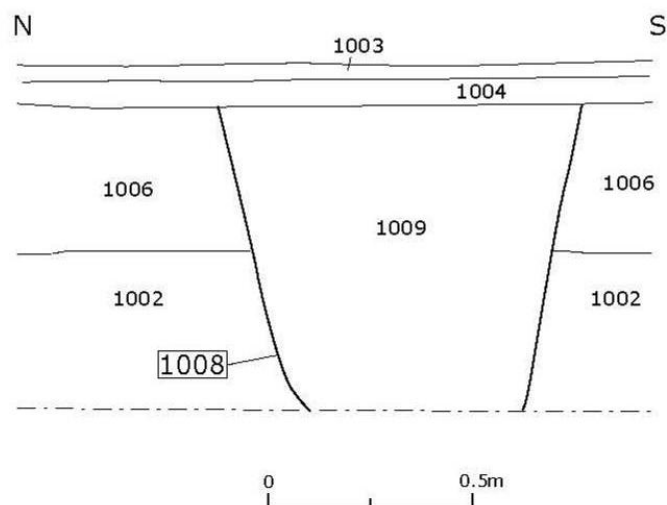
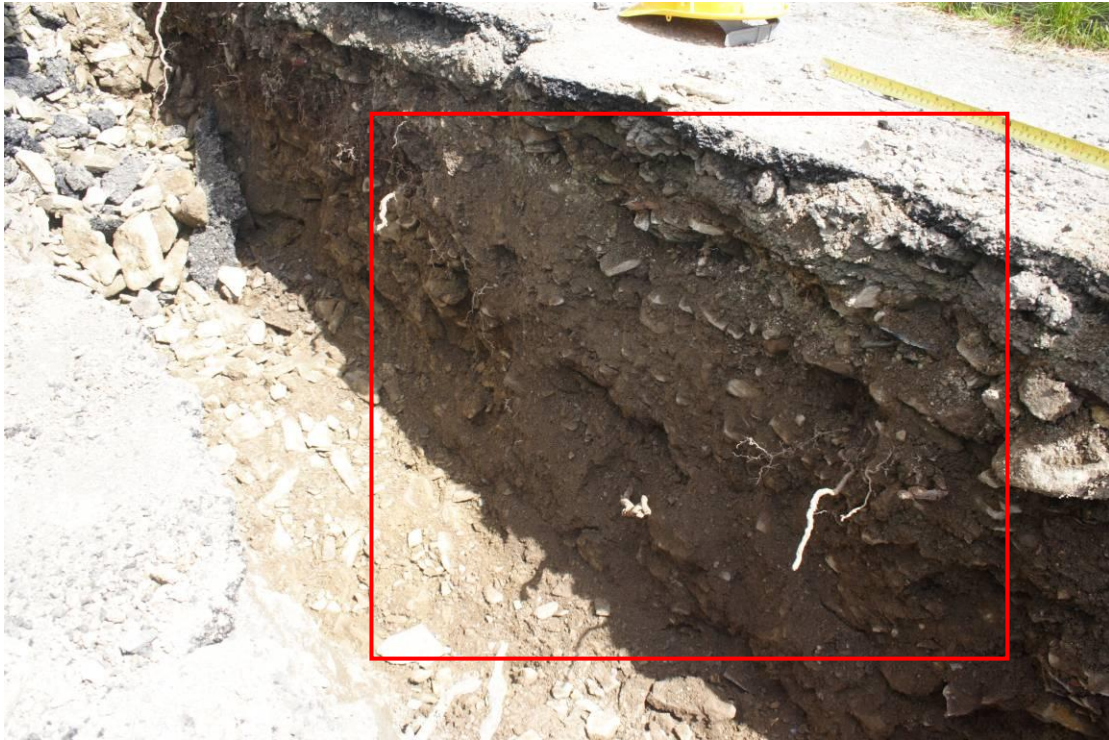
- 3.3.7 A grave cut [1008] (Photo 6 and Figure 5) was revealed around 14m from the southern end of the trench, which projected beyond both edges of the trench (Photo 6). Articulated human bones were just visible at the base of the west side of the trench and were not disturbed by the excavation works (Photo 6), the burial presumably lying just below the trench base. The grave cut through layers (1002) and (1006) but was overlain by the gravel layer (1004). The visible area of the grave measured 0.82m in width x 0.60m in depth. The grave fill consisted of a mid to dark brown silty clay (1009) containing frequent inclusions of small sub angular stone.

Figure 5: West facing section of grave cut [1008]

Photo 6: West facing section containing grave cut [1008]

- 4.1.4 An undated grave cut was recorded in the main drainage trench. It is expected that many more grave cuts would have been present within the trench, but were not identified within the confines of the excavated area.

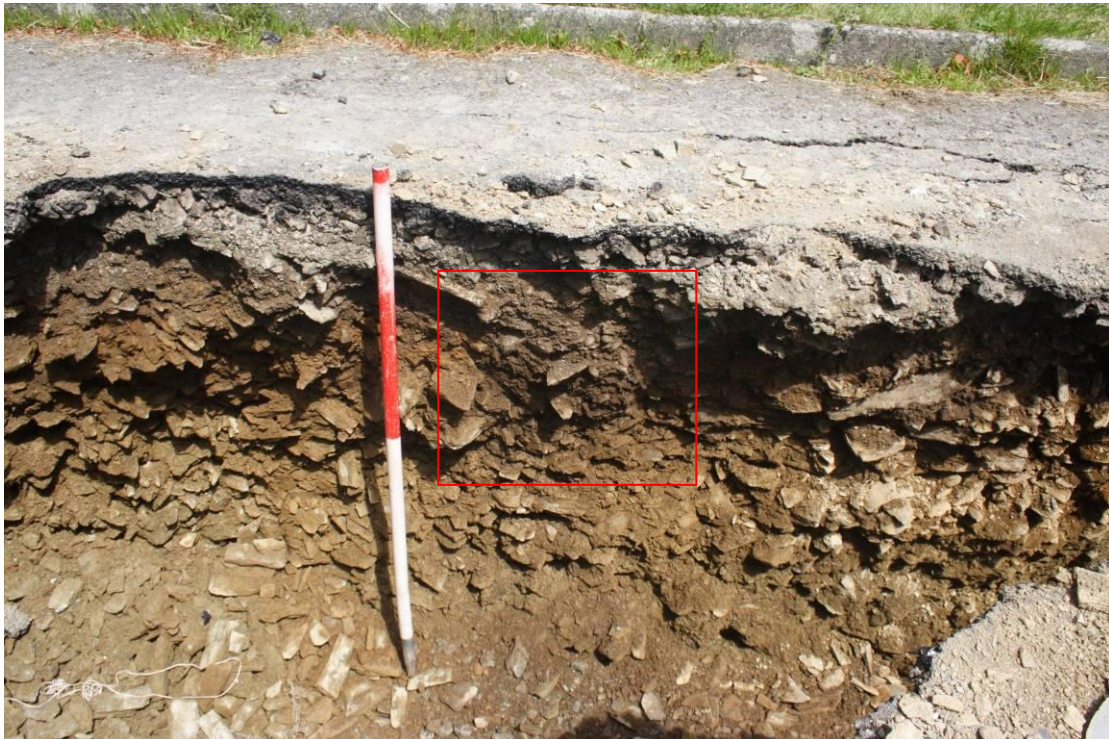
- 3.3.8 A small feature measuring 0.30m at its widest point, tapering to 0.06m at its base, with a depth of 0.20m was revealed within the west facing section 19m from the south end of the trench (Photo 7). A single fill (1011) was identified within the feature cut [1010] which comprised a dark brown silty clay containing frequent small sub angular stones. The cut [1010] appeared truncated through the natural soils and may have been overlaid partially by (1006).

Photo 7: East facing view of small feature [1010]

- 4.1.5 A small pit or linear feature was also recorded in the main trench. Its date and function is not known. It is conceivable that this represented the very end of a grave cut running to the east.

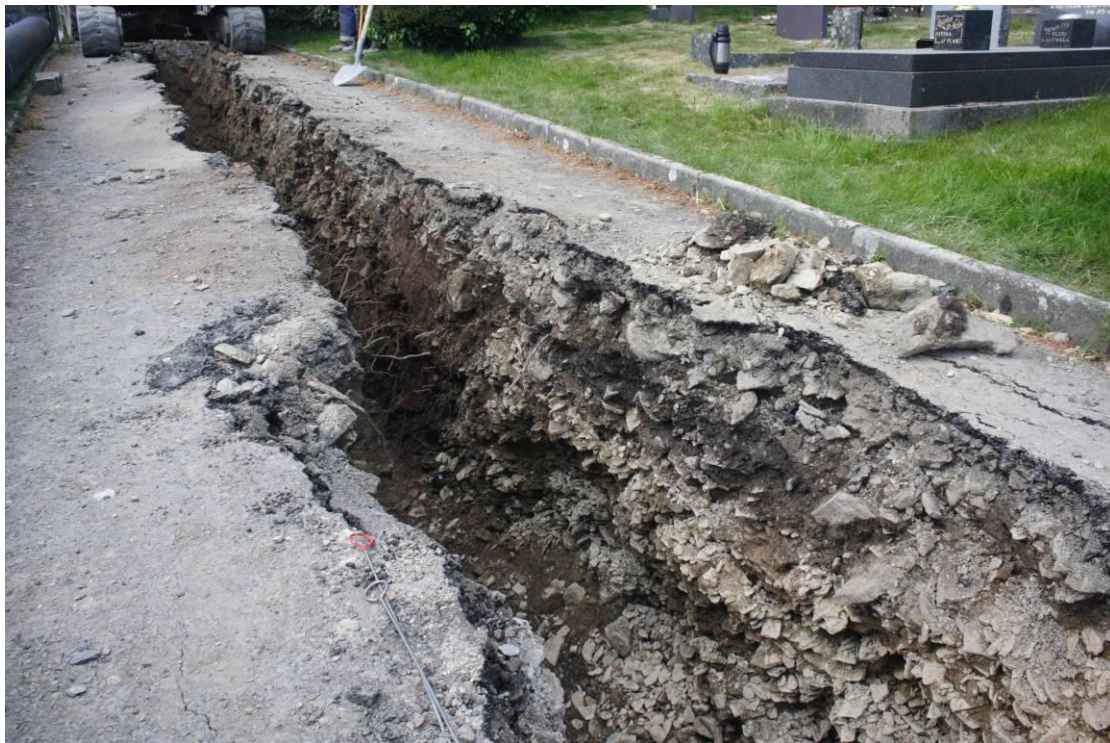
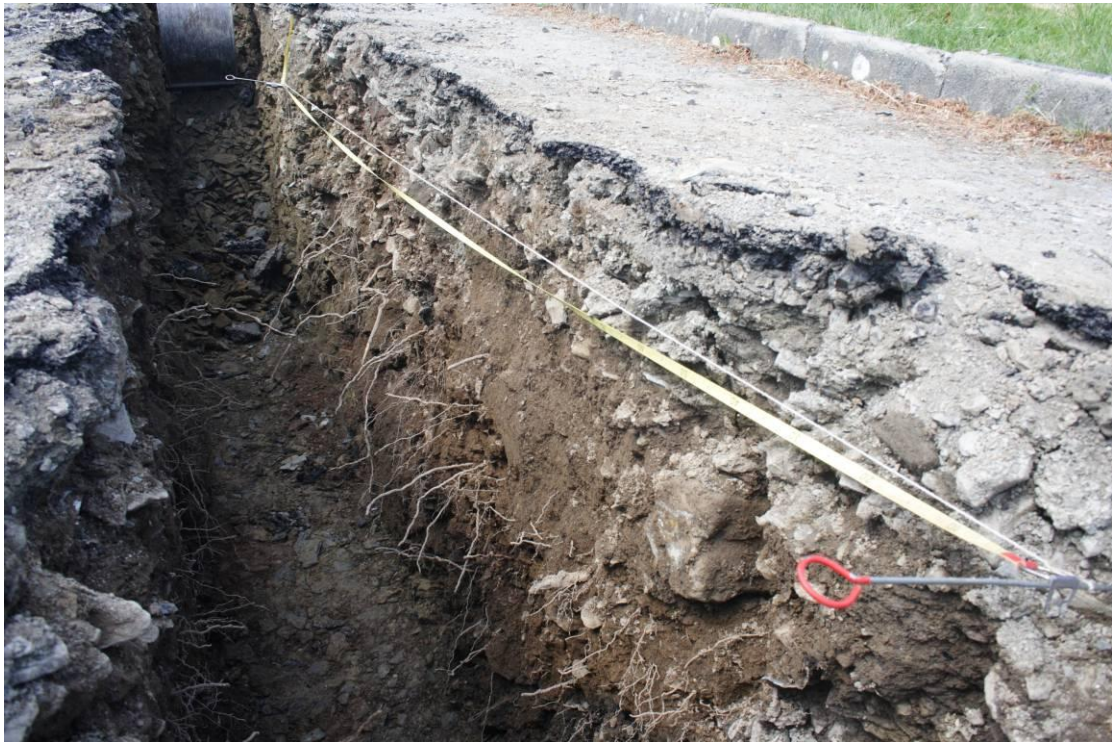
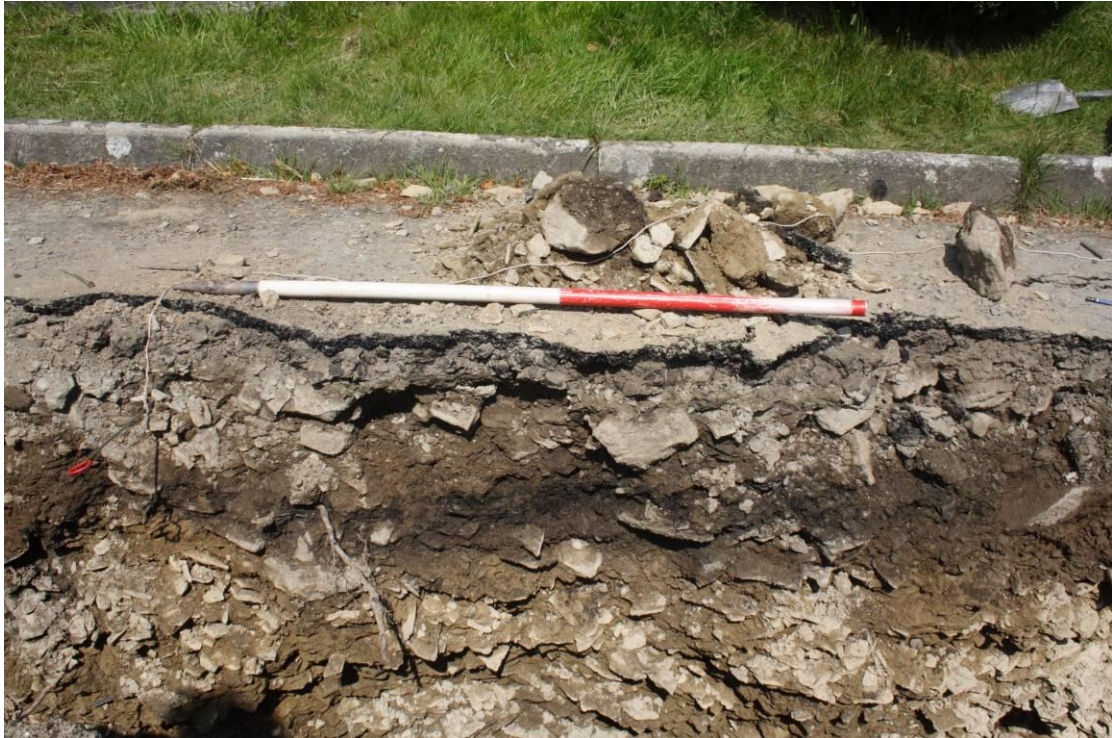
- 3.3.9 Towards the northern end of the trench a group of archaeological features and deposits were revealed: a large ditch [1013]; possible remains of a bank (1014) located on the southern side of the ditch; and a possible underlying buried soil layer (1012). All three features were visible within both sides of the trench.

- 3.3.10 On the eastern side of the trench, ditch [1013] measured 3.62m in width with a depth of 1.20m, whilst on the western side it had a smaller width of 3m. The eastern side of the exposed ditch was recorded in detail as it showed the clearest indication of the stratigraphic sequence. The ditch [1013] was cut through two layers on the southern side seen nowhere else in the trench. The first was a possible buried soil layer (1012), and the second may have been part of a former bank on its southern side (1014). Layer (1014) consisted of a light to mid brown silty clay which contained frequent small sub angular stones. It had a maximum depth of 0.2m. The underlying soil layer (1012) had a maximum depth of 0.18m and comprised a dark grey silty clay with frequent flecks of charcoal. This continued from the southern side of ditch [1013] for a length of 1.7m.

- 3.3.11 Ditch [1013] (Photos 8-10) contained two separate fills, (1015) and (1016). The primary (lowest) fill (1015) consisted of a 0.4m deep dark brown silty clay which contained occasional small sub angular stones. A small patch of degrading clay was also seen within the ditch which could be the remnants of daub. The upper ditch fill (1016) consisted of a 0.8m deep light brown silty clay with frequent inclusions of small sub angular stones.

Photo 8: South side of ditch [1013] with dark soil layer (1012) and layer (1014) above

Photo 9: North view along pipe trench during recording of ditches [1013] and [1017]. Fill (1018) can be seen as the far less stony area within the section

Photo 10: West facing section of possible bank material layer (1014) overlying dark soil layer (1012)

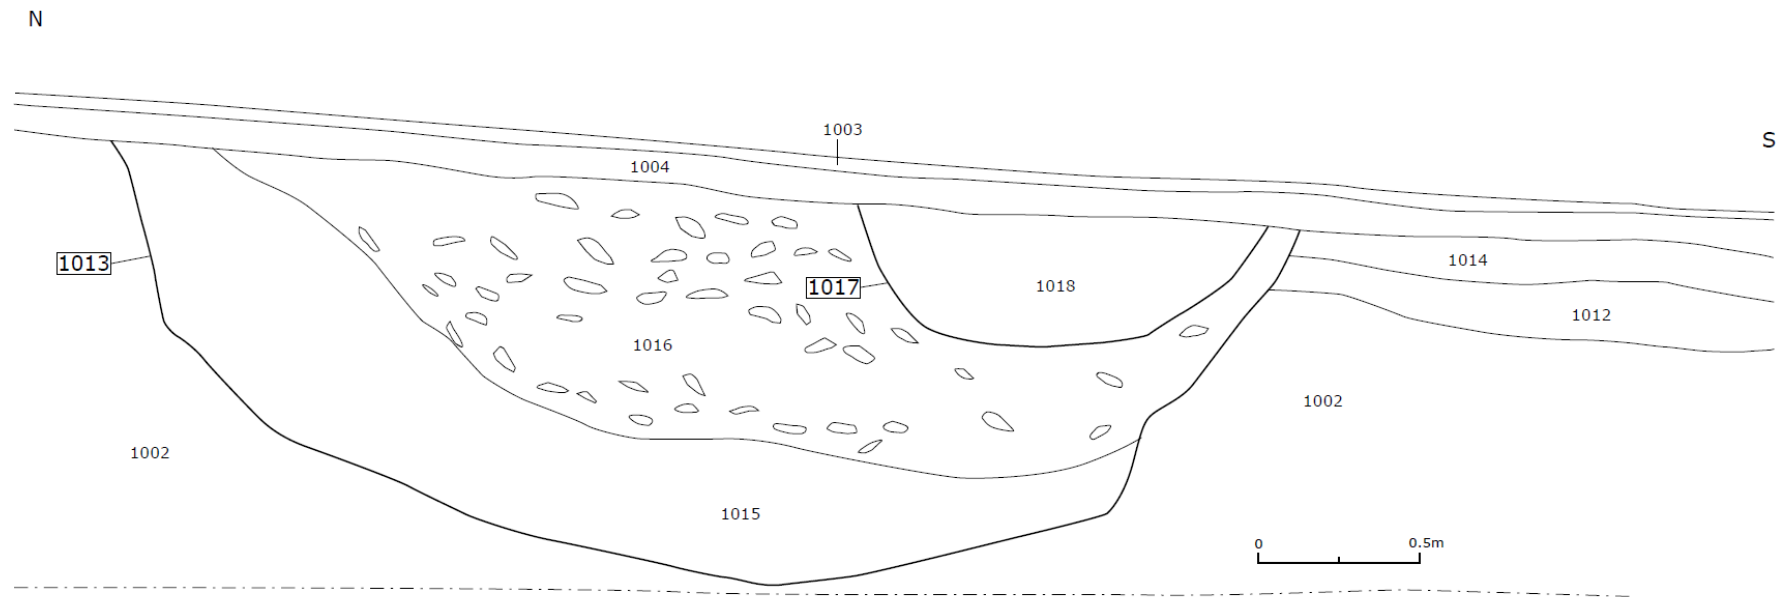
- 3.3.12 A recut of this ditch, or a later feature, cut [1017], was also recorded in the section (Figure 6). This feature measured 1.18m in length and 0.4m in depth. It cut into fill (1016) on the south edge of the main ditch [1013]. The fill of this ditch recut or later feature comprised a light brown silty clay (1018) with fewer inclusions.

Figure 6: West facing section of ditches [1013] and [1017].

- 4.1.6 Perhaps the most interesting features revealed in the drainage trench are the large ditch and the re-cut or later ditch seen near its northern end. The larger and earlier ditch was widest on its eastern side and it is considered that this may indicate the ditch turned slightly southwards. No dating evidence was recovered from the fills of the ditch, nor from the later re-cut. The size of the ditch and its location would suggest it is a fairly early feature, pre-dating any 19th century rebuild of the church as later grave cuts were present in the area to either side of the feature. On the southern side of the ditch two layers could be seen which pre-dated the earlier ditch. The lower layer was dark and had the appearance of a former topsoil layer, perhaps the original ground surface through which the ditch was excavated. The upper layer was more akin to a redeposited natural and the excavator suggested that it could have been material from a former bank on the inside of the ditch. It is difficult to try and interpret the ditch and possible bank with any certainty as only a very small section of it was visible within the drainage trench. It could represent an earlier boundary around the church later filled perhaps to allow expansion of the churchyard (as was also done at the turn of the 20th century). Charcoal was present within the possible buried soil layer which may be suitable for obtaining a radiocarbon date, although obtaining a date should be done with caution as the interpretation of the layer, seen only in the confines of the drainage trench, is uncertain.

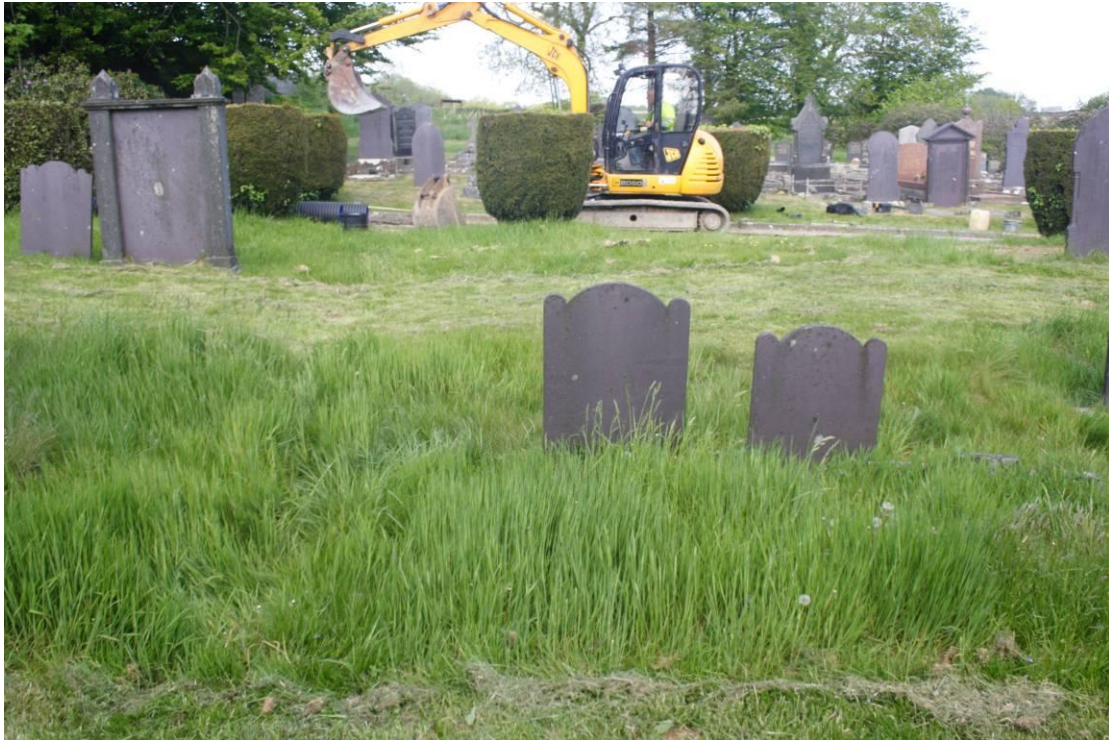
- 4.1.7 A linear undulation was noted through the churchyard to the immediate west of the ditch and may indicate a continuation of the feature westward. The depression could also indicate the line of a former pathway marked on late 19th and early 20th century maps (Photo 11; Figures 9 and 10). The pathway could also be associated with the later re-cut of the ditch.

Photo 11: Potential continuation of ditch [1013] to left of gravestones in foreground, seen as depression in ground surface.
