NATIONAL BOTANIC GARDEN OF WALES REGENCY RESTORATION PROJECT

PHASE 1 ARCHAEOLOGICAL INVESTIGATIONS AND STRUCTURE RECORDING 2015

INTERIM REPORT

RHIF YR ADRODDIAD / REPORT NO. 2015/61 RHIF Y DYGWILLIAD / EVENT RECORD NO. 108883

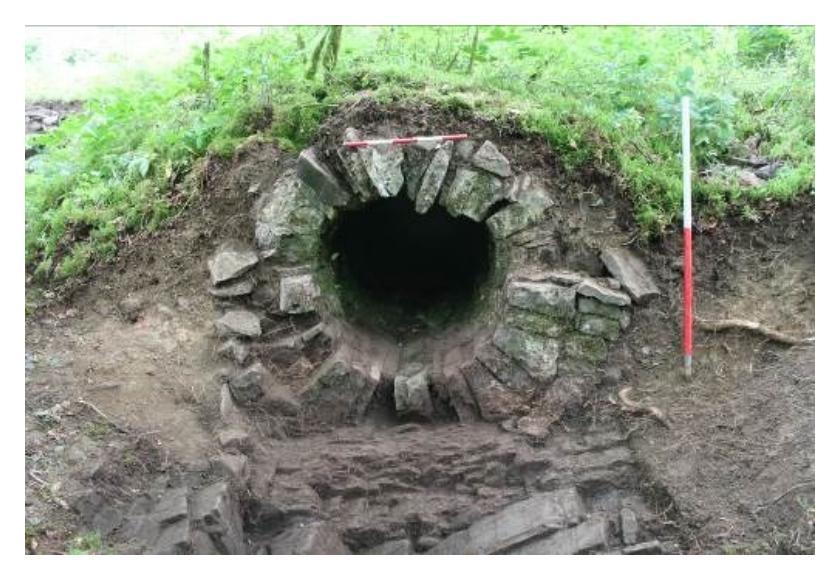
Photo 1: Outlet of diversionary dam culvert 1AS1

- For reasons of safety, the outflow at the north end of this culvert should be blocked up to prevent access.
- If culvert 1AS1 were incorporated into the scheme, it is recommended that the south end of the culvert is cleared of the fallen tree, tree roots and fallen masonry to obtain more evidence of its relationship with culvert 1BS8 (if any survives).
- The north end of the culvert should be consolidated.
- If it is cleared of fallen masonry etc., the south end of the culvert it is likely to need consolidation and blocking up.

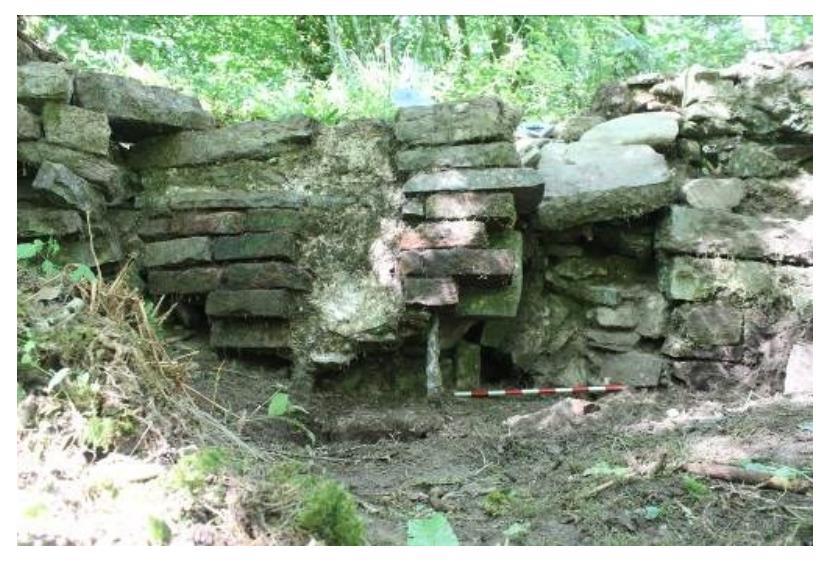
Culvert 1CS7 (Photo 15) is located on the western end of the Llyn Felin dam. It appears to have been used to control the height of the water in the lake, by passing the Llyn Felin Cascade (1BS8) and the Diversionary Dam Cascade (1DS10). On the south side of the dam, the partially damaged culvert intake was partially excavated. Due to the unstable nature of the structure it was not possible to excavate deeper down to reveal the entire culvert opening, but the visible remains suggest that the remains of a sluice mechanism are likely to be present below the present ground surface.

Photo 15: The inflow point and sluice for Culvert 1CS7 on the south (lake-side) side of the Llyn Felin dam

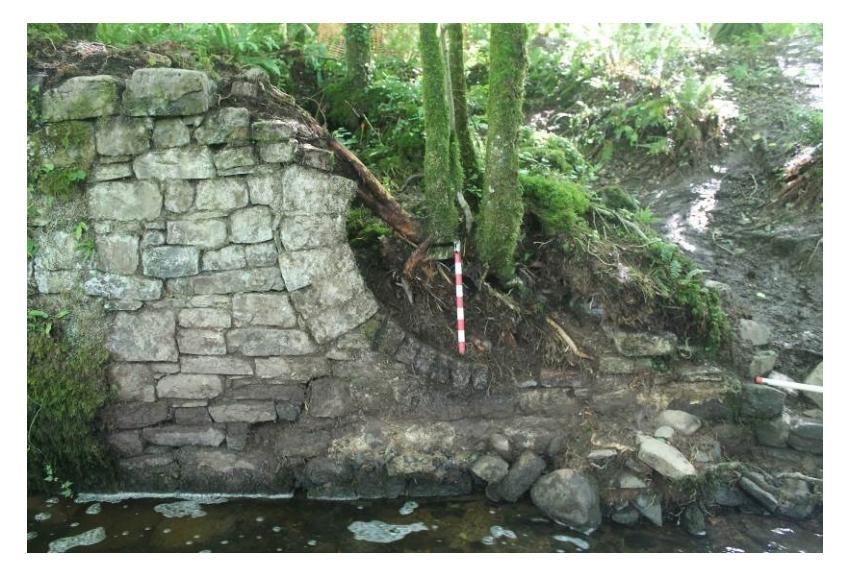
The outflow at the north end of the culvert (Photo 16) has been repaired with red brick.

Photo 16: The outflow of Culvert 1CS7. Note red brick repairs to the base of the opening

- Further investigation and recording may be desirable, depending on the potential impact of any proposed re-instatement of this structure.
- If the culvert is to be restored to its original form and function, further excavation may be needed to better understand the details of the culvert intake and its presumed sluice arrangement.
- Young trees could be removed from some locations to prevent further damage to the culvert.
- Open ends of the culvert could be consolidated to prevent further collapse.
- Open ends could be blocked to prevent access into the culvert.

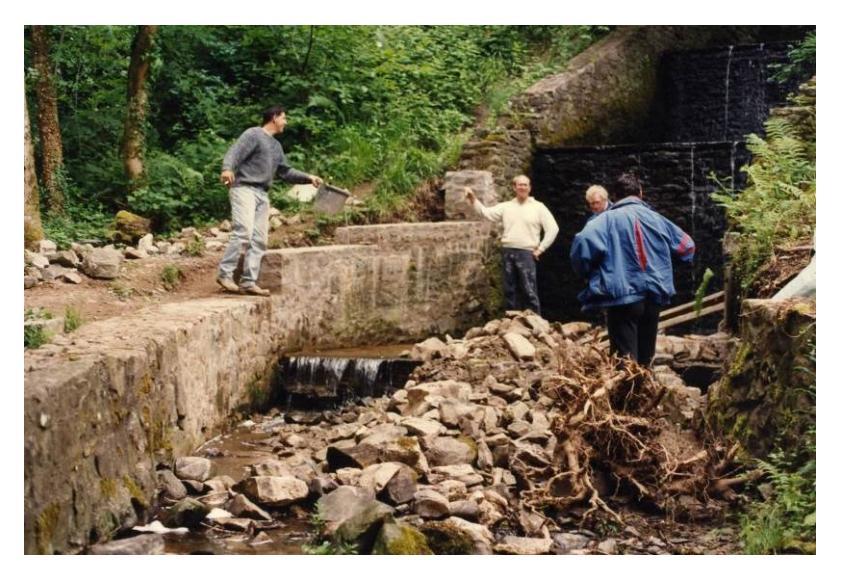
Some photographs taken during repair works in the 1980s (Photos 41 and 42) are useful in identifying the extent of rebuilding for the lower parts of the cascade, the upper parts rely on what can be discerned in the existing masonry.

Photo 41: Repairs to the cascade in the 1980s

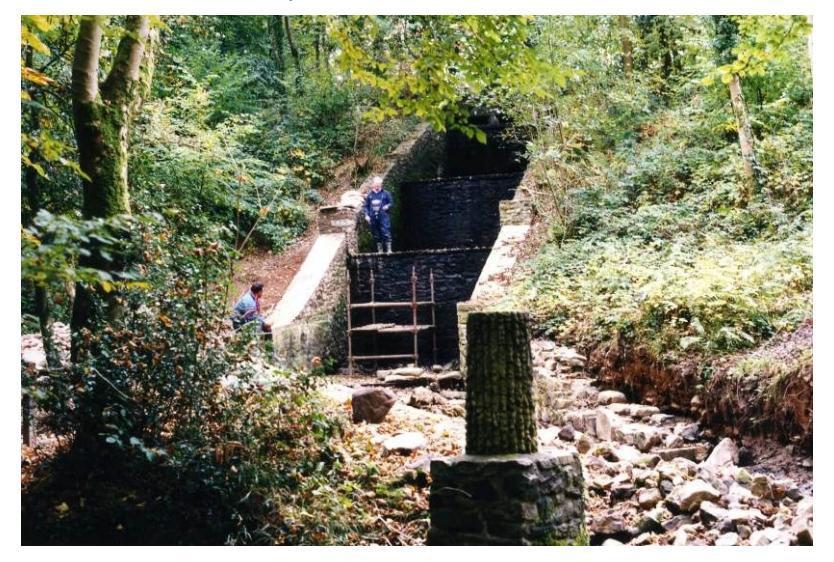
Photo 42: Repairs to the cascade in the 1980s

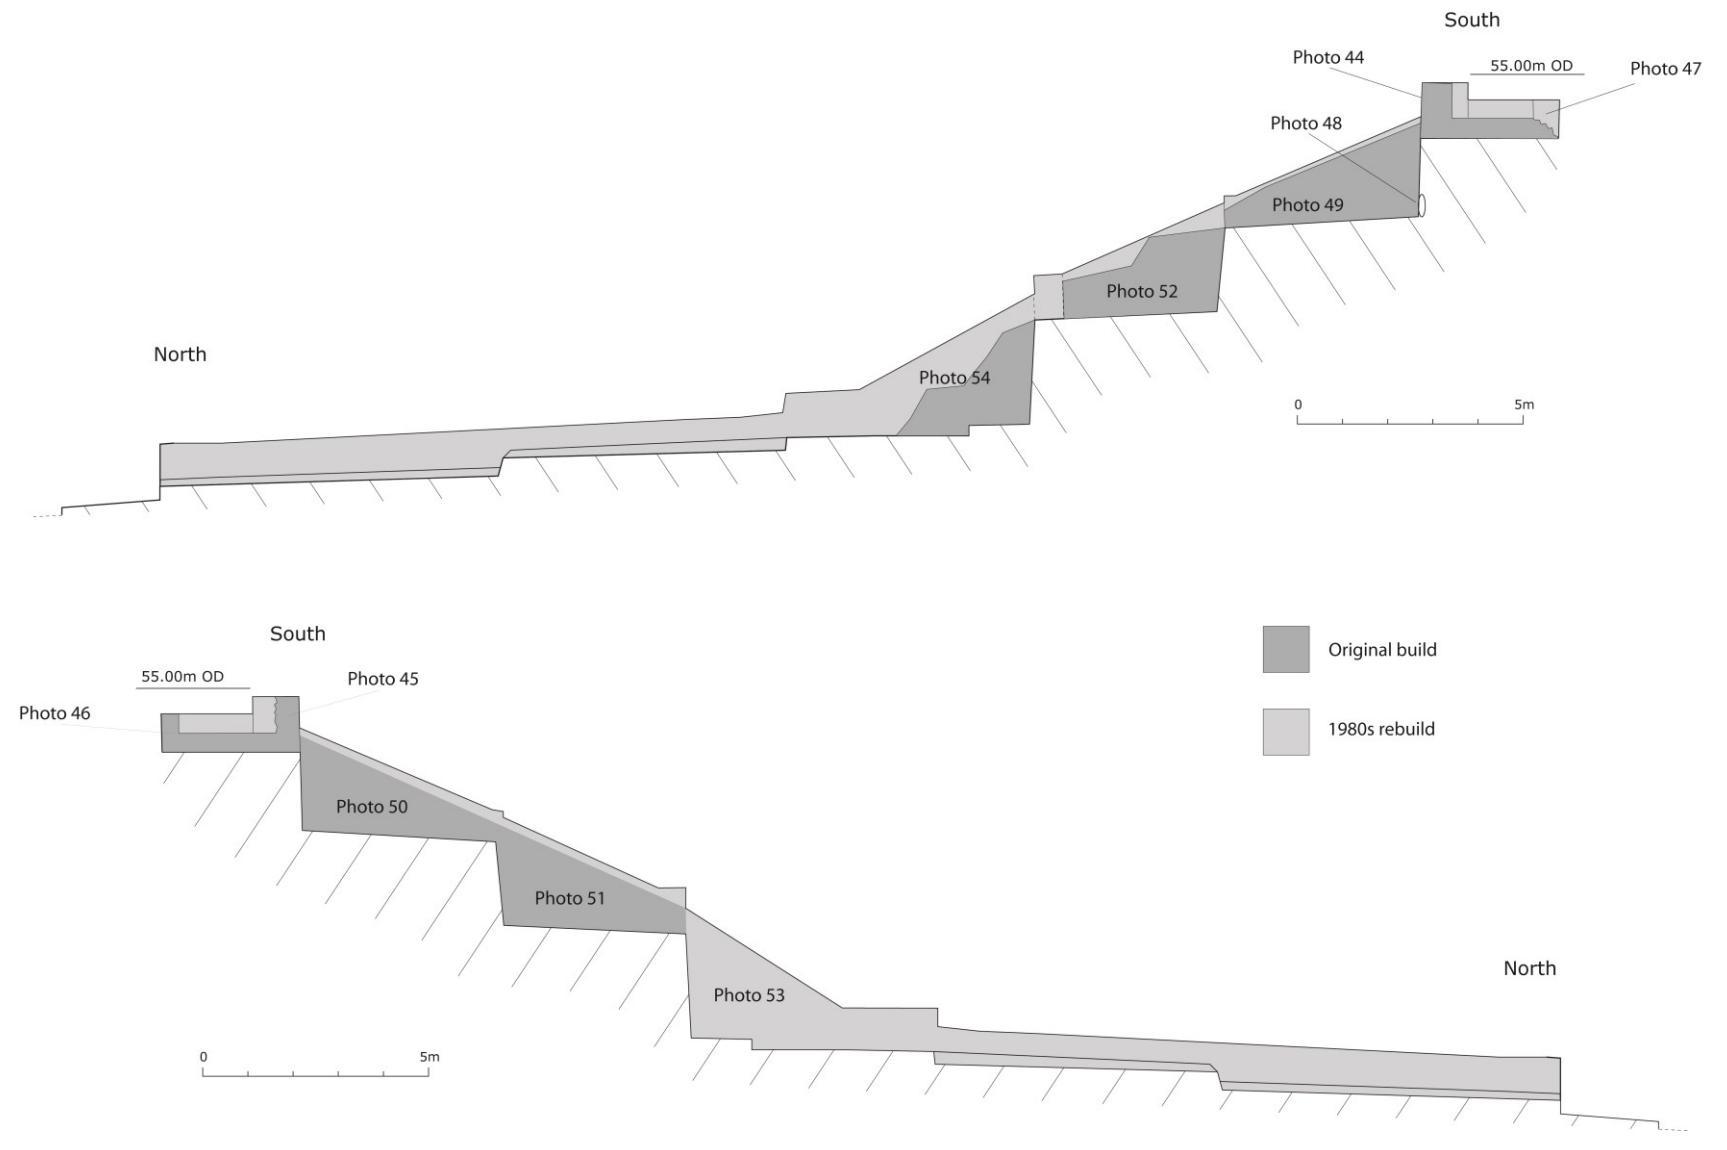
Figure 35: Plan showing repairs to the cascade (with photo references)

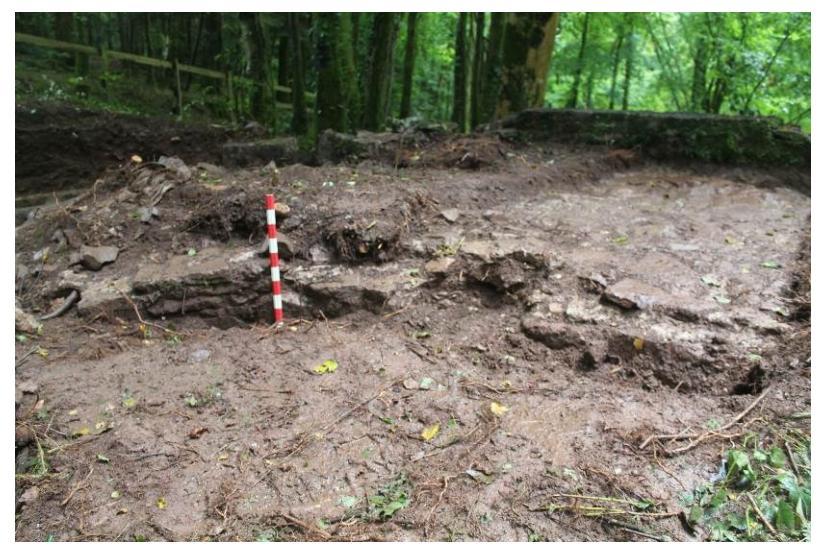
The cascade spillway is shallow and is lined with large dressed stone slabs. Some are linked with metal staples. The east side of the spillway has been repaired. There are also a few other holes in some of the slabs, but they do not appear to be regularly positioned.

Photo 58: Exposed parts of the south side of the waterfall

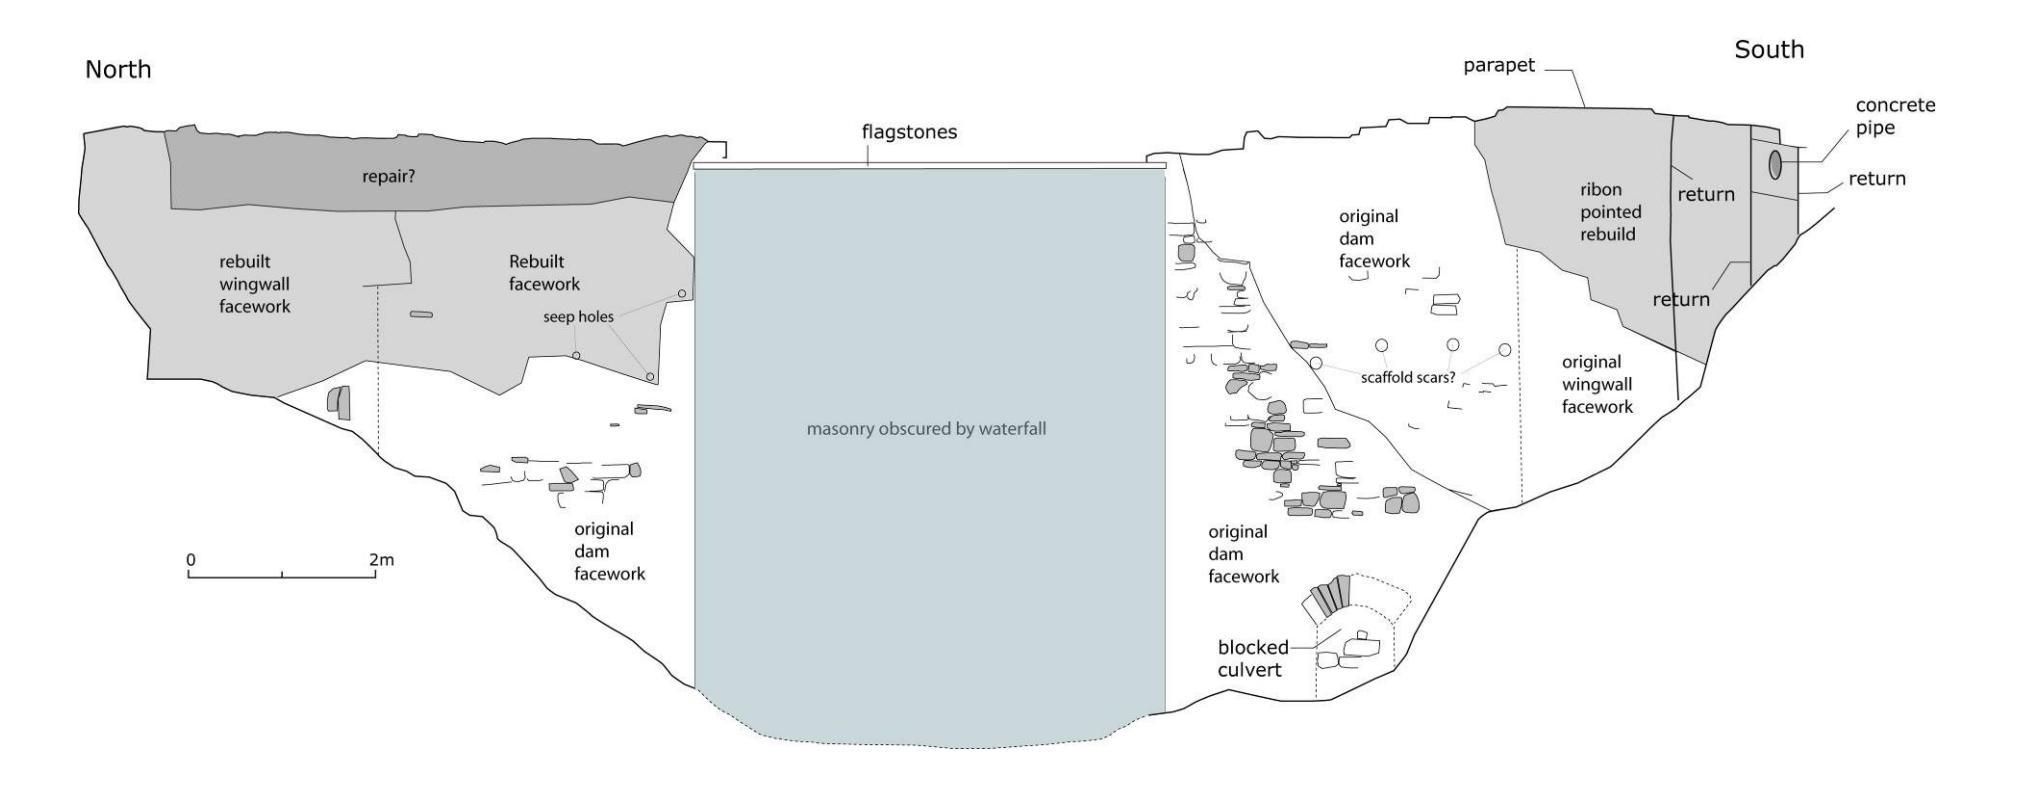
Figure 39: West facing elevation of the great waterfall

Drainage pipes inserted on the north side of the dam, coupled with the evidence of backfilling of the dam core and the absence of a parapet, may suggest that this side of the dam has been more substantially repaired or rebuilt.

- Visible cracks and leaking suggest that the north side of the dam still requires substantial repair or rebuilding.
- It is possible that there was originally a bridge over the cascade spillway, but because only part of the west side of the dam was cleared of overburden, no evidence was revealed. On the east side, later disturbance may have destroyed any evidence formerly present.
- Further investigation of the flanking revetment walls (currently inaccessible) on the east and west sides of the dam may provide additional information as to whether the dam was originally symmetrical or not, and may even provide clues as to how it was bridged.
- The overflow pipe may only have had a temporary function. If it is to be retained and restored to function, it may be necessary to ensure that the right angle bend does not get blocked up with debris.

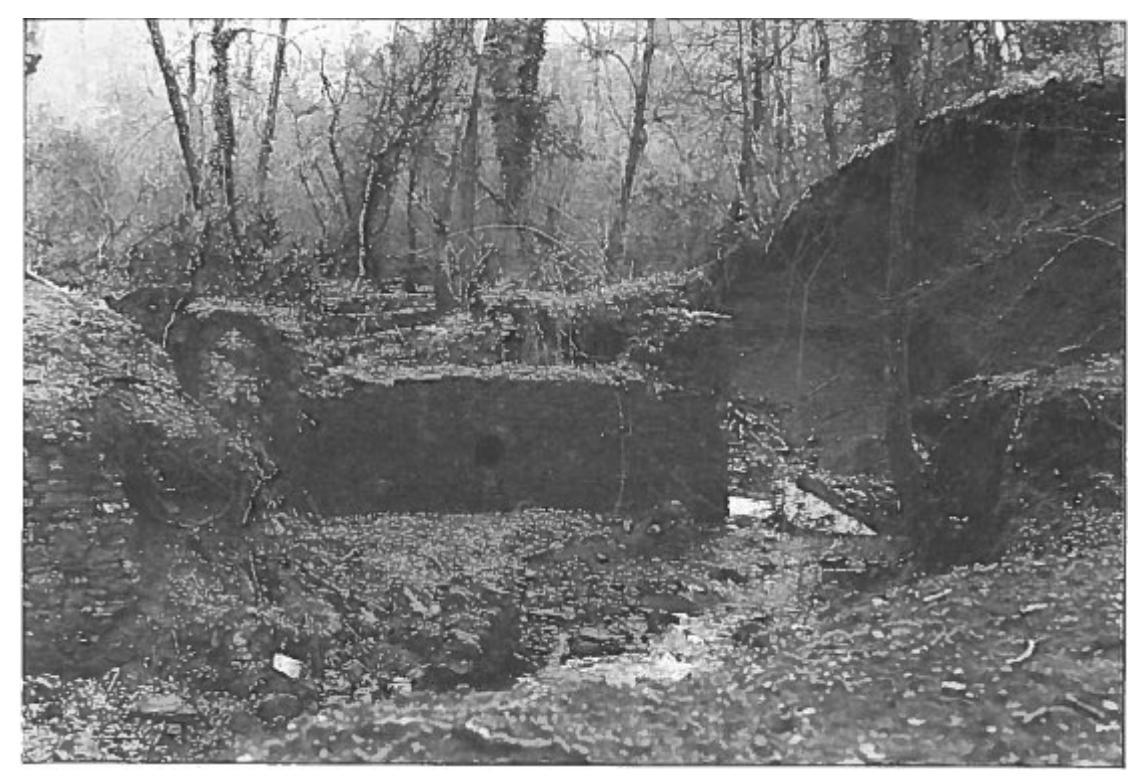
Photo 68: Structure 52 before repairs

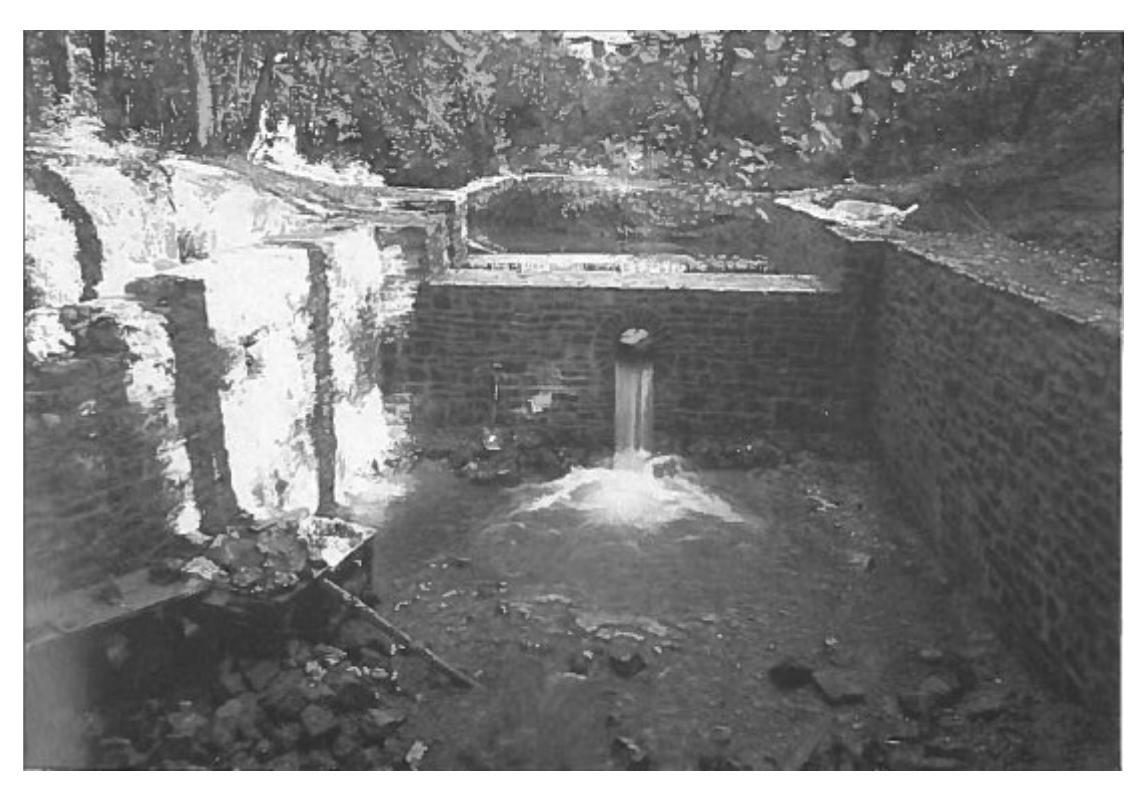
Photo 69: Structure 52 after repairs

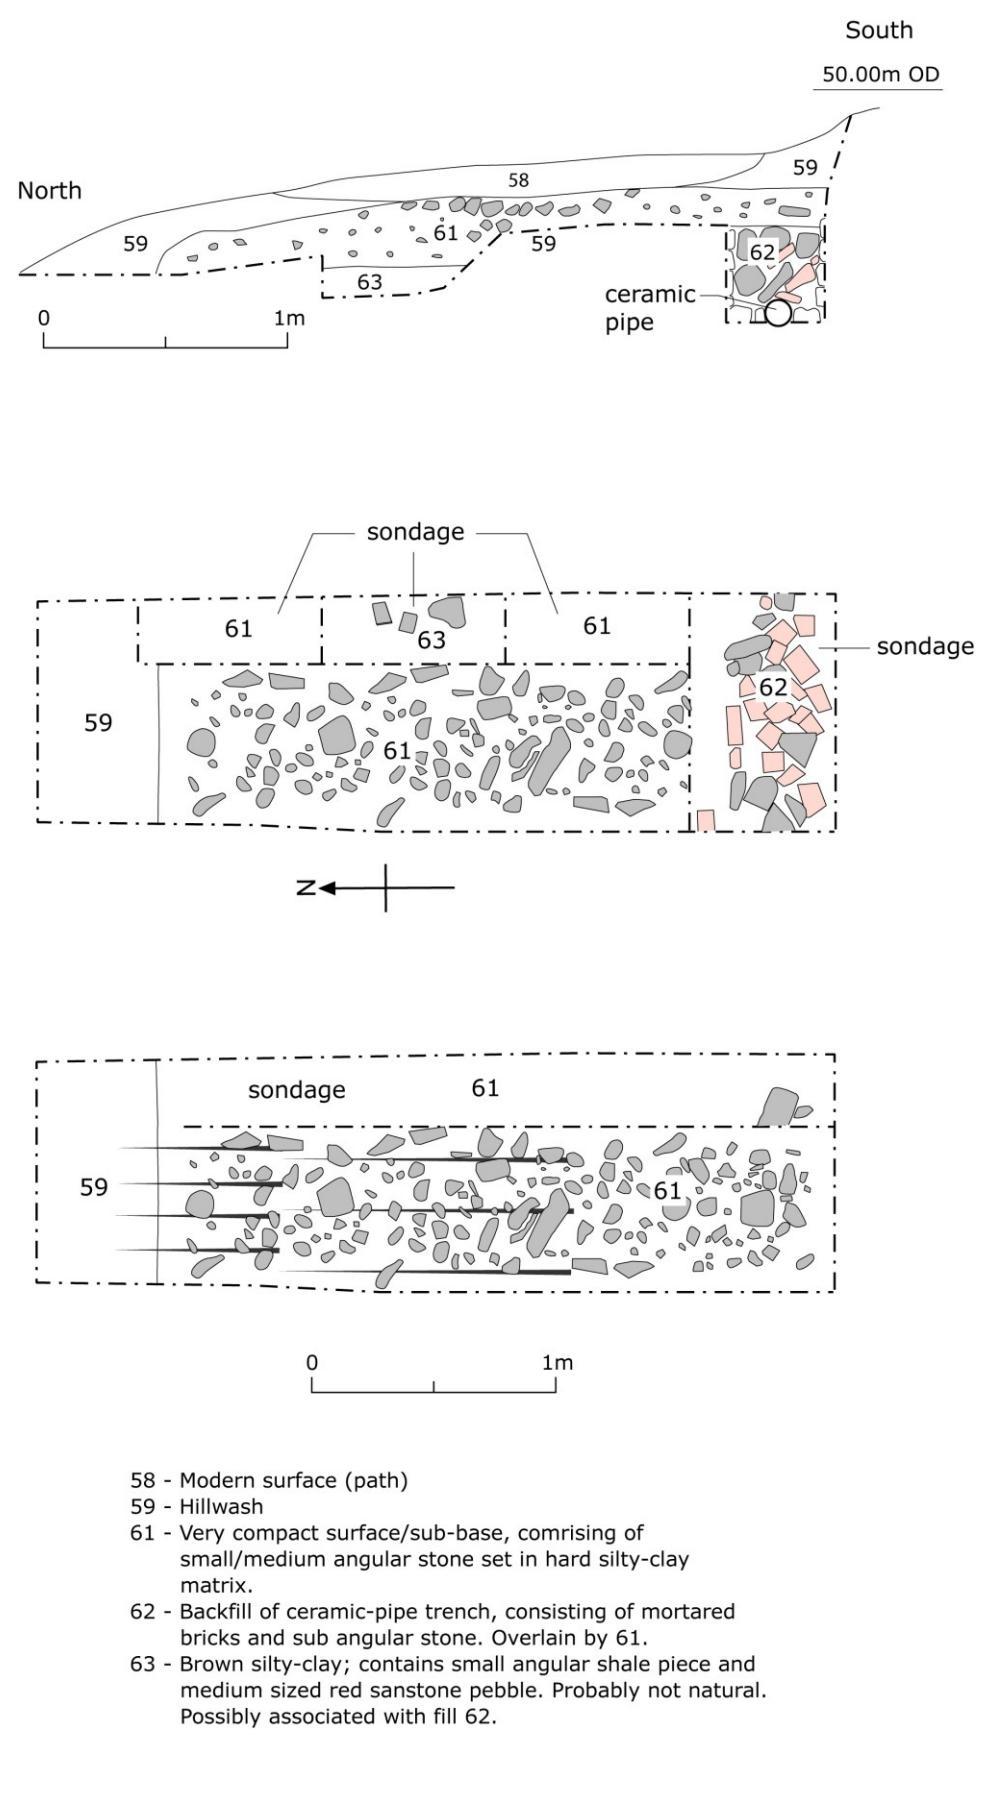
Photo 74: Site 6C track surface with brick filled pipe trench. Looking north
