NEW DRAIN AND SOAK AWAY AT ST. MARY'S CHURCH, CARDIGAN, CEREDIGION: ARCHAEOLOGICAL WATCHING BRIEF

RHIF YR ADRODDIAD / REPORT NO. 2016/45
RHIF Y DIGWILLIAD / EVENT RECORD NO. 109383

Medi 2016
September 2016

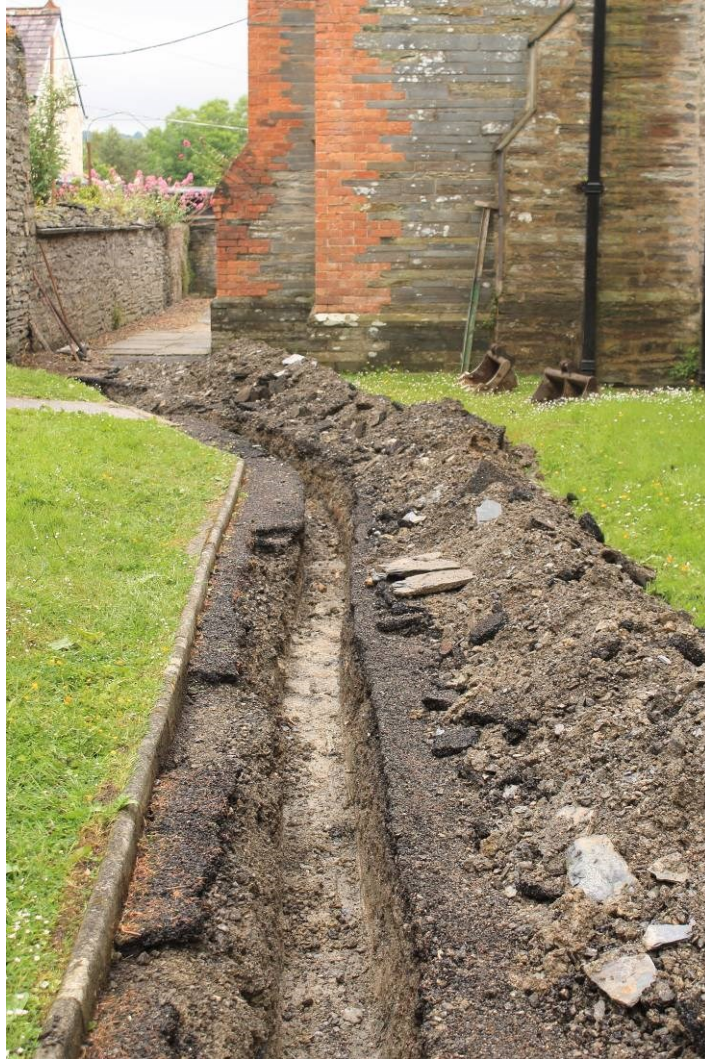
- 4.1 Figure 3 shows a plan of the position of the works to the north of the church. Photo 1 shows the location of the eastern end of the new drainage trench, dug through the tarmac pathway along the north side of the church. The channel terminated approximately opposite the west wall of the north transept, and was 0.3m wide and 0.4m deep.

Photo 1: The eastern end of the new drainage channel, cut through the tarmac path on the north side of the church

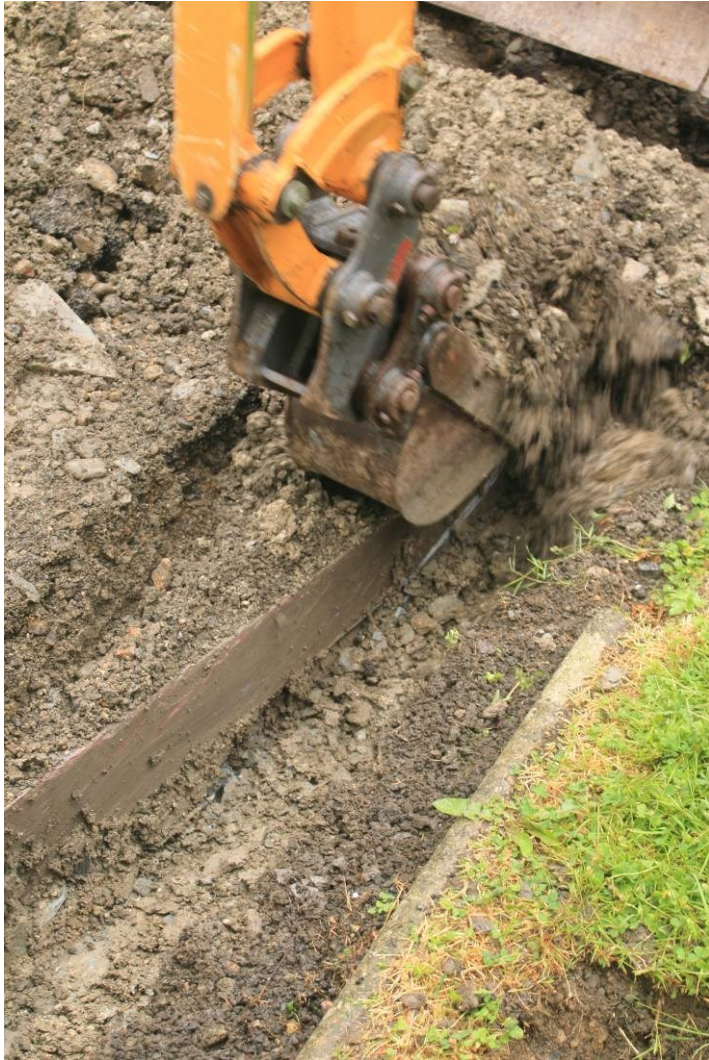
- 4.2 Approximately one metre west of the eastern end of the drainage channel, a stone kerb (Photo 2) was uncovered and removed. It was upright, perhaps indicating the placement of an earlier path. The drainage channel crossed it at an angle of about ten degrees, and no more such remains were encountered thereafter. Another two metres west of this, the new drainage changed direction to follow the tarmac path, and at this point a ceramic drain pipe of c.15cm in diameter was met at the southern trench edge (Photo 3). The pipe was at a depth of about 20cm and was not disturbed.

Photo 2: The kerb stone of an older pathway was discovered and later removed

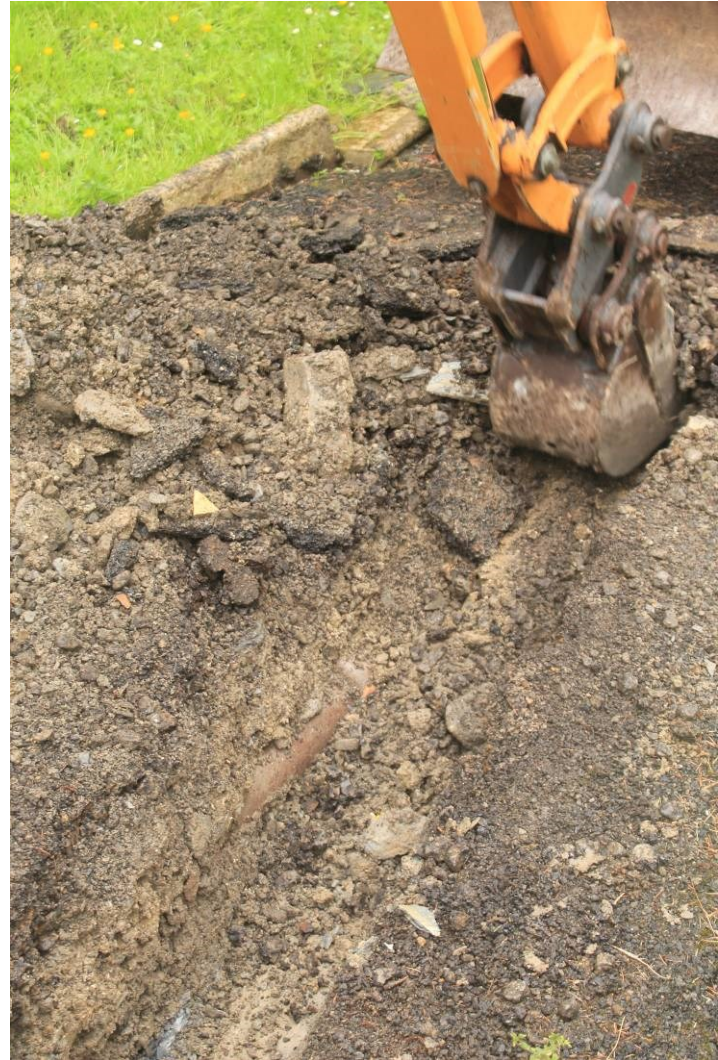
Photo 3: A ceramic drainage pipe is revealed at the south edge of the trench

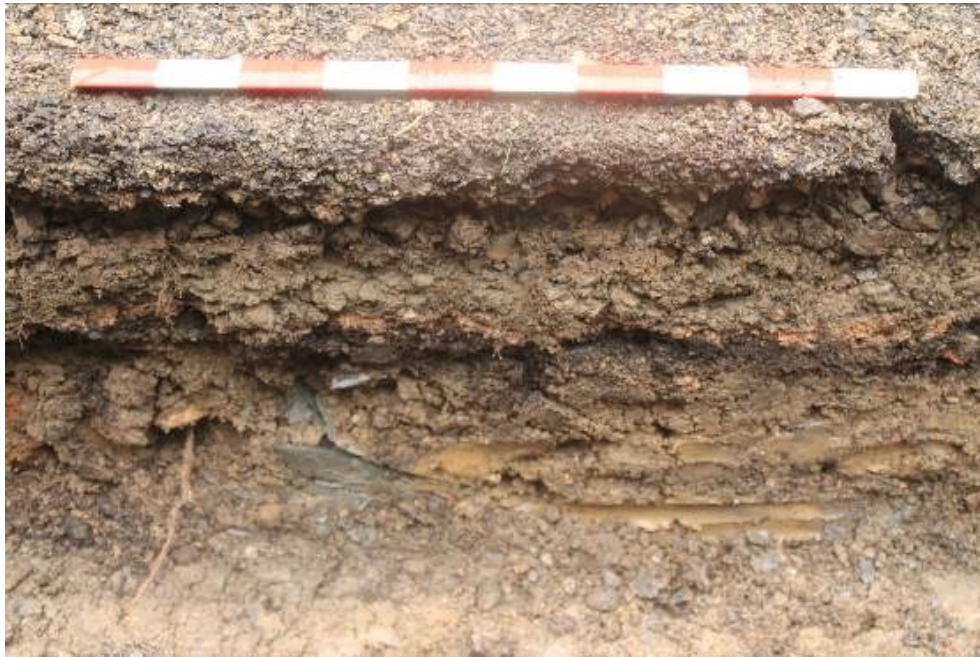
- 4.3 Along all of the north and south-facing sections of the new channel, underlying make-up layers of the tarmac path could be seen. A light yellowish-brown clay had been used below the current path, and also beneath what seemed to be an older path surface that showed as a thin dark brown layer. This layer was made up of buried soil and ash and was so dark due to its high humic content and the presence of fragments of coal/charcoal. Photo 4 shows these layers in section and the clay-silt pebbly river deposit seen at the bottom of the trench beneath them. Photo 5 shows a similar section but this time with a layer of slate near to the base, which occurred at regular intervals about two metres apart along the trench, indicating burials beneath.

Photo 4: South-facing section of the drainage trench, with a 0.5m scale

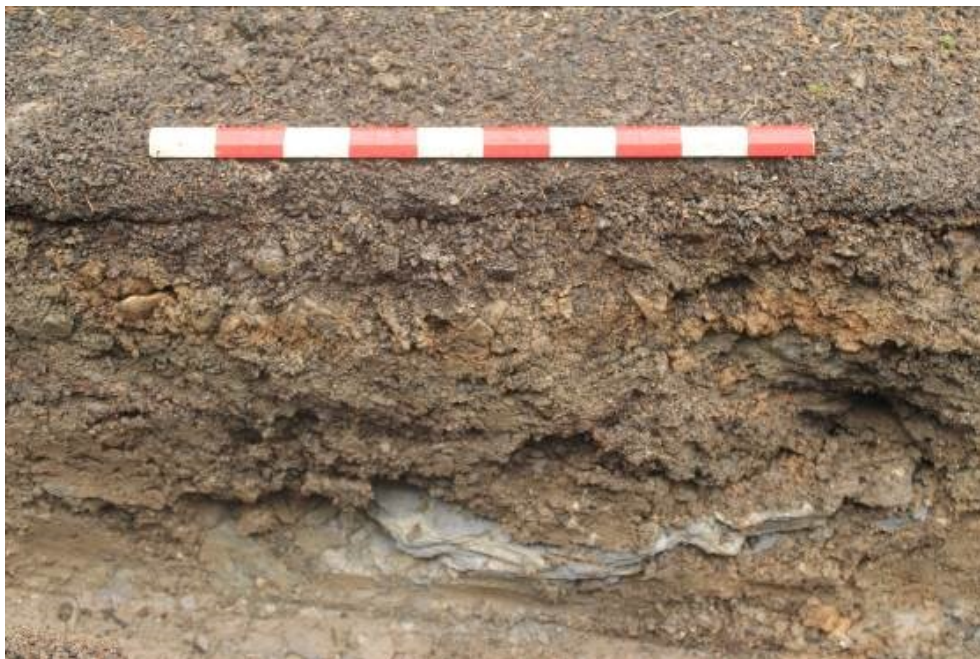
Photo 5: South-facing section of the drainage trench, showing slate indicating the top of a burial, about 3m west of the eastern end of the trench, with a 0.5m scale

- 4.4 Photo 5 shows the first slate grave-cover encountered, at about three metres west of the eastern end of the trench. No human remains were seen at this point, as they probably lay beyond the trench edge to the south and beneath it. The next three grave-tops encountered were directly in line with the new channel at its base. From two of these the slates were removed, revealing burials beneath, but the third was a little deeper and the slates were left in situ (Photo 6). Photo 7 shows the tops of long bones revealed upon the removal of slates in the second burial from the east (about 5m from the eastern end of the trench). The position of the bones revealed showed the conventional Christian burial style: supine with head to the west. No signs of wooden coffins or textile shrouds were observed, but these are likely to have perished long ago if they were present. No headstones were found, and no other upright stones were seen, indicating that that the slates only covered the graves rather than forming part of a stone coffin (known as a cist) seen in Early Medieval burial practice.

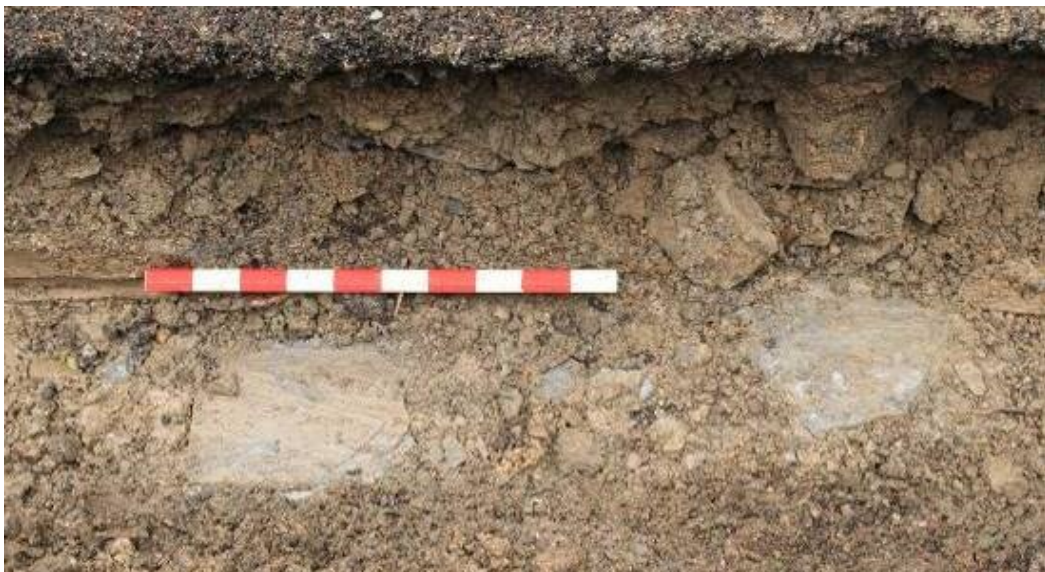
Photo 6: Burial at base of trench, indicated by its slate covering, about 9m west of the eastern end of the trench, with a 0.5m scale

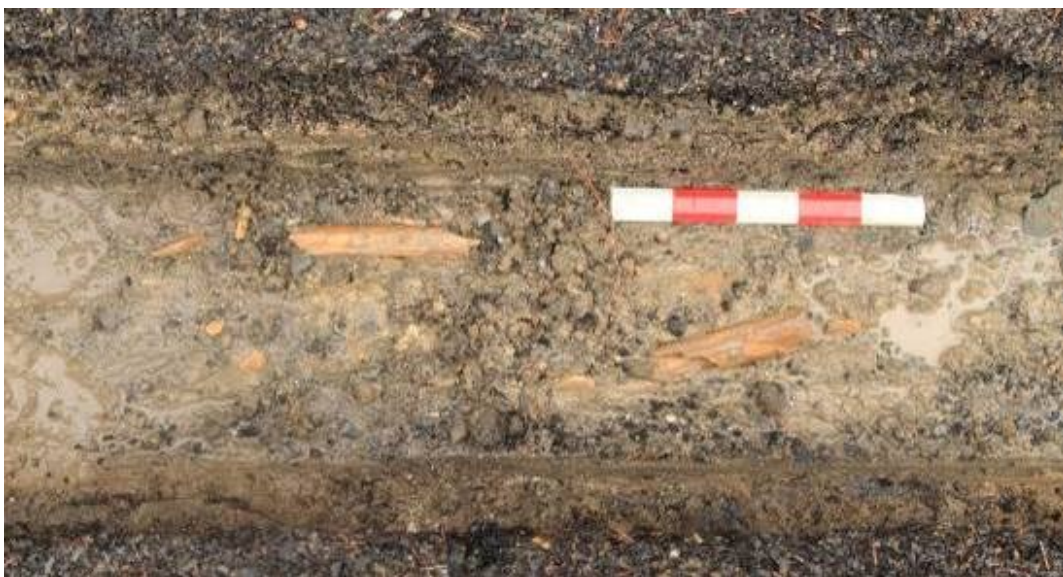
Photo 7: Top of long bones of a burial revealed underneath slates approximately 5 metres west of the eastern end of the trench, with a 0.5m scale

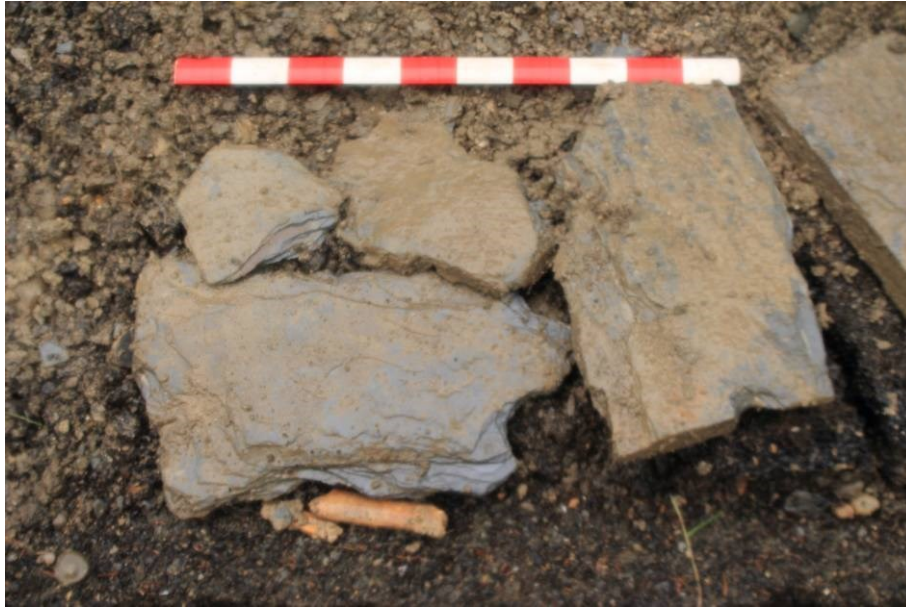
- 4.5 The slates used to cover the burials were dark silvery-blue in colour, rough edged, and a number had nail holes indicating their previous usage as roofing slates (Photos 8 and 9). The slates measured 4cm thick on average, much less refined and far heavier than roofing slates today. Slates of similar size were found just north of this area and at a similar depth during a previous watching brief (Schlee 2012), although no nail holes were reported. At that time, two of the slates appeared to be intentionally placed vertically, and were interpreted as being so in order to prop up gravestones that had since been removed. It is difficult to give an age for these slates, but likely that they were used for roofing in the medieval period and reused for the graves in the Post-Medieval period.

Photo 8: Examples of the thick roofing slates that had been re-used to cover burials, 0.5m scale

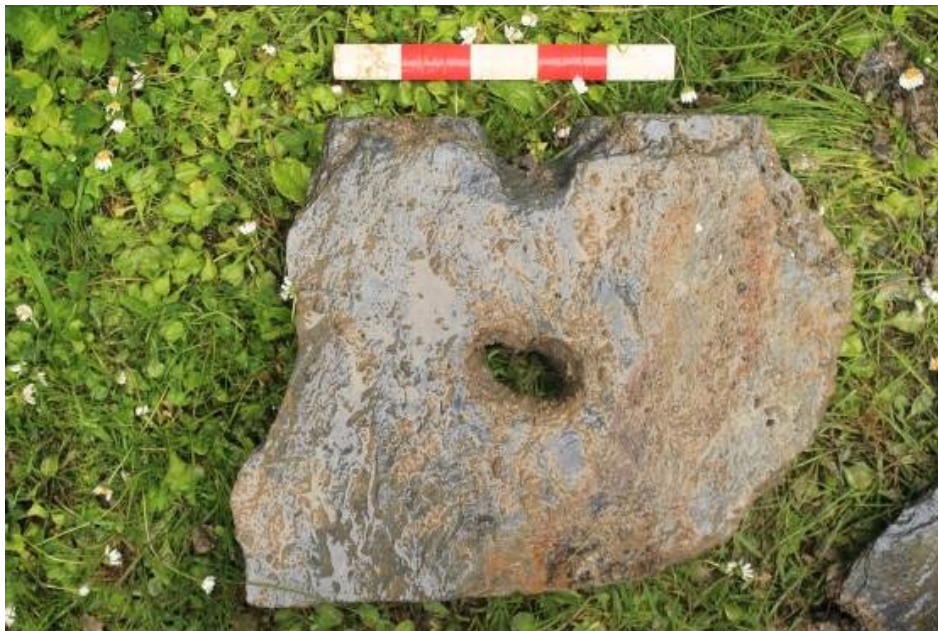
Photo 9: The best example of the recovered roof slates re-used to cover burials, with two large nail holes, 0.25m scale

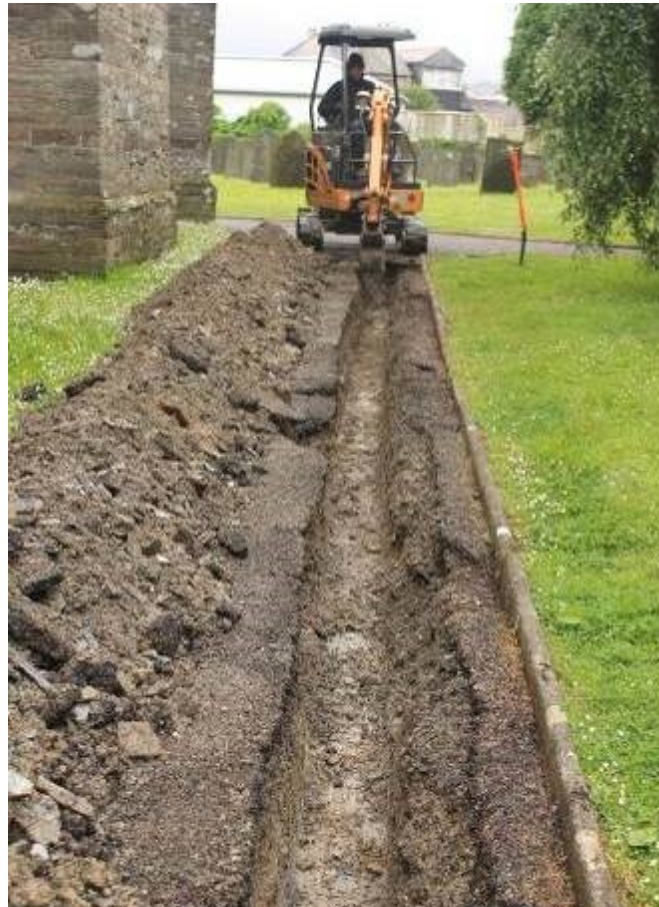
- 4.6 Photo 10 shows the complete extent of the drainage trench cut through the tarmac path along the northern side of the church before it changed direction west-southwest-wards towards the north wall of the church near its west end. From the same point at the church wall, another narrow trench about 0.5m deep was excavated in a northwesterly direction away from the church for about four metres. It crossed the tarmac path again and some of the grass-covered graveyard before terminating at the position of the new soakaway. A plan view of the groundworks at this end of the church was obtained from the top of the church tower (Photo 11). Within a metre of the church wall, the ditches were dug to depth of 0.9m in order to facilitate works to the church wall.

Photo 10: The western end of the long straight section of the new drainage channel cut through the tarmac path along the north side of the church

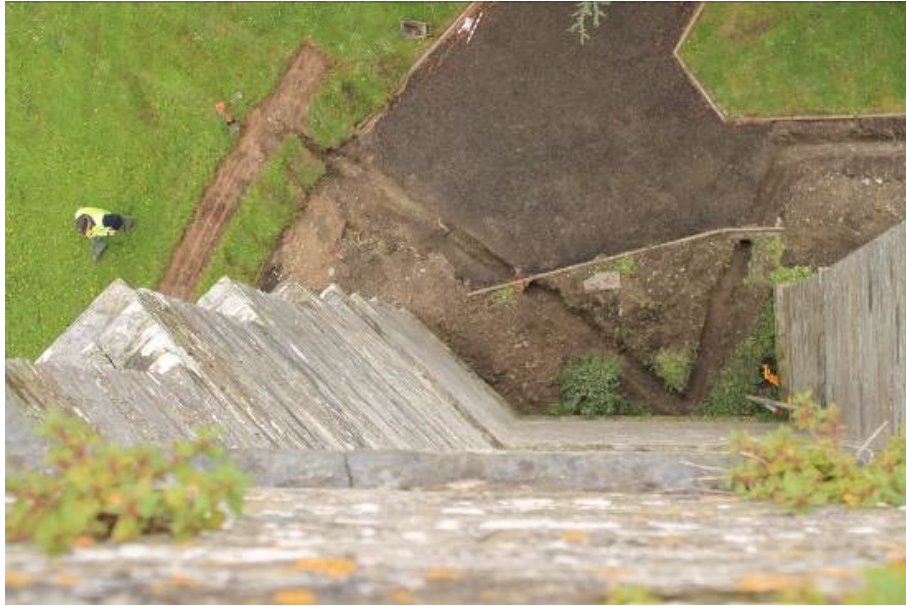
Photo 11: Plan view of the groundworks at the west end of the north side of the church. Two drainage ditches leave the church wall, one heading northwest towards the new soakaway in the grass, and the other heading for the longer drainage channel cut through the tarmac path along the north side of the church

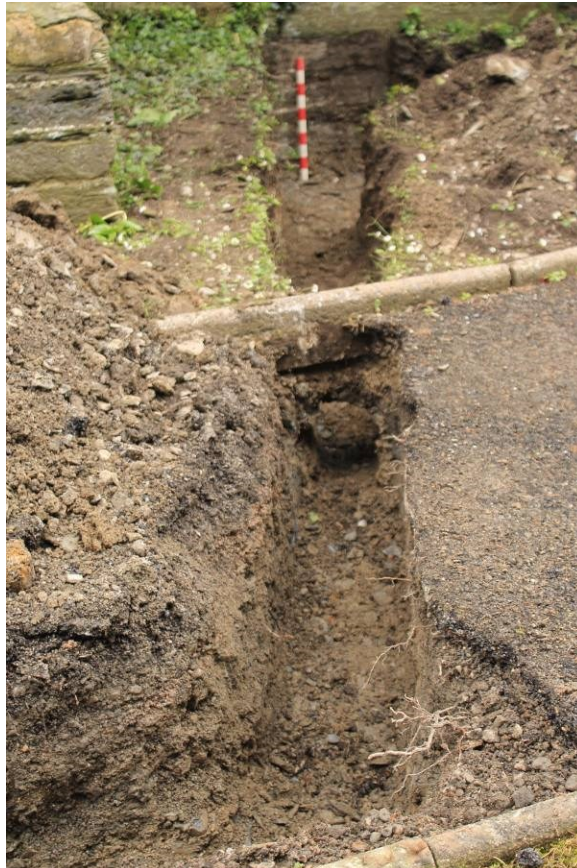
Photo 12: The short section of drainage channel excavated between the long section of drainage channel along the path and the north church wall near its west end, looking west-southwest, with a 0.5m scale

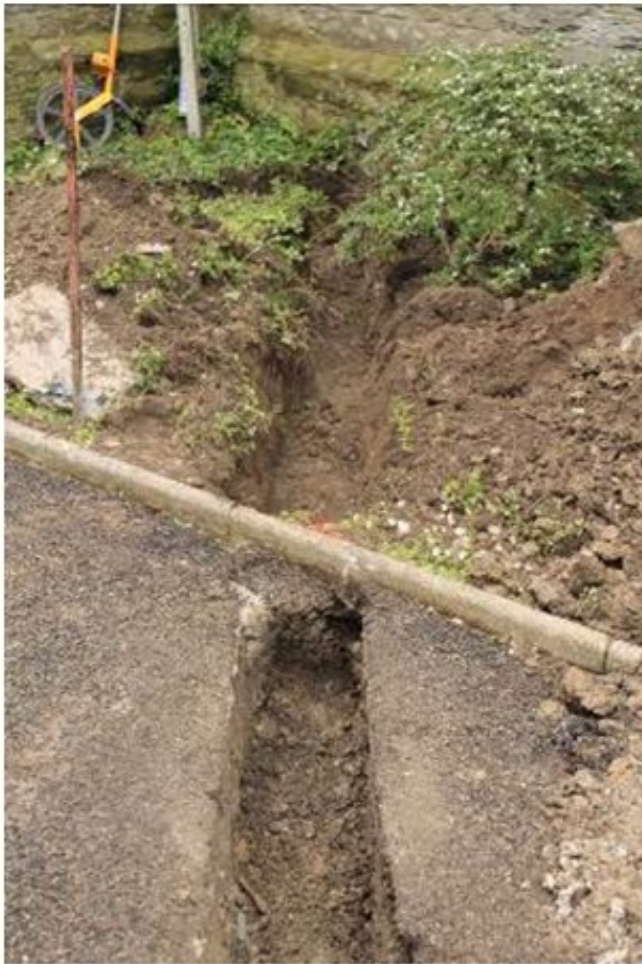
Photo 13: The short section of drainage channel excavated between north church wall near its west end and the soakaway, looking southwest

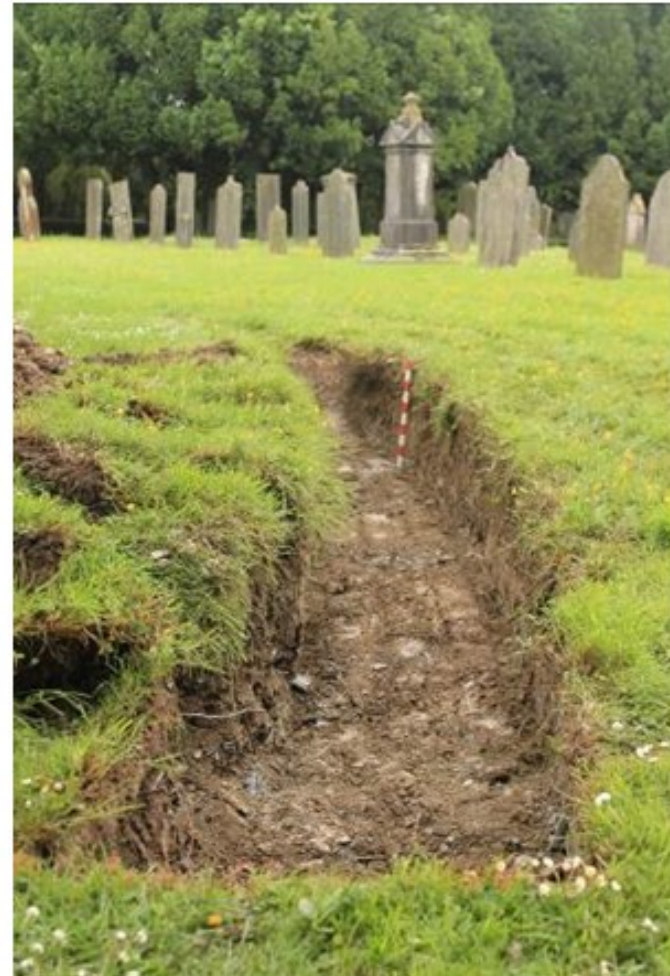
Photo 14: The new soakaway after excavation, looking northwest, with a 0.5m scale
