**HAFOD: CAE GWARTHEG FELLING  
(RECORD NO. 35850)  
ARCHAEOLOGICAL RECOMMENDATIONS**

**Report commissioned by: Forest Enterprise  
Report by: K Murphy BA MIFA**

HAFOD: CAE GWARTHEG FELLING (35850)  
ARCHAEOLOGICAL RECOMMENDATIONS

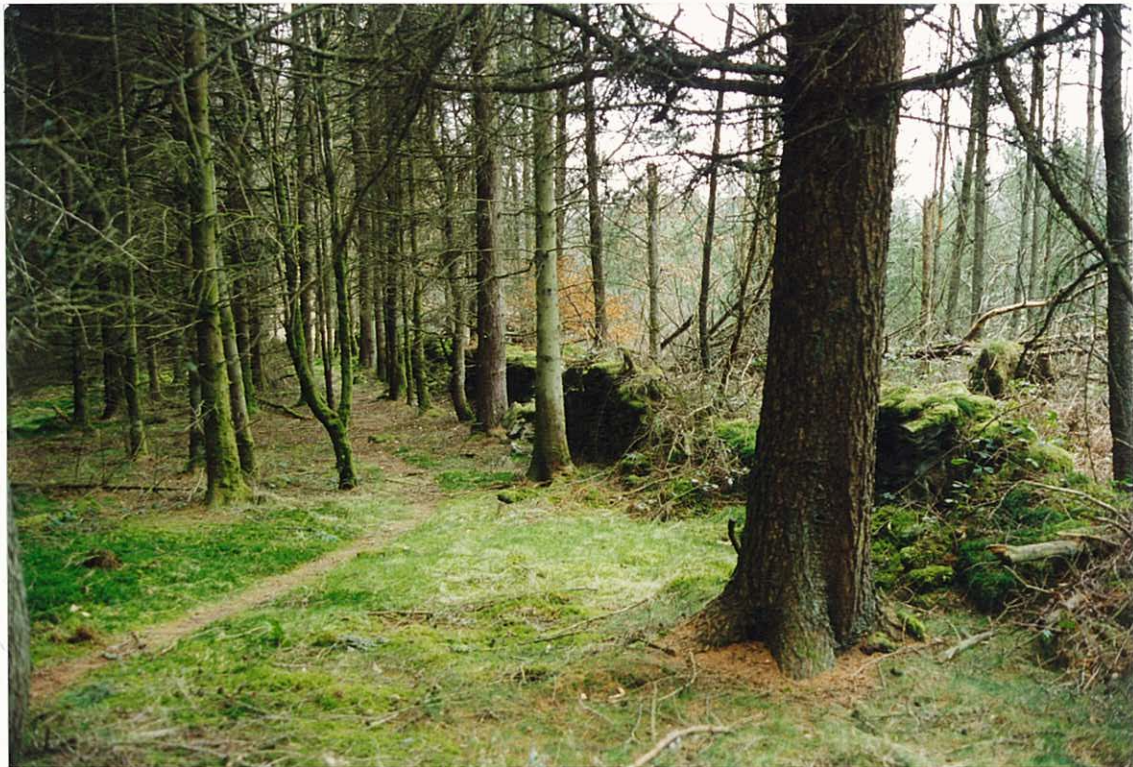
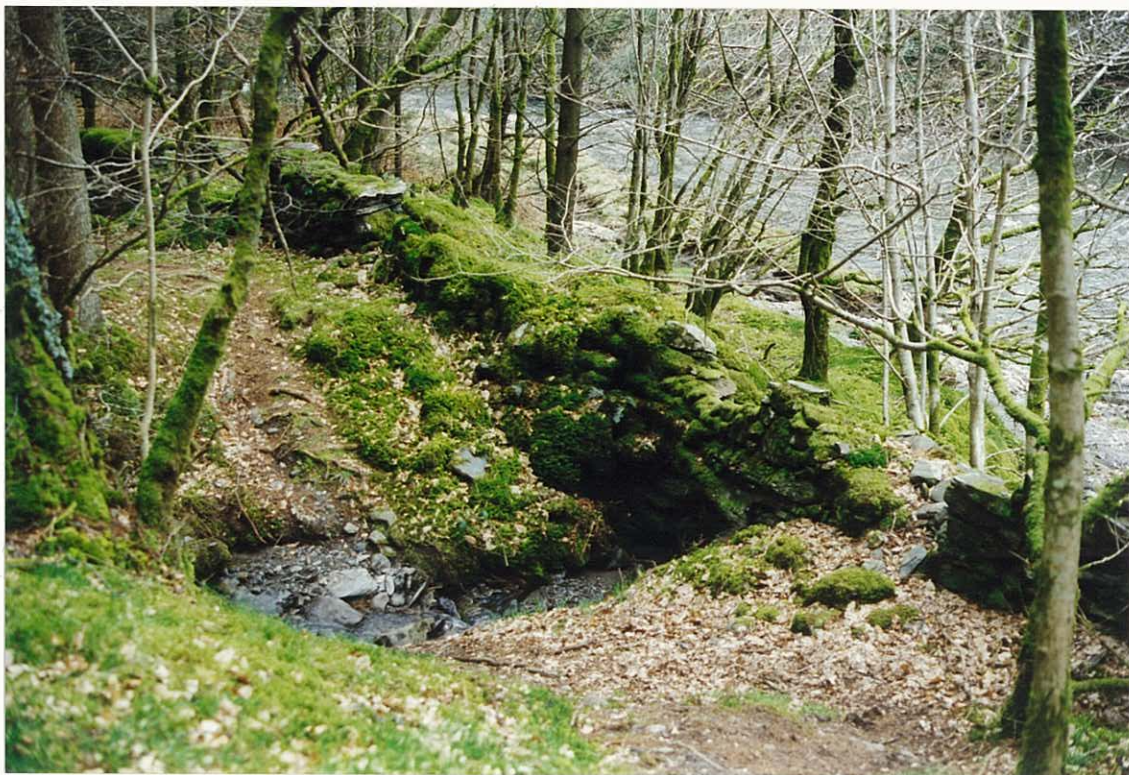
**33538. Wall** (Photos. 1 & 2. General shots). A dry-stone wall running alongside the River Ystwyth. Well-built with some capstones pitched at 45 degrees *in situ*. A gateway is present where the track 33950 crosses this wall. The wall stands in places to its full height of c. 1.5m, but is generally lower due to collapse. Some short sections of complete collapse are present. The style of the wall indicates that it may have been built by Thomas Johnes as part of his estate improvements.

*Value:* 3

*Recommendations:* Care should be taken during felling not to unduly damage this wall. Should access be required for an extraction track, then the existing gateway or one of the breaches caused by collapse should be utilised.

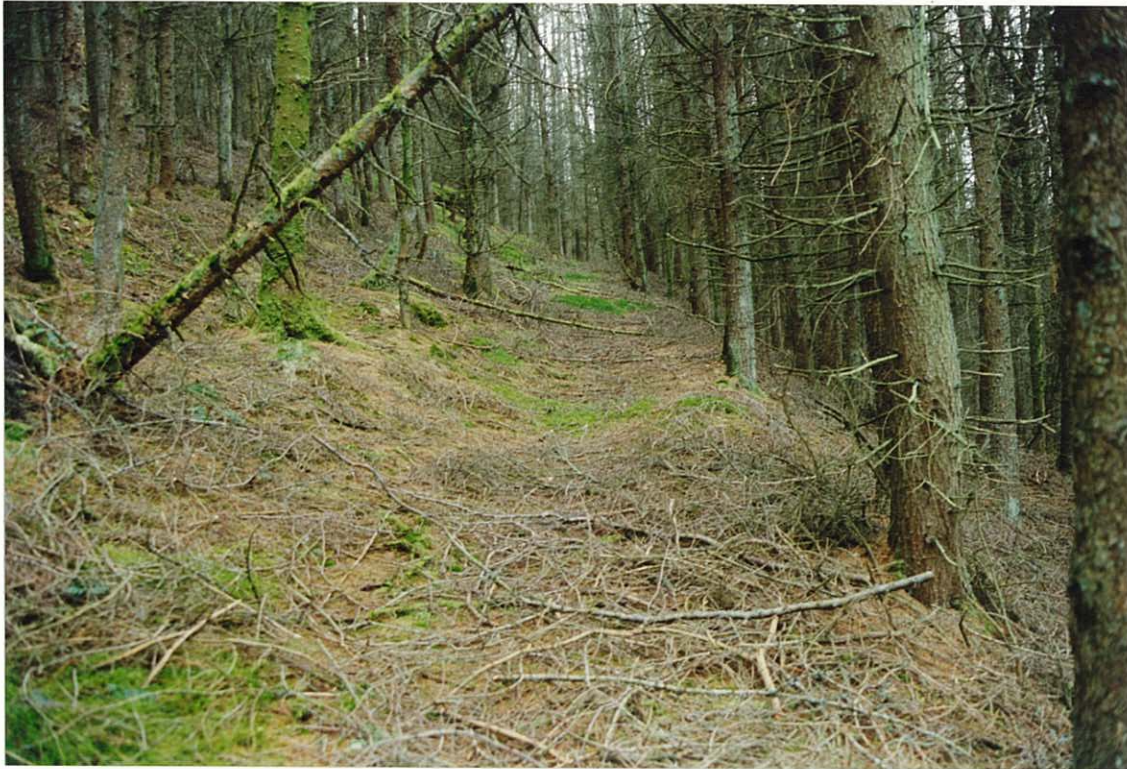
PHOTO. 3

**32950. Track** (Photo. 3. General shot). This track runs diagonally up a steep hillside on an earthwork terrace. It fades out on the higher slopes to the south-west. At its north-east end it passes through a gateway in the wall 33538 and is presumed to ford the Ystwyth as its line seems to be continued by track 32938 on the opposite bank. The date of this track is unknown - it is not shown on the Ordnance Survey 1:2500 1st Ed.

*Value:* 3

*Recommendations:* This is a robust element of the historic landscape. The only recommendation is therefore that heavy vehicles should not use this track in wet weather if there is a danger of causing deep ruts.

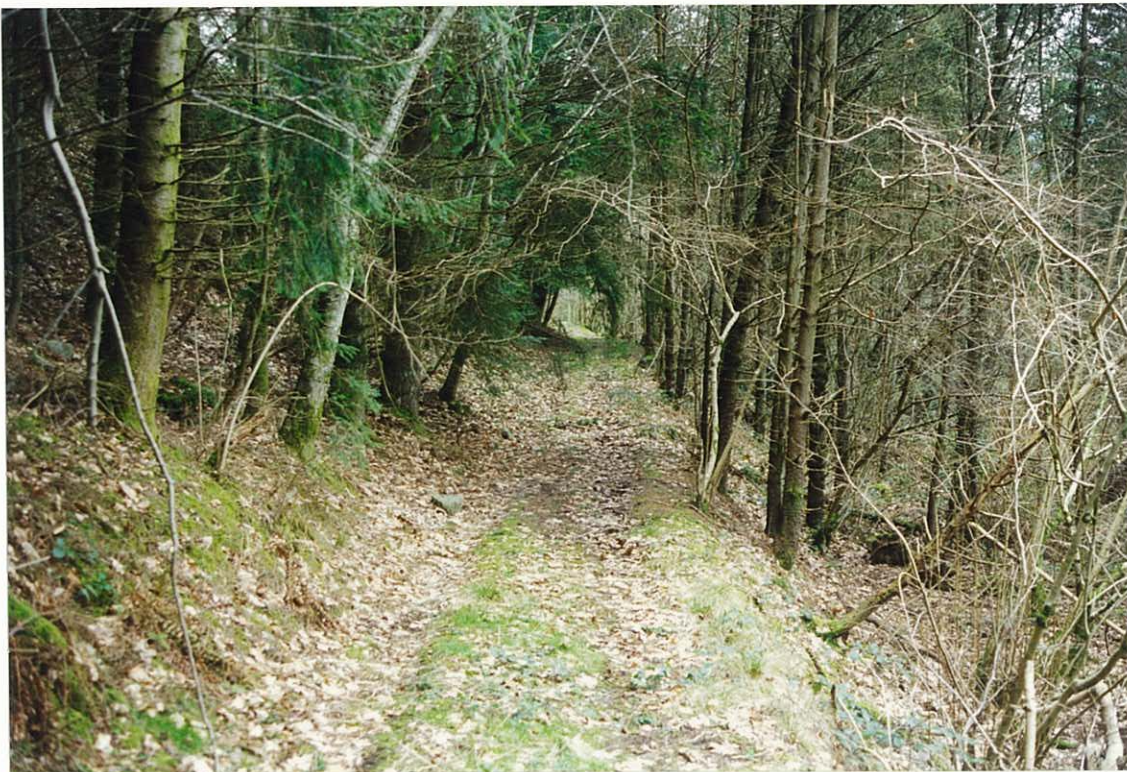
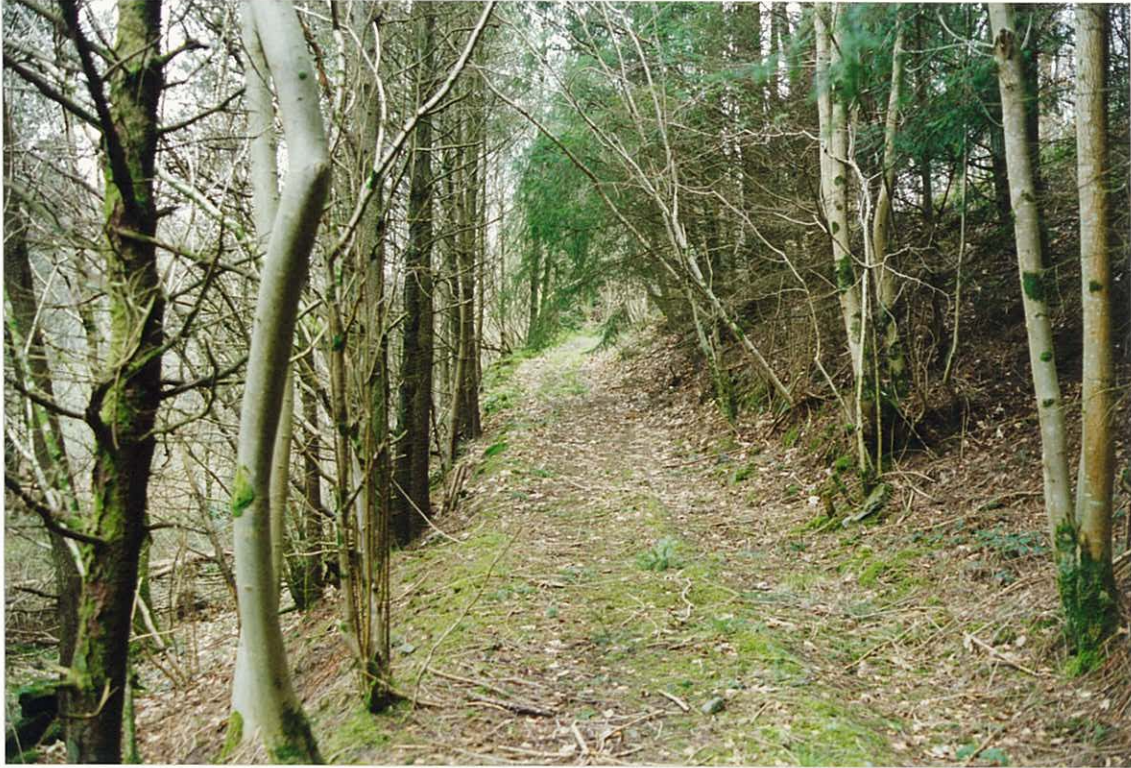
**32983. Track** (Photos. 4 & 5. General shots). On the north bank of the Ystwyth. Included here as a possible route of an extraction track from felling on the south bank. This track runs down a steep south-facing slope from a carriage drive to its north on a well-built terrace c. 3m wide. From a hairpin bend to the east the track runs across the flood plain of the Ystwyth. Here in dense undergrowth there is no physical evidence for its course. Wheeled vehicles have used this track in the recent past as rutting has revealed a cobbled/hard-core surface on the terraced section.

*Value:* 2

*Recommendations:* Should it be necessary to use this track for extraction purposes, then a new hard-core surface should be provided on its terraced section to prevent rutting and disturbance to the original surface.

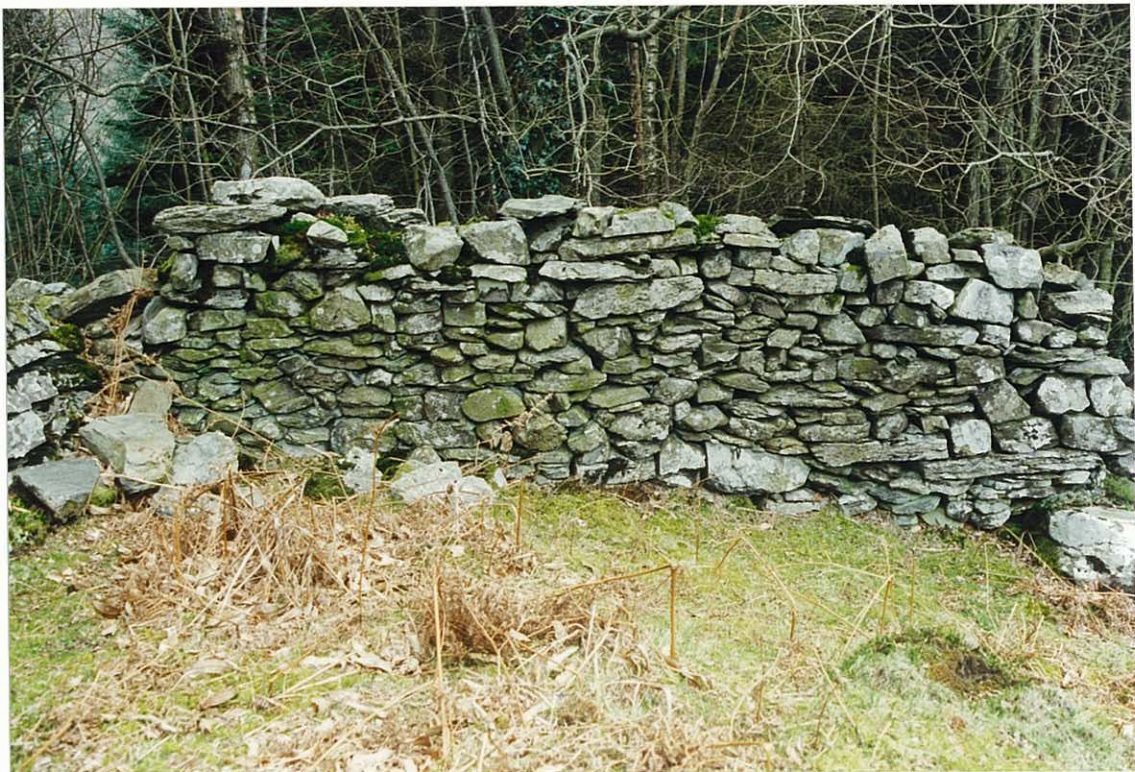
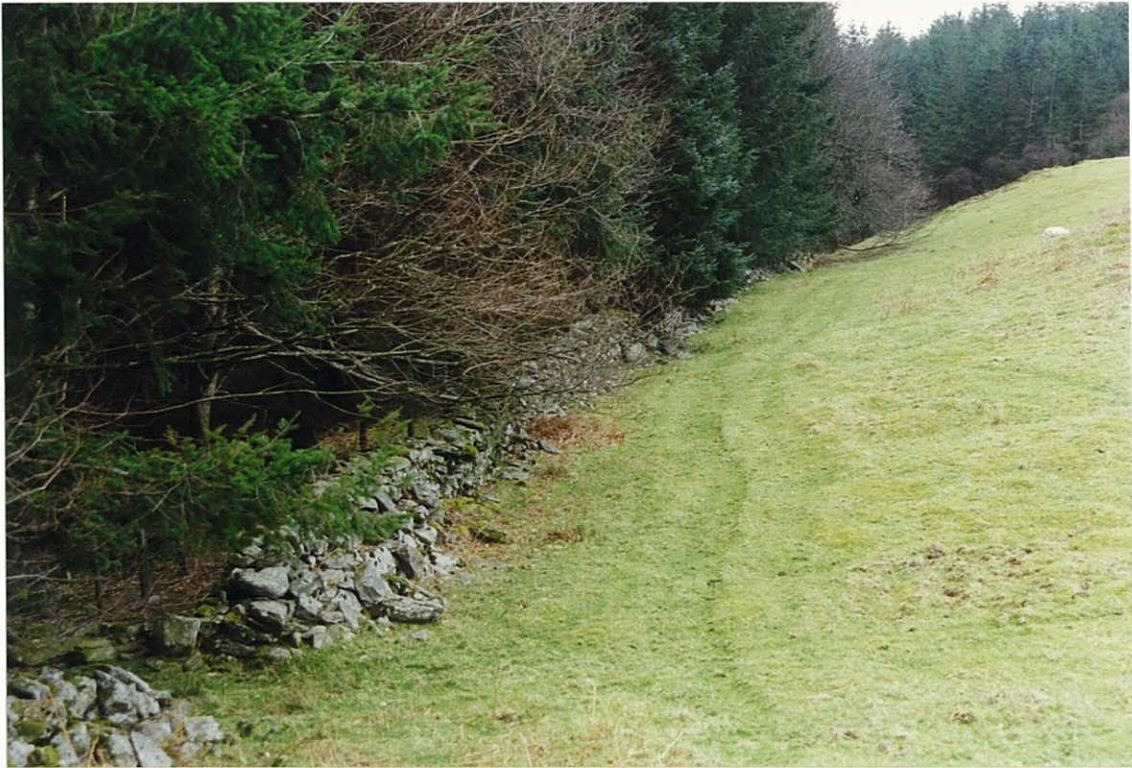
**33537A. Boundary wall** (Photos. 6 & 7. Detail of wall and general shot). This Dry-stone wall stands to its full height of c. 1.5m in a few sections with capstones pitched at 45 degrees, but is generally lower. There are some short lengths of complete collapse and several breaches have made for access. Wall probably built by Thomas Johnes during estate improvements.

*Value:* 3

*Recommendations:* Care should be exercised during felling not to further damage this wall. Should access be required for extraction then one or more of the existing breaches should be used.

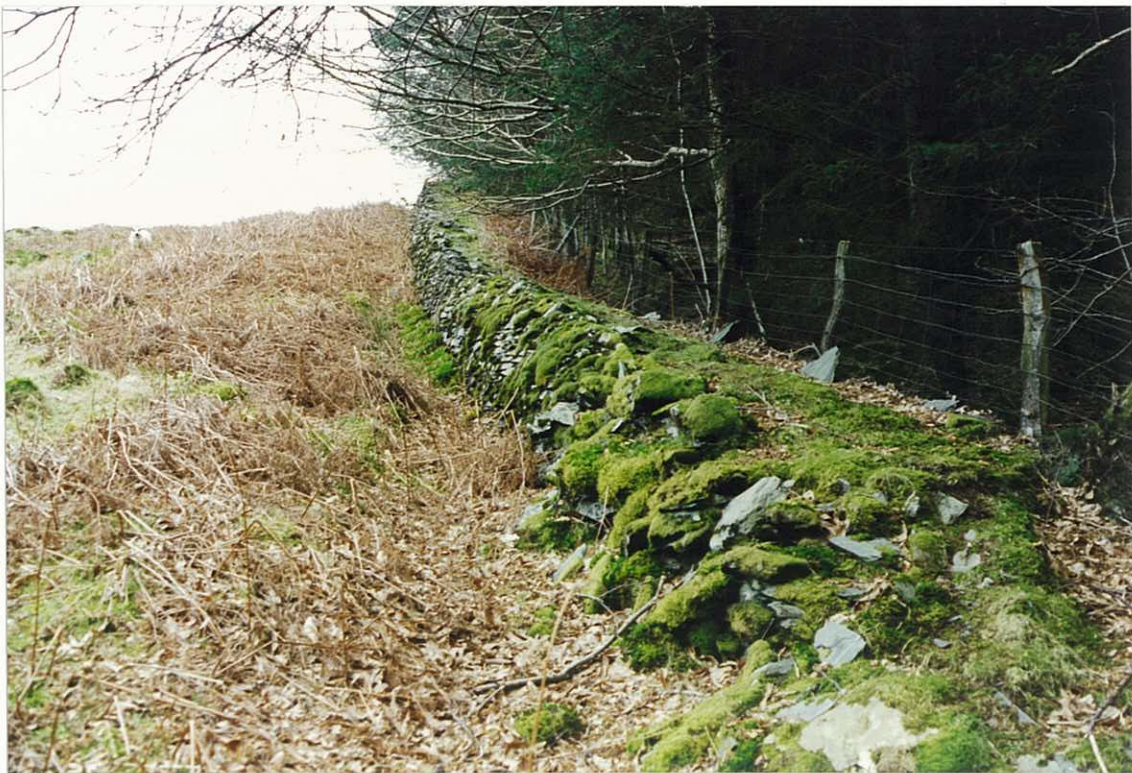
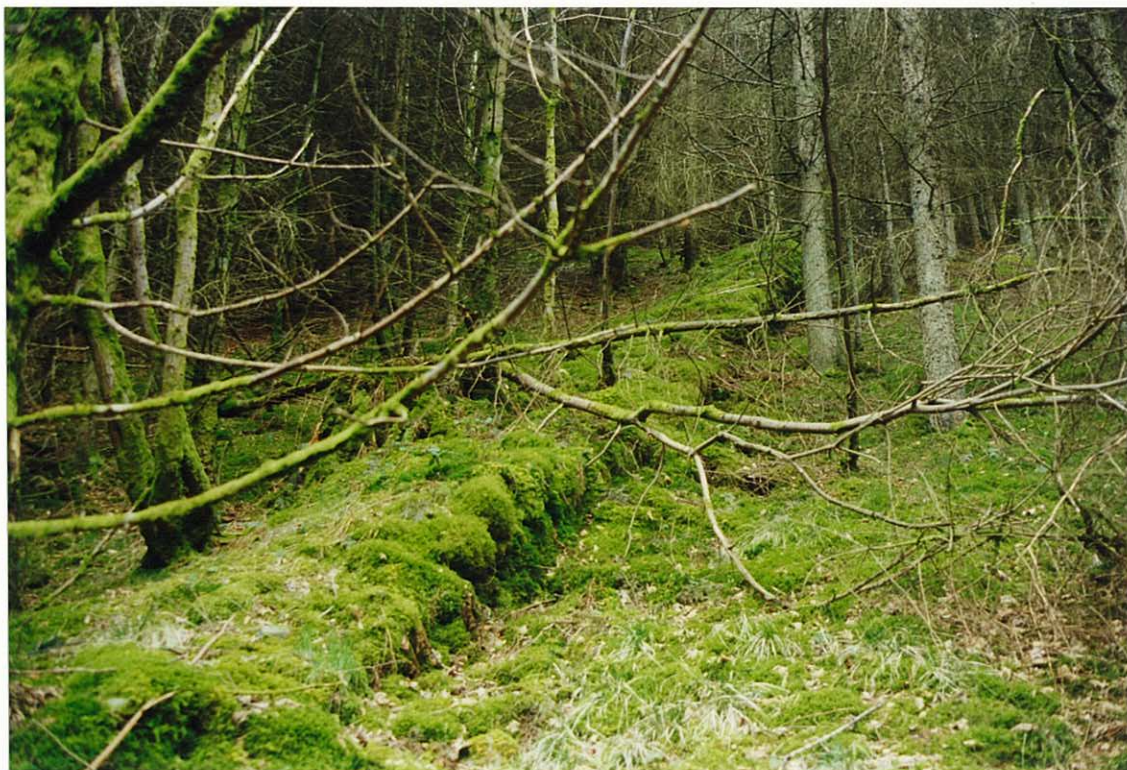
**33537B. Boundary bank/wall** (Photos 8 & 9. General shots). This boundary seems to have been originally a bank onto which a wall-facing was later added. It is generally in good condition. Its date is unknown, though the wall-face may have been added by Thomas Johnes during as part of his estate improvements.

*Value:* 3

*Recommendations:* This is a robust element of the historic landscape. Should access be required through this boundary for extraction access, then a single breach should be made. The bank/wall terminals to this breach should be restored to so prevent decay of the boundary.

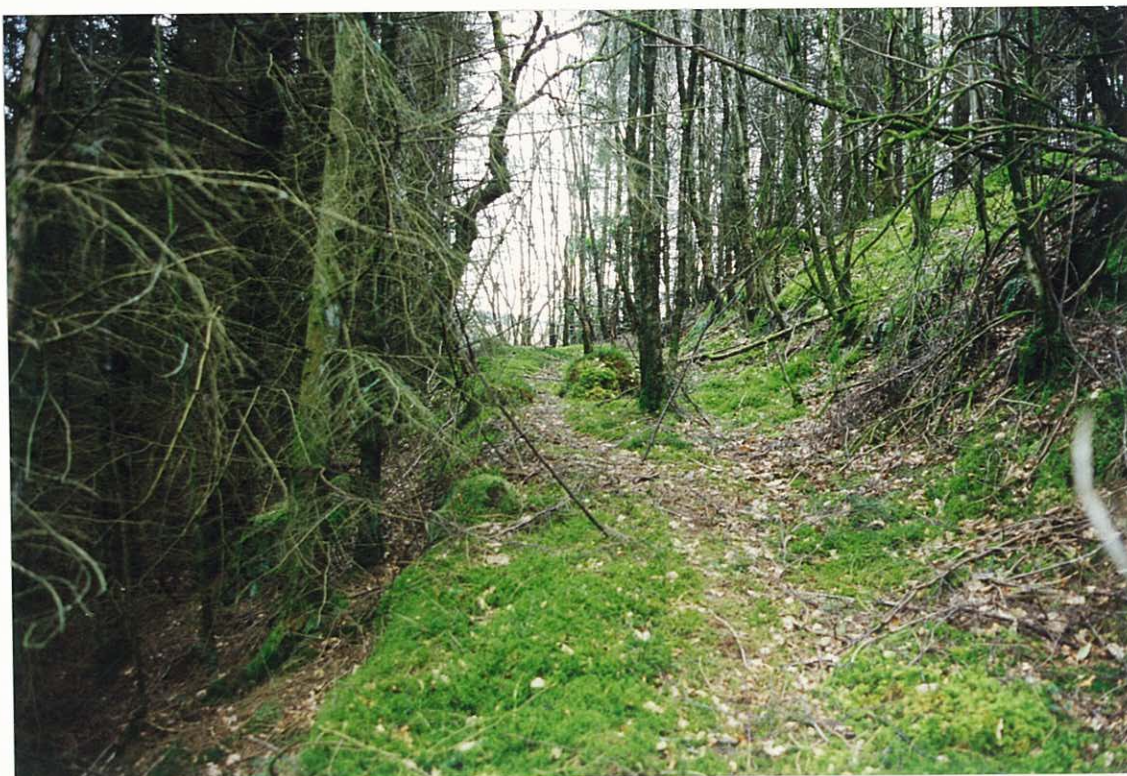
PHOTO. 10

**32949. Track** (Photo. 10. General shot). This track runs diagonally up the steep valley side on a terrace 2 - 2.5m wide. The terrace is revetted on the down-slope side by a stone wall. At the up-slope end this track is closed off by the boundary 33537B.

*Value:* 3

*Recommendations:* Elements of this track are vulnerable to damage by felling and extraction - it should not therefore be used as an extraction track. The outer edge of the track with the revetment wall is also vulnerable to damage. Logs/trees should not be dragged across this outer lip unless it is protected.

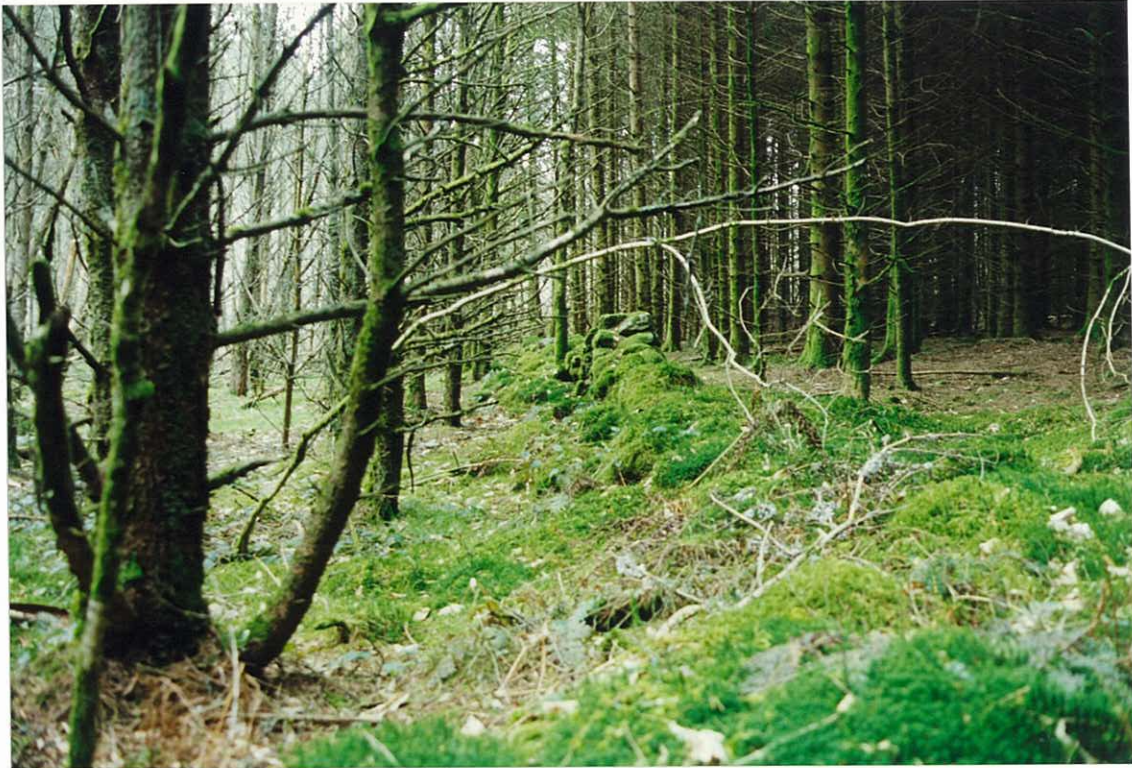
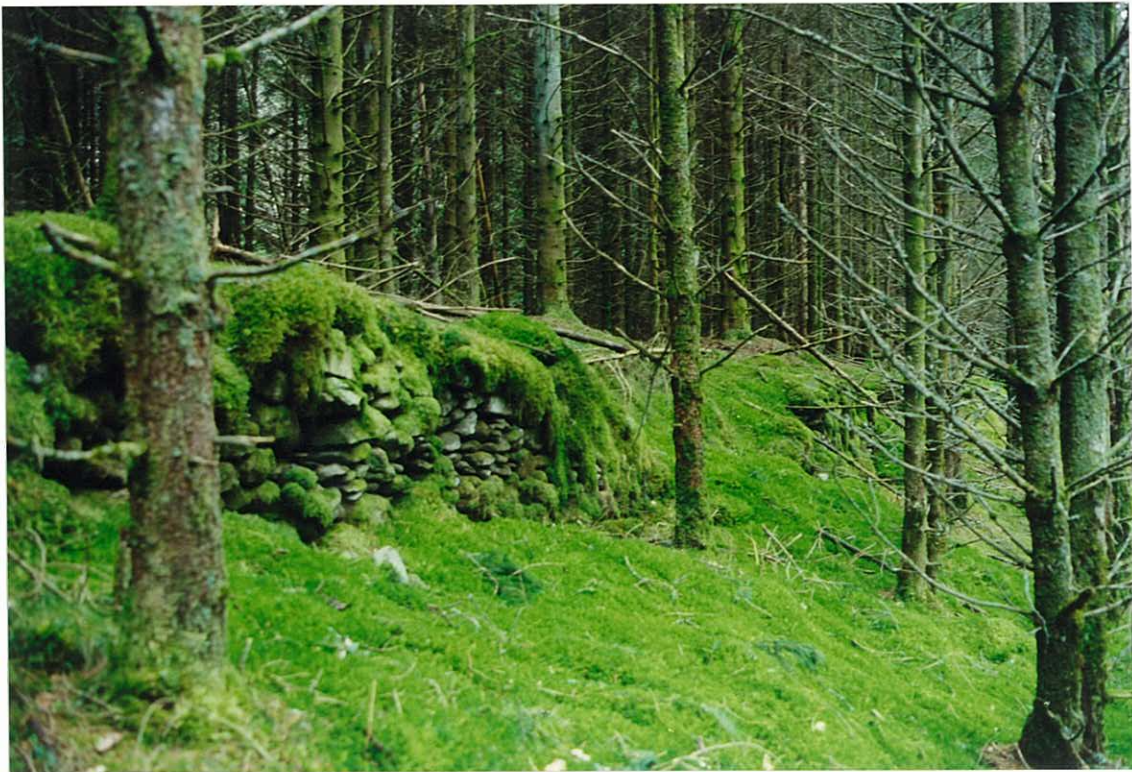
**33535. Wall** (Photos. 11 & 12. General shots). At its North-east end this dry-stone wall has collapsed. The rubble is moss-covered. Further to the south-west the wall revets a natural terrace c. 2m high. The wall is again in poor condition.

*Value:* 3

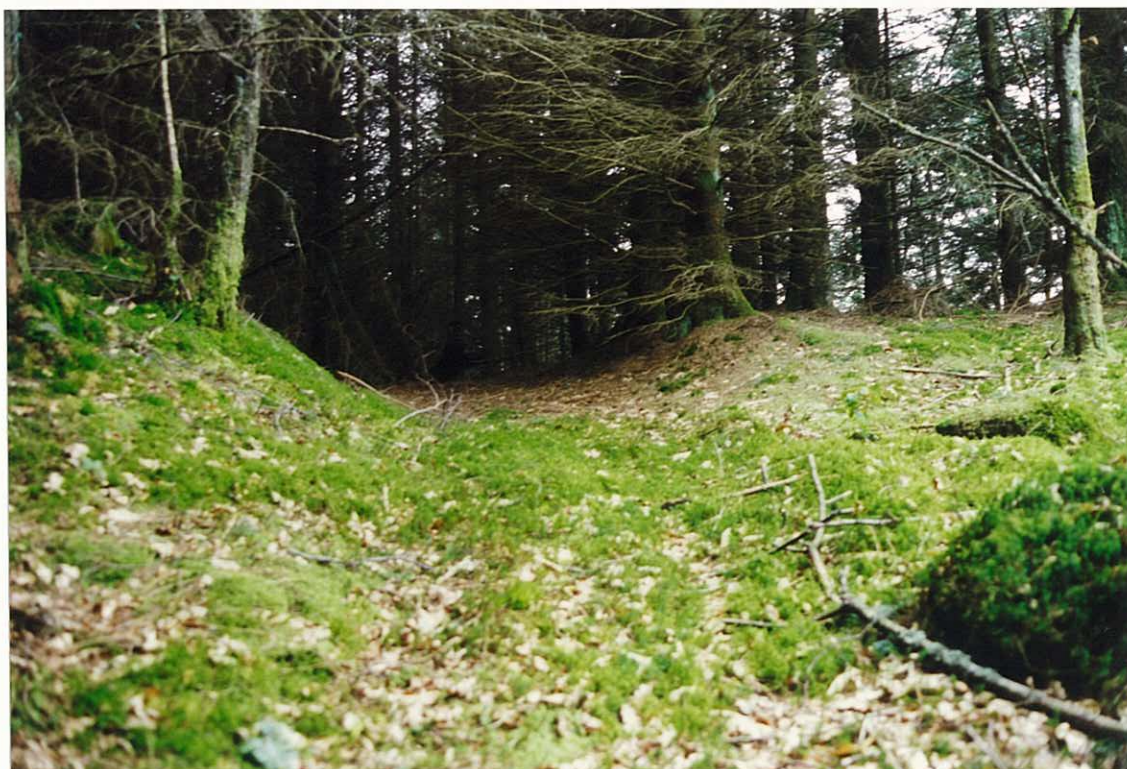
PHOTO. 13

**33540. Path** (Photo. 13. View of extraction track where it overlies path). The course of this path is not now easy to detect on the ground. Towards its south-west end a slight earthwork hollow may mark its course. At its north-east end a hollow-way over 1m deep is probably the remains of an old extraction track and overlies the course of this path.

**33541. Path.** (Photo. 13. As above). As with 33540, the line of this path is difficult to trace on the ground and its course is followed by an extraction track.

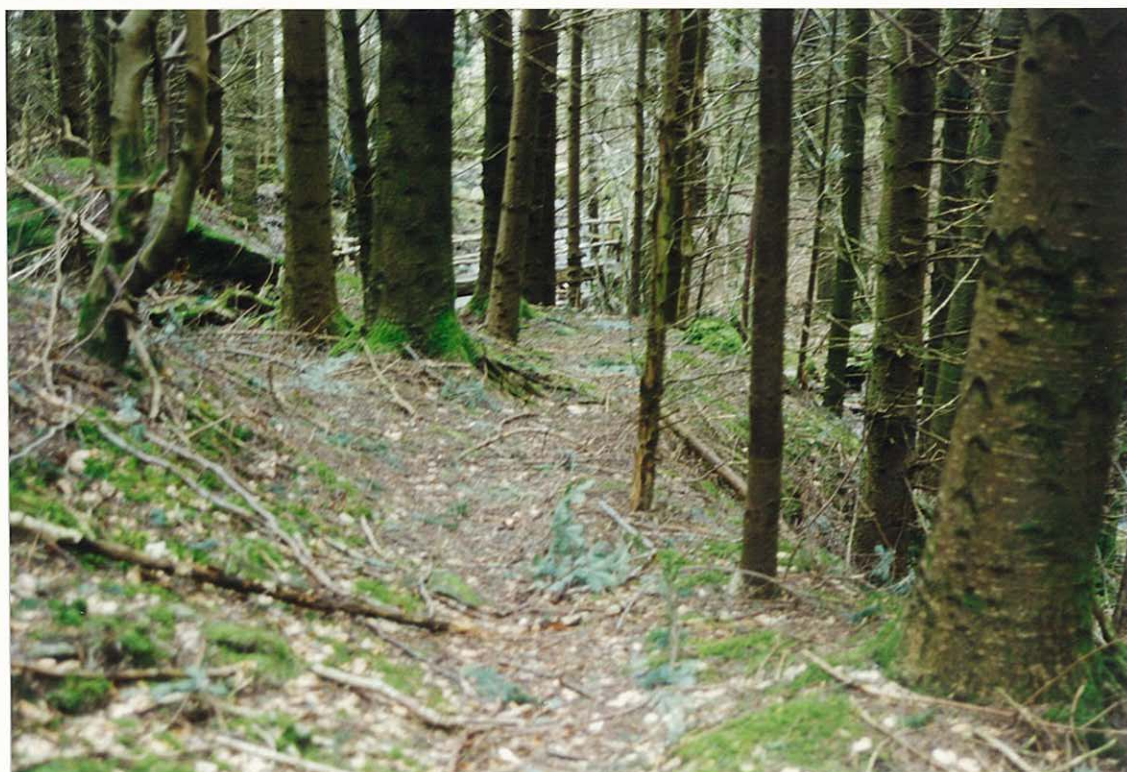
PHOTO. 14

**32954. Path** (Photo. 14. General shot). A terrace up to 2m wide leads up from the Nant Ffin bridge to the foot of a small waterfall. It is not certain if this terrace is a natural feature that has been enhanced to provide a path or is an entirely artificial feature. Either-way, the path on the terrace leads to a possible viewing point at the foot of the waterfall. Possibly created by Thomas Johnes. Conifers have been planted on the terrace.

*Value:* 3

*Recommendations:* This is a fairly robust element of the historic landscape and given its location it is unlikely that any substantial damage will occur to it during felling operations.

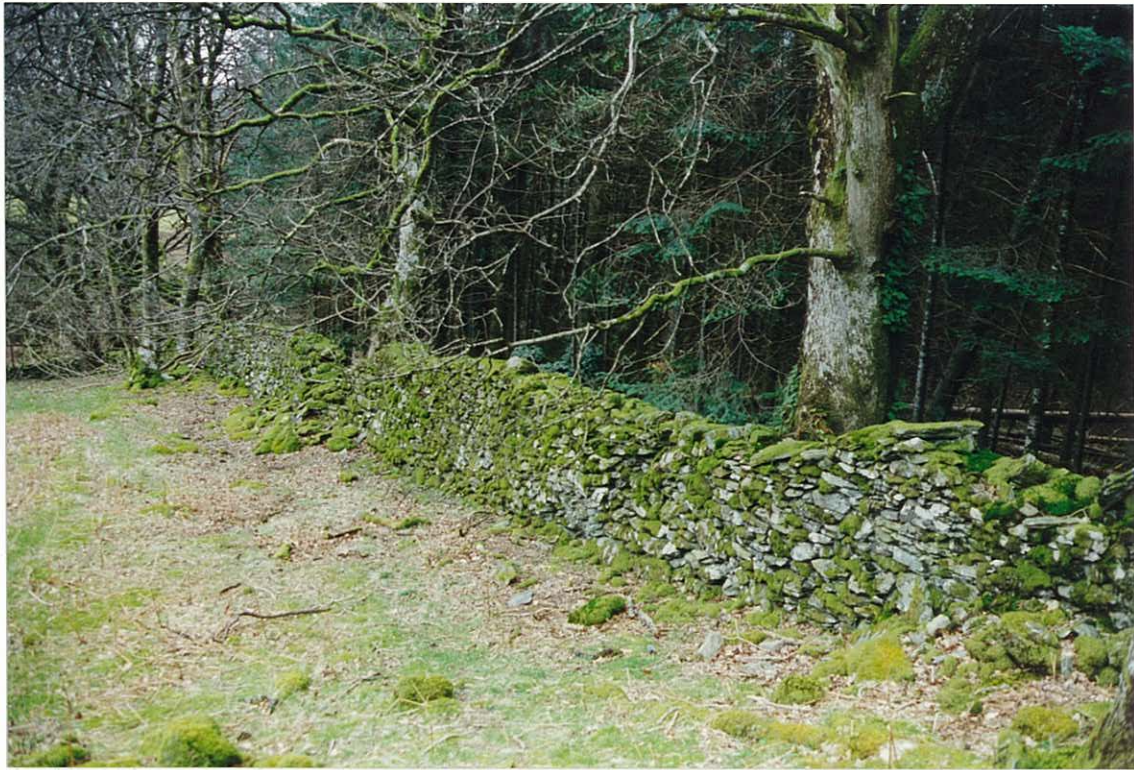
PHOTO. 15

**33563. Wall** (Photo. 15. General shot). The wall is in good general condition. In some lengths it stands to its full height of c. 1.5m with capstones set at 45 degrees *in situ*. Some areas of collapse. Broadleaf trees have been planted at regular intervals alongside this wall. This wall was probably built by Thomas Johnes as part of his estate improvements.

*Value:* 3

*Recommendations:* Precautions should be taken to ensure that no damage occurs to this wall during felling operations.

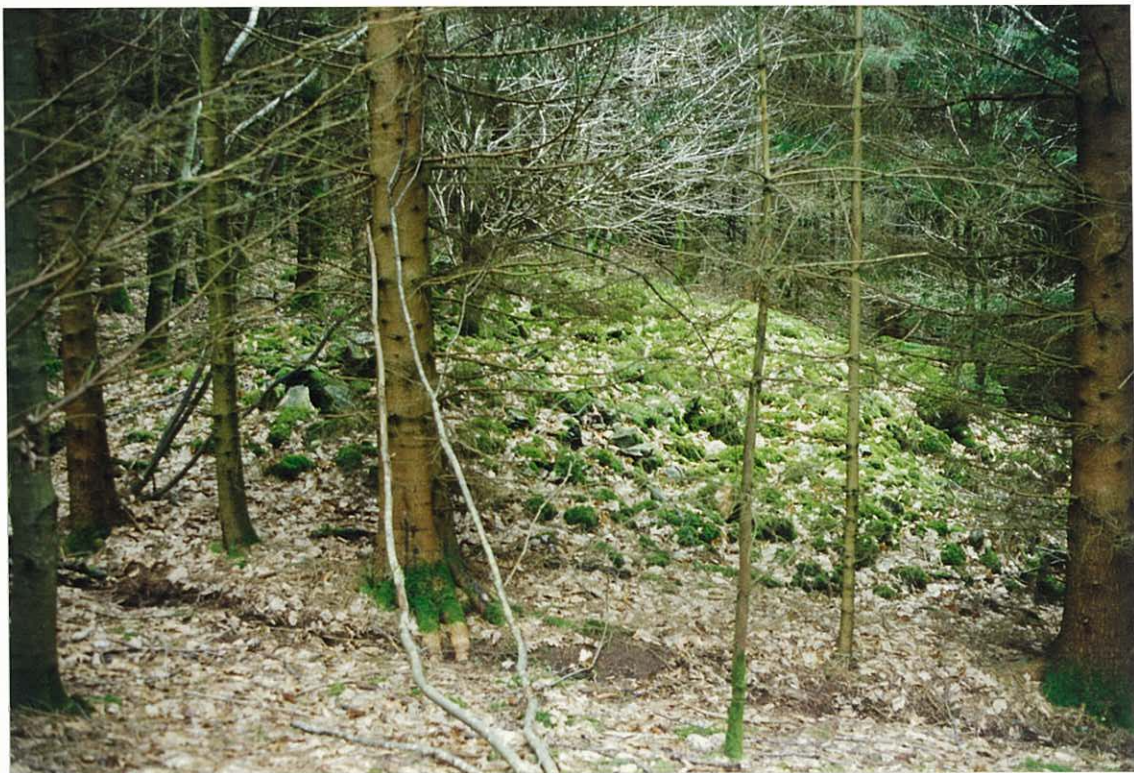
PHOTO. 16

**35416. Stone Dump** (Photo. 16). See also report *Hafod: Proposed Felling - Archaeological Recommendations*, November 1997. A massive dump of stone, c. 30m by 30m and 4m high. There is no obvious structure to this dump. Its date is unknown, but it may be the result of clearance off wall 33547 in association with the construction of the forestry drive, and therefore of recent date.

*Value:* 4

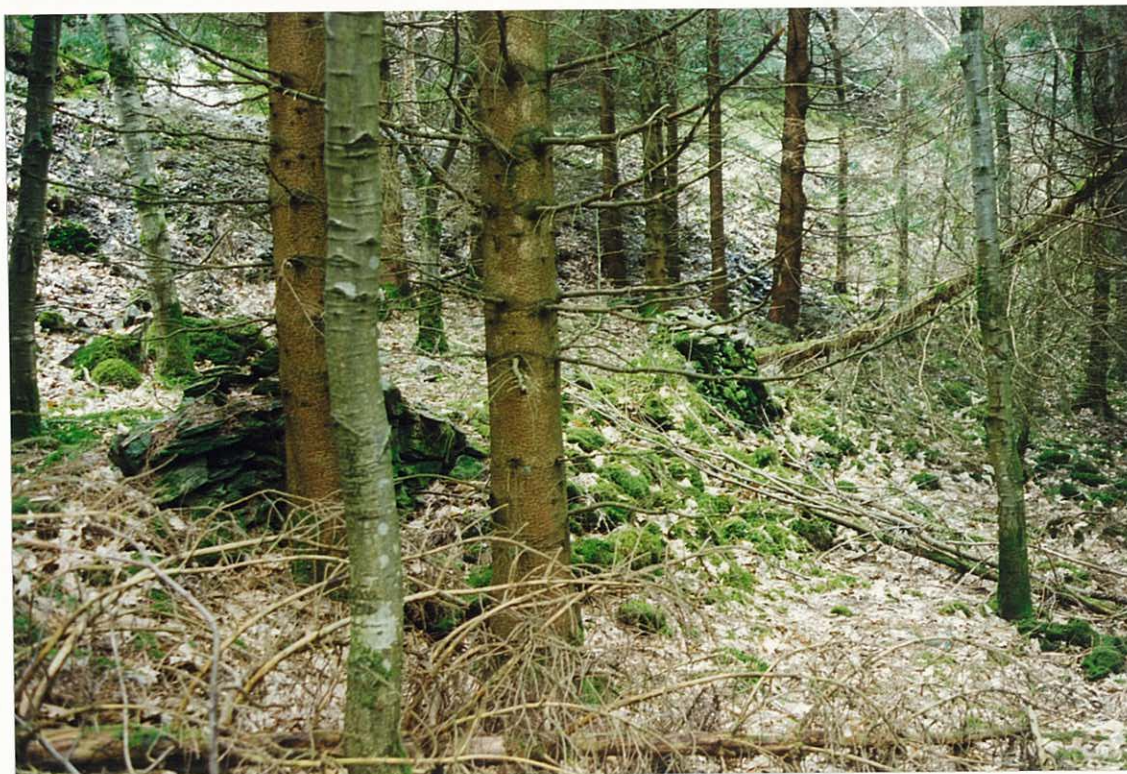
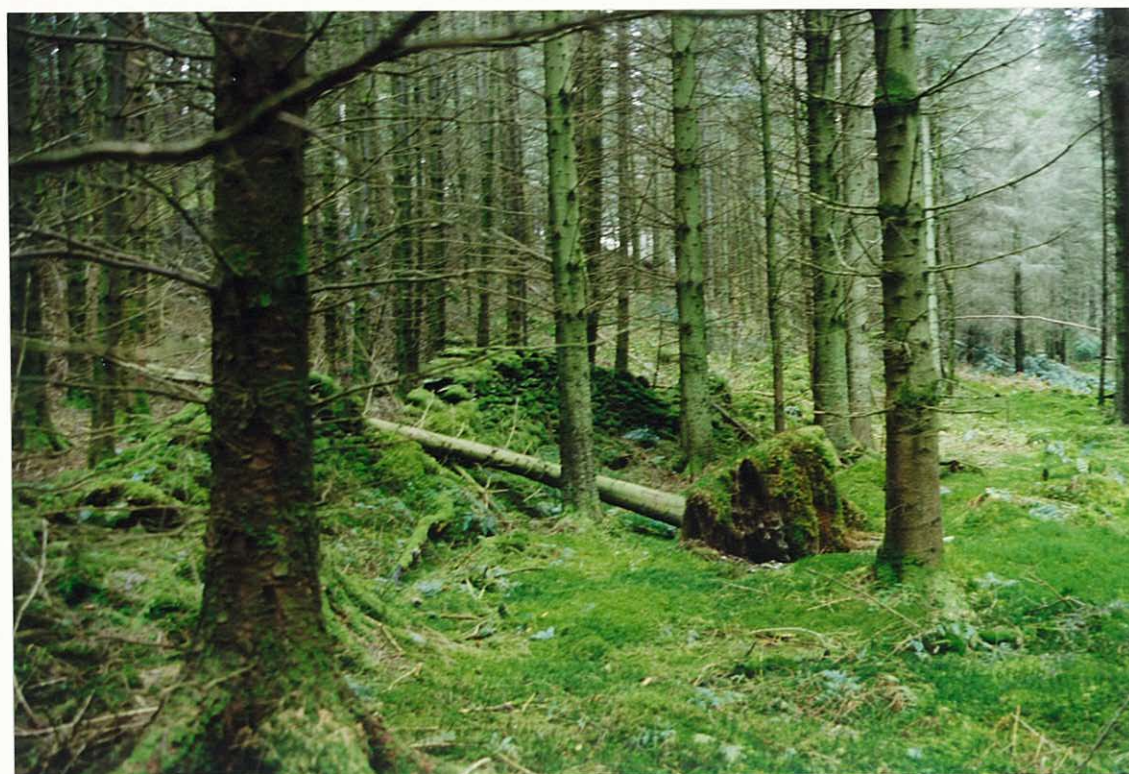
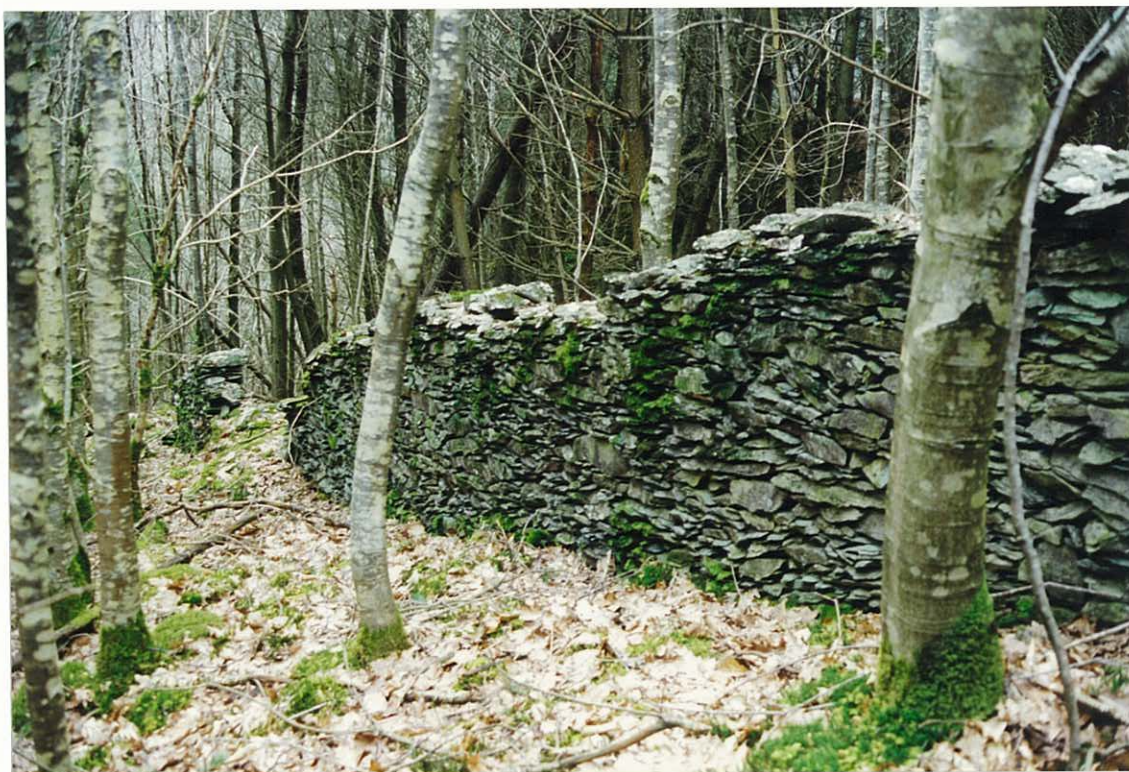
**33547. Wall** (Photos. 17, 18 & 19. General shots and detail of wall). See also report *Hafod: Proposed Felling - Archaeological Recommendations*, November 1997. A well-built dry-stone wall which survives to its full height complete with capping stones in several places, but generally it is beginning to collapse and stands to less than 1m high. At A it has been breached for access. To the south-west of A it has been mostly buried or destroyed by a forestry drive, though at its far south-west end it is in better condition.

*Value:* 3

*Recommendations:* Access across/through for extraction should be via the already created breach at A. Creating further breaches in the wall should be avoided, but if necessary these should be made where the wall is in a collapsed state.

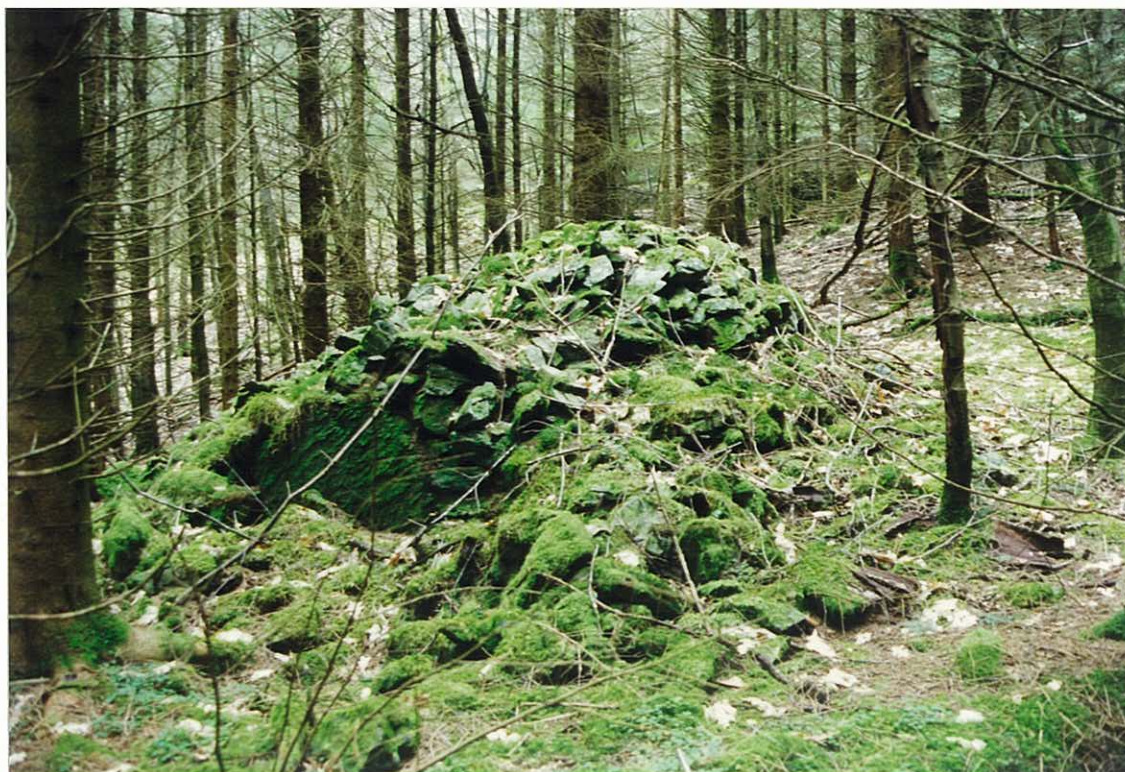
PHOTO. 20

**35847. Stone dump** (Photo. 20). Conical dump of stone, 6m diameter, 3.5m high. On the north side a revetment wall to this dump indicates some structure. Possible deposited as a result of the demolition of wall 33547 during forest drive construction and therefore modern.

*Value:* 4

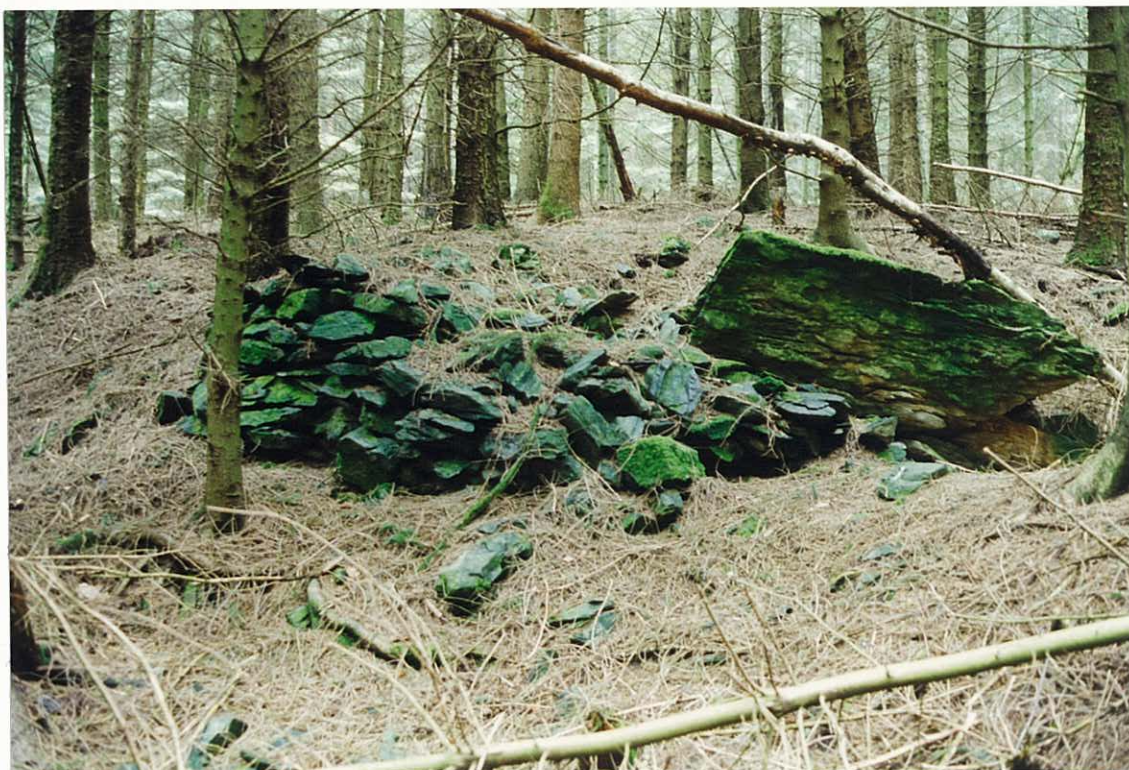
PHOTO. 21

**35848. Stone dump** (Photo. 21). Dump of stone approximately 4m across and 2m high, revetted with by a dry-stone wall on the north side. As with 35847 and 35416 it is probably derived from the demolition of wall 33547 and is of modern date.

*Value:* 4

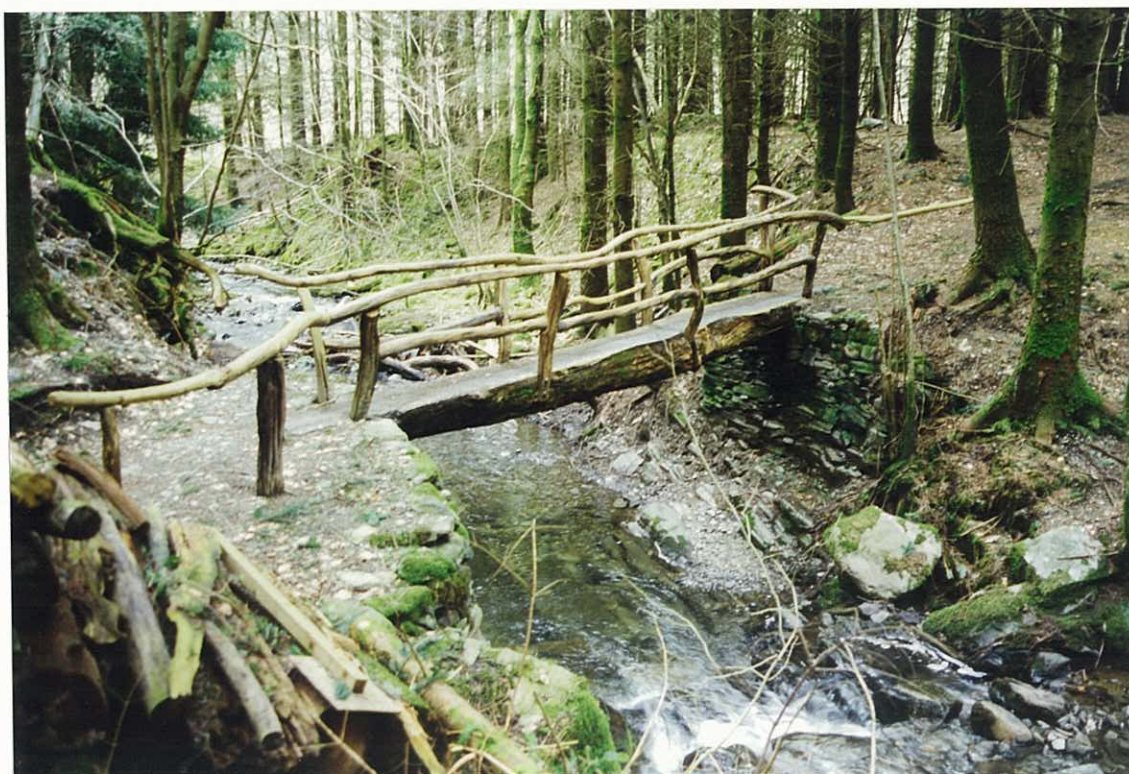
PHOTO. 22

**32948. Nant Ffin Bridge** (Photo. 22). The style of the dry-stone abutments on this bridge suggest that it may be of late-18th century date and connected with Thomas Johnes's improvements. The bridge has now been restored for pedestrians - its lies on a public footpath.

Value: 2

Recommendations: Care should be taken during felling so that no damage occurs to this bridge.

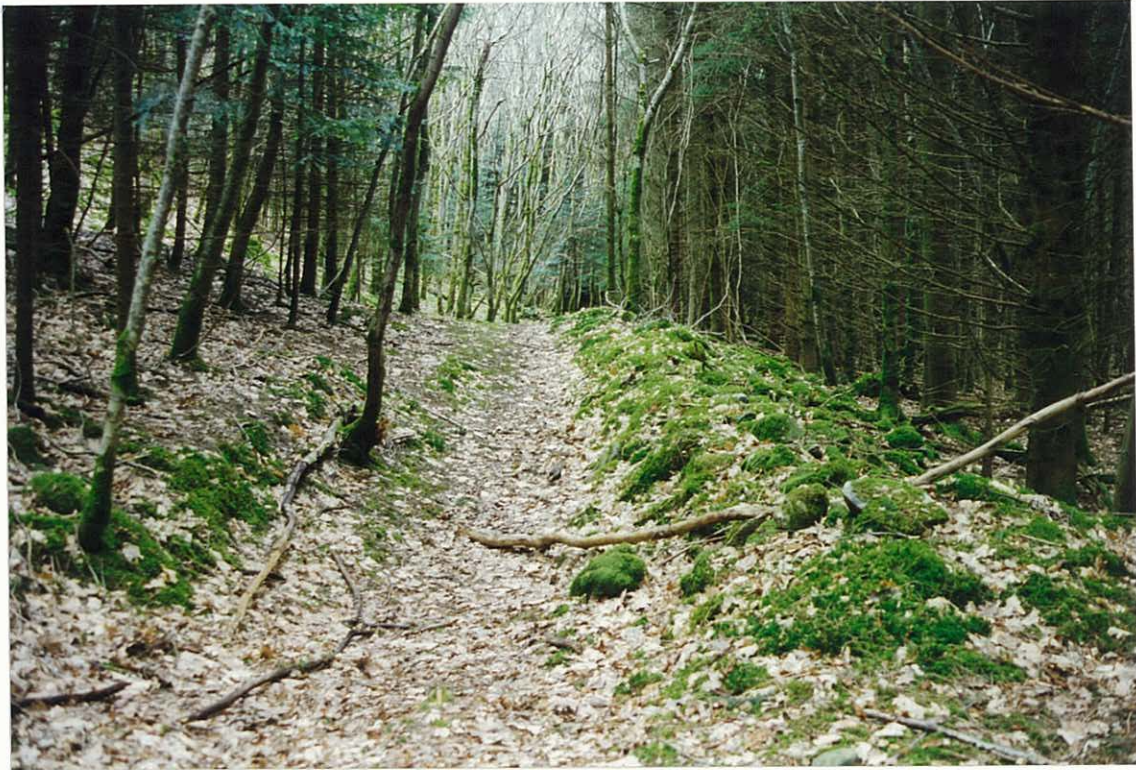
PHOTO. 23

**32947. Wall** (Photo. 23. Wall to right of track 32946). See also report *Hafod: Proposed Felling - Archaeological Recommendations*, November 1997. A ruined dry-stone wall. Mostly represented by a low rubble bank with hardly any upstanding masonry. There is a breach/low point in the rubble bank at A adjacent to a small stream. This may be a route used for extraction in the past. The wall encloses a roughly rectangular area which may have been a garden.

Value: 3

Recommendations: Action should be taken to prevent further damage to the wall. The breach at A should be used as the access point through across the wall. No new breaches should be made.
