**HAFOD: CAE GWARTHEG FELLING  
(RECORD NO. 35850)  
ARCHAEOLOGICAL RECOMMENDATIONS**

**Report commissioned by: Forest Enterprise  
Report by: K Murphy BA MIFA**

HAFOD: CAE GWARTHEG FELLING (35850)  
ARCHAEOLOGICAL RECOMMENDATIONS

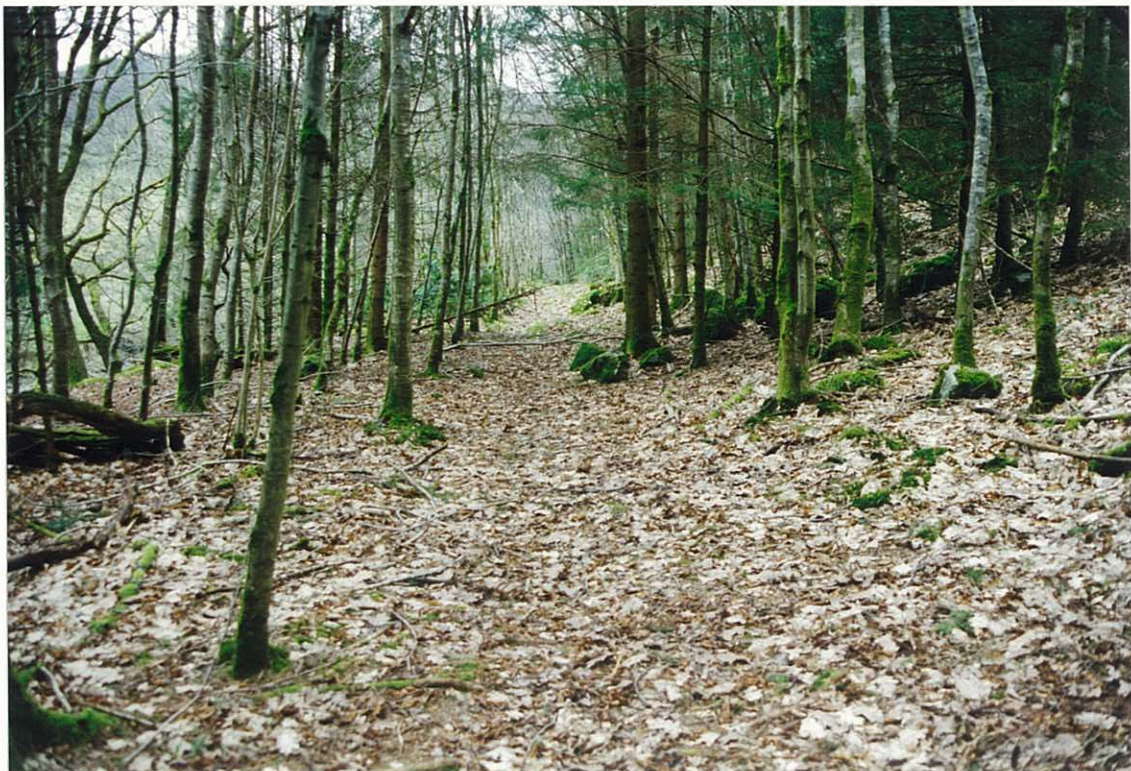
PHOTO. 24

**32946. Nant Ffin Track** (Photos. 23 & 24. General shots). See also report *Hafod: Proposed Felling - Archaeological Recommendations*, November 1997. Towards the Alpine Bridge this track runs along a distinct terrace cut into the valley side. On flatter ground by the wall 32947 and Nant Ffin, its exact course is not clear though its general line is not in doubt. Perhaps created by Thomas Johnes in the late-18th century. Now followed by a public footpath.

Value: 2

Recommendations: Where the track runs along level ground the potential damage is slight. There is the potential for damage where the track runs on the terrace. Here the dragging of felled trees across the track should be avoided, or if this is not possible the outer lip of the terrace should be protected where trees are dragged across it.

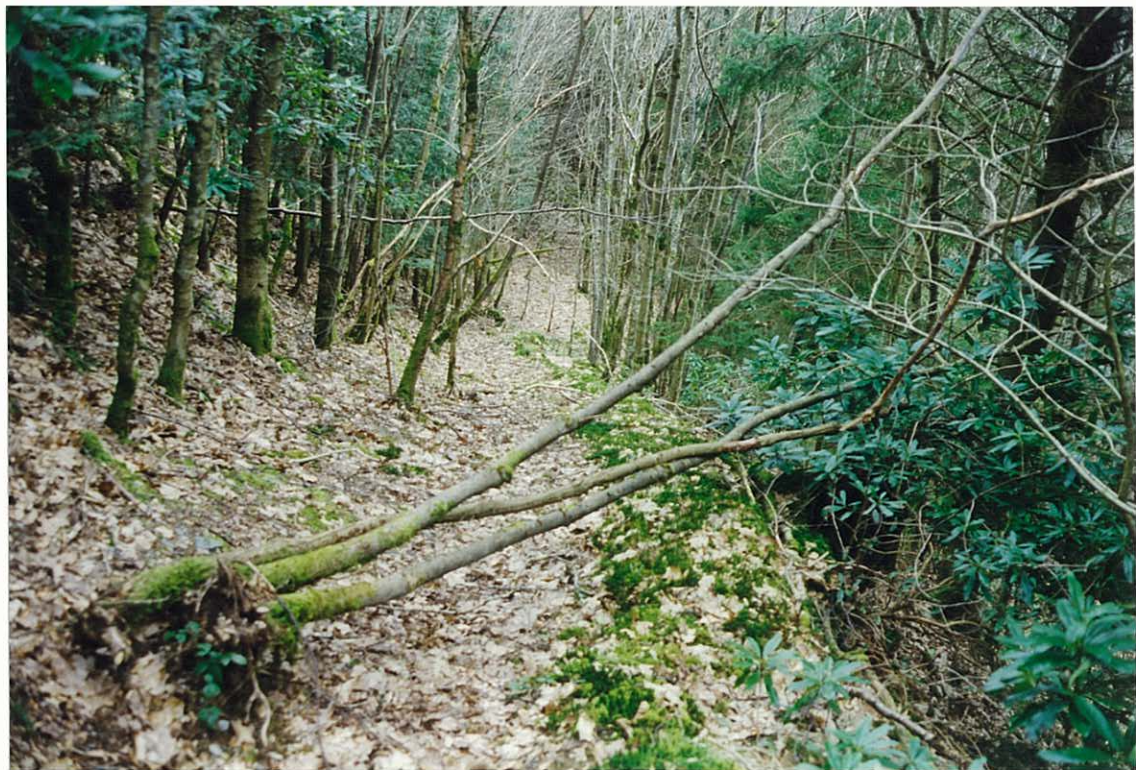
PHOTO. 25

**32958. Path/Track** (Photo. 25. General shot). This track/path runs diagonally up a steep slope on a 3m wide terrace which is revetted on the down-slope side by dry-

stone walling. Surface disturbance at its lower end suggests that this track may have been used for extraction purposes in the past.

*Value:* 3

*Recommendations:* This track should not be used for extraction purposes. Care must be taken to prevent damage to the potentially vulnerable outer lip of the track during felling and extraction.

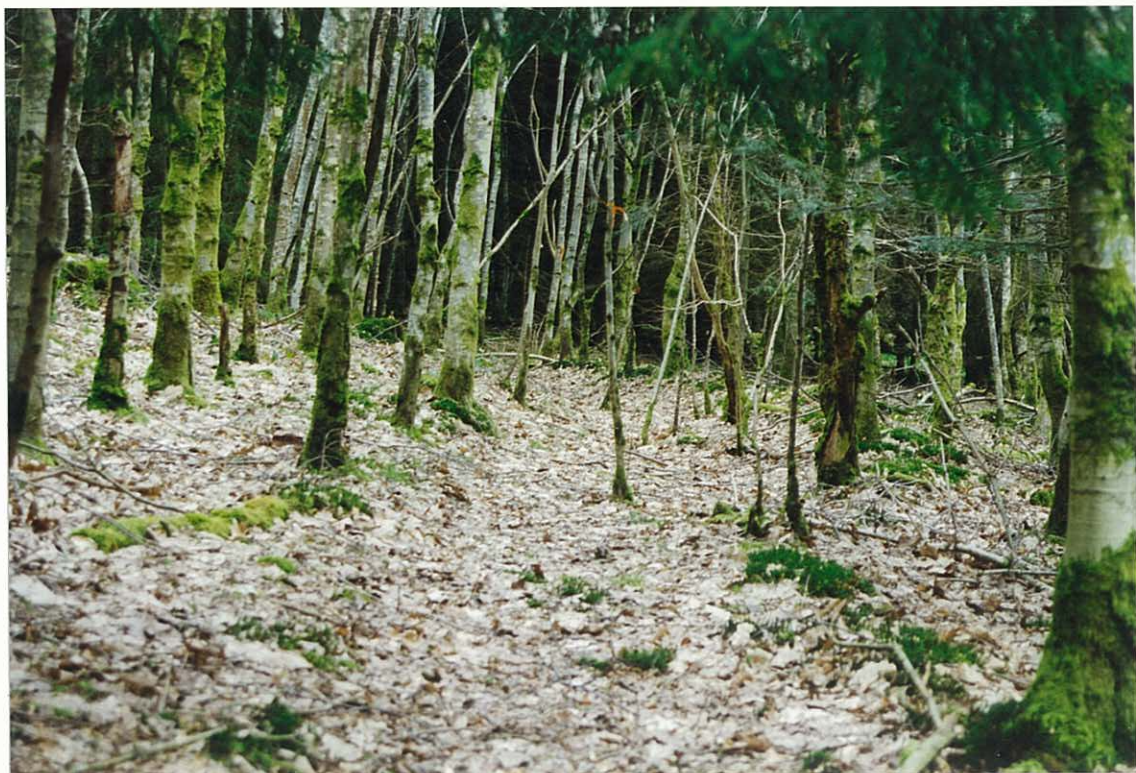
PHOTO. 26

**32959. Path.** (Photo. 26. Showing low linear hollow at west end). See also report *Hafod: Proposed Felling - Archaeological Recommendations*, November 1997. At the eastern end there is no clear trace of this path on the ground. To the west of wall 33547, it exists as a linear hollow some 2m wide and 0.3m deep with a low bank to the north-west. Further to the south-west its course becomes lost amongst ruts and hollows caused by extraction. It is likely that here the course of the path is followed by an extraction track.

*Value:* 3

*Recommendations:* The surviving earthwork element of this path to the west of wall 33547 should be protected from damage during felling and extraction.

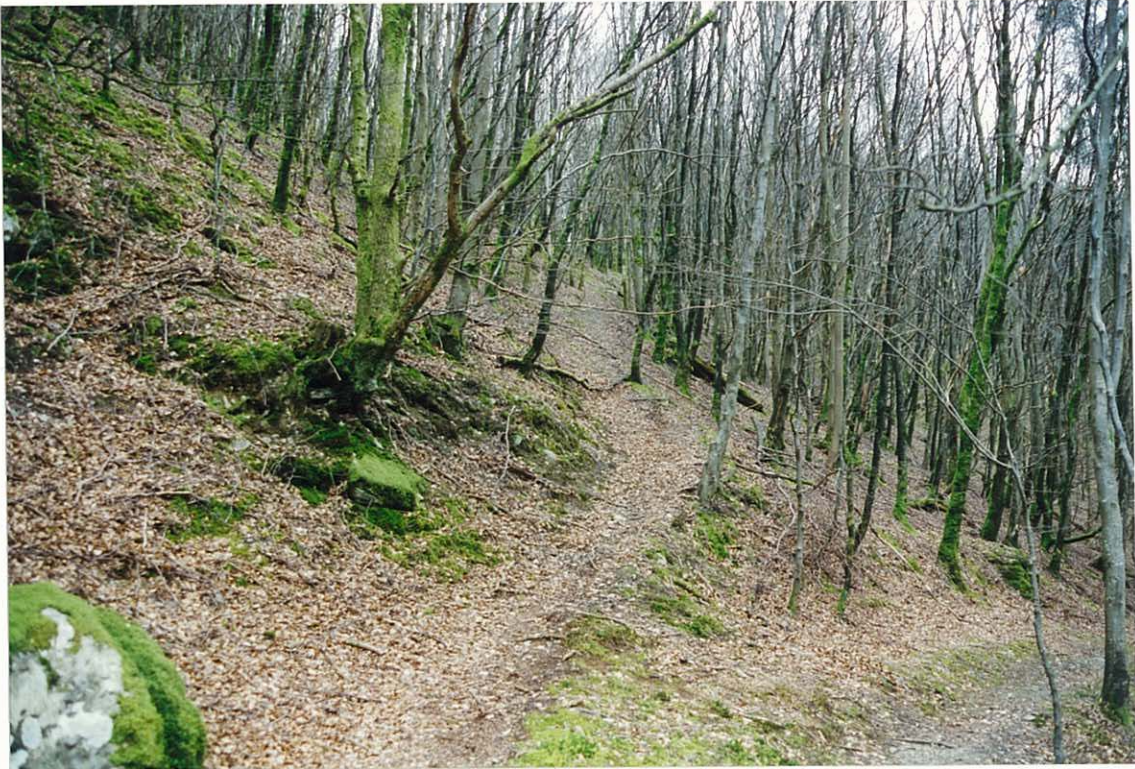
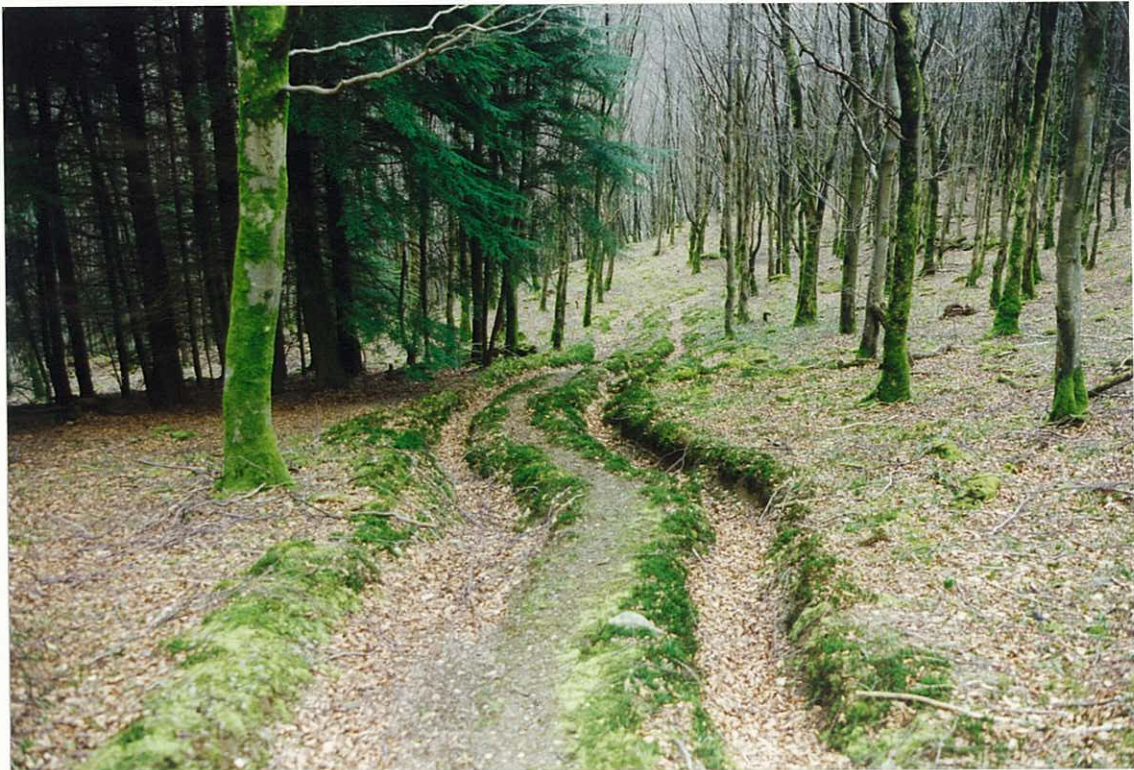
**32956. Path** (Photos. 27 & 28. 27 shows terrace on lower slopes. 28 shows rutting on higher slopes). This path runs up a steep valley side from the Alpine Bridge. On the lower slopes this path is located on a distinct terrace cut into the valley side. On the higher slopes wheeled vehicles have caused deep rutting and the line of the path cannot be traced. Its date is uncertain: it may be the work of Thomas Johnes.

*Value:* 2

*Recommendations:* Action should be taken to ensure that the terraced section of this path on the lower slopes is not damaged during felling or extraction.

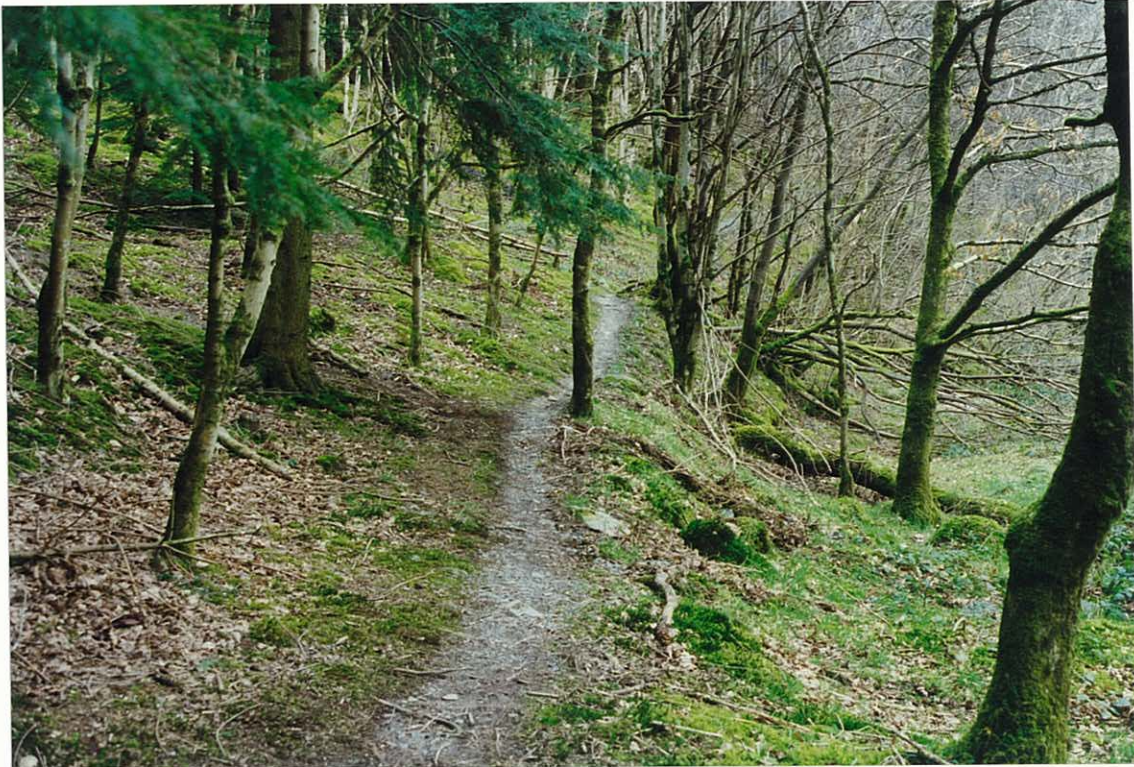
PHOTO. 29

**32992. Path** (Photo. 29. General shot). This is a worn path, there is no indication of engineering. At its western end it runs diagonally down a steep valley side from the terrace of track 32994. It crosses Nant Bwlch Gwallter by a simple railway-sleeper bridge. This path has been recently incorporated into a Hafod circular walk.

*Value:* 3

*Recommendations:* Because of its location and slight physical remains it is unlikely that this feature will suffer any damage during felling.

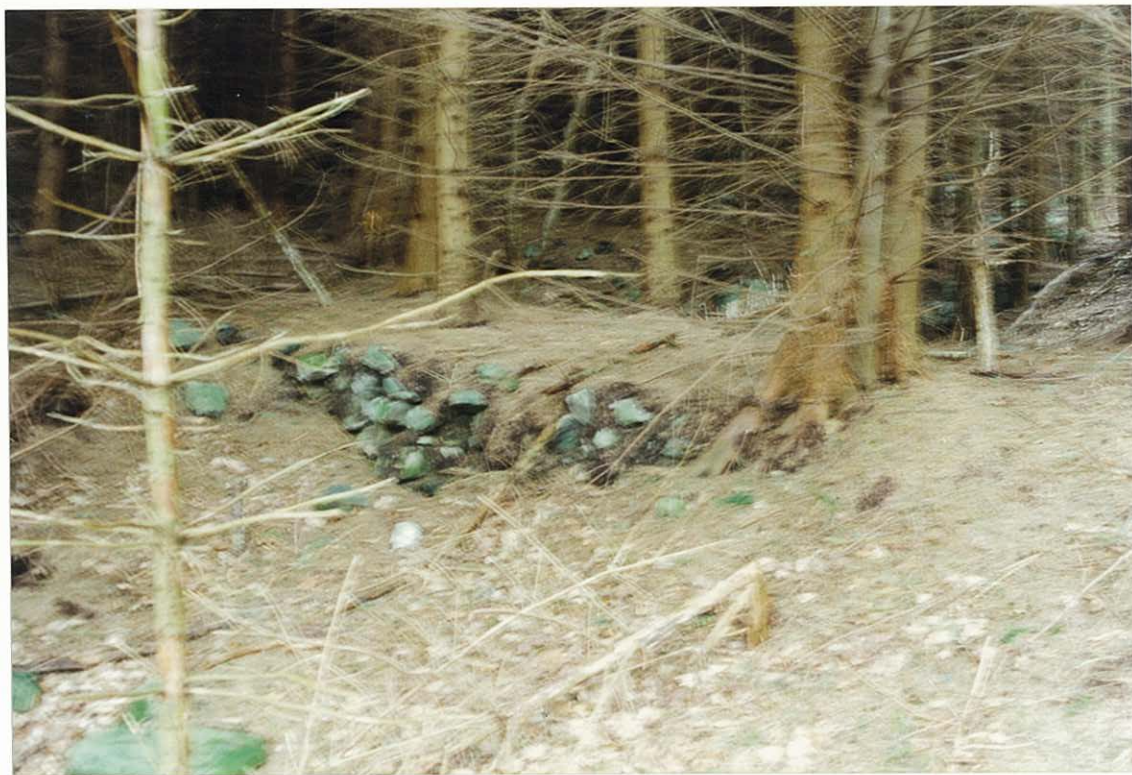
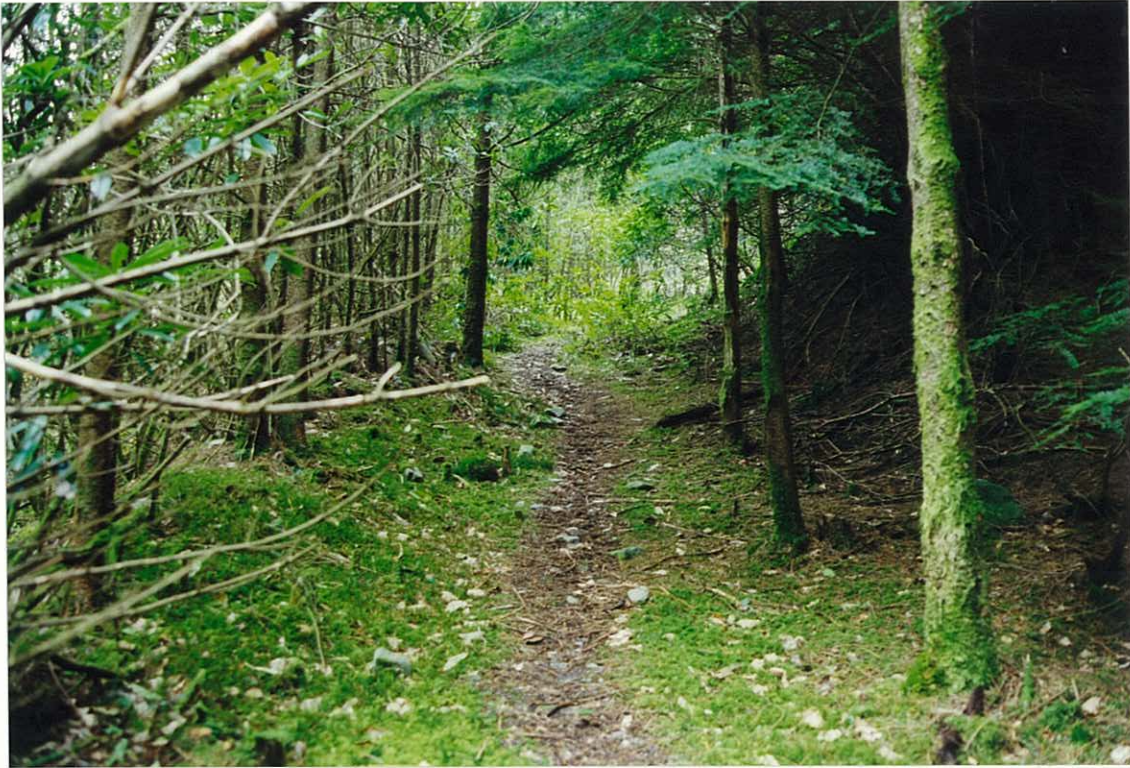
**32993. Track - public footpath** (Photos. 30 & 31. 30 shows causeway across gully. 31 the extraction track running up the steep slope on the course of this track.). This track was superseded by track 32994 from the Alpine Bridge up to bridge 33001 on Nant Bwlch Gwallter. At its western end this track is cut across by 32994, but to the east its course soon becomes apparent on the ground. It runs on a terrace 3m wide and crosses a shallow gully on a stone-built causeway. To the east of the causeway, in

dense woodland, the line of this track becomes indistinct. The Ordnance Survey 1:2500 1st Ed. map shows this track turning to the south to the west of Nant Bwlch Gwallter to run up a steep slope. On this steep slope an extraction track has destroyed all evidence of this earlier track. A public footpath follows the course of this track from the Alpine Bridge to where it turns sharply to the south.

*Value:* 2

*Recommendations:* The terrace on which this track is located and the stone-built causeway should be protected during felling and extraction. The causeway in particular is vulnerable to damage.

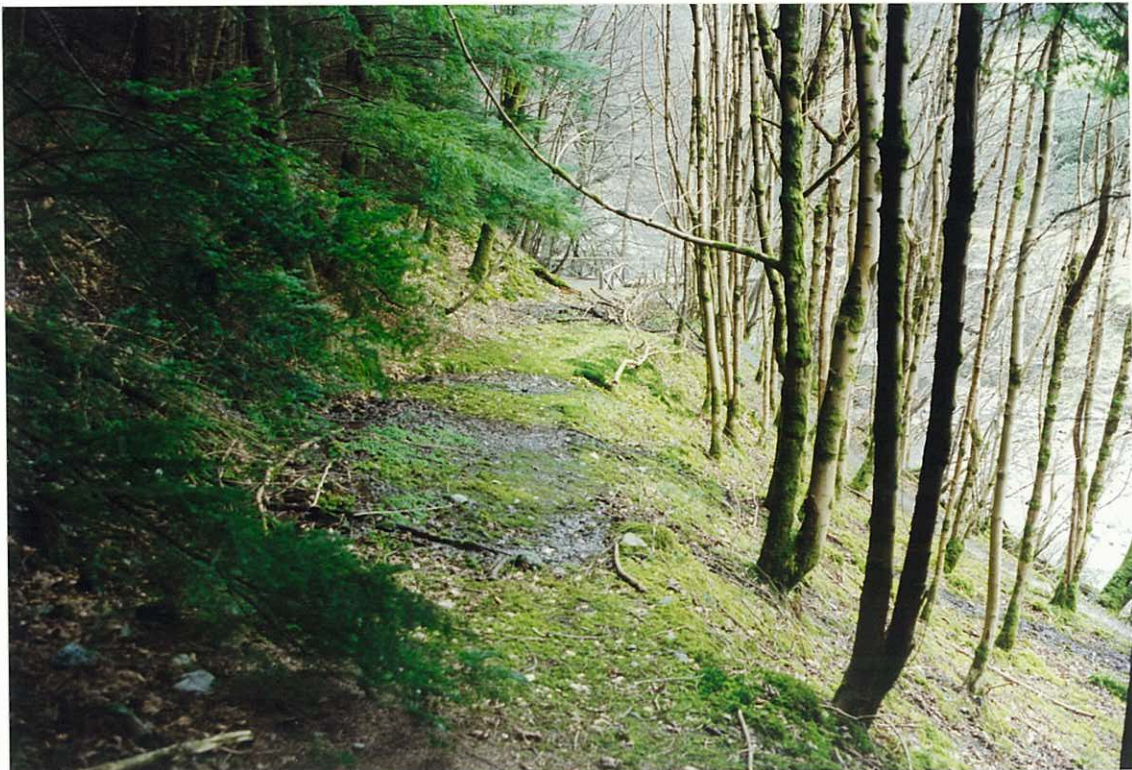
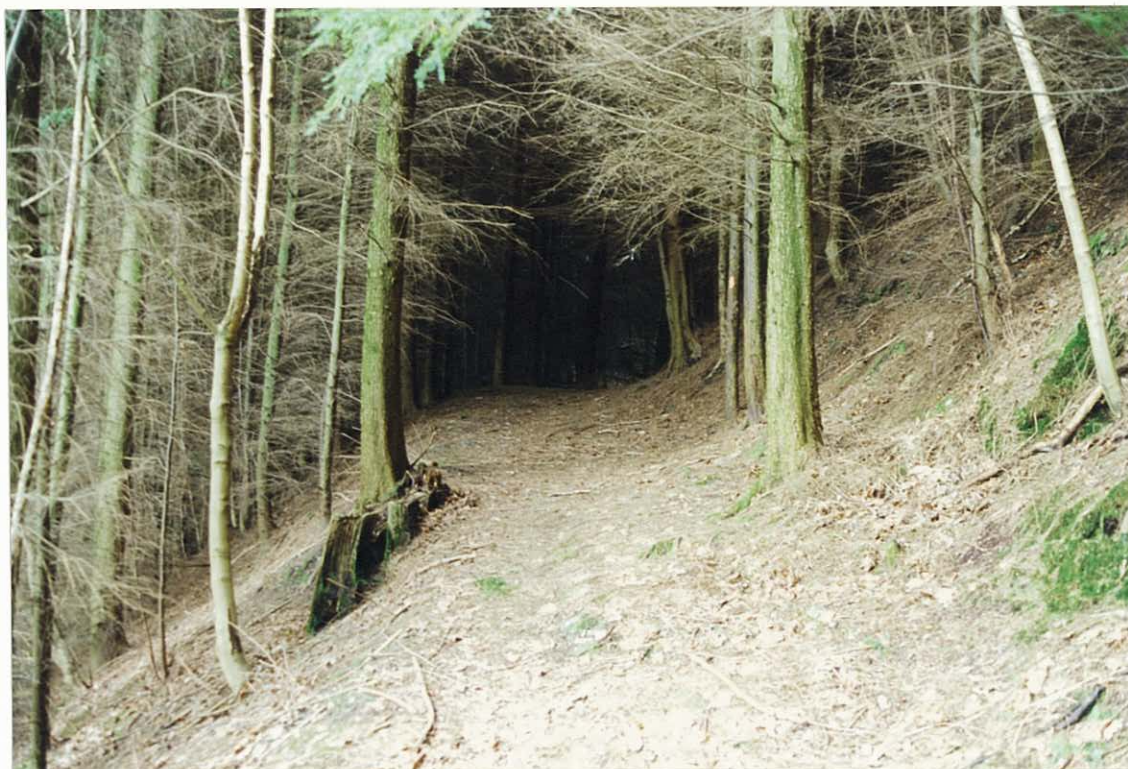
**32994. Alpine Bridge Track** (Photos. 32 & 33. General shots). A well-engineered track running up the steep valley side to the east of the Alpine Bridge. It lies on a terrace, rock cut in places, and revetted by stone walling on the down-slope side where it crosses a gully. Towards the bridge on a steep slope the track is beginning to suffer severe water erosion and unless immediate remedial measures are taken it will be lost. Elsewhere the track is a fairly robust structure. At its eastern end it has been truncated by an extraction track. This track seems to replace track 32993 and is probably of early- or mid-19th century date. Its course probably overlies Johnes's late 18th-century Gentleman's Walk.

*Value:* 2

*Recommendations:* Heavy machinery should not use this track. The potentially vulnerable outer edge of this track should be protected is felled logs are to be hauled across it.

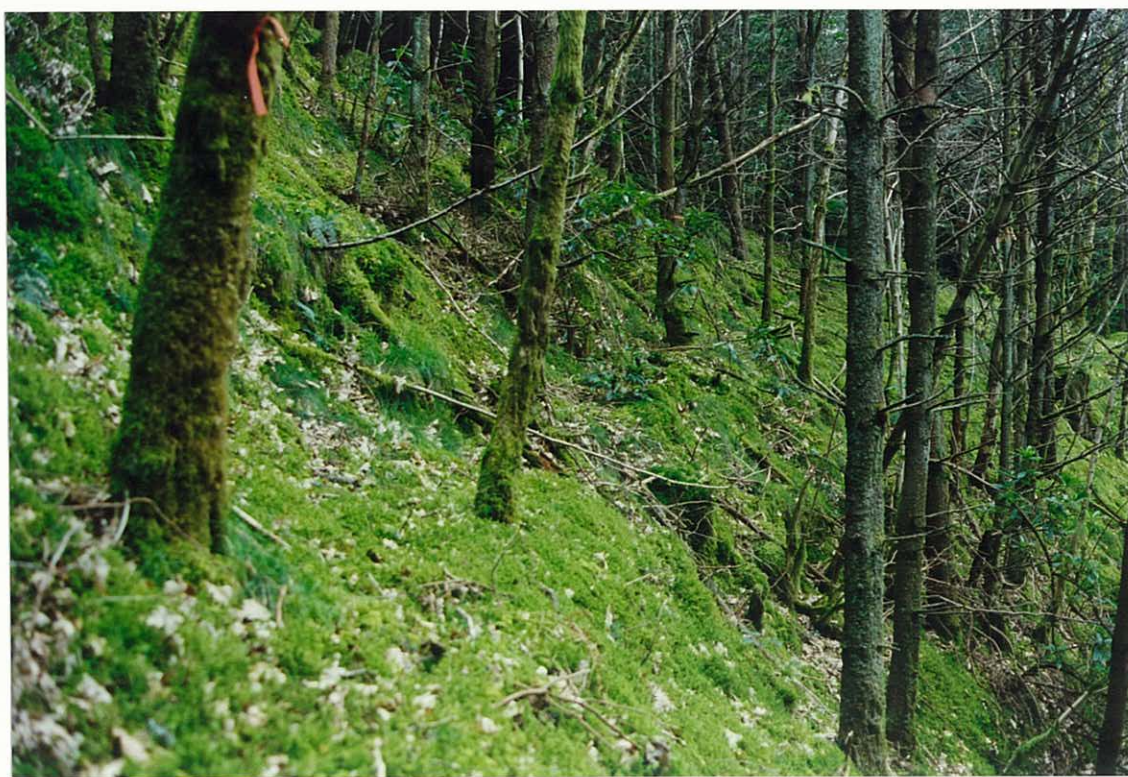
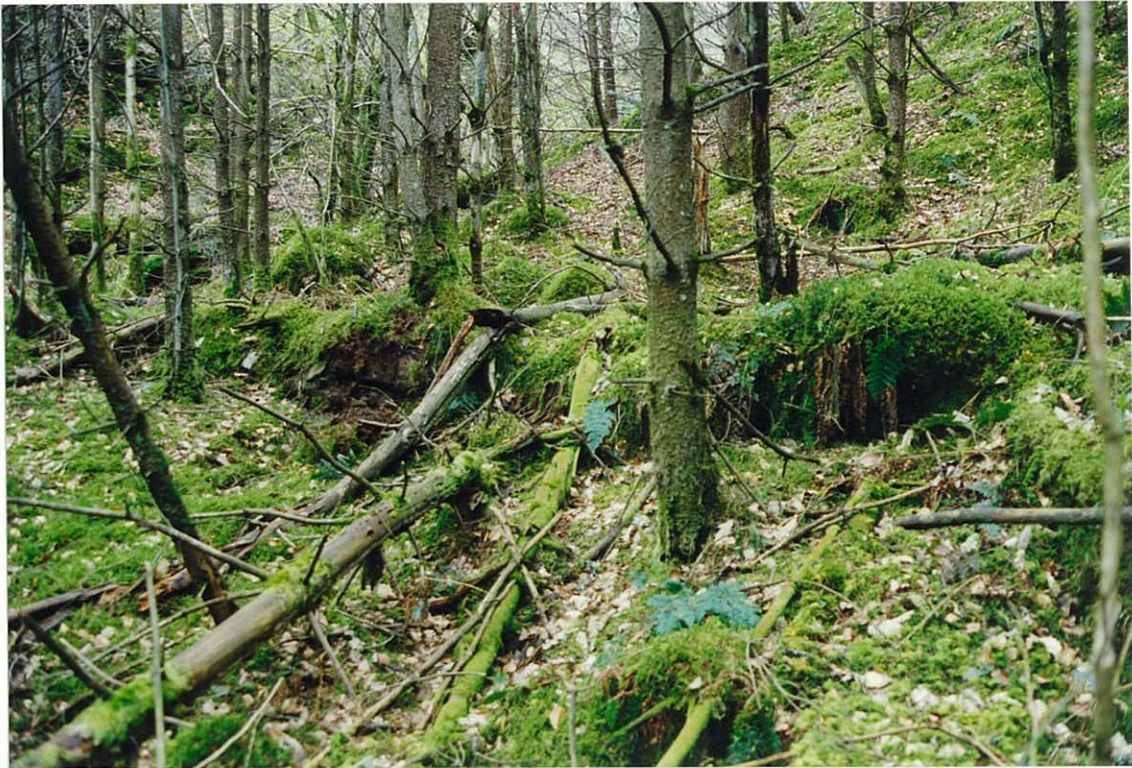
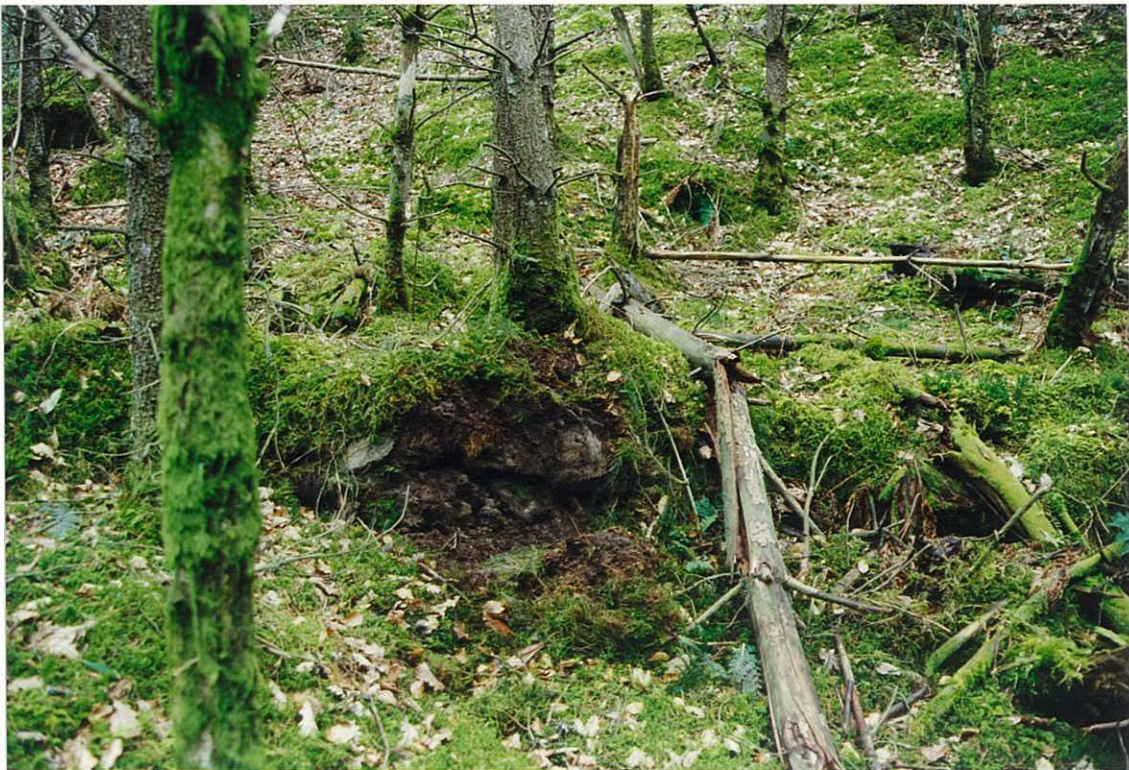
**33000. Path - The Gentleman's Walk** (Photos. 34, 35 & 36. General shots and detail of revetment wall). The walk runs down a steep slope to a crossing point of the Nant Bwlch Gwallter on a narrow, well-constructed terrace approximately 1m wide. The terrace is revetted for most of its length on the down-slope side by 3-4 courses of dry-stone walling. This is part of the Gentleman's Walk constructed in the late 18th-century. It is potentially a vulnerable feature.

*Value:* 2

*Recommendations:* Great care must be taken during felling and extraction to ensure that no damage occurs to this path. Logs must not be hauled across the line of the path.

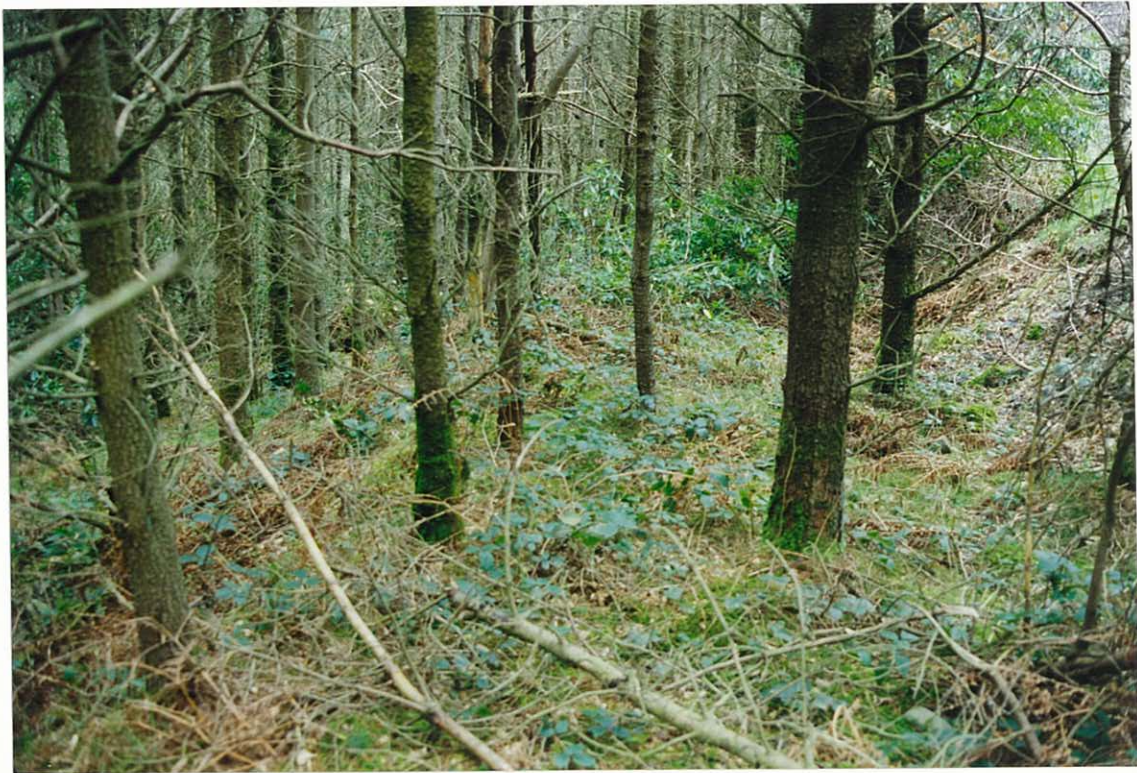
PHOTO. 37

**35849. Path - Gentleman's Walk** (Photo. 37. Shot of terrace on spur). From the bridge 33001 to the east the Gentleman's Walk must have lead up a very steep and now eroding slope - here there is no trace of the walk. Physical remains of the walk survive where it crosses a spur at A. Here there is terrace cut into the hillside with a

low bank built-up on its down-slope side. This terrace is lost amongst dense undergrowth immediately to the east of A. Further to the east it is likely that the line of this path is overlain by the forestry drive.

*Value:* 2

*Recommendations:* Care should be taken during felling to ensure no damage occurs to the earthwork terrace at A. Logs should not be hauled across this earthwork.

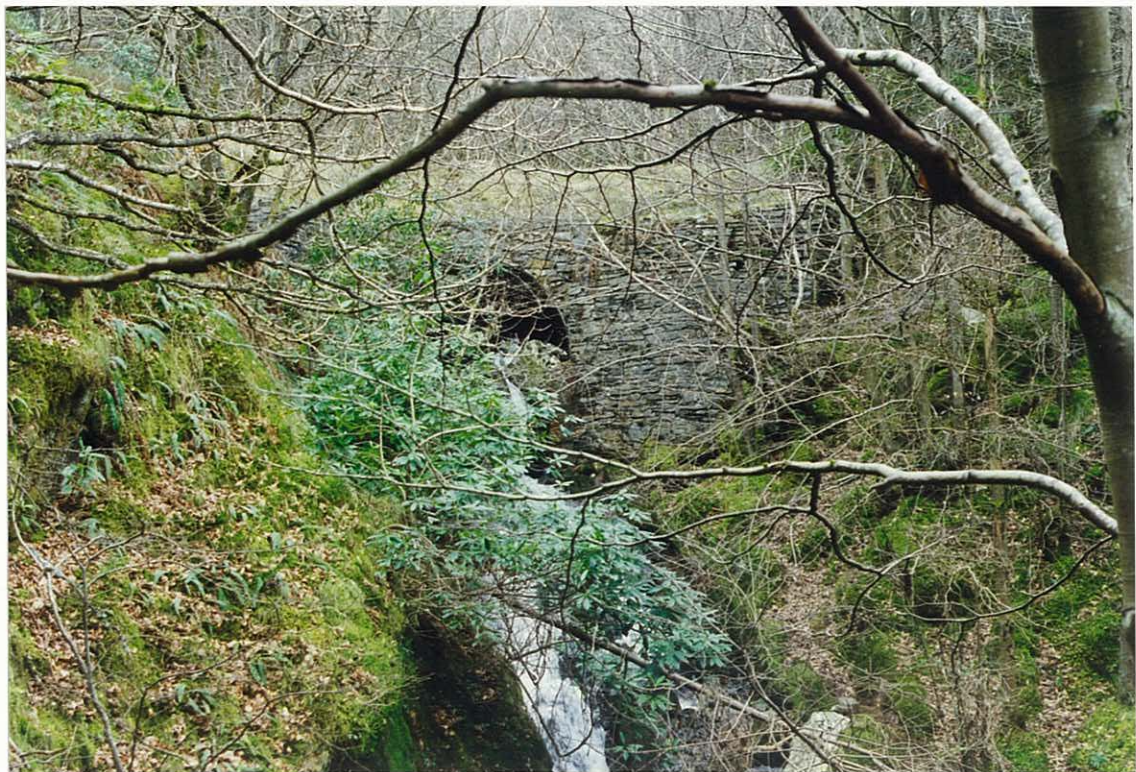
PHOTO. 38

**33002. Pont Allt Dihanog (Photo. 38).** Stone-built abutments survive on the downstream side of this bridge. The remainder of the structure has been rebuilt in concrete in order to carry a forestry drive. The construction on the original bridge is late 19th-century or early 20th-century.

*Value:* 2

*Recommendations:* There is little chance of any damage occurring to this structure during felling.

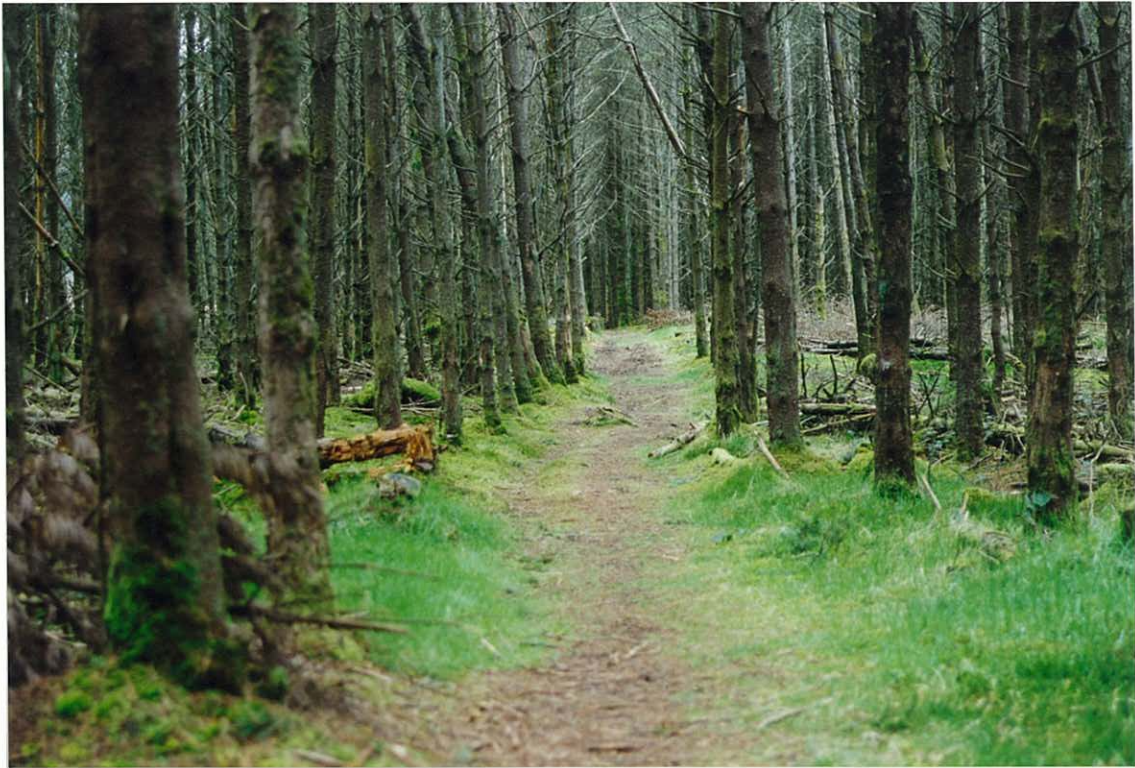
PHOTO. 39

**32992. Path** (Photos. 39 & 40. 39 is a general shot, 40 shows the junction of this path where it drops down into the hollow-way of track 32997). There is no structural evidence for this path to the east of Nant Bwlch Gwallter. It follows the easiest line through dense forestry. Now part of a circular walk. A public footpath follows part of its course. At its eastern end it runs down into the hollow-way of track 32997. At this point there is deep rutting caused by wheeled vehicles.

*Value:* 3

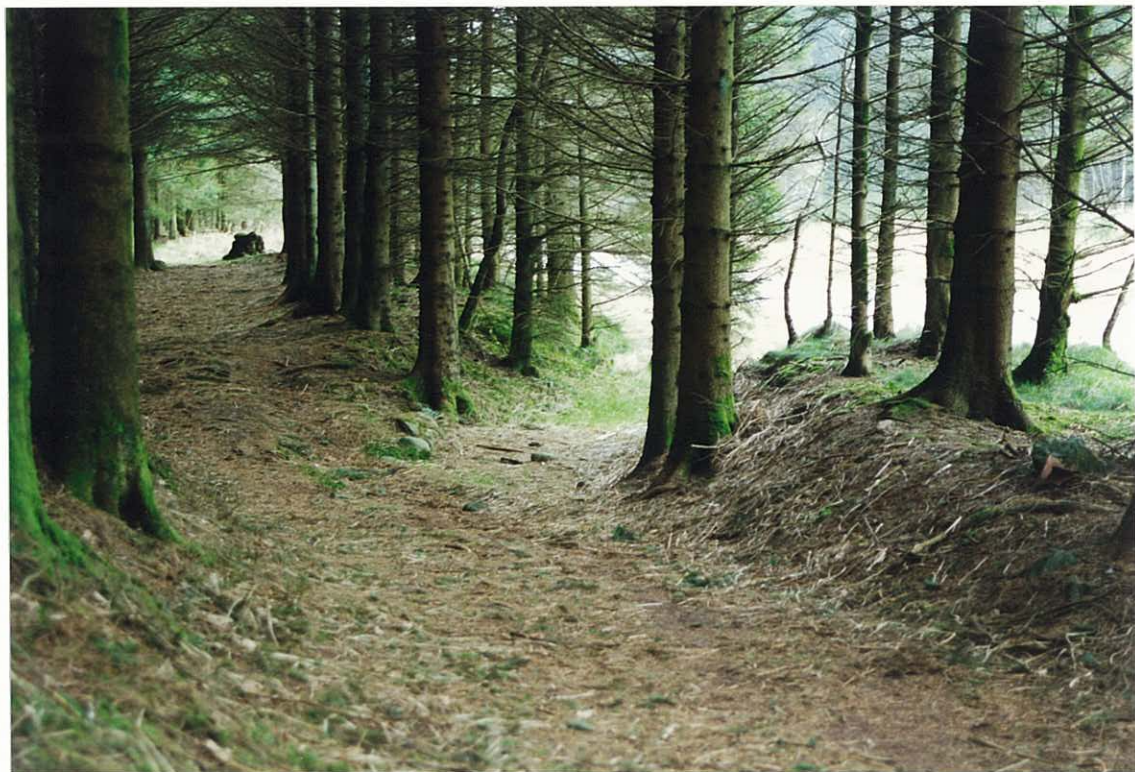
PHOTO. 40

**32997. Track** (Photos. 40, 42-44. 40 shows hollow-way and junction with path 32992, 42 & 43 the junction of this track and the forestry drive, 44 the causeway element of the track). This track is well-defined. At its eastern end it now runs down from a forestry drive and then along a low causeway with a steep drop on the northern side down to the flood plain of the Ystwyth. At its western end it runs in a slight hollow-way down to the flood plain to a fording place of the Ystwyth. This track forms part of the Hafod circular walk and is a public footpath. It is a robust element of the historic landscape.

*Recommendations:* If this track is to be used during felling operations, then action should be taken to prevent deep rutting by wheeled vehicles during wet conditions. Rutting could be a particular problem in the hollow-way where there is surface water. Here it is recommended that a hard-wearing surface is constructed.

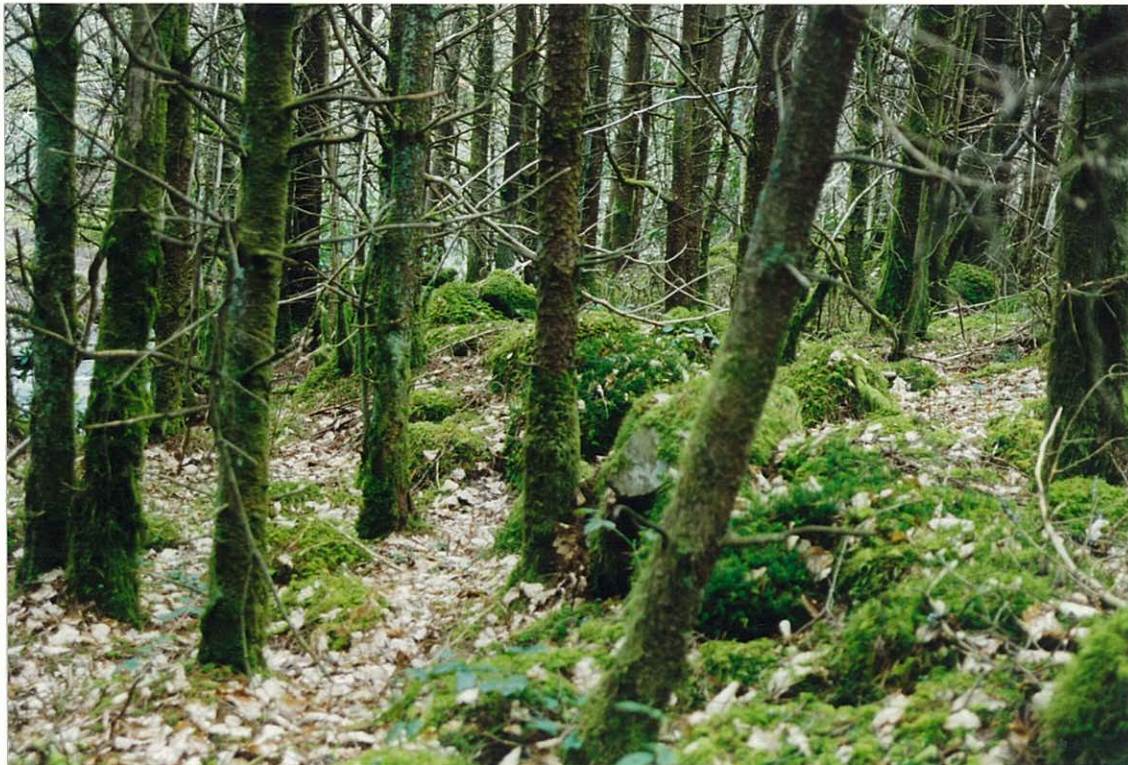
PHOTO. 41

**33581. Rubble boundary** (Photo. 41). A short length of wall, now reduced to a linear rubble heap. This wall presumably predates most of the other boundaries on the Hafod estate. Its date of construction is unknown.

*Value:* 3
