BURRY PORT HARBOUR

AN INITIAL ARCHAEOLOGICAL ASSESSMENT

PART 2 - ILLUSTRATIONS

Project Record No. 36920

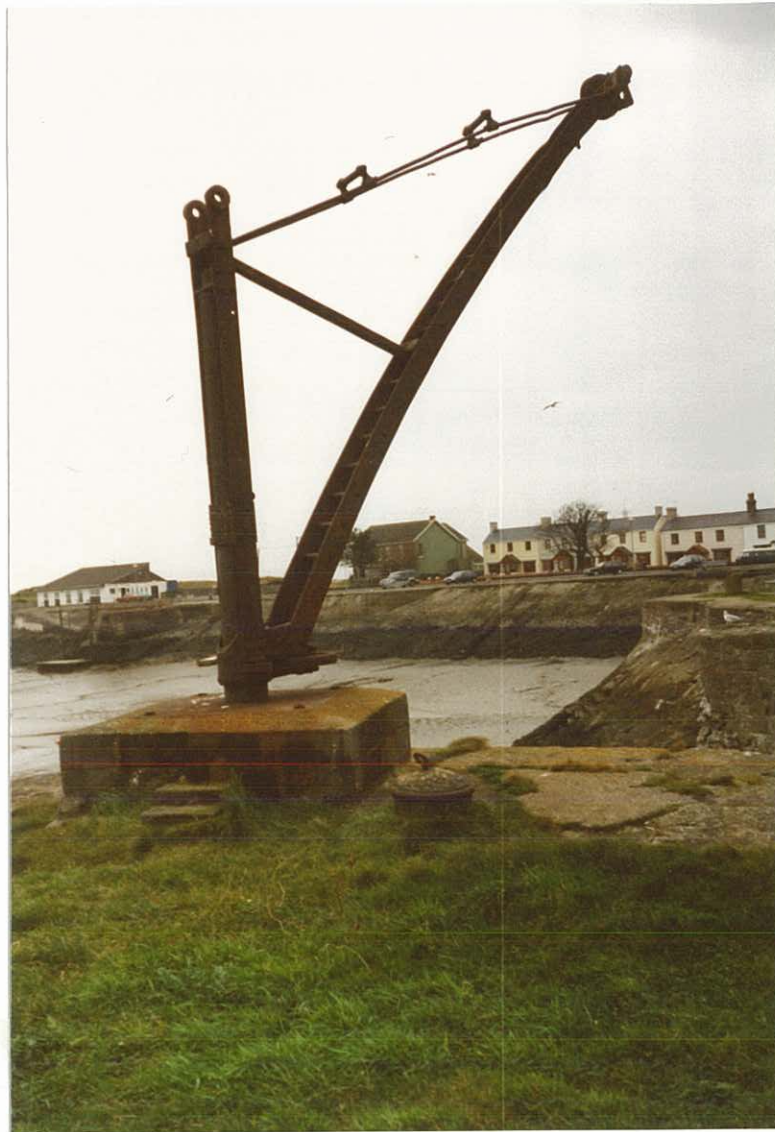
On the east side of the lock is an iron crane on a limestone block base (PRN 36943), not *in situ*. Nearby are two surviving pairs of iron 'mushroom' bollards of 19th century date (Fig. 2; 2) and an earlier 20th century concrete lamp-post with iron gas-lamp bracket - *in situ*? (PRN 36946). There is a further bollard

Plate 7. The East Dock sluice showing the crane, from the east, December 1998.

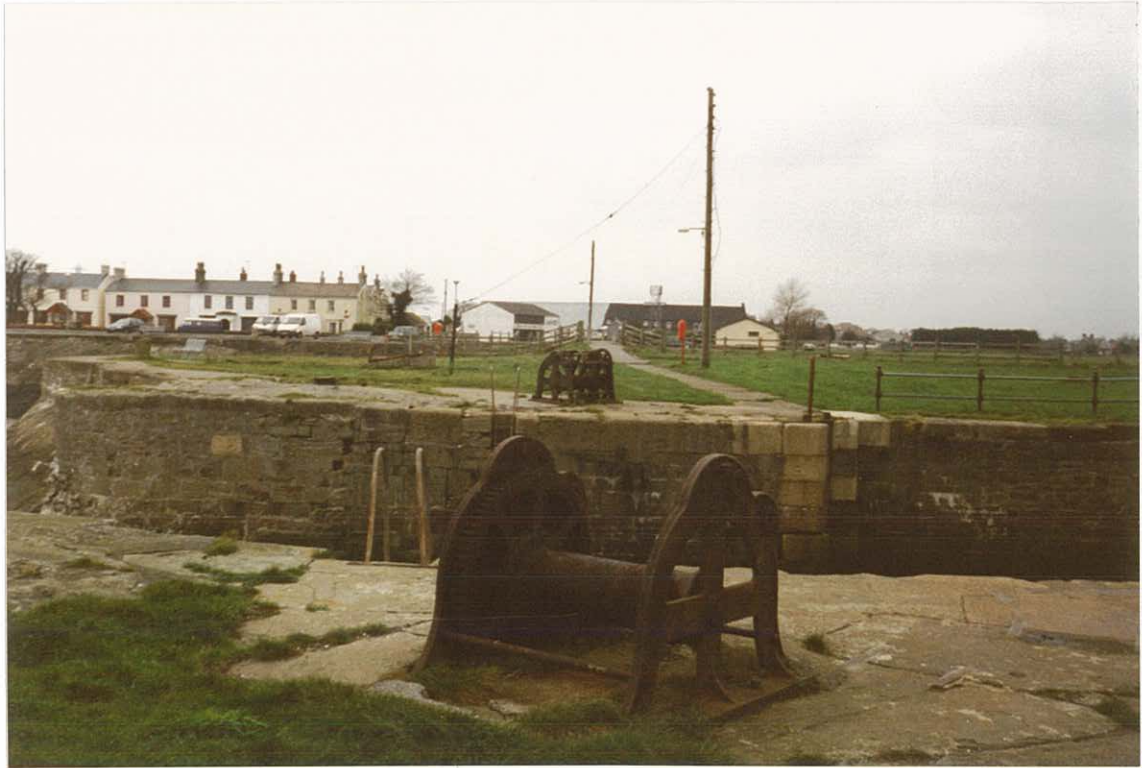
The East Dock today retains most of its structure and some fittings. The lock sluice is approximately 22.00m long (north-south) and 13.10m wide (east-west), with a paved sill approximately 3.00m above the level of the floor of the Outer Harbour (J. W. Williams, Burry Port Harbourmaster, *pers. comm.*). It is constructed from well-coursed and squared rubble from a local source ('Gwar Mac' - see above), with curved quoins to the north and south. The gates pivoted within well-finished semicircular-sectioned chases, at the summit of which are areas of finely-cut flat stones, held together with lead ties and carrying iron guide-pins for the former gate chains. Either side of the lock is an iron hydraulic capstan winch (PRNs 36944 and 36945), made by Tunnett and Walker & Co. of Leeds in 1904 and used for closing the lock gates but now incomplete. There is a further, square-sectioned chase to the north and south on both sides, the southern chases now with 20th century iron ladders. The east lock wall also features a regular arrangement of square sockets. On the summit of the lock sides, to both east and west, and lying north of the winches, are stone lined shafts, now choked with vegetation, presumably representing mountings for equipment (Fig. 2; 1).

Plate 8. The East Dock sluice showing the winches, from the east, December 1998.

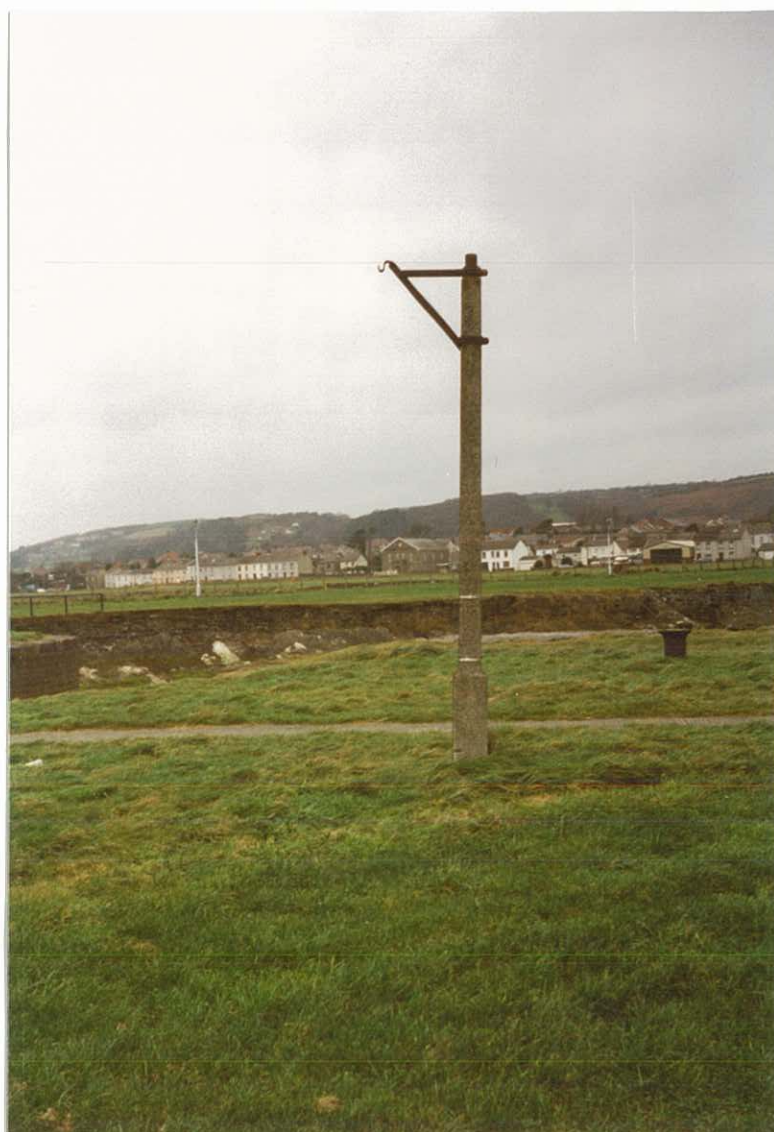
Plate 9. The East Dock sluice showing the lamp-post, from the east, December 1998.

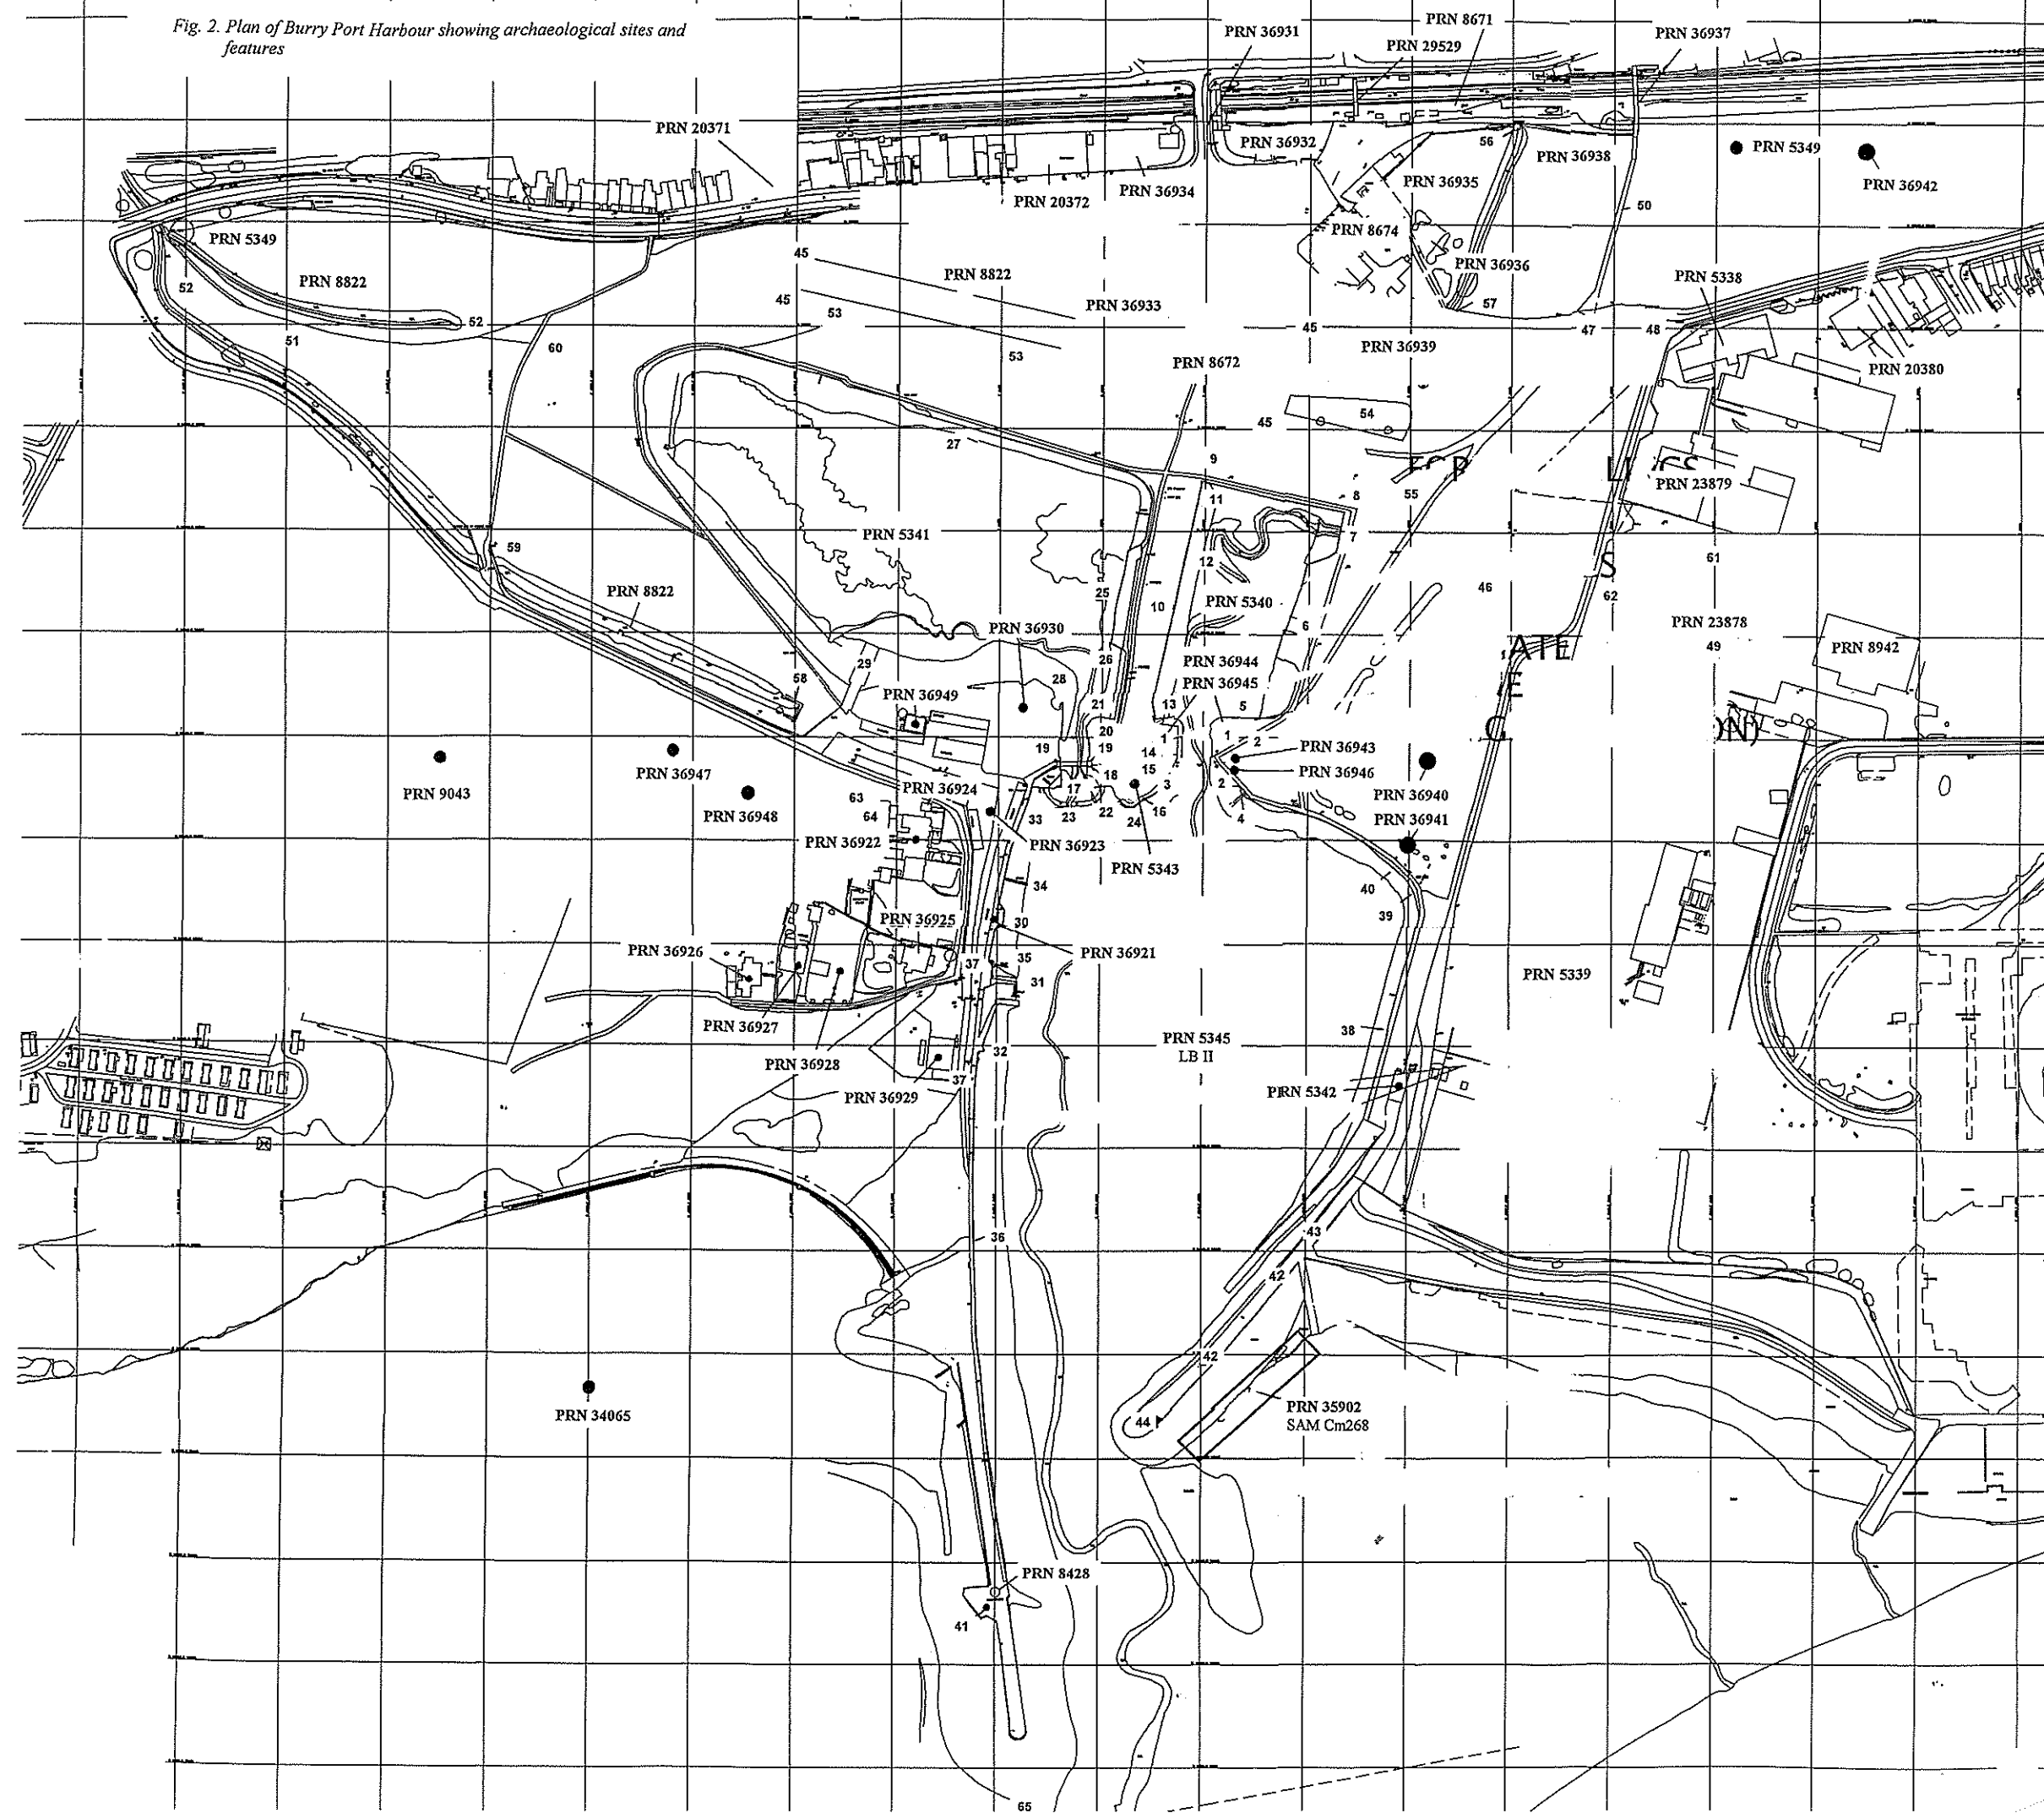
Fig. 2. Plan of Burry Port Harbour showing archaeological sites and features

on the west side (Fig. 2; 3). Immediately east of the sluice is a large-bore iron pipe, set in concrete within the battered sea wall of the Outer Harbour, possibly representing an outfall from the East Dock; it is associated with late 20th century concrete steps (Fig. 2; 4). On the north side, towards the sluice interior, is a raised area of quayside wall, possibly staging, and retaining a single timber upright (Fig. 2; 5). The walls of the East Dock interior are in roughly coursed and squared local rubble, all apparently of one build (1836-9 - see above), but the east and west sides have a battered base in cruder rubble which, though secondary, is probably early. The central section of the east side projects into the dock and is not battered; this area was built out in 1904 when the hydraulic hoists were installed; at the summit, in the centre of this area, the concrete base of one of the hoists can be seen in the grass (Fig. 2; 6), associated with two iron mooring rings. To the north, within the batter, is a sluice from the Nant Dyfatty, rebuilt in concrete in 1982 (Fig. 2;7).

The northern sea-wall is lower than the present concrete surface indicating the level of former staging and walkways. An 19th century iron bollard survives at each corner of the north side of the dock (Fig. 2; 8 & 9); the western may be a re-used capstan.

There is now no evidence of any projecting stages on the quay down the west side of the dock, but towards the south end is a concrete plinth, two timber uprights and a sleeper representing one of the pre-1904 tipper bases (Fig. 2; 10); it corresponds with an area of weathering in the battered base.. There is a damaged, ?19th century brick and masonry stairway at the north end (Fig. 2; 11). To the south is a second sluice in the batter, leading from the West Dock and dating from 1900-1901 when the latter was disused (Nicholson, 1991, 135); it has since subsided and the area above is packed with concrete blocks (Fig. 2; 12).

At the junction with the central island the quay wall features moulded iron railings from the later 19th century and probably *in situ* (Fig. 2; 13); a further line of railings to the south-east are different and appear to be re-used from another site. Also lying on the central 'island', near the remains of the Customs House (PRN 5343) are an iron ratchet mechanism set upright in the ground (Fig. 2; 14) and a large iron anchor set in a concrete plinth (Fig. 2; 15); neither are *in situ*. To the south are two flights of 19th century masonry steps in the battered base (Fig. 2; 16), these steps are noticeably wide and may have been intended for the Customs Officer (*see Customs House, PRN 5343, below*).

The battered base may first have been concreted over in 1904 (see above), but the present concrete finish was laid in the early 1960s (J. M Williams, Burry Port Harbourmaster, *pers. comm.*) and is very inadequate, having broken away in areas taking the masonry with it.

A 19th century iron bollard lies immediately east of the lock (Fig. 2; 22), while the truncated remains of the 1900-1901 timber coffer dam be seen to seaward either side of the lock (Fig. 2; 23). A small gauge iron outfall pipe, in concrete, leads from the top of the west side of the lock (Fig. 2; 24).

The rubble batter continues beyond the vertical sea-wall, right around the West Dock, but is very informal and in poor condition in areas, particularly to the south. There is less 1960s concrete over the batter; however, in areas, particularly the former stage north-west of the lock, it is in even worse condition and has been infilled with rubble dumping (Fig. 2; 28).
