TIR GOFAL MANAGEMENT PLAN: HERITAGE MANAGEMENT INFORMATION (HE2)

Prepared for: Pontfaen Farm

**Tir Gofal Reference No W/11/1215
ACA Report No. 2006/49
Project Record No. 40421**

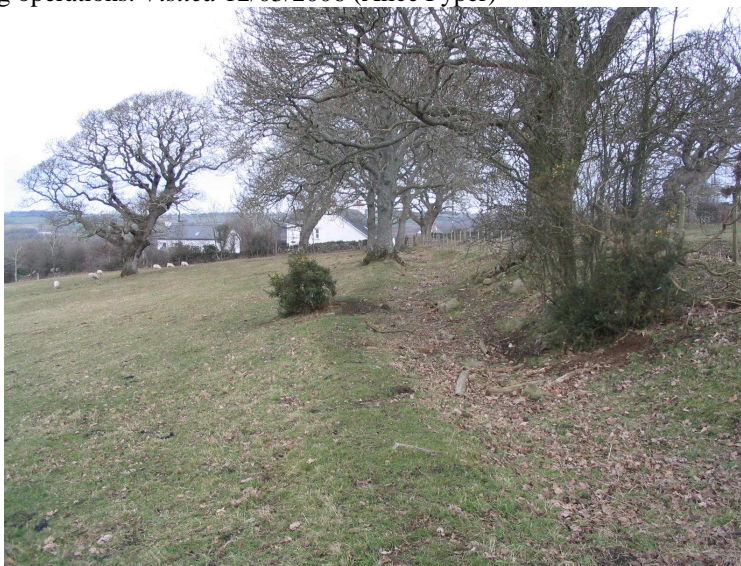
The course of the leat shown on the 1st edition Ordnance Survey map of 1889 is still traceable on the ground going through the parkland. The farmer believes that the leat supplied the mill 'Ty Glyn' with water. The leat apparently starts just to the south of the Ciliau Park boundary, diverting from the Nant Faen, although the mouth of the leat was not visited. Where it enters the park it is visible as an earthwork channel c. 4 m wide and c 0.5m deep with a slightly raised bank on the west side. The channel is now dry. Some self seeded trees now line the sides of the channel. A slot has been cut through the leat at the southern end in the 20th century to create a sheep dip (PRN 56192). The leat continues to hug the contours along the valley sides and in most places it is still visible as an earthwork depression. There are one or two sections which have been eroded by reseeded operations. *Visited 12/03/2006 (Alice Pyper)*

In places the course of the leat survives well as an earthwork channel

Care should be taken with any further reseeding or cultivation not to erode the earthwork remains of the mill leat.

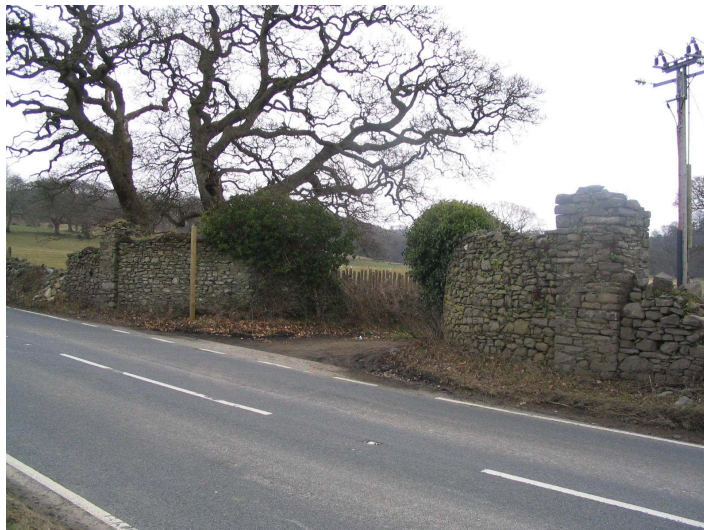
The entrance gateway to Ciliau park was probably erected by William Lewis (Palmer, 2004, 56). A farm gate now takes the place of the original gates, but the stone piers to either side with internal curving side walls remain, although somewhat overgrown with ivy and the wall tops decaying. *Visited 12/03/2006 (Alice Pyper)*

The entrance gates to Ciliau Park.

It is recommended that the restoration of the entrance gateway is undertaken to stabilise these decaying structures. The ivy should be removed and the wall tops consolidated. It is understood that restoration of these entrance gates will be undertaken through the scheme by National Trust masons.

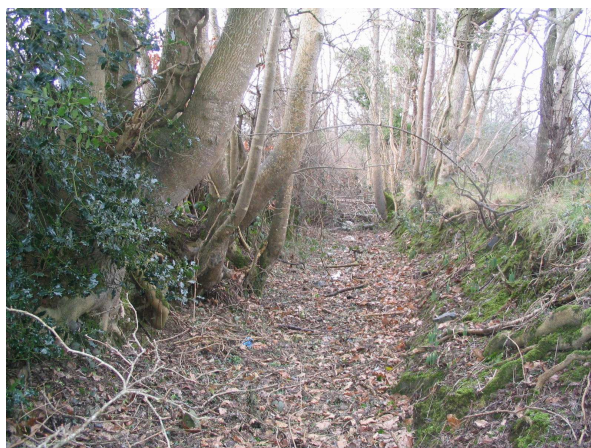
The 1st edition Ordnance Survey map of 1889 shows a mill race, fed by a sluice on the Afon Aeron supplied water to the Corn Mill at Pandy. The leat survives as a channel c. 2 m deep c. 3 m wide. Evidence of stone lining at the head of the leat. Mature trees have now colonised the banks to either side. *Visited 12/03/2006 (Alice Pyper)*

The leat survives as an impressive deep earthwork channel, lined with trees.

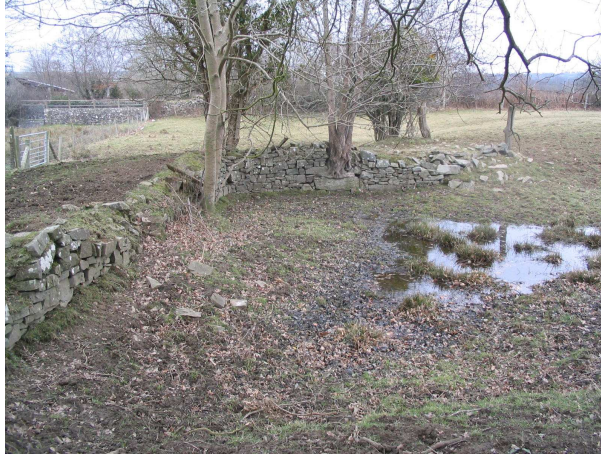
A holding pond is located on the south side of the road to serve the water wheel at Pontfaen farm. The pond is now largely dried up. A drystone revetment wall over a 1m high remains at the lower (northern) end of the pond with a metal sluice gate and chain in situ. This pond in conjunction with that further upstream (PRN 56190) supplied the waterwheel behind Pontfaen farmstead (PRN 56196). Self seeded ash and alder grow from the top of the revetment bank. *Visited 12/03/2006 (Alice Pyper)*

The revetment band and sluice gate still survive although the pond no longer holds water

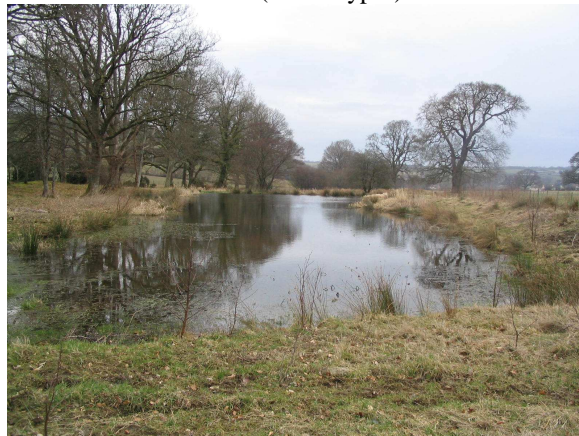
A large pond within a fenced off enclosure, recently redug. A large revetment bank of earth has been constructed at the northern end of the pond. It is fed by an inlet at the south end and a overspill channel at the northern end drains water back into the Nant Faen. Where the Nant Faen runs parallel to the pond it has been straightened and dug out. *Visited 12/03/2006 (Alice Pyper)*

The higher holding pond has been recently redug and now holds water

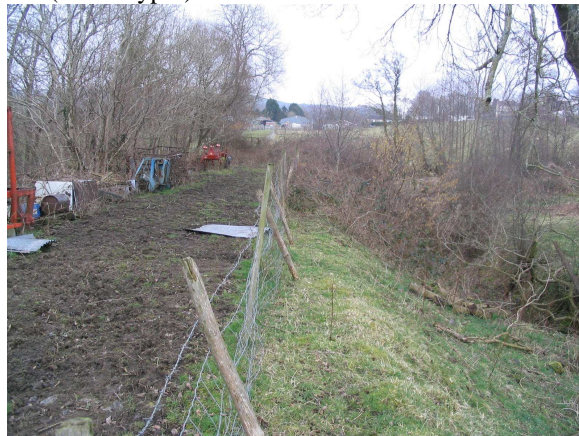
Disused railway. The former 'Aberayron' Branch railway which ran from Lampeter to Aberaeron completed in 1911. The railway fed into the line linking Aberystwyth and Carmarthen. There were halts along the branch line at Llanerchaeron, Crossways, Ciliau Aeron, Felinfach, Talsarn, Blaenplwyf and Silian. It closed to passengers in 1951, but milk trains continued to run between Lampeter and the creamery at Felin Fach until 1973. *Visited* 12/03/2006 (Alice Pyper)

The course of the disused railway is still a prominent feature in the landscape

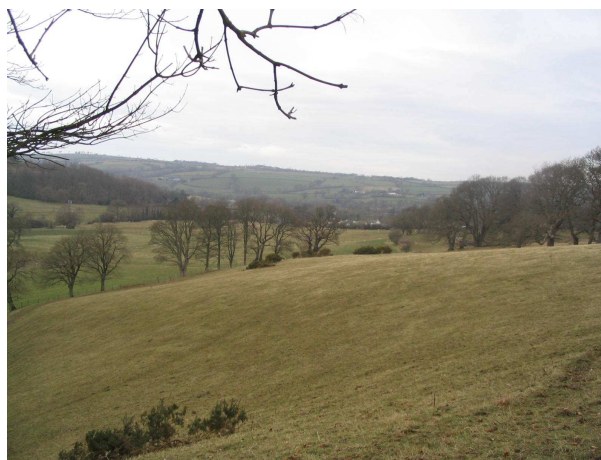
The B4339 at Ciliau Aeron forms the eastern boundary of the parkland which extends to the west side the Nant Faen valley. It encompasses a gentle, conical hill on the western slopes of which swathes of deciduous (mostly oak) trees have been planted. To the south is a large pocket of deciduous woodland enclosed by a bank (2m wide) with the remains of stone wall upon it and on the exterior is a relic ditch c. 2.5 wide and c. 0.5 m deep. A section of herringbone pattern wall survives at the west extent of the woodland. Elsewhere the boundary wall of the park survives; in places up to 1.75 m high and the entrance gateway itself (PRN 56194) survives almost to full height. The lower lying land of the valley base have a few isolated specimen trees planted. While many of the parkland trees survive some have been lost and damaged. *Visited 12/03/2006* (Alice Pyper)

Looking northwest across the parkland into the Nant Faen valley.

The parkland character of the landscape is retained while the mature parkland trees survive, however some of the park trees have been lost since the 1st edition Ordnance Survey was published. It would be advisable therefore to consider planting replacement trees in the parkland in the future. Any proposals effecting the registered parkland should be carried out in consultation with both the National Trust and Cadw: Welsh Historic Monuments.
