TIR GOFAL MANAGEMENT PLAN: HERITAGE MANAGEMENT INFORMATION (Call Out)

Prepared for: Castell Martin

Tir Gofal Reference No: W/11/0525

Report Number: 2005/116 Project Record Number: 45905

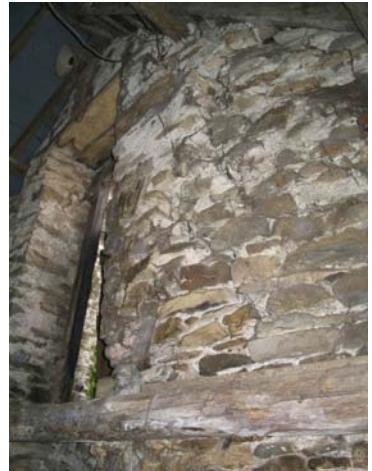
Doorway in western gable-end, showing area of collapsing stonework to right.

The lower and upper sections of the gable-end have slumped, and are now bulging precariously into the building. To the north of the building, a continuation of the west gable-end wall forms a retaining wall for the hillside. The farmhouse is built on the slope above the outbuilding, that this north-south wall retains.

The timber lintel should be replaced, to help stabilize the north wall. The western gable-end wall will almost certainly require rebuilding. In order to retain the historic integrity of the barn, rebuilding should be done using appropriate materials, ie. stone of local origin, lime mortar, and a lintel which matches the original.

Cambria Archaeology cannot advise on the structural stability of the building, or the stability of the hillside. However, a stone and lime mortar wall may not be deemed sufficient to prevent future collapse. Advice should be sought from a structural engineer on this matter. It may be possible for retaining work to be incorporated behind the wall of the traditional building, so that it does not affect the method of construction used for the wall itself.

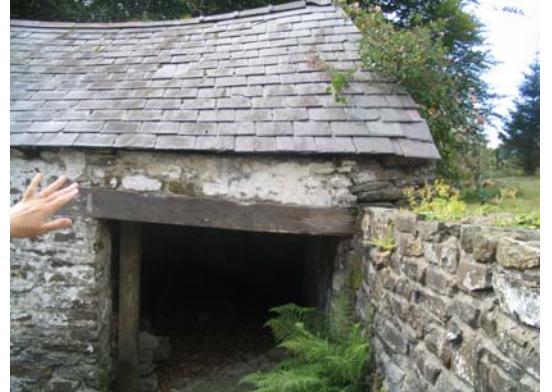
Low cart entrance at west end of southern outbuilding, showing retaining wall to right of the picture.

The most likely explanation is that the wooden lintel above the cart entrance has become rotten where it enters the retaining wall. The lintel now slopes down towards this point, above which is a stress crack running vertically through the stonework. The place where the gable-end/ retaining wall meets the north wall of the building has been particularly susceptible to water penetration. This is further evidenced by pronounced deterioration of the lime mortar between the stonework in this area, and the absence of lime wash. (There was formerly a coat of lime wash on at least the northern exterior wall of this building - it is still extant on parts of the north elevation).

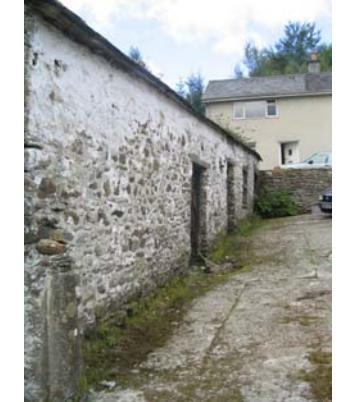
North elevation of southern outbuilding, looking west towards farmhouse

On the northern elevation of the building are two doorways of standard width and one window. At the west end, a low entranceway, wide enough to afford access for a cart, adjoins the collapsing gable end (this cart entrance may be a later addition to the building). All openings have wooden lintels.

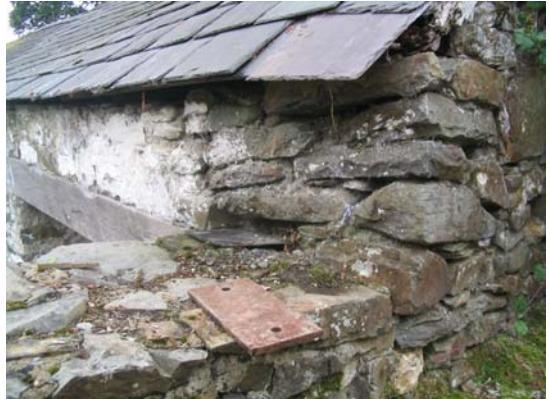
Detail of deterioration on northwest corner of southern building

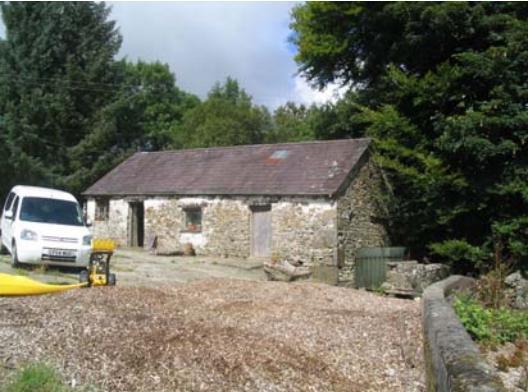
The owners are keen to replace doors and windows on the building on the north side of the yard, to make it more secure for storage. The building is single-storey, of rubble-stone construction, with remnants of limewash on the south-facing exterior wall.

The northern outbuilding viewed from the southeast

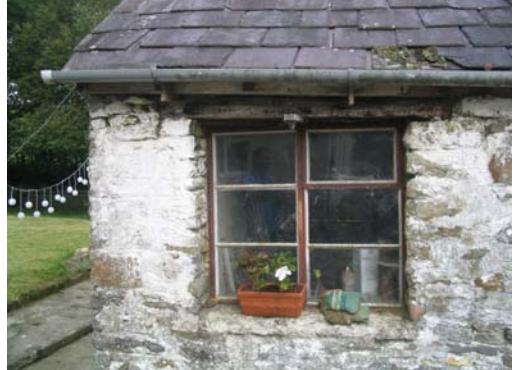
On the southern elevation, facing the yard are two sets of window and door openings, all of which have timber lintels. The window openings are currently glazed, although this may not be an original feature on an outbuilding such as this. The present windows are of different types (the western one has a metal frame), and are certainly not original. However, if possible it would be preferable to retain the metal-framed window, as it is indicative of the historic development of the building. Mild steel windows were produced from the First World War to the 1970s. Synonymous with the dominant manufacturer, Crittall, they exist in a wide variety of styles and standard sizes (SPAB technical advice sheet 'Metal Windows' March 2002).

Detail of metal-framed window on southern elevation

If the building was used as a dairy, as suggested above, the window openings were probably shuttered prior to the addition of glazing. Wooden shutters without glazing may be the most appropriate option for the window openings. Wooden shutters would also provide greater security on the building.

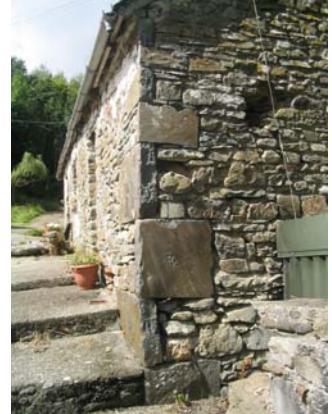
Forming the southeast corner of the building, are a number of large, neatly dressed stone flags, which are not typical of the remainder of the stonework evident in the building. These flags seem to have been used to consolidate a collapsing corner, and appear more appropriate for flooring than wall construction. The obvious conclusion is that they were re-used from a floor; although the flags show no major signs of wear consistent with this use on the exposed faces.

Detail of southeast corner showing stone flags
