# A 'CLOM' COTTAGE AT LLWINDAFYDD, CEREDIGION

A STANDING BUILDING SURVEY

Report No. 2003/123

REPORT NO. 2003/123  
PROJECT RECORD NO. 49738

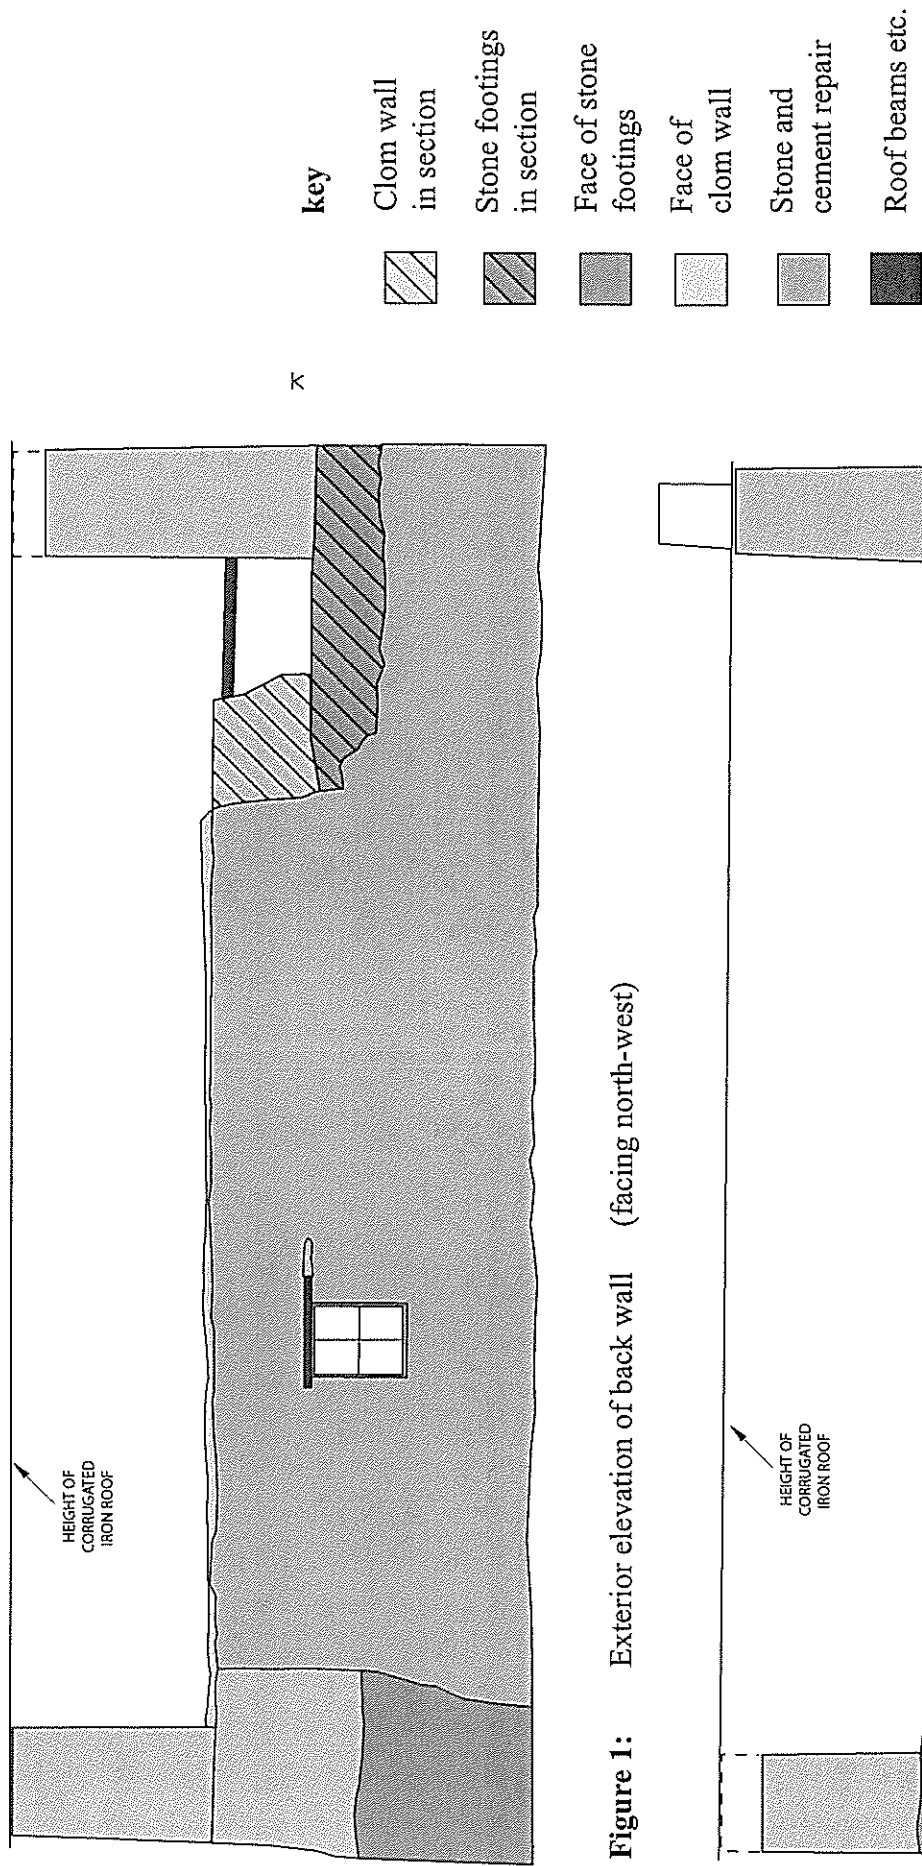
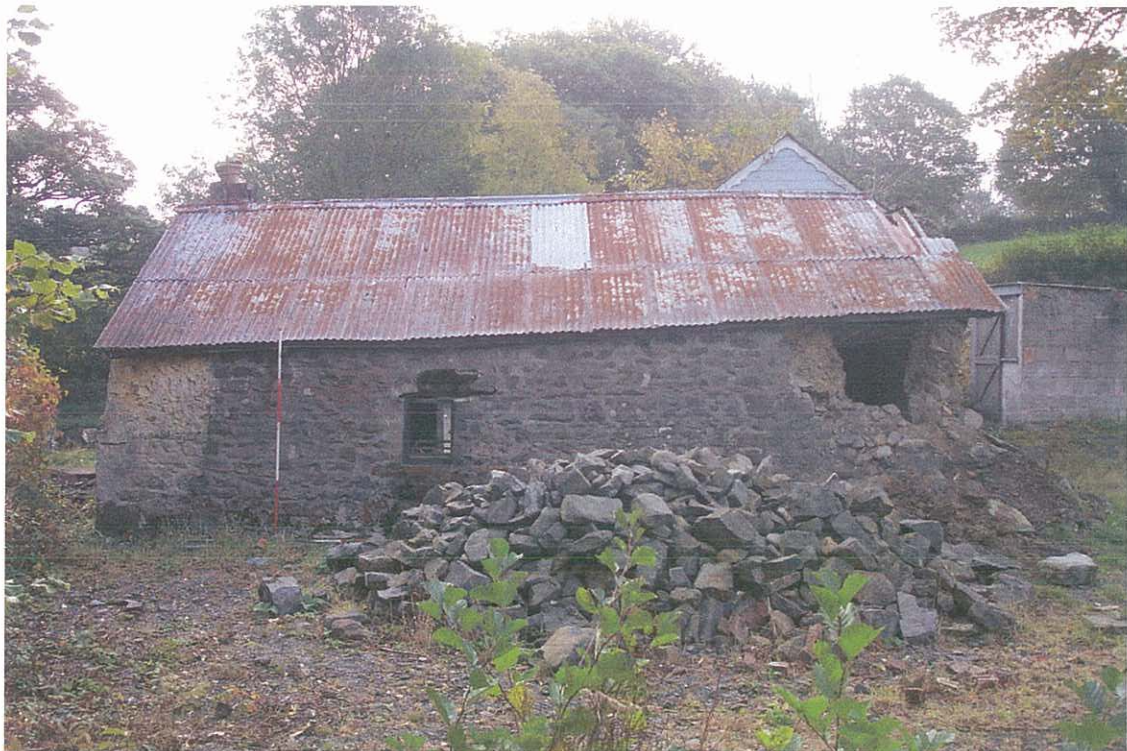
**Figure 1:** Exterior elevation of back wall (facing north-west)

#### **3.1.2 Back elevation (facing north-west) (Photo 2, figure 1)**

The rear exterior elevation appears originally to have been of stone construction to a height of approximately 1.3 meters, with a 'clom' superstructure. This build survives at

the northern end only. It may also have survived until recently at the southern end, but this has since collapsed. The central stretch of the wall appears to have been faced in cement mortared stonework, presumably to prevent deterioration of the original 'clom'. It is possible that the central portion has been entirely rebuilt. The single window with a wooden lintel and no sill, has a metal frame and is probably not an original feature since its sill is below the top of the stone footings (see also interior elevation).

**Photo 2:** Rear external north-west facing elevation (looking east)

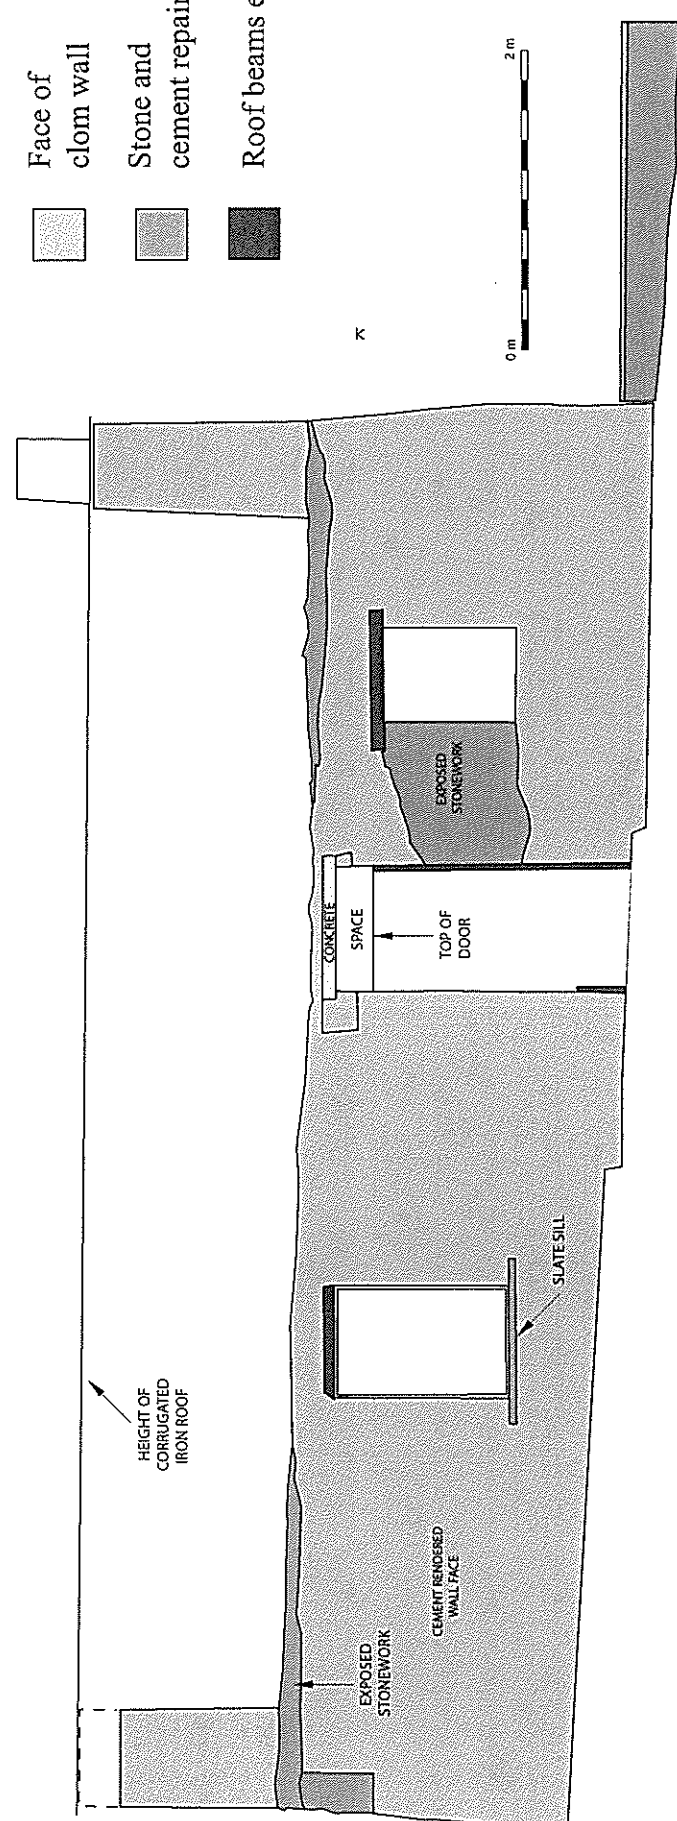
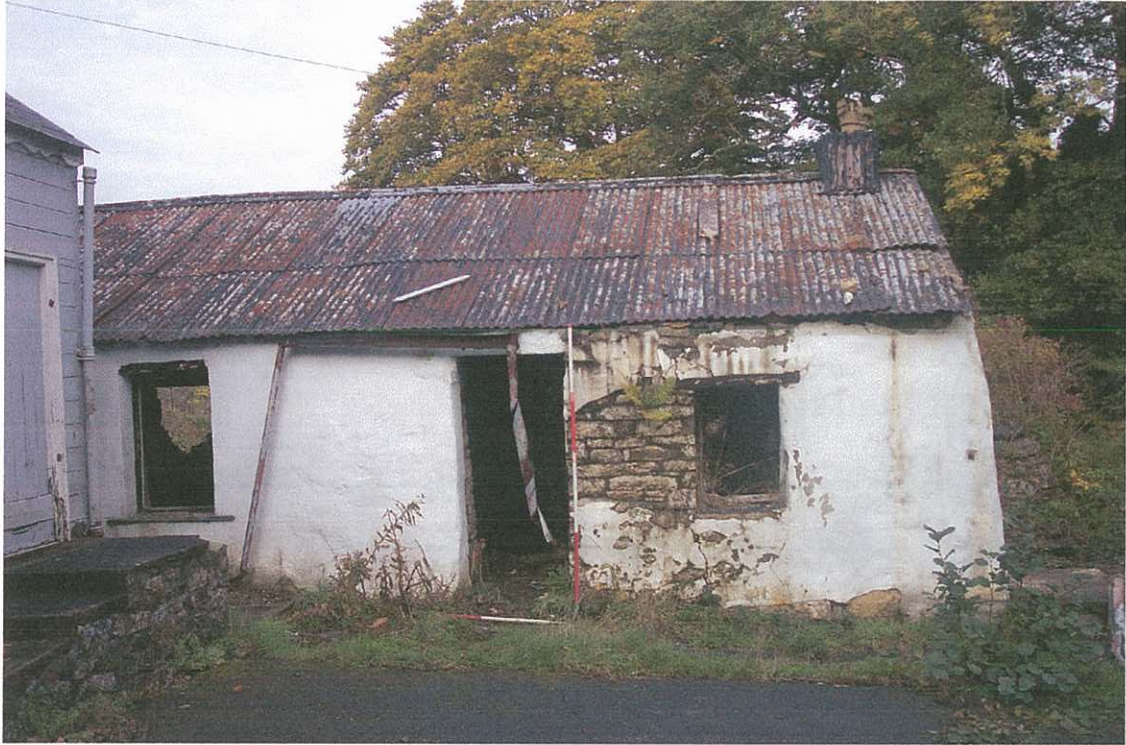
**Figure 2:** Exterior elevation of front wall (facing south-east)

#### **3.1.1 Front elevation (facing south-east) (Photo 1, figure 2)**

The majority of the front exterior elevation was covered in a white painted cement render. This was sufficiently intact to obscure the majority of the underlying wall fabric, but the areas where the render was removed suggested that this side of the building was entirely constructed from stone (at least on the exterior), bonded with an earth mortar. Either this was the case from when the building was first constructed, or it is as a consequence of alterations to the windows and doorway having been made. The larger window, with a slate sill at least is probably a later alteration. The small window may be original and has no sill.

The doorway shows signs of having been altered at least once. The present day door lintel is of concrete, but the existence of an earlier, lower lintel can be implied from an in-filled void, and from the fact that the door itself is lower than the existing doorway.

**Photo 1:** Front external south-east facing elevation (looking west).

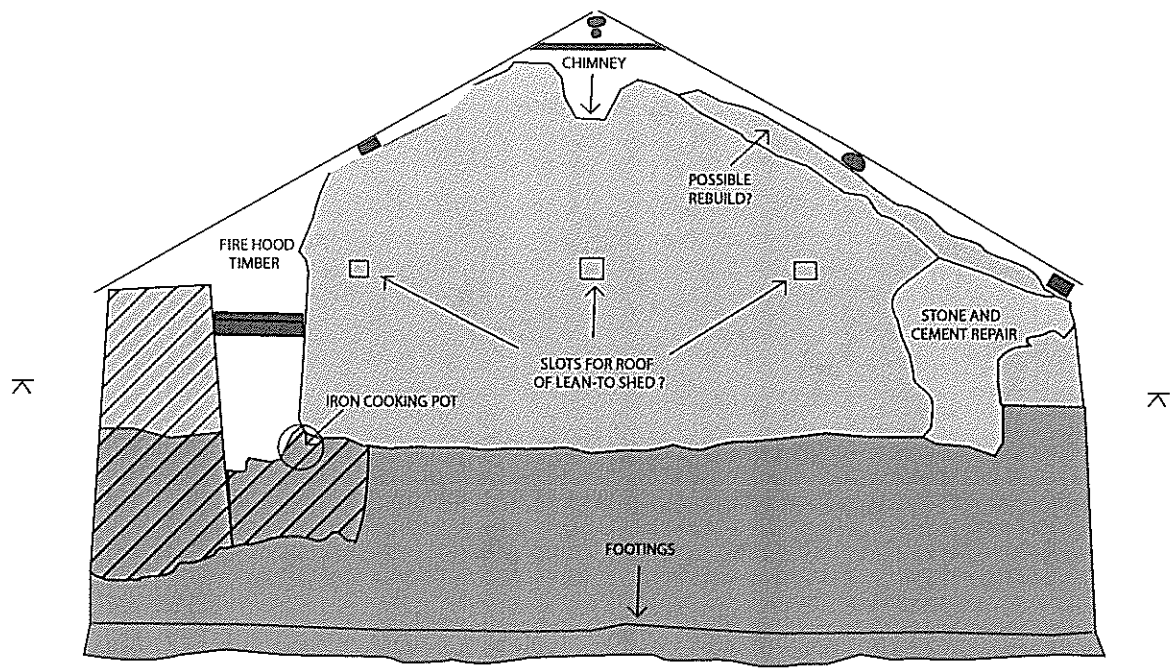
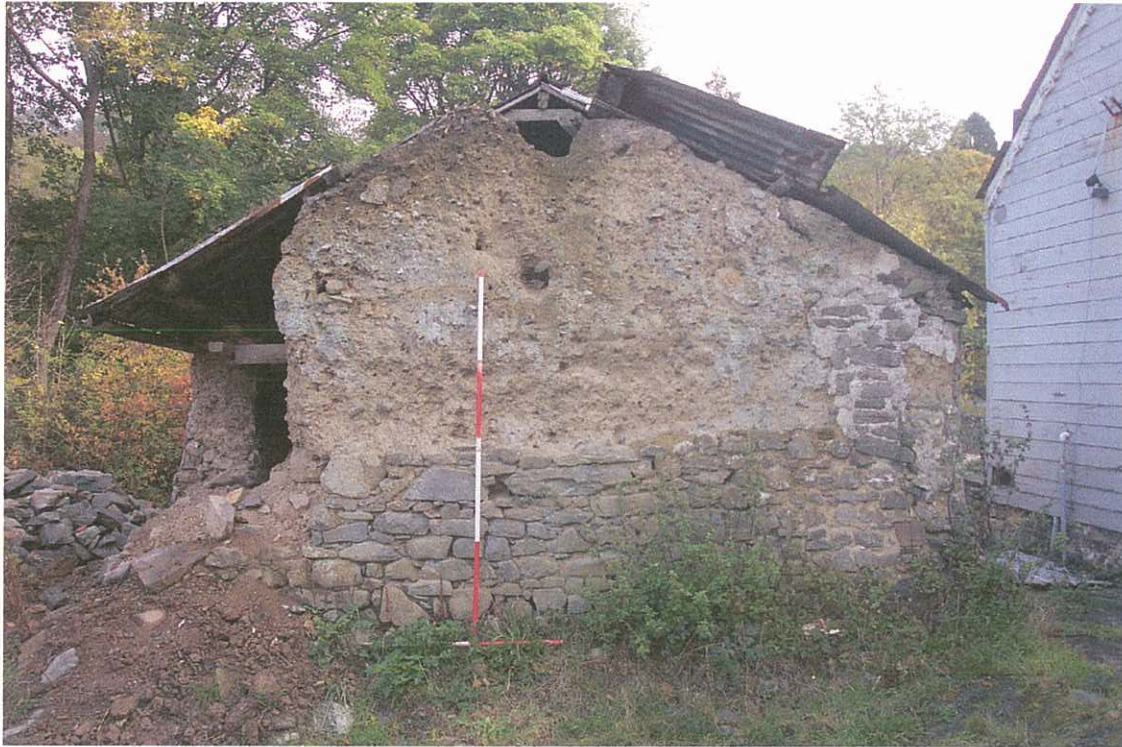
Figure 3: Southern external elevation

### **3.1.4 South end (facing south-west) (Photo 3, figure 3)**

The southern gable end most clearly demonstrates the original construction of the cottage. Apart from some recent collapse, the original fabric remains largely unaltered. Within the 'clom' portion of the wall are three slots, infilled with 'clom', but which would originally have held roof timbers for a lean-to. Due to weathering there is no surviving evidence of limewash or render on the wall face. There is a small area of stone and cement repair work on the right hand side of the elevation.

**Photo 3:** External south-west facing elevation (looking north)

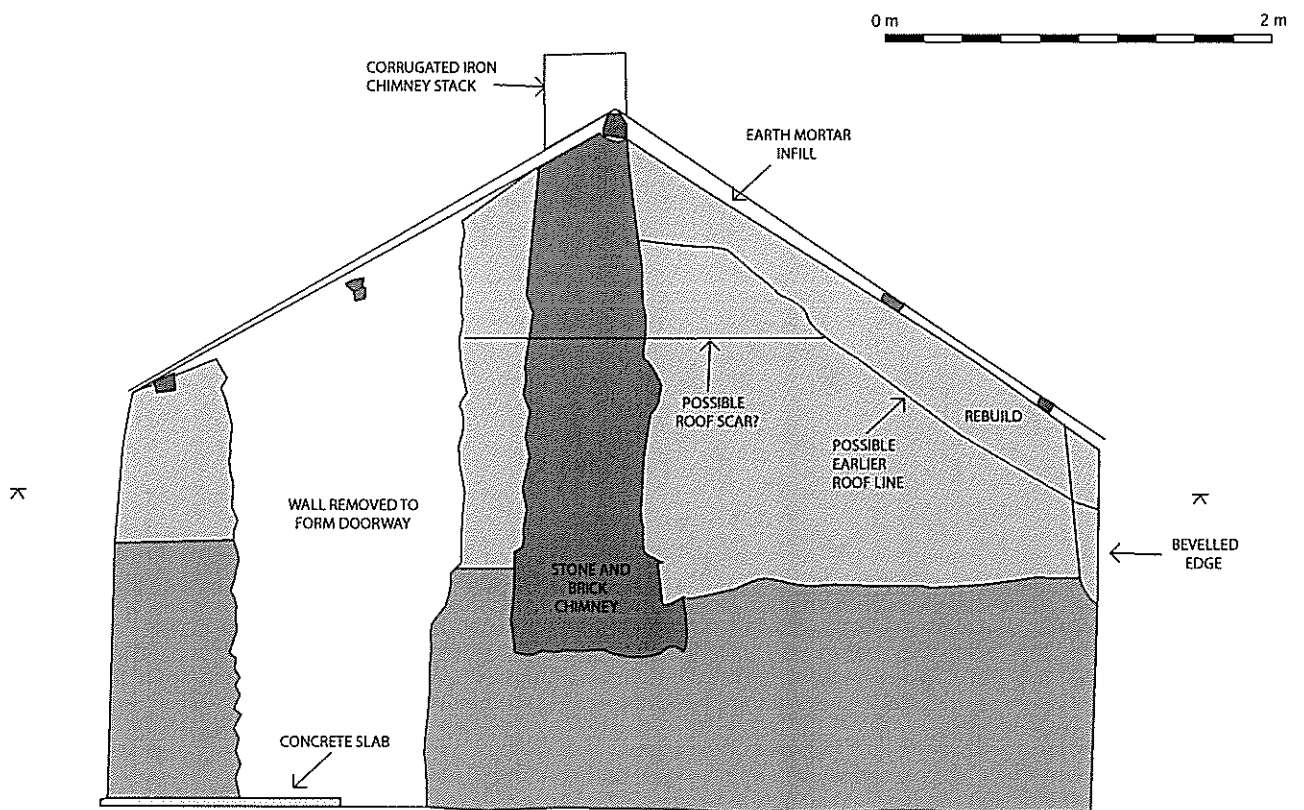
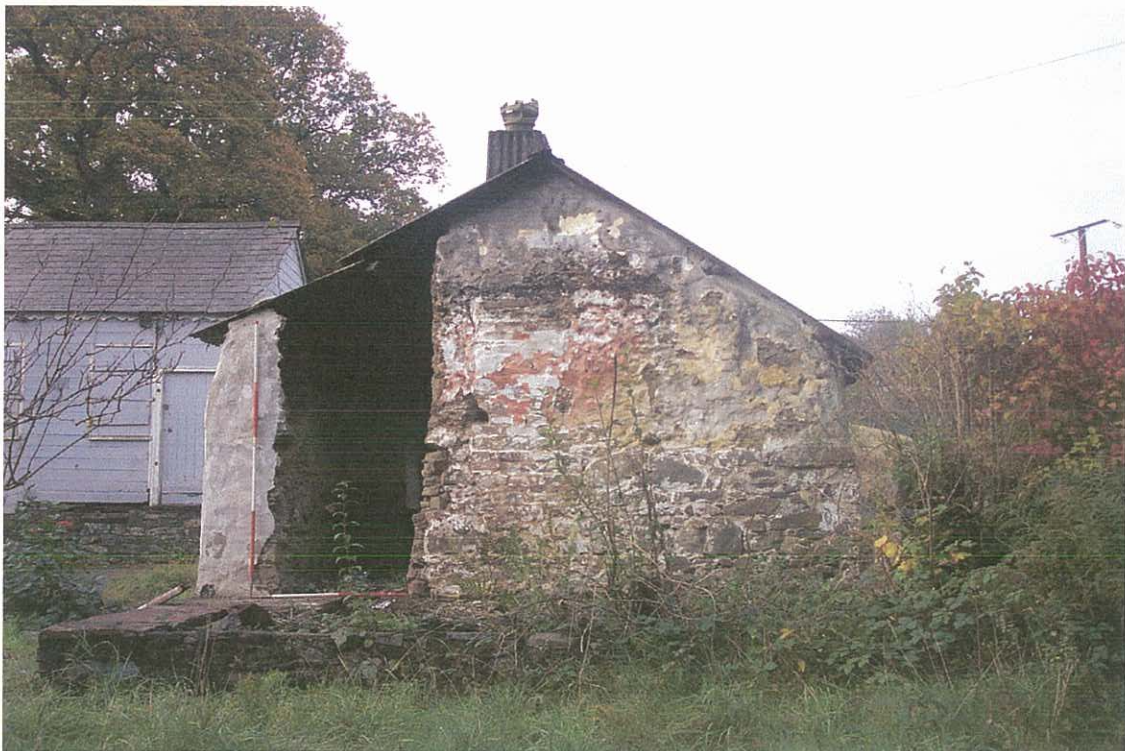
Figure 4: Northern exterior elevation

### **3.1.3 North end (facing north-east) (Photo 4, figure 4)**

The northern external gable end elevation has been altered to give access between the cottage and the shed that stood at the northern end the exposed faces of stonework where the footings have been removed have been roughly pointed with cement. There is no surviving evidence of any door or window openings in this elevation. The wall has not been cement rendered, but still retains evidence of a considerable thickness of limewash laminations. A possible horizontal scar in the 'clom' 2.5m above ground level (also indicated by a change in the colours of limewash), may suggest a lean-to shed once stood here but there is no evidence of associated structural framework. The corner with the front is of 'clom' superstructure further suggesting the front elevation has been rebuilt. There is possible indication that the roofline on the right hand side has been raised, possibly when the chimneystack was constructed or the building was re-roofed.

**Photo 4:** External north-east facing elevation (looking south)

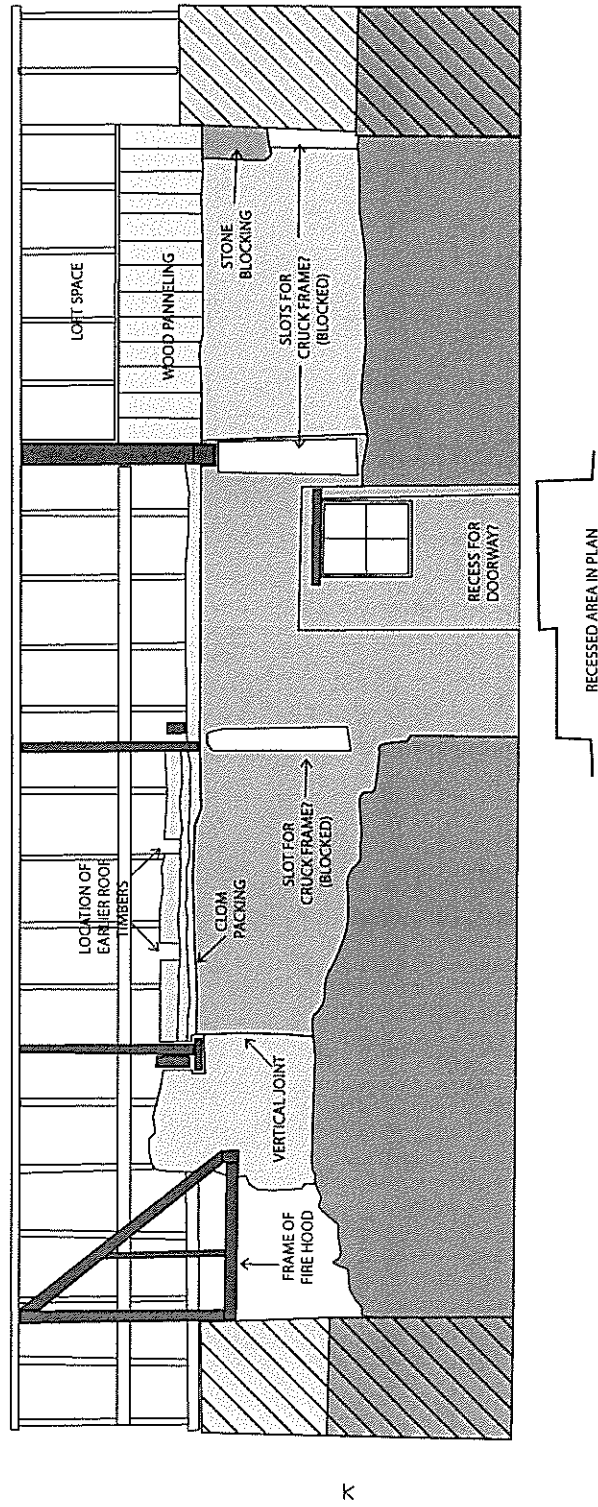
Figure 5: Back wall interior elevation

### **3.2.2 Back wall (facing south-east) (figure 5)**

The back wall appears to be the most complicated elevation, suggesting considerable alterations have been made to the original building. The north end appears little altered, being of 'clom' construction above stone footings, there are traces of limewash on the wall face. Immediately to the right of the window recess is a blocked up cruck frame slot for the original roof. Another probable slot survives at the far northern end of the wall. Another portion of original 'clom' construction survives at the southern end of the wall, part of which has recently collapsed. The straight joint between the 'clom' and stonework here, may be the remnant of another cruck frame slot or a window opening, insufficient survives to be certain. The central portion of the elevation appears to consist of a stone and earth mortar superstructure above stone footings. While this may be a repair, it is less recent than the exterior stonework shell. On top of this section of wall three layers of 'clom' can be discerned, separated by limewash. These layers are presumed to be infill between the tops of the wall and the roof. They may suggest the number of times the roof has been replaced. The window recess also appears to have undergone a series of repairs and alterations. The large recess has a light iron lintel supporting the stonework above. This recess may originally have been a doorway that was later converted to a window recess.

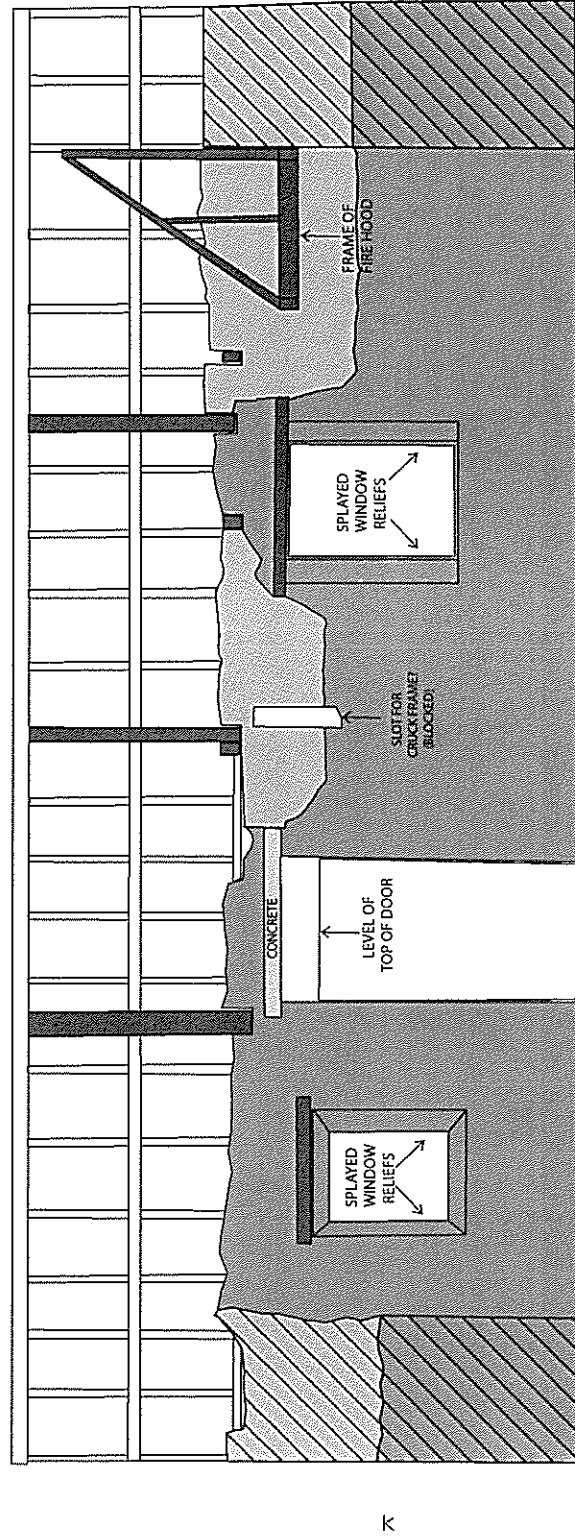
Figure 6: Front wall interior elevation

### **3.2.1 Front wall (facing north-east) (figure 6)**

To the left of the doorway the wall fabric is of cement mortared stonework, replacing or masking any original, or earlier fabric or features. Surviving panelling suggests that the left end of the cottage was partitioned off immediately left of the doorway. To the right of the doorway the wall fabric has been covered with a rough cement skim, possibly intended to be plastered over. Where missing, the upper portion of the wall is revealed to be of 'clom' construction, except above the window, again suggesting it is a later insertion. A single cruck frame slot survives within the 'clom' and is partially blocked with stones.

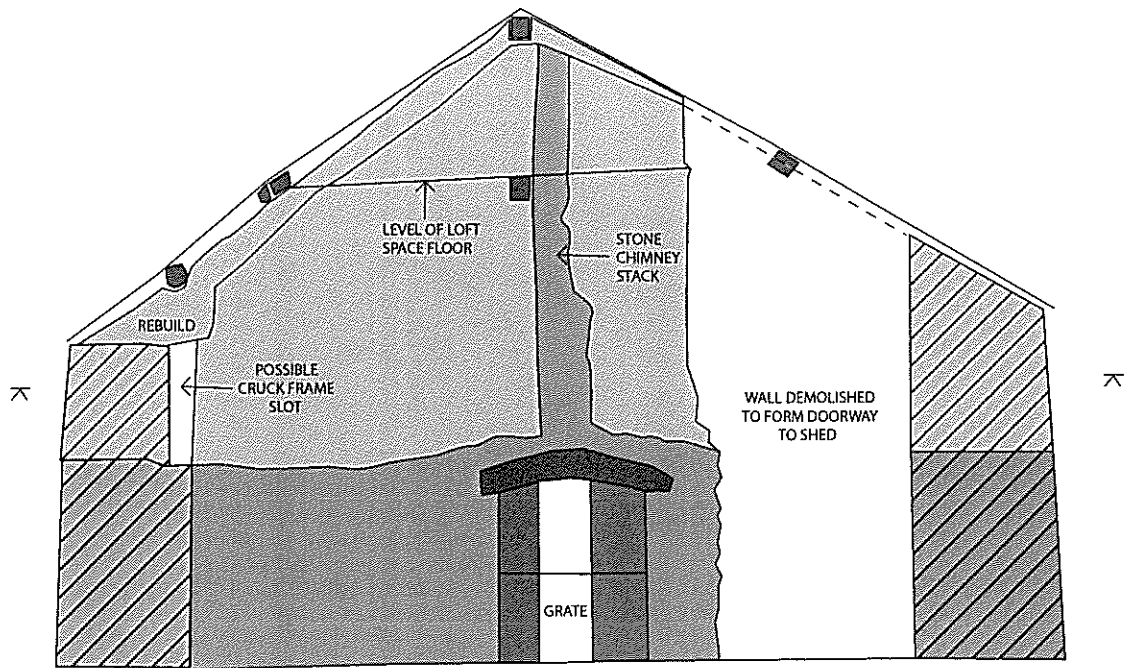
**Figure 7:** Interior elevation of northern wall

### **3.2.3 North end (facing south-west) (figure 7)**

The north gable end interior elevation has been partially demolished on the right hand side, presumably to create a doorway to the adjoining shed, of which only the footings now remain. The rest of the elevation appears largely unaltered, with the exception of the fireplace. This was probably a later insertion. It is also possible however that the fireplace is an original feature but that it has been altered. A cruck frame slot survives on the left side corner.

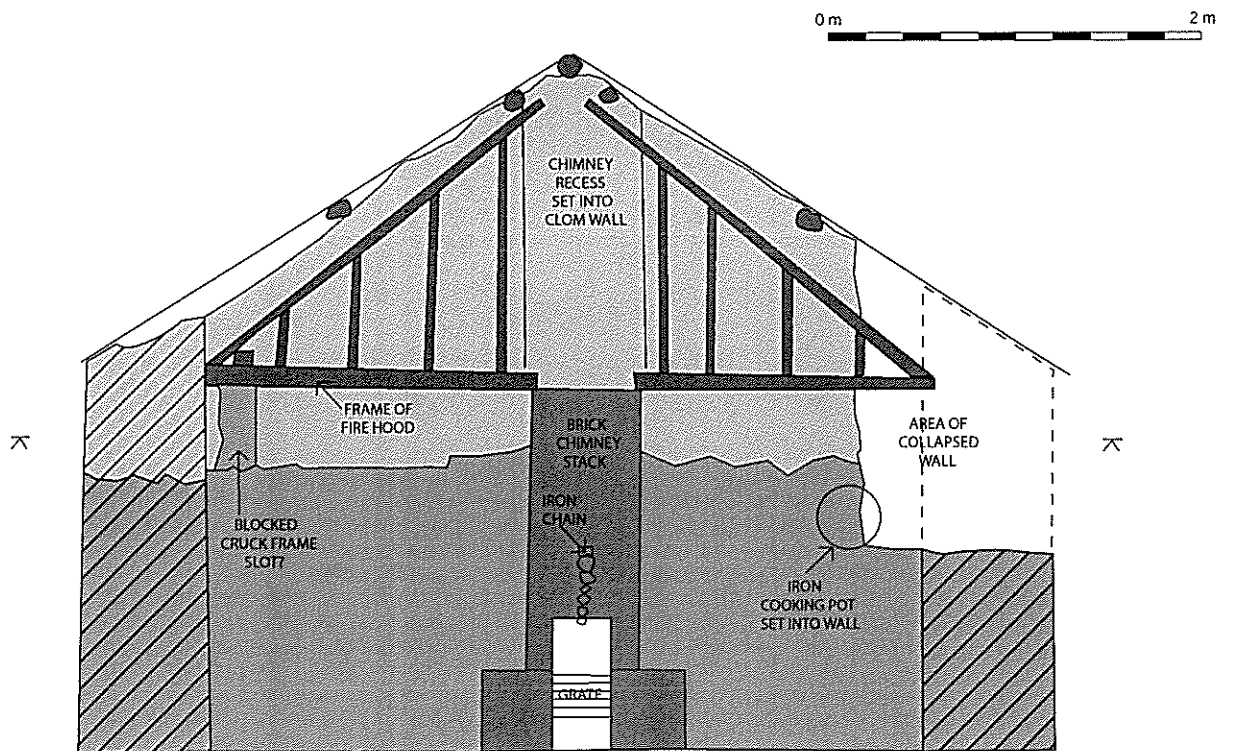
**Figure 8:** Interior elevation of southern wall

### **3.2.4 South end (facing north-east) (figure 8)**

The southern end interior elevation is mostly rendered on the right hand side, but due to recent collapse is revealed to be of 'clom' construction over stone footings. An iron cooking pot has been set into the wall, presumably to act as a 'cubby hole'. It was later filled in with stones and earth mortar and rendered over. The left hand side of this elevation has lost its render. A possible blocked up cruck frame slot is discernable in the left corner of this elevation. The central fireplace is a relatively modern brick built feature that appears to be contemporary with the wooden fire hood. The chimney recess set into the 'clom' may be a remnant from an original fireplace and hood.

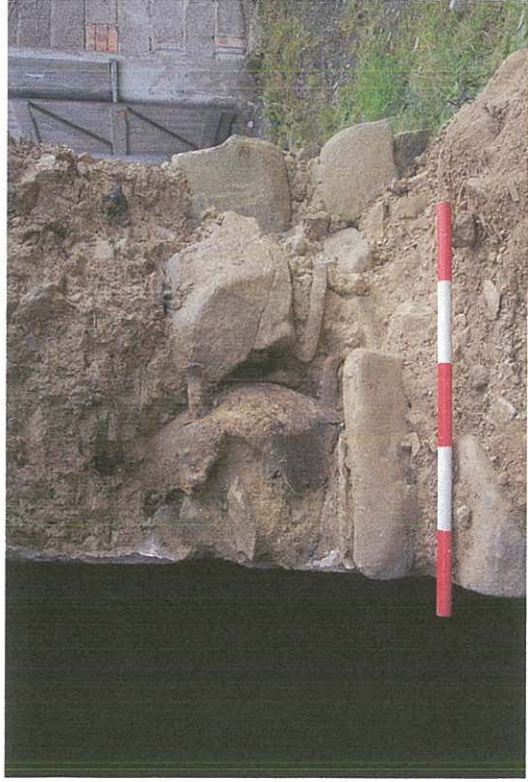
**Photo 5:** Cross section through wall showing cooking pot.

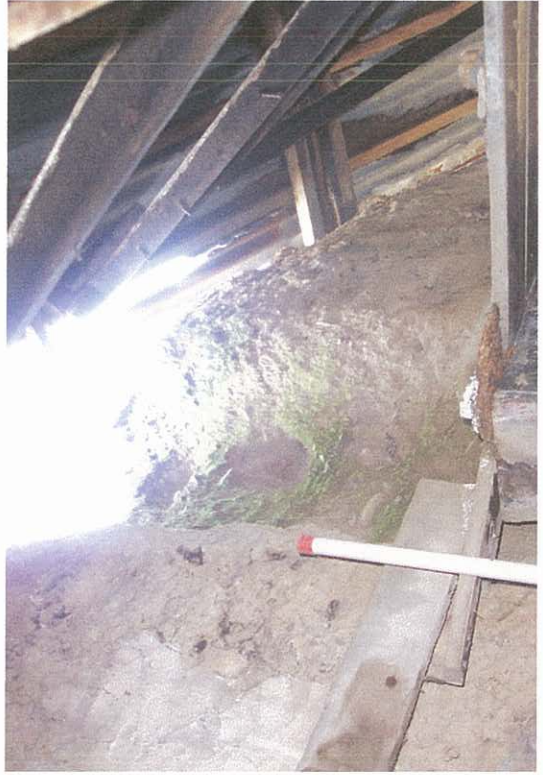
**Photo 7:** Chimney recess in clom wall (south end)

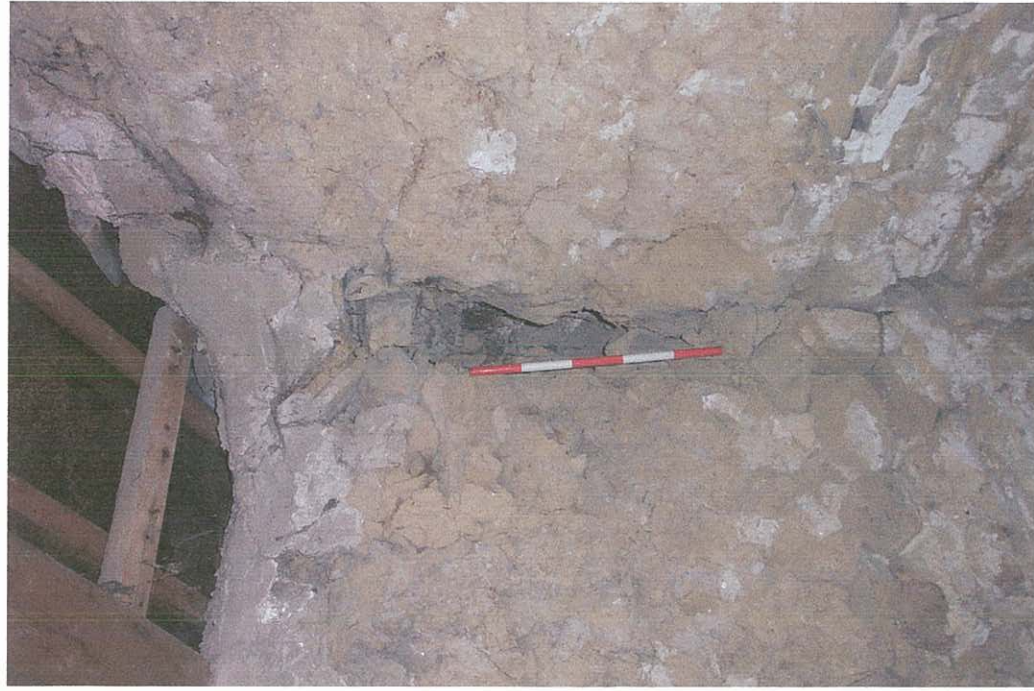
**Photo 11:** Possible crack frame slot (north-west corner)

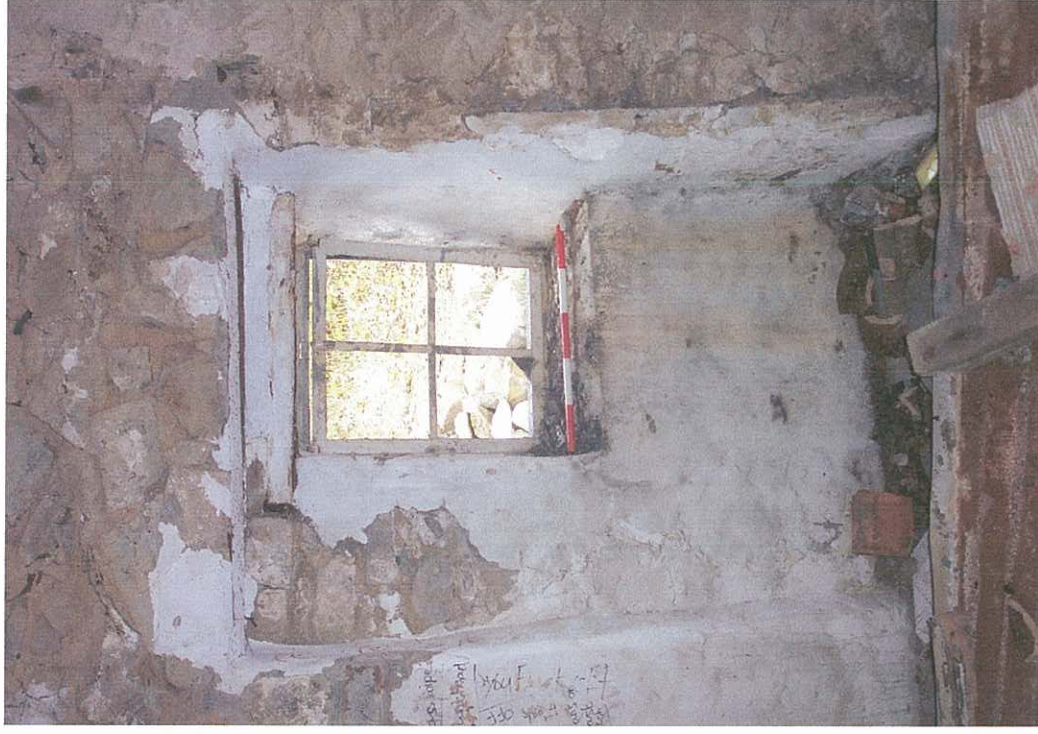
**Photo 12:** Detail of window recess (interior back wall)
