# TIR GOFAL MANAGEMENT PLAN: HERITAGE MANAGEMENT INFORMATION (Call Out) Prepared for: Tyn y Fron

Tir Gofal Reference No: W/11/5095

Report Number: 2005/117 Project Record Number: 53677

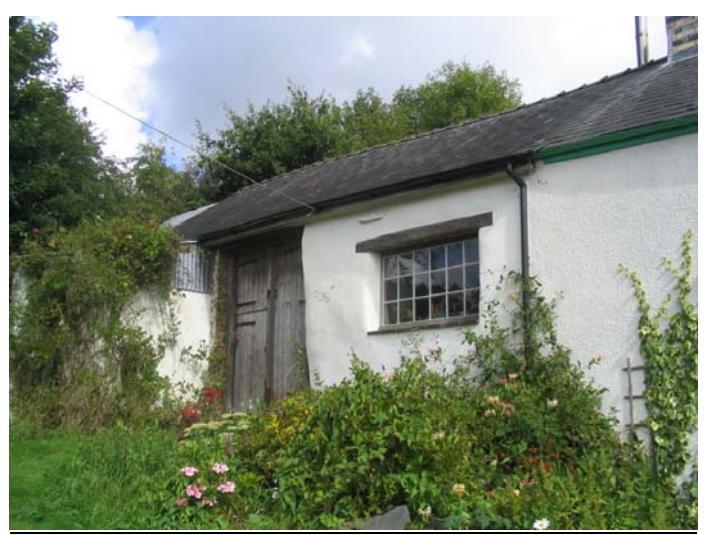
The threshing barn, showing paired doors on the western elevation

time. This building has been renovated and is now used as a workshop. It appears to be in a good state of repair, and retains a number of original features.

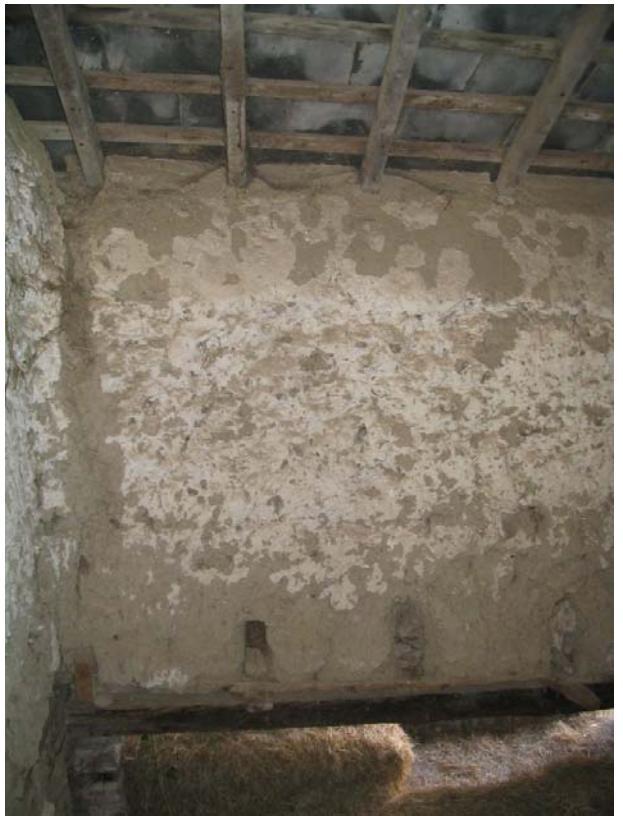
The building at the north end of the western range is two storey, with a slate roof. The lower part is constructed of rubble-stone, whilst the upper storey is constructed of clom, however, more recent repairs have incorporated breeze-blocks into the structure. The north gable-end is built into the hillside with a doorway at second story level (ground level on the outside of the building). The doorway gives access to a loft, although during modification to the buildings, the original loft has been removed. The joists now run longitudinally along the length of the building, supporting an upper floor, which is currently used for storage. The joists originally ran across the width of the building, and their former positions can be seen inside the building, in sockets within the clom on the east and west walls.

Sockets in the clom on the east wall show the former position of joists supporting the upper floor.

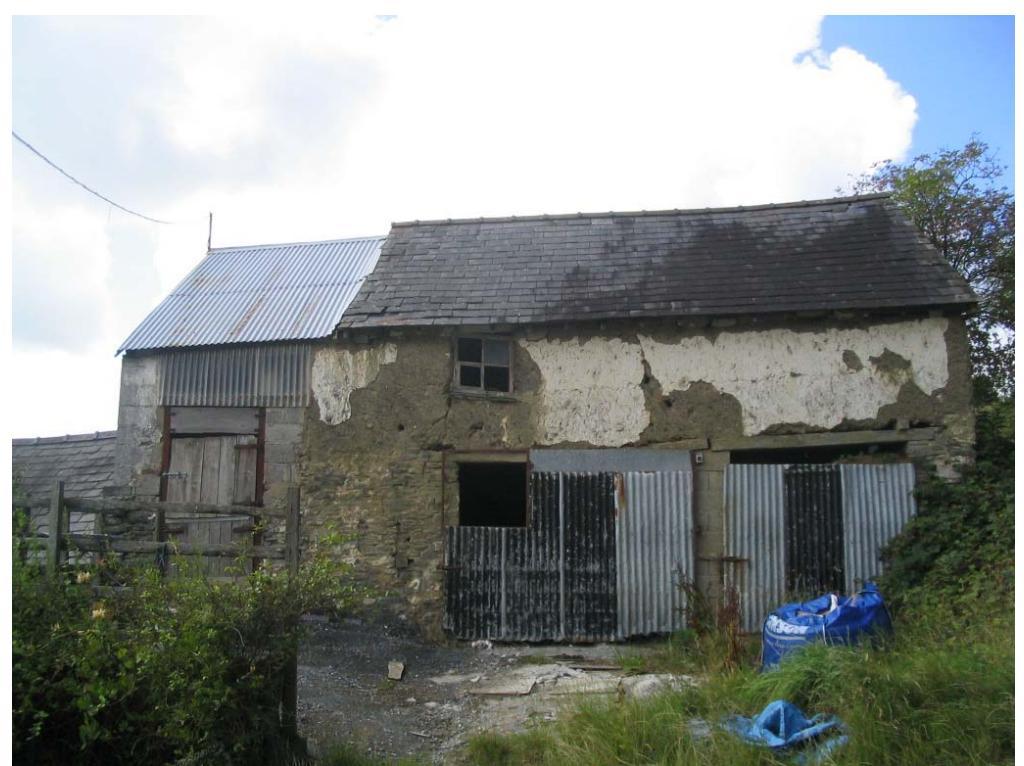
Below this floor at ground level is an area that was probably a cart house in the past. There are two wide entranceways at ground level on the east elevation. Two wooden lintels are supported on either side by the original fabric of the building, but are now supported centrally by a pillar made of breeze-blocks.

The building at the north end of the western range (east elevation, showing wide entranceways at ground floor level, and remaining protective lime render).

On the east elevation, there is what appears to be an original window to the second storey. At this level the remains of the protective coat of lime wash can be seen. However, the condition of this wall is deteriorating – much of the lime wash has disintegrated, and several stress cracks and animal burrows can be seen within the fabric of the wall. The west elevation of this building is also in a poor state of repair, with the clom now exposed to the elements. Again, the protective coating of lime wash has disintegrated, and slates missing from the eaves are allowing the core fabric of the wall to be dissolved by penetrating water.

Repairs to the surface of the clom need to be made in order to prevent damp from penetrating the core fabric of the walls. Roof slates should be replaced where necessary, to prevent water from penetrating wall tops.

Holes in clom are often the result of animal activity. Large holes and tunnels are often made by rats. Fill in tunnels and render over. Medium sized holes could be caused by birds looking for nest sites, fill and render over in the autumn, so that nesting birds are not disturbed.

Protective lime render should be re-applied to exposed walls to prevent erosion of the surface of the clom. (Schofield and Smallcombe, 2004)

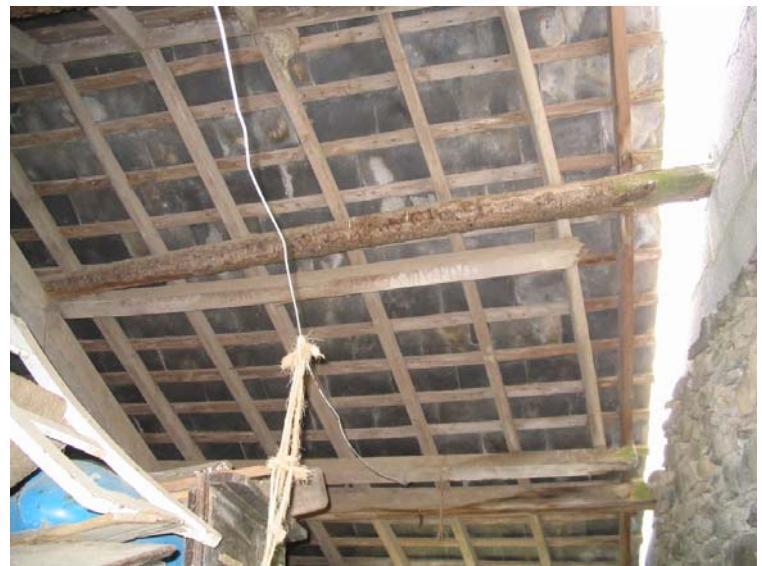
The south gable-end of this cart house abuts a single-storey building that forms the southern element of the western range. The upper part of this gable-end is now built of breeze-blocks, so its original form is uncertain. The lower part of the wall is rubble-stone, and it seems likely that the element now built of breeze-blocks was formerly clom. This would have allowed for the provision of sockets for the roof purlins of the southern building. These purlins are no longer tied into the southern gable end of the cart house, and the roof of the southern building has separated from it leaving a wide gap. From inside the southern building, it is apparent that the apex of its roof has shifted southwards (longitudinally) with relation to the building. The rafters lean to the south, so that the points at which they meet at the apex are no longer directly above the point at which they meet the wall tops, a process known as 'racking'. Racking must have occurred prior to the current slates being hung, as the slates are laid with joints running vertically, compensating for the angle of the roof timbers.

Inside the southern building of the western range, showing the 'racked' roof.

The join between the roof of the southern building and the gable-end of the cart house should be consolidated.

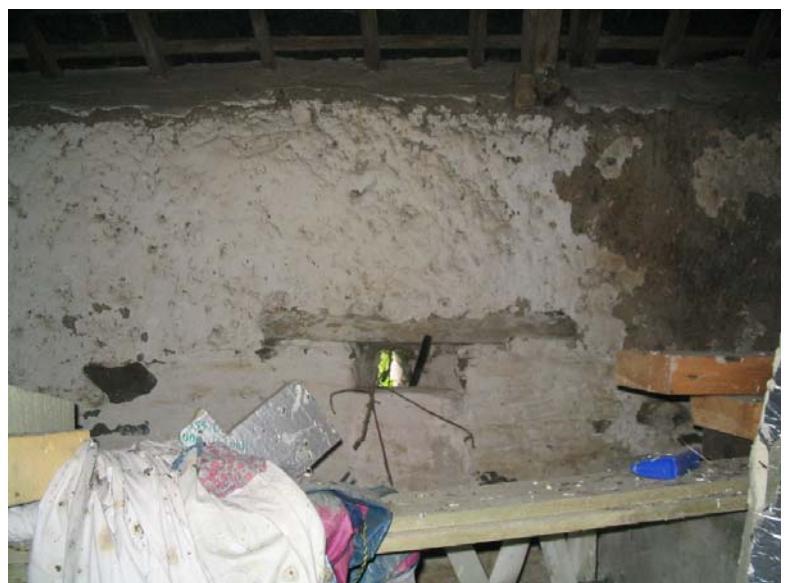
In the western wall of the building, ventilation slits with wooden lintels are visible, but have been blocked. There is currently a breeze-block outbuilding attached to the external face of the western wall. From within this outbuilding it is possible to see the former position of the ventilation slits.

Blocked ventilation slits in west wall of southern building.

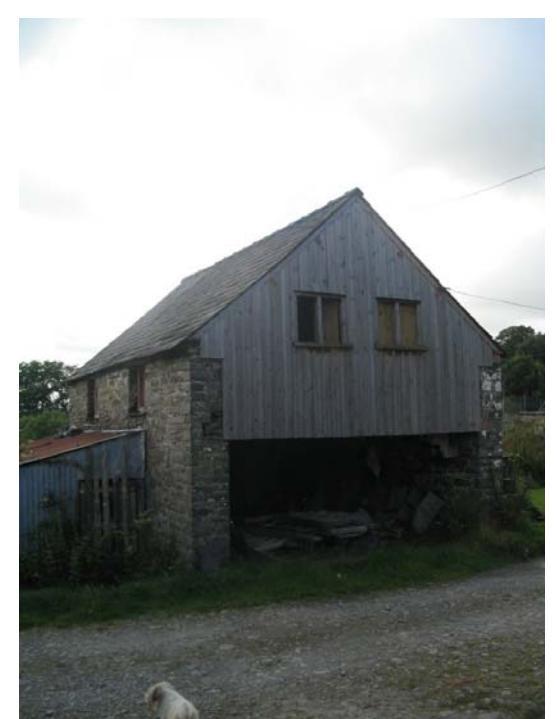
South-east of the two rows which form the main focus of the farmstead are two further outbuildings. The most southerly building is built of rubble-stone to a height of one and a half stories. It is the only building in the range that does not appear to have a clom element to it. At second storey level, there is a loft, with two small window openings on the south elevation, and one window and a doorway on the north elevation, which is reached by an external set of stone steps. The ground floor has ventilation slits in the stone walls and is accessed by a single, wide entranceway on the eastern gable-end of the building. This gable end now has timber cladding to the upper storey, but it is not clear whether this is an original feature of the building. The building is in good repair generally.

Southernmost outbuilding showing timber cladding to gable end.

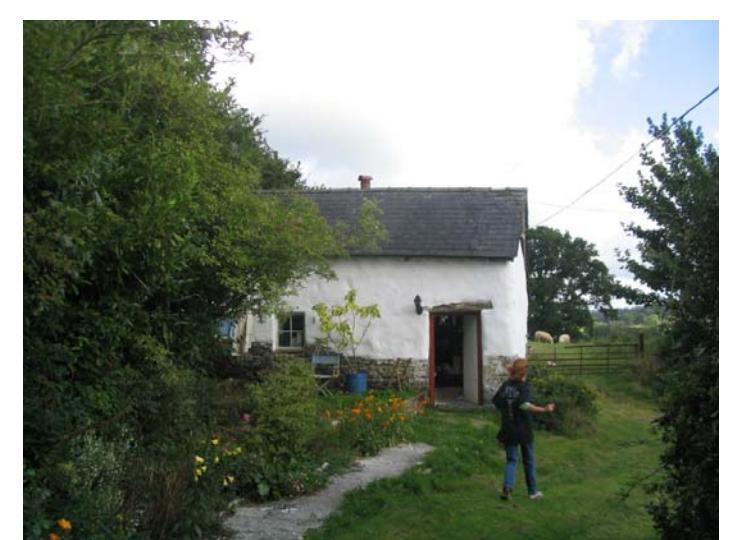
To the north, and set back from the rear elevation of the farmhouse is a small twostorey building, made of rubble-stone and clom, and roofed with slate. It appears on the second edition Ordnance Survey map, but not the first, making it the most recent building within the historic farmstead. The building has been recently repaired, and modified to incorporate a chimney. It is not clear to what extent the remainder of the building has been modified, but externally the building appears well looked after, and repairs that have been made are in keeping with the style of the rest of the farmstead. The owner has sourced earth from the immediate vicinity to carry out repairs to the clom elements of the building.

Small building to the rear of the farmhouse, repaired using locally sourced clom.
