#### TIR GOFAL MANAGEMENT PLAN: HERITAGE MANAGEMENT INFORMATION (Call Out)

Prepared for: Hafod yr wyn

#### Tir Gofal Reference No: W/11/5165

Project Record Number: 53683 Report Number: 2009/30

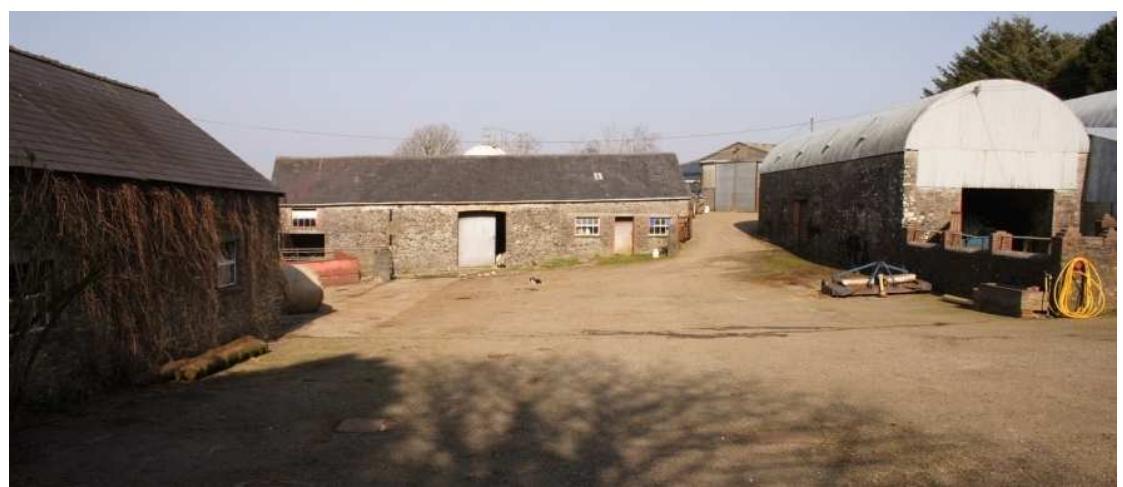
Hafod-yr-wyn farmstead, with the old house on the left, threshing barn and cow shed in the centre and the stable, cart shed and hayloft (now under corrugated-iron) on the right.

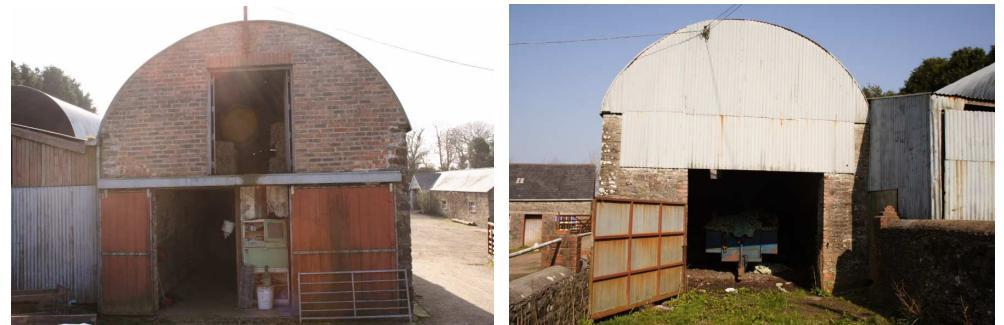
The focus for this report is the stable and cart shed range that has undergone some modifications. When the slate roof collapsed it was replaced with curving corrugatediron, changing the pitched, gable-ended profile to a semi-circular wagon-roof shape reminiscent of a Dutch barn. This dates, according to the owner, to 1957. The original gables of the building have now gone, rebuilt in red-brick on the northeast facing end and replaced with corrugated-iron on the southwest facing end. The ground floor end walls and the two-storey sidewalls have survived.

(Left) northeast- facing end wall partially rebuilt in red-brick and (left) southwest-facing end wall partially replaced with corrugated-iron.

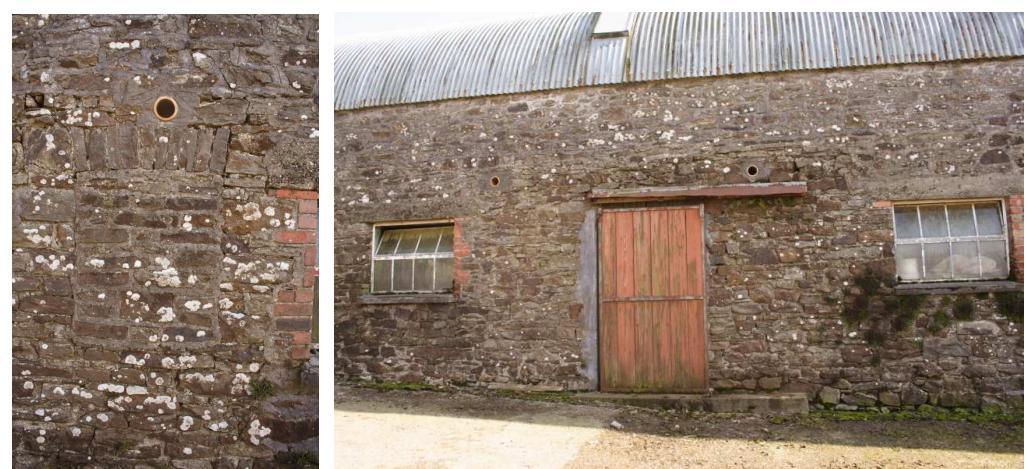
Many of the groundfloor door and window apertures in the building, including the doorway within the northeast-facing end wall, the four metal-framed windows in the façade and three doorways in the rear wall that lead out into a modern lean-to extension, have red-brick dressings and are possibly later additions to the building. The stable doorway, later consolidated with concrete, and a now blocked-up window within the façade have lintels of pitched stones and are likely to be original features.

(Left) blocked-up window with lintel of.pitched stones (Right) original stable doorway and possible later window apertures within the building façade.

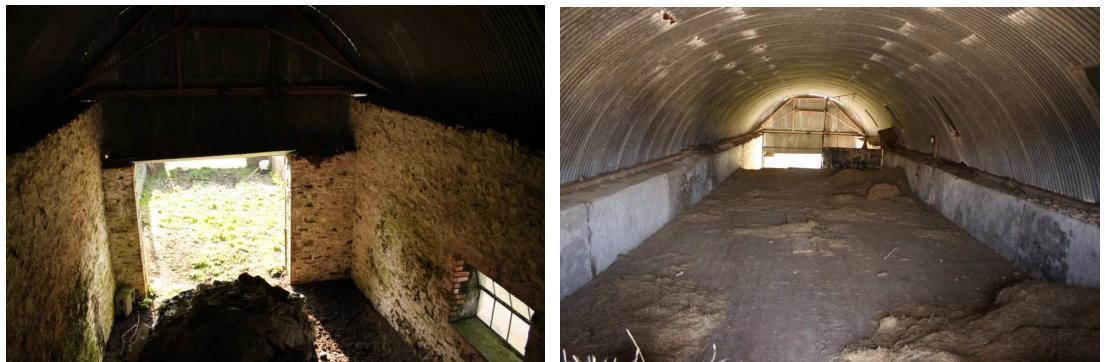
The cart shed has a single large opening within the southwest-facing end wall. The original lintel is now missing, replaced by corrugated-iron sheeting. The cart shed is open to the roof and separated from the stable block by a structural wall, with a doorway leading from one to the other. The interior walls have been whitewashed. Timber steps attached to this wall lead up to the hayloft above the stable.

(Left) interior of the cart shed and (right) the hayloft, looking southwest.

The hayloft floor is of wooden planks and timber wall plates lie along the masonry wall tops, which are consolidated in part with concrete, to provide an anchorage for the domed corrugated-iron roof. Nothing remains of the original timber frame that would have supported a pitched roof. The hayloft doors, now set within the northeast facing red-brick end wall, are solid wood planking and painted grey.

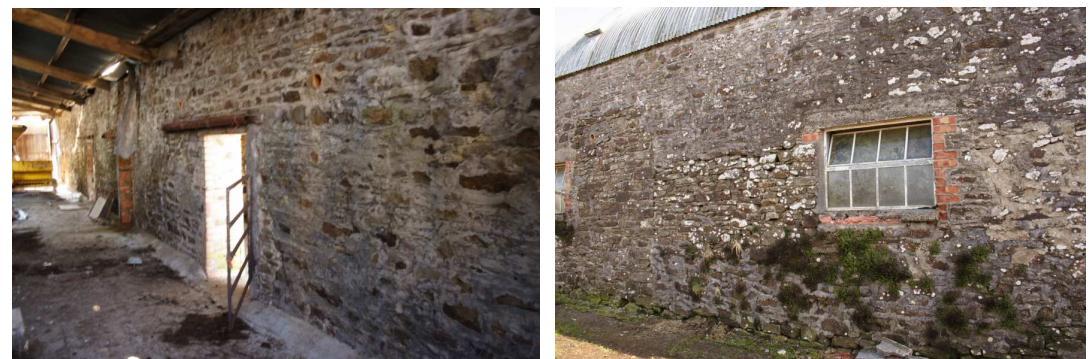
The penetrating damp evident on the rear wall of the stable block is largely the result of drainage failure along the edge of the adjacent lean-to. The owner intends to remove the lean-to, which should alleviate the main problem and allow the building wall to breathe and dry out. Vegetation growth on the building façade also requires remedial action.

(Left) external rear wall of the stable abutted by modern lean to and (right) vegetation on the façade.

- Consolidate areas of loose masonry using a traditional lime mortar mix, trying to follow the original mix and appearance as far as possible.
- Re-pointing is necessary where mortar has weathered back to a depth equivalent to the joint width or is very loose.
- Cut back vegetation on the walls, leaving the roots in situ. Spot treat to prevent re-growth.
