# COAST PATH MAINTENANCE AND EROSION CONTROL AT PORTH Y RHAW PROMONTORY FORT, SAM Pe273

RHIF YR ADRODDIAD / REPORT NO. 2006/118 RHIF Y PROSIECT / PROJECT RECORD NO. 62160

September 2006

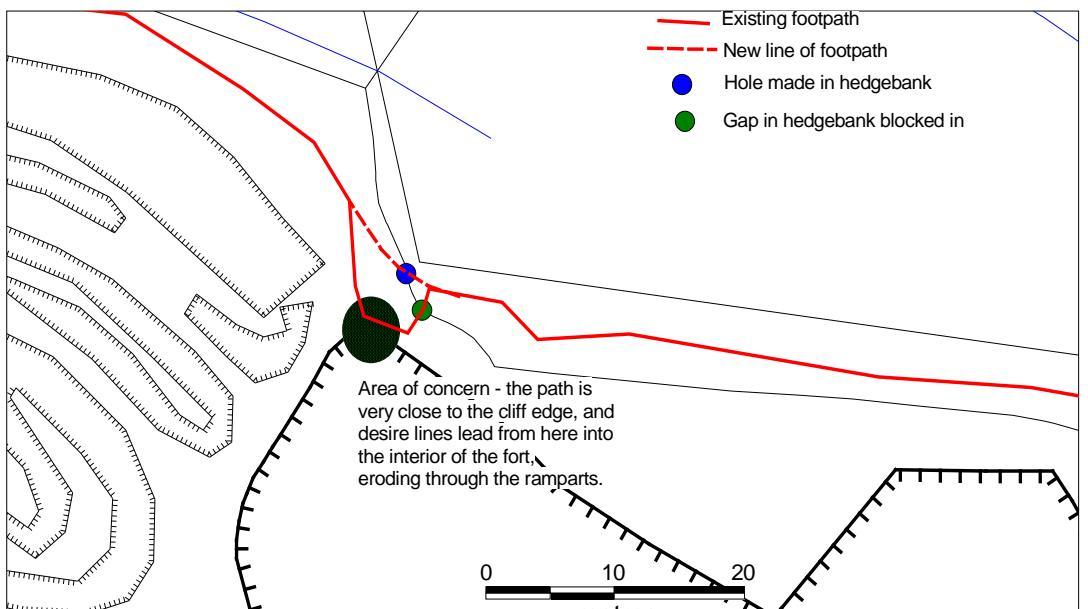
Figure 3: showing the location of repairs carried out in area 1.

**Area 1**. At the east end of the footpath a new route was put in place. The old route passed very close to the cliff edge, and was also so close to the ramparts that strong desire lines were leading into the interior of the fort and eroding through the outer ramparts. The new route was created by 'punching' a hole through an extant hedgebank and using that material to block the existing route, which passed through a hole in the hedge nearby. Access is still possible into the interior of the fort, but since the obvious route up and across the ramparts is now closed off it is hoped that people will be discouraged from going this way. It is also clearer now where the official line of the coast path runs.

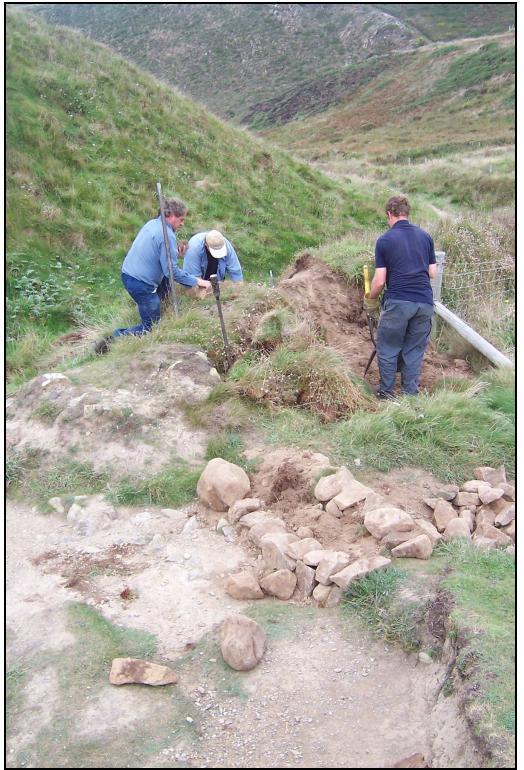
Photo 1: In the foreground, the lines of stone show where the existing footpath is being blocked. These stones will form the facings of the new, low hedgebank which is being built in such a way as to quickly blend in with the surrounding boundaries. Behind this, a new gap is being created to route the path around the bank of the rampart.

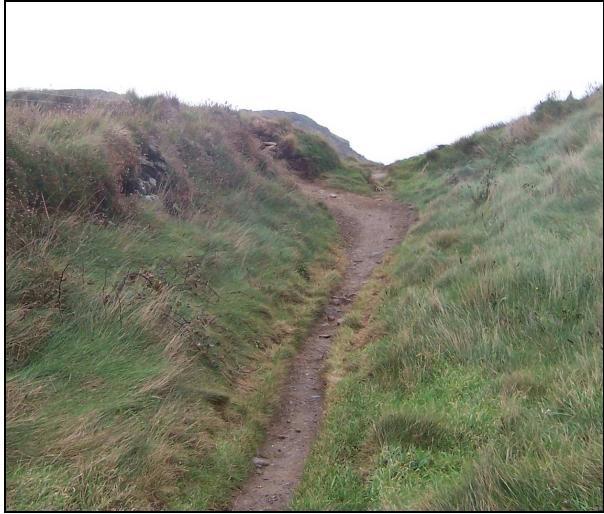
Photo 2: Looking east along the footpath, the rampart is to the right of the picture. The line of the old path continued straight on and is now blocked, the new path is the one which swings to the left and passes through a new gap in the hedgebank. This will help to route visitors away from the cliff edge and also away from the most heavily eroded area of the earthworks.

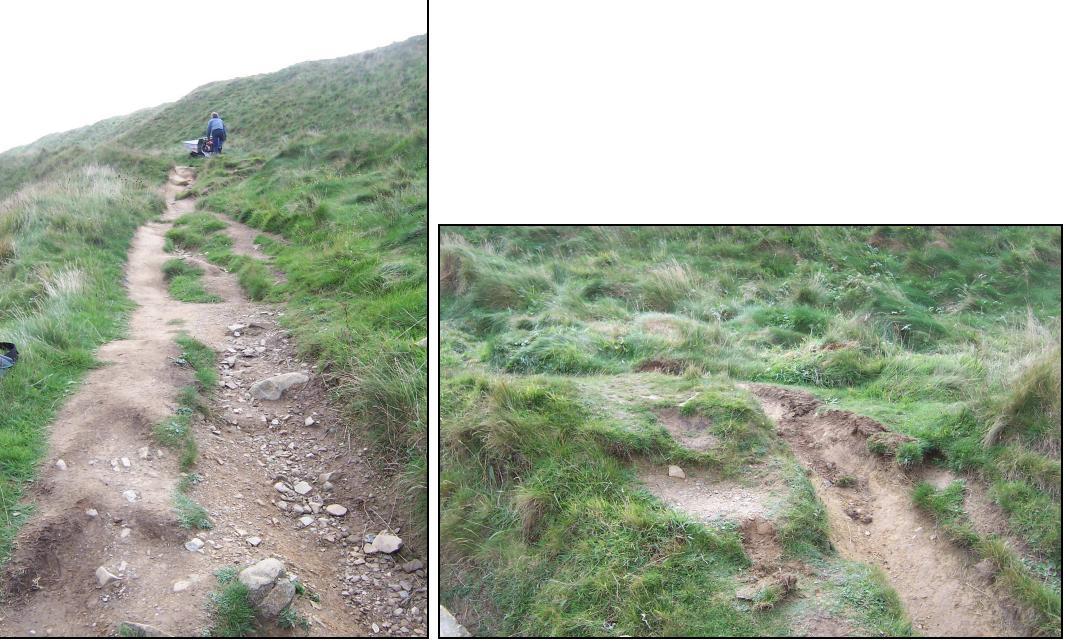
**Area 2.** In this area, the footpath climbs up, and crosses, the shallow outer rampart before running alongside it. The path had eroded deeply into the rampart and was very muddy and slippery in bad weather. Consequently it was also very braided, as people tried to avoid walking in the mud.

Photos 3 and 4 (above): Showing the footpath before any works were carried out. Photo 3 (left) shows the path running to the east, where the figures are standing in the photograph is the point at which it crosses the ramparts. The path was very worn and was, at points, continuously braiding causing a wider area of disturbance. Photo 4 (right) shows the main path cutting into the earthwork of the outer rampart.

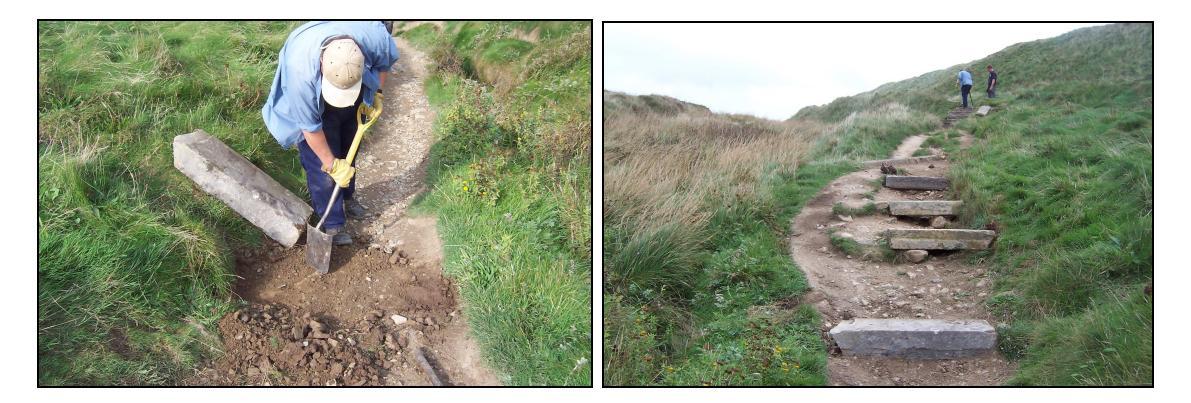
Photos 5 and 6 (above): showing the steps under construction. Photo 5 (left) shows how little ground disturbance was needed to bed the stones in place. Photo 6 (right) demonstrates how the steps will help to dictate a single route - the path to the left of the steps was later infilled.

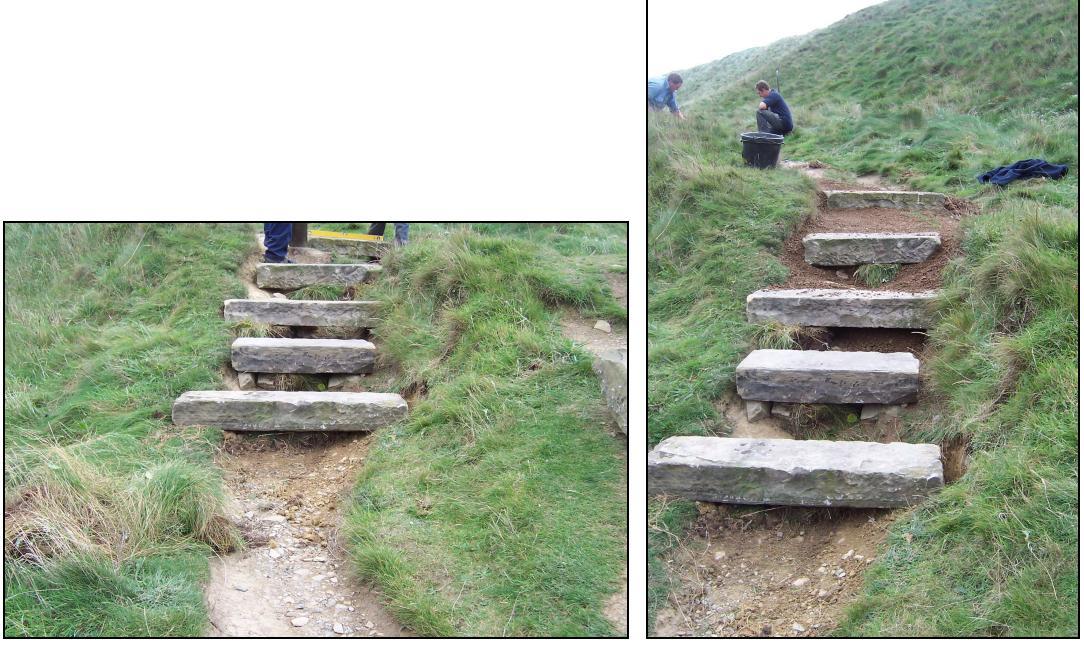
Photos 7, 8 and 9 (above and below) showing one set of steps under construction. The steps are built up from the ground surface (above left) and the aggregate is introduced (above right) to fill the gaps and bed the steps securely in place. Photo 9, below, shows this set finished.

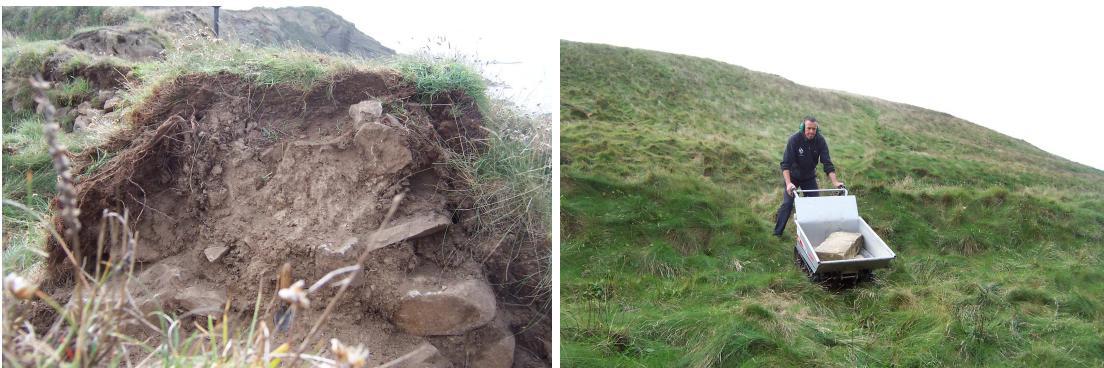
Above left: close-up of the section through the hedgebank Above right. Area 2: transporting stone to build the steps. Work was carried out when the ground was dry in order to avoid causing disturbance whilst doing this.

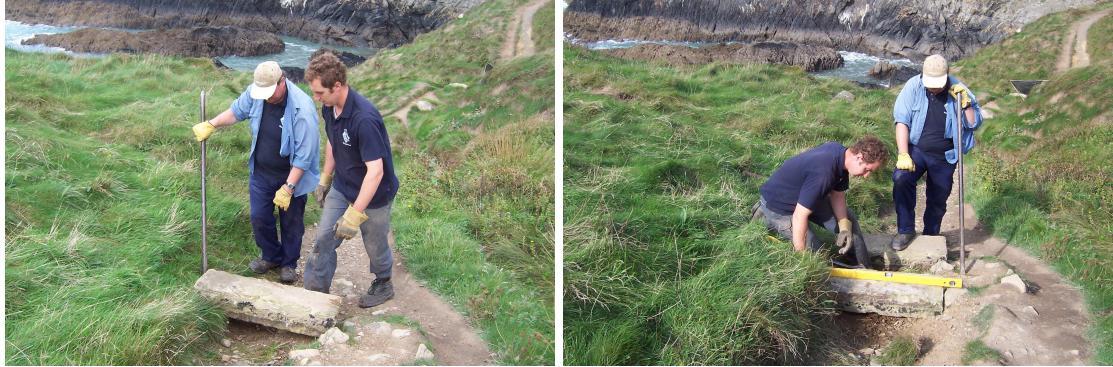
Above left and right: laying the steps in place

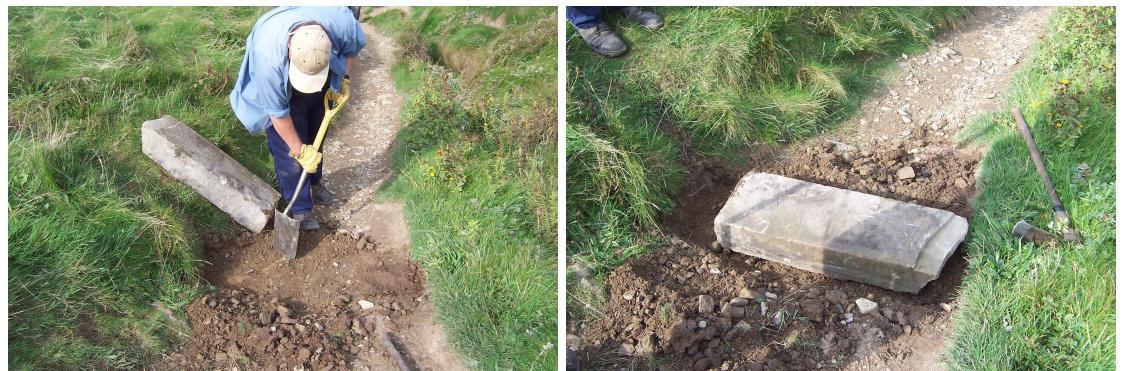
Above left and right: very limited ground disturbance necessary to level the stones in.

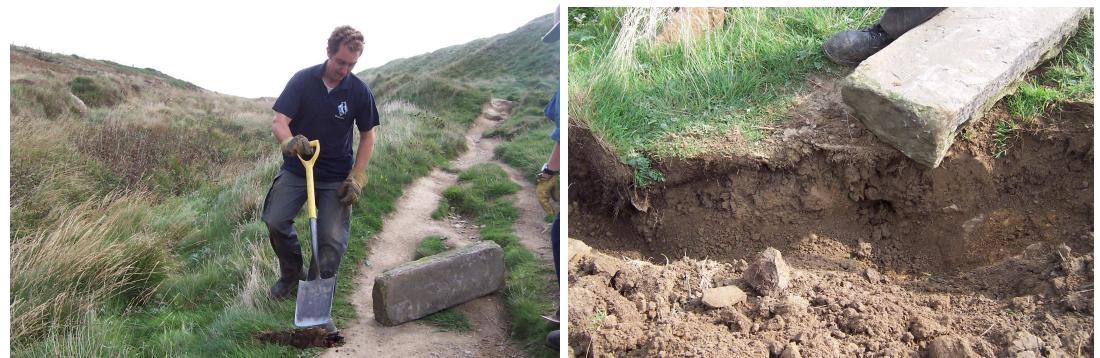
Above left and right: digging a small trench to hold the stone grips
