EXCAVATIONS AT THE COLD BATH HOUSE DINEFWR PARK

JULY 2007

RHIF YR ADRODDIAD / REPORT NO. 2007/74 RHIF Y PROSIECT / PROJECT RECORD NO. 63189

EXCAVATIONS AT THE COLD BATH HOUSE DINEFWR PARK 2007

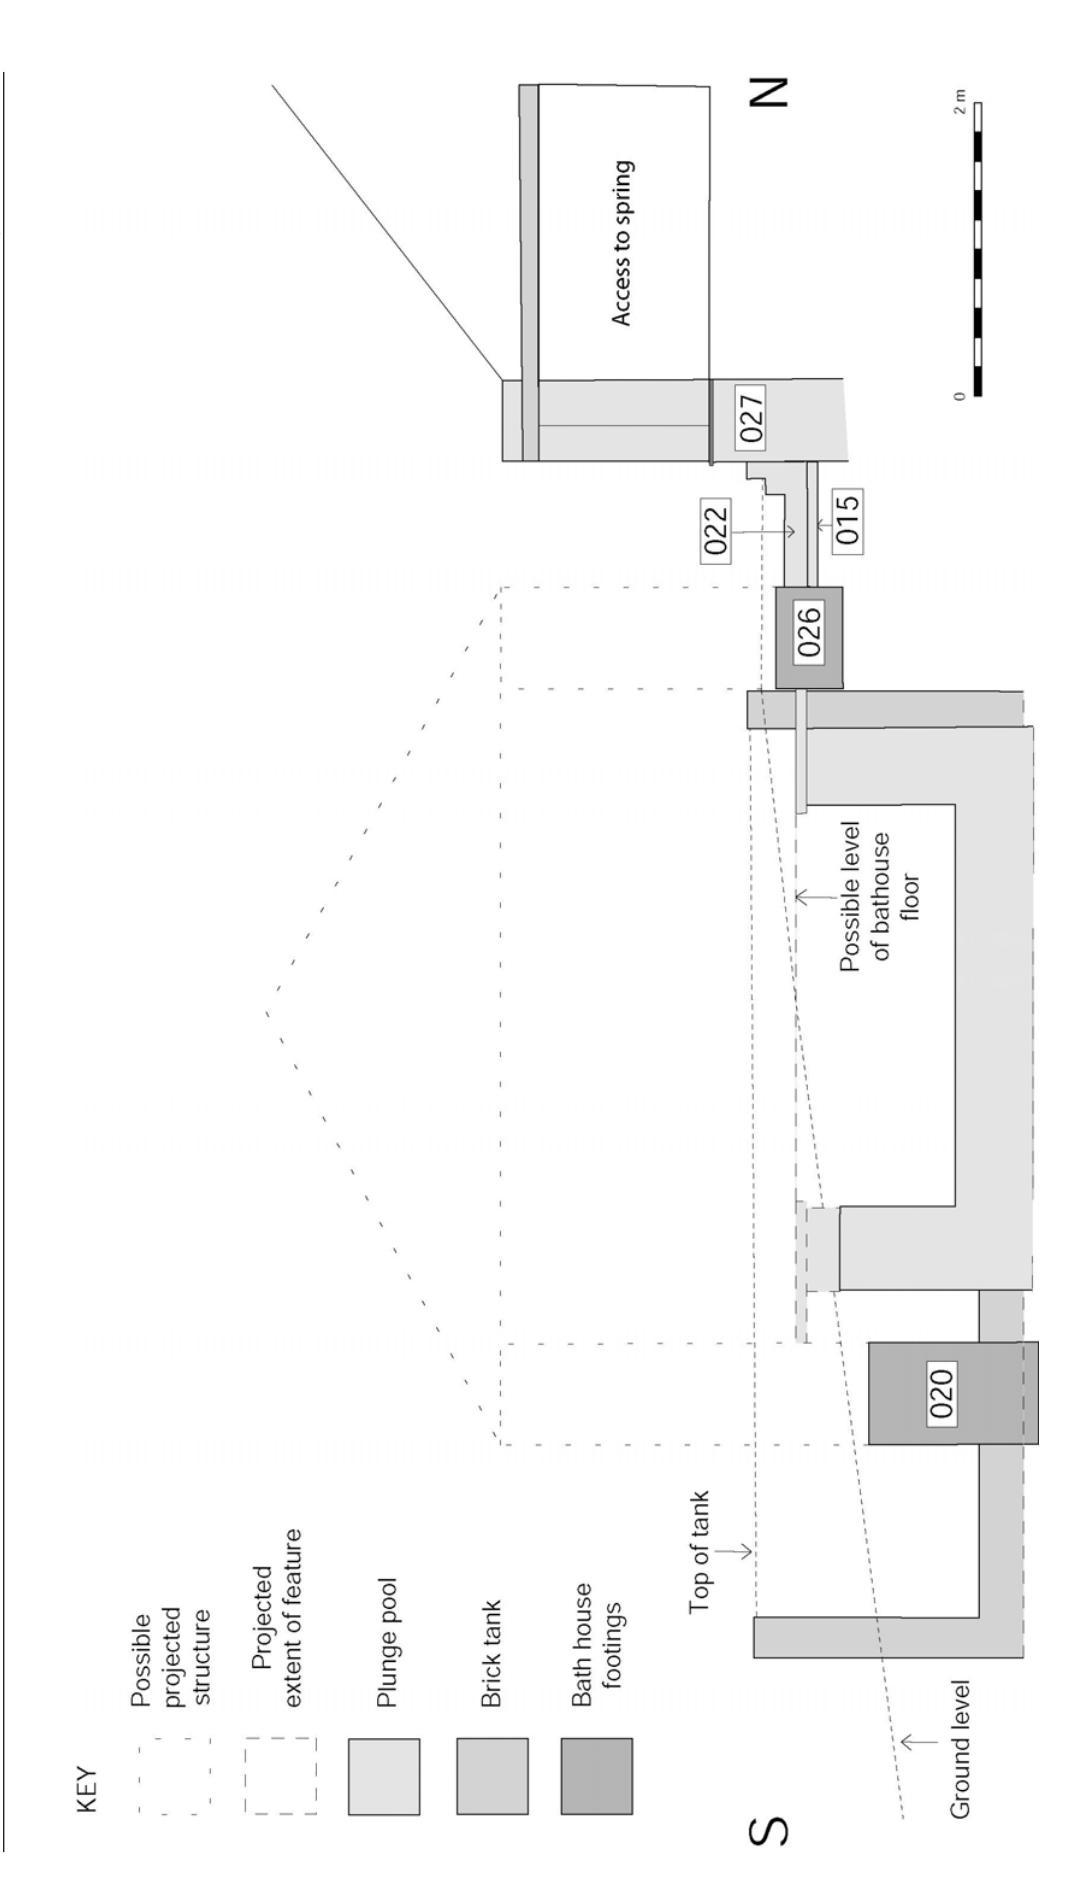
Figure 2: Schematic transect through excavated structures

The later red brick tank cuts through the plunge pool and the south wall of the building, but the north and west walls may remain intact. Although not excavated, comparison of the levels of the base of the brick tank and the base of the plunge pool suggests that brick tank has cut through the base of the plunge pool (see figure 2).

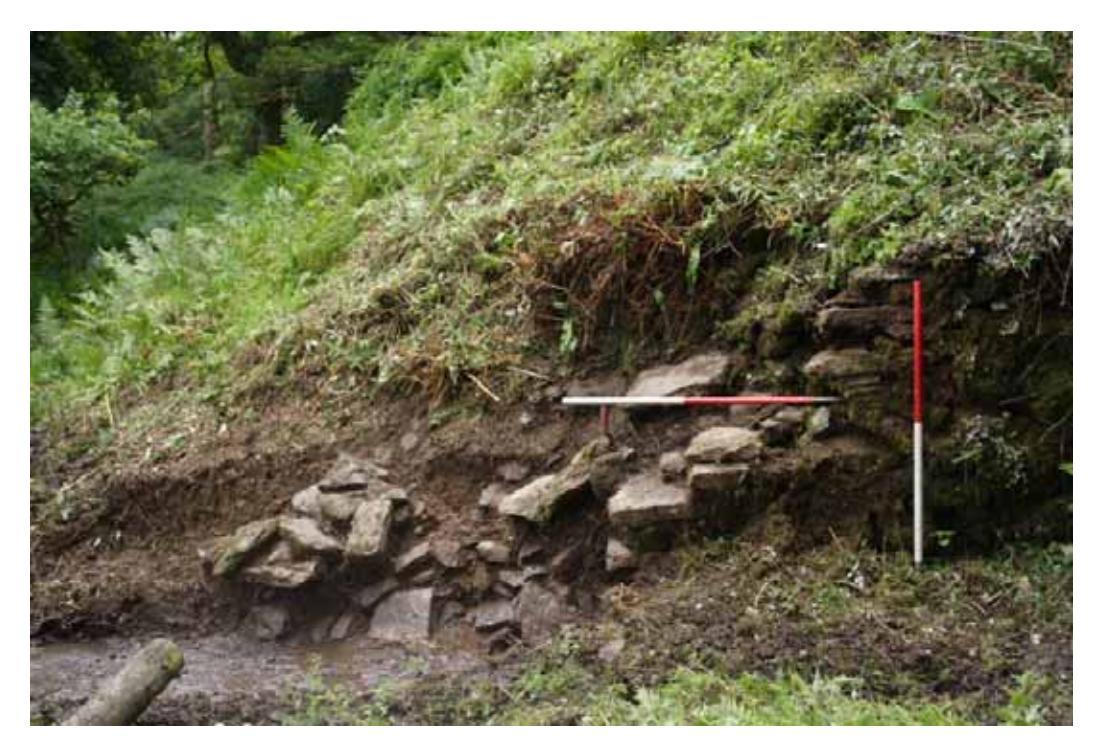
The approximately L-shaped retaining wall cut into the hill slope defines the north and west limits of the site. The western length has collapsed at its southern end, where it has been undermined by the flow of spring water. The wall face shows evidence of at least one repair (see photo 1). The northern portion of the retaining wall (photos 2,3 and 4) also shows evidence of at least one re-build. The basal 0.60m of the wall is the original construction. The later rebuild is set back from the lower face, forming an irregular ledge or sill.

Photo 1: East facing side of retaining wall (collapsed)

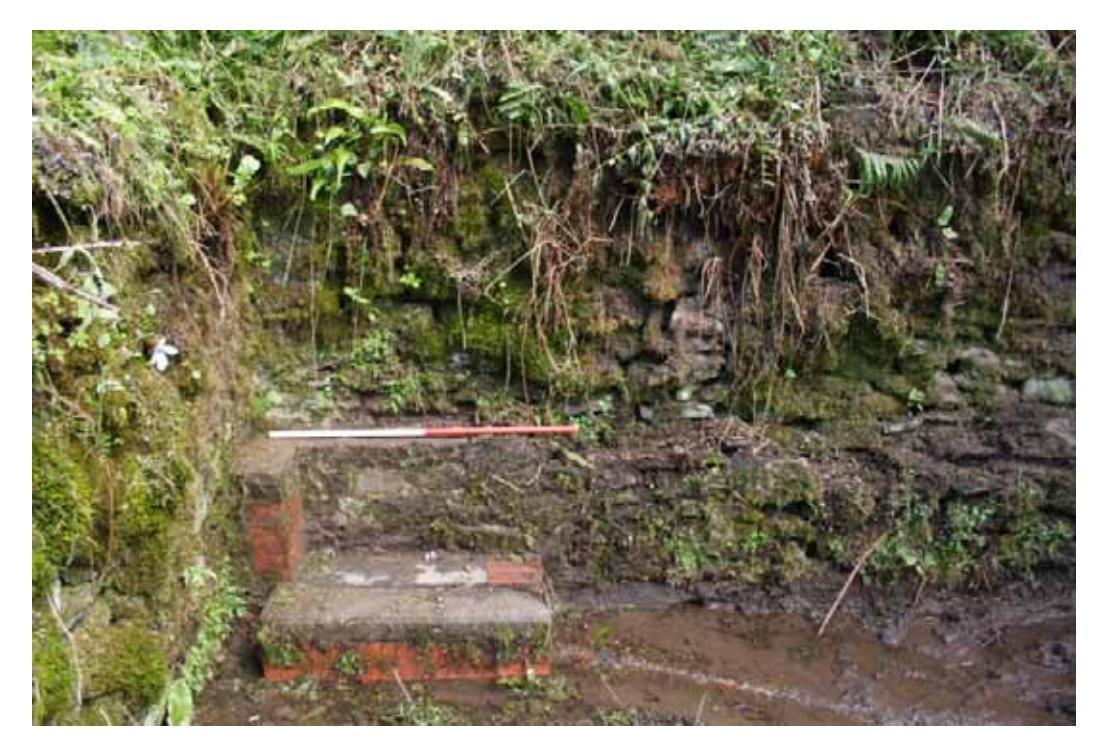
Photo 2: West end of south facing retaining wall with later brick and stone water management feature

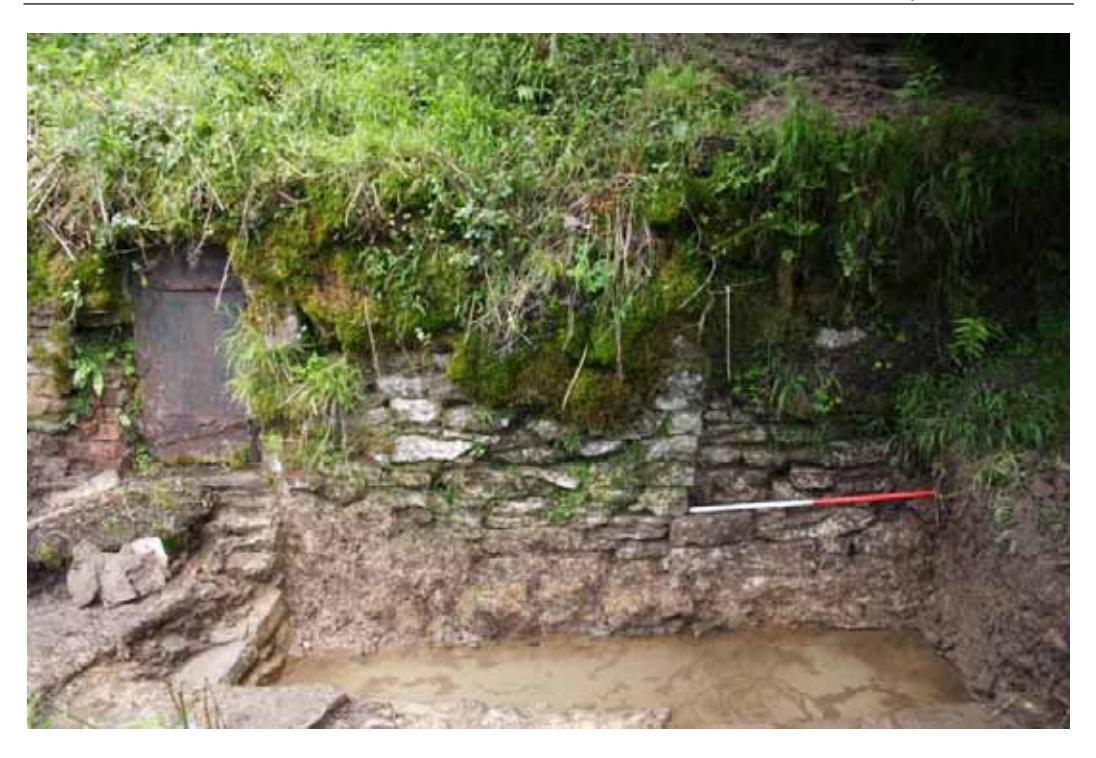
The area between the retaining wall and the brick tank has been covered with concrete, obscuring pipework associated with the brick tank and also obscuring remnants (022) of the connection between the retaining wall and the original plunge pool (photos 3 and 5).

Photo 3: South facing retaining wall showing door to spring, and exposed masonry (to left) connecting spring to bath house. Beneath the water is a stone surface

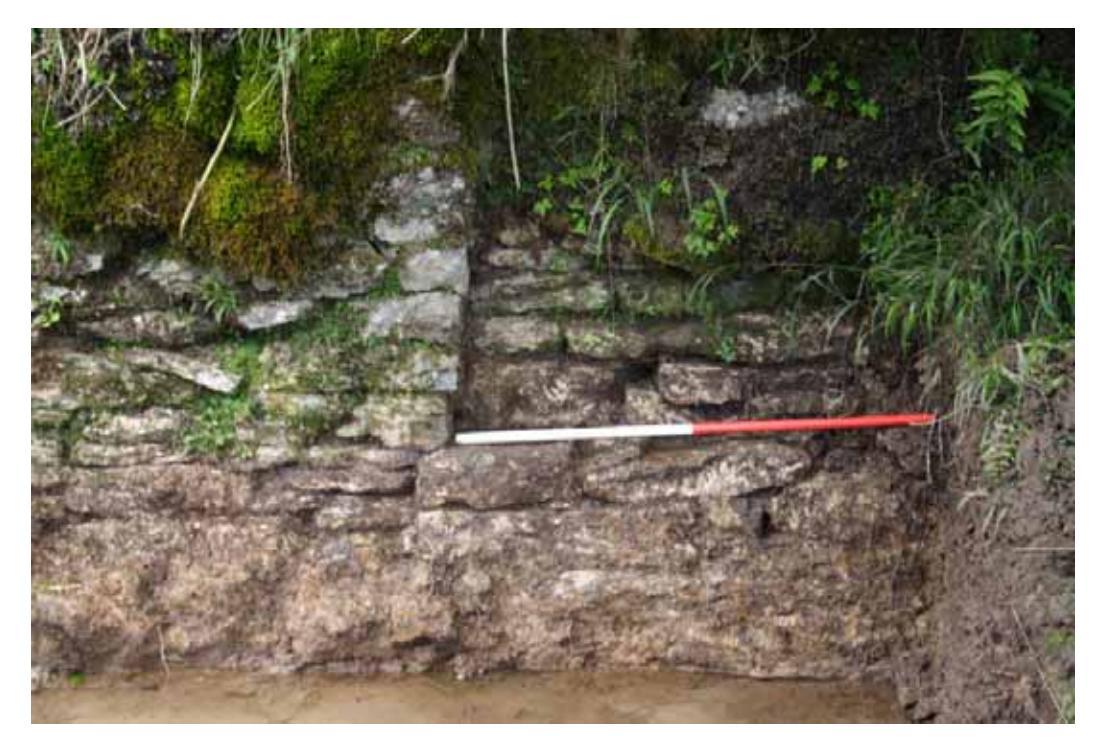
Photo 4: Detail of recess/rebuild in retaining wall

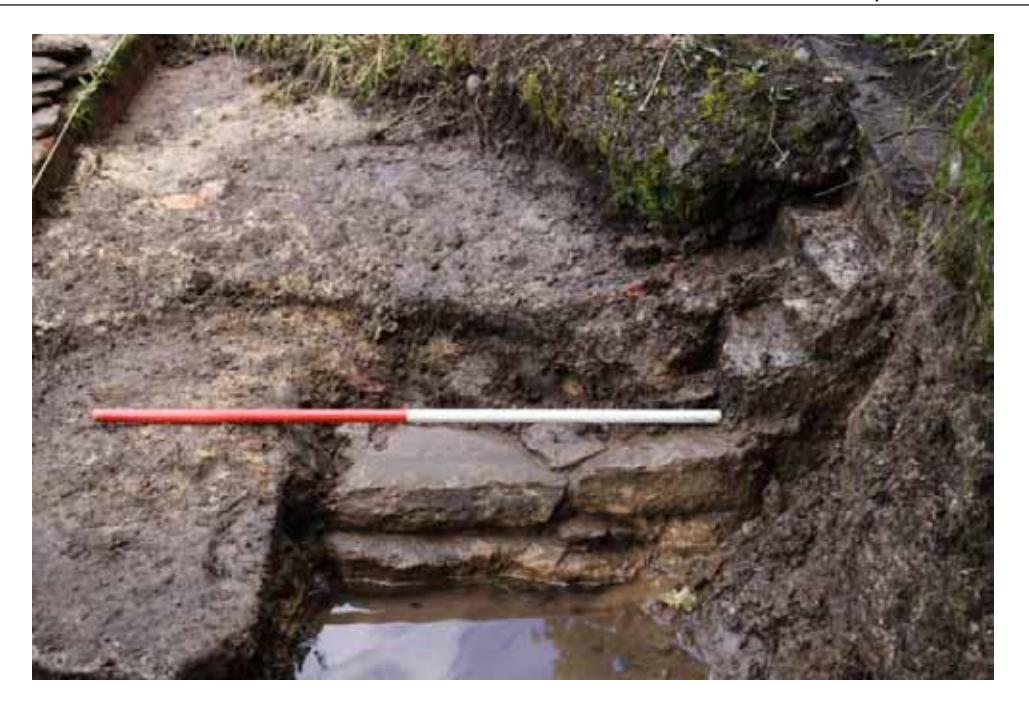
Photo 5: Detail of exposed masonry linking the bath house to the spring

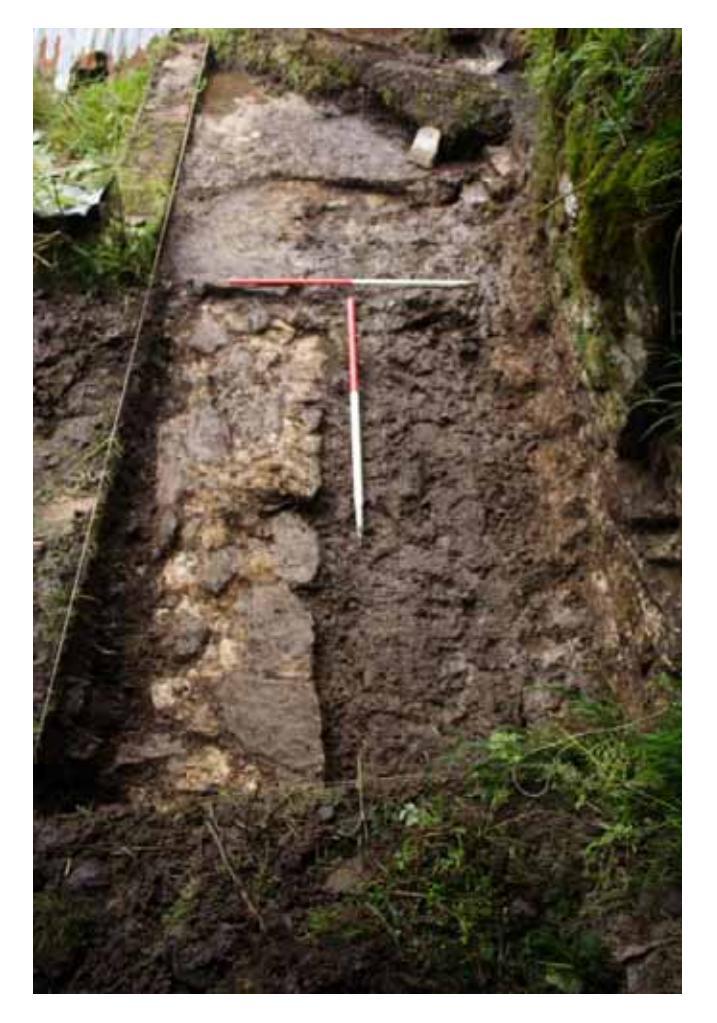
Photo 6: The north wall of the bath house (left) looking west

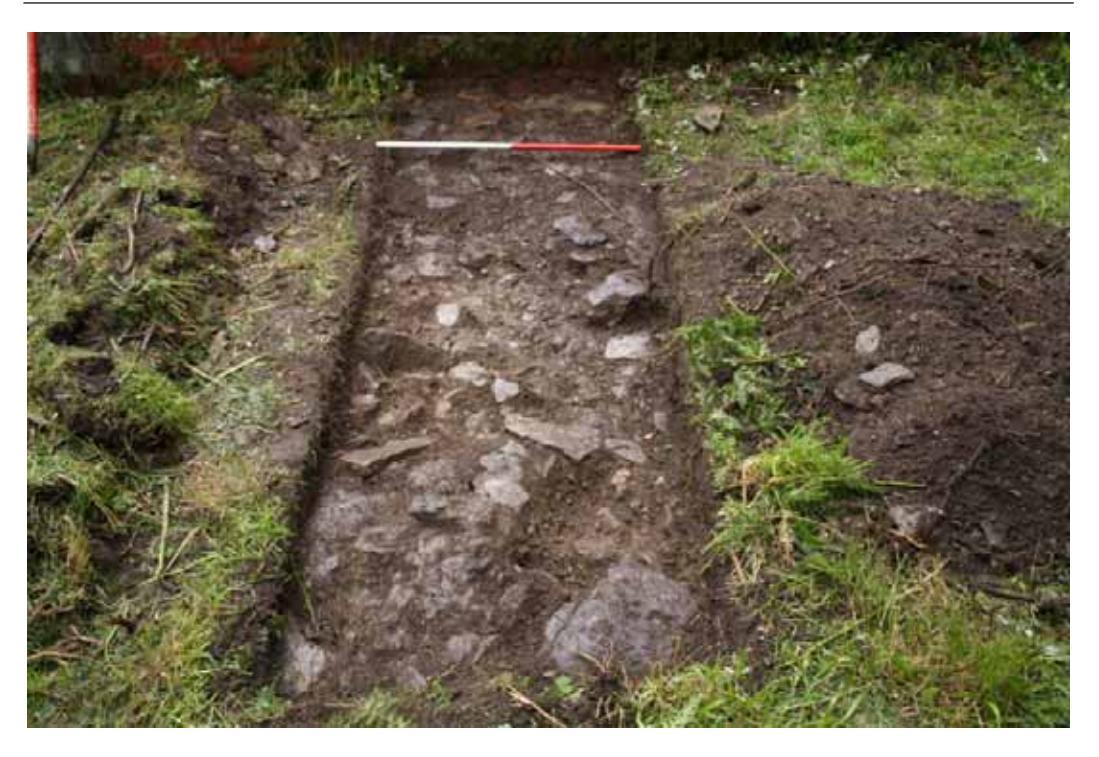
Turf and topsoil (001) was removed to reveal the top of a deposit of demolition debris (011) extending across the whole of the excavated area (see photo 7). The demolition debris included roof tiles, ceramic drainage piping, mortar fragments, rubble stone and glass fragments.

Photo 7: Exposure of top of demolition rubble

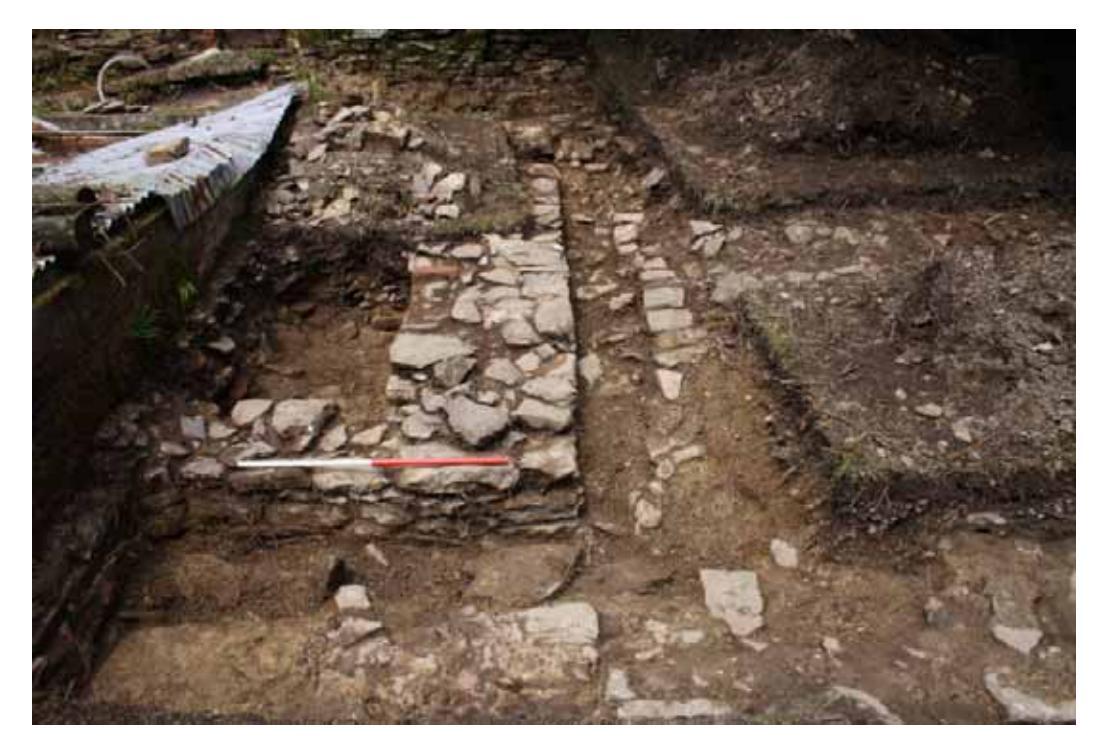
Photo 8: Pool walls (left center) and south wall of bath house (foreground), looking north. Note aligned stonework (023) to right of pool walls.

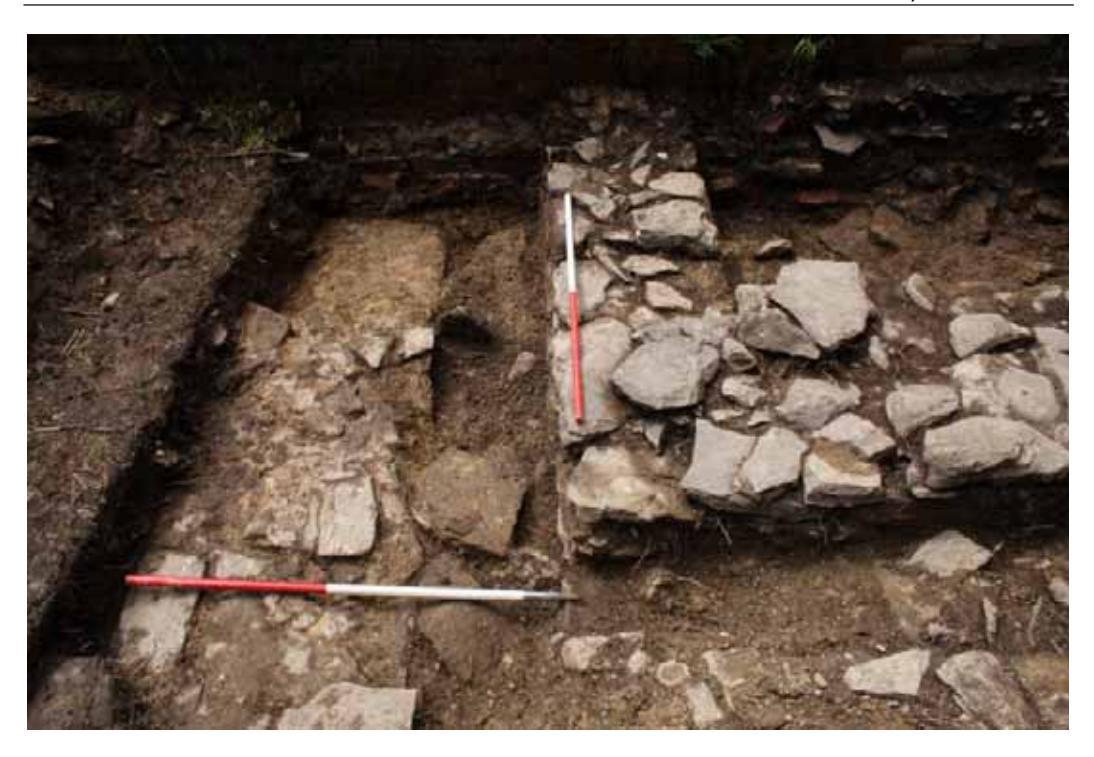
Photo 9: Southeast corner of pool structure (right) looking west, with south wall of bath house to left

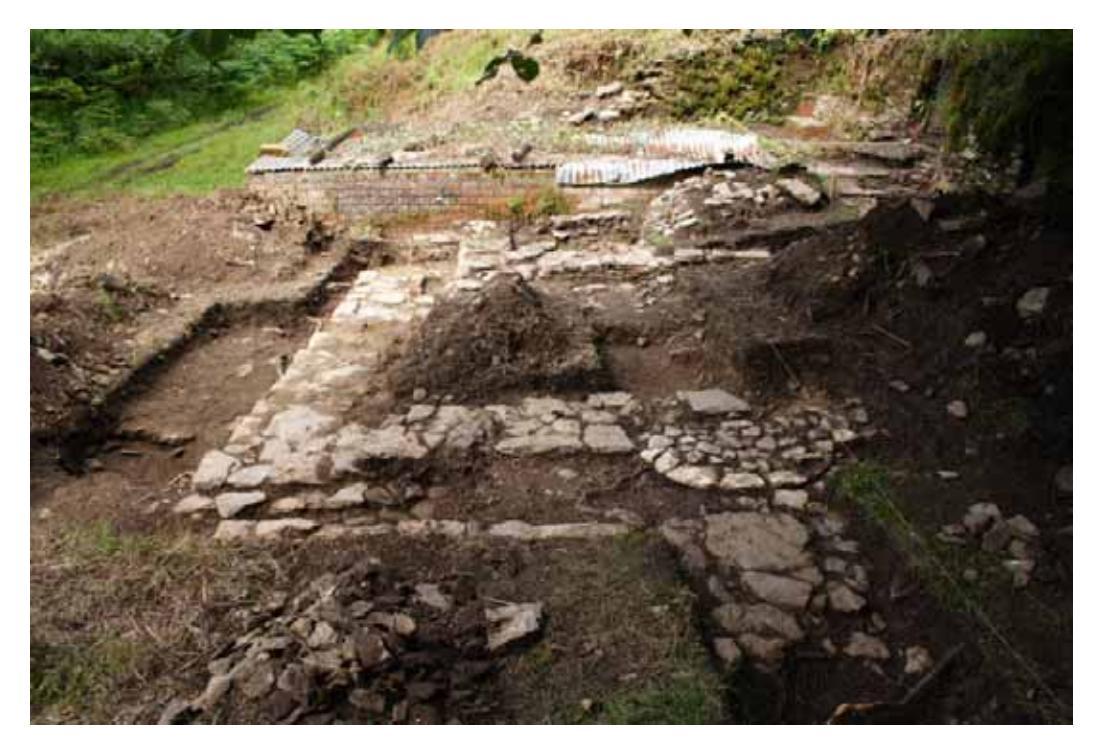
Photo 10: Exposed footings looking west. Note remnants of stone flag surface in foreground

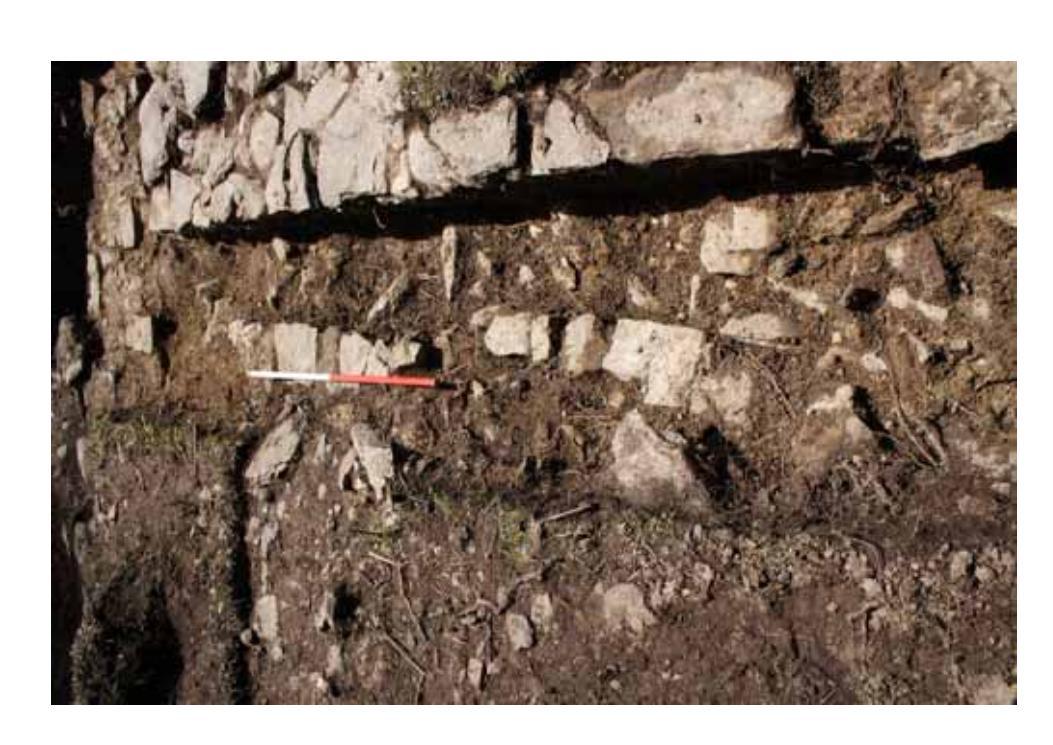
Photo 11: Aligned stonework 023, looking south

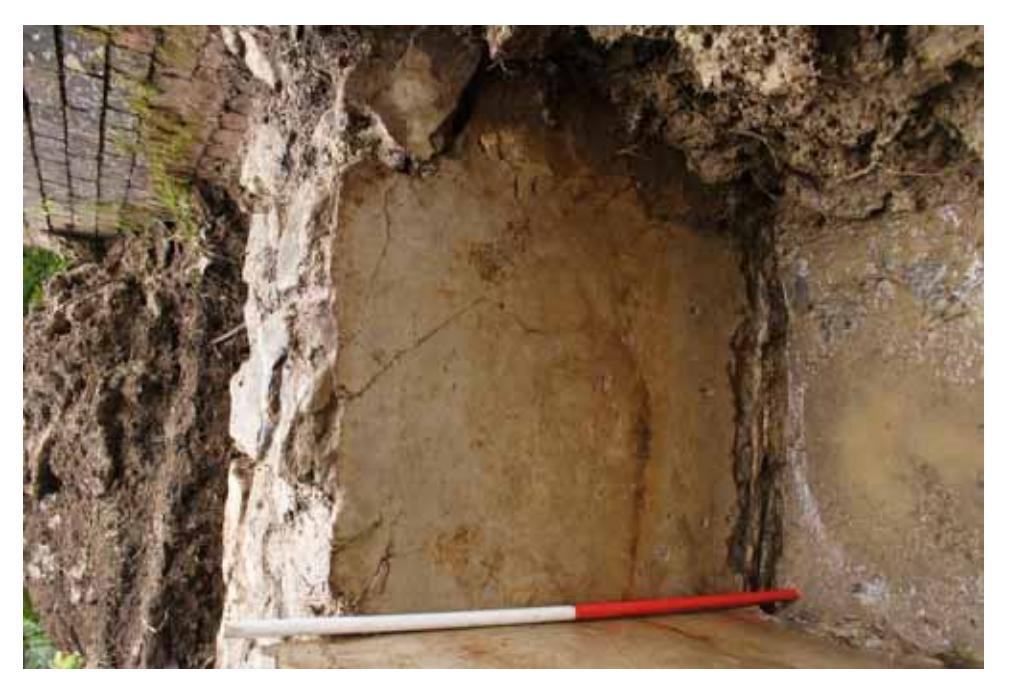
The interior of the plunge pool was found to be faced with very hard smooth lime mortar, with no evidence of paint, tile grouting scars, or other evidence for having been faced with a more durable or decorative material. The base of the plunge pool, however, had been removed, perhaps suggesting it had been lined with marble.

Photo 12: Plaster lining of plunge pool, looking south

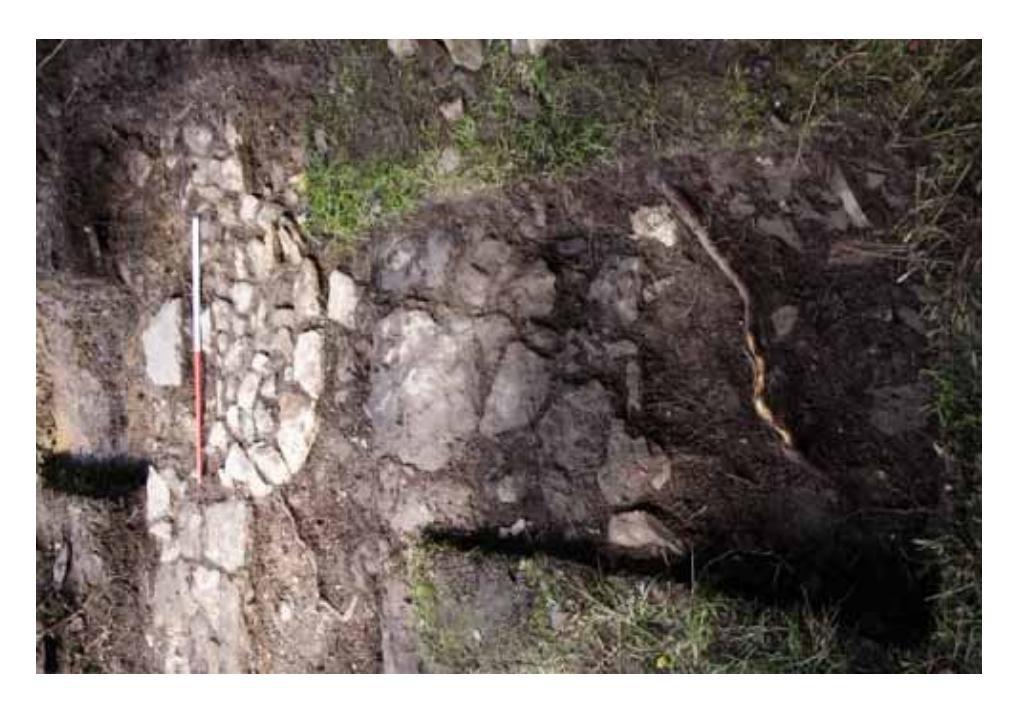
Photo 13: Semi circular step footings 030 and remnants of surface 028, looking west

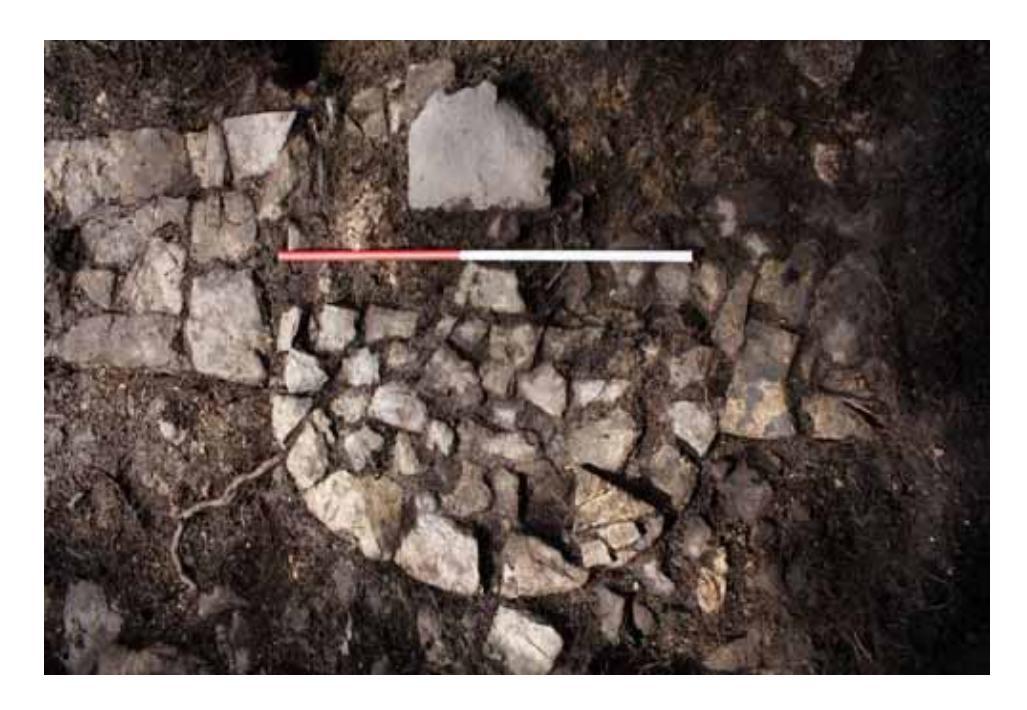
Extending from the wall face half way along the footings of eastern wall, a semicircular arrangement of stones was revealed, with a diameter of 1.20m. These are presumed to indicate the location of a semi-circular stepped entrance into the building. The stones forming the outline of the semi-circle are of dressed limestone, and appear to be covered by a layer of lime concretion, perhaps derived from the spring water. The interior stones are not dressed, but are recessed into the footings. There was no surviving evidence of the stones of the semi-circle ever having been mortared, perhaps suggesting they were a bedding layer or in-fill behind steps of finer materials and construction, that was subsequently robbed for re-use elsewhere.

Photo 14: Detail of semi-circular step footings 030, looking south

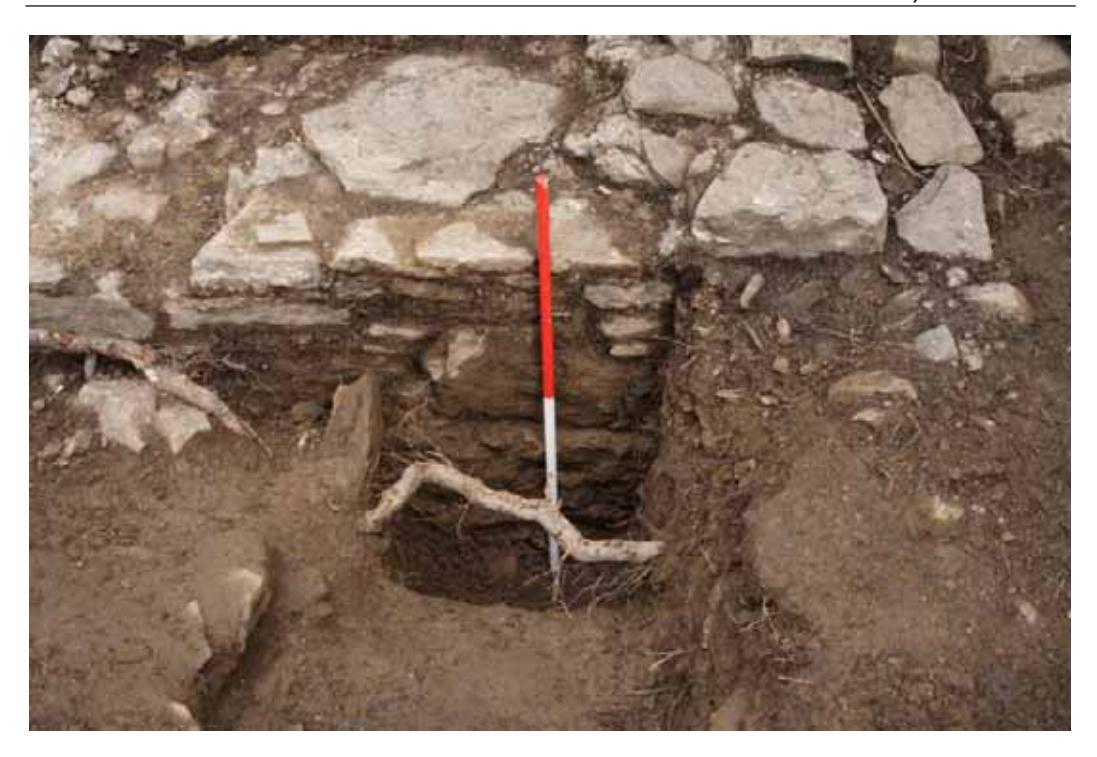
Photo 15: Exposed footings of wall 020 looking north

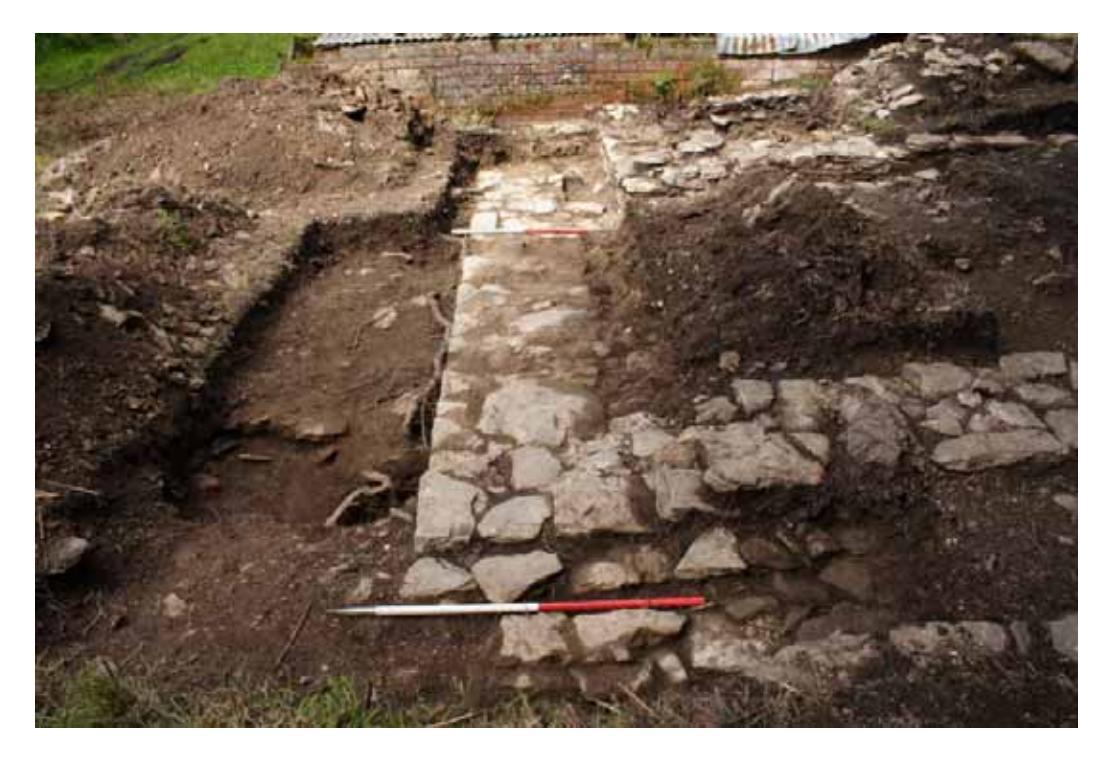
Photo 16: Bath house footings looking west

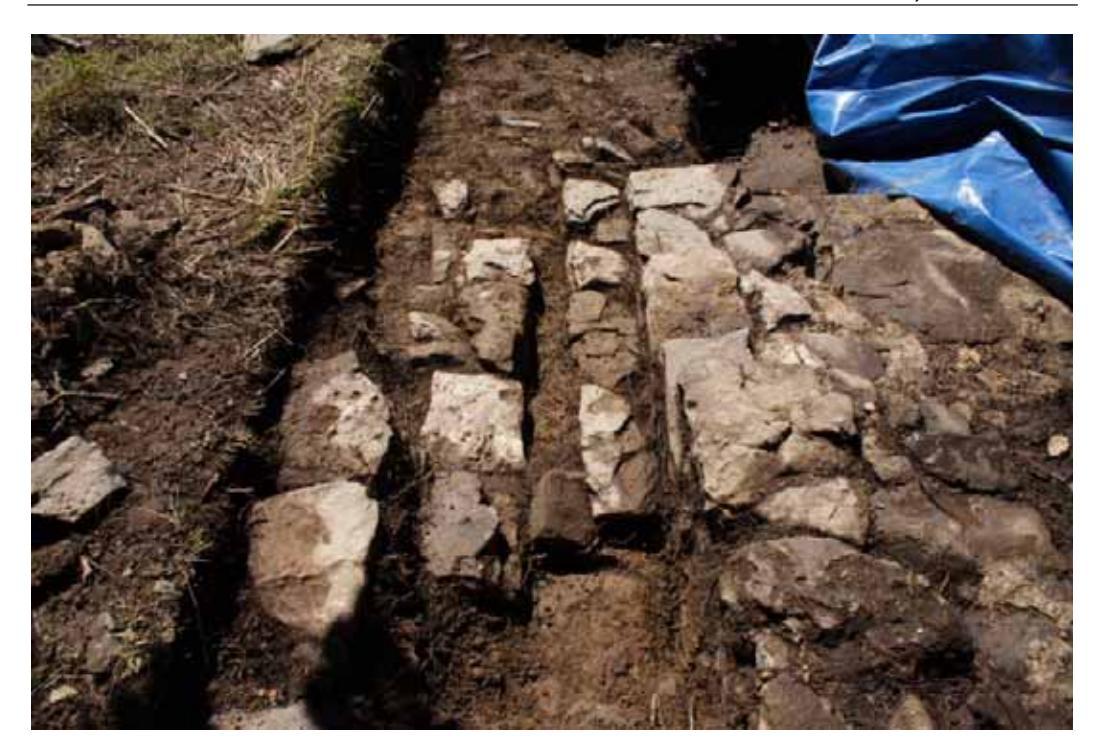
Photo 17: Surface 028 (to left), aligned stonework 029 (center), and wall 025 (to right) looking south

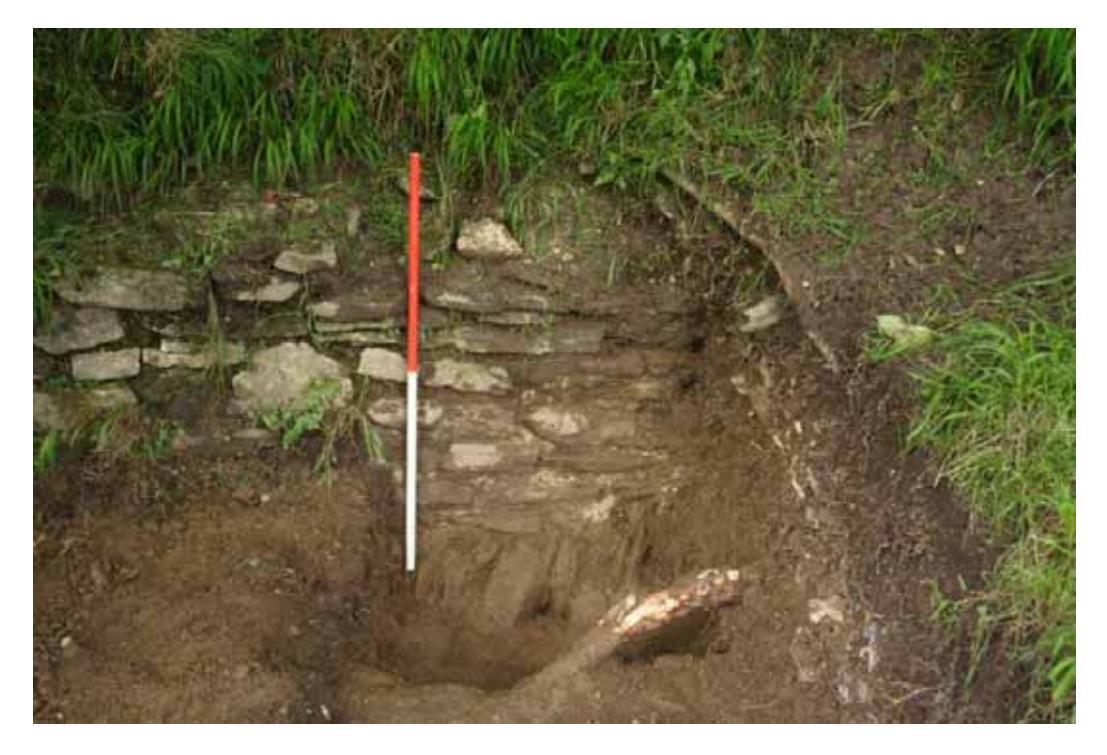
Photo 18: Retaining wall 027, built on top of bedrock

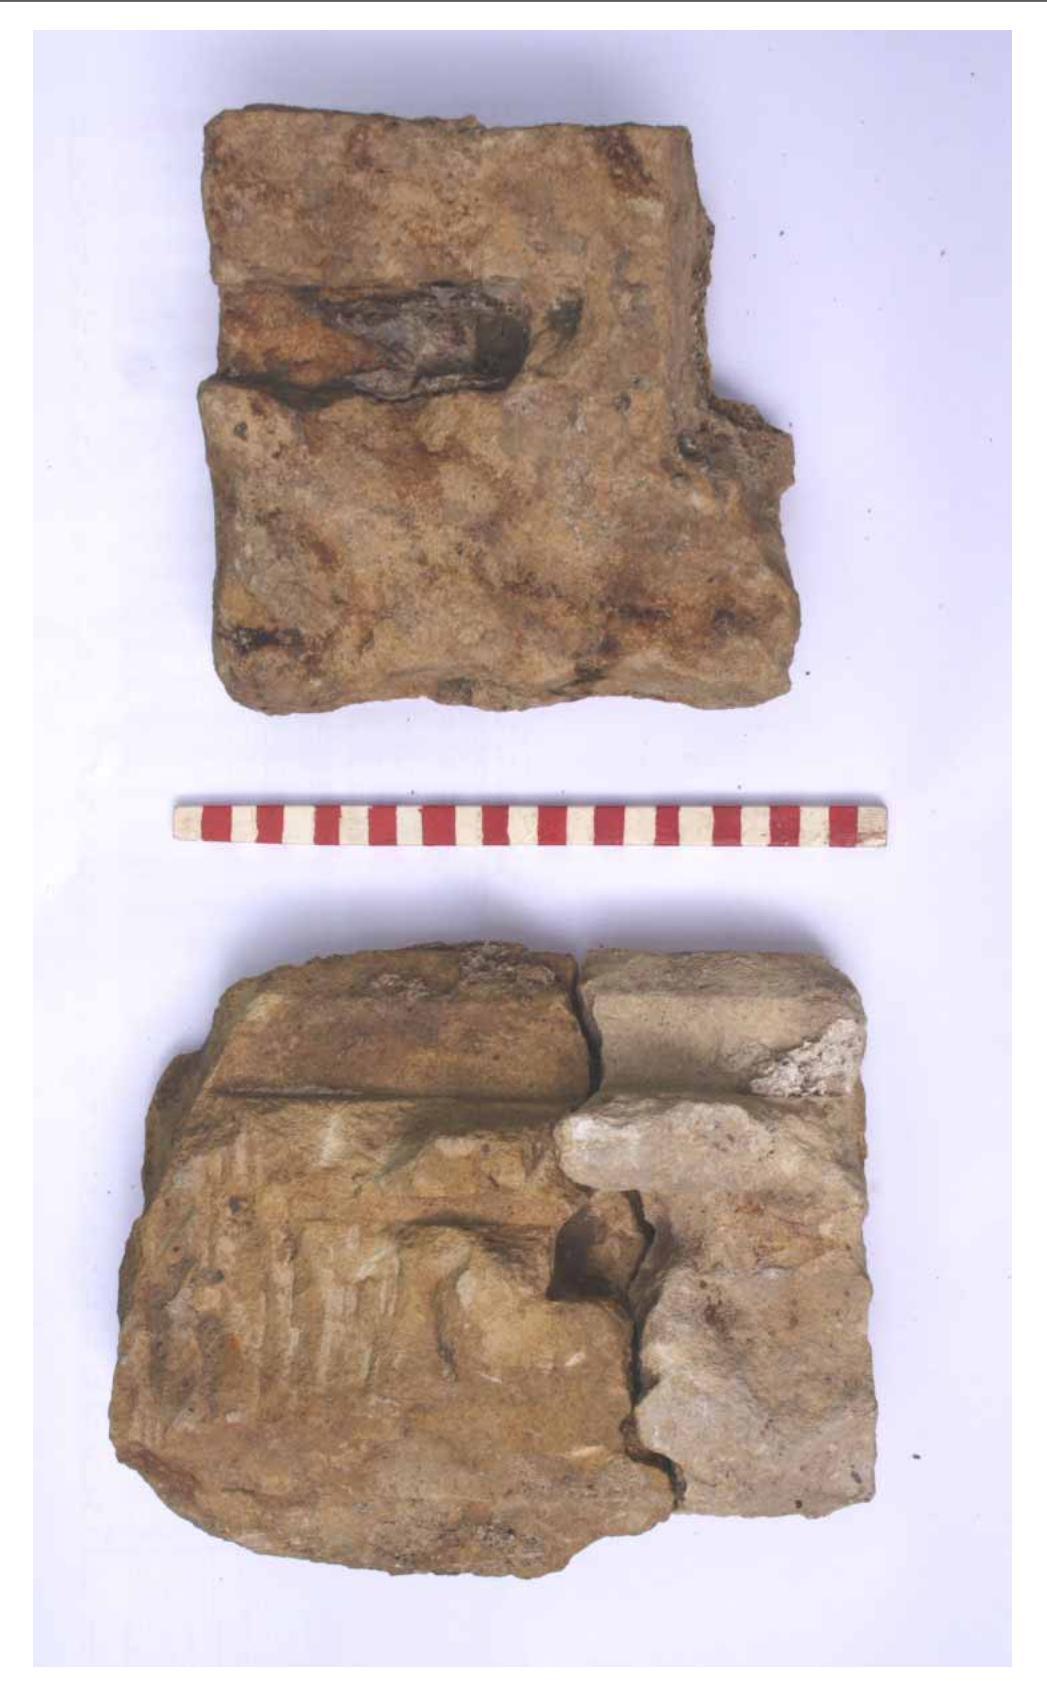
Two fragments of carved oolitic limestone were recovered from within the backfill of the pool (see photo 19). These are thought to be fragments of window surrounds, although it is not possible to confidently extrapolate the style of openings from the fragments recovered.

Photo 19: Fragments of dressed stone window surrounds recovered from backfill of plunge pool (25cm scale)

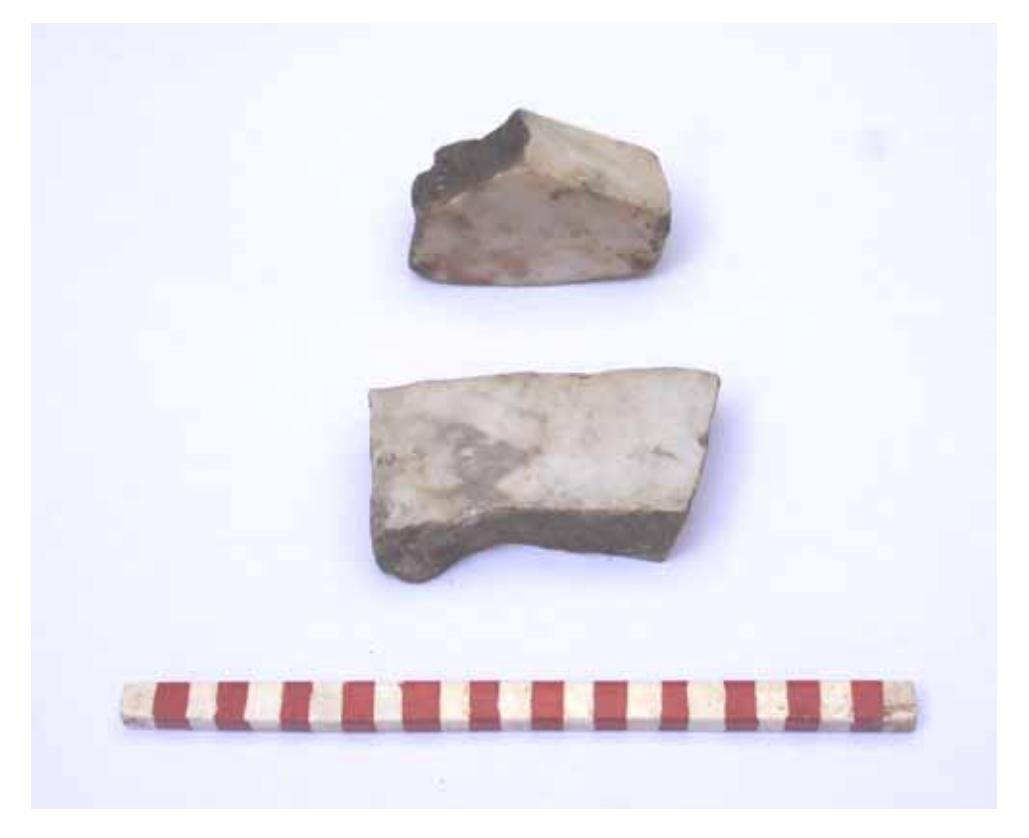
Fragments of marble were also recovered (see photo 20). These are presumed to be remnants of the material with which the floor and walls may have been clad.

Photo 20: Fragments of polished marble recovered from demolition debris (25cm scale)
