# EXPLORATION TYWI! DAN YR ALLT, LLANGADOG ARCHAEOLOGICAL EVALUATION 2009

RHIF YR ADRODDIAD / REPORT NO. 2010/7 RHIF Y PROSIECT / PROJECT RECORD NO. 98683

### EXPLORATION TYWI – DAN YR ALLT, LLANGADOG ARCHAEOLOGICAL EVALUATION

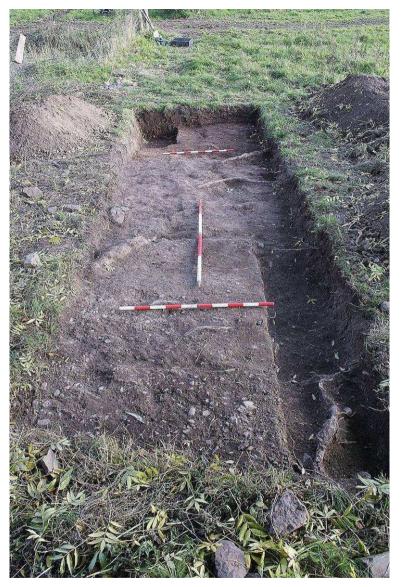
The topsoil (101), a mid grey-brown clayey-silt containing sub-angular stone and charcoal flecks, was removed by hand. The topsoil covered the entire trench to a maximum depth of 0.2m. Finds were sparse, but included some small fragments of  $19^{\text{th}}/20^{\text{th}}$  century pottery and porcelain and fragments of stone roof tile.

Underlying the topsoil at the northern end of the trench was a layer of compacted sub-rounded stone (102), *c*.1m wide but with uncertain edges. Initially it was thought this may represent the remains of a pathway, but its location close to an animal water trough would suggest this is trample caused by animals congregating around the trough.

Under both 101 and 102 was a large compact stony layer (103) extending for at least 3.6m from the northern end of the trench and sloping gradually eastwards following the natural slope of the ground. This deposit may have extended further east but was disturbed by root action. A sondage was put through this deposit demonstrating it thinned to the east, which averaged 0.25m thick, but the base was not reached at the northern end. Intermixed with the stony soil were lenses of crushed coal but no finds. The coal lenses indicate the layer was purposefully deposited, possibly laid down as a hardcore base for a former trackway.

Photo 2: ESE facing shot of Trench 1. 2 x 1m & 1 x 2m scale

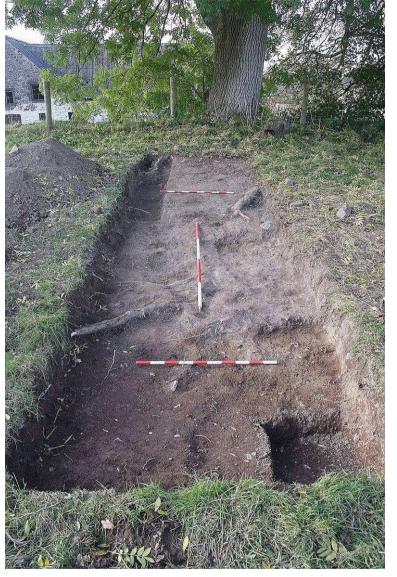
At the southern end of the trench was a 0.27m thick deposit of mid-brown, firm, sandy-clay (104) underlying the topsoil. This deposit was very similar to 103 but generally siltier with fewer stones. The relationship between 103 and 104 was obscured by root action. A sondage measuring 0.7m by 0.6m in the corner of this deposit showed it to be lying directly on the natural gravels. No finds were recovered.

Photo 3: WNW facing shot of Trench 1 2 x 1m & 1 x 2m scale

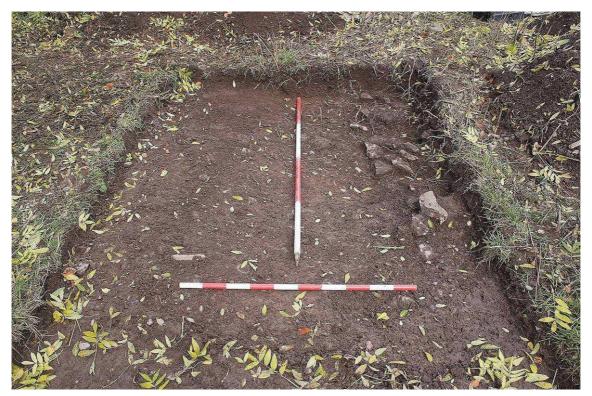
The topsoil (201) was found to be very similar in character to the topsoil recorded in Trench 1 (101). This overlay a layer (202) of light brown, firm, silty-clay with common small to medium stone inclusions. This deposit was spread throughout the trench, and contained some coal fragments and fragments of late postmedieval porcelain and pottery.

Towards the northern end of the trench, this overlay a deposit (203) of mid brown, friable, silty-clay with large angular stone inclusions and spreads of crumbly white lime-mortar. This would appear to represent a thin spread of demolition rubble extending into the trench from the east. The interface between 202 and 203 was not very distinct.

Photo 4: NE facing shot of Trench 2. 1 x 1m & 1 x 2m scale

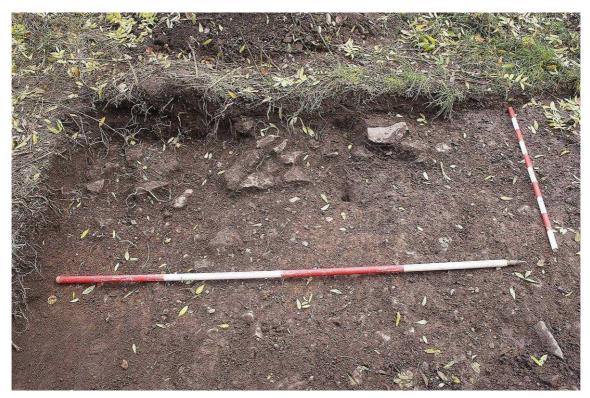
The removal of the looser demolition rubble (203) revealed the remains of a compacted stony surface (204) along the northeastern edge of the trench. This consisted of medium sub-rounded stone set into a mid brown silty-clay forming a hardened area extending 0.44m into the trench and running for 2m north-south, sloping slightly down to the north.

Adjacent to this surface was a small sub-square stake-hole void (205)  $0.04m \times 0.04m$  and 0.21m deep, set at a slight angle, leaning to the east. The stake hole lies at the western limit of the stony spread but no other stake- or post-holes were visible within the trench.

Photo 5: SE facing shot of possible stone surface in Trench 2. 1 x 1m & 1 x 2m scale

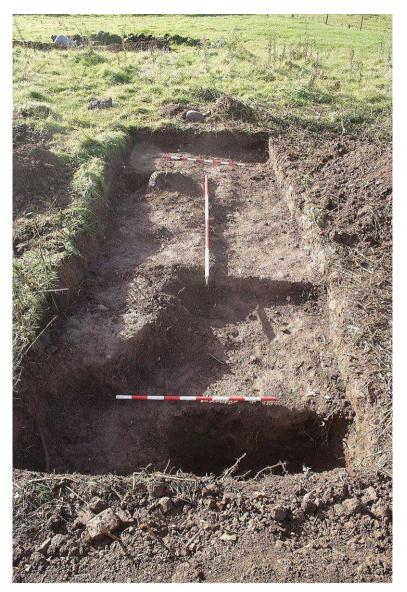
The topsoil (301) in this area comprised a 0.4m thick deposit of mid reddishbrown friable silty-clay. This very clayey deposit was clearly modern as it contained a broken fencepost with nails, plastic, and a fragment of water pipe. Some late post-medieval glazed pottery, roughly dressed stone and pinkish concrete were also recovered. This would appear to be a dumped deposit, which according to local information was dumped during the construction of the modern hardcore track running along the bottom of the slope through the former site of the mansion.

Photo 6: SW facing shot of Trench 3 2 x 1m & 1 x 2m scale

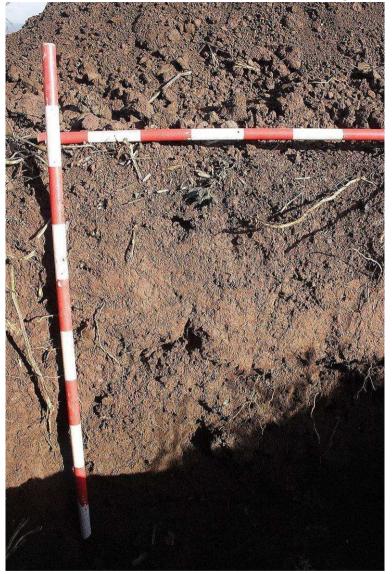
Underneath the topsoil was a well-mixed layer (302) 0.35m thick of mid grey, firm, sandy-silt with abundant sub-angular stone and occasional charcoal and coal fragments. The presence of the coal and charcoal suggests this is also a dumped deposit, although no finds or building debris was recovered.

A 1.1m by 0.6m sondage demonstrated that layer 302 lay directly over an undisturbed subsoil (303) at that point. The subsoil consisted of a mid brown-grey clayey-silt with evidence of plant root action.

Photo 7: NE facing shot of section of Trench 3  $2 \times 1m$  scale

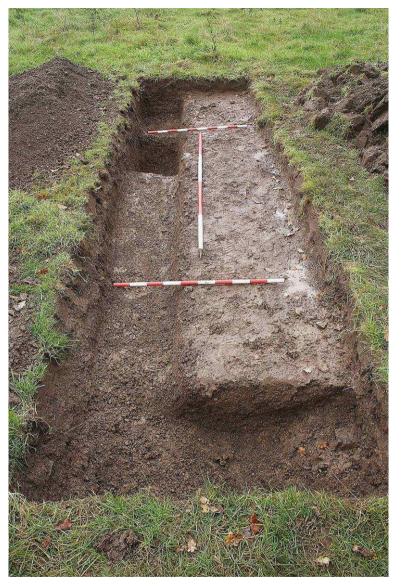
At the western end of the trench, layer 402 appeared to fill an irregularly shaped cut (405). This measured 0.39m deep and 1.05m north-south. It had a steep, slightly convex southern edge, and a shallow, slightly concave northern edge and an irregular base. The irregular nature of this feature suggests it may be natural in origin, possibly a former tree bowl.

Photo 8: SE facing shot of Trench 4 2 x 1m & 1 x 2m scale

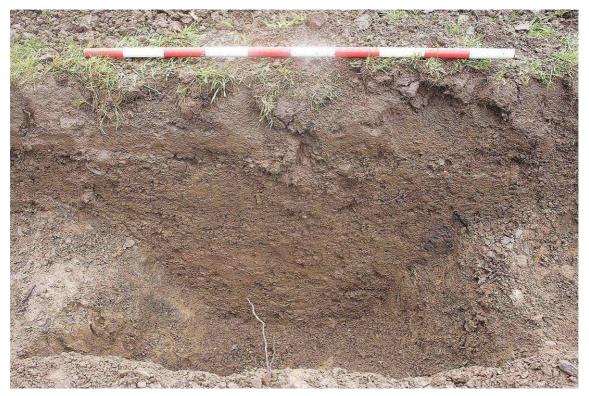
A 0.6m wide section was cut through layer 402, which revealed the remains of a ditch (404) beneath. The ditch measured 0.77m wide, 0.31m deep, and was aligned roughly north-south. It had steep straight sides and a concave base, appearing U-shaped in profile. Layer 402 filled the upper parts of the ditch but underlying this was a single fill (403). This fill was a mid orange-brown, clayey-silt with the occasional sub-angular stone and charcoal fleck inclusions. The interface with layer 402 was uncertain in areas, but it appeared to slope down to the east, suggesting the fill was tipped in from the west. This ditch corresponds with one of the ditches apparent on the geophysical survey; no other ditches were identified within the trench.

Photo 10: NNE facing shot of ditch 404 in Trench 4. 1 x 1m scale

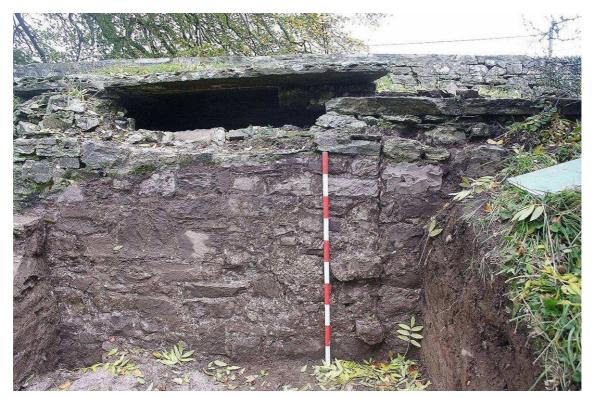
Room 2 was the central room, measuring 2.9m east – west by 2m north – south, and 2.4m high from the level reached in Trench 5 (photo 13 – 15). The walls were built of large, roughly faced greystone rubble that appeared a mix of rough coursing and random rubble, all bonded with a light grey mortar mainly flush to the external face although covering the face in places. The room was also roofed with a series of large 0.08m thick stone slabs, overlapping the roof of Room 1. Internally the walls of the room were plastered or lime-rendered. Access was only via the internal opening with Room 1, but a small square window high in the western wall provided light. There was also an opening below the roofline in the eastern wall, but it is unclear if this was caused by the partial collapse of the wall or represented an original opening. Joist holes indicated that a raised platform stood internally against the western wall, and marking on the internal render indicated some structure stood upon this platform, against the wall, extending the full width of the room.

Photo 13: WNW facing shot of the eastern wall of Rooms 1 and 2, showing the construction break on the right. 1 x 1m scale

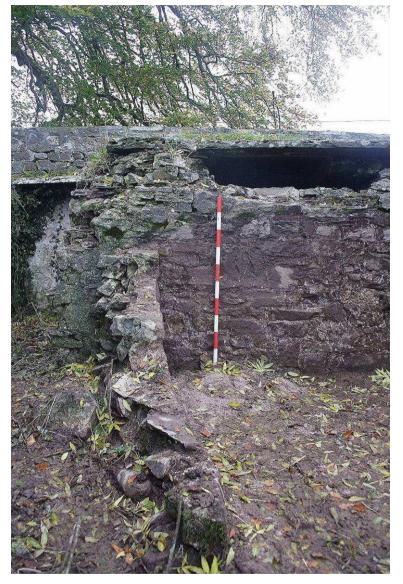
The excavation of Trench 5 against the external eastern face of Room 2 revealed a short section of partially tumbled stone wall extending eastwards from Room 2 (photo 14). The wall measured 1.6m long, 0.25m wide, and survived to a maximum height of 0.8m. It was roughly aligned east - west, curving slightly to the north. It was constructed of large random greystone rubble with a light grey mortar, roughly faced on its northern side and un-faced on its southern side. It was clearly a later addition as it butted against the external face of Room 2.

Photo 14: WNW facing shot of Room 2 with attached wall forming an outer enclosure. 1 x 1m scale

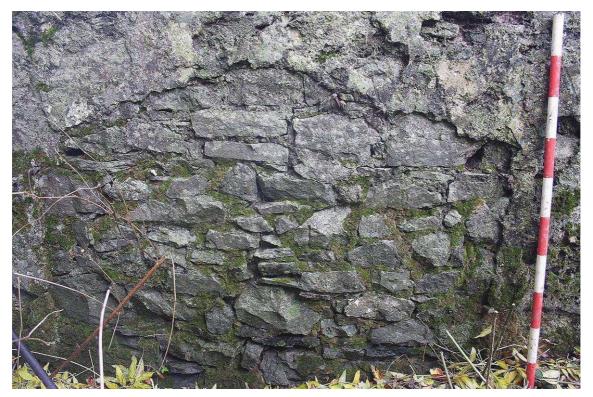
remained as a roof covering 0.4m wide against the western wall, but otherwise this room was unroofed. Internally the walls were roughly plastered, or lime rendered. A small area 1.15m wide and 0.8m high against the northern wall remained un-plastered (photo 17), framed by some iron nails secured in the wall. This would appear to represent a small lean-to like structure or more permanent piece of furniture formerly stood against the internal face of this wall. Access to this room was from the east. The eastern wall had completely collapsed, but dressed stone at the eastern end of the southern wall indicated the original entranceway would have stood at the southern end of the eastern wall.

Photo 17: NNE facing shot of evidence of lean-to type structure in Room 3. 1 x 1m scale
