ARFORDIR COASTAL HERITAGE 2009-2010

RHIF YR ADRODDIAD / REPORT NO. 2010/23 RHIF Y PROSIECT / PROJECT RECORD NO. 99087

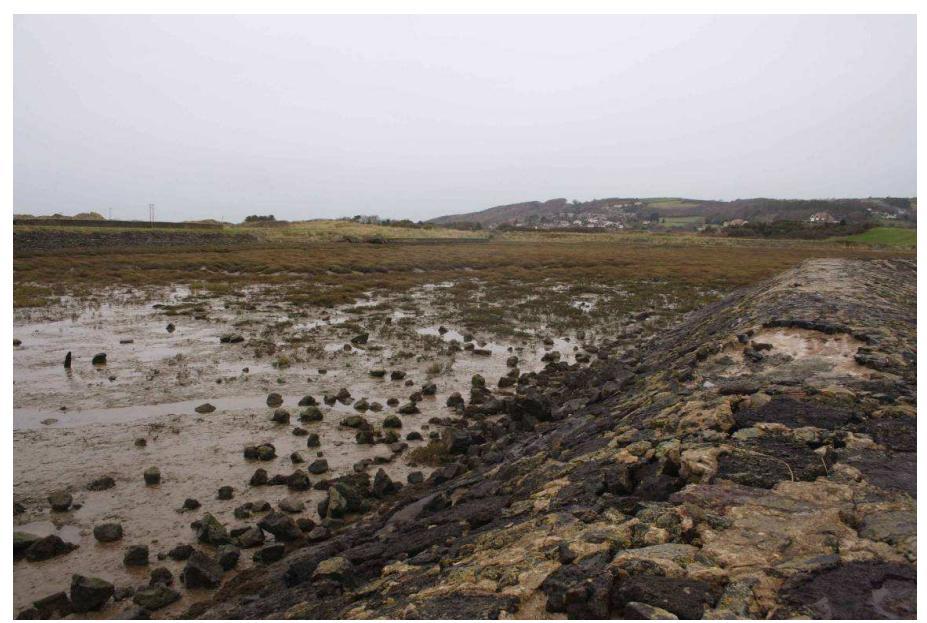
i) Pembrey Harbour, Carmarthenshire – PRN 5344; SAM CM 296. The eastern breakwater of the harbour site is suffering from erosion, with the top layer of slag blocks which form the surface having been removed. The majority of the western breakwater is in a stable condition, having been recently restored and stabilised, although the extreme western end is suffering from erosion.

Photo 8: Pembrey Harbour, eastern breakwater

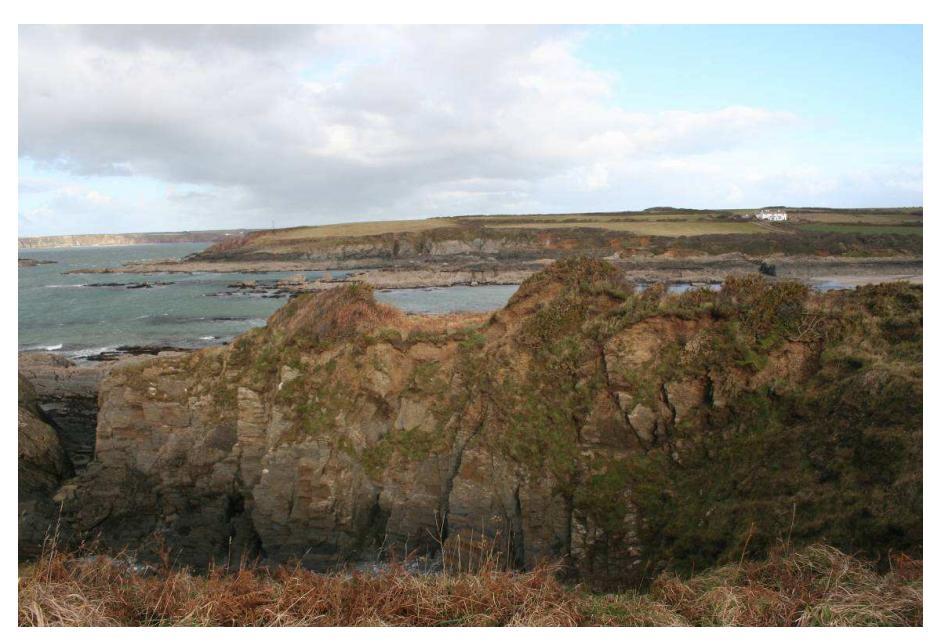
lies on a narrow promontory and has suffered from significant erosion.

Photo 11: West Angle Iron Age Promontory Fort

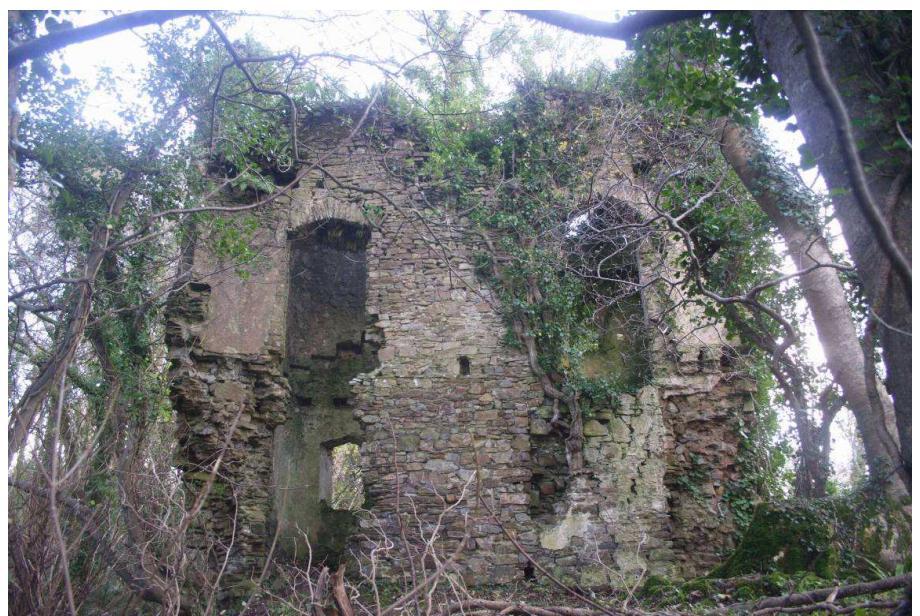
v) Boulston Manor, Pembrokeshire, PRN 3363. This site represents the remains of a medieval manor house, extended in the 16th century and with walled gardens added in the 19th century. The site has long since been abandoned and is in a very bad state of repair. The majority of the superstructure of the building has been removed, but the substantial remains of two three storey towers survive. An undercrofts also survives between the two towers. The walled garden is subject to tidal erosion along the water front. The building is not afforded any protection from Scheduled Monument or Listed Building status, yet would seem to be a site of high archaeological and historical importance.

Photo 12: Eastern stair tower at Boulston Manor

The site of Boulston Manor is considered to be of high importance. The site should be revisited later in the year in order to monitor its degradation and the waterfront erosion and the possibility of undertaking a buildings survey project in collaboration with the RCAHMW will be discussed.

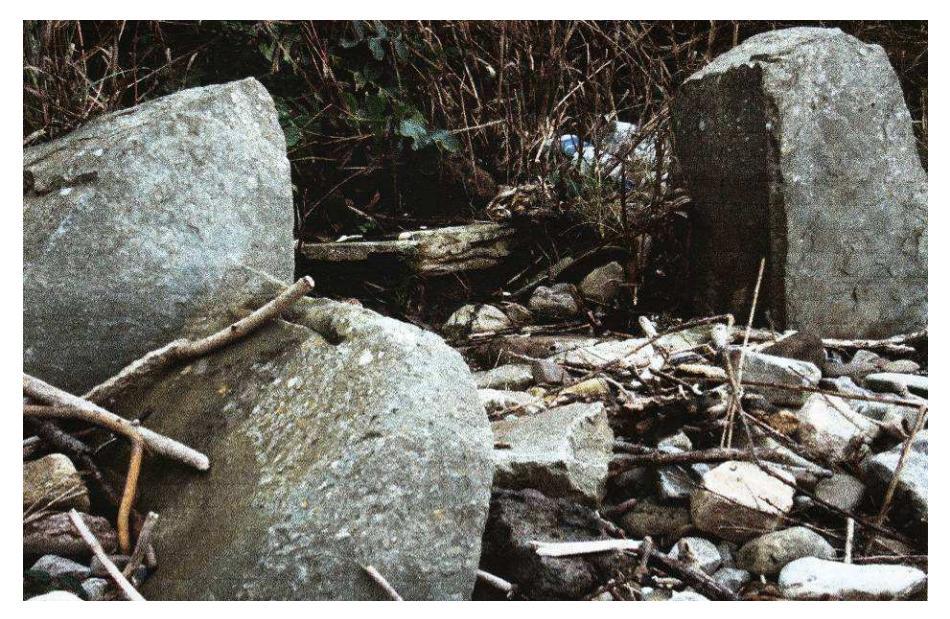
Photo 24: Doorway into Building 2 in October 2007. Note that there is a large stone in front of the door which is no longer present, and that the ground level corresponds with the top of the threshold stone. (Owen Harris)

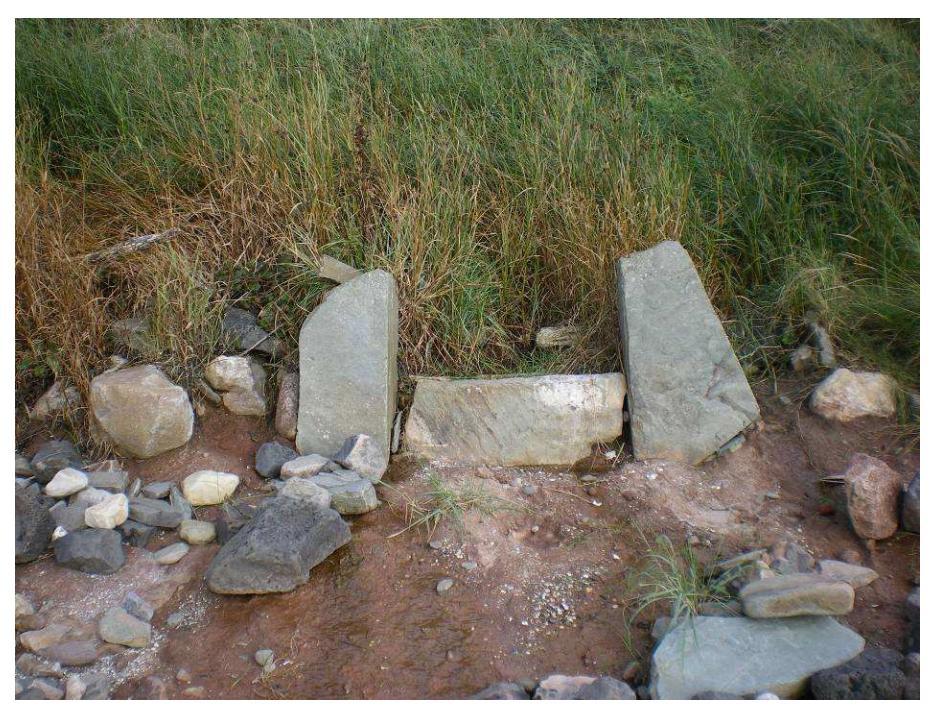
Obvious changes to the site have taken place in the last few years. This has included the recovering of Building 4 by the sand dune following its exposure during a storm in 2007, as noted above. The threshold of the doorway into Building 2 has evidently been exposed in the last few years and is likely to be dislodged in the near future. The entire length of the western wall of Building 2 has already been eroded, such that only a few of the larger stones on the inside face of the wall survive, but these will not last for very much longer.

Photo 25: Doorway into Building 2 in September 2008, note that the threshold stone and adjacent uprights are completely exposed to their base (Owen Harris)

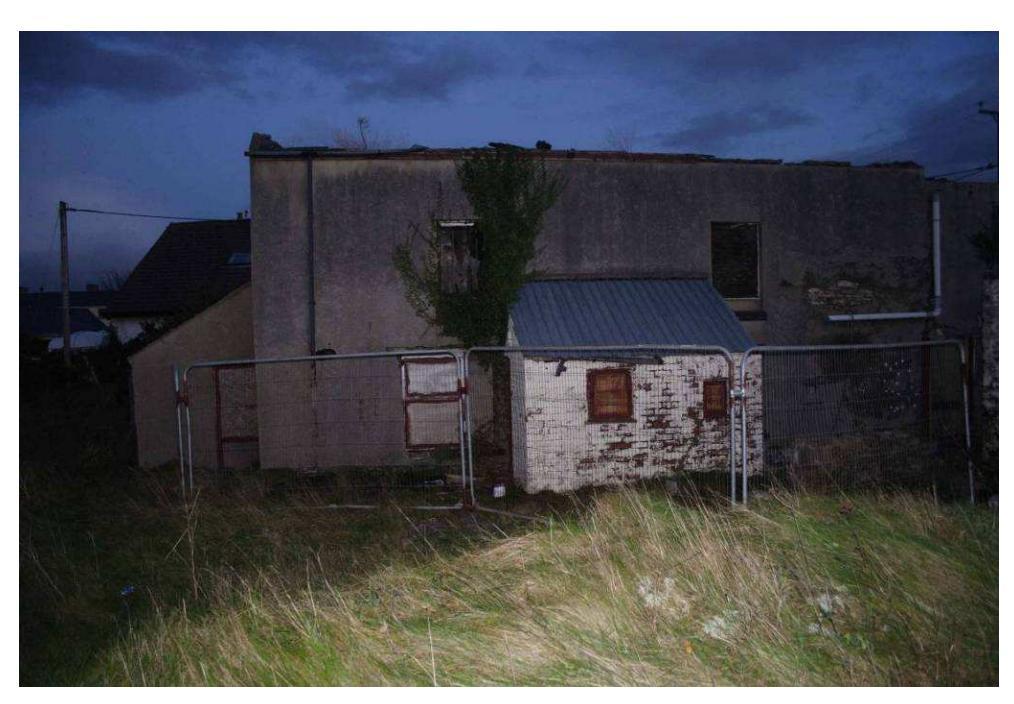
The former dwelling has not been subject to coastal erosion, however the building is no longer occupied, appears to have been subject to a fire and vandalism (photo 3). The house has been surrounded by metal fencing in an attempt to prevent entry, but was seen to be ill fitting in places with gaps permitting access to the site. The building is probably beyond repair and will no doubt be

Photo 3: Sandhurst, Burry Port

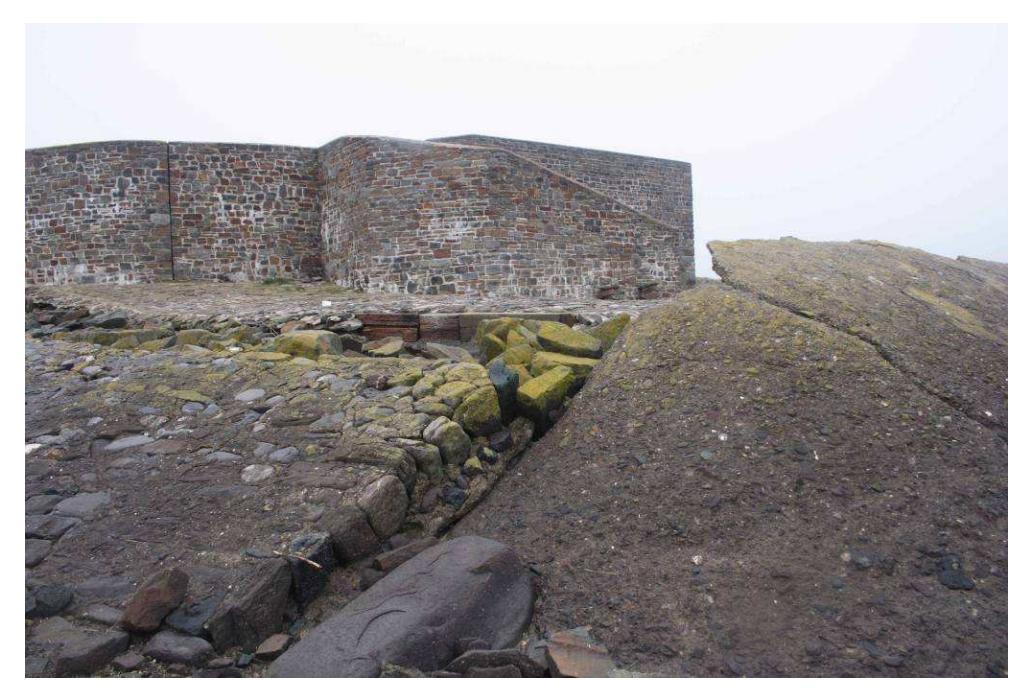
The western breakwater survives in much better condition, containing both areas of slag block and mortared stone block. The western breakwater was extensively restored recently with the construction of the Millennium Coastal Park, which runs to the end of the breakwater. A former lighthouse was present at the western end of the breakwater (PRN 8759), as was a pill box (PRN 31368), although the pillbox is no longer present. Even with the extensive renovation work, the far end of the breakwater has begun to suffer from coastal erosion, with parts of the stonework beginning to become dislodged and removed (photos 6 and 7).

Photo 6: View from end of western breakwater towards renovated stone work and also showing more recent erosion in the foreground

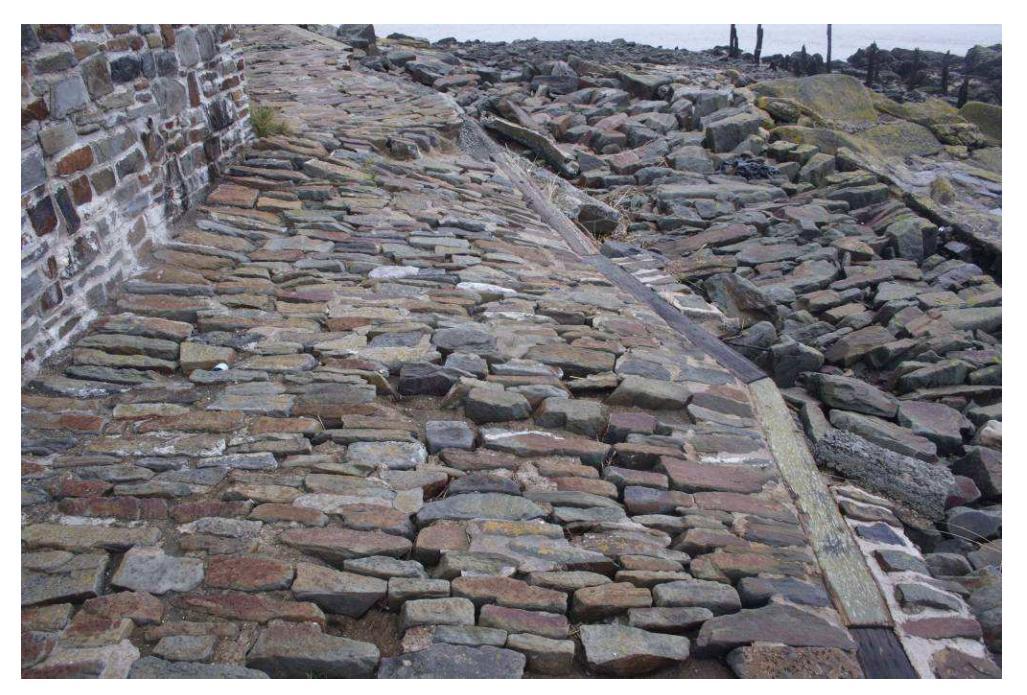
Photo 7: End of western breakwater showing effects of coastal erosion

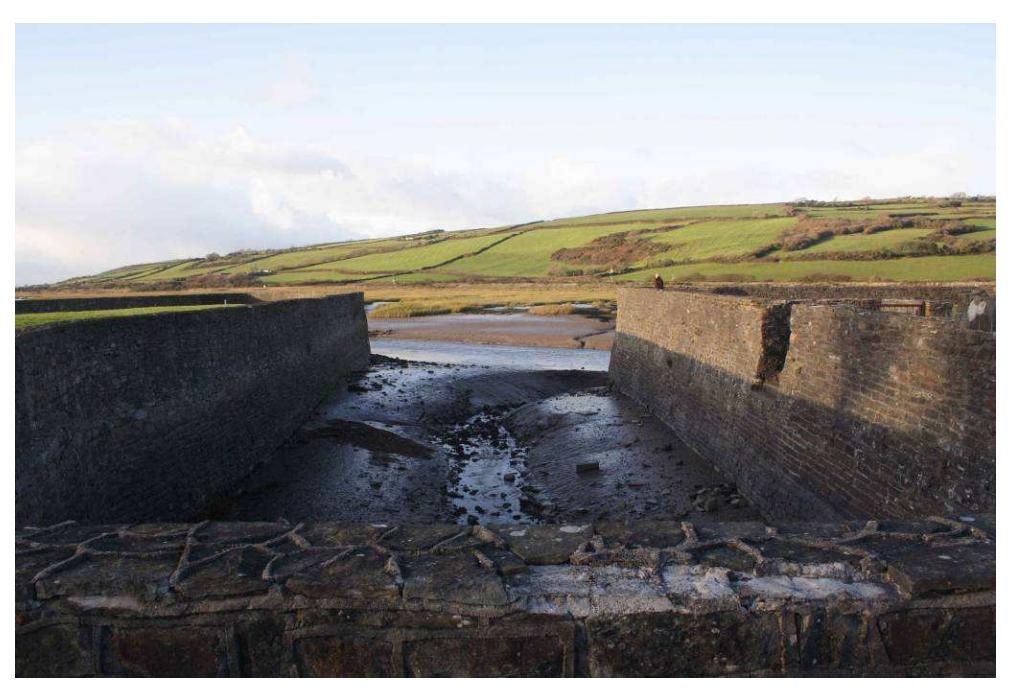
The quay structure appears to be in a good state of repair, and has evidently been subject to restoration and stabilisation works (photo 8). The area is the subject of gradual silting, presumably as it is no longer a functioning quay and there is no need to keep the waterway clear. At the entrance to the quay some undermining of the quay wall appears to be occurring and there has been an attempt to stabilise the structure using corrugated iron sheeting part of which appears to have been washed away (photo 9). This stabilisation work is far more haphazard than is apparent over the rest of the quay.

Photo 8: Kidwelly Quay showing dock

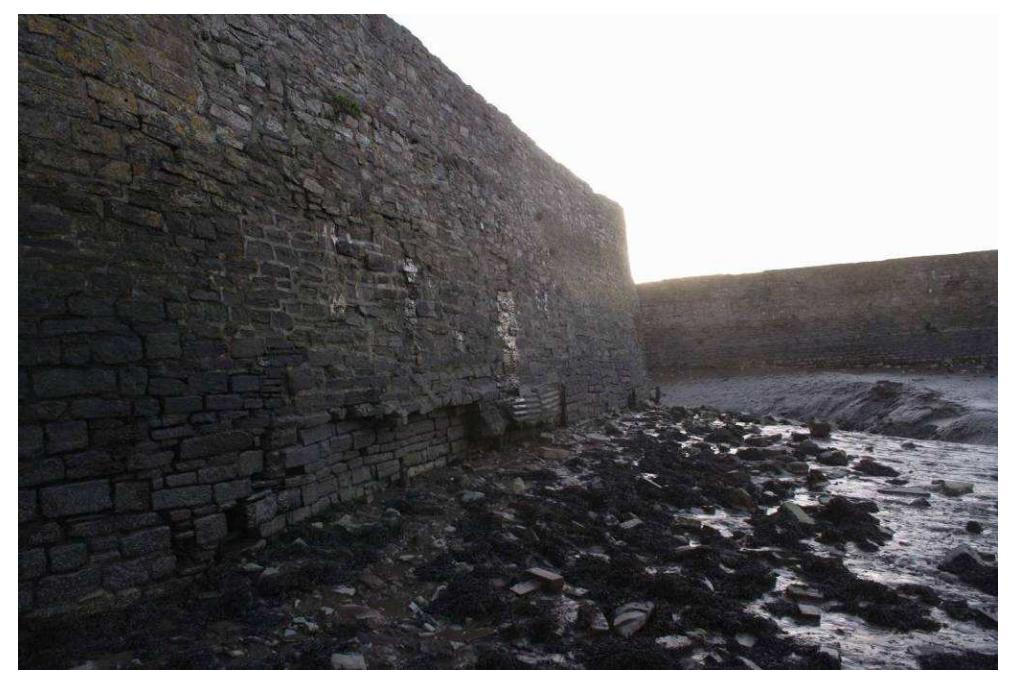
Photo 9: Kidwelly Quay showing some erosion damage at base of quay wall

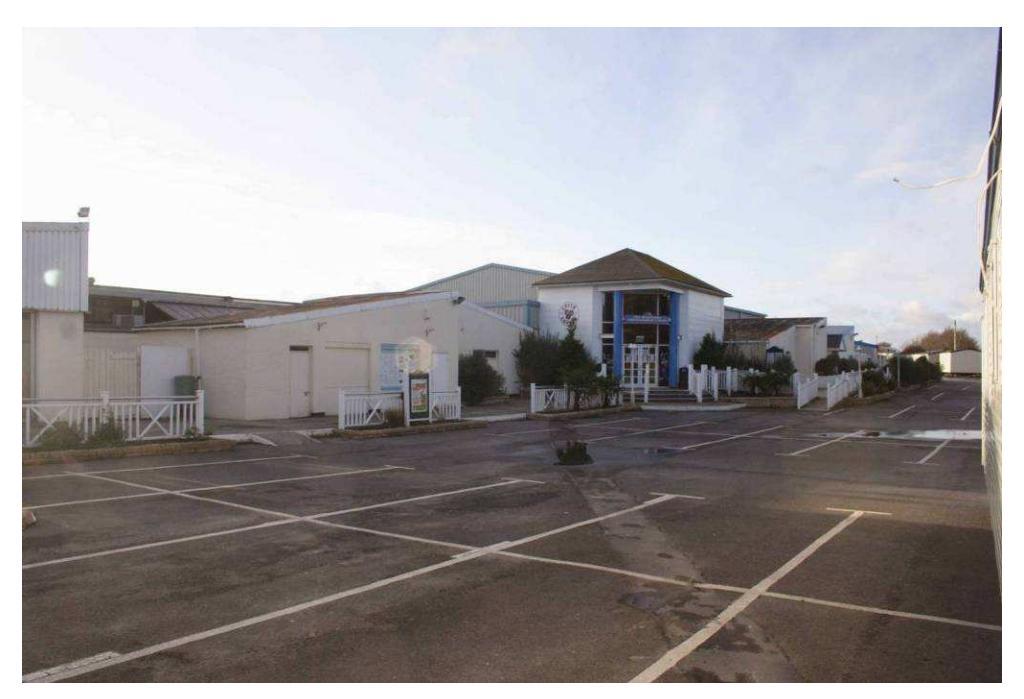
The site is recorded on the regional HER as nearly destroyed. The site visit revealed that the farmstead had been completely demolished and replaced by the entertainment complex of the Carmarthen Bay Holiday Park (photo 15). The site is no longer extant.

Photo 15: Former location of Bertwyn Farmstead, replaced by modern entertainment complex building of Carmarthen Bay Holiday Park

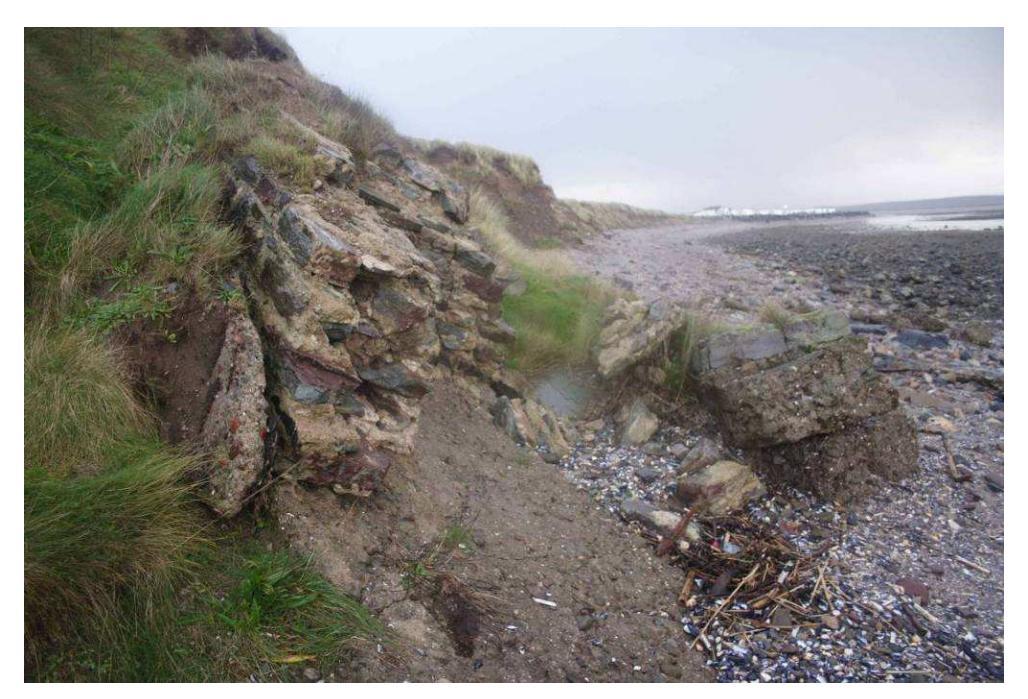
Photo 16: Collapsed part of the gun battery now lying on the edge of the beach

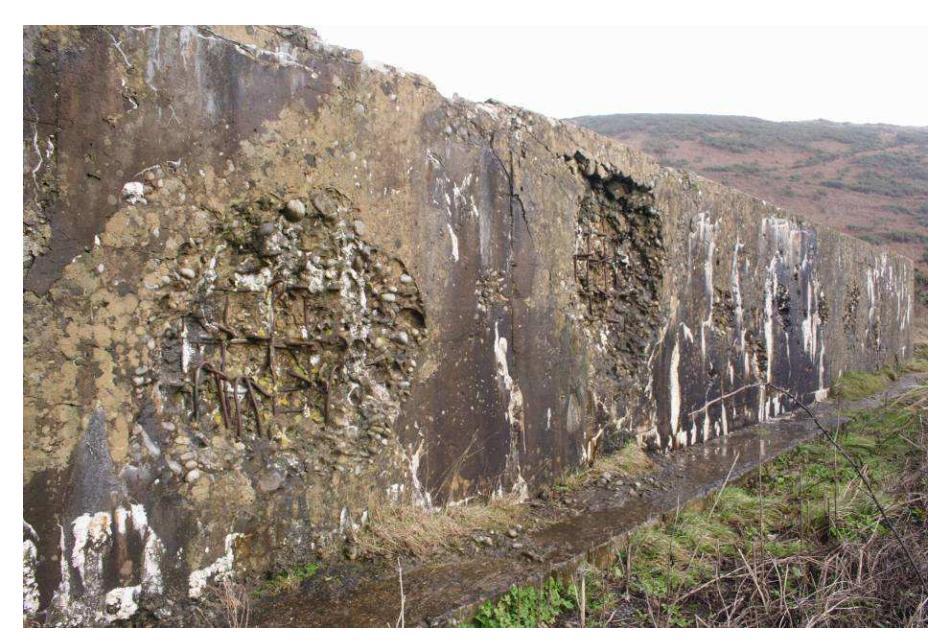
Photo 21: Concrete tank trap? PRN 33467, showing damage from shelling

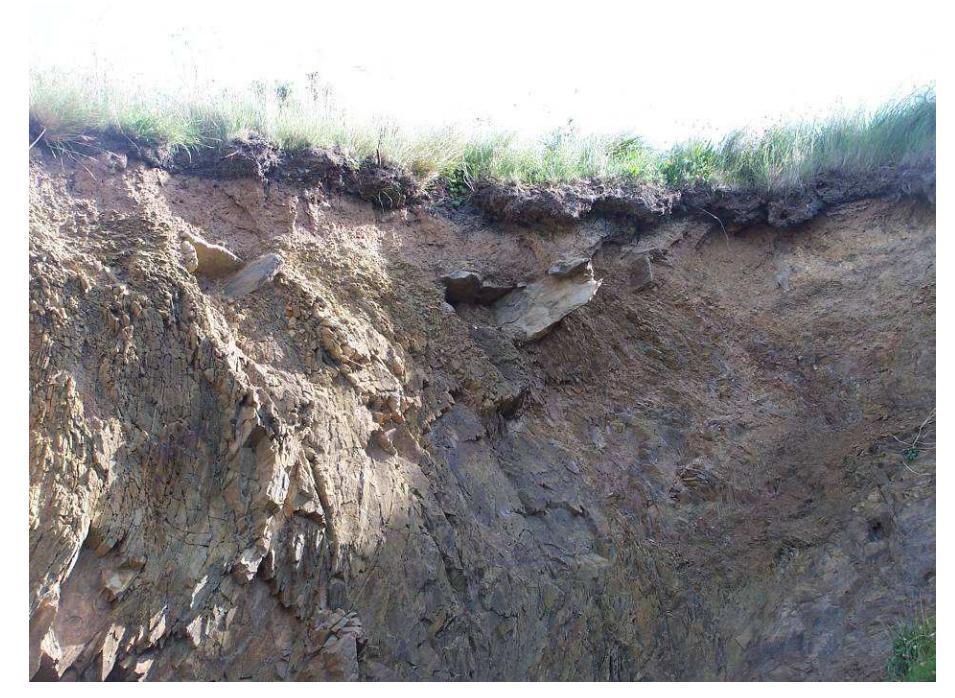
Photo 32: West Angle Bay early medieval cemetery cist burials eroding from cliff, with three graves exposed (new grave on right hand side of photo)

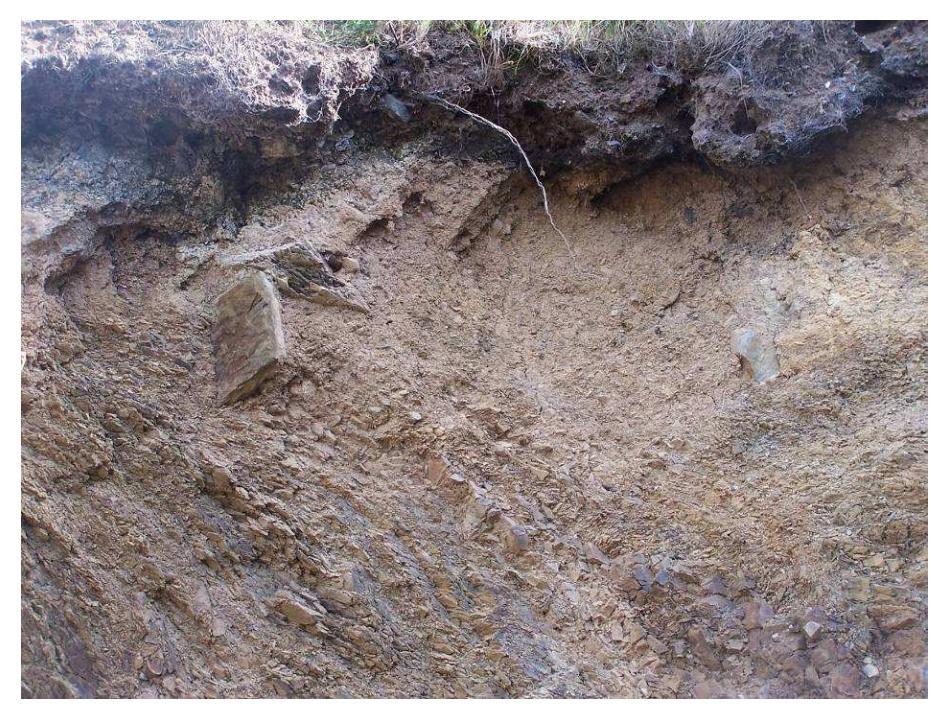
Photo 33: West Angle Bay early medieval cemetery showing cist grave first exposed in the summer of 2009

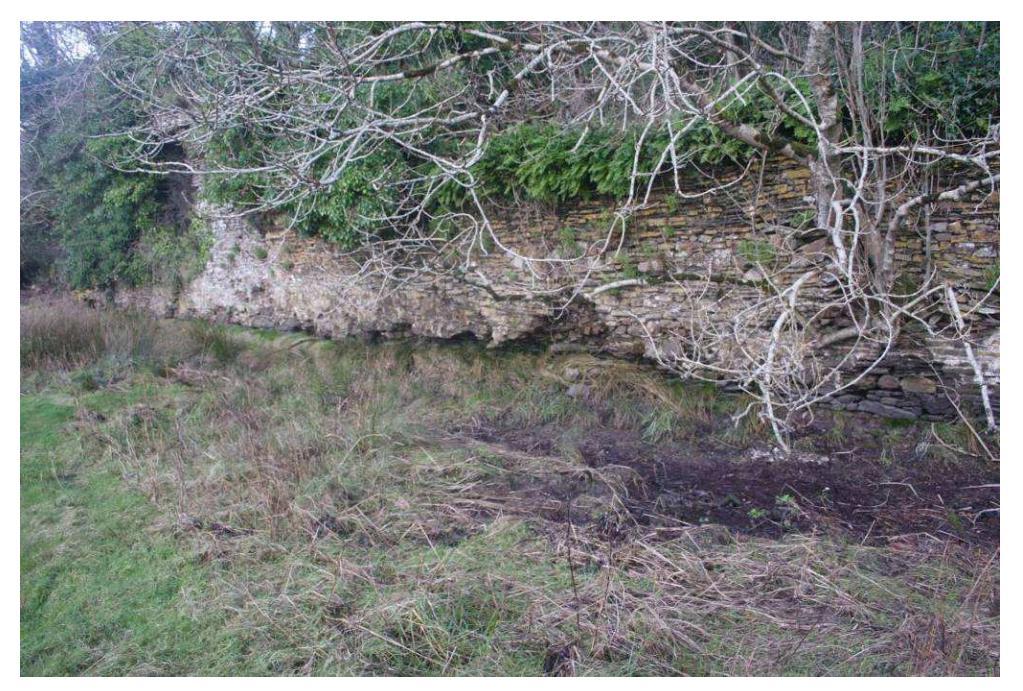
Photo 44: Undermining of waterfront wall of Boulston manor due to coastal erosion

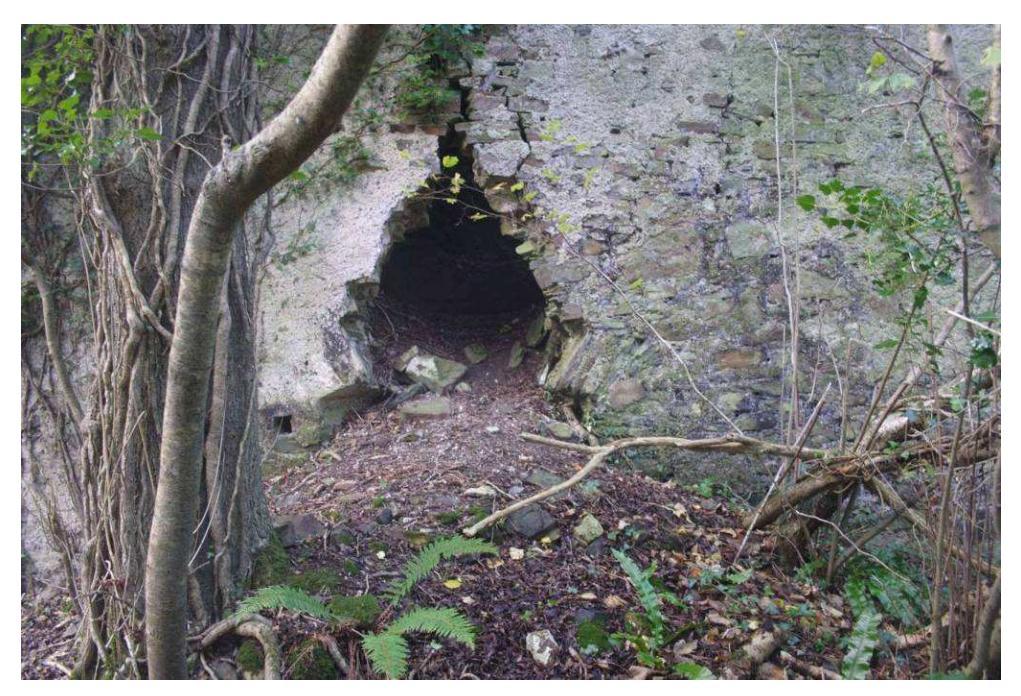
Photo 45: Substantial breach at base of eastern masonry block (stair tower)

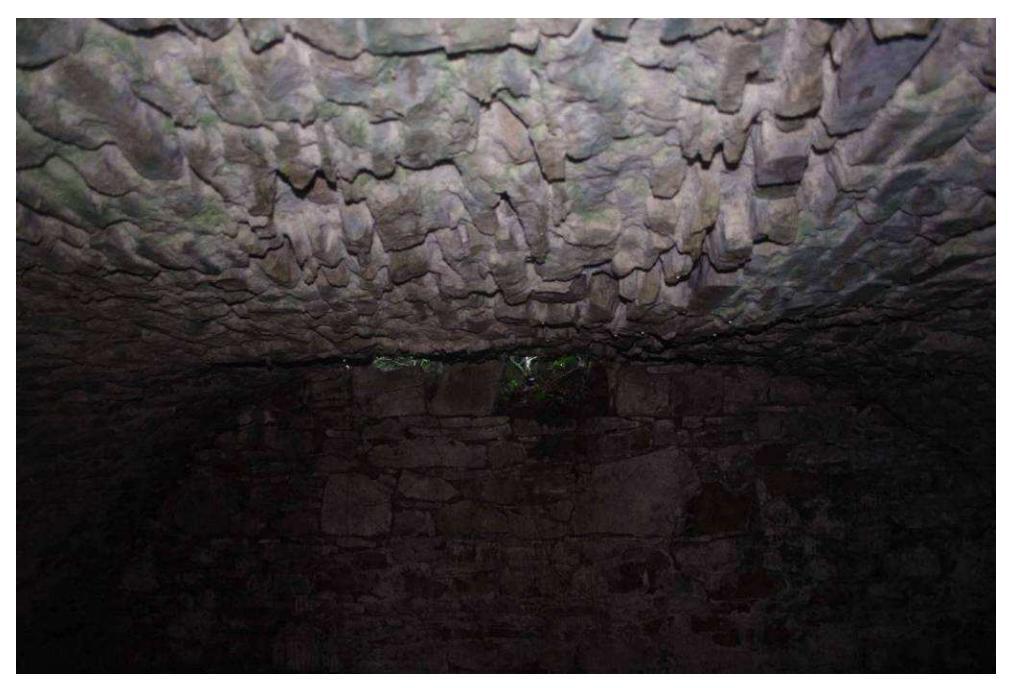
Photo 46: Subsidence visible in underside of undercroft roof.

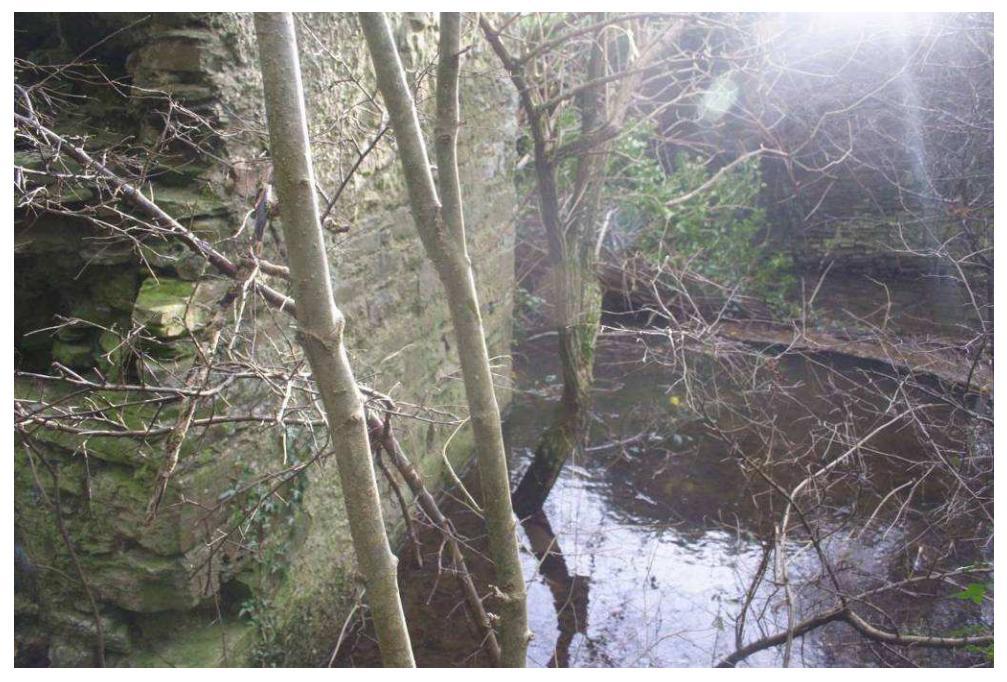
Photo 47: Water undermining corner of standing western block of masonry of Boulston Manor

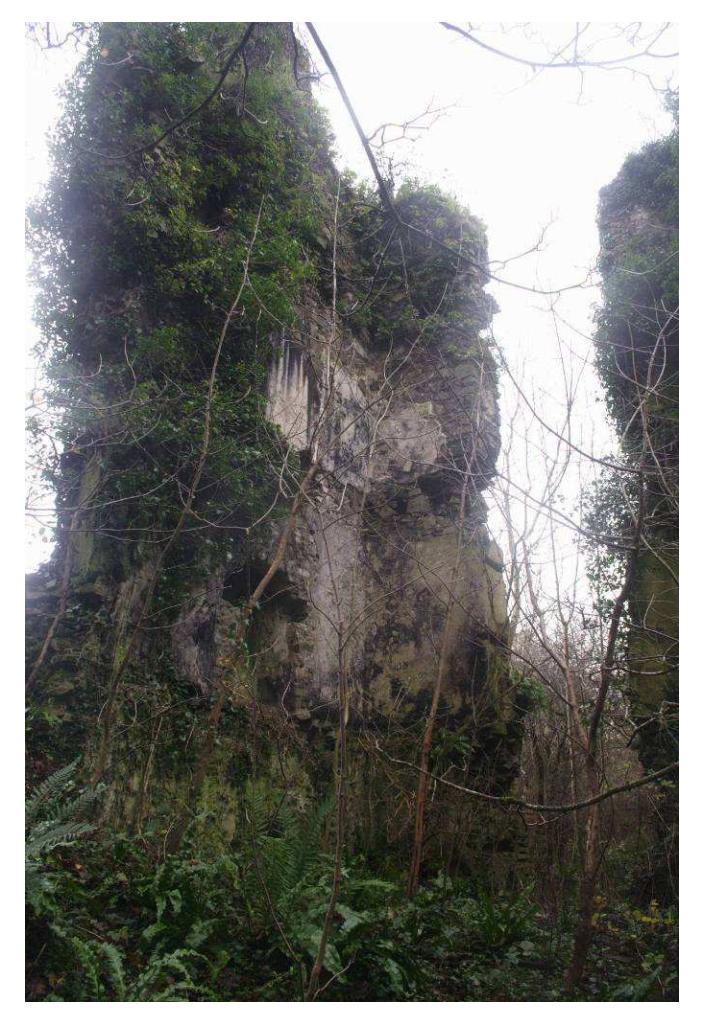
Photo 48: Boulston Manor western surviving block, showing poor state of repair
