HARDSTANDING ON EAST BANK OF NANT CWMFELIN BOETH RUNNING NE OF

KNOWN ROMAN ROAD CROSSING. To be read in conjunction with separate 'stream plan' and 'stream sections' drawings

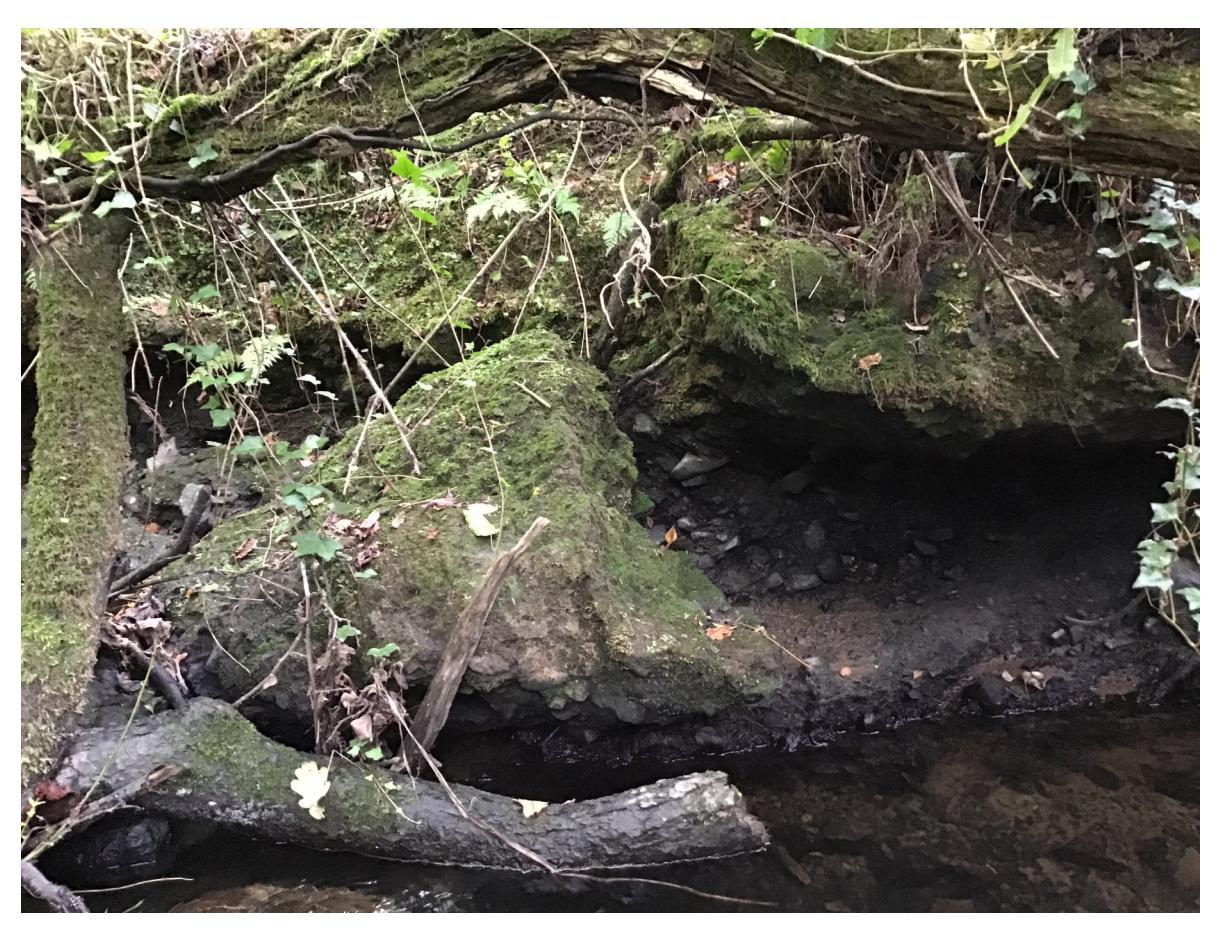
This consists of a broken line of 'concreted' slabs of stones fused together in an unknown matrix, projecting from the E bank of the Cwmfelin Boeth stream for a length of 25m and 700mm above the summer water level, just N of the Roman road crossing. These are being eroded underneath by flooding, yet still maintain a cantilever until the shear force becomes too much and they break off into the water leaving a fresh concreted edge showing behind. A number of small slabs of this broken-off material can be found under water in the vicinity on the river bed; but the largest remains where it has fallen, a triangular piece ex. 870 x 650 x 300 thick. Although this material looks like modern concrete, it is weaker and the smaller lumps could easily be smashed by a blow from a hammer.

Broken off lump viewed from stream ex. 870 x 650 x 300mm

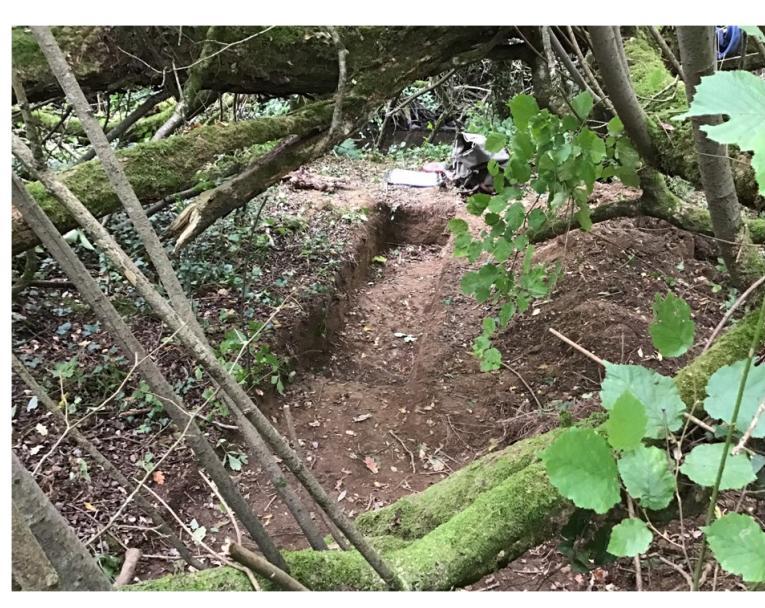
The location is marked on the bank section. Unfortunately, the E bank of the stream creeps round from NE to ENE, and a skewed uncovering trench, not normal to the river bank, made the error worse, so that the trench ended up N-S instead of NW-SE.

Uncovering trench looking from south

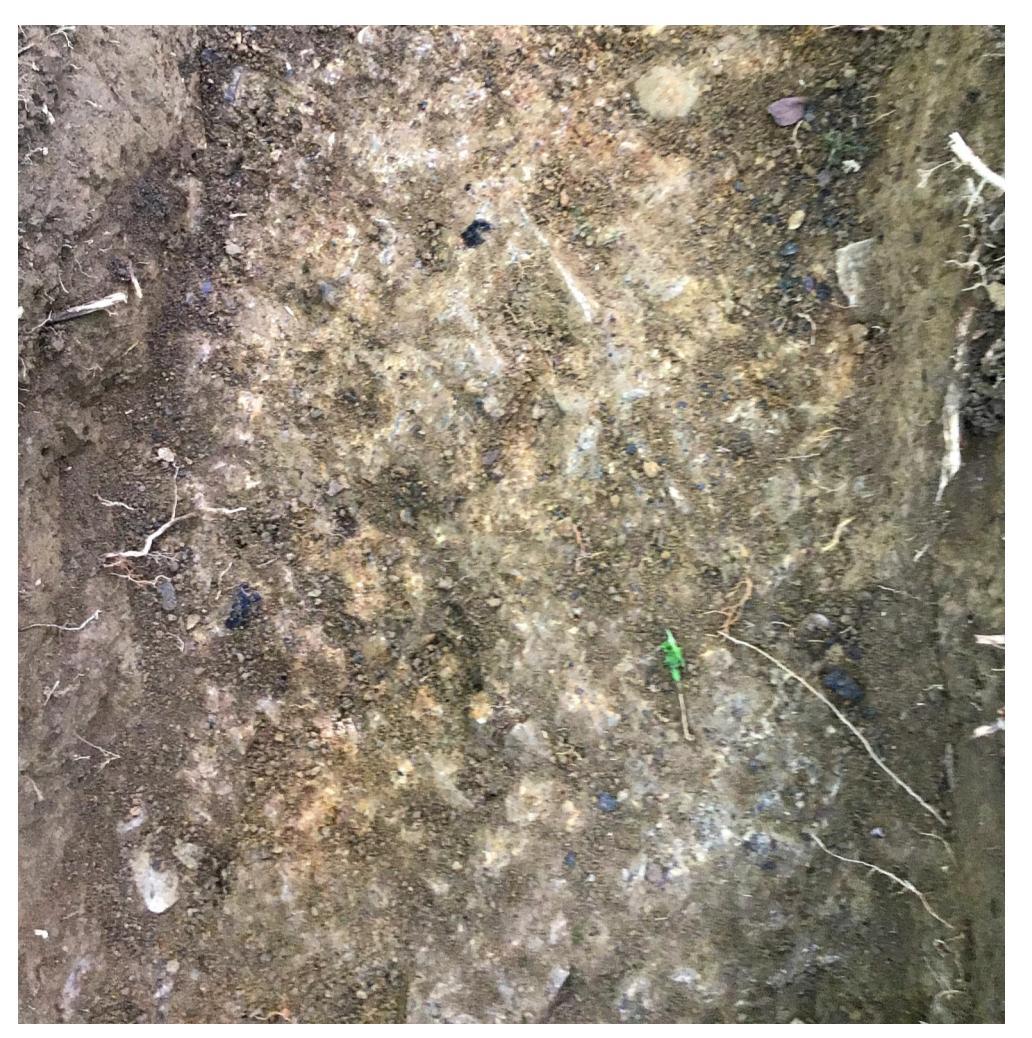
The surface of the hard concreted material was immediately found 300mm down and uncovered as it rose inland into the scrub away from the stream.

'concreted' hardstanding surface

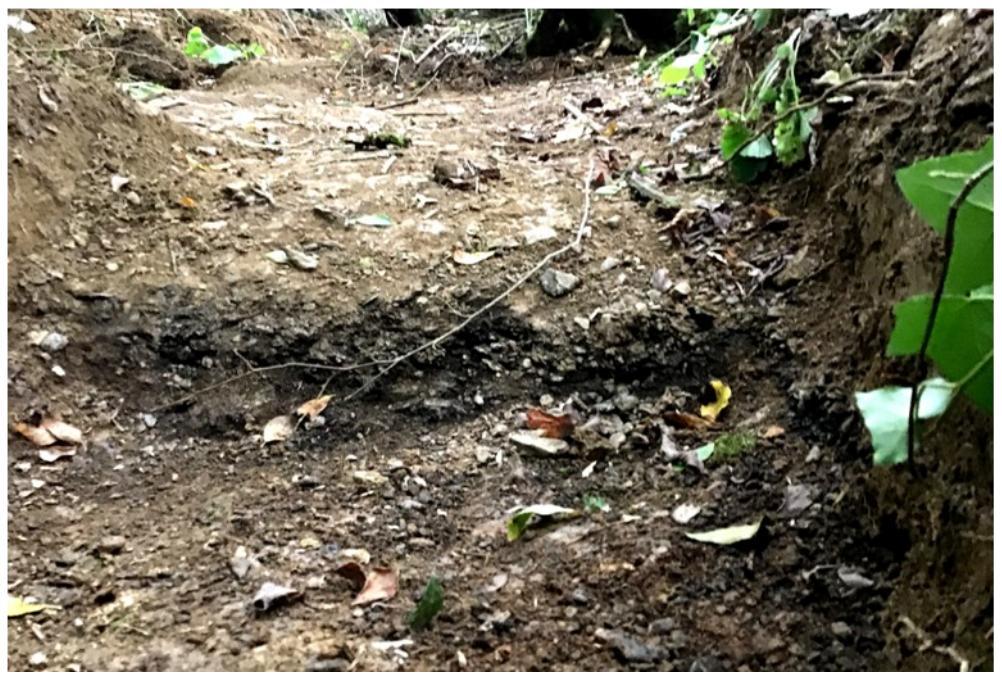
After 1200mm in, the surface changed to a hard black gravel layer, but the concreted layer continued on about 75mm beneath this. It was assumed that floods had removed the gravel layer nearer the stream.

Edge of gravel layer with 'concreted' layer passing underneath it.

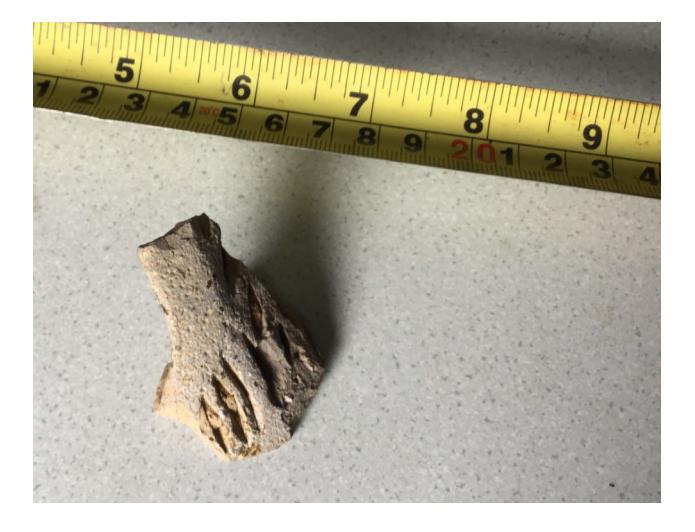
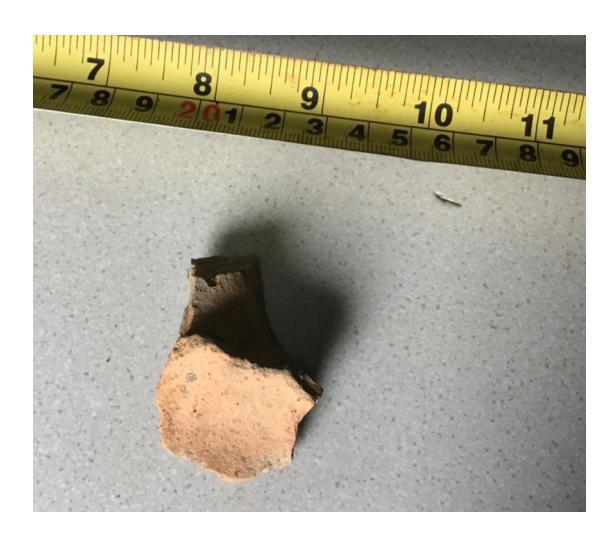
A portion of ceramic jug (probably where the base of the handle met the jug body) was found near the third verge.

part of ceramic jug 2 views

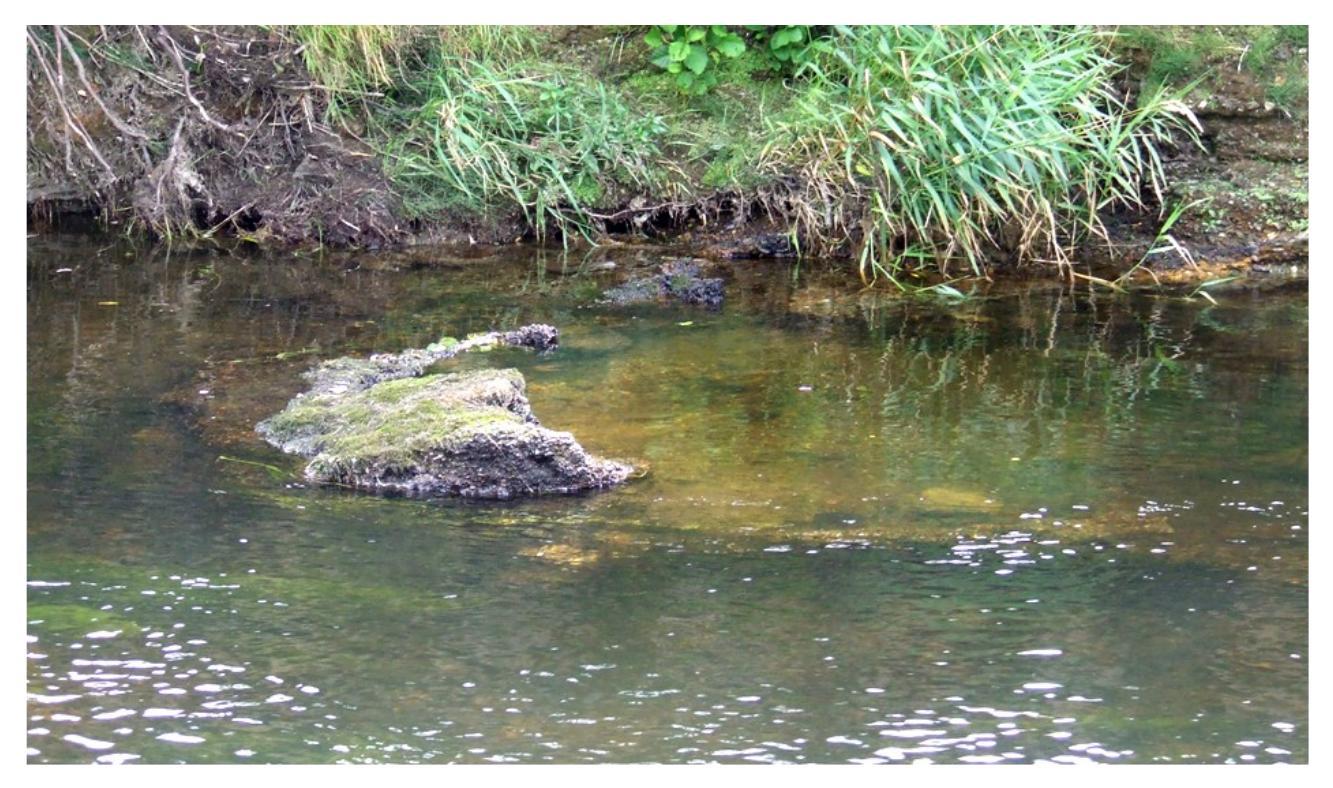
2) At a suspected Roman road crossing of the Western Cleddau at Red Hill, Haverfordwest, where a large chunk of road, complete with agger slope, is stranded out in mid-river by the bank migrating east.

'Concreted' section of road in Western Cleddau

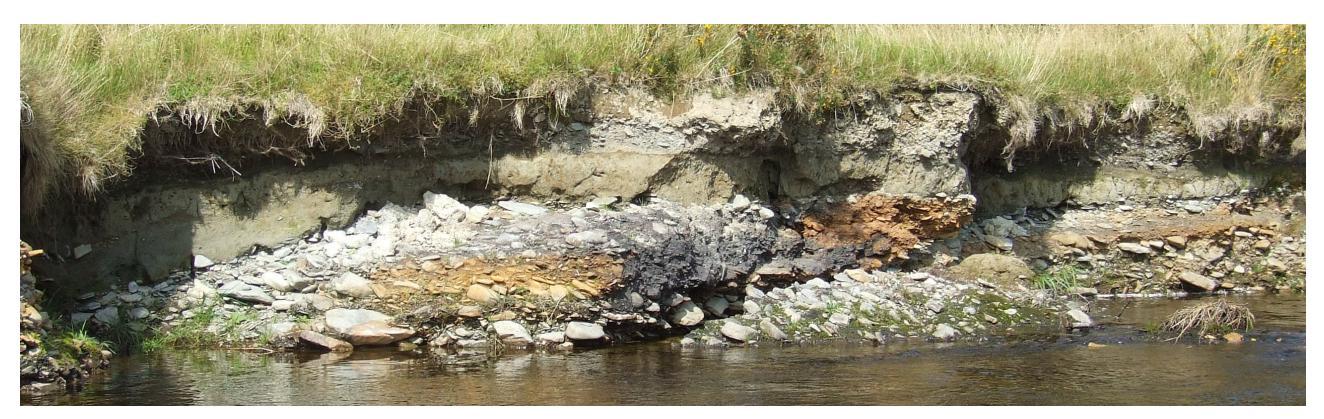
3) A long section of 'concreted' road, believed to be on the Cae Gaer to Trawscoed route, is gradually being undermined in the Mynach river, E of Devil's Bridge. **See below**.
