Raby's Furnace, Furnace, Llanelli

Archaeological Watching Brief

Report No. 1192

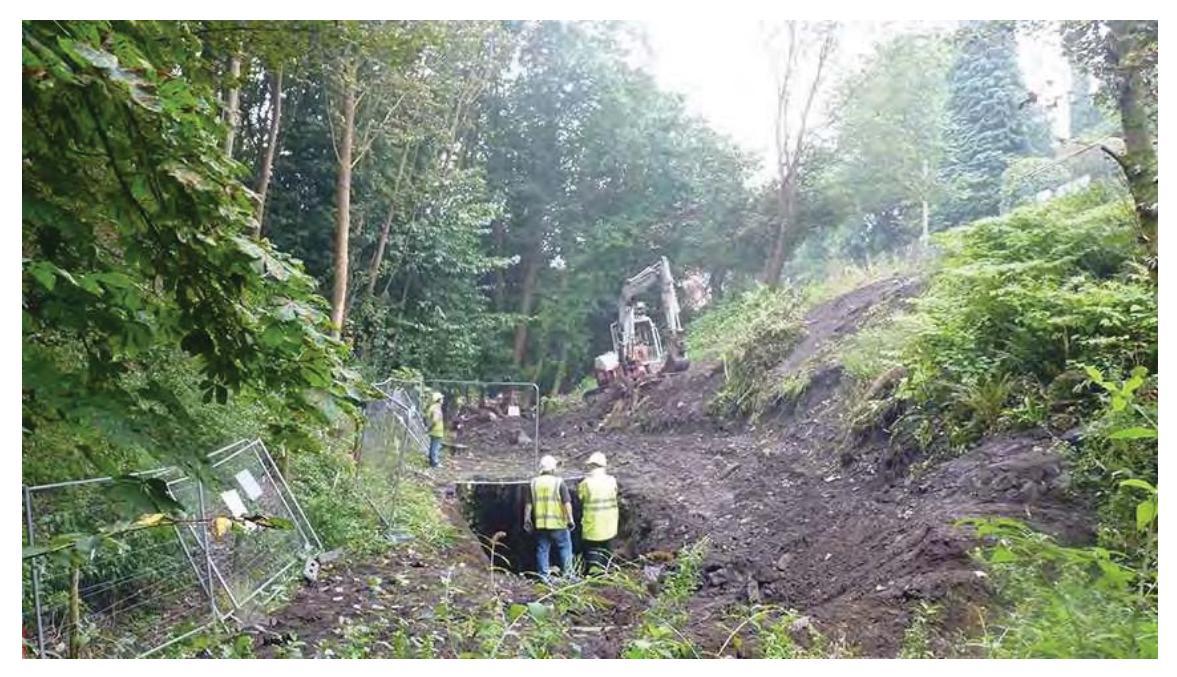
Photo 1: View south down the small valley along which the culvert runs. Showing the area of collapse and the extent of the scoured area at the valley bottom.

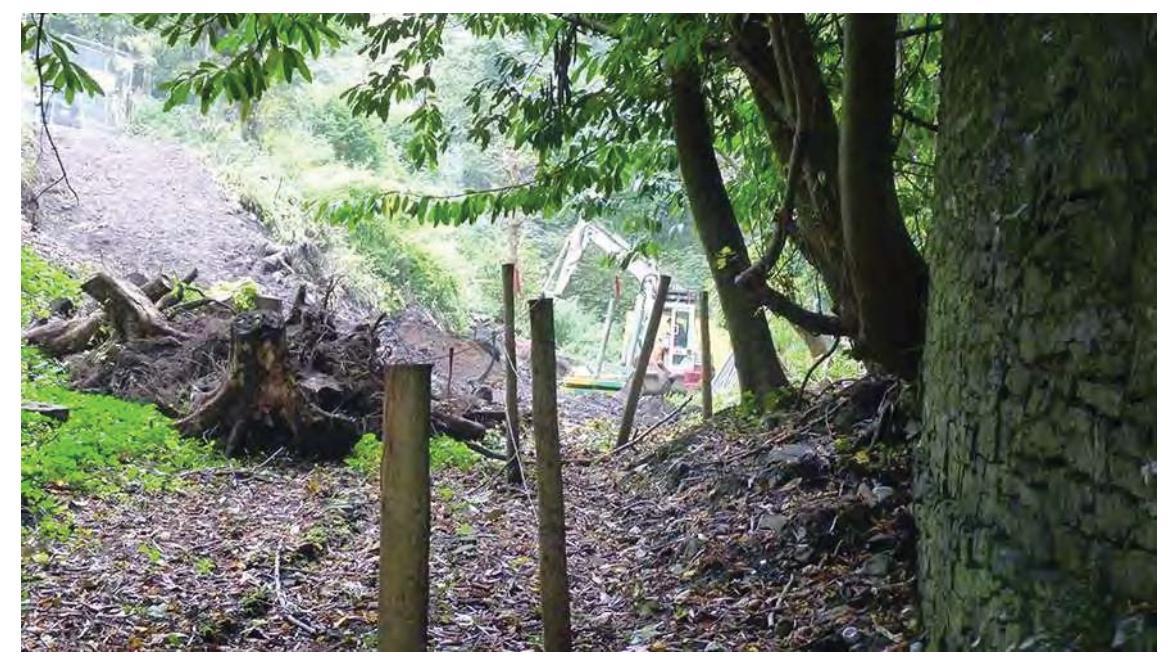
Photo 2: View north up the valley. The wall on the right is associated with the former ironworks, the machine is sat at the southern edge of the collapsed area.

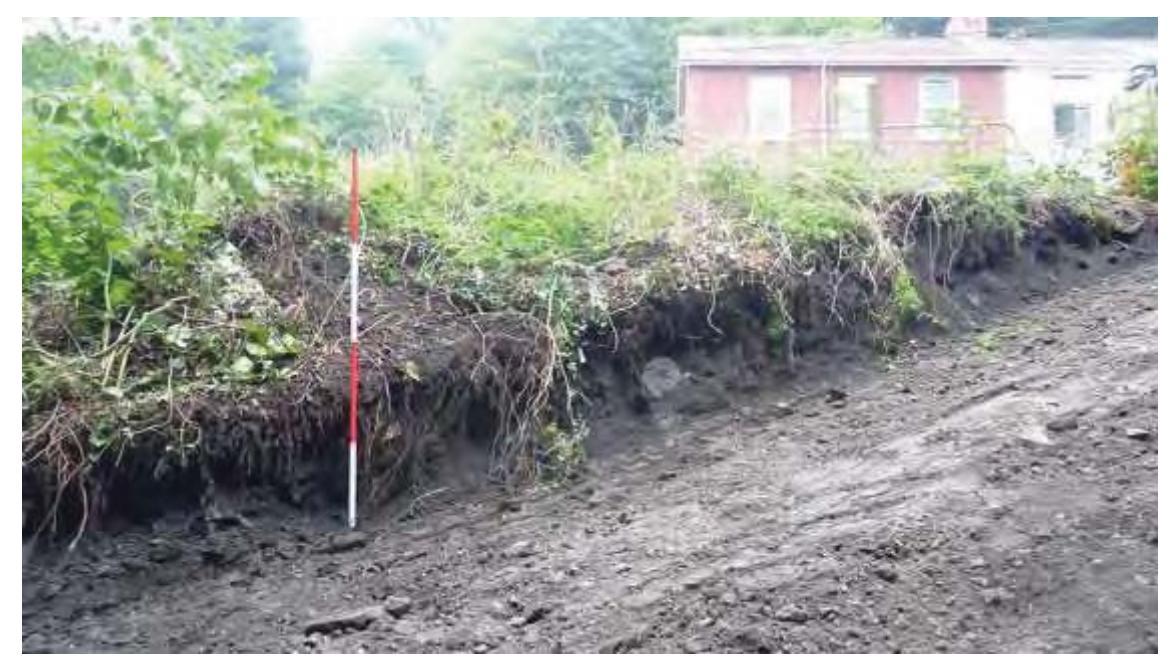
- 5.1.3 The access ramp was 2.8m wide and ran in a southeast direction for *c*.15m. The western edge of the ramp cut into the valley edge to a depth of 0.8m; the eastern edge and south-eastern end of the ramp was created from built-up material. Where the valley-side was exposed it consisted of a loose, dark brown-grey, sandy-silt with abundant medium to large sub-angular stones. No archaeological features were exposed by, or present within, this deposit, which appeared to consist of imported modern material, possibly associated with road widening activity, previous work on the culvert or quarrying waste. The very loose nature of the material suggested a relatively modern date; no finds were recovered.

Photo 5: West facing shot of the modern deposits revealed by the creation of the access track. 2m scale.

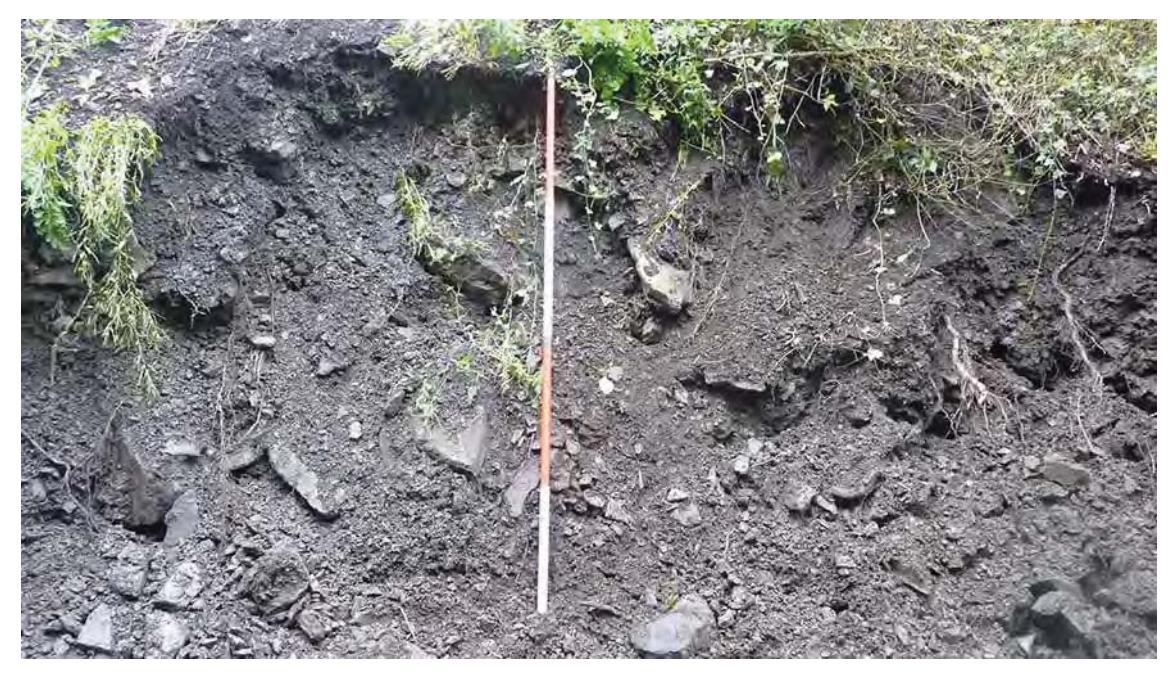
- 5.1.4 In order to both access and assess the area of collapsed culvert, an area *c*.32m long by *c*.7m wide at the base of the valley was cleared of vegetation and landscaped. This work exposed surface deposits across the entire area, all of which could be readily associated with modern disturbances, presumably those associated with previous culvert repair work undertaken immediately to the north. Nowhere were original ground levels or pre-modern disturbance deposits uncovered. No evidence of the previous tramway or early-19th century structures was revealed. At the same time, a section of ground on the western side of the valley was exposed to allow for the passage of machinery onto the site. This revealed material at the base of the slope that corresponded closely to that exposed by the cutting of the access ramp, suggesting the upper deposits on the western side of the valley at this point also consists of imported modern material.

Photo 6: West facing shot of the edge of the scoured area at the base of the valley. Showing the current profile of the western side of the valley is made up of loose modern material. 2m scale.

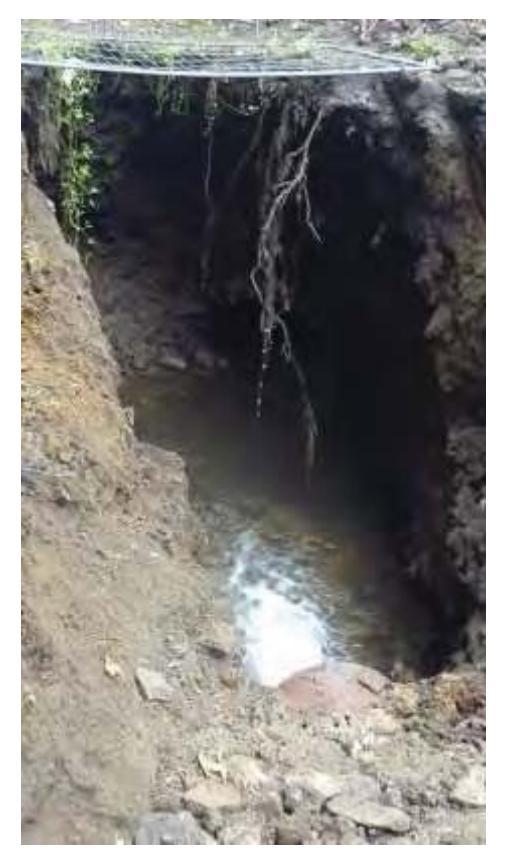
- 5.2.1 A section of culvert *c*.5m in length had collapsed, roughly from the point at which the modern pipe inserted during the last phase of repair work ended. This pipe had been inserted into the existing stone culvert, but this appears to have concentrated the flow of water, which was clearly very strong, onto specific points of the culvert, weakening and eventually collapsing the stonework. The water then washed away the stonework and scoured out an area several metres in diameter eventually causing the ground to collapse.

Photo 7: South facing shot of the area of collapse, with the surviving section of culvert visible at the rear.

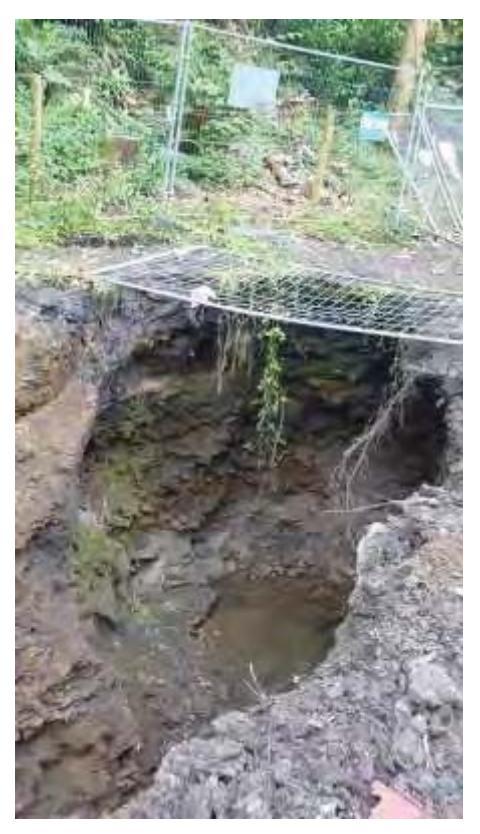
Photo 8: View of the collapsed area, facing southeast.

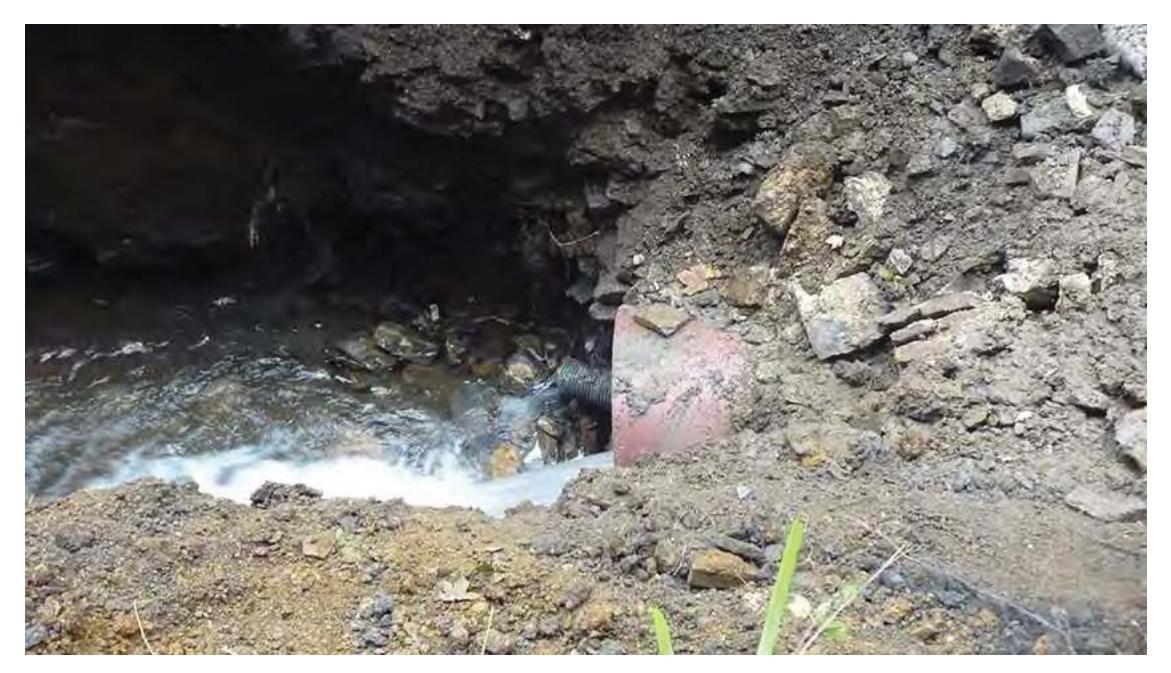
- 6.3 This previous work appears to have contributed to the collapse of the current section. An area, *c*.5m in length, had fallen in and the strong flow of water exiting from the repair pipe associated with the previous repair had removed the culvert in this area.

Photo 9: West facing shot of the northern end of the collapsed area, showing the pipe inserted through the culvert in the previous stage of repair work.

5.4.1 The archaeological watching brief ceased when the exposed deposits had been recorded, thus allowing repair work to the culvert to be undertaken. This work comprised attaching a new metal pipe to the existing one exposed at the northern end of the area of collapse. This pipe was then inserted into the stone culvert as far as the manhole. This new section of pipework incorporated a downward curve to take some of the force of the water flow out of the pipe and prevent the scouring effect that had occurred at the end of the previous section of pipework. No *in situ* remains or collapsed remnants of the original stone culvert survived in the area of collapse, so this section of pipe was encased in concrete and in-filled with imported material.

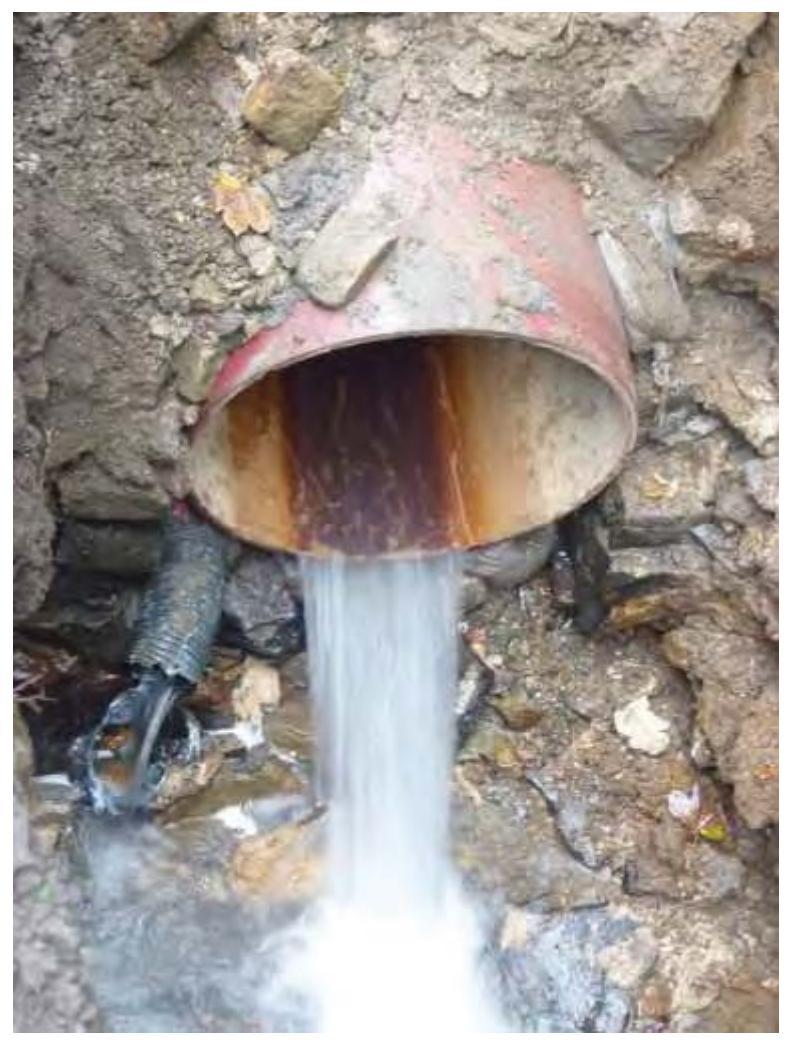
Photo 10: Close-up of the inserted pipe. The remains of the stone culvert is visible on either side of the pipe.

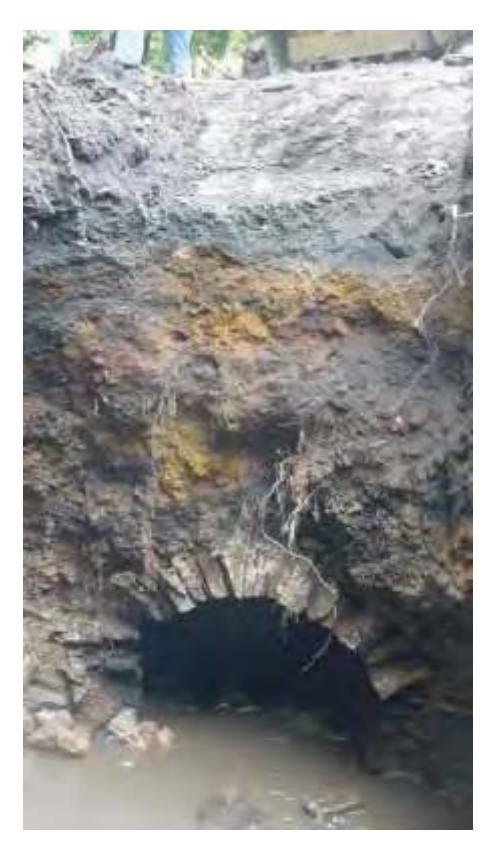
Photo 11: South facing shot of the surviving section of culvert showing the depth of material above it.

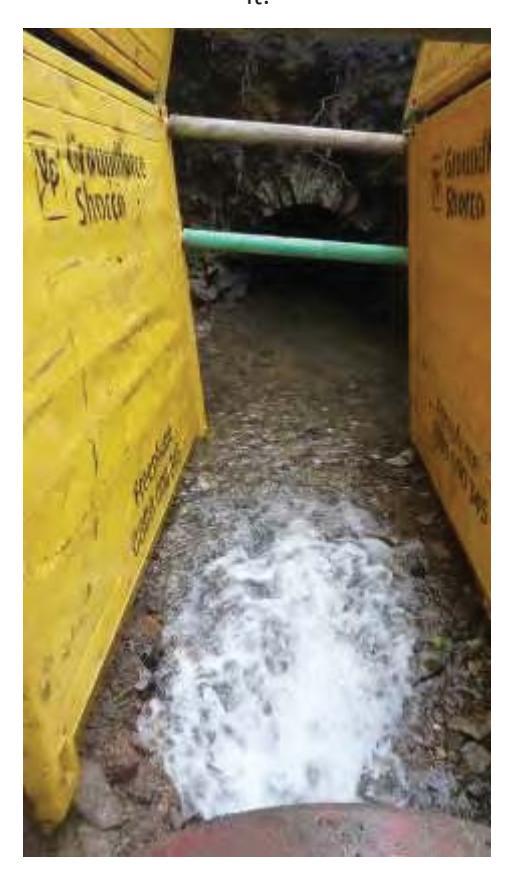
- 4.2.3 The base of the collapsed area was *c*.3m deep. Therefore, shoring was brought in to provide a safe working area for the repair work. This did not, however, allow a close examination of the surviving section of the stone culvert. Along with potentially unstable overhanging deposits around the edge of the collapse it was not possible to undertake accurately measured and levelled drawings of the culvert and surrounding deposits. Records consisted of high resolution digital photographs (using a 14MP camera), sketch drawings and written AW context sheets.

Photo 12: Facing south, showing the surviving section of culvert and the extent of the shoring within the collapsed area, demonstarting the difficulties of getting a detailed recording of the surviving culvert.

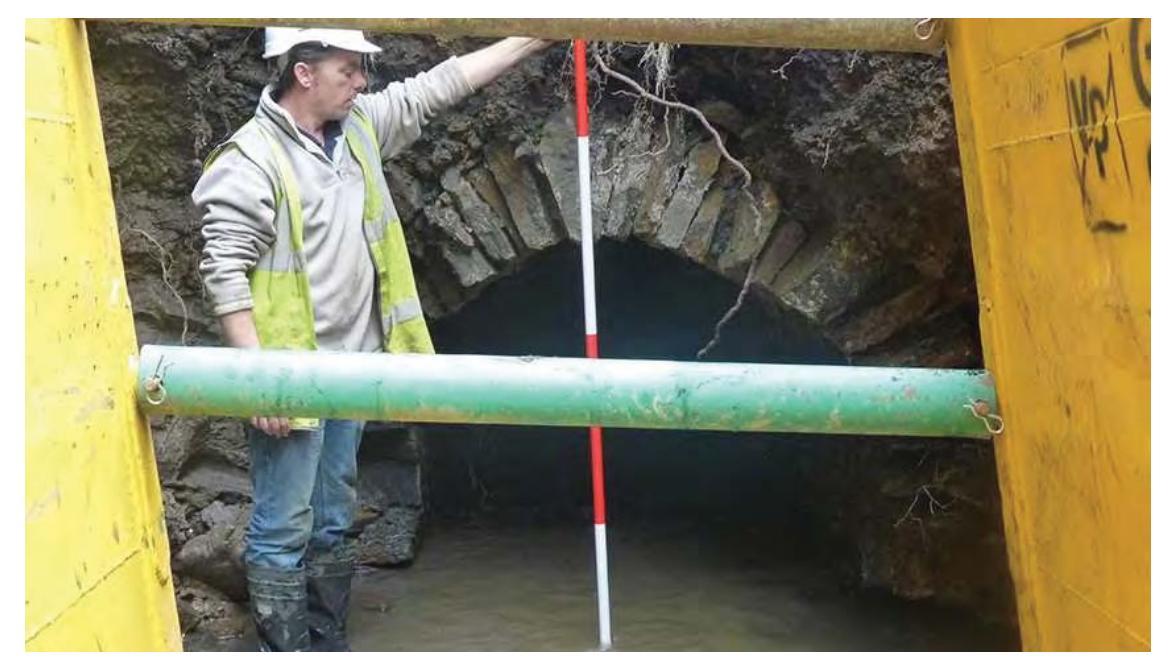
Photo 13: Facing south, surviving section of culvert with 2m scale. Taking scale photos was not feasible due to overhanging deposits.

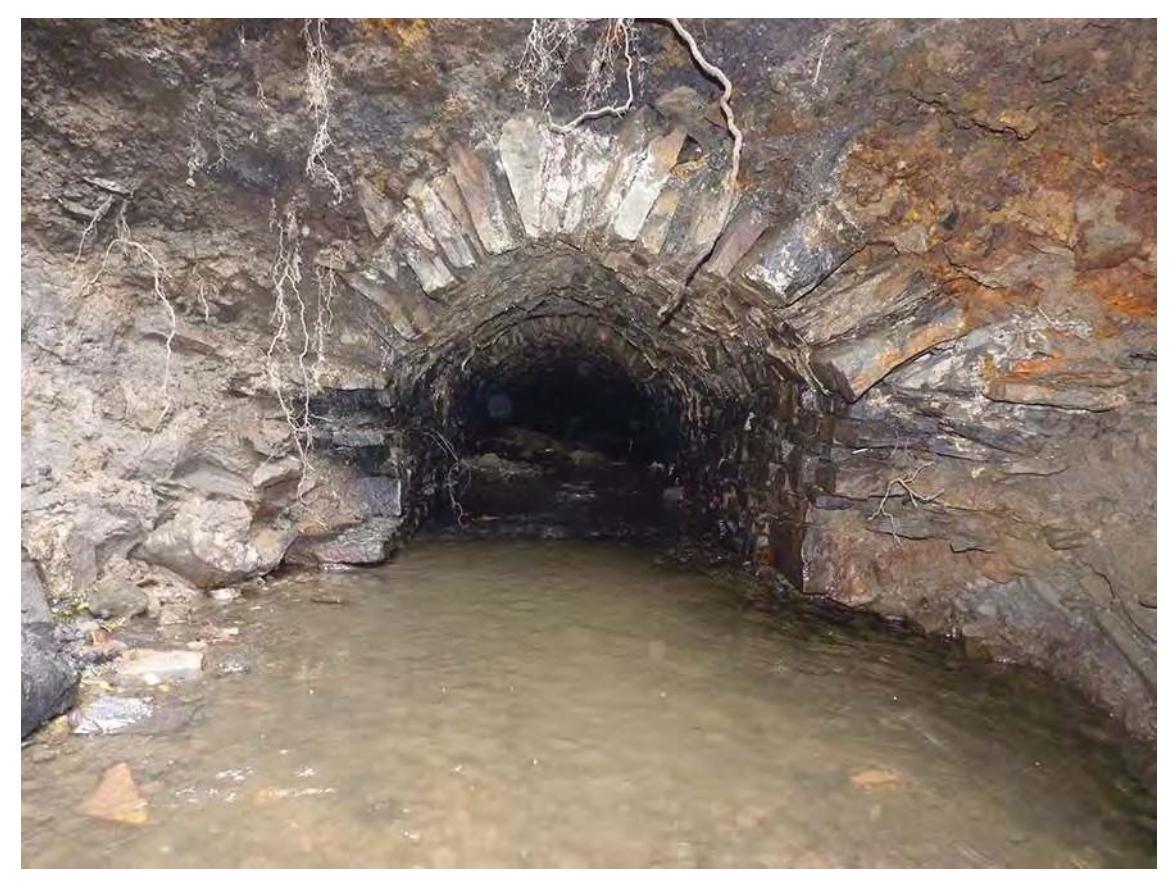
Photo 16: South facing view down the surviving section of culvert. The opening for the manhole is visible in the roof of the culvert a short distance in.

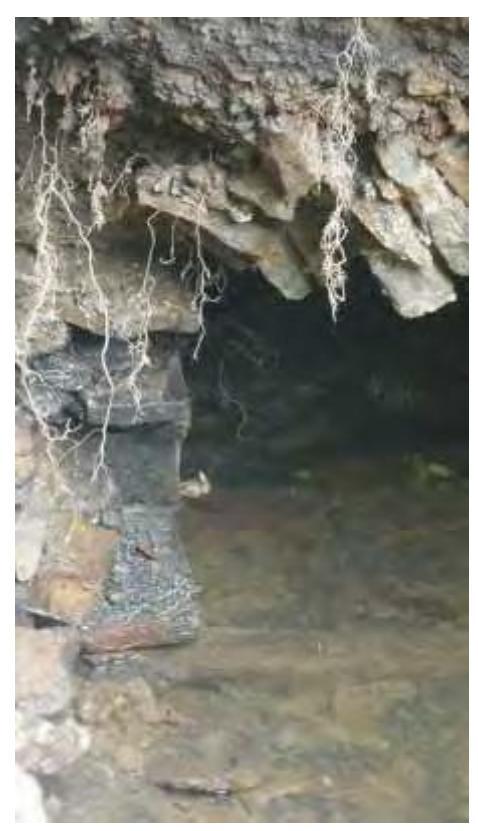
Photo 18: Detail of the eastern wall of the culvert, also showing the tied-in wooden beams along the base of the culvert.

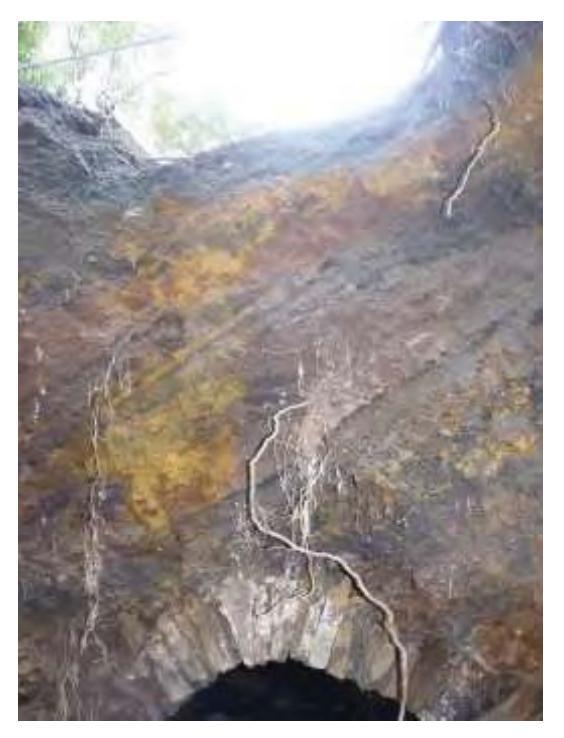
Photo 21: Backfill deposit visible in section above the culvert. Shows tip lines coming in from the west, and iron staining suggesting these deposit derive largely from waste material from the iron working processes.

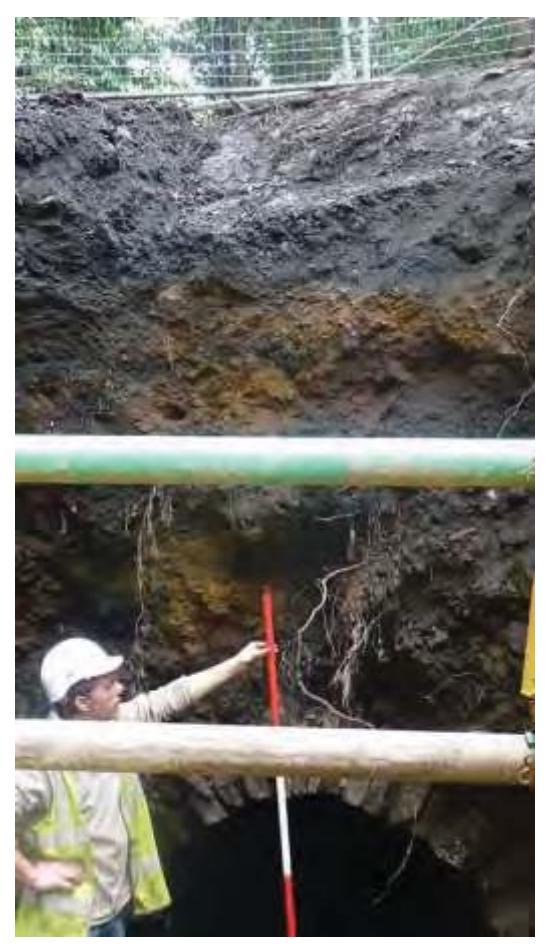
- 5.2.11 These deposits were overlaid by *c*.1m to 1.5m of dark, grey-brown, clayey-silt mixed with stony-ashy deposits. This was a very mixed deposit representing a combination of topsoil and material formed by past landscaping and repair works.
- 5.2.12 No finds were recovered from, or visible within, any of the deposits underlying the modern topsoil.

Photo 22: Backfill deposits above the culvert, also showing the dark layer of modern disturbance and overburden at the top. The partial scale shown is a 2m scale, divided into 0.5m segments.

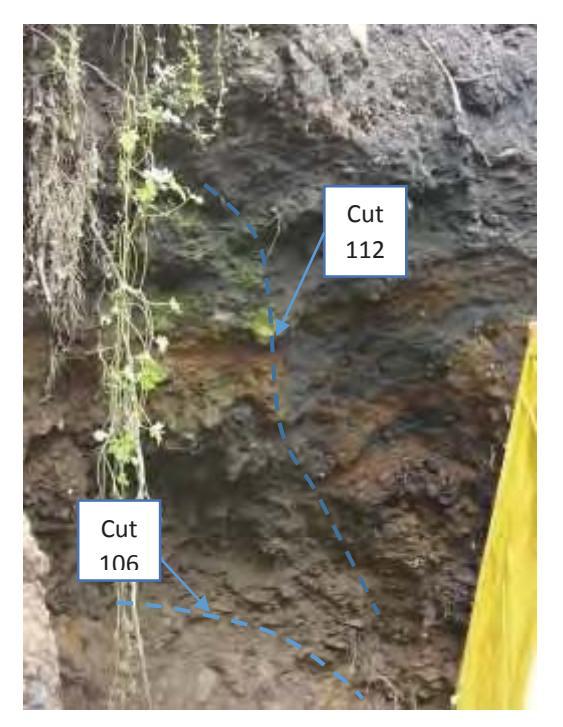
- 5.2.8 A second cut-line (cut 112) is visible as an insertion through these overlying layers (deposits 107 110). It has steep, slightly concave sides, which again are largely visible only on the eastern side, as tumbled material obscures the western side. It extends down to the arched roof of the culvert, presumably for later repair or maintenance works, or possibly for work associated with the construction of a nearby manhole, located *c*.3m to the south. The cut is backfilled with a series of ashy-gritty deposits (deposits 113 138), all of which appear to represent waste material from furnace workings. Tip lines within these deposits indicate that they were tipped in from the western side of the valley base.

- 6.5 Subsequently, a cut was made into the overlying material to gain access to the top of the culvert. This was presumably either for repair work to the culvert or connected to the construction of a manhole access shaft *c*.3m to the south of the collapsed area. This later cut was also in-filled with what appeared to be waste material from the ironworks, so it probably occurred either during the working life of the furnace or subsequently during the demolition works that occurred during the earlier part of the 19th century.

Photo 23: South facing shot of the deposits revealed above the culvert, showing the original construction cut (106) and the later re-cut (112).

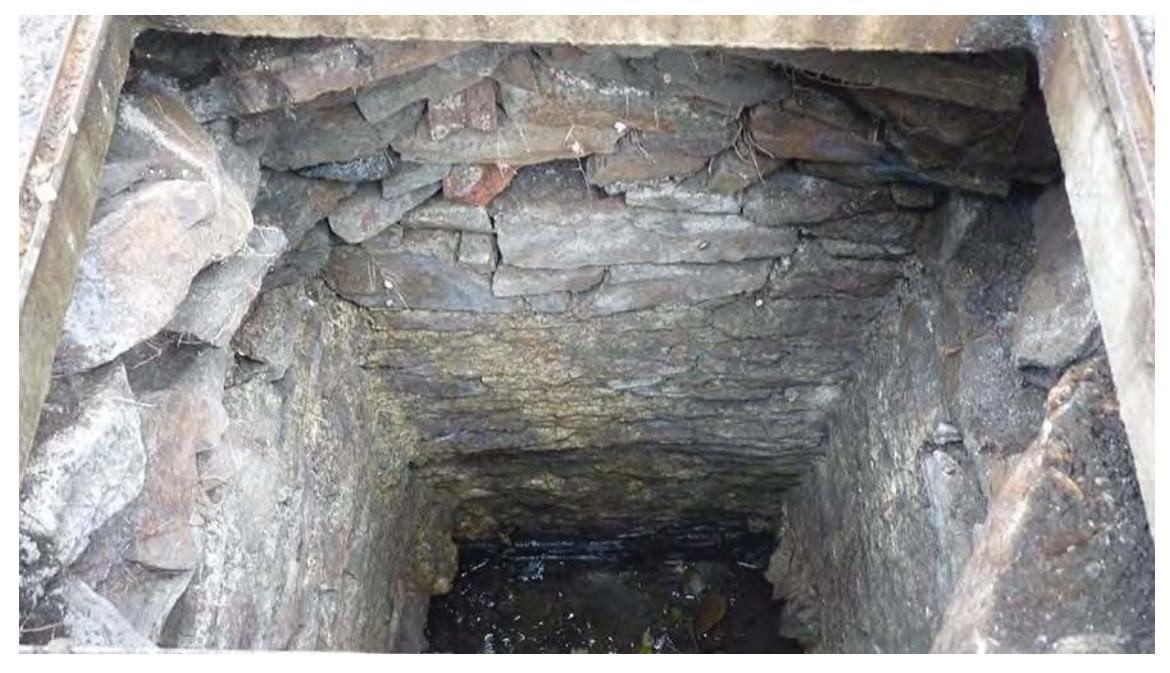
Photo 26: East facing shot of the manhole opening, showing the line of the culvert at the base running left to right and the mortared wall of the shaft topped by unmortared slightly corbelled stonework now carrying the modern concrete and metal manhole cover.

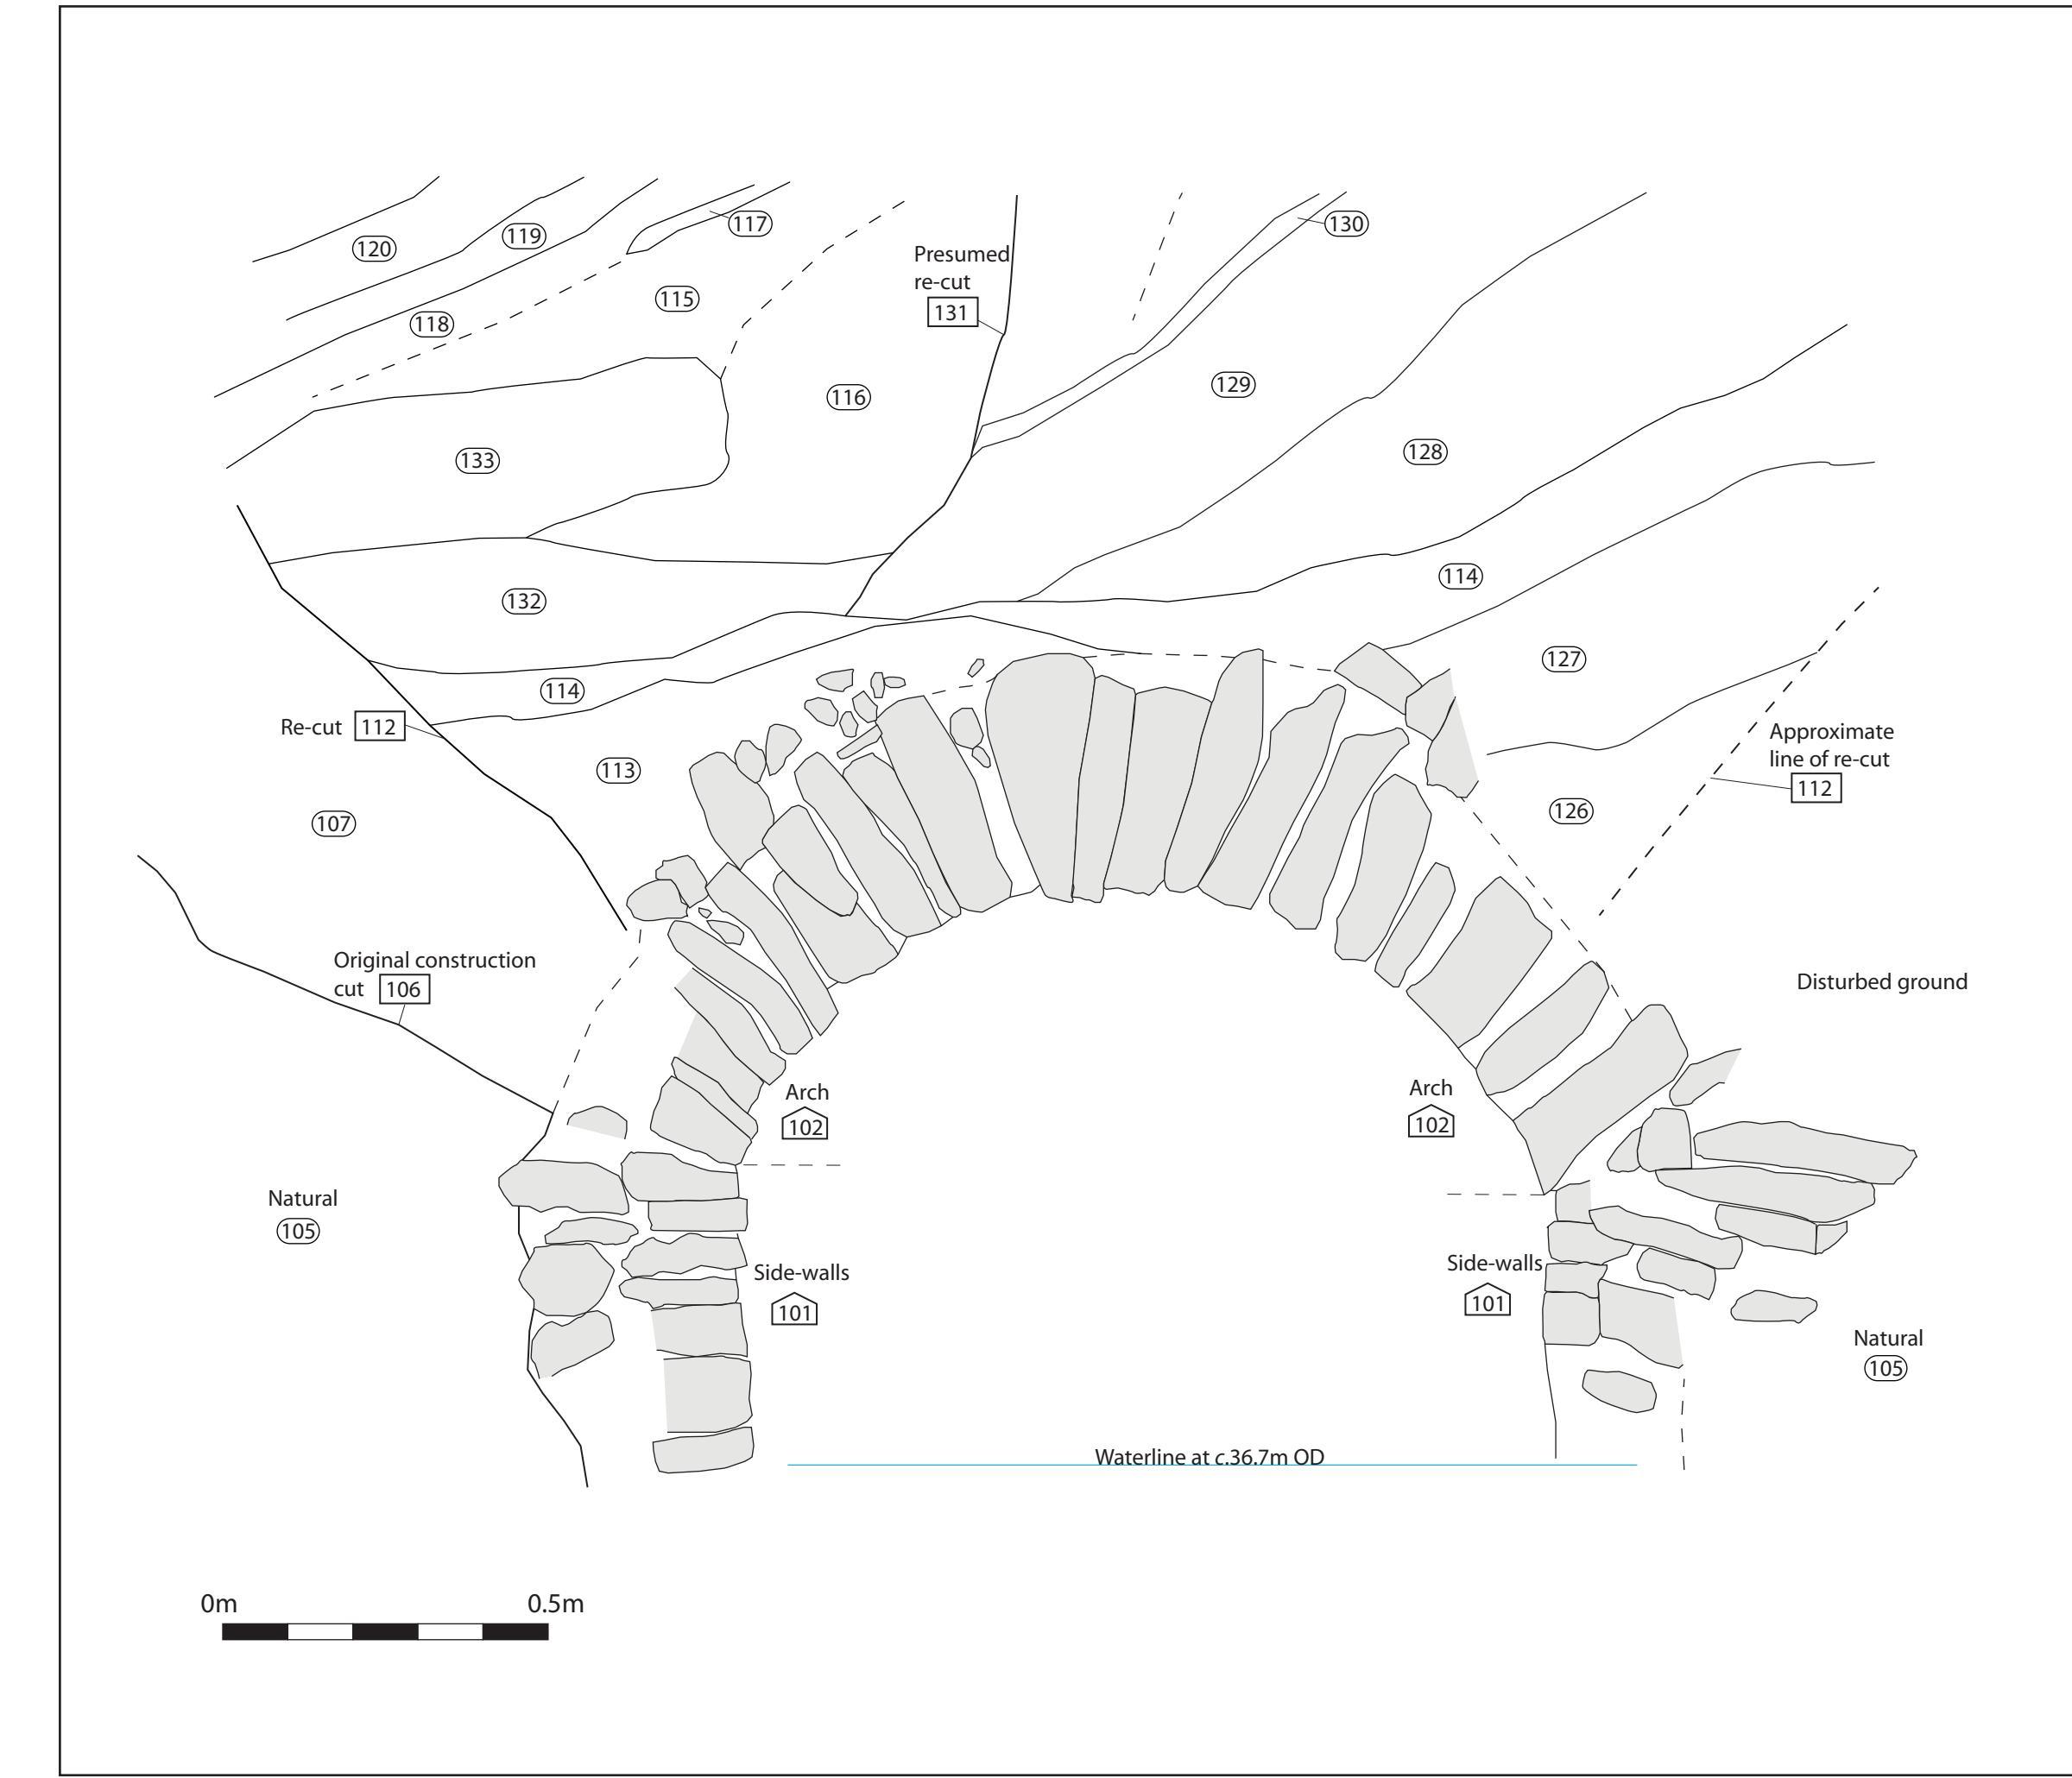
Fig. 6: Profile of the exposed north-facing section of culvert and overlying deposits at Raby's Furnace, Llanelli. Dimensiosn should be taken as approximate as close measurement of features and deposits were not possible on Health & Safety grounds.

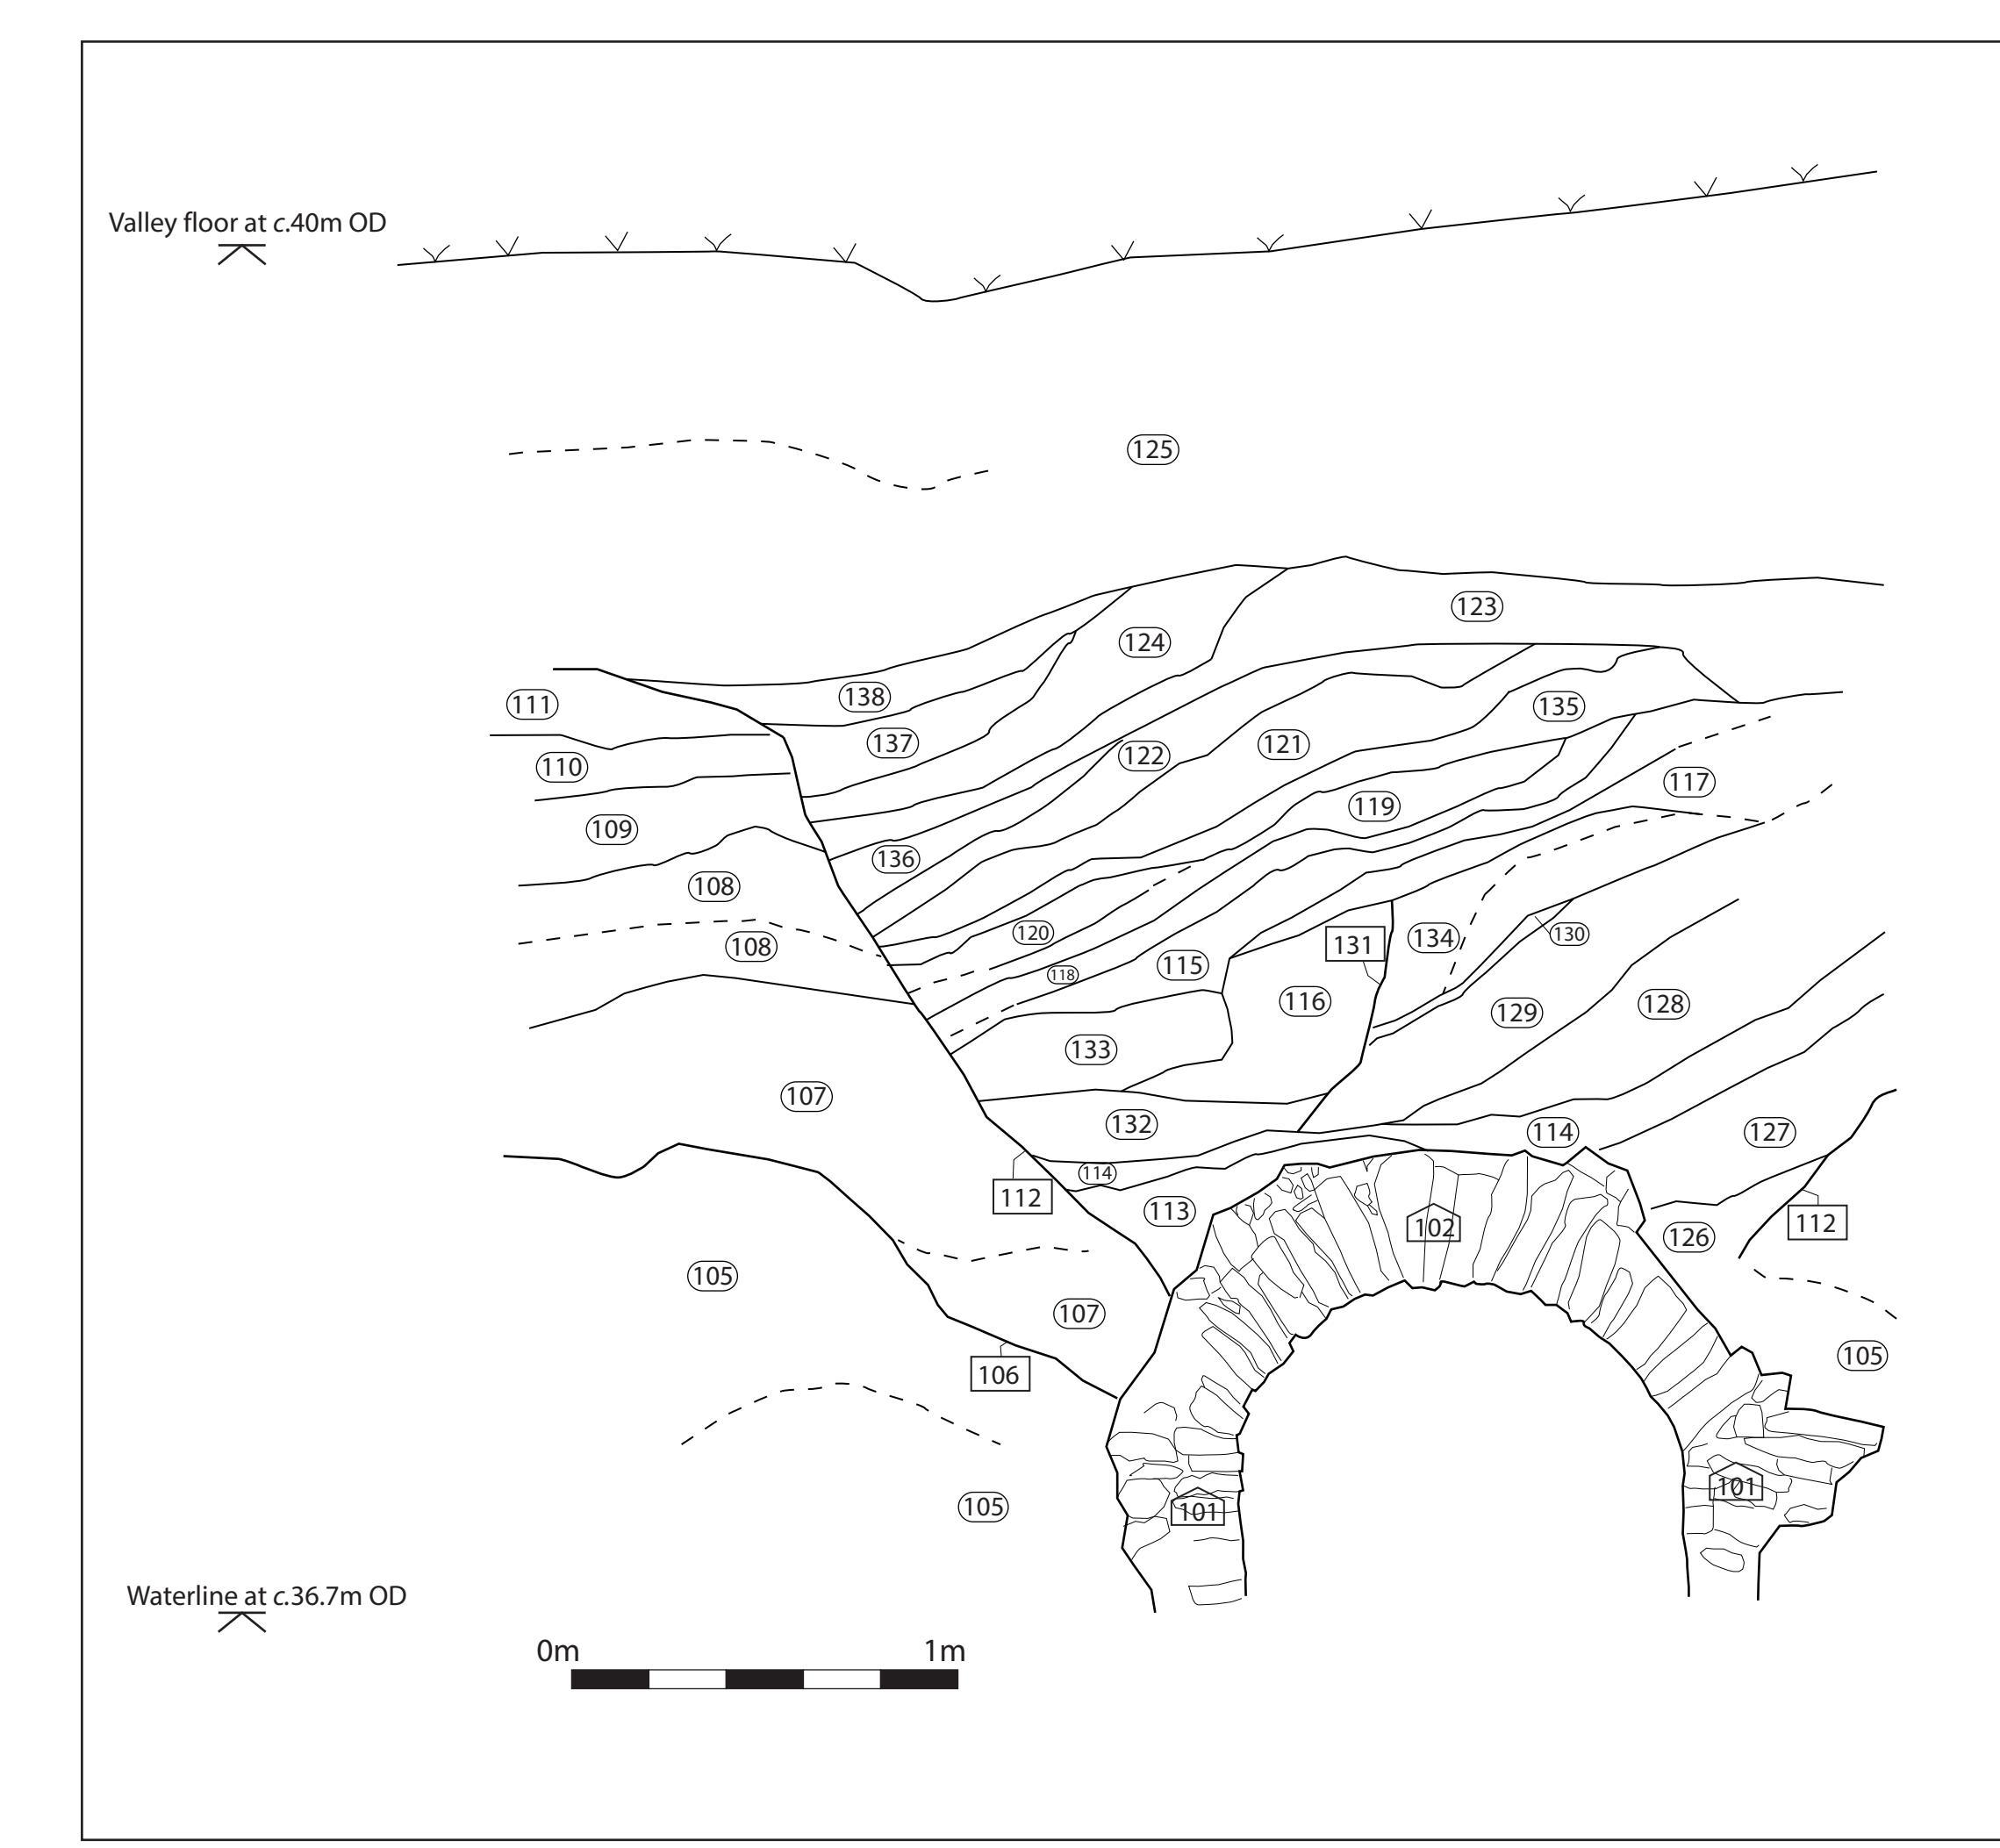
Fig. 7: North facing section of deposits revealed overlying the culvert in the area of collapse at Raby's Furnace, Llanelli.
