HERITAGE IMPACT STATEMENT

WORK CARRIED OUT AT THE HEN TY FFERM,
PENRALLT, LOGIN, WHITLAND, CARMARTHENSHIRE,
SA34 0TL

MR G R & MRS J LEWIS

MARCH 2019

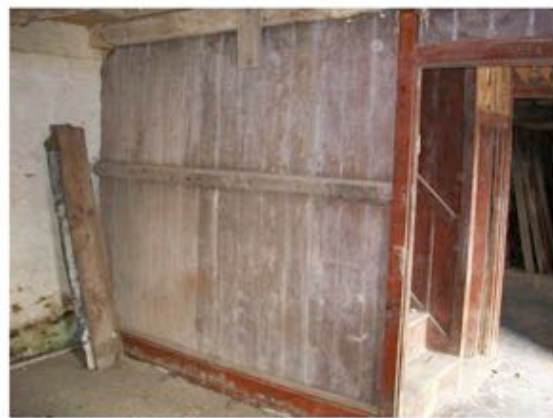
Above: Existing partition before works with varnished joinery in faded condition

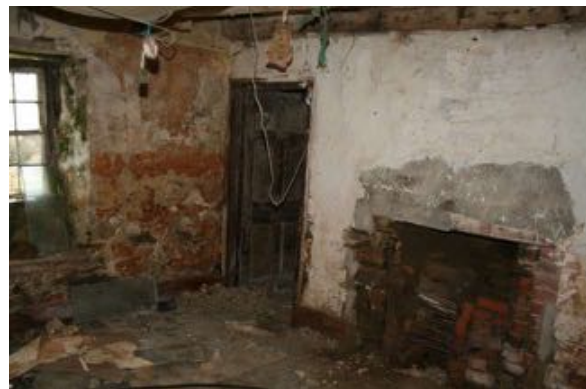
Above: Existing limewash and painted joinery showing condition with patch cementitious repairs, spalling, aglae around windows and peeling limewash

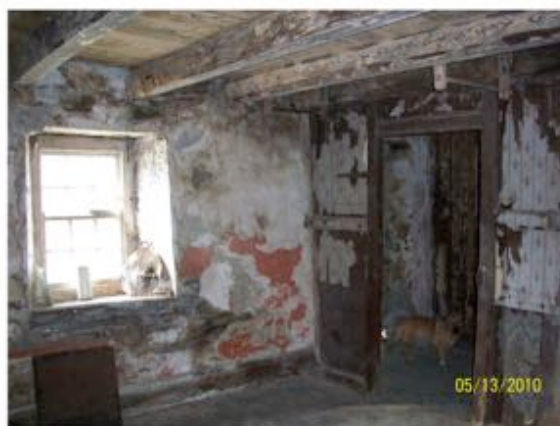
Above: Existing finishes with limewash over plaster, painted and varnished joinery with partial wall paper over partition. Note poor condition

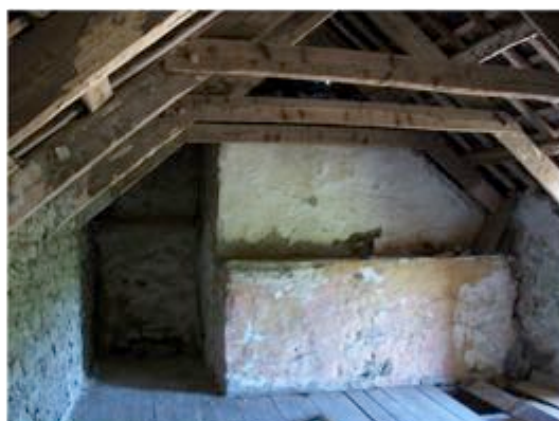
Above: Existing limewashed and bare stone finishes in poor condition and absent ceiling but decoration visible to bottom of rafters

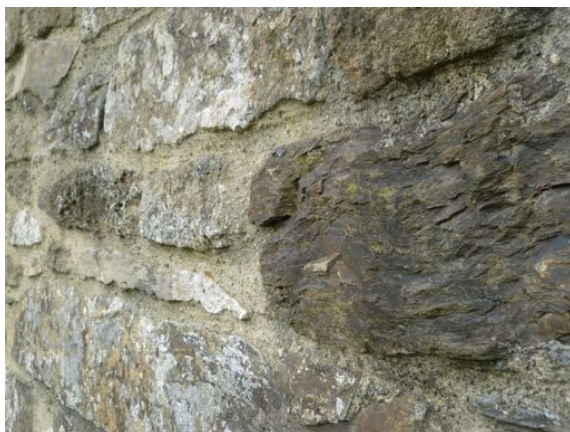
Above: Traces of limewash with complete loss over shaley stone surfaces

in this region are rich in iron and this leaches through limewash finishes unless there is regular application. Although the protective properties of a limewash cannot be dismissed, there are examples of exposed stone buildings in the locality which demonstrate that the stone is relatively robust to the exposed location with notable absence of decay. The pointing material suffers the worst with earthen mortars being eroded and cementitious mixes causing spalling and water ingress. Given that the stonework has been pointed in suitable lime mortar mix, this provides the most durable long term solution. The applicants have essentially conserved as found with unavoidable loss of limewash during pointed and rebuilding works.

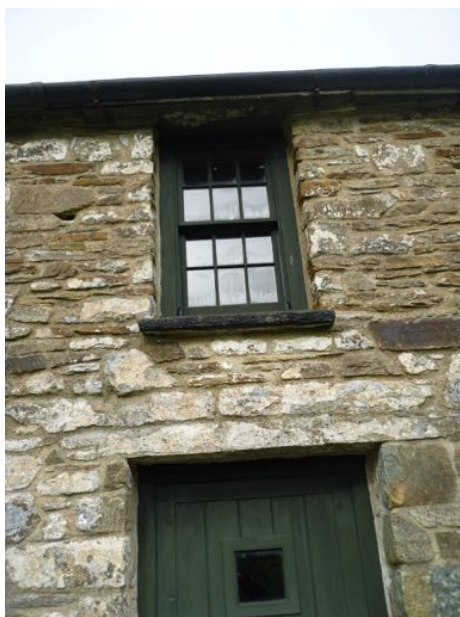
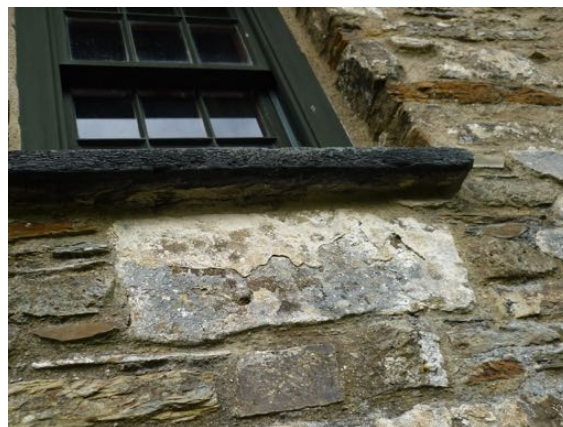
Above: Limewash adhered to bigger stone with loss over smaller stones

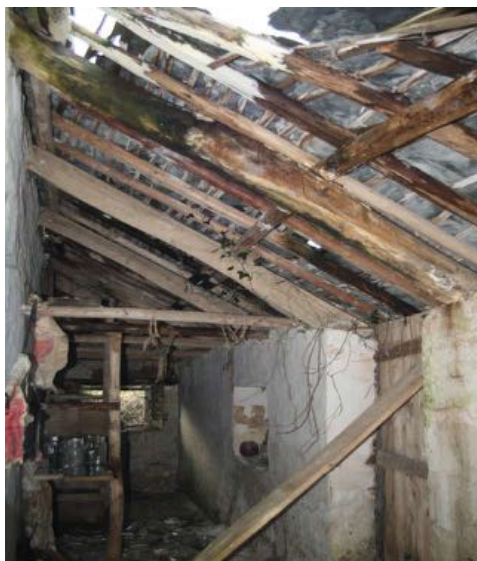
The roof covering over the lean-to had sustained damaged which would have been apparent at the time of the listed building consent application in 2006 and yet neither the agent nor conservation officer addressed the need for re-slating the roof in order to replace the roof timbers. Stones from the western chimney had also fallen and crashed through the roof covering of the lean-to. Extensive ivy growth along the north west corner of the roof had also displaced several slates. Several common rafters needed replacing with repairs to the purlins and principle rafter which could not take place with the roof insitu. The engineer's report stated that the roof timbers would be replaced however with the assumption that the roofs would be renewed. The applicant wanted to conserve as much of the original timber as possible however and did not follow the engineer's advice with rotten timbers replaced locally on a like for like basis.

Above: lean-to interior at west end showing condition of roof before development

As part of the re-roofing the original slates and ridge tiles were salvaged and reused helping to conserve fabric. Matching second hand slates and ridge tiles were also brought in to make up the difference so aesthetically, the roof character has hardly changed. Matching section cast iron rainwater goods were also fitted. The re-slating works allowed the insertion of lead soakers and flashings around the chimney stacks providing a more effective and durable detail against the weather.

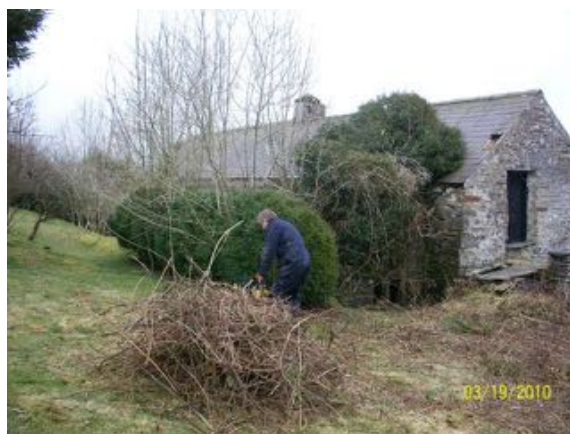
Above: Ivy growth to the NW corner prior to development

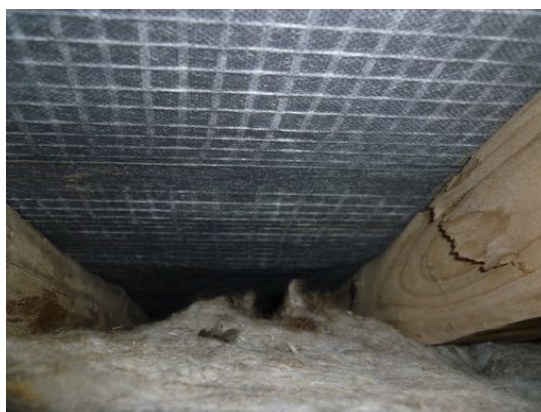
Below: View of the roof void in 2019 with roof timbers, felt and insulation in good order

- The applicant has installed a breathable roofing felt with localized strips of bituminous felt required along the ridge to comply with the bat license. The felt was laid in accordance with the manufacturer's recommendations by ensuring that moisture into the roof space is minimized. A vapour control layer was fitted to the new ceilings along with sealed penetrations and ducted mechanical ventilation extracts removing moisture from high source levels such as showers.

- The roof space is also ventilated with gaps and over fascia vents laid to the eaves on all roof slopes. Insulation has also been positioned to maintain a 50mm air gap along the underside of the rafters too helping the air circulate. During an inspection of the roof space on 19th February 2019, air movement within the roof space was apparent with no musty odor, signs of condensation or mould on any of the roof timbers of underside of the roofing felt. This is some 7 years since installation illustrating that the alteration has not caused any damage from the initial increase in moisture from wet trades during development or from subsequent occupation from both humans and bats.

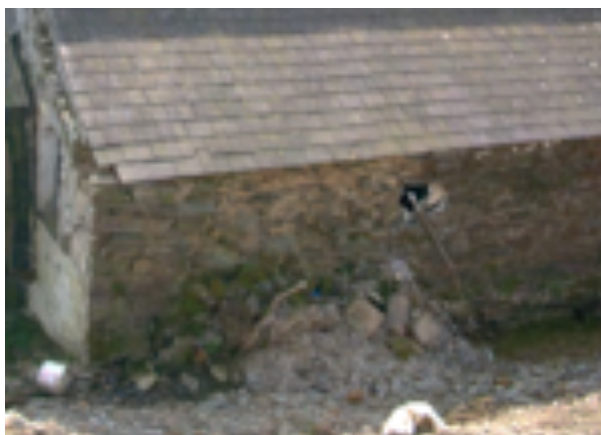
The house is situated on steeply sloping bank with the ground level to the north almost level with the eaves level of the lean-to. In accordance with the approved plans, the bank was lowered and a land drain introduced. Surface water had historically collected along the north wall of the lean-to and pooled towards the east end. During dry periods, water emerged from under the floor exiting at the southern side of the house. Loose stone visible above the higher ground level had already been noted in the structural report and following excavation a small section of detached stone outer skin was exposed. The roof was temporarily supported whilst the area was rebuilt locally using the salvaged stone and lime mortar.

Above: local masonry collapse post excavation

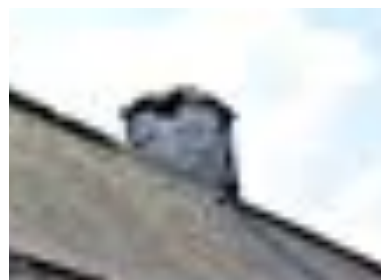
The existing chimneys were in very poor condition. The eastern stack had been dismantled down to roof level and capped off with slate and a ridge tile. The western chimney masonry was in a dangerous state with substantial cracking on all faces, loss of masonry and loose sections. Attempts appeared to have been made to limit water ingress with roofing slates laid flat followed by a perimeter of rubble stone, another roofing slate with rubble stone on top to try and weight it all down. Daylight was visible around the west chimney internally and with the absence of any mortar fillets or stone water tabling for protection against water ingress. Timber decay was noted around the chimney areas.

Above: capped east chimney and poor state of west chimney viewed from south west and north east in 2010

Listed building consent included the rebuilding of both chimneys with a note referring to cement hanuching and lead flashings but there was no detail on the drawing with the absence of chimney pots or flaunching. Other than using salvaged stone and lime mortar, rebuilding like for like was also difficult in that the chimneys had been effectively capped off and much original detail lost. The listed building consent referred to using a 'traditional detail' with no condition requesting the precise detail to be agreed later. The chimneys were therefore rebuilt with lead flashings and a squared chimney top as illustrated on the drawings. Given the roof was being reslated at the same time (instead of

repair), the mortar haunching was substituted with lead soakers as a more durable solution and a lead tray was introduced to limit water ingress down the chimney. The absence of a chimney pot and protection to the flue also had to be addressed given weather conditions in this area which suffer from heavy rainfall with water ingress inevitable. Although water ingress was a historic concern too, the use of sealed appliances such as stoves are particularly vulnerable with modern metal liners which provide no masonry buffer. There is also a lot less tolerance to staining and dampness in the modern home with more valuable internal furnishings and electrical equipment at risk. Although the conservation officer has expressed concern over the as built detail, the alternative options all have an impact as A – C outlined below:

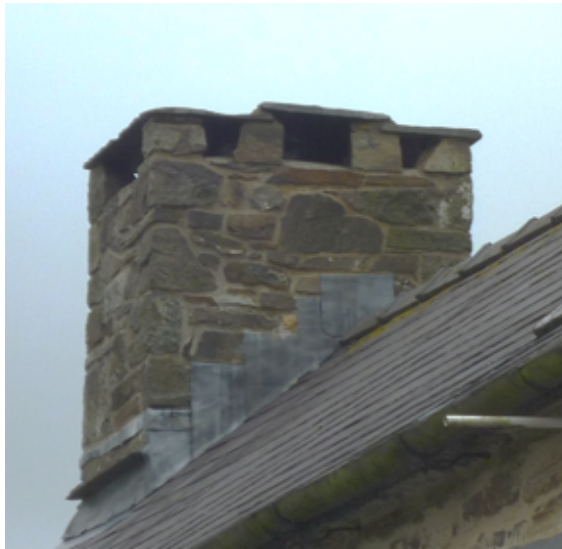
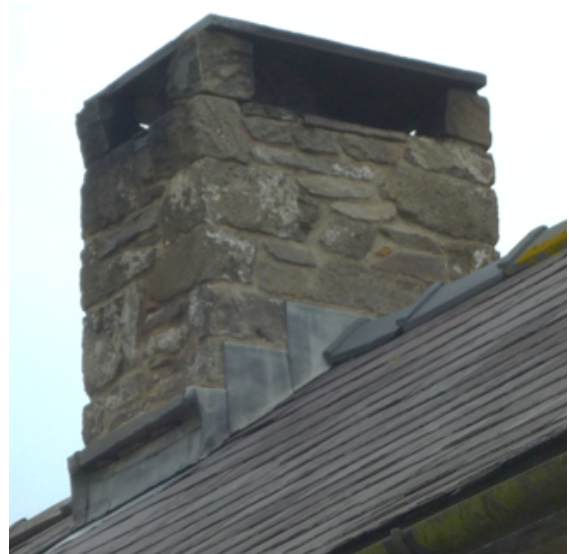
Above: Completed east chimney (left) and west chimney (west) both viewed from north west at close range.

The chimneys as rebuilt continue to be the preferred option by providing a simple square shape that has deep historical precedent whilst offering shelter in an exposed location. It should also be noted that the consented plans had an external metal flue pipe shown on the north elevation penetrating the lean-to roof for a new boiler. The applicants have therefore been able to eliminate this alteration and ensure that both chimneys are in working order.

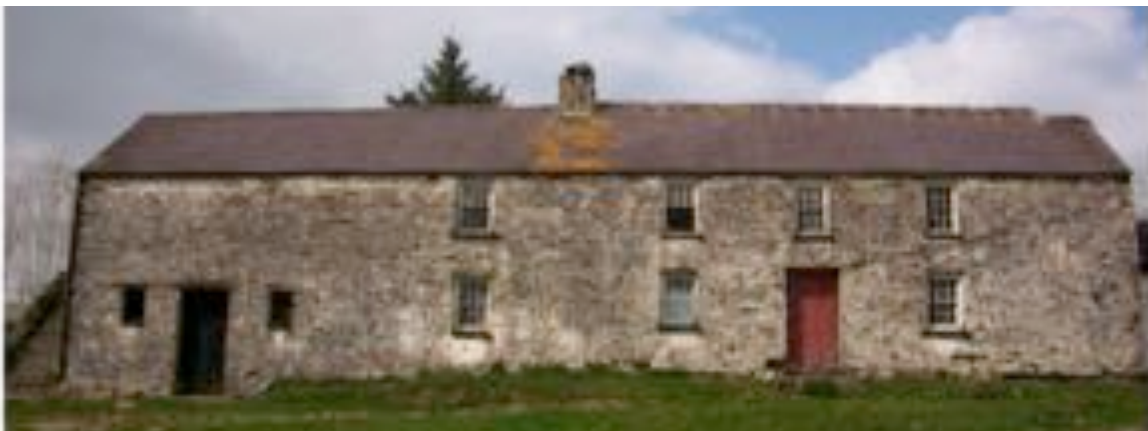
Above: Pre-development south elevation. Sash windows replaced like for like with solid boarded doors modified with addition of small vision panes. Former stable openings with single timber shutter (left) replaced with glazed four pane side hung casements.

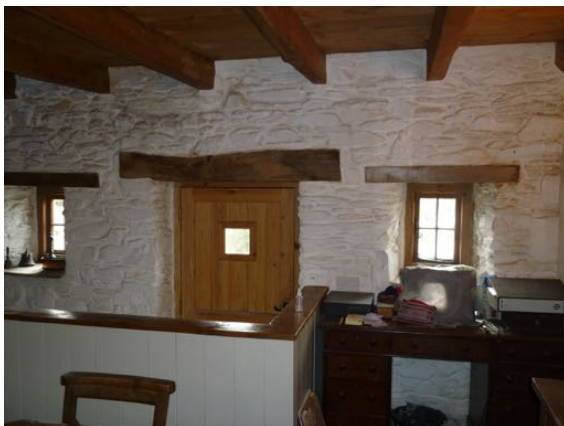
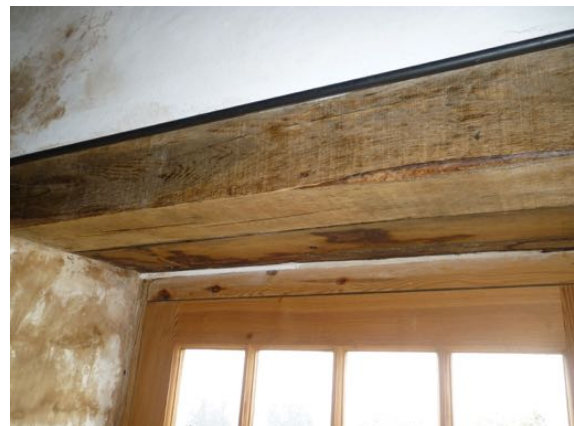
Above: Typical examples of timber lintels replaced with oak lintels used internally and oak lining added to conceal concrete lintels to wall core.

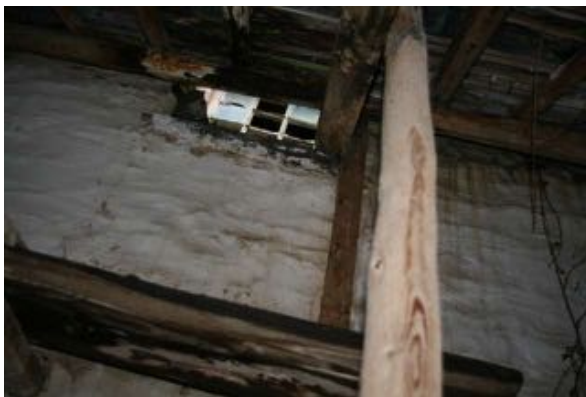
Little attempt had been made to protect this area from weather ingress with a gap between the roof slating. The window also had a number of missing glass panes with timbers and masonry sodden in this area. Whilst this detail could have been improved, the proposals also showed the insertion of a new staircase directly below. A new opening required headroom above for the staircase and this essentially necessitating removal of masonry up to roof level. Keeping the window was therefore not possible as the consented staircase would not have enough headroom.
