YMDDIRIEDOLAETH ARCHAEOLEGOL GWYNEDD GWYNEDD ARCHAEOLOGICAL TRUST

REPORT ON THE FOURTH SEASON OF THE TRE'R CEIRI CONSERVATION PROJECT JUNE TO NOVEMBER 1992

PART 1: TEXT

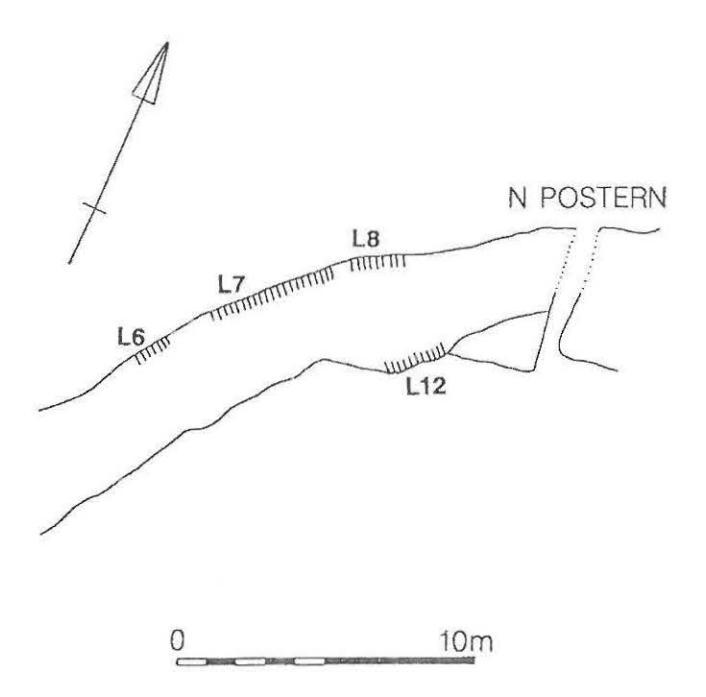
Fig.3. Wall L6 - M, locating collapses conserved during 1992 season.

This was a small area of instability at the top of the outer face (Plate 1). A 1m length of the upper course had become loose as the wall stepped up 0.45m at the east of the collapse. No *in situ* masonry was removed. The wall top was stabilised by placing several heavy headers onto the loose masonry (Plate 2).

1.6m east of L6 there was a 4.2m long dip in the outer face (Plate 3). The face was standing to a height of 1.4m to the west, falling to 1.0m in the centre of the collapse and stepping up steeply to 1.6m to the east. The *in situ* masonry was stable but core material was spilling forwards over it.

There was a 1.7m wide and 0.9m deep collapse in the top of the outer face at this point (Plate 5). The core was retained above the collapse up to a height of 0.7m but was beginning to slip forwards. After the unstable core was cleared the face was rebuilt to the height of the surrounding extant masonry (Plate 6). No *in situ* facing was disturbed.

The loose core material was removed along with a few larger stones recently disturbed from the wall top. The dip was filled with large stones to retain the core (Plate 4).

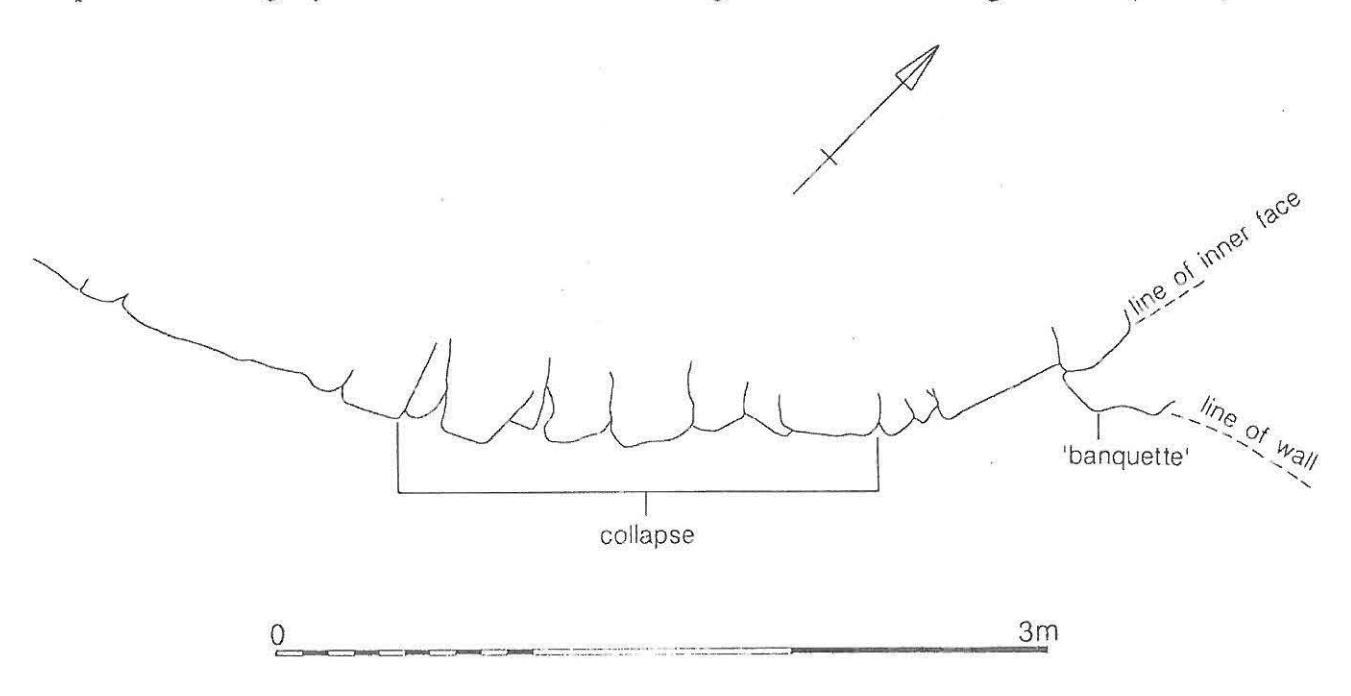
Fig.4. L12, after removal of tumble, showing bulge in wall.

A 2.9m wide and 1.0m deep collapse had occurred just to the west of the banquette at the north postern (Plate 7). There was a pronounced bulge in the wall at this point and it was assumed that the basal courses had slipped forward, causing the collapse.

The stones at the edge of the collapse were numbered and the tumbled masonry cleared. After clearance it became obvious that several courses of masonry had survived beneath the rubble (Plate 8). The basal courses had not slipped forward and the bulge in the wall was original masonry. This was planned, see fig. 4. Stones B,C,D,E, and Q were removed during clearance. B was too short to put back, the rest were replaced as closely as possible to their original positions. Stones H to P were held in place during dismantling by packing the void beneath K. H was pushed back slightly. The face was rebuilt to the height of the core standing behind it (Plate 9).

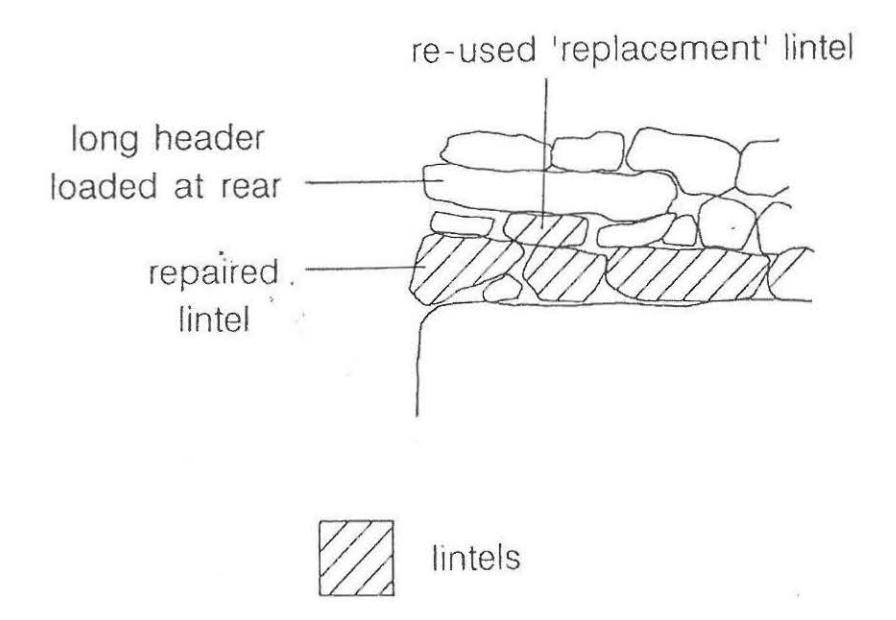
Fig. 5. Method for reducing loading on the repaired lintel.

It was not possible to accurately assess the load bearing capacity of the repaired lintel. It was thus necessary to avoid point loading and minimise the weight bearing on the centre of it. This was achieved by placing the now discarded replacement lintel above and behind the repaired stone and running long headers over this as in fig. 5. A void was thus produced above the repaired lintel which was loosely packed with stones.

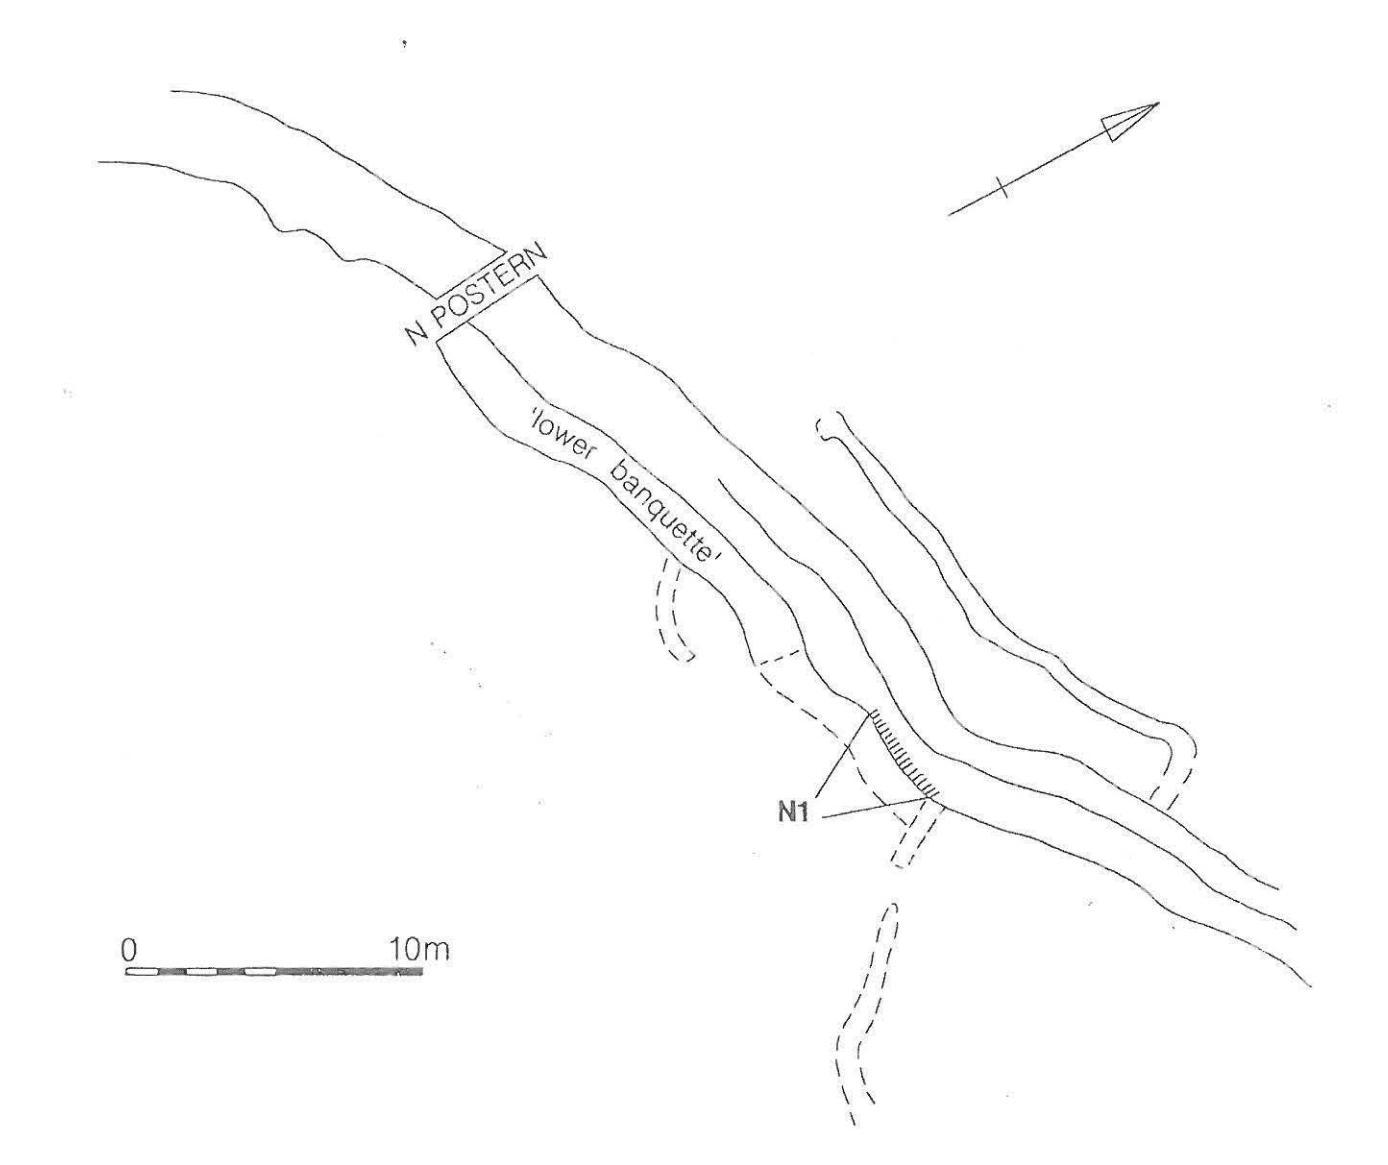
Fig.6. Wall M-O showing position of collapse N1 (after Plowman Craven, 1980).

A 3.7m length of the inner face had collapsed where the wall steps up the hill 23m east of the north postern (Plates 16 and 17). The face stands to a height of 1.5m to the west of the collapse and 1.6m to the east where the ground rises 1.1m and is revetted by a face running south at 90° to the main rampart. The parapet stands to a height of 0.2m above the collapse and is in a ruinous condition.

The stones at the edge of the collapse were marked A-Z and the collapsed rubble cleared. After clearance it could be seen that the face was still standing to a height of 0.5m at the centre of the collapse. A number of large flat stones lying at the base of the wall at ground level were uncovered. These appeared to be a continuation of the 'lower banquette' that runs east from the north postern. All *in situ* facing was stable and it was not necessary to disturb any of the marked stones.

Loose core was removed and the face was rebuilt to the height of the surrounding masonry using the stones cleared from the collapse (Plate 18). There was an area of potential weakness in the face at the east of the collapse where there was a 0.5m step up in the wall. *In situ* masonry was in danger of displacement so the face was graded up to the top of the step to provide greater stability (Plate 19).

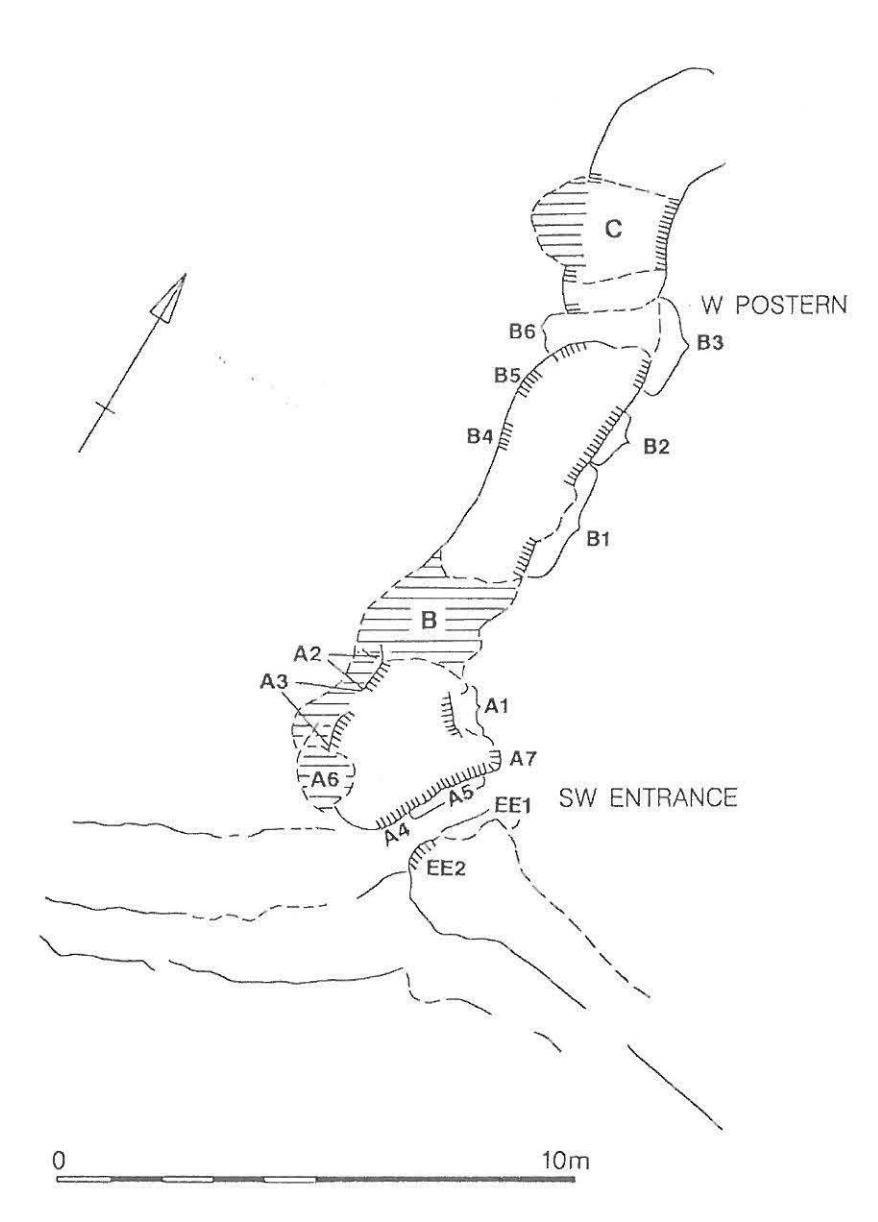
Fig.7. Wall EE-D, showing areas conserved during the 1992 season (Plan, S.D.Boyle, 1992)

The outer face had collapsed completely for 3.5m at the north of C (Plates 20 and 21). 0.5m of facing remained to the south of this standing to a maximum height of 0.8m (Plate 22). This was built from small stones and was only marginally stable. The upstanding masonry was numbered. The rubble at the north of the collapse was cleared revealing large amounts of loose core which tended to fall forwards over the cleared area. The core was pinned giving a degree of stability, and the clearance completed. Part of the facing at the south collapsed during clearance, it had presumably been supported by the tumbled masonry. This revealed the lower courses which were tipped forwards at an angle of about 30° (Plate 23), presumably caused by a movement or settling of the scree. In view of its weak construction of small stones it seems unlikely that the face standing above this could have survived such a major upheaval. It is therefore conceivable that this length of facing was a later, possibly modern, rebuild. It was decided to dismantle this face as it was extremely fragile and as the lower courses needed to be reset. The line of the wall was recorded and all the marked stones removed.

There was a 2.8m long dip in the inner face here (Plate 28), the wall falling from 1.0m at the north to 0.4m at the centre of the collapse and stepping back up to 1.0m at the south. There were a number of slabs lying at the base of the wall and behind the facing. All *in situ* masonry was stable and the loose stones were set on top of this, thus grading the step at the south for greater stability (Plate 29).

3.6m of facing had been lost (Plate 24), the tipped forward lower courses gave a good indication of the wall line at the south. It seems safe to assume that the face ran in a straight line between this and the surviving wall to the north. There appeared to be little virtue in trying to reset the numbered stones as they were too small and probably not original. The collapse was rebuilt to a height of 1m to retain the core and discourage visitors from climbing over the wall (Plates 25-27).

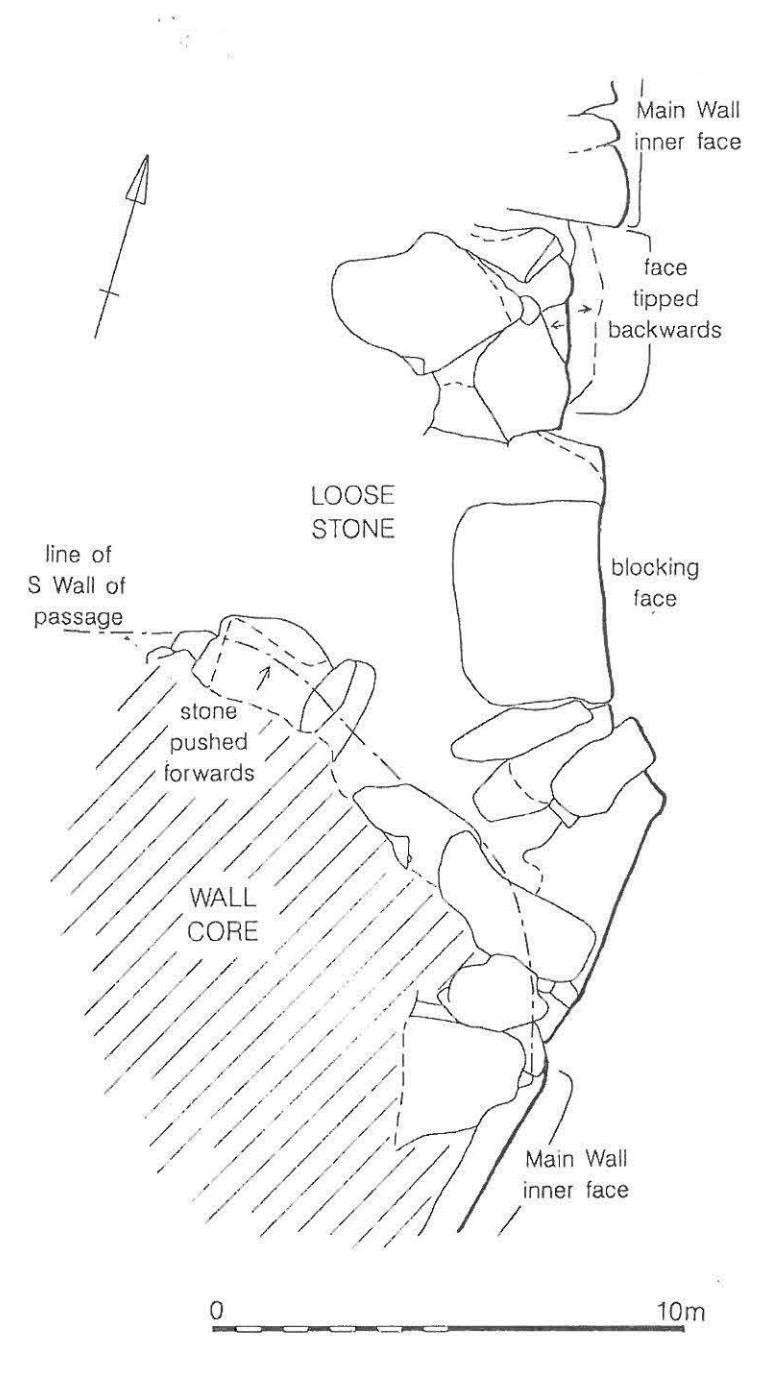
Fig.8. West postern, after clearance.

The outer face (Collapse B6) curved inwards to a 0.8m wide, rubble choked, entrance (Plate 30). The face was stable and stood to a height of 1.0m. The passage running through the wall contained some rubble which had apparently fallen from the sides (Plate 31). No facing was visible at this point. The inner end of the passage was less well defined (Plate 32) being a 3.2m long dip in the inner face (collapse B3). The face falls from a ragged 0.6m at the south to 0.2m near the north end of the collapse. At this point the face steps up to 1.0m, possibly defining the north side of the entrance. The low facing was partially obscured with loose stone.

When the tumbled masonry was removed from the outer end of the passage a rough face constructed from large blocks of stone, up to 0.4m long, was revealed (Plate 33). This was blocking the entrance and clearly abutted the south side. No clear relationship could be seen on the north side as the incurving outer face appeared to be partially collapsed.

The loose stone was cleared from the inner face revealing two courses of uncharacteristically rectangular blocks, up to 0.8m long, running across the northernmost 2m of the entrance (Plate 34). One of these blocks had tipped backwards, apparently into a large void in the scree beneath the wall . The main inner face could be traced, curving inwards behind the blocking face to form the south wall of the passage (Fig. 8 and Plate 35). The northern wall could not be traced, it may have been lost as a result of the scree movement seen in this area. The line of the passage was clear however as it contained few small stones characteristic of the wall core (Plate 31). The postern had obviously been blocked at both ends without infilling the passage. It was therefore decided to build up the outer blocking face to the height of the rest of the wall thus discouraging access at this point (Plate 37). The inner face was stable but very low. Several abortive attempts were made at adding masonry to this, it was felt however that this was masking the entrance and adding little to the stability of the wall. The face at the south of the collapse was stabilised by placing heavy slabs on the wall top. Several small stones were added to the rest to support potentially fragile masonry but no height was added to the wall (Plate 38).

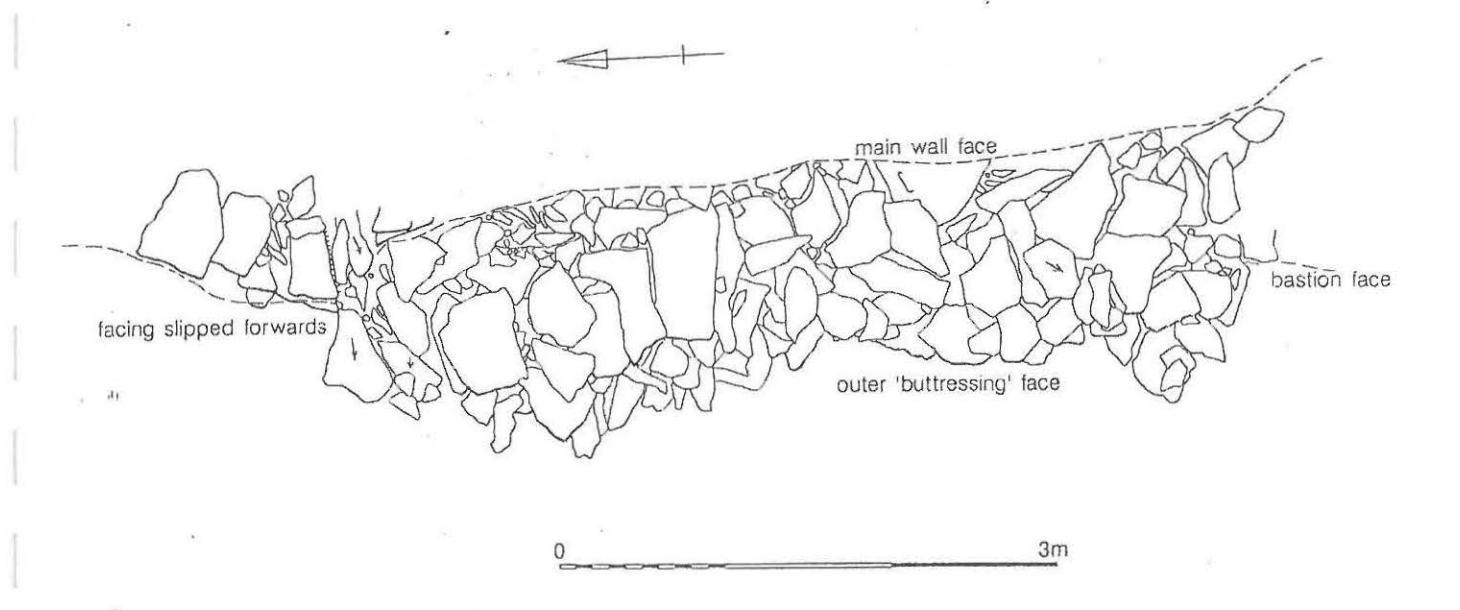
Fig. 9. Collapse B, outer face, after clearance.

The damage caused by the footpath running over the rampart was most evident at this point (Plate 62). Dallimore recorded the collapse as being 2.0m wide in 1978, at the beginning of this

seasons work it was 5.0m wide. At the north end of the collapse 1.2m of the face is still standing to a maximum height of 1.4m. This stretch of facing deviates 28° to the west from the line of the wall and is bounded to the north by an apparent straight joint (Plate 63). A few tumbled stones were removed from the base of the wall revealing the lower courses. It could now be seen that several large slabs near the base of the wall had slipped forwards by at least 0.3m taking the whole of this length of facing with them (Plate 64). The lower 0.3m appeared to be stable with loose recently disturbed masonry above it. There was no visible surviving facing for the next 2.5m, the erosion around the footpath had reduced this area to a featureless rubble slope with stone spilling downhill for several metres (Plate 65). Beyond this was a 1.0m length of very unstable and ragged facing running towards and apparently in front of the bastion (Collapse A2, Plates 66 and 62). The facing seemed to be built on loose scree and the most southerly portion was beginning to slide downhill. Unfortunately between initial recording in June and conservation in August this length of facing had further collapsed making it difficult to trace. The loose rubble was carefully cleared from the collapse but no lower courses were found.

The innermost face was 1.0 to 1.2m high and was stable. This face appeared to be uniformly weathered, all the stones were rounded with no sharp edges (Plate 70). it was similar in appearance to the outer face standing elsewhere on the fort although having been buried it lacks the covering of grey crustose lichen that grows on every undisturbed stone on Tre'r Ceiri. At the south the face runs behind the bastion (Plate 71). A small void between the bastion and the buried face was revealed when loose stone was cleared from the wall top making it possible to trace the face within the wall, running from north to south, for some 1.8m (Plate 72). It then turns 90° to the east where it could be traced for a further 3.5m. The void was between 0.05 and 0.2m wide at the top and continued down into the wall in front of the face for up to 1.3m. It was therefore obvious that the bastion was a separate construction that had been butted against the wall. As the bastion was semi-collapsed the core had shifted somewhat forming a void along the abutment.

The face that had been uncovered in front of this was less well defined. It stood to a height of 0.75m at the north falling to 0.5m at the south and was very roughly built from a mixture of large slabs and headers and smaller irregular stones (Plate 73). This could be traced for a length of 6m, running 1m south of and parallel to the innermost face described above. The line of the facing could not be established with any certainty at the south. Its relationship to the slipped forward face to the south and the bastion to the north could not be established due to its ruinous condition. It seems unlikely that this face stood to any great height due to its poor quality of building. The most probable function of this masonry seems to be as a buttress, stabilising the scree at the base of the wall. Similar features can be seen to the south-east of the south-west entrance and in the scree to the north of the fort. however as the morphology and extent of this feature could not be clearly defined any interpretation must be conjectural. In view of its inherent instability any consolidation work would entail almost total destruction so the area was planned (Fig. 9) and photographed and the face carefully reburied.

The relationship between the innermost face and the facing to the north of it was somewhat problematic. the slipped forward facing was standing 0.3m in front of the line of the buried face. The buried face however ended in an area of collapse and clearly did not run behind the slipped forward face (Plate 74). If the basal course of the slipped forward facing is plotted in relation to the rest of the wall the face is nearly continuous albeit with a pronounced bulge at the point of collapse. It was thus decided to rebuild this area as a continuous face. The stable but off line masonry to the north was marked (Plate 63) and the recently disturbed stones above it cleared. Stone H was loose and so was pushed back flush with the rest of the face and the collapsed stone was removed from the gap between the two lengths of facing. During this clearance several voids were revealed where the facing had slipped forward and become detached from the core. These were packed and the collapse was rebuilt, connecting the two lengths of facing (Plate 75).

The rest of the newly exposed face was in good condition. Two stones were loose and were marked A and B (Plate 76). A was pushed back 0.2m and B was removed and reset. Standing above the extant face was about 0.3m of loose displaced core and stones from the wall top (Plate 77). This was cleared and several courses were added to the wall in order to retain the core (Plates 78 and 63). This added a maximum of 0.6m to the height of the face.
