# TRE'R CEIRI IRON AGE HILLFORT MANAGEMENT PLAN

Ymddiriedolaeth Archaeolegol Gwynedd Gwynedd Archaeological Trust Ffordd y Garth, Bangor, Gwynedd

by D. Hopewell with appendix by G. Smith

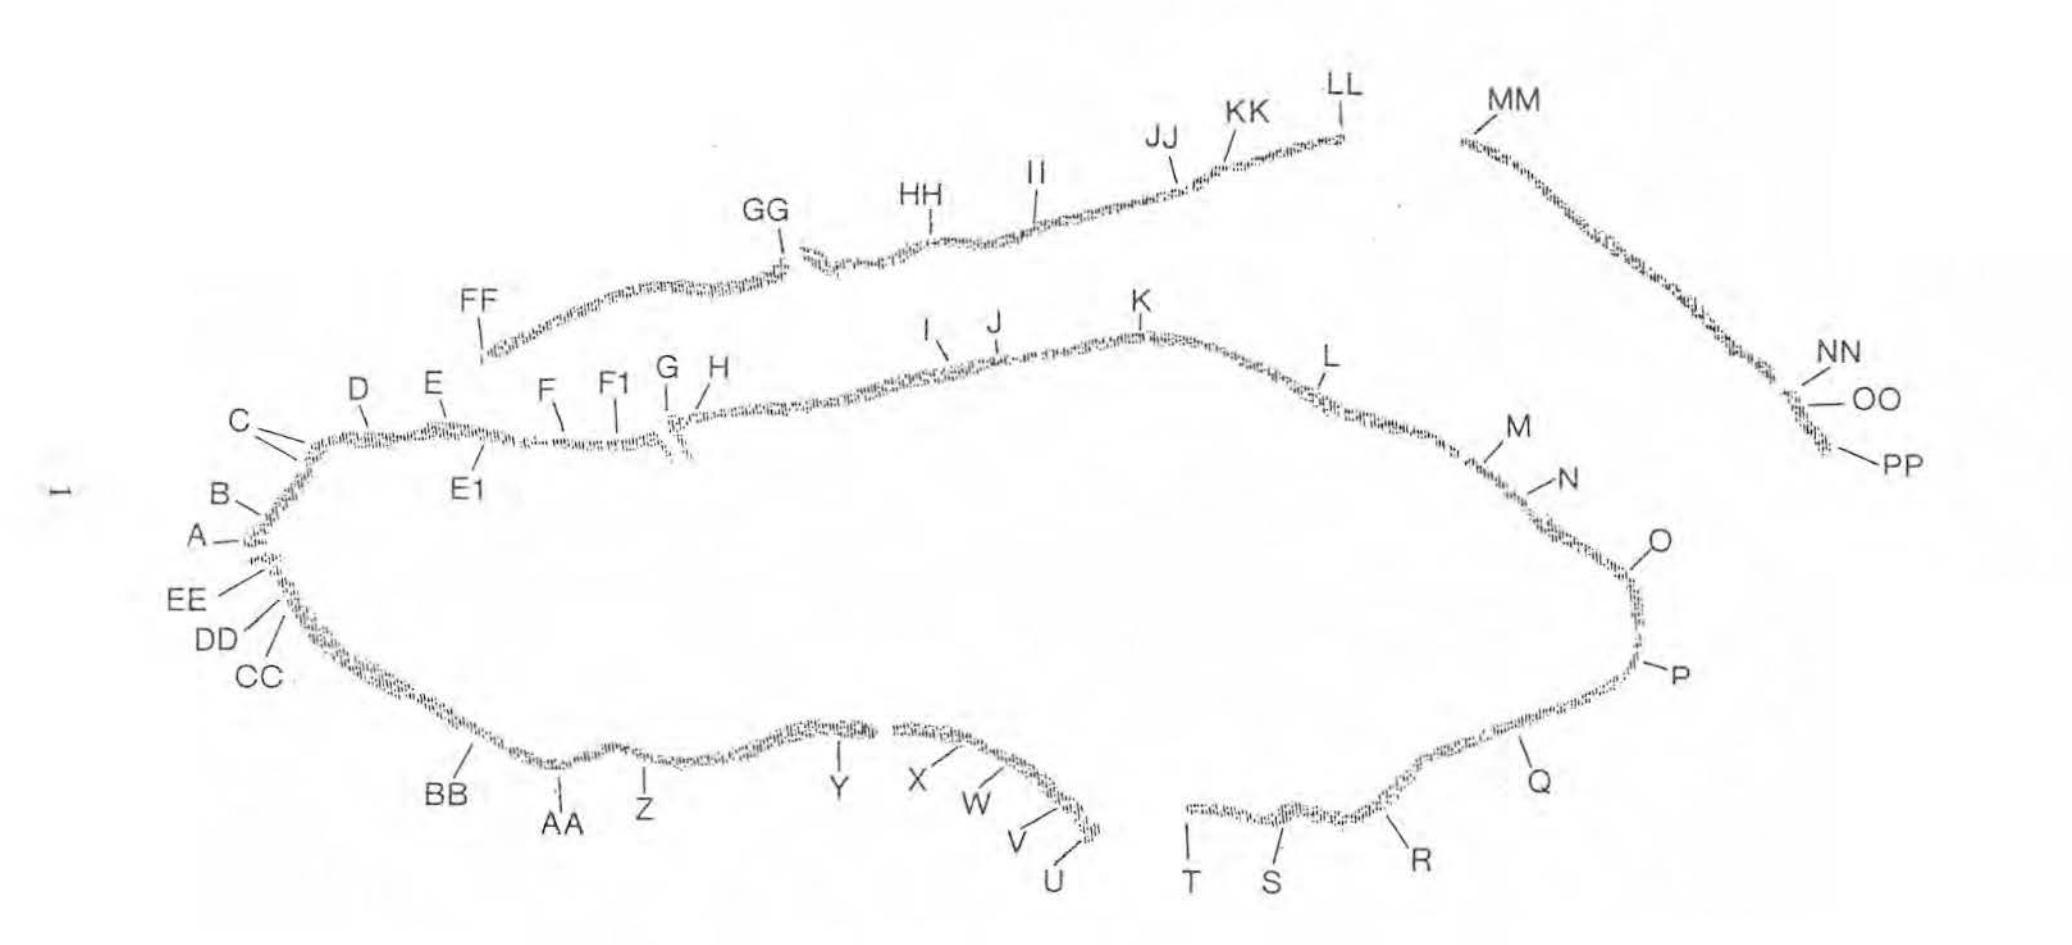
Fig. 1 The Ramparts: points of collapse (after Dallimore 1978).

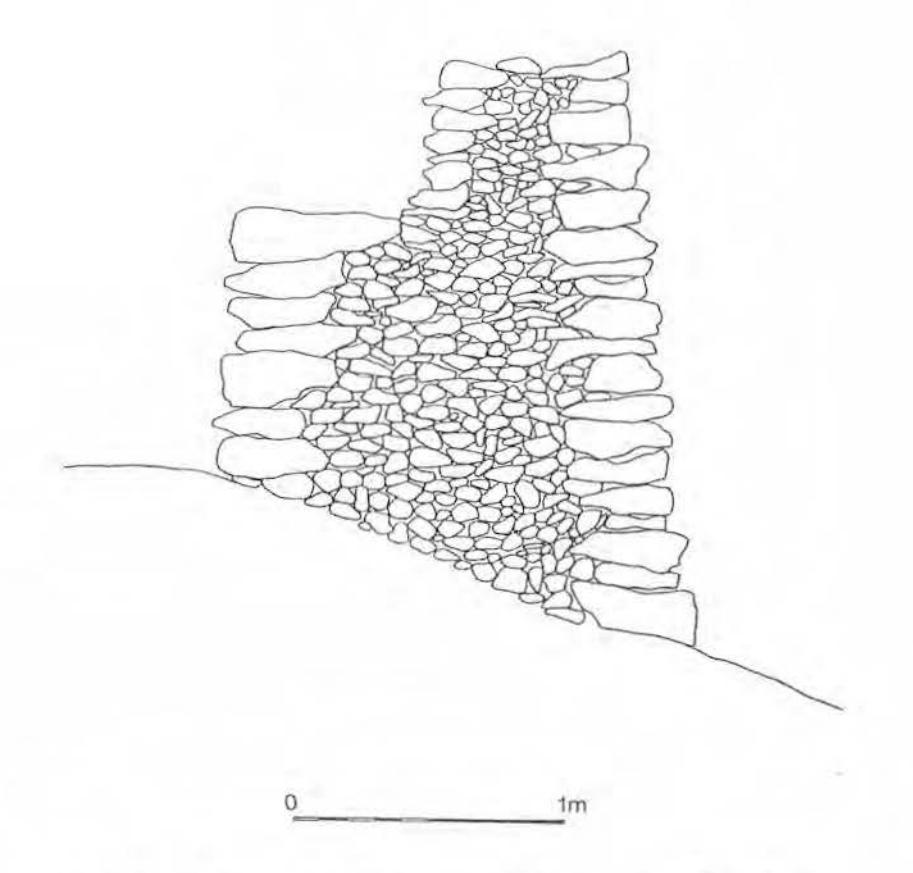
Fig. 3 Sketch section through the ramparts at the north of Tre'r Ceiri

The ramparts are faced with long stones running into the wall, known as headers, and filled with a core of loose stones (see fig. 3). The masonry is not coursed and forms a very uneven face. This is in contrast with modern dry-stone walls, which use a combination of headers and stretchers (stones placed with their length in the direction of the wall), coursed to form a flat face. The masons have therefore had to modify and refine their techniques over the five years of the project, initially taking great care over the selection and placement of stones in an attempt to mimic the original style. This sometimes resulted in a face that was a little too even, although excellent results were often produced - collapse K, for example. The style of the Iron Age builders seems to have relied less on careful stone selection (the stones do not fit together in a regular fashion as in modern masonry), resulting in a very uneven face containing many small voids. The masons have now modified their technique, selecting stones less carefully, while still making sure that the headers lock together, the weight of the stone providing much of the stability of the face. The placement of the core is very important: facing within the core at the south-west entrance bastion suggests that the stone was not just thrown in but carefully placed. The masons have now developed a technique of packing the core very carefully behind the headers, providing greater stability to the rather uneven facing.

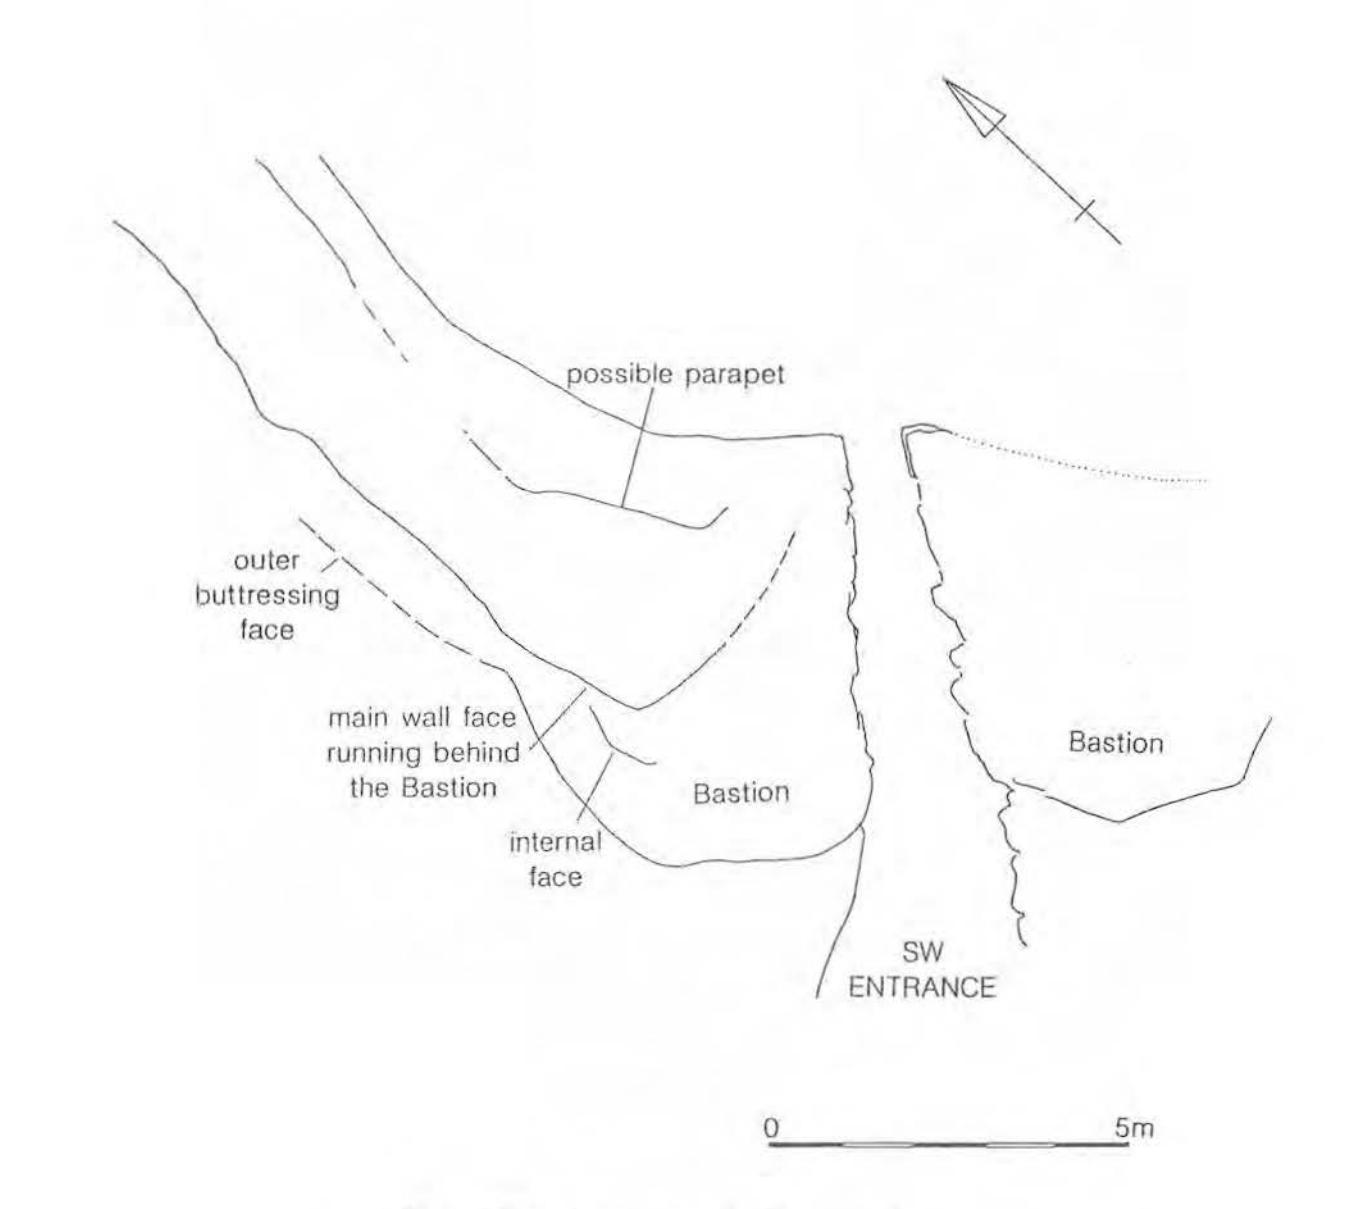
# 1. The south-west entrance (fig. 4)

Fig. 4 The south-west entrance after conservation.

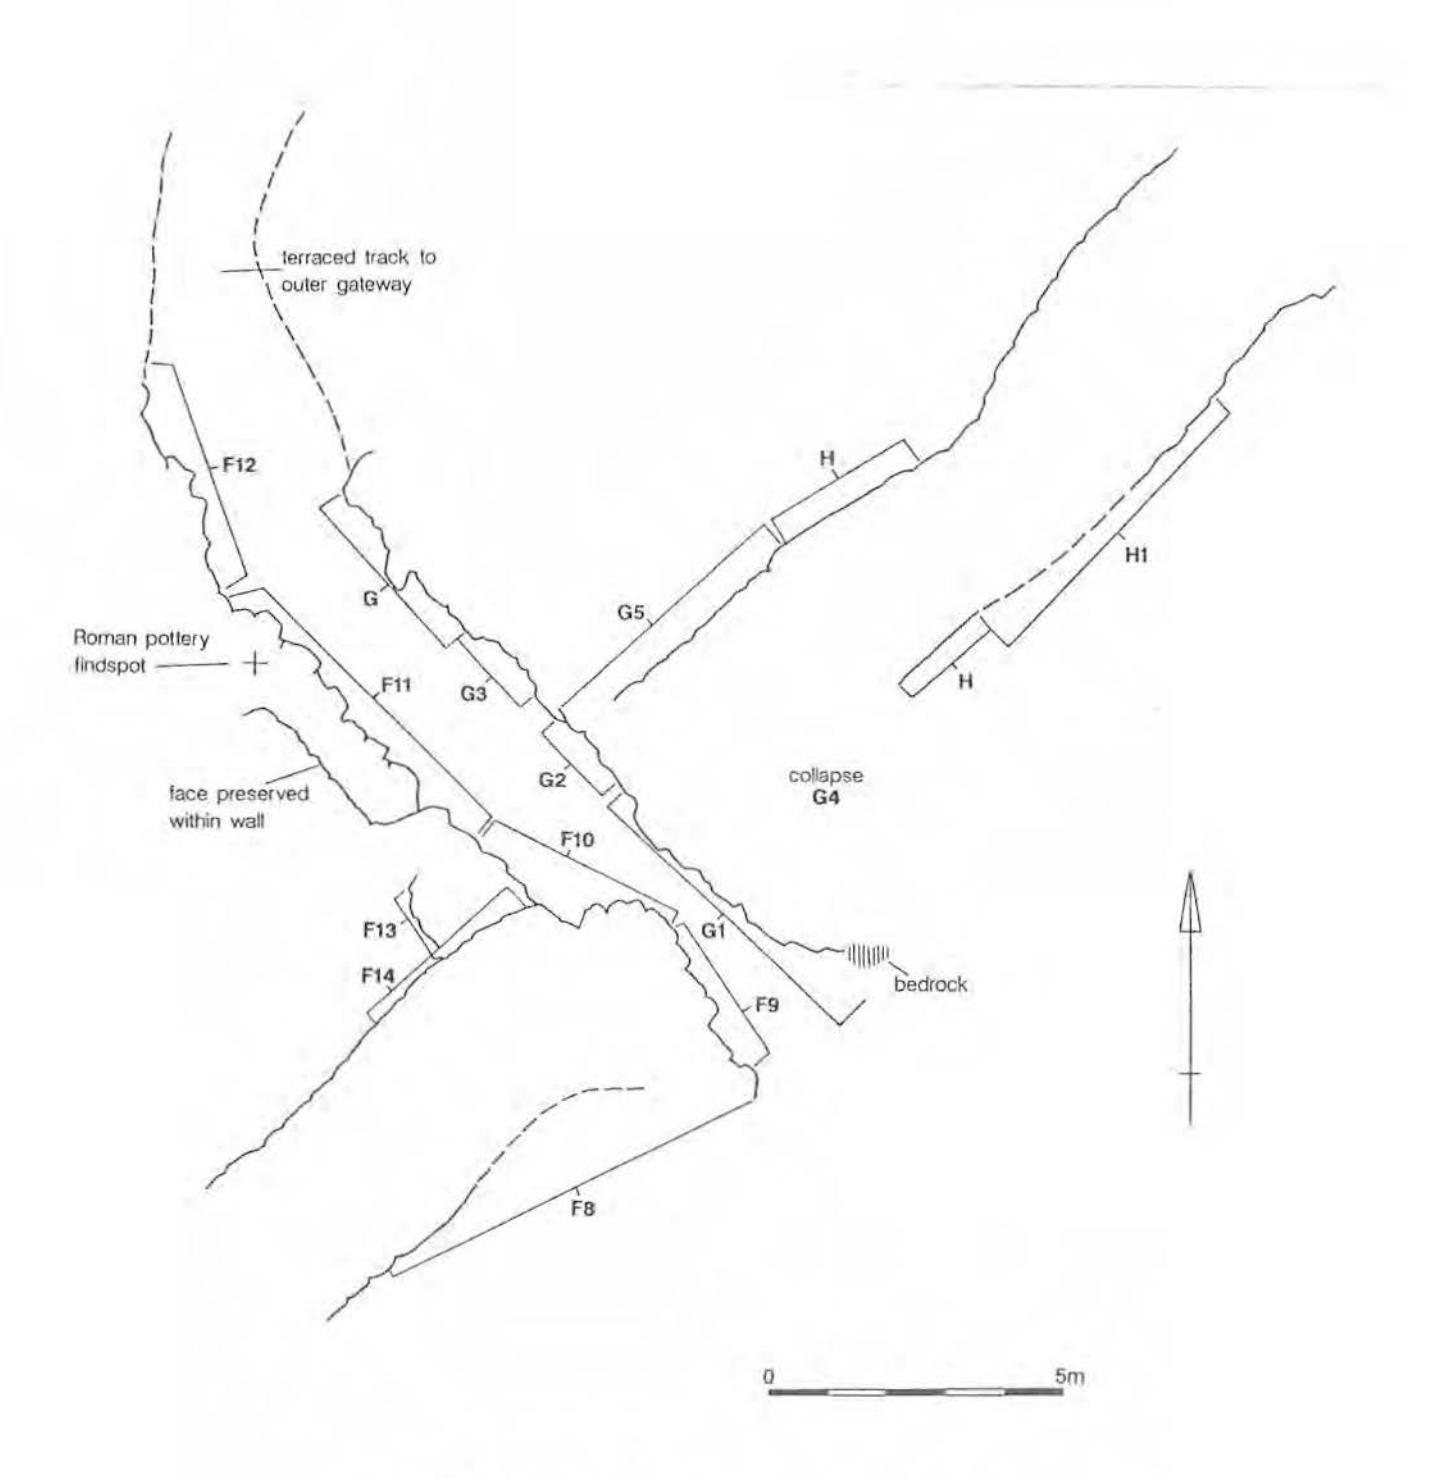
# 3. The north-west entrance (fig. 5)

Fig. 5 The north-west entrance after conservation.
