Report on the Third Season of the Tre'r Ceiri Conservation Project May to October 1991

Part 1: Text

S. D. Boyle

Ymddiriedolaeth Archaeolegol Gwynedd Gwynedd Archaeological Trust

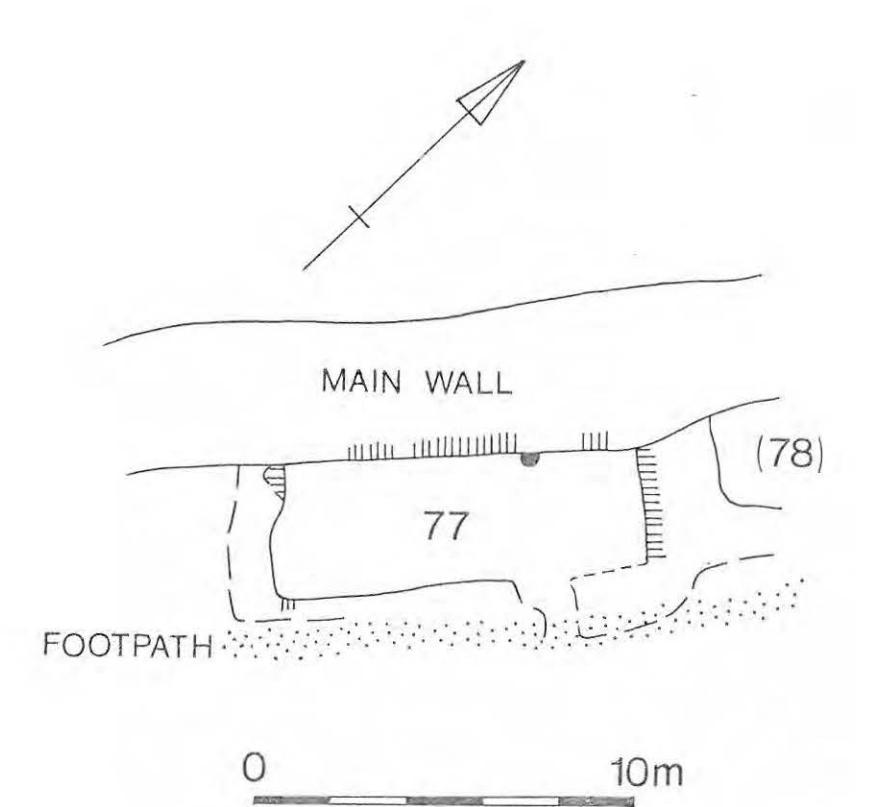
Fig 3. Hut 77 after 1980 Plowman Craven plan, with modifications.

The south-west wall stood up to 1.0m high and was generally in good condition (Plate 2), although there was a hole at the west corner, dug 0.4m below ground level. This hole exposed the facing of the fort wall, demonstrating that the hut had been built against it. The north-west wall was also up to 1 metre high, although it dipped to about 0.7m halfway along (Plate 3). Towards the north corner was a short stretch of loose, slumped walling (Plate 4), and against the base of the wall was a recently dug hole 0.4m in diameter and 0.4m deep.

The north-east wall of the hut was much collapsed, and only a short stretch of facing survived (behind and to the left of the right hand scale in Plate 5), while the south-east wall was mostly grassed over except at the south corner, where there was a short stretch of facing up to 1 metre high. A stone lying in front of this had clearly fallen from the wall face (Plate 6). At the entrance the wall was reduced to footings, but the line indicated on Fig 3 was fairly clear. A footpath ran along the outer edge of this wall.

The hatching on Fig 3 indicates the stretches conserved. The two holes in the hut floor were filled in, and the hole in the southeast wall was plugged with the fallen stone. Some work was necessary on the north-east wall to prevent further slippage, but this was limited to stabilising the remains by inserting a few

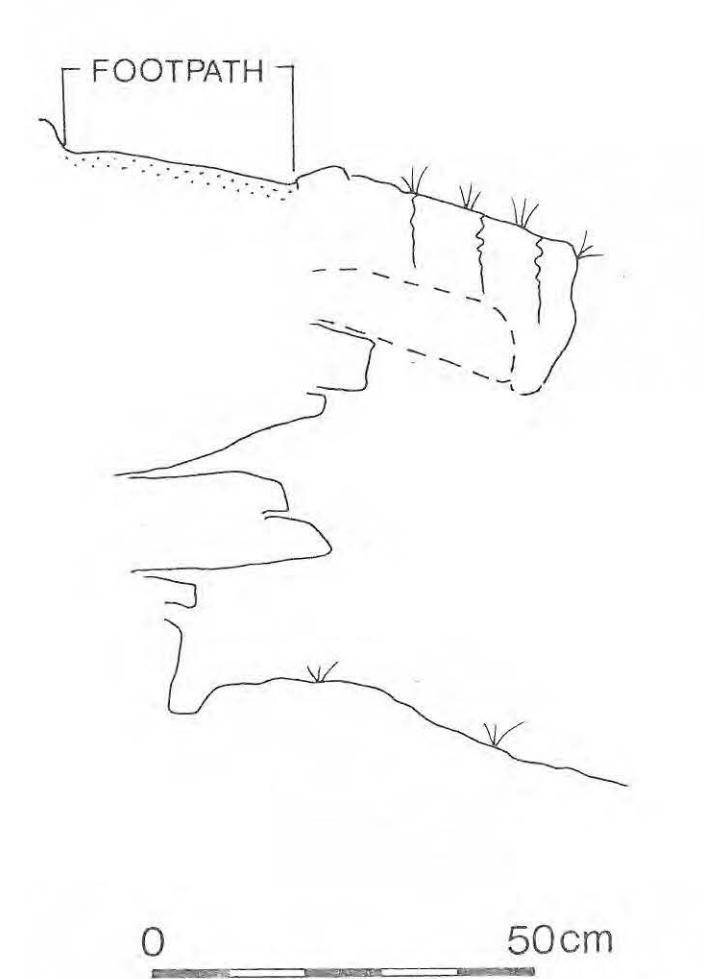
Fig 6. Hut 112A. Profile of south wall.

The most interesting feature of this hut is at the south-west corner (Plate 17). Here the south wall stands about 0.8m high, and the upper courses overhang the lower in what appears to be the remains of corbelling. In Fig 6 the uppermost stone had fallen (dotted line), but matted roots still preserved a shape into which a stone lying at the base of the wall fitted neatly. This stone is likely to have been squeezed forward by pressure from the footpath above and so the void it left may not indicate its original position, but the stones below it all lay either horizontally or tipped back away from the face, and all were fairly secure, so that it appeared unlikely that there had been significant movement of the face here. The remains appear to suggest corbelling - the clearest indication of such a building

This hut was not scheduled for consolidation in 1991, and as it is not adjacent to the main wall it is excluded from the current Scheduled Monument Consent. However, there was a real danger that pressure from the footpath immediately above the overhang would cause futher damage, and so as an emergency measure a pier of flat slabs was constructed beneath the most vulnerable point to provide support until proper consolidation works are undertaken. No attempt was made to build this in the style of the original, and it now obscures the overhang, but it will not be difficult to dismantle it without damaging the original work when this hut is consolidated.

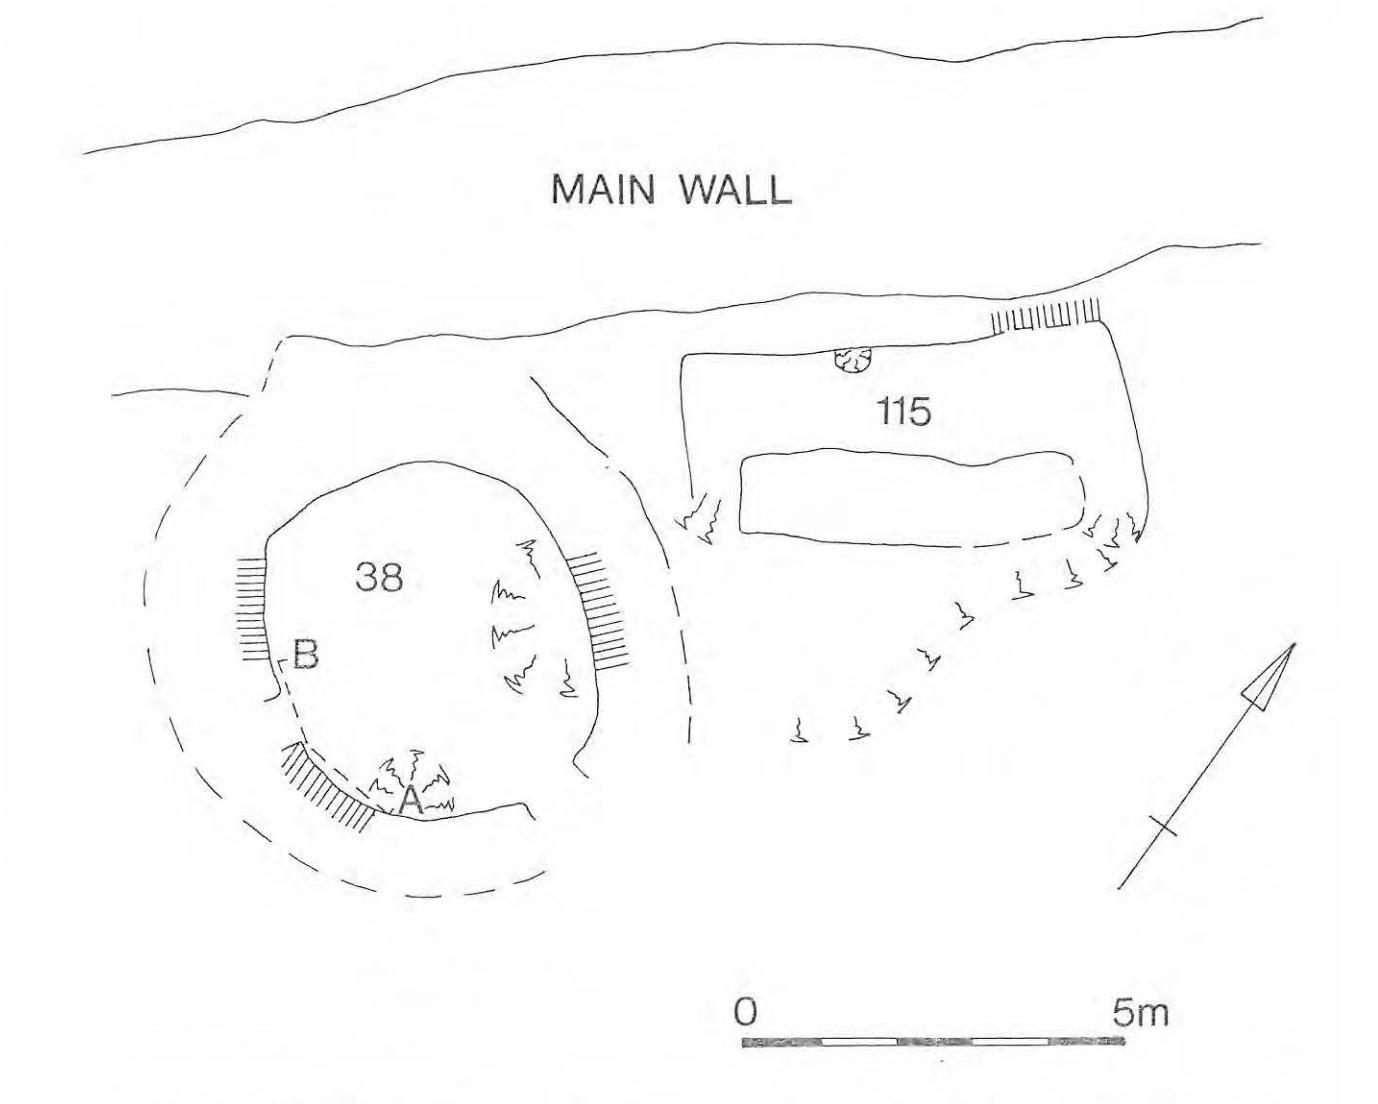
Fig 8. Huts 38 & 115. Amended version of 1980 Plowman Craven survey.

Fig 8, which shows the hut before conservation, is based on the 1980 Plowman Craven plan, amended during 1991. The hut was well defined, almost circular with a diameter of about 4.2m within walls 1.0m - 1.5m thick (Plate 26). The inner face of the wall stood to about 1.2m, although it was only 0.9m high on the southwest. Only on the north and north-east did any built outer face survive, and here it was no more than three courses high (Plate 27).

Apart from securing the uppermost stones of the inner face, repairs were necessary in four places: on the south, where the wall had collapsed into the hut; on the south-west, where the upper half of the wall was loose; on the north-east, where the upper courses had been lost; and at the 'entrance' on the east, which was choked with loose masonry. There were also two large holes in the hut floor, one on the north-east and one on the south-east, both against the wall. The north-east wall was tackled first. At the base of the wall was a large hole 2m x 1m and 0.6m deep. This extended 0.4m beneath the hut wall, and only one long slab prevented the collapse of the entire wall (Plate 28). Loose masonry in the void was cleared away and the void was packed with large stones. The hole in the hut floor was filled in with stones lying on the hut floor and 'spare' stones left over from repairs to other parts of the hut. The dip in the wall top above this hole, 1.3m wide, was filled with seven large slabs. One unstable stone (marked 'R' on Plate 28) was removed as it could not be properly secured.

To the west of this dip, as far round as the west 'corner' only minor works were needed. Large stones were used to secure the top of the wall, and one small void just below the wall top was filled. This work occasionally involved the removal of small loose stones.

Rather more work was needed on the south-west side of the hut, where, for about 1.4m, the loose upper courses had begun to slip out of position (Plate 29). Five large stones were reset, and a further three stones were added. The five stones which were relaid are marked on Plate 29 (A - E), although as they were already displaced the stones themselves were not marked before work began. Plate 30 (to the right of the scale) shows this stretch of wall after conservation.

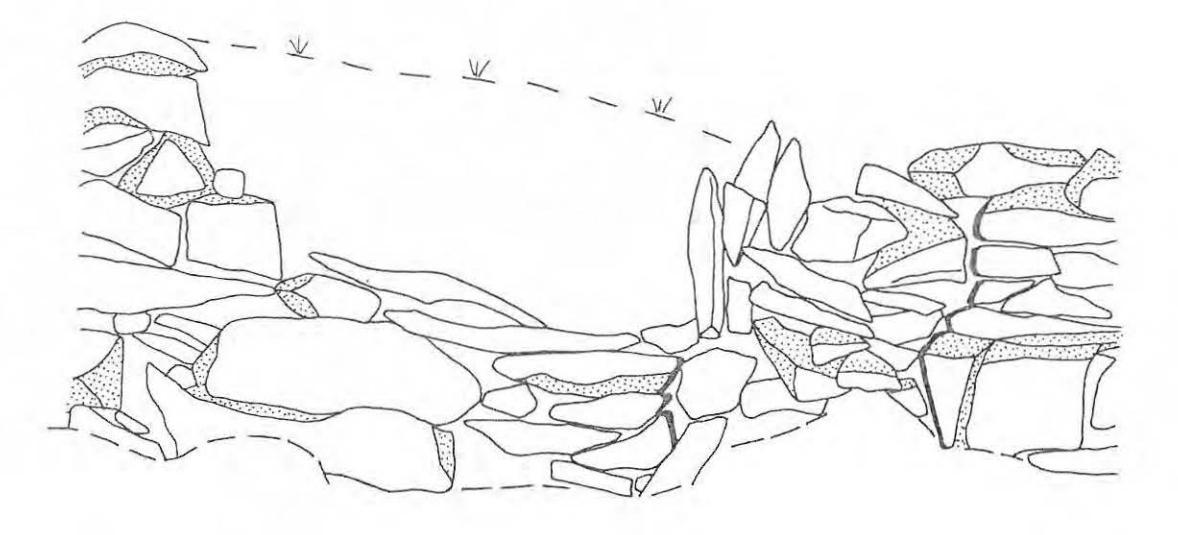
Fig 9. Hut 38: elevation of blocked south-west doorway, after clearance of collapsed rubble.

Beneath the rubble about 0.5m of the wall face survived, but more interesting was the discovery that there had been an entrance to the hut at this point (Plate 32 and Fig 9). This would appear to have been a more suitable position for a doorway than the east side of the hut, where the steeply rising ground outside the entrance identified by earlier surveyors would have caused problems with drainage. However, this south doorway had been blocked with large headers, some of them set on edge and wedged in place with what would appear to be a certain amount of care (Plate 33). Therefore, if this was the original entrance, it was certainly blocked before the hut was finally abandoned.

In rebuilding the wall most numbered stones were replaced approximately in their original positions. Between these stones and the entrance some 0.3m of facing was added so that the wall top graded down towards the edge of the doorway. 'Leftover' stones were than spread in front of the wall to bring ground level up to that across most of the rest of the hut (Plate 30). From the east edge of the doorway this repair measured 1.4m wide.

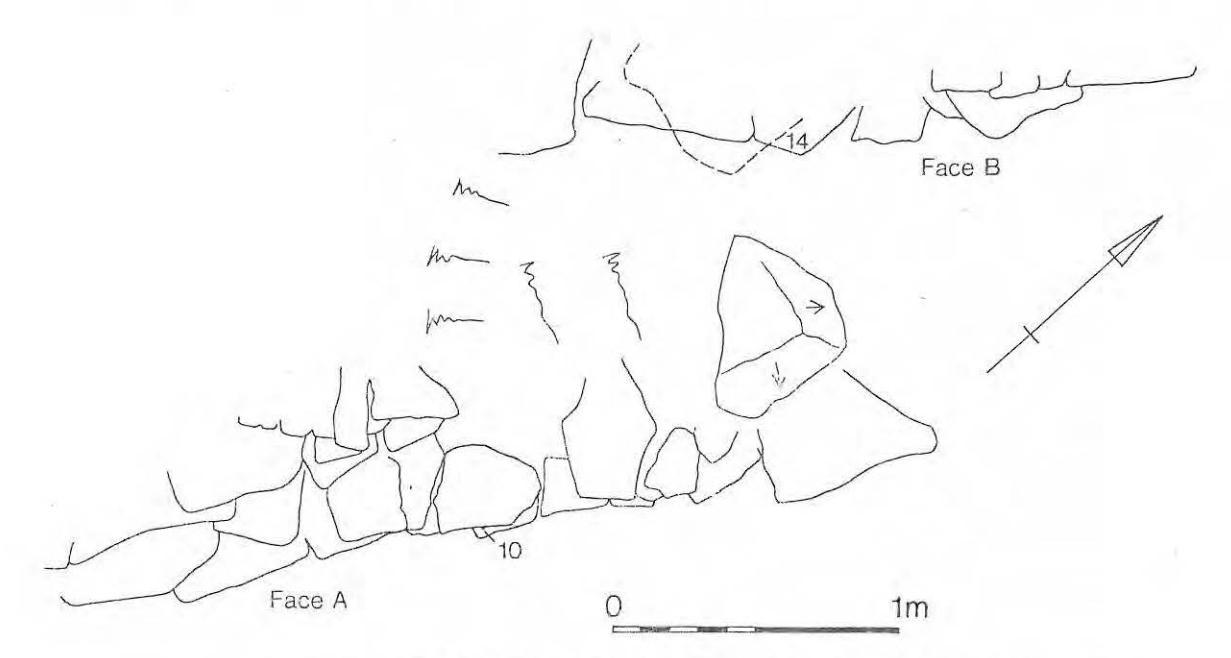
Fig 10. Collapse H5 after removal of tumbled masonry.

Before conservation this feature was still well defined, although much of the surviving masonry was unstable. As it provided easy access to the wall top it was used frequently by visitors, with the result that stones from the top of the wall had spilled down the surface of the ramp, and the wall faces on either side were loose and in danger of collapse. It was clear that some dismantling would be necessary, so all loose masonry was first marked (Plates 43 & 44).

During removal of the collapsed material, a watch was kept for any evidence that the two wall faces turned to meet each other, but no sign of such a turn emerged. Instead it appeared that the overlap extended further in both directions. Fig 10 shows H5 after clearance. Before conservation the face running up from the south-west (Face A) could be traced as far as Stone 10, but once the loose was removed, facing stones could be followed for another metre. The other face (Face B) had been visible up to stone 14, but during clearance large boulders were uncovered continuing its line for almost a metre before disappearing into the wall core (Plates 45 & 46).

The exact form of the original ramp must be to some extent a matter of conjecture, and two attempts were made at rebuilding it before a satisfactory effect was achieved. Plate 47 shows the second rebuild. At the end of Face A the wall was dismantled to the line shown on Plate 43. All but two of the marked stones were replaced close to their original positions: Stones A and B had no 'length', and were of such awkward shapes that they could not be reset securely. Other large headers were then used to grade this wall face down to ground level. The total width of the repaired stretch was 2.3m, its height dropping from 1.2m at the south-west end (0.5m being 'new') to 0.3m at the north-east (original work no higher than ground level).

Rather less work was needed on the south-west end of Face B, where, apart from already tumbled material, only Stones K and L (Plate 44) were removed. It has been noted above that during clearance this face was found to continue into the wall core. The surviving courses of this continuation were stable and provided a firm base for rebuilding. At the north-east end of the collapse the wall face was built up to 1.05m high, the height being graded down towards the south-west to the level of the top of the wall core. Between 0.35m and 0.55m of facing was added here.

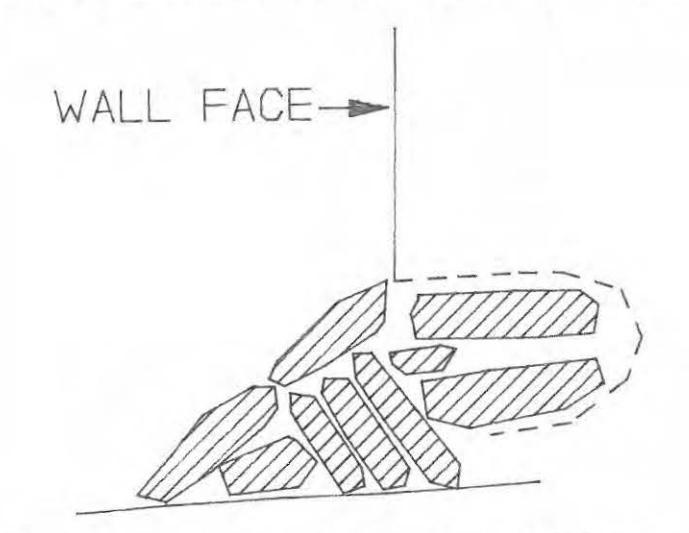
Fig 11. Diagram showing buttressing technique, Void H12.

Beneath the north-east edge of H8 was a small void at the base of the wall, around which loose masonry was in need of support (Plate 52). Stones were inserted into the void and pinned by placing large stones against them, angled down towards the wall base (see Fig 11). The work was then covered with large looselyplaced stones, forming a 'buttress' 0.6m high, 0.9m wide and extending up to 1.0m from the wall face (Plate 53).

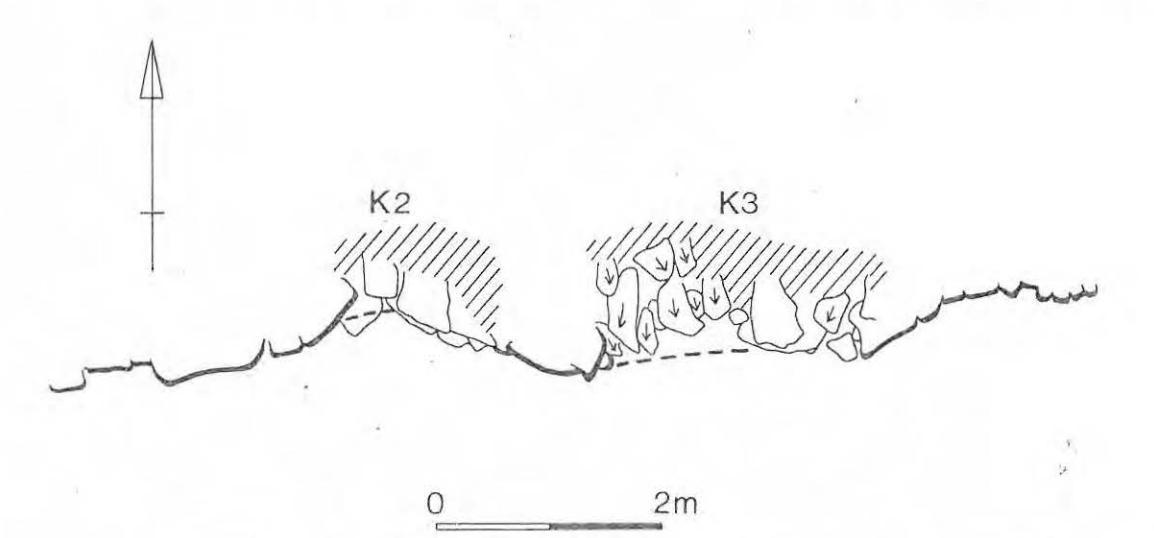
Fig 14. Collapse K2 and Collapse K3, after removal of tumble.

Immediately east of K2 was another stretch, 2.5m wide, where the inner face had collapsed (Plate 111). Stones had spilled forwards from the wall top, and a surviving stretch of parapet immediately above the collapse was at risk. At the east edge the upper courses of the standing wall had slumped backwards towards the core. Some of these were clearly unstable, and so before work began they, and the stones around them, were numbered.

The tumbled stones were cleared away, showing that of the basal courses only three stones survived: one set on edge, one large block and a long header on top of this, all at the east edge of the collapse (Plate 112 and Fig 14). To the west of these were a number of long headers, all angled sharply downwards and lying on loose core material. These may have been slumped facing stones, but it is also possible that they formed part of the original core.

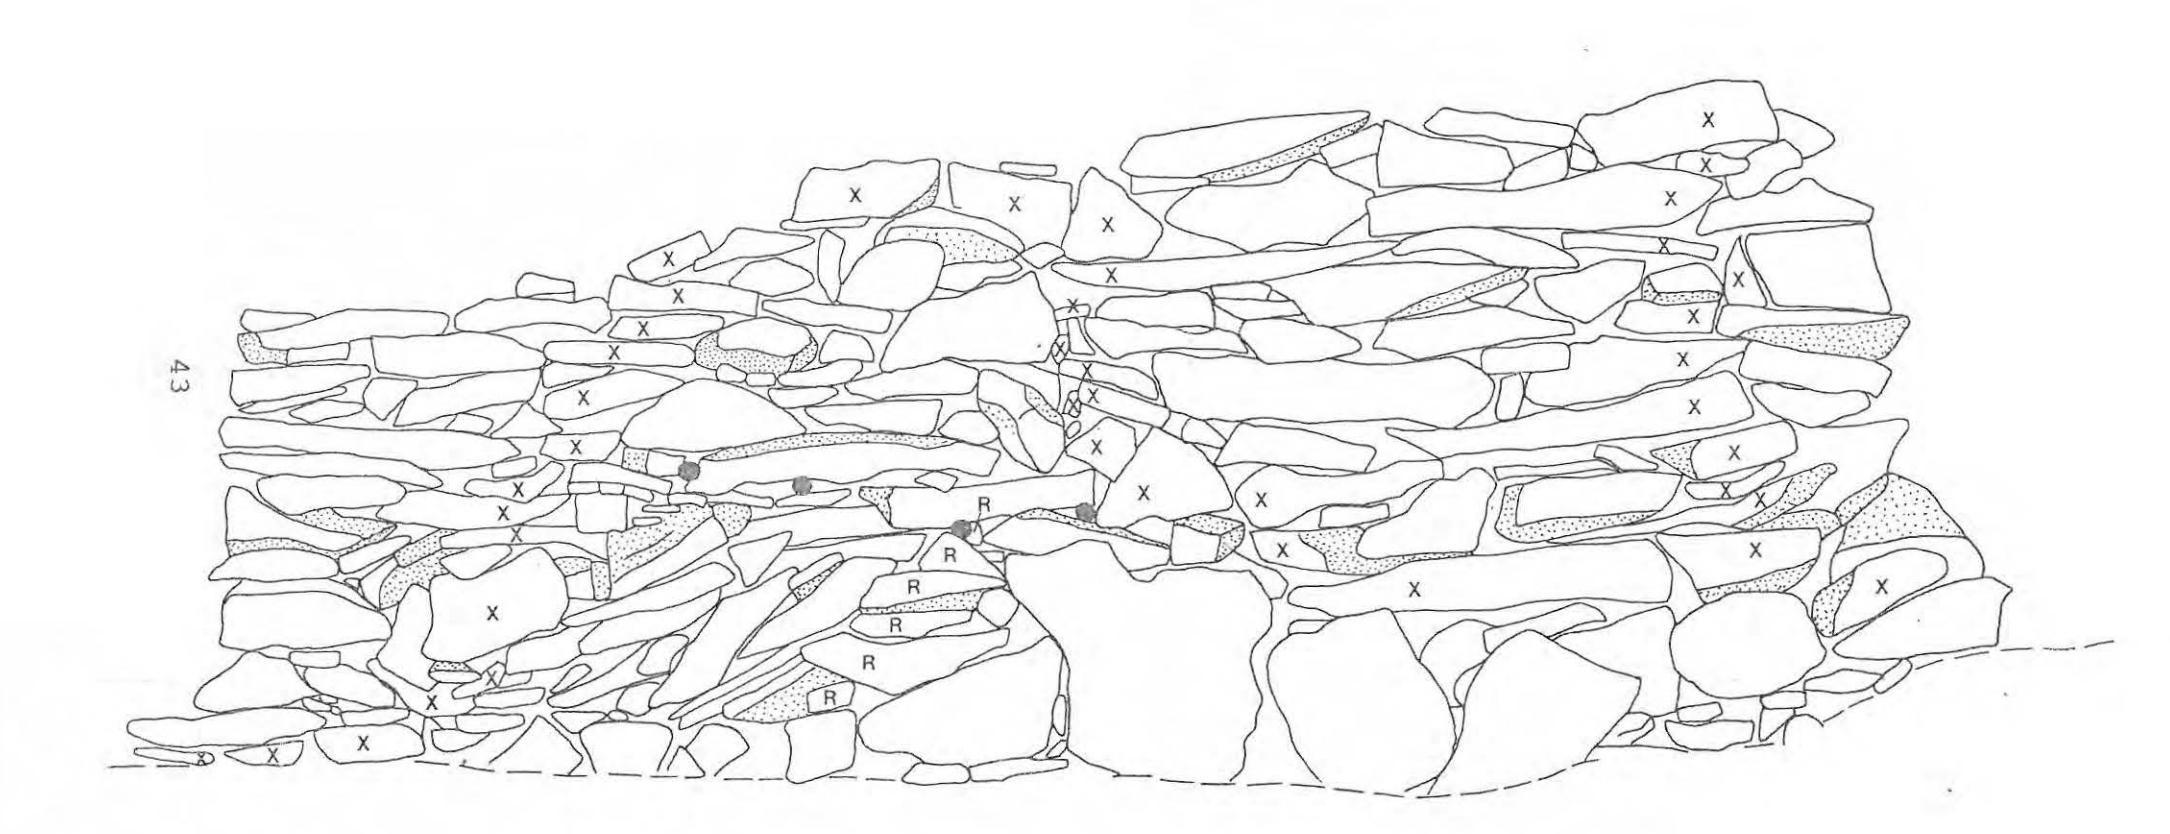
Fig 15. North postern. Elevation of east wall of passageway.

Stones marked 'R' on Fig 15 were then pulled out, leaving a void 0.4m deep, 0.5m high and about 0.5m wide. Before work began it had been intended that some of the wall core would be removed to accommodate long pinning stones, but the core turned out to be well packed and secure: indeed it was probably doing much of the work of holding the wall up.

Three large stones were used to fill the void, with some small rubble used as packing. These were carefully selected from the scree outside the fort wall to provide the best possible fit, although one had to be trimmed slightly. The result is illustrated on Plate 141.
