REPORT ON THE FIFTH SEASON OF THE TRE'R CEIRI CONSERVATION PROJECT APRIL TO SEPTEMBER 1993

prepared for Cyngor Dosbarth Dwyfor by D. Hopewell illustrations by H.F. Riley April 1994

Gwynedd Archaeological Report No. 98

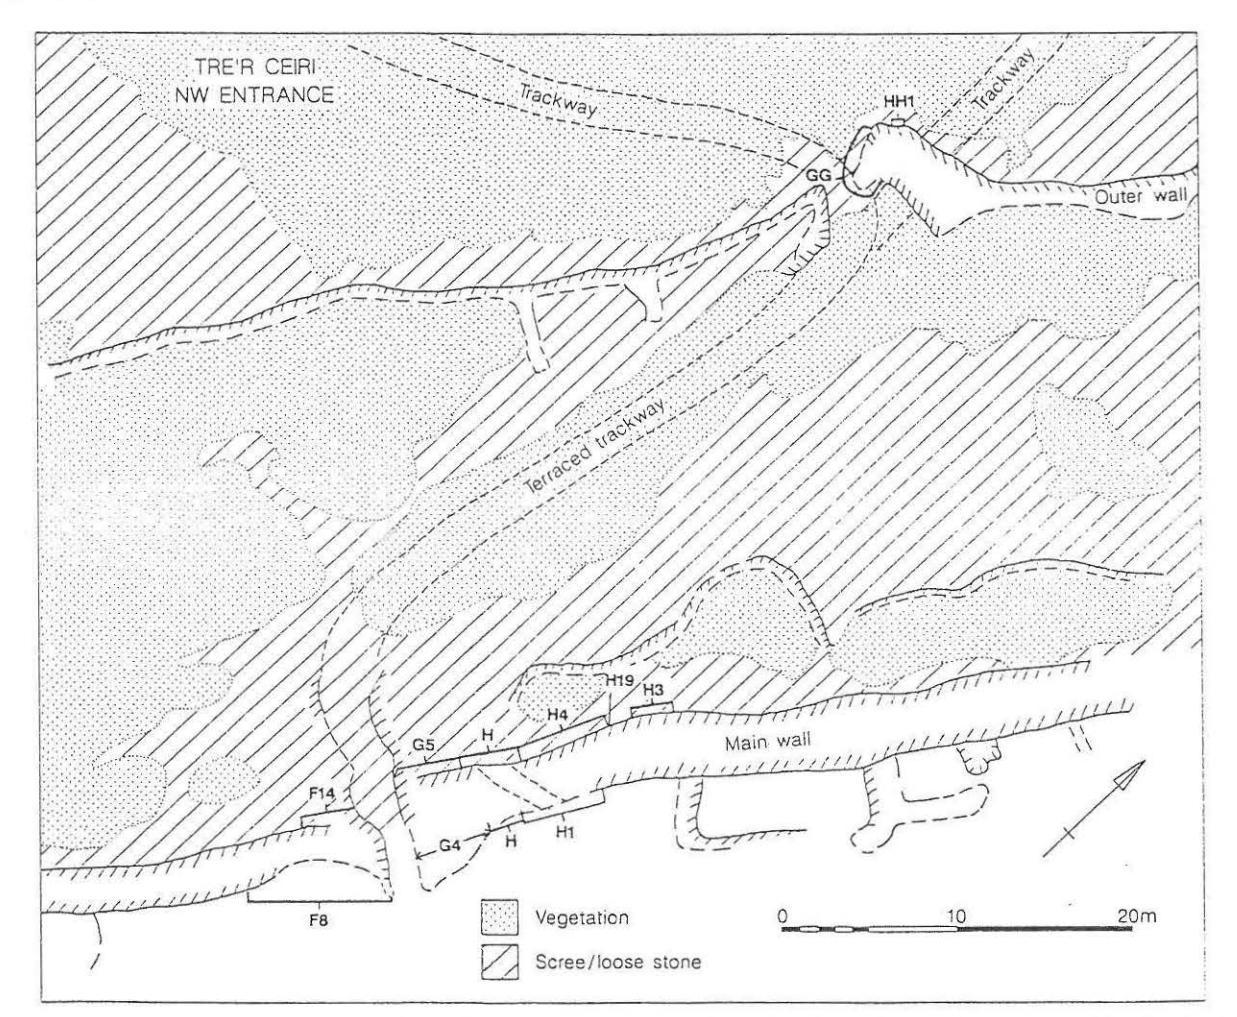
Fig. 3. The north-west entrance and environs before conservation, showing collapses for conservation in the fifth season (for collapses within the north-west entrance see Fig. 4).

An 8.0m length of inner face to the south-west of the north-west entrance was in a state of collapse, falling from 1.25m at the south-west to ground level 5.0m from the entrance (Plates 1 and 2). Loose core had spilled forwards and was standing 0.4m above the standing face. The 5.0m of lost facing (Plates 3 and 4) corresponded to a rise in ground level as the entrance was approached. No facing could be traced for any of this area, the wall line being indicated by a very loose rubble slope. The rubble was standing to a height of 1.0m at the south-west, gradually falling to the same level as the interior of the fort and the top of the north-west passage walls at the north-east of the collapse.

The loose core was cleared from the top of the standing facing. The facing was sound except for a small void which was packed with a stone (Stone A, Plate 5). No *in situ* facing was disturbed and a maximum of 0.3m of masonry was added in order to retain the core. Care was taken to emulate the very irregular facing at this point, and the edge of the wall was stabilised with large slabs (Plate 5).

A small amount of rubble was cleared from the presumed wall line running from the end of the surviving face to the edge of the passage, but no basal courses were revealed. This area was causing no threat to surviving masonry so the rubble was replaced. Care was taken to produce a graded slope at the south-west to support the core and semi-collapsed facing at this point (Plates 6, 7 and 8).

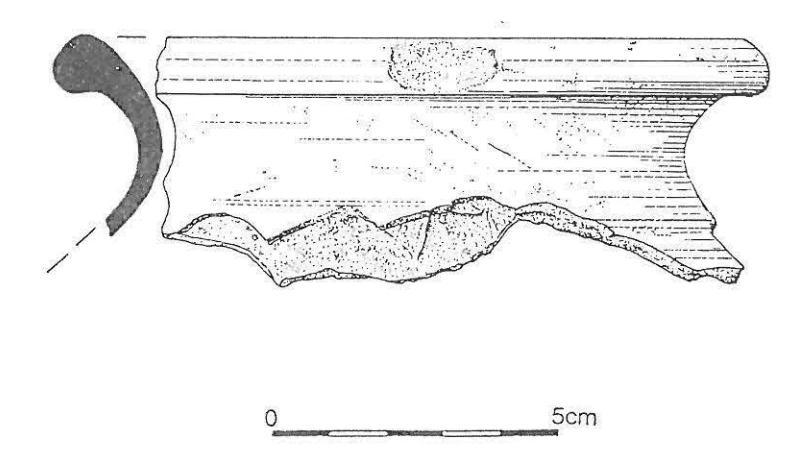
Part of a mid 2nd- to 3rd-century Severn Valley ware jar was recovered from the core as the masons were making space for the new basal course. This consisted of a large rim sherd (Fig. 12) and 24 smaller fragments, representing c.70% of the vessel rim altogether, all found within a scatter of about 0.25m diameter (Plate 75). The findspot was midway between the hidden face and the line of the passage facing, and about 0.2m above the level of the passage The core at this point appeared to be relatively undisturbed and was certainly less floor. jumbled and loose than that cleared from above it. It is probable, considering the small extent of the scatter, that the recovered portion of the vessel was broken in situ. The original piece of the jar, which would have been about 0.12m in diameter, could not have fallen through the standing masonry as it was too large to have passed through the voids in the wall, suggesting that it was deposited during the construction of the inner facing. The area has been very disturbed, however, so some caution must be exercised in the interpretation of this evidence, but it does strongly suggest that the final phase of the entrance was constructed after the mid 2nd century.

Twenty-four sherds from a single constricted-necked jar in hard, well-fired Severn Valley ware with common moderate sand temper c0.3mm and occasional brown ironstone inclusions c0.3mm. (Fig. 12) The jar has a slightly undercut rim, cf. Webster (1976) no 3, for which a mid 1st-3rd century date range is suggested. The rim and shoulder is burnished and there is a slight cordon on the shoulder. About 70% of the circumference survives. The date of the piece may be clarified a little by the evidence from Segontium (Webster 1993), where Severn Valley ware does not appear before the mid 2nd century. Since the source of material at Tre'r Ceiri is likely to have been through the Segontium vicus it seems unlikely this piece arrived here before that date. Weight 125g.

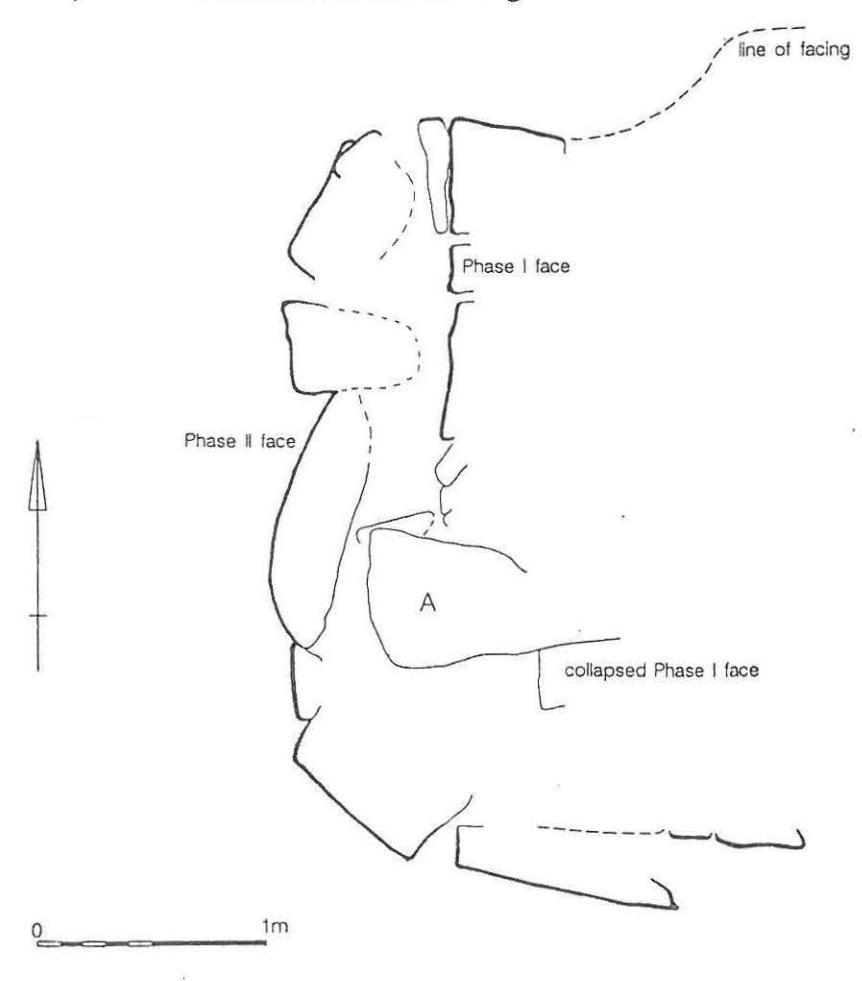
Fig. 16. Collapse GG after clearance.

The loose stone was cleared from the collapse, revealing a partially collapsed face with the lower courses of another, later, face standing 0.5m in front of it (Fig. 16 and Plates 110 and 111), forming a rounded end to the passage wall.

The earlier face had collapsed at its south-eastern corner. This may have been caused by a movement in the lower courses. Stone A on Plate 112 and Fig. 16 had obviously slipped out of the wall, causing the face above to collapse. The large basal stone beneath this had, unusually, been laid as a stretcher, presumably to accommodate the already collapsed facing, suggesting that the later face had been built as a buttress after the earlier face had failed. The western corner of the earlier facing was standing to a height of 2.5m and was stable, but the buttress was completely lost in front of this. The buttressing could not have been bound into the earlier facing at this point and would have been only one stone deep and would thus have been inherently unstable.

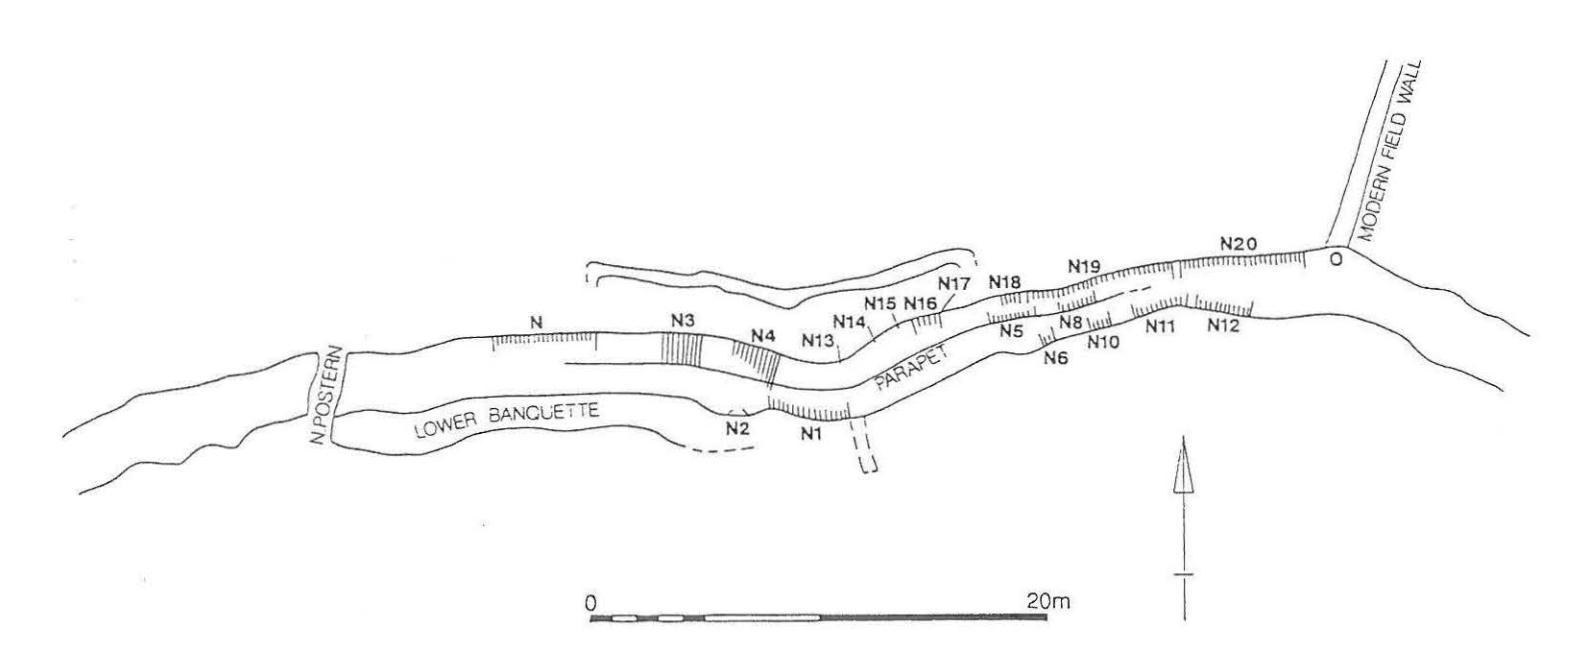
Fig. 17. Wall N - O, showing areas for conservation in the fifth season.

The 'lower banquette', a low (0.6m high) step against the inner face at collapse N, was generally stable. A number of large stones lying at the foot of the wall (Plate 117) had obviously been displaced from the top of the banquette, thus threatening the stability of the structure. It was not necessary to disturb the banquette, the fallen stones simply being placed in the dips in the facing. These stones are marked with crosses on the post-conservation Plates 118 and 119.

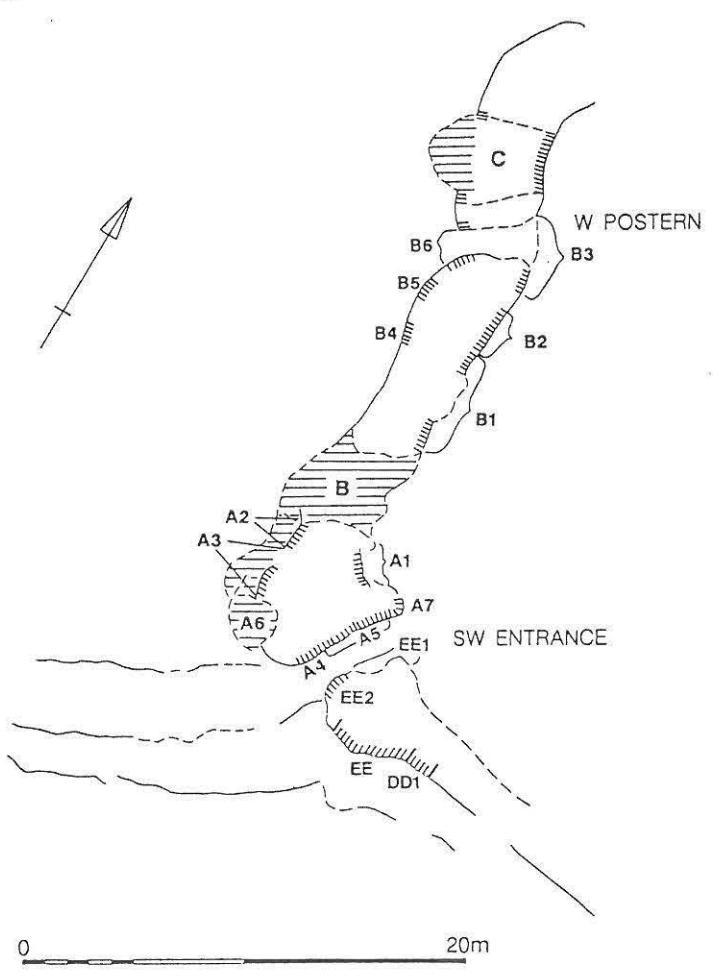
Fig. 19 Wall DD - EE, including areas for conservation in the fifth season.

After clearance of the loose rubble it became clear that the upper courses of the wall had slipped off the still intact basal course, thus causing the collapse (Plates 152 and 153). The basal course continued to within 0.6m of the edge of DD1 on a line 0.4m to the south. If this line was projected an point of abbutal would be formed about 0.4m from the west end of DD1. In contrast with the north-west side of the entrance, the rampart face could not be traced behind the curve of the bastion. Plate 155 illustrates the relationship between the two faces. The facing has been highlighted on the photograph to clarify the line of the

masonry. A 0.8m high face was built along this line abutting the west end of collapse DD1 (Plates 156 and 157).
