DOLWYDDELAN
RAW WATER MAIN UPGRADE
ARCHAEOLOGICAL ASSESSMENT (G1210)

Gwynedd Archaeological Trust Report No. 115

DOLWYDDELAN RAW WATER MAIN UPGRADE (GAT Project G1210)

FIELD WALK-OVER REPORT - July 25 1994

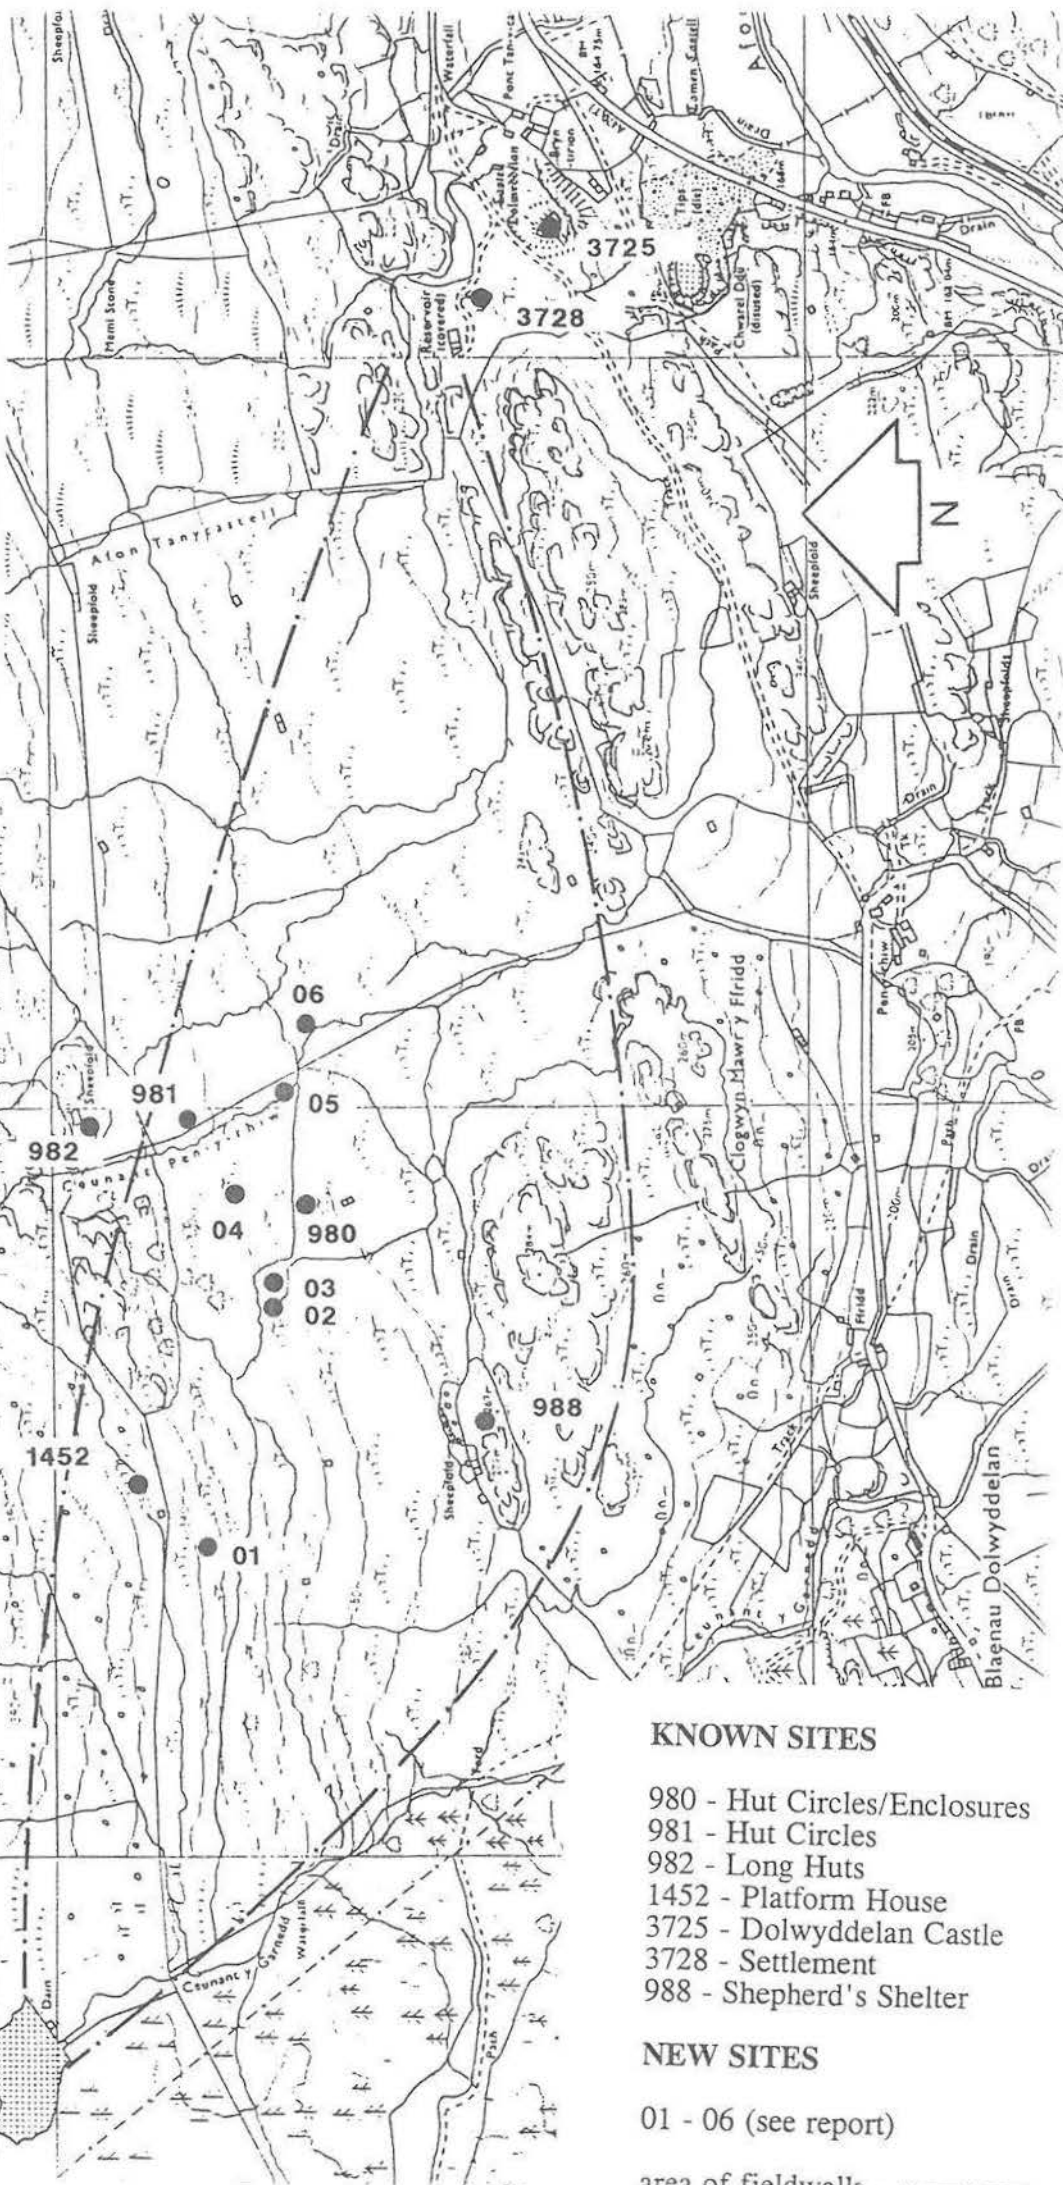
Fieldwalk Corridor
and
Site Locations

The locations of all features are marked on the accompanying plan, and were as follows, working from the western end of the walk-over corridor:

- 01 - 06 (see report)
