MAENAN STREAM WALL, CONWY VALLEY

Archaeological Mitigation

Project No. G2396

Report No. 1212

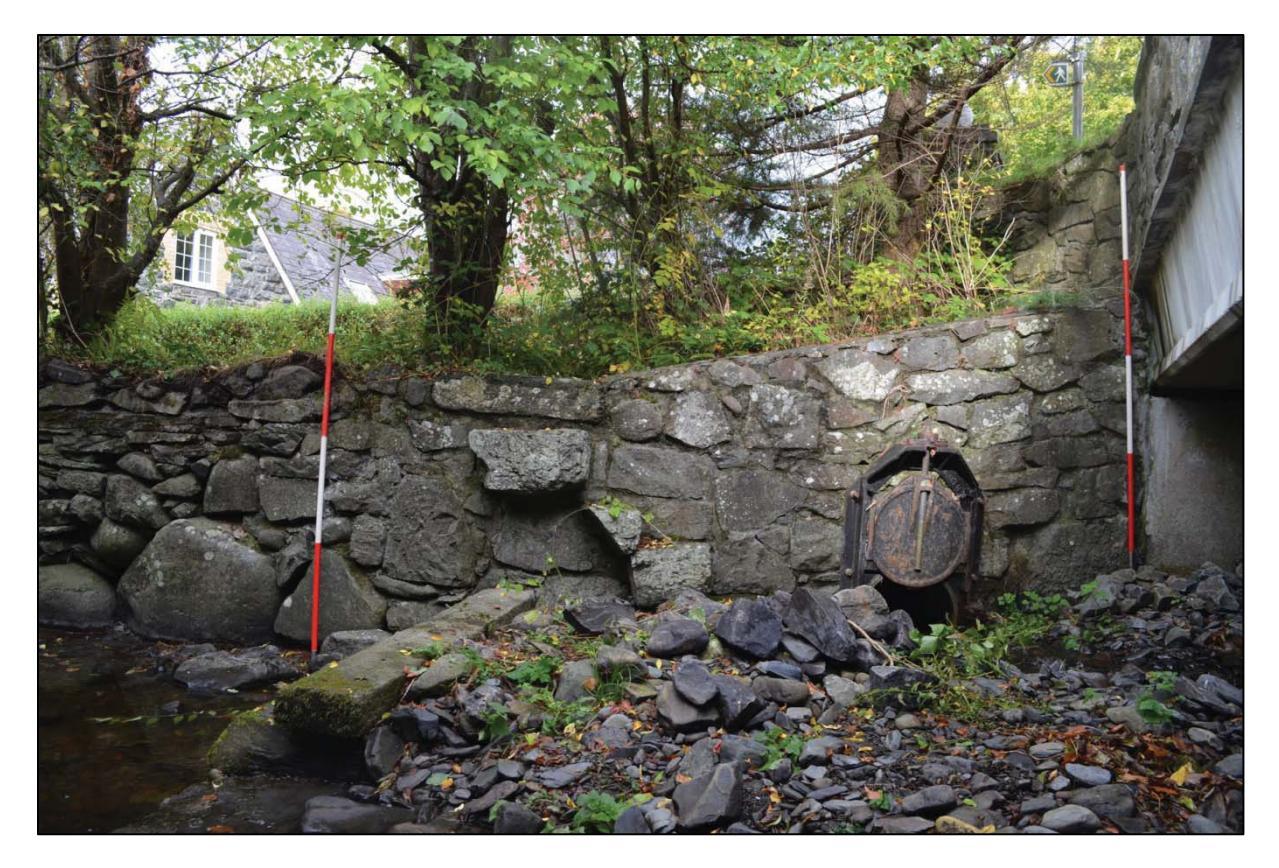
Section A measured 3.7m in length, 0.45m in width and 1.45m in height at the northeast end, dropping to 1.35m at the southwest end. This short section represents a rebuild associated with improvements to the A470 trunk road.

The wall was rubble built of fairly well sorted angular blocks, roughly faced and randomly coursed. The masonry was pointed and capped using a cement based mortar.

A circular cast iron sluice (PRN 64655) was located within this section at the base of the wall, *c*.1m southwest of the A470 bridge. The sluice was inserted as part of the rebuild and was designed to channel water into the stream from the gardens of the nearby Abbey Farmhouse group of buildings.

Plate 01: Southeast facing elevation of Section A; scales 2 x 2m

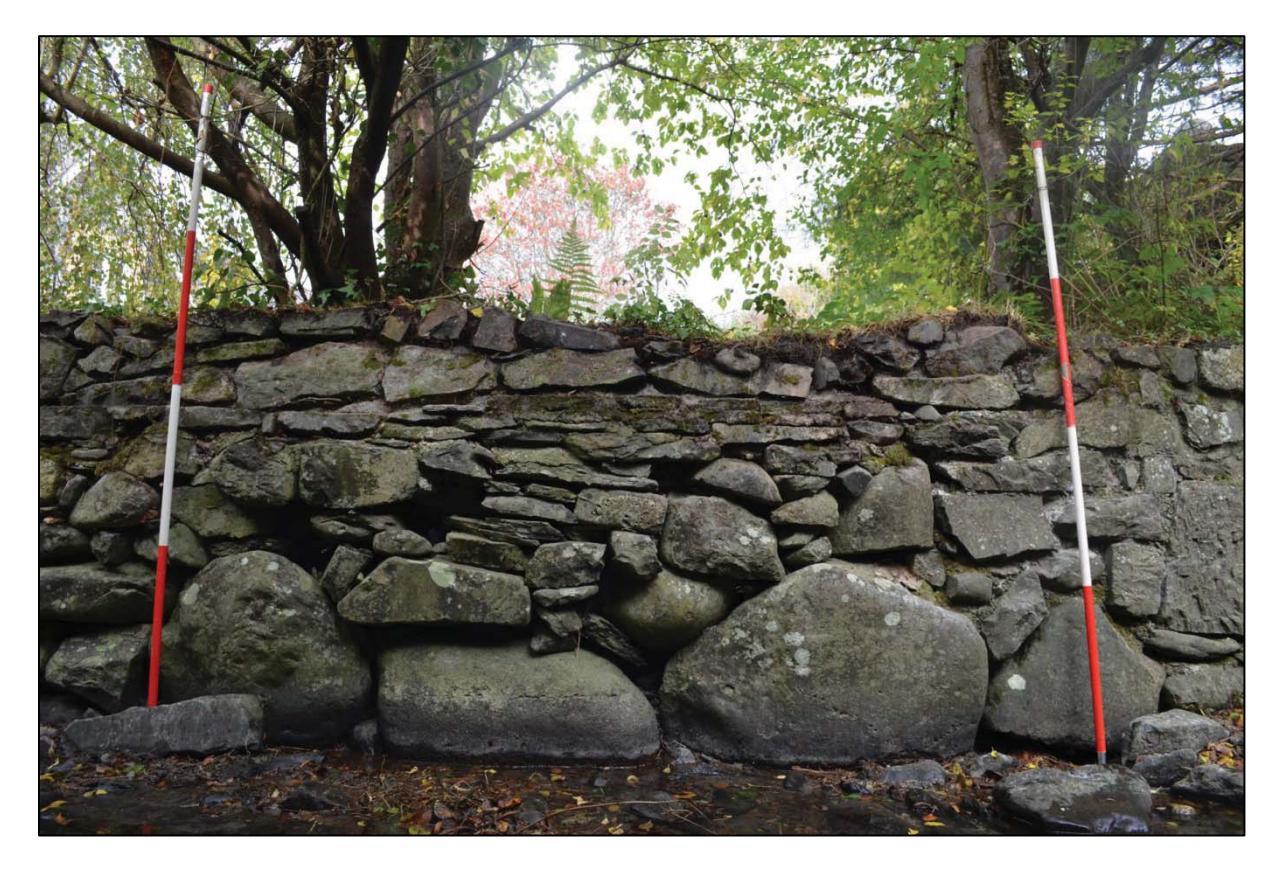
Section B continues on from Section A with no change in course or height. This section of wall appears to pre-date Section A, which represents a rebuild associated with improvements to the A470 trunk road. This section of wall appears to comprise two separate phases of masonry: the lower section stands 1.0m high and is rubble built from a mixture of sub-rounded river boulders and sub-angular quarried cobbles, with the larger boulders at the base; it is randomly coursed and sparsely pointed using a coarse lime mortar. GAT Report 1039 states that there is nothing to indicate that this is modern walling and it could be of 18th or early 19th century date (*ibid.* 17). The upper phase is 0.35m high and is rubble built of poorly sorted, sub-angular quarried cobbles. It is randomly coursed and sparsely pointed also using a coarse lime mortar with the top left flat and uncapped. The upper phase may date to the 1950's (*pers. comm.* local resident).

Plate 02: Southeast facing elevation of Section B; scales 2 x 2m.

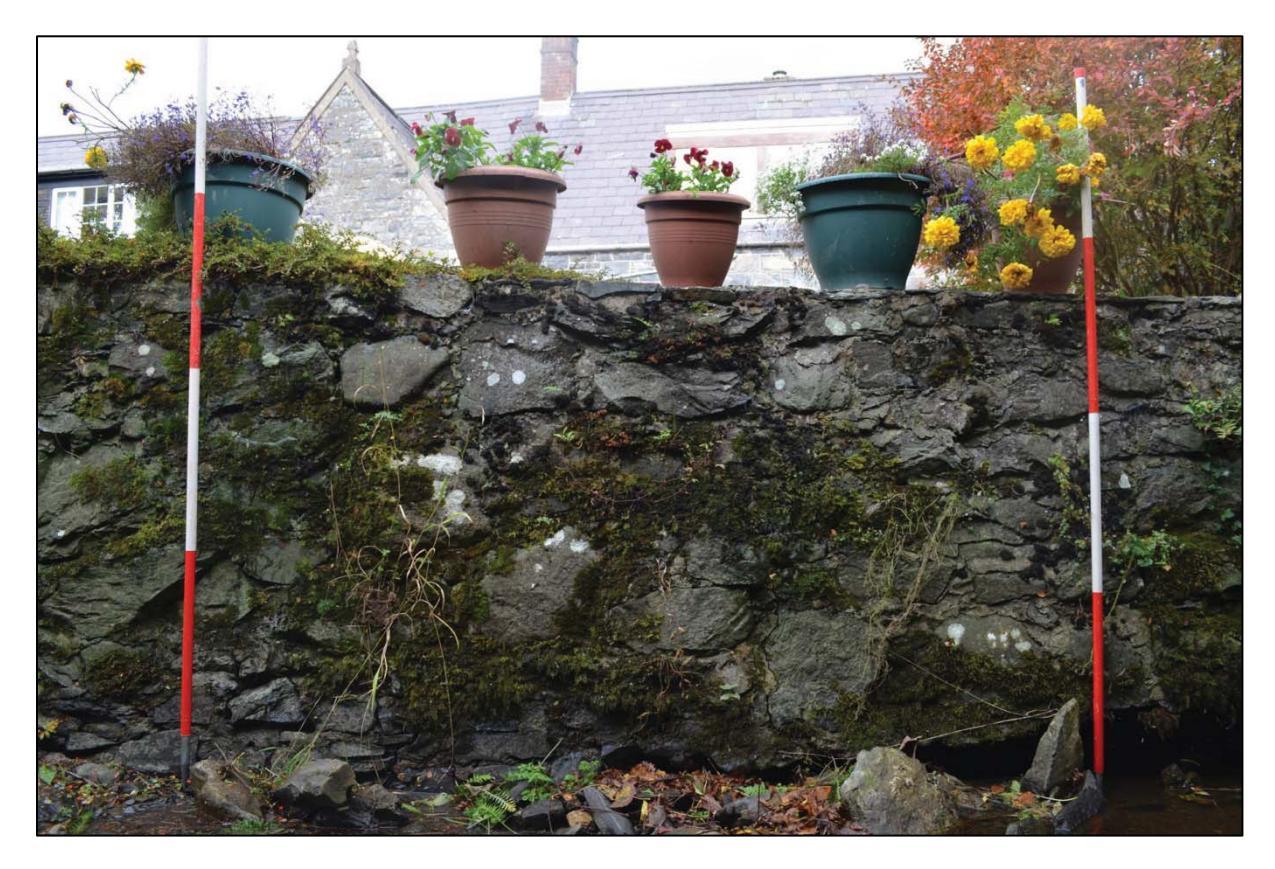
Section C measures 9.65m in length, 0.45m in width and stands 1.5m high. It is rubble built of moderately sorted, medium to large cobbles; these are primarily sub-angular quarried blocks with roughly hewn faces, though there are also some sub-rounded cobbles, most likely obtained from the river. It is randomly coursed and heavily pointed using cement based mortar; the top is left flat and uncapped.

At its northeast end, Section C initially runs southeast before turning and continuing southwest; thus creating a slight dog-leg in the boundary and narrowing the channel by some 0.7m. At its southwest end the wall features a second right angled bend, turning to run northwest for some 1.3m before meeting section D. It is probable that this section is relatively late in date: it is very regular and straight, with vertical sides and comprises a single phase of construction.

Plate 03: Southeast facing elevation of Section C; scales 2 x 2m.

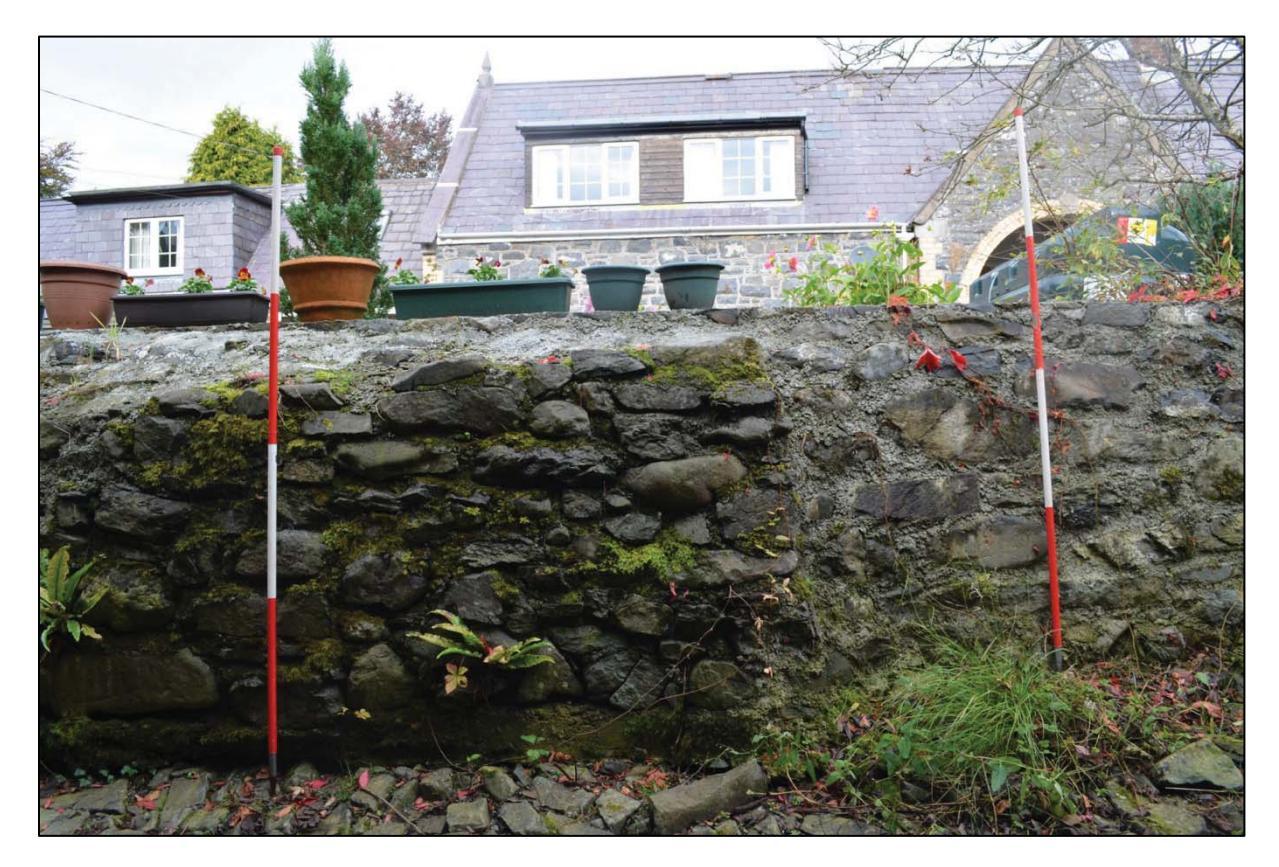
At its northeast end, section D of the wall initially runs southeast, forming a division between the gardens before turning and continuing southwest to form the stream boundary. Again it is probable that this section is relatively late in date; it is very regular and straight, with vertical sides and comprises a single phase of construction (see plate 5). Section D appears to be of similar structural style and phasing as Section C, based on the materials used.

Plate 04: Southeast facing elevation detailing the southwest end of Section D and the northeast end of Section E of the northern stream wall of NantLlechog. View from the southeast; scales 2 x 2m.

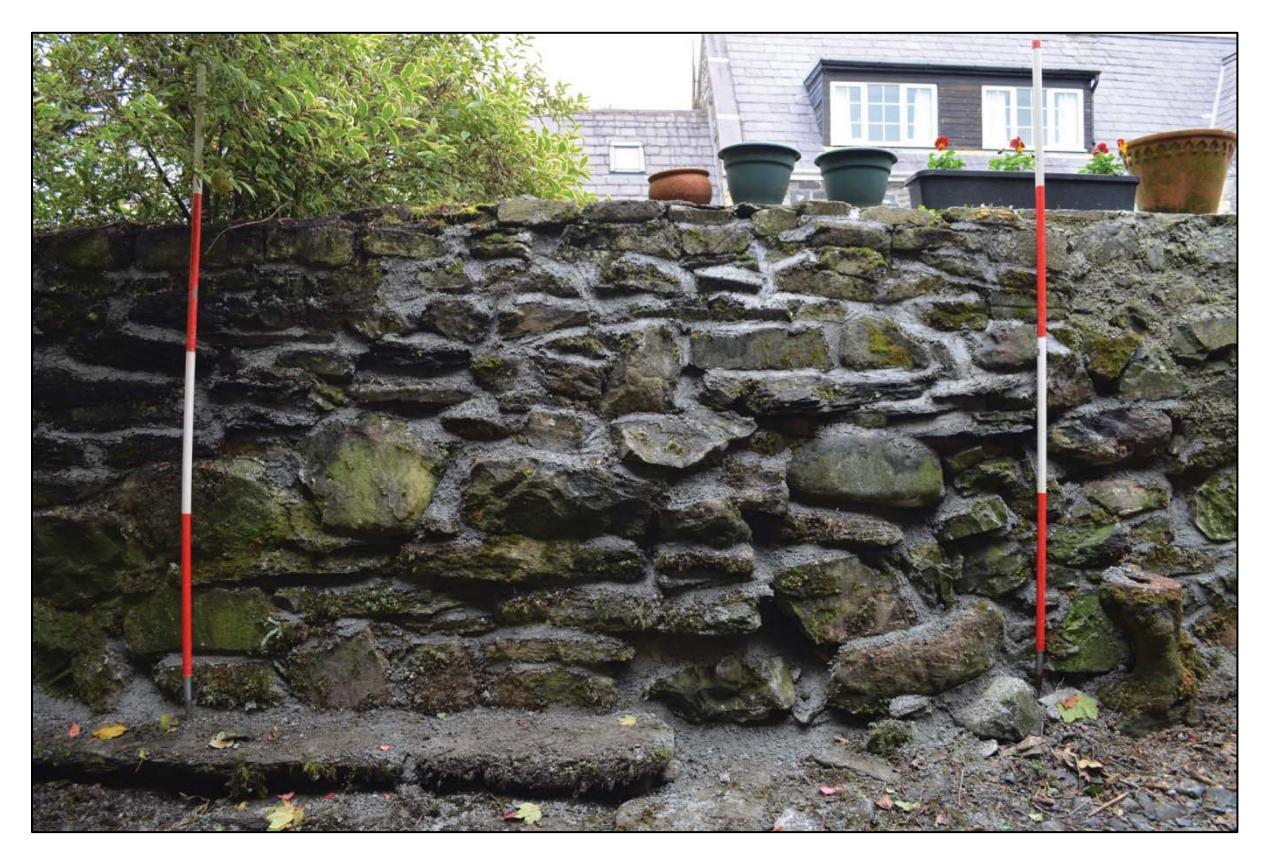
Section E comprises an earlier phase of wall, which survives in poor condition, with the wall described in Section D continuing for *c*.6m behind it, acting as reinforcement (see Plate 04). Section E measures 17.5m in length and has a maximum width of 0.6m. At its northeast end it is squared off, indicating a deliberate break in this original boundary; the purpose of which is unclear (see Plate 04). At this end the wall stands to what appears to be its full original height of 1.35m, but as it continues southwest the height decreases to 0.75m, apparently due to collapse. After 6.3m in length this early phase returns to full height and continues at this level for 5.35m, after which it reduces down again to some 0.7m for the final 5.85m. It is rubble built of moderately sorted, medium to large cobbles; these are primarily sub-angular with roughly hewn faces, though there are also some sub-rounded cobbles, most likely obtained from the river. It is randomly coursed and of a dry stone construction.

Although only one distinct phase of masonry was identified within this wall, there are several areas of probable repair, and at the northeast end, the mortar used for Section D has also been applied to the top of this.

Towards the base at the mid-point of this section, two layers of large slabs project into the water channel (Plate 05) that appear to be steps. The largest slab measures 1.15m in length but is only 0.07m thick. It is suggested in GAT Report 1039 that these may have formed the base of a bridge pier, associated with a crossing point detailed on the First Edition County Series Map for Caernarvonshire (sic), sheet XIV.9, published in 1890 (Figure 03).

Plate 05: Southeast facing elevation of Section E, detailing the stone slabs visible at the base of this section that may have formed the base of a bridge pier, associated with a former crossing point; scales 2 x 2m.

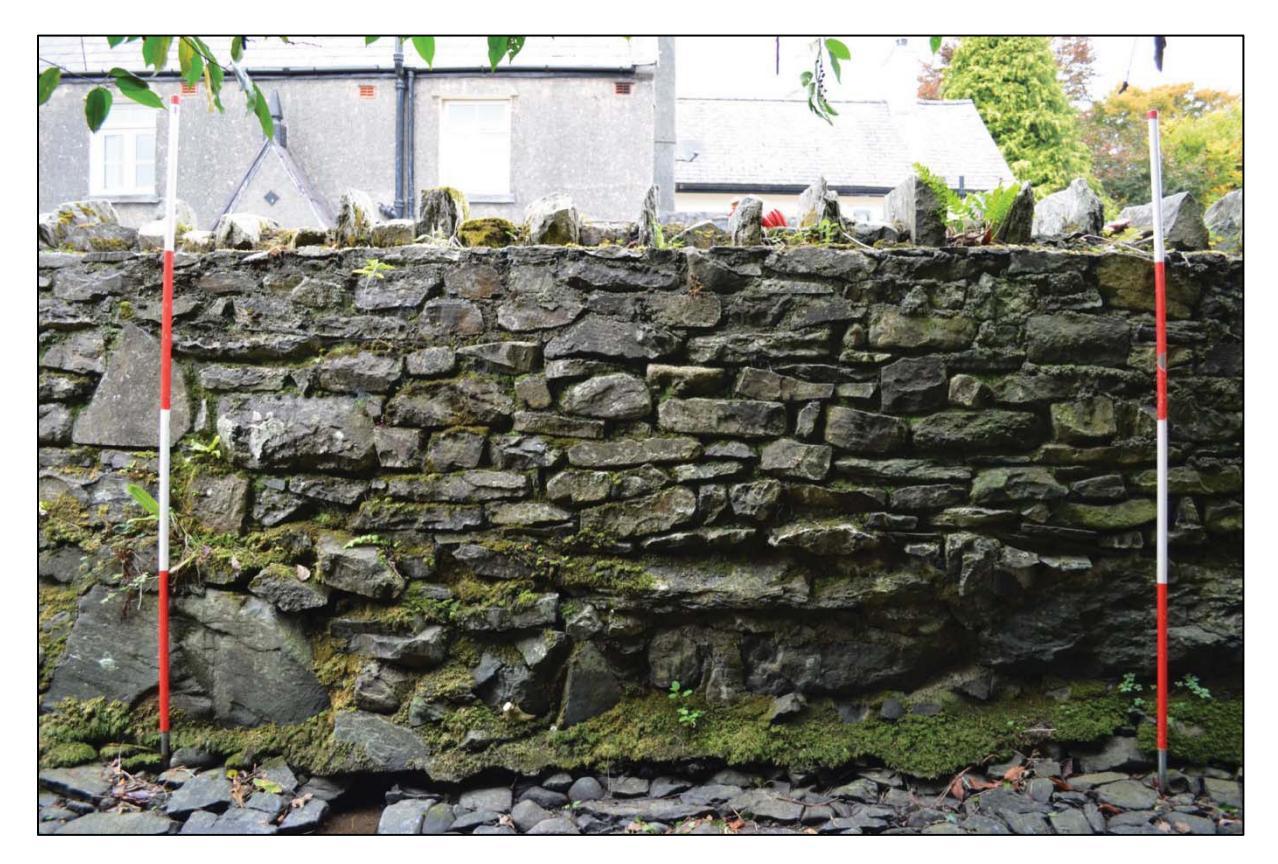
Section F measures 26.0m in length and 1.9m in height at either end, but dropping to 0.5m in height for much of its length. Section F appears to be a later phase than Section E and has been constructed as a reinforcement for the southwestern end of Section E. Section F comprises two structural phases: an earlier phase forming the lower level of the section, which measures 0.7m in height and was rubble built from predominantly moderately sorted sub angular/rounded boulders. The later phase, forming the remaining height is rubble built of moderately sorted, small to medium sub-angular cobbles and features stock proofing along the top. The masonry is randomly coursed and pointed using coarse cement based mortar throughout. The interface between the two phases is undulating and indistinct, suggesting the earlier phase was in a poor state of repair when the second phase was added

Plate 06: Southeast facing elevation of Section F; scales 2 x 2m.

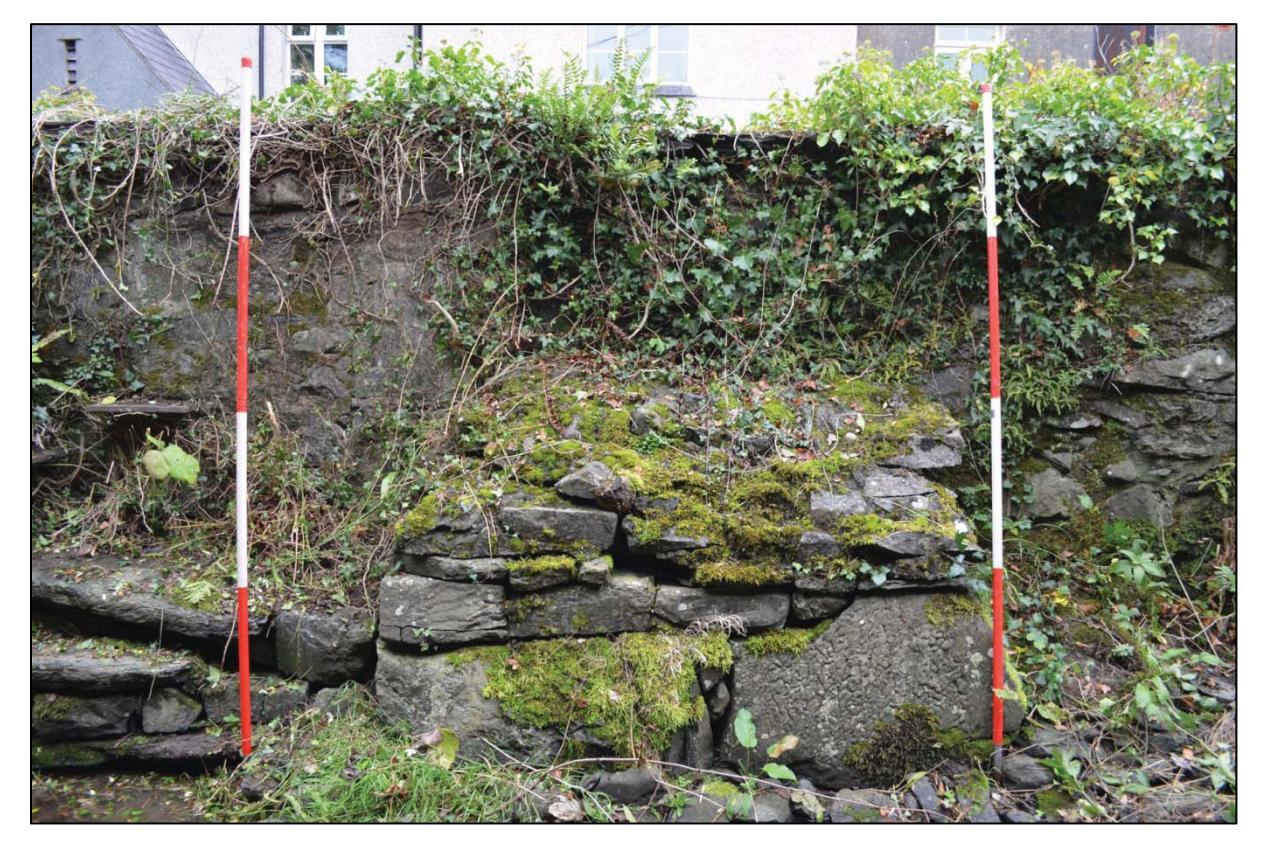
Section F of the stream wall stops to the immediate northeast of a substantial rubble built bridge pier which extends out into the channel; a matching pier appears evident on the opposite side of the stream. GAT Report 1039 dated this structure to the early 19th century This structure stands 1.0m high and is 1.75m wide; it is constructed of sub-angular, roughly hewn blocks which increase in size towards the base (see plate 08). A central gateway originally set into the wall above the pier appears to have been blocked by section F of the wall. The wall to the southwest of this blocked gateway appears to be of a separate phase, though it initially continues on the same course and at the height as the preceding wall. After 1.5m this wall turns and runs southeast for some 0.75m before terminating. A series of steps allowing access to the stream are constructed in the corner formed by this wall; the lower steps are formed of large stone slabs up to 1.1m by 0.4m in size, whilst higher up two cut slate steps are set into the masonry of the wall (see plate 09). The assessment suggests that the lower steps and the bridge piers are contemporary but that the walls and the upper steps are later additions (*ibid*. 18).

Plate 07: Southeast facing view of the bridge pier in Section G; scales 2 x 2m.

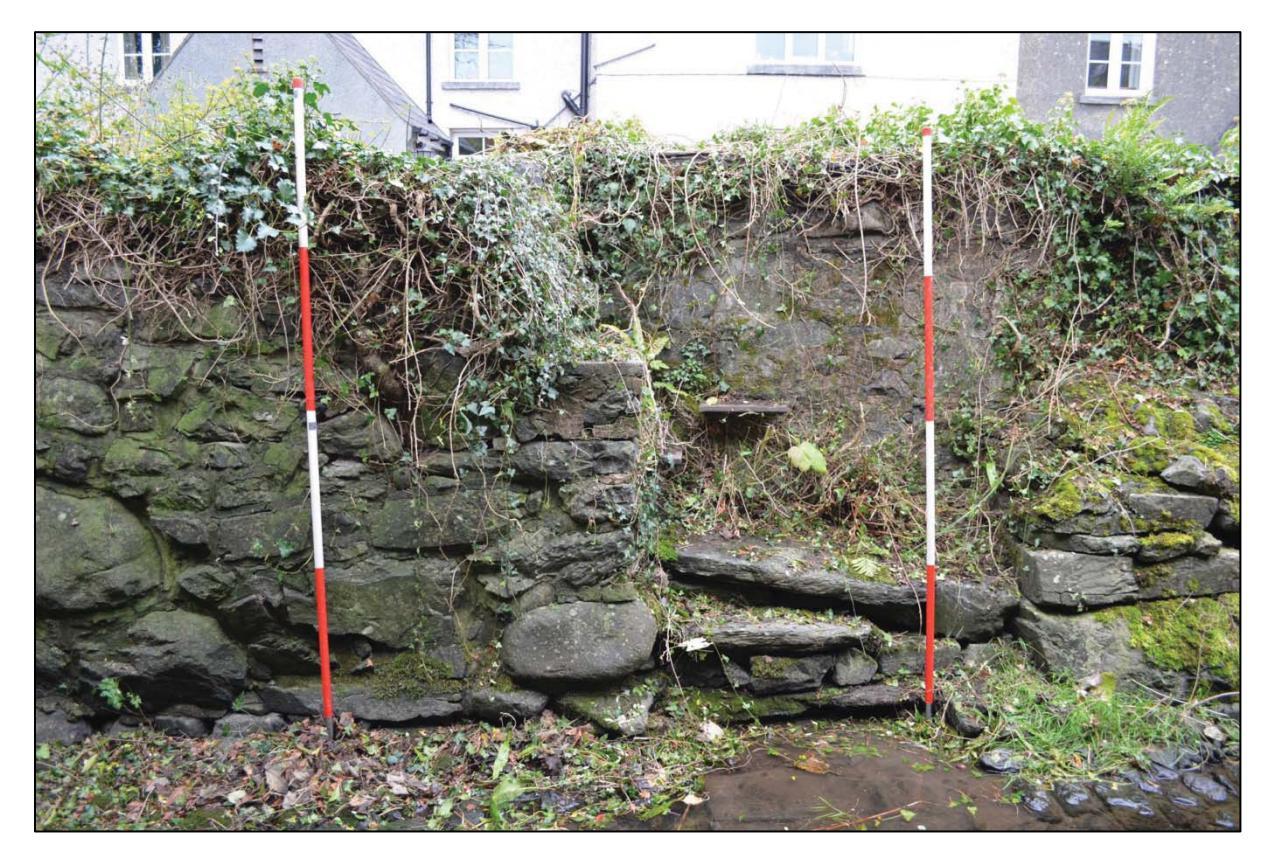
Plate 08: Southeast facing view of the steps in Section G; scales 2 x 2m.

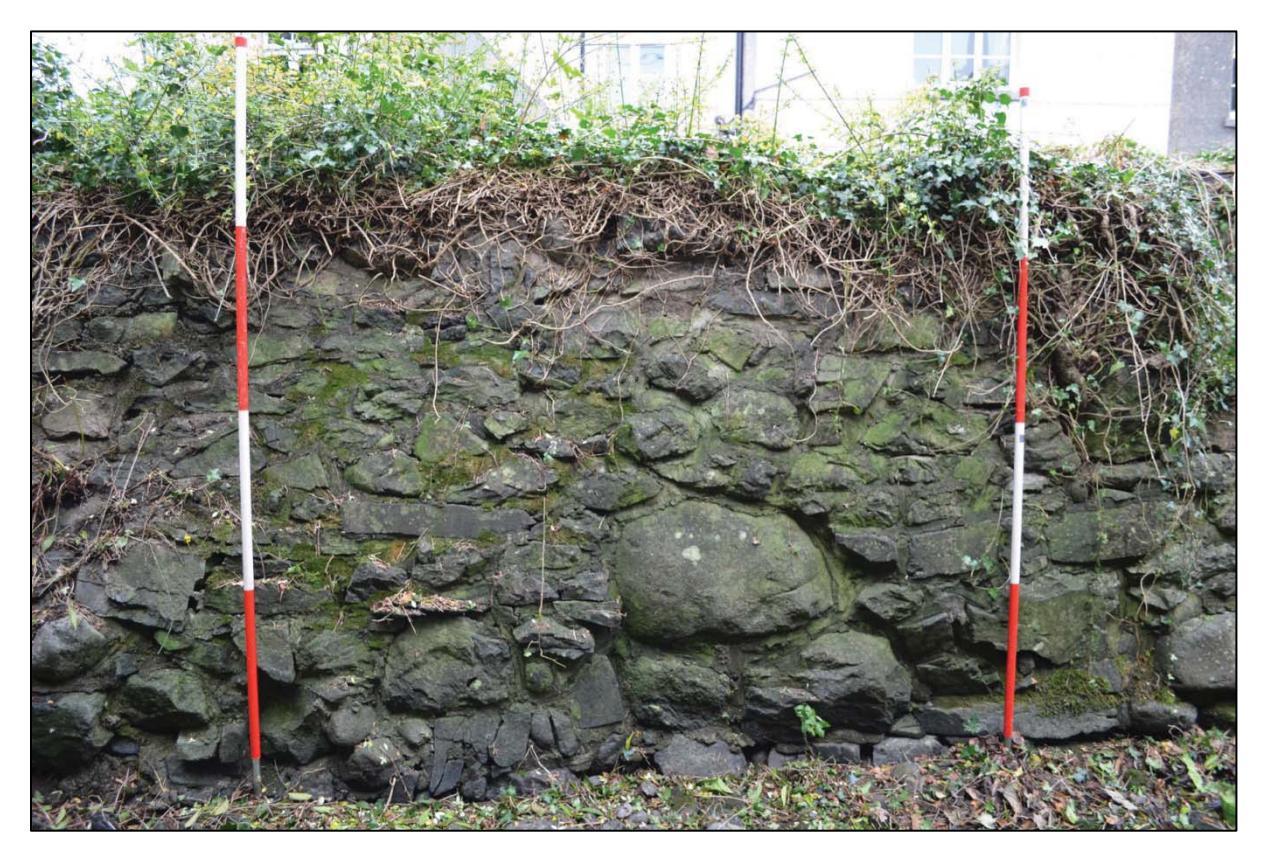
This section comprises a single phase of building, which survives to full height, though there are some areas of slumping and collapse, and the course meanders somewhat. Based on these irregularities it was interpreted that Section H, represents an earlier structural phase.

Plate 09: Southeast facing elevation of Section H; scales 2 x 2m.

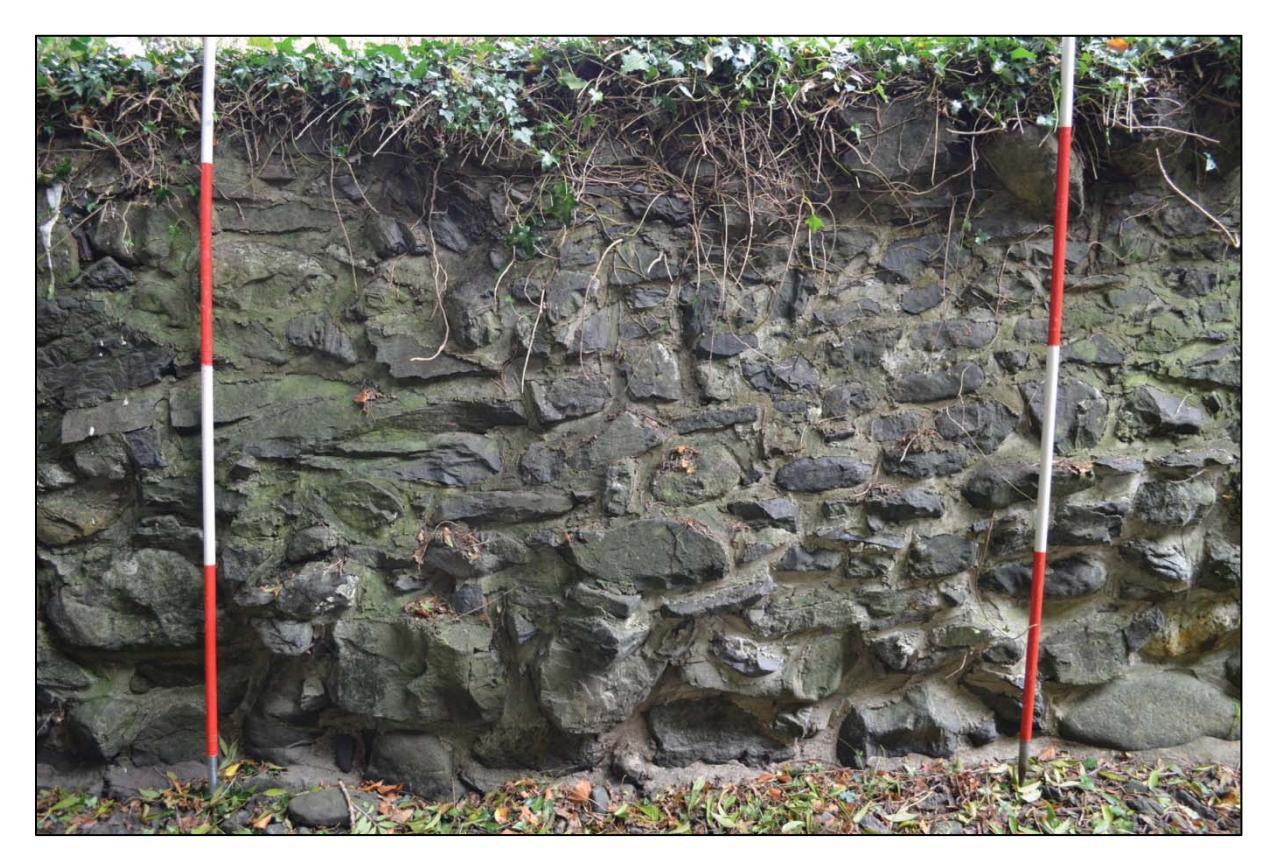
This section comprises a single phase wall very similar to Section H, with the exception that this is very regular and straight and the pointing is a little heavier (see plate 11) It is 8.2m in length and continues on from the preceding section with a matching height and width.

Plate 10: Southeast facing elevation of Section I; scales 2 x 2m.

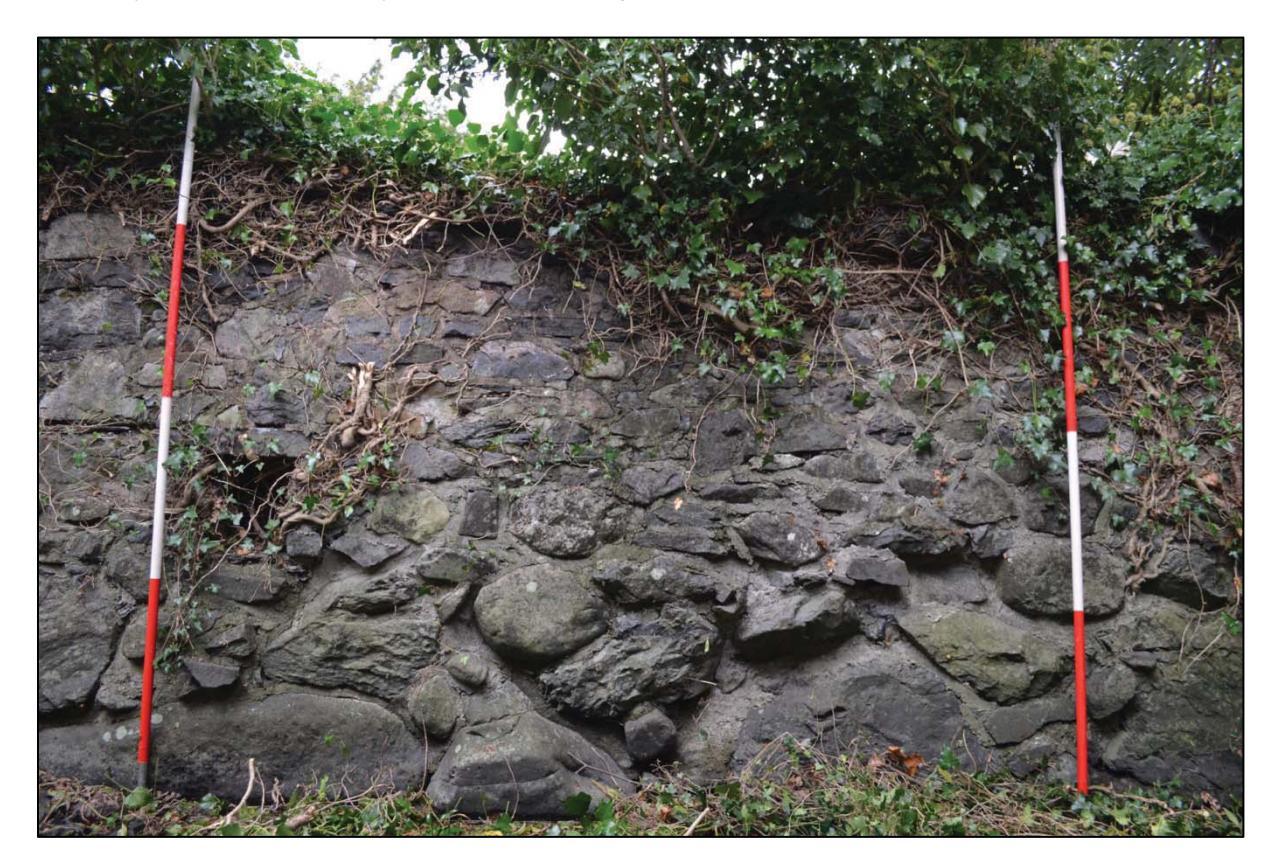
Section J comprises two separate phases of masonry: the lower section stands 0.7m high and is rubble built of a mixture of poorly sorted, sub-rounded river boulders and cobbles. It is randomly coursed and pointed using cement based mortar; the upper phase is 1.2m high and is rubble built of fairly well sorted, sub-angular quarried cobbles, which are randomly coursed and pointed using cement based mortar. The top is left flat and uncapped. A small rectangular opening, likely to be a drain is built into the masonry 0.9m from the end of this section. This drain is located 0.7m above the stream, at the base of the second phase of masonry and approximately parallel with the ground level on the northern side of the wall.

Plate 11: Southeast facing elevation of Section J; scales 2 x 2m.

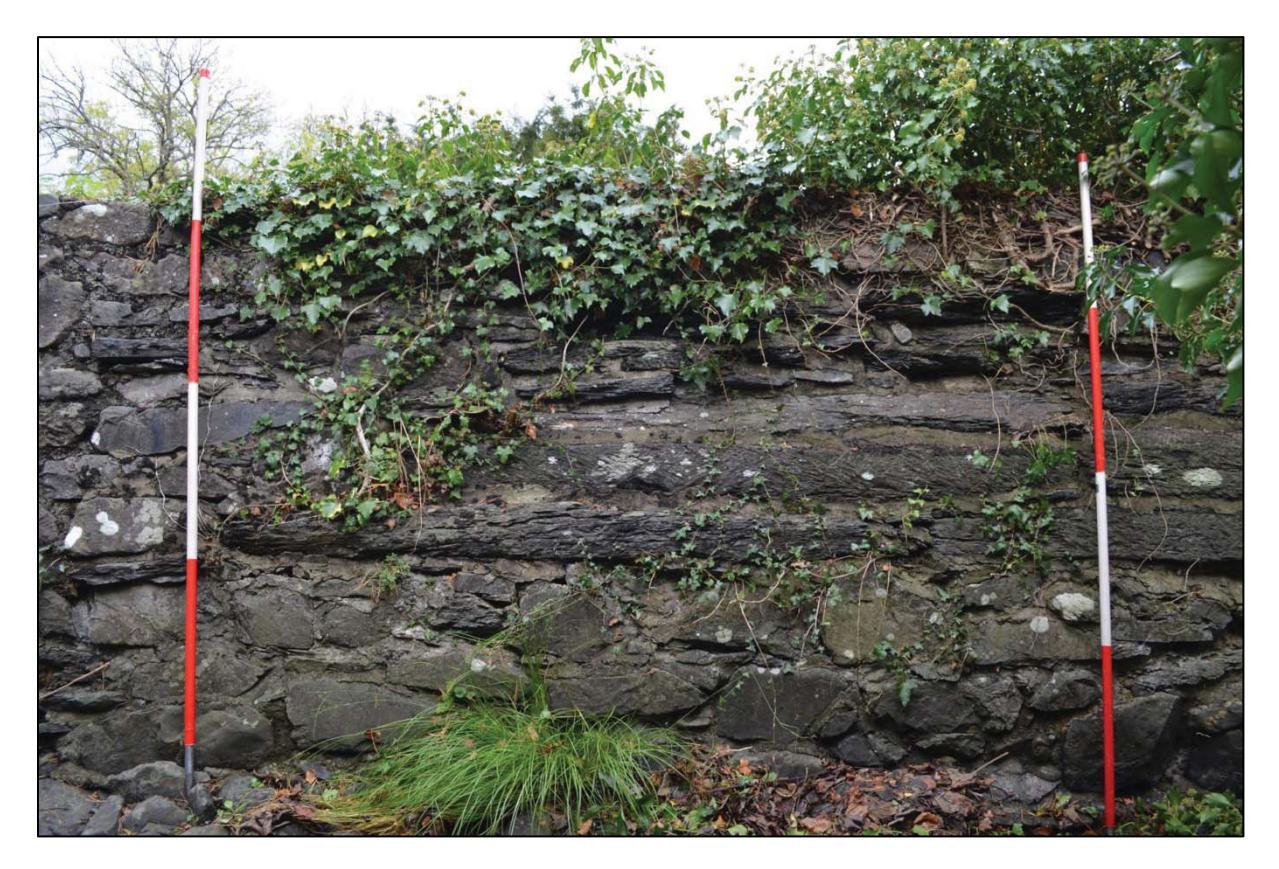
Section K measures 4.4m in length and stands 1.95m high at the northeast end, dropping to 1.7m at the southwest end. The lower section stands 0.7m high and is rubble built of fairly well sorted, irregular, roughly hewn blocks. It is randomly coursed and pointed using cement based mortar. The upper phase is 1.2m high and is rubble built of fairly well sorted, long slabs (up to 1.5m in length). It is partially coursed and pointed using cement based mortar; the top is left flat and uncapped.

Plate 12: Southeast facing elevation of Section K; scales 2 x 2m.

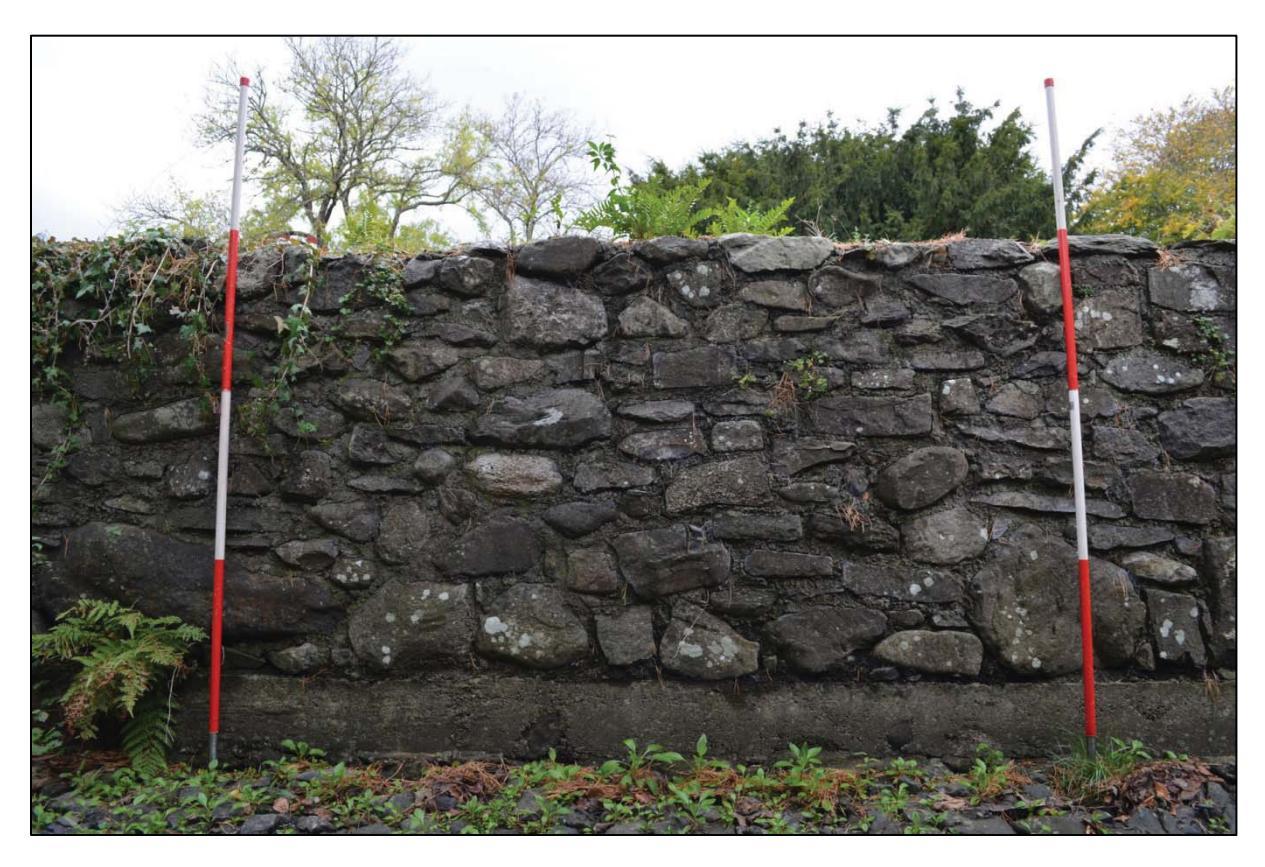
Section K measures 9.9m in length and stands 1.7m high; it comprises a single phase of masonry and is very straight and regular. Section K is rubble built of fairly well sorted, irregular, roughly faced cobbles, with occasional sub-rounded boulders. It is randomly coursed and pointed using cement based mortar. An even skim of cement, 0.25m, high runs along the base of this wall.

Plate 13: Southeast facing elevation of Section L; scales 2 x 2m.

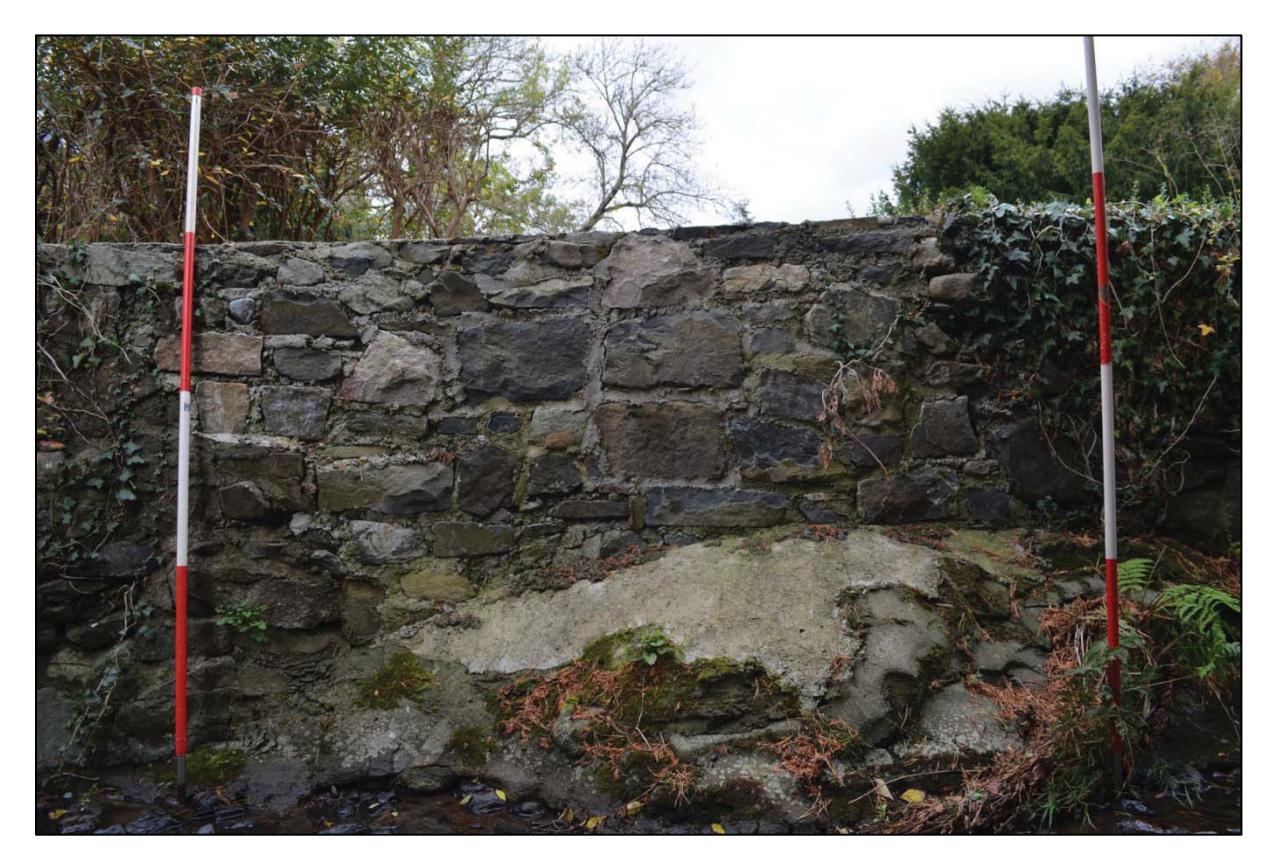
At the location of Section M, the stream changes course, turning to run northwest. The section of wall on the inside of this bend appears to have collapsed fairly recently (some rubble remains at the base but otherwise this section appears to have been re-built using imported stone.

Plate 14: Southeast facing elevation of Section M; scales 2 x 2m.
