ABERLLYN MINE

ARCHAEOLOGICAL ASSESSMENT

Prepared for Snowdonia National Park Authority

Gwynedd Archaeological Trust Report No. 133

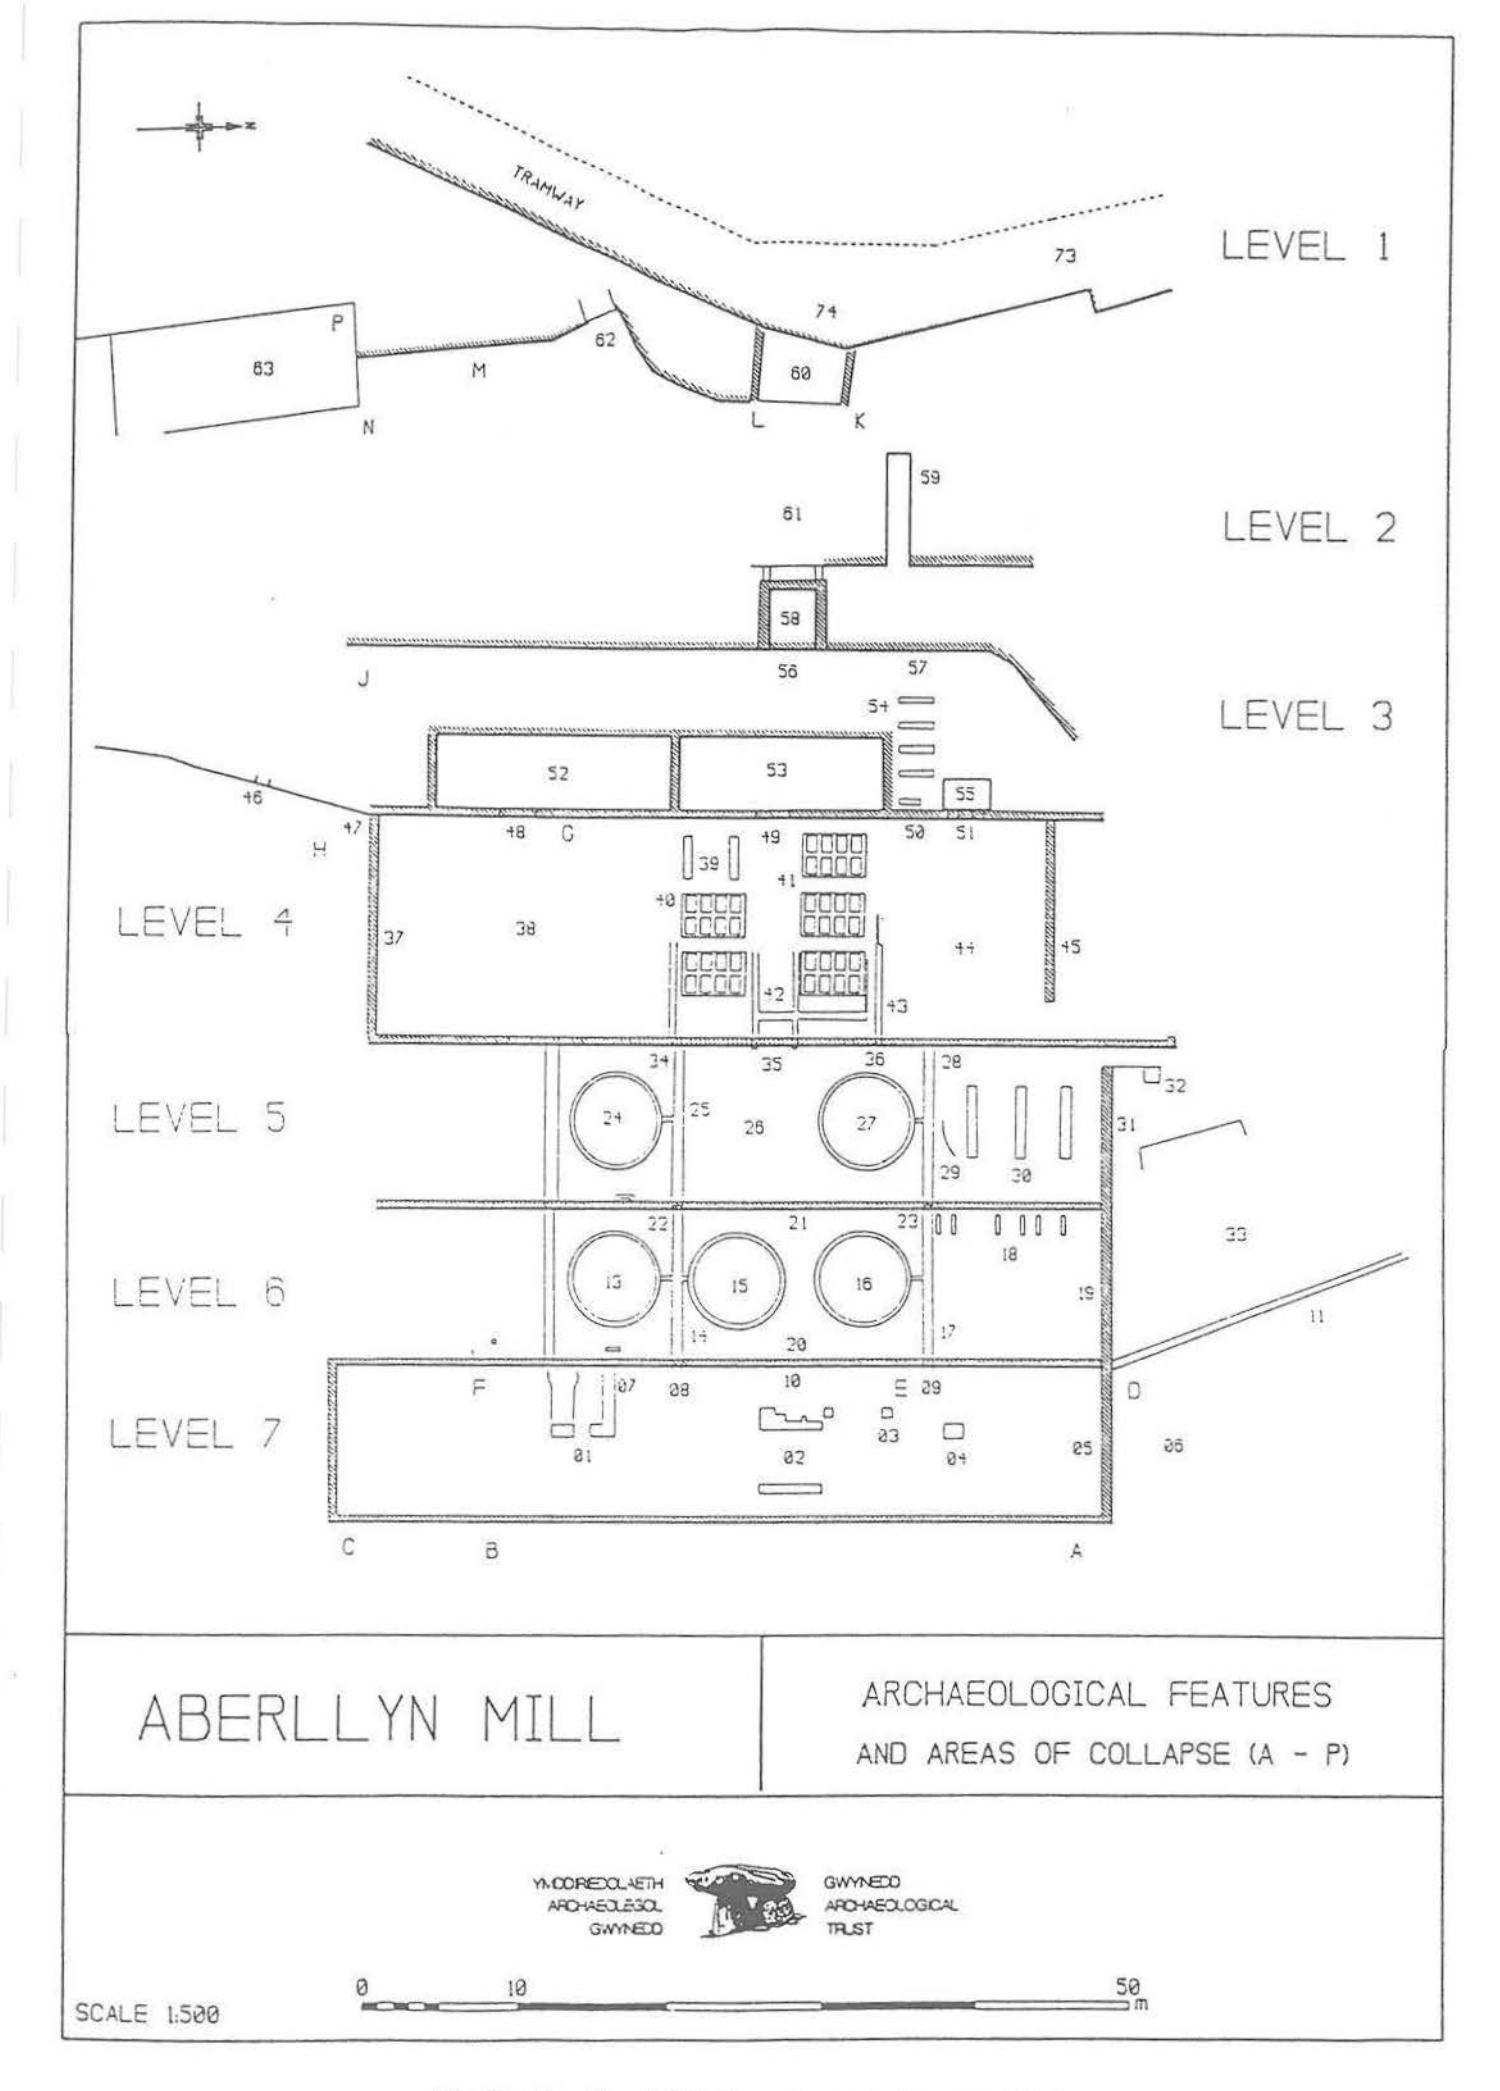
Fig 9 Aberllyn Mill: Location of features 1994

It was decided at the start of the survey to number each feature separately, as far as was practical, because of the wide variation in type, construction and condition. Around 140 records are included in the gazetteer, some of which contain several features of the same type. The sites were recorded onto record forms or directly into a database loaded onto a field computer. The sites were marked on a base map enlarged to 1:1250, although no new sites were accurately surveyed. The available plans of the mill were found to be too inaccurate to use for archaeological purposes and it was necessary to produce a new plan using tapes and offsets, although this is not necessarily definitive at this stage (Fig 9).
