Archaeology Chapter for Environmental Statement for Penrhyn Quarry, Bethesda

Project No. G2098

Report No. 1397

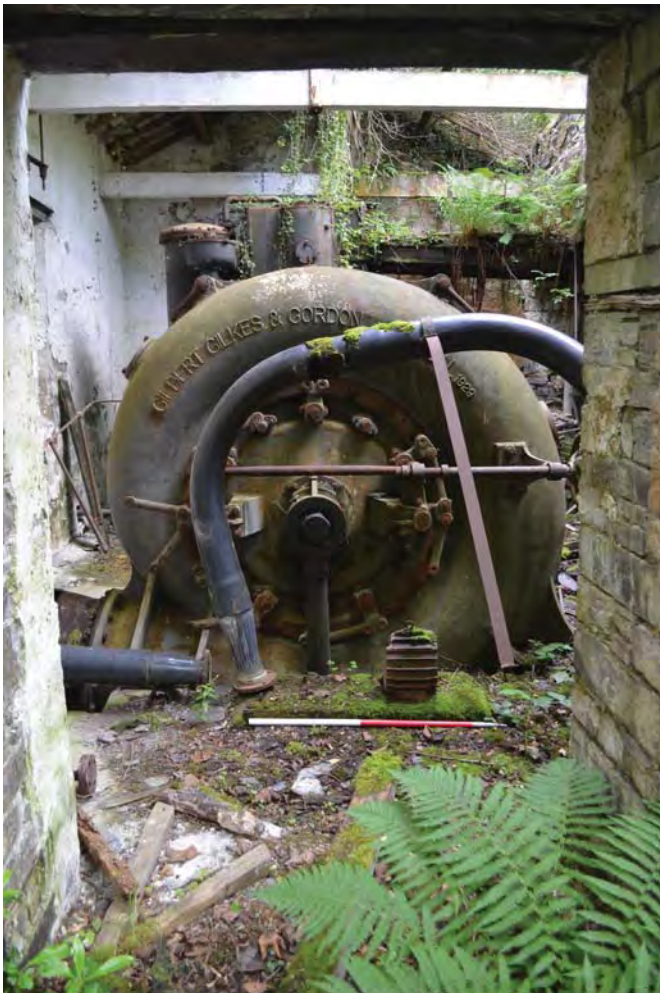
Plate 4. Turbine in Compressor House PRN 5698/60021

- 12.62 Apart from the two well-preserved water-balances the only surviving machinery is found in a compressor house (PRN 5698/60021) (plate 4), which provided compressed air to drive machinery in the quarry. This still contains a turbine, which was driven by water brought in through a large pipe and the compressor that the turbine powered. The compressor dates from 1918 and the turbine from 1929, making them early and important examples.

The building is slate built with slate cut by a circular saw. This building actually houses a turbine coupled to a vertical cylinder air compressor (Gwyn 2015, 89). The plate on the turbine has a date of 1929 and the plate on the air compressor has a date of 1918. No date stone above the entrance could be seen despite nothing obscuring this area. The large iron pipe running from the building is still intact and in quite good condition. The pipe brought water in to power the turbine, which drove the air compressor, which powered drills and other machinery in the quarry (Gwyn 2015, 90).

Condition: Near Intact, Fair. Half the roof is still in place but overgrown and very vulnerable. The rest of the building is sound and well-preserved.

Management recommendations: Carver (1993) recommends removing the equipment from this building and conserving the equipment, but getting it back into working order in situ could be a better option if this is possible. Options need discussing with GAPS.

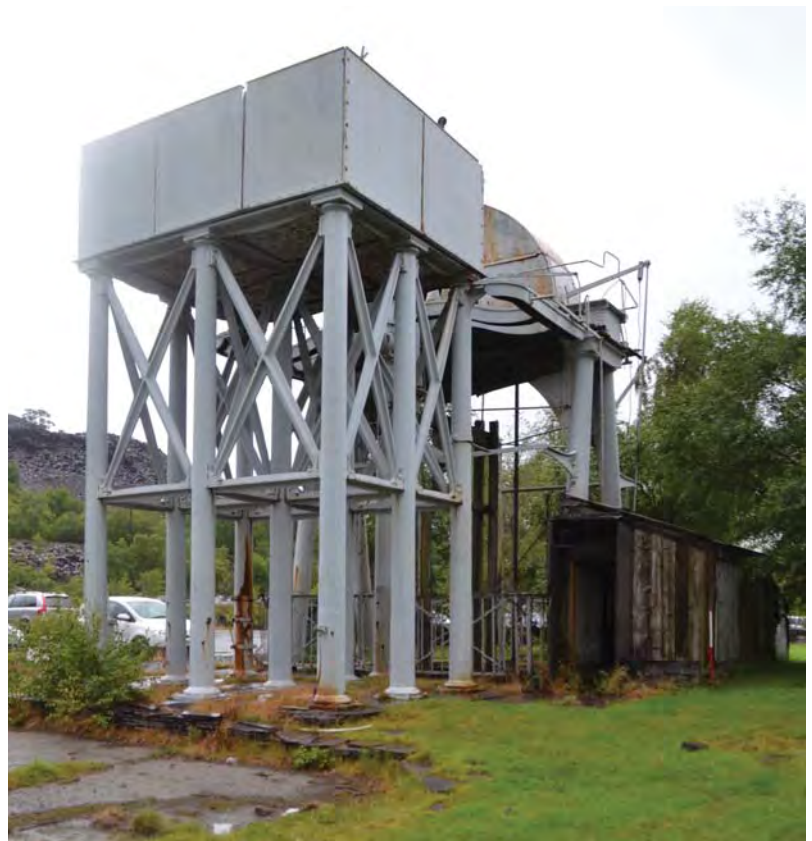
Plate 11. "Sebastopol" water-balance
shaft and headframe PRN 59998

- 12.84 The water balances with surviving head frames require active preservation or they will rapidly deteriorate. Conservation management plans should be produced for these.
