REPORT ON THE EIGHTH SEASON OF THE TRE'R CEIRI CONSERVATION PROJECT APRIL TO SEPTEMBER 1996

Prepared for Cyngor Dosbarth Dwyfor by D. Hopewell

GWYNEDD ARCHAEOLOGICAL TRUST REPORT NO. 246

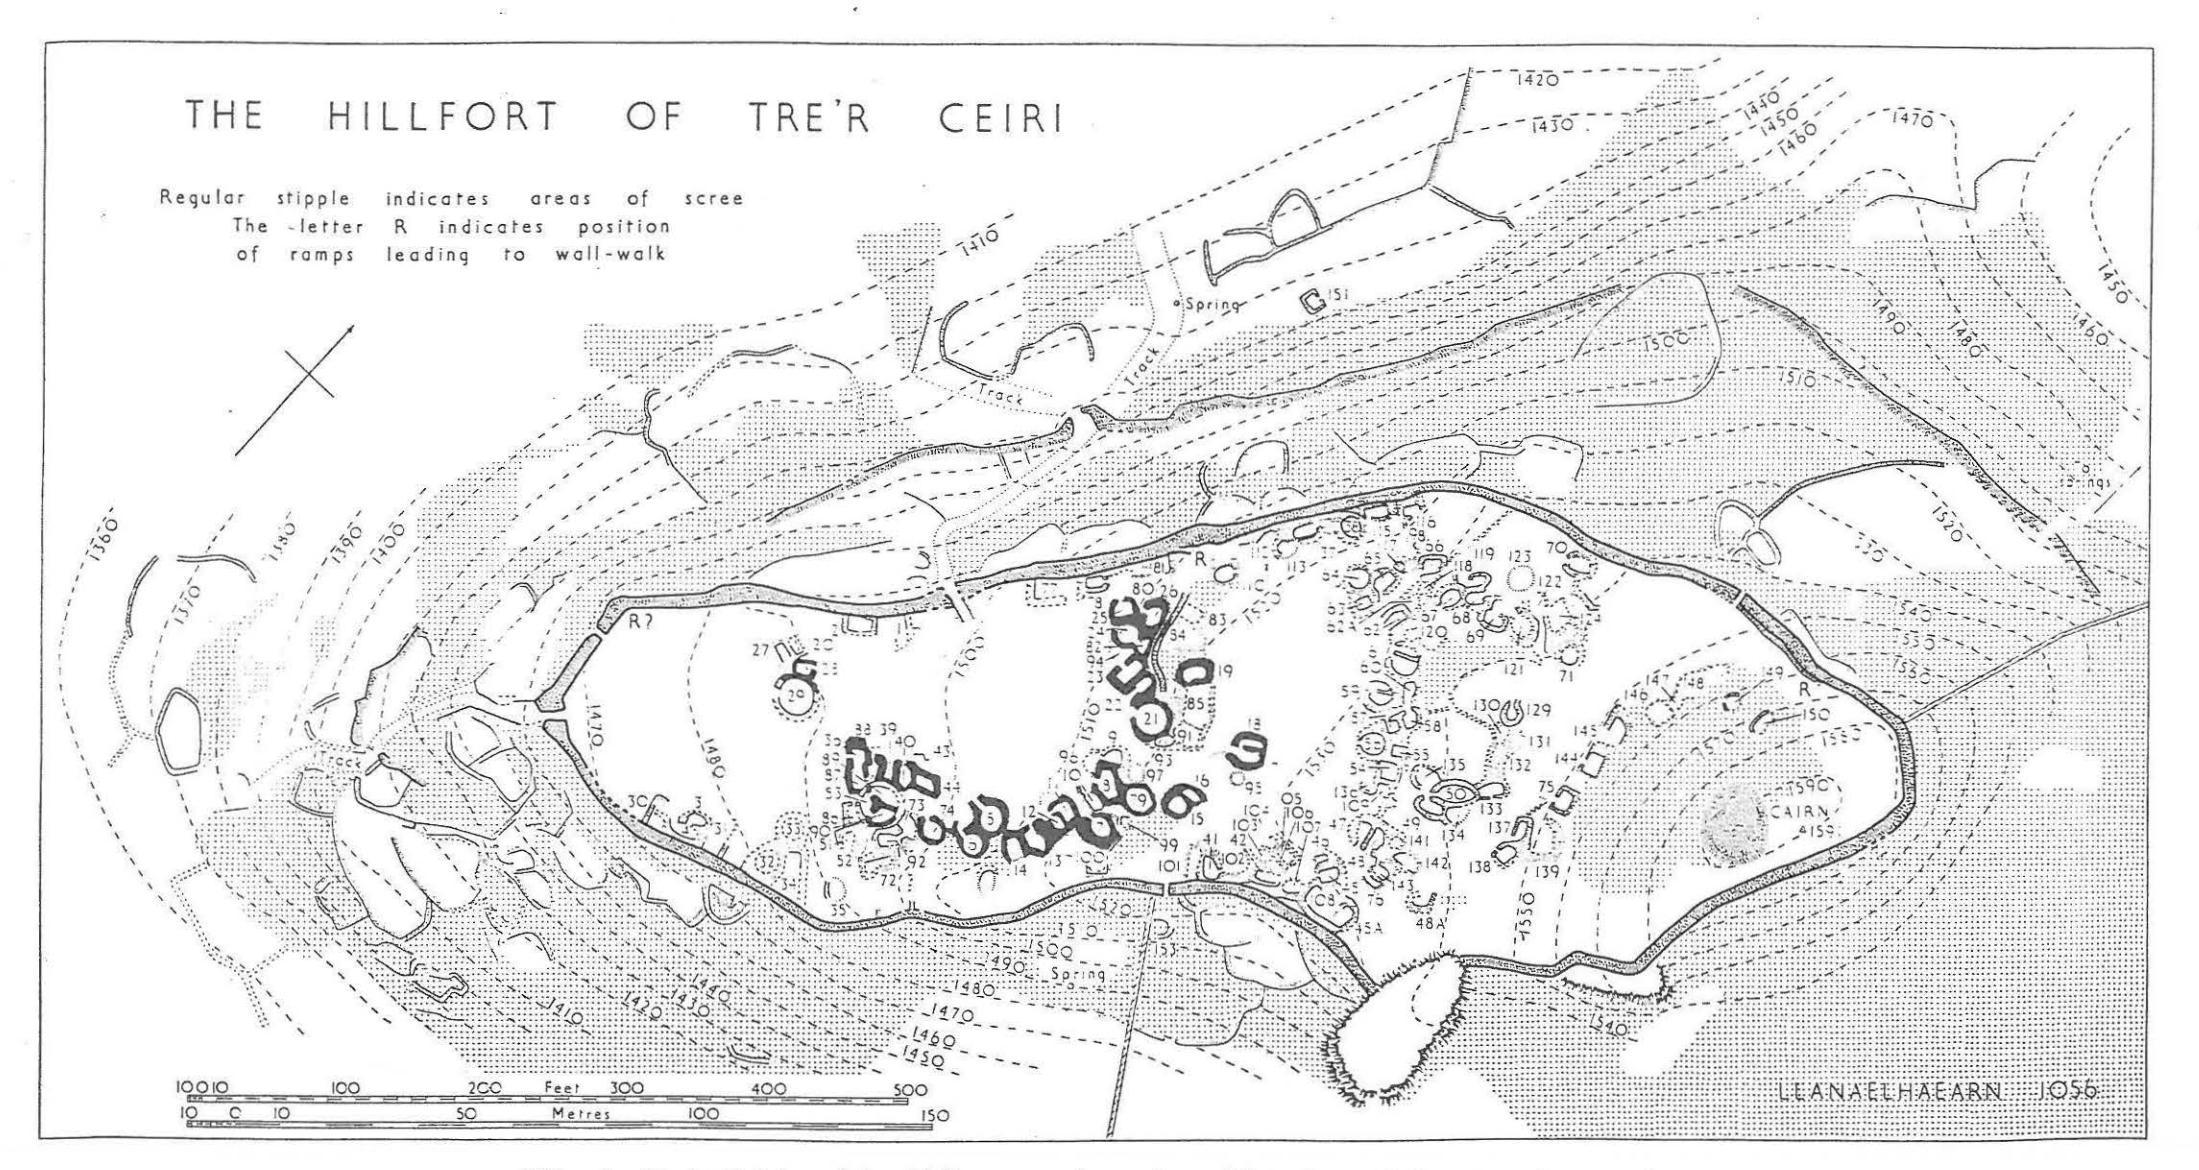
Ffig. 1 - Tre'r Ceiri; ardaloedd lle gwnaethpwyd gwaith cadwraethol yn ystod tymor 8 Fig. 1. General Plan (after R.C.A.H.M.W., 1960), showing areas for conservation in the eighth season.

The eighth season was the first to concentrate wholly on the huts. The arc of 57 huts in the south-west half of the fort (see Fig. 1) was designated for conservation during this season. Of these, 35 required consolidation work, 14 had been reduced to close to ground level and were stable and 9 had been conserved in previous seasons and required no more work. The weather during the working season was drier and colder than usual and very little time was lost as a result of severe conditions.

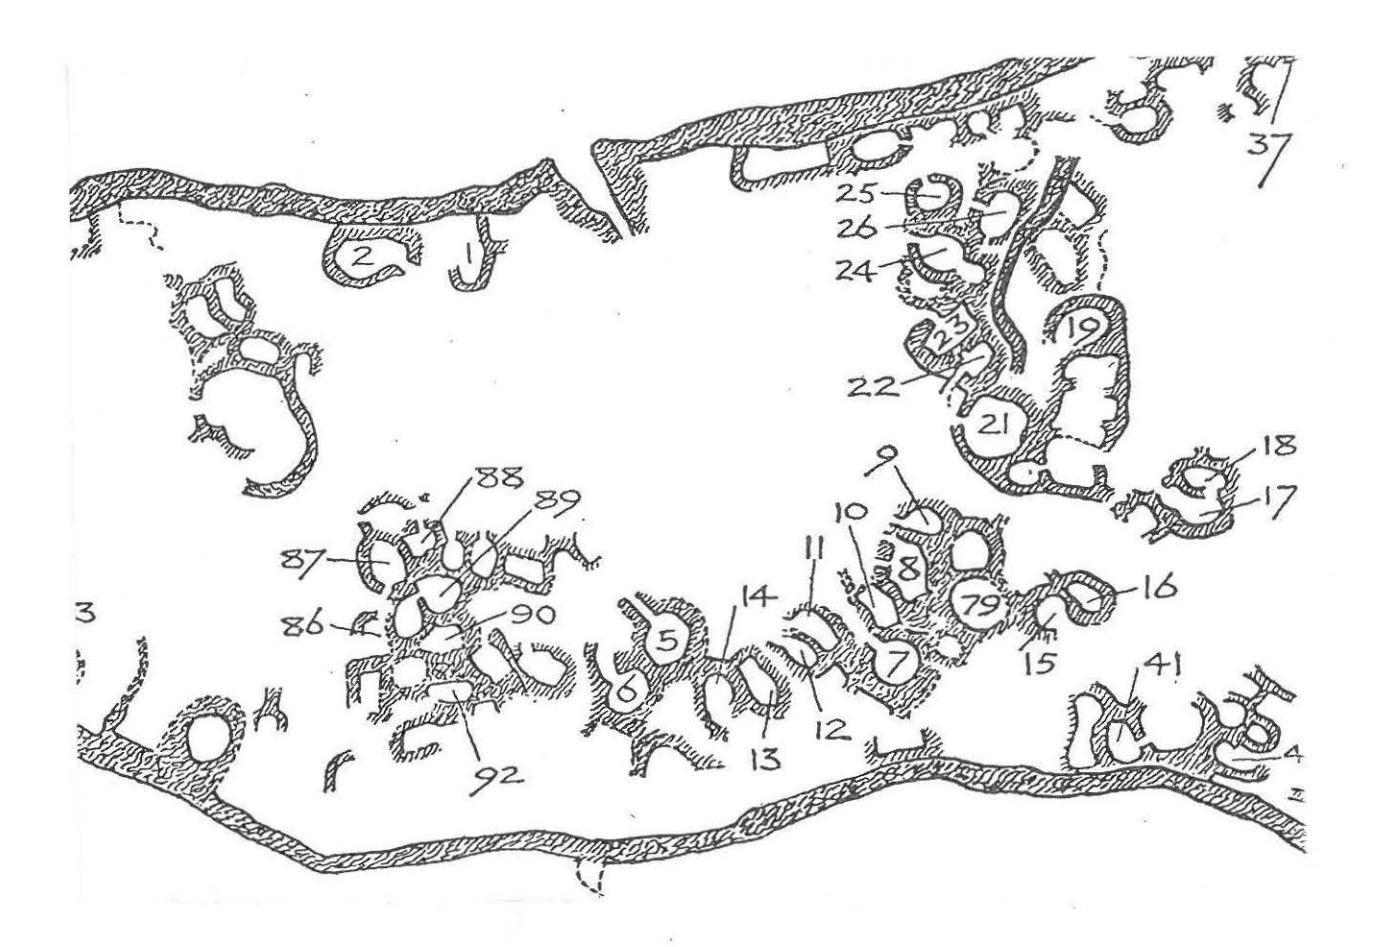
Fig. 6 The central area of Tre'r Ceiri (Hughes 1907)

Hut 21 was excavated by Hughes in 1906 (Hughes, 1907). He recovered several 'pot boilers' and four small pebbles. His plan of the hut (Fig. 6) shows a sub-circular structure with an entrance on the south-west. Griffiths described the hut, in his survey of 1946, as having an internal diameter of 22 ft. (6.7m) with inner facing standing to a height of between 2 ft. (0.6m) and 4 ft. (1.2m) on all sides apart from the south where only the footings remained. Dallimore recorded serious collapses in both the western and eastern walls.

The most noticeable feature of the hut at the beginning of the 1996 season was a 5.5m wide collapse in the eastern wall encompassing almost a third of the circumference of the hut. Walls elsewhere were low but generally stable. It appears that there has been a gradual deterioration of this hut over the last 90 years possibly as a result of its proximity to the main footpath through the site.

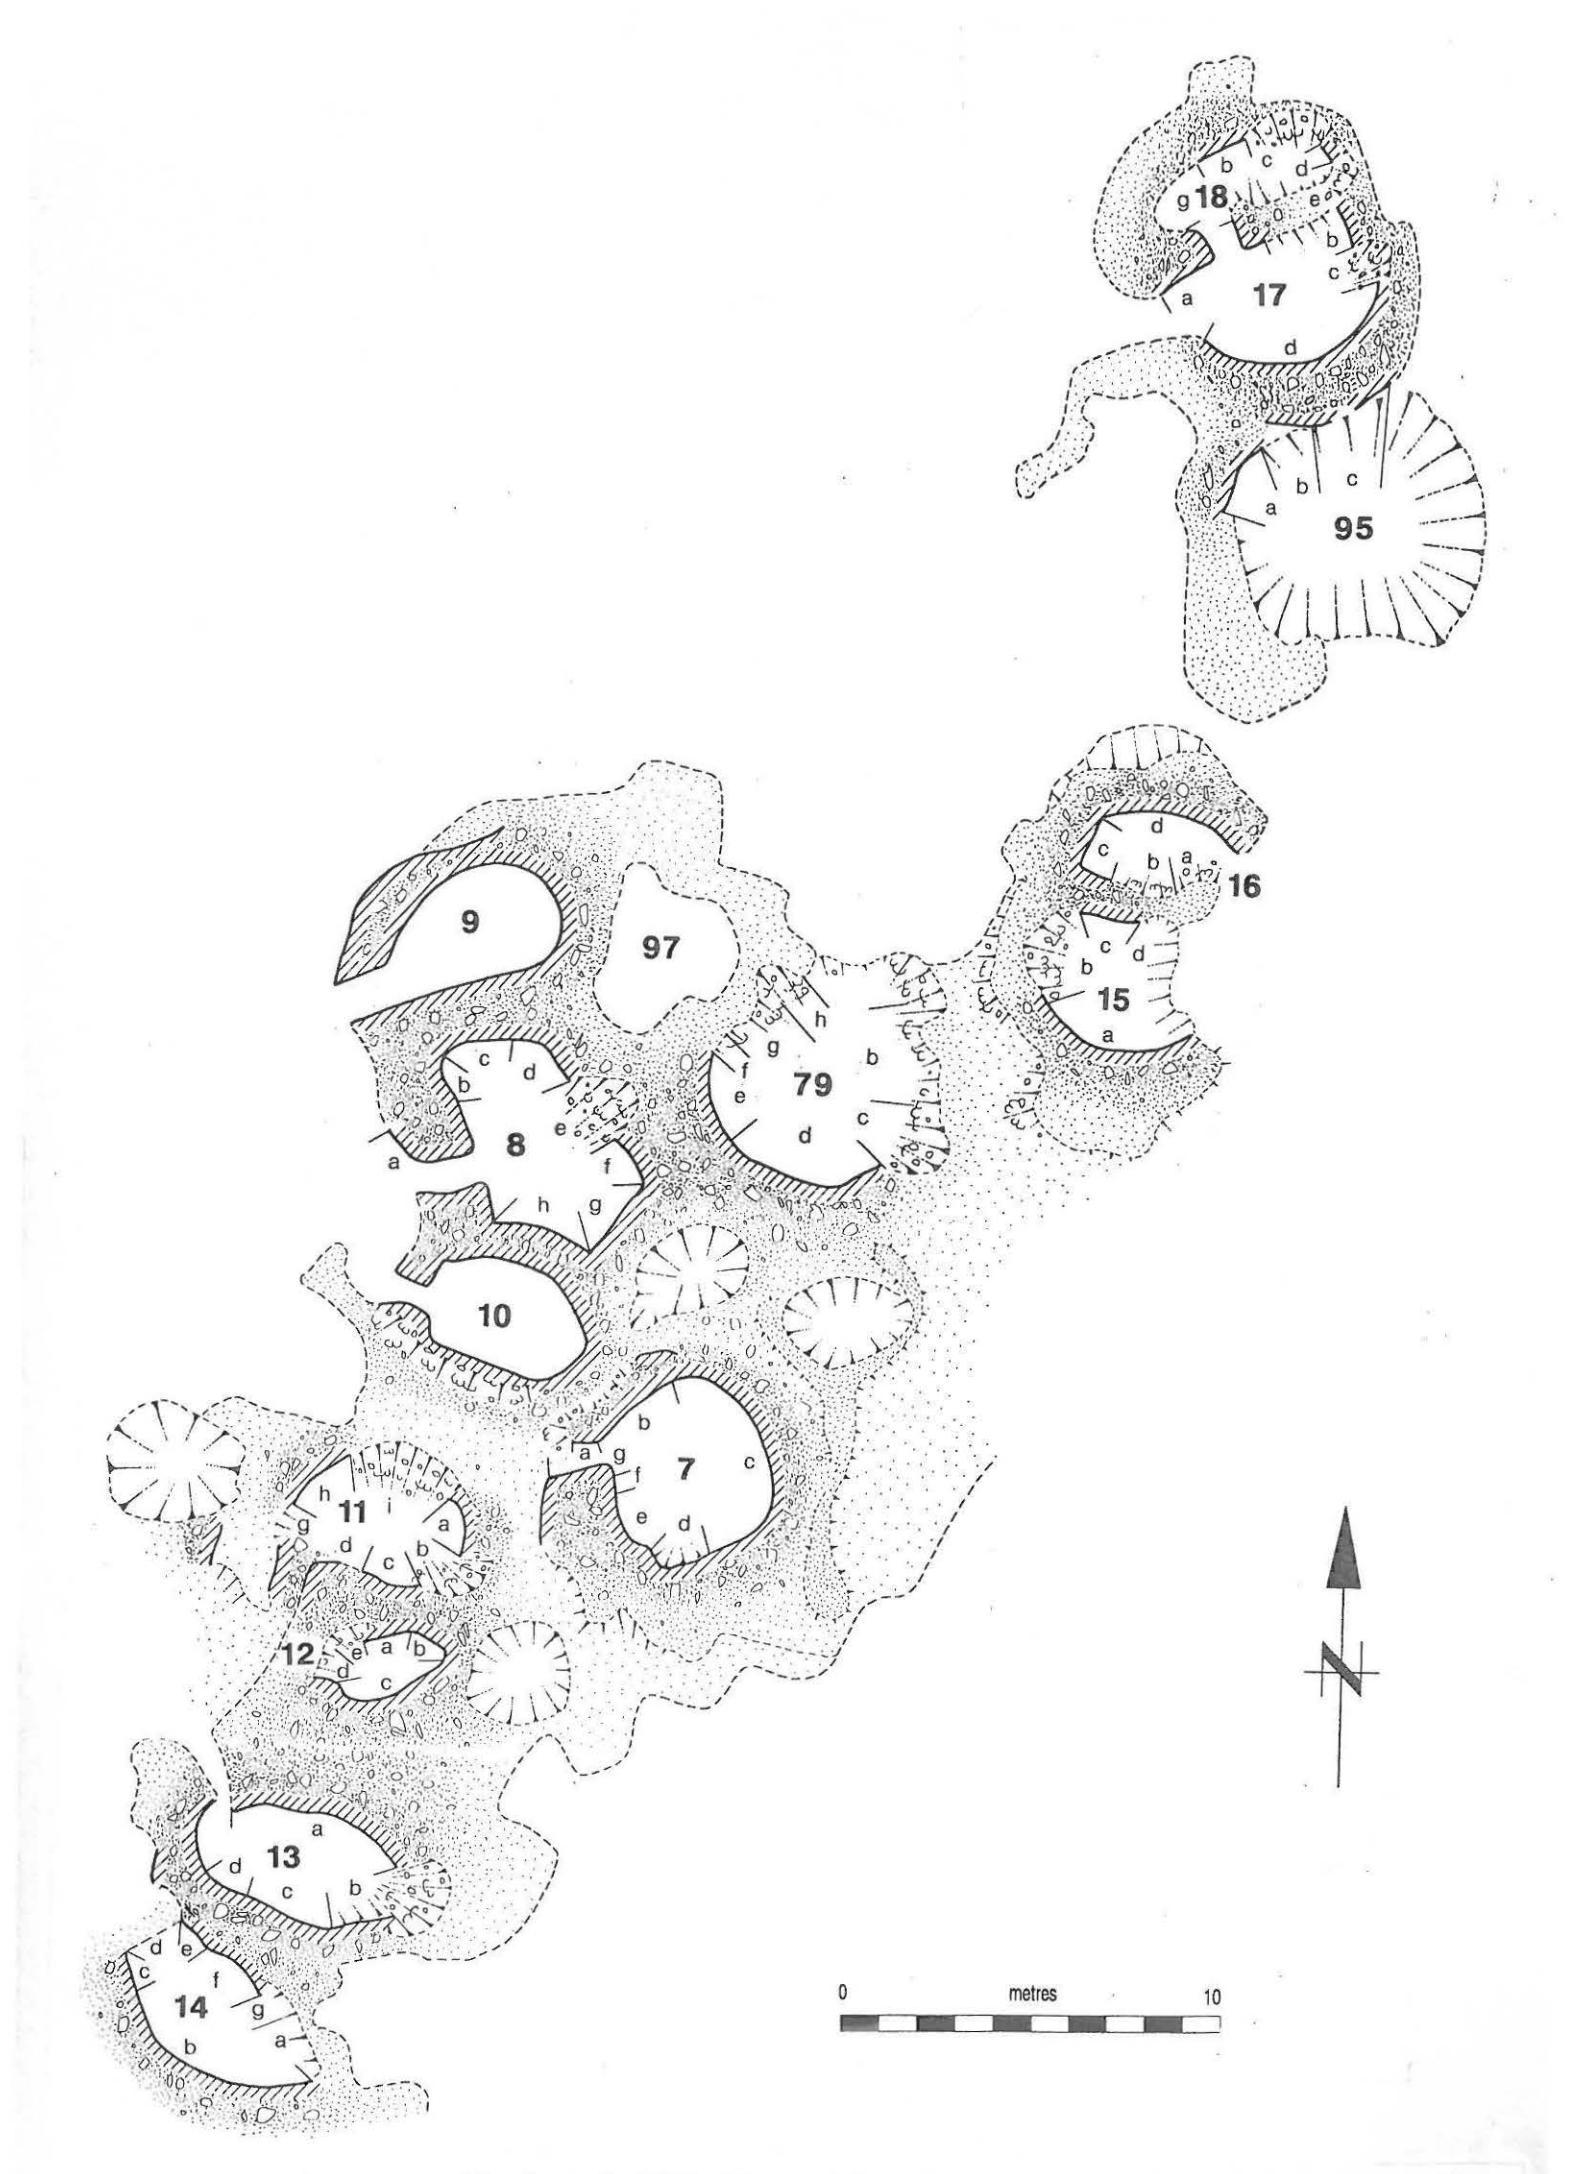
Fig. 8 - scale 1:200 - The central south-eastern group of huts before conservation.

Stone had spilled into the interior of the hut from this 2.0m wide collapse (Plate 138). There was no visible facing and there had been some recent erosion. The collapse was cleared and a rough basal course was found (Plate 139). New masonry was added to this, bringing the height of the face up to 0.8m (Plate 140).

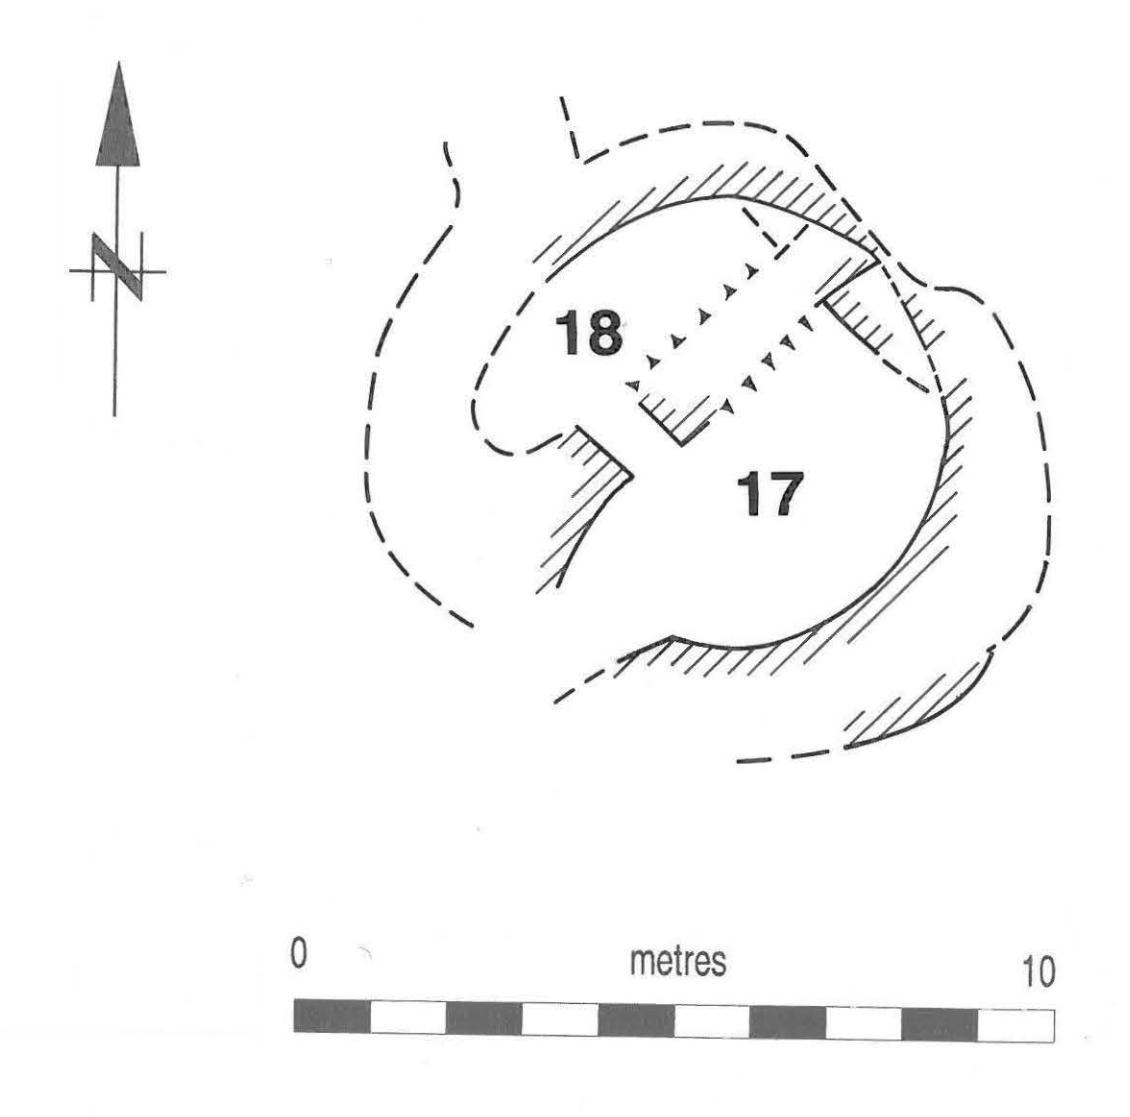
Fig. 11 Huts 17 and 18 after clearance

Plate 125 shows a general view of this feature taken from the inside of hut 18. Facing standing to a maximum height of 0.6m, could be traced on both sides of the passage. The south-east end of the passage was blocked by fallen stones. The facing in hut 17 to the south-west of the passage (17a) could be traced for 2m and was, despite its jumbled appearance, stable (Plate 126). The loose stone was cleared from around the entrance allowing the extent of its survival to be better assessed. Plate 127 shows the area after clearance. The facing on the south-west side of the passage (18a) was well defined at the south-east end but only the base of the wall had survived towards the north-west (Plate 128). The interior of hut 17 was full of turfed over stone and this end of the passage could not be seen. The *in situ* facing was stable so the collapse was cleared of fallen stone and new facing constructed up to a height of 0.8m (Plate 129). This also supported the masonry in collapse 17a (Plate 130).

The north-east side of the passage was less stable, several stones were marked and these are shown on Plates 131 and 132. One long stone (A) ran along the length of the passage. This appeared to have slipped off the base of the wall (B). Stones C and D were loose facing stones and E was a single stone that was balanced on top of the others. Stones C, D and E were taken from the wall and stone A was lifted onto the base of the wall. Stones C and D were reset close to their original positions. Stone E was turned through 90° and reset on the wall top. A number of other stones were added behind stone E thus producing a stable structure (Plate 133).

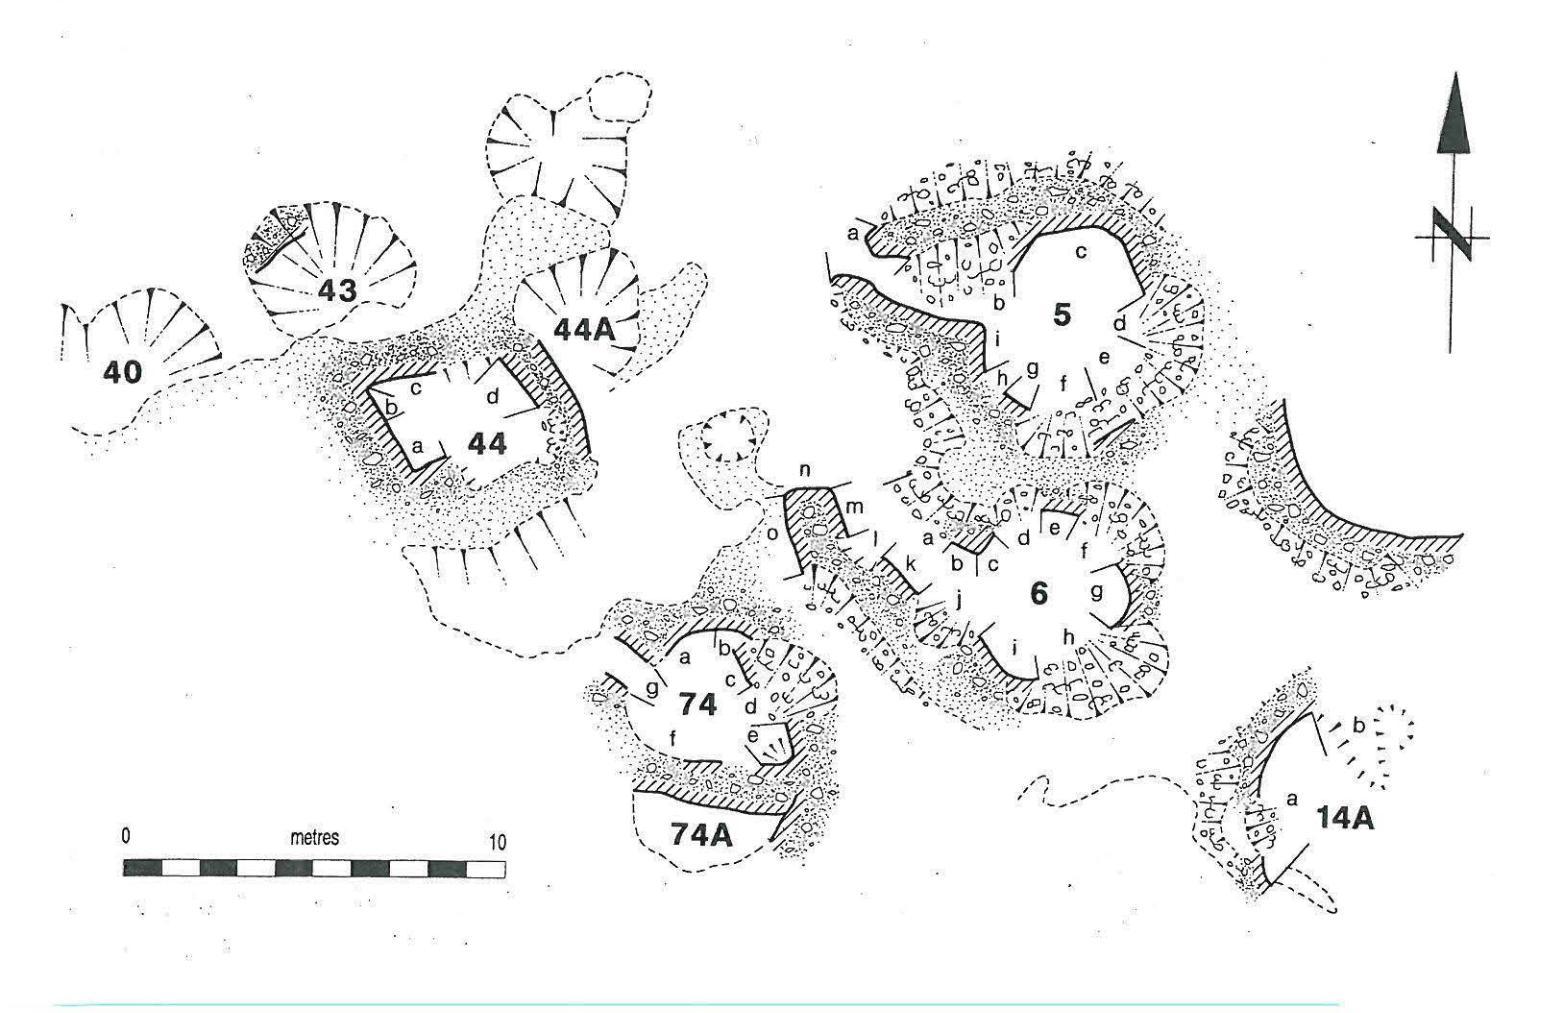
Fig. 13 - scale 1:200 - Huts 5,6,74 and 44 before conservation.

The entrance was visible as a dip in the north western wall with some surviving facing surviving on both sides. There had been some recent disturbance here and one large unweathered slab was lying in the passageway (Plate 364). A small amount of loose stone was cleared from the passage floor and the wall tops. The central part of the north-east side of the passage was well defined with facing surviving to a height of 0.4m most of which was below the level of the current passage floor (Plate 365). The inner corner appeared to have collapsed. As this area was reasonably stable and the hut had not been excavated there was no further clearance. The large slab from the floor of the entrance passage and several other stones were used to stabilise the top of the north-east side of the passage (Plate 366). The south-west side of the passage was secure and facing could be seen below ground level indicating that the entrance was 0.8m wide. No further action was taken here.

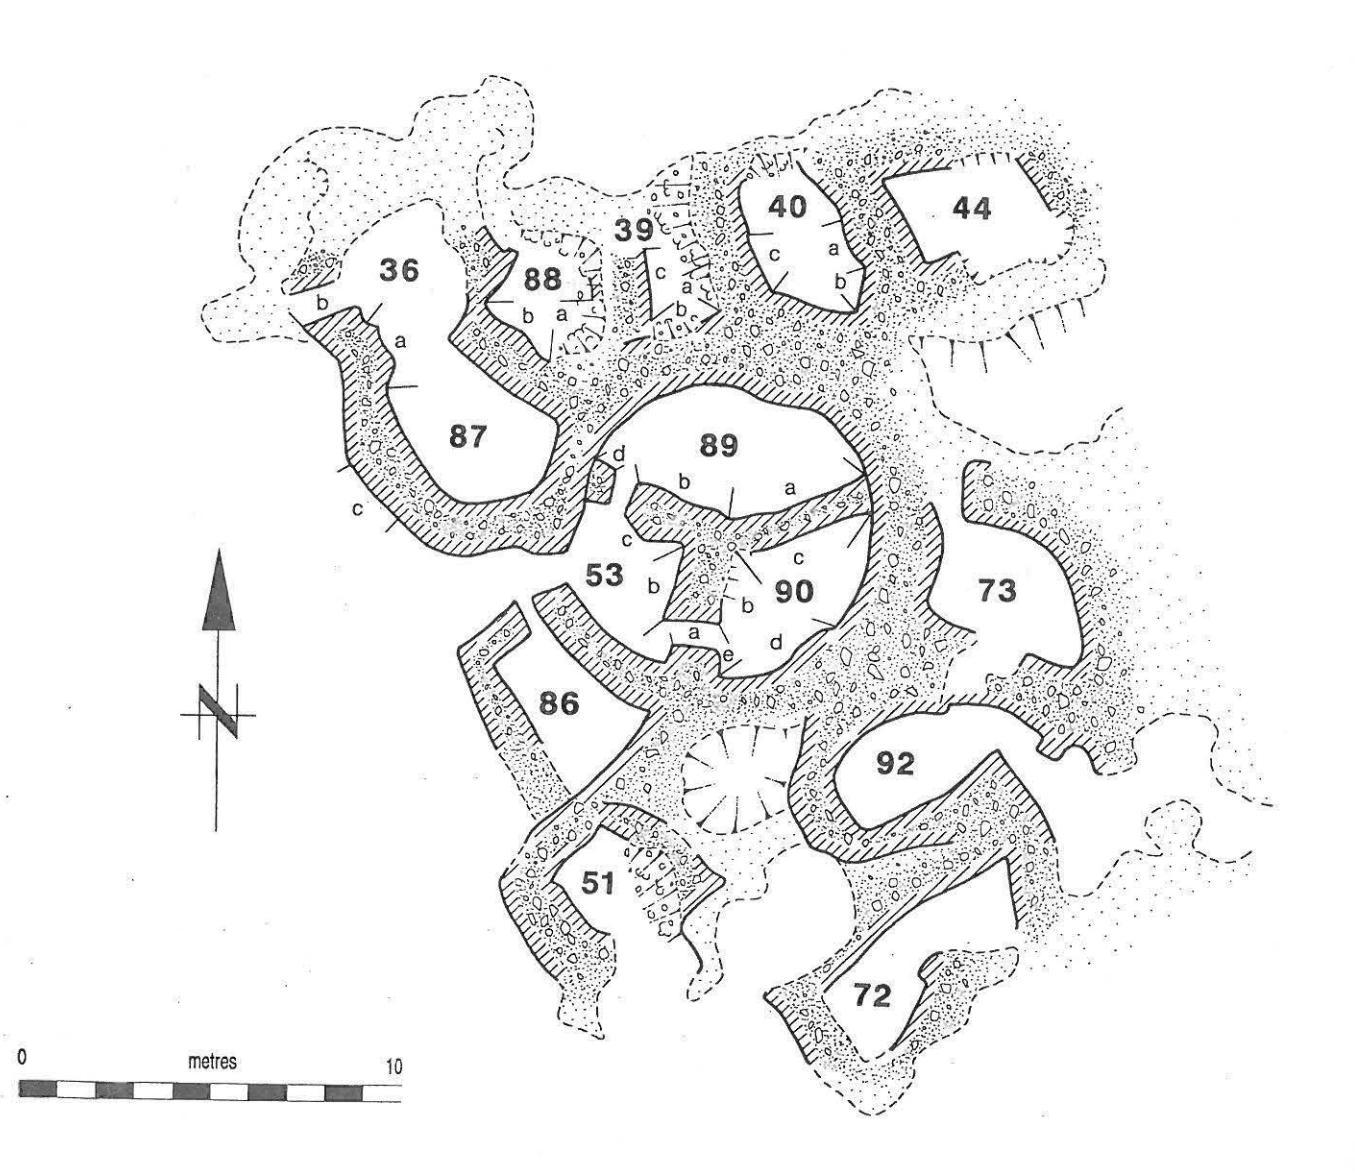
Fig. 17 - scale 1:200 - Huts centred around sub-divided roundhouse 53/89/90 before conservation.

The door jamb, a 0.6m long protrusion from the wall, was examined by Hogg in 1956. He stated that it was of one build with the outer wall. Only the basal course and one large but obviously displaced stone were visible at the beginning of the present season (Plate 423 between the horizontal scales). The large stone and some spilled core was cleared in order to provide a stable base for the addition of stable masonry (Plate 424). The roundhouse wall did not continue behind the jamb. This does not necessarily show that it was constructed at the same time as the roundhouse as stated by Hogg. There are signs of collapse in the base of the wall to the north-west and it is possible that the jamb was built in front of a partially collapsed wall. Other roundhouse subdivisions and blocking walls were built in front of collapses, the north-eastern end of hut 17 (collapses 17b and 17c) is a good example. This again suggests that the subdivisions were added to a severely dilapidated or abandoned roundhouse. A stable base was constructed and the large stone was reset. Two further stones were added to the jamb and three large irregular stones were added to the wall top in order to discourage visitors from using this as a point of access to the wall top (Plate 425). The wall is however very low in this quadrant of the hut and visitor management in the form of notice boards and way-markers is the only way of lessening erosion here.
