# LLANWNDA TO PENYGROES GAS PIPELINE

# ARCHAEOLOGICAL ASSESSMENT (G1493)

Report No. 267

prepared for British Gas Transco

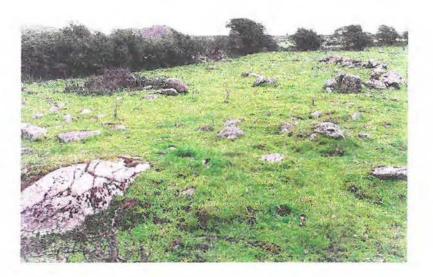
Site 15: Enclosure

#### 15. Possible Structures - SH48345465

Category E/B Impact: considerable

The south-east corner of Field No. 3069 is separated from the remainder by a terraced bank, below which is a large number of boulders. Although a definite pattern is difficult to trace, there do appear to be distinct lines and mounds which suggest the presence of former structures. North-west of this area is another probable settlement site (site 30 below).

**Recommendation for mitigatory measures:** Survey and limited examination perhaps combined with geophysical survey to gain a clearer understanding of the nature of the site, and to allow appropriate mitigatory recommendations to be made.

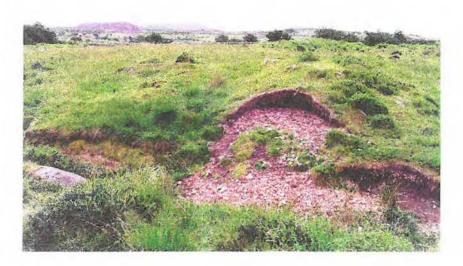
Site 29: Burnt mound

# 29. Burnt Mound - SH48295494

A burnt mound (PRN 1388) in the centre of field number 3300 on the south bank of a small stream running west to east across the field. The mound is crescent shaped with an opening facing the stream which is c.10m across and 5m deep. The east end of the mound is 1m high rising to 1.5m to the west. The mound has an overall diameter of c.13m.

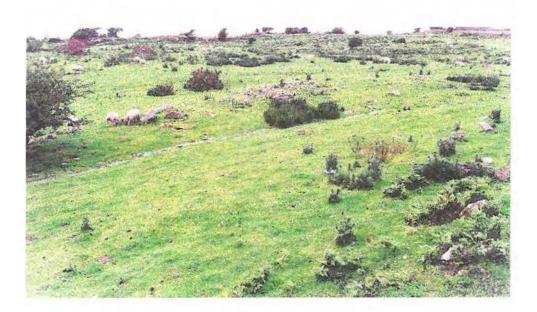
Site 21: Rectangular structure

#### 21. Remains of a Structure - SH47935332

Category C Impact: considerable

**Recommendation for mitigatory measures:** This site would need to be fully recorded by excavation if it were to be affected. It is therefore recommended that the pipeline avoids the structures.

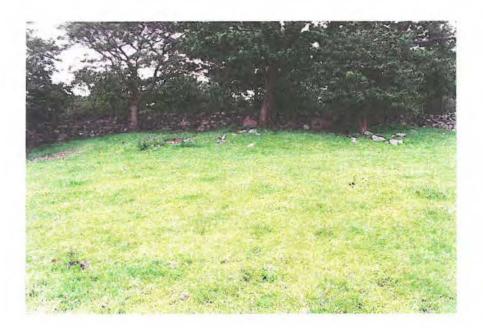
Site 25: Raised platform

Against the north-east boundary wall of field number 7917 is a raised rectangular platform c.15m long and c.8m wide. The platform is some 0.2m-0.3m high. There are three oak trees and one blackthorn growing on it, with several large boulders on the surface. It is probably the site of a former rectangular building, but there are no foundations visible. Its location would suggest it may have been a field barn, although a house site of medieval or early modern date is possible. There is a blocked entrance in the boundary wall adjacent to the road just to the west of the site.

**Recommendation for mitigatory measures:** Avoid if possible, otherwise record and investigate in advance followed by a watching brief.
