**BANGOR CITY LINKS  
MEMORIAL SQUARE**

**ARCHAEOLOGICAL RECORDING & WATCHING  
BRIEF**

**REPORT NO. 315**

**Ymddiriedolaeth Archaeolegol Gwynedd  
Gwynedd Archaeological Trust**

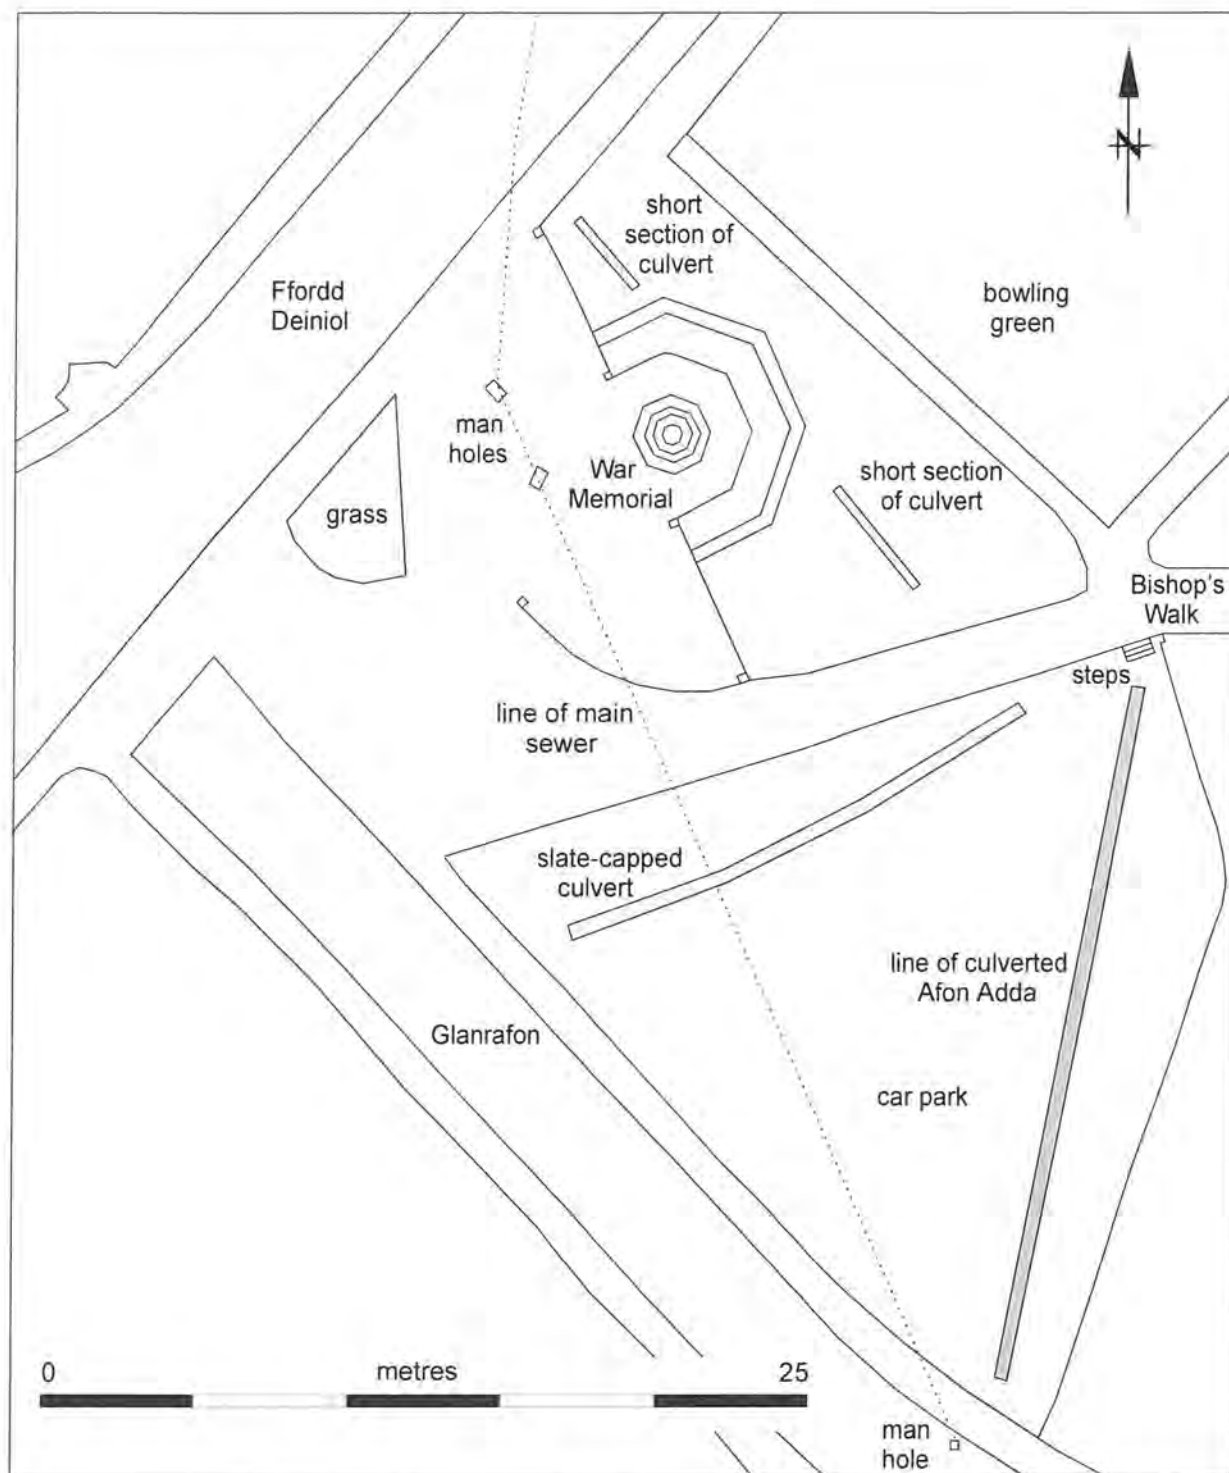
Fig 1: Location of features at Memorial Square - Bangor

During the refurbishment it was possible to ascertain the alignment of various features traversing Memorial Square. This was achieved through observation and from the study of a topographical survey produced by Digital Mapping Surveys which was supplied by Cyngor Gwynedd. Chris Burns of Cyngor Gwynedd supplied a tracing of the culverted river and the slate-capped drainage feature which were superimposed on the topographical map. These were then digitised and redrawn to produce Fig 1 which shows the location of significant features.

towards the east although the exact angle has not been established. The alignment of a 22m section of the 0.23m diameter pipe carrying the culverted Afon Adda is illustrated in Fig 1.

It was also established that the current main sewer ran north from a man hole in Glanrafon, under two man holes to the west of the War Memorial and on towards Ffordd Deiniol. Under Ffordd Deiniol it joined another main sewer running south-west to north-east in the direction of Theatr Gwynedd. The approximate alignment of this feature, consisting of a large brick-lined tunnel at a depth of c. 8m, is shown in Fig 1

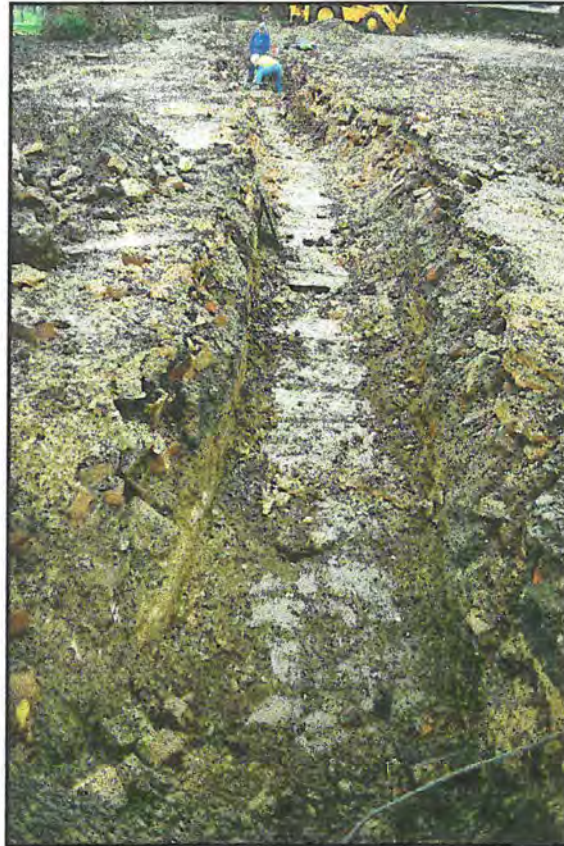
A stone culvert was identified and exposed by machining in the old car park a few metres to the south of Bishop's Walk. A 16m length of this feature was exposed running east west roughly parallel to Bishop's Walk and curving slightly to the south. It was located 1m below the present ground surface and consisted of a stone built culvert 1.1m wide externally and 0.5m wide internally. A small section of the culvert was cleared of accumulated silt by hand and found to be 0.43m deep with a slate base. The side walls of roughly built stone were cemented using a lime mortar. The culvert was capped using dressed slate slabs 1.1m long by 0.4m wide and 3-4cm thick. This feature, which is illustrated in Plate 1 and Fig 1, was not disturbed during the refurbishment work. From the position and direction of this culvert it is likely that it was constructed in the 19<sup>th</sup> century to drain into Afon Adda.

Plate 1: Slate-capped culvert viewed from the west

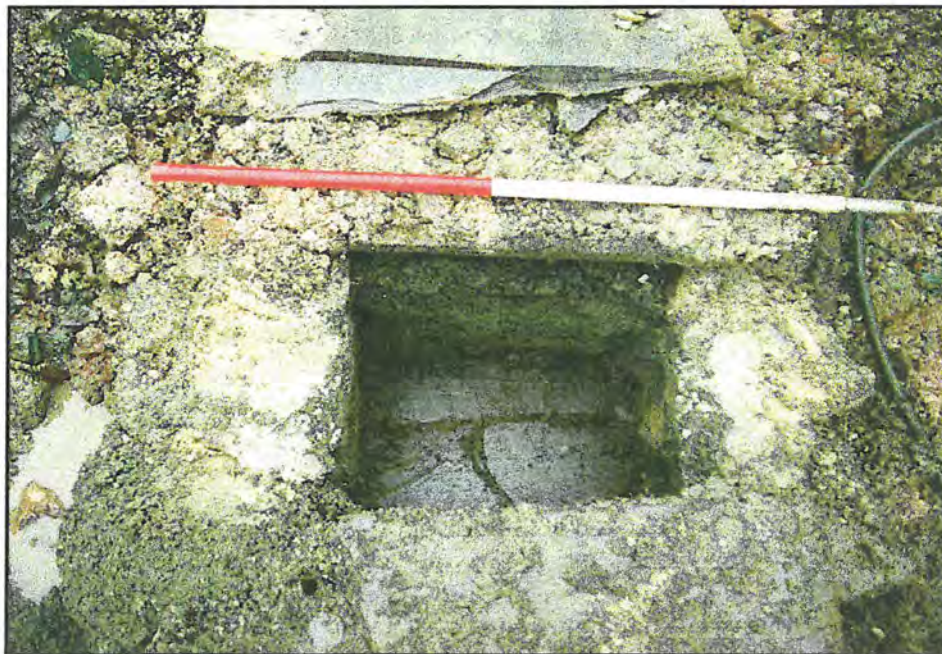
Another section of drainage culvert was excavated a few days later to the north of Bishop's Walk located between the War Memorial and the bowling green. A 4m length of narrow culvert, 0.25m wide, was exposed during machining 3m to the south east of the War Memorial steps. It was overlain by 1m of mid-brown stony soil and ran north south. The sides were roughly built of mortared stone and slate and the top was capped with flat stones of irregular shape which were mostly of slate. There was water in the culvert running in a northerly direction and sediment to a depth of c. 0.6m but it was not excavated further. Originally Geotec Terram sheeting was laid on top of this feature and the area back-filled but the area had to be excavated to a greater depth later in the scheme and this feature was destroyed. The culvert is illustrated in Plate 2 and its location is indicated in Fig 1.

Plate 2: Interior construction of slate-capped culvert

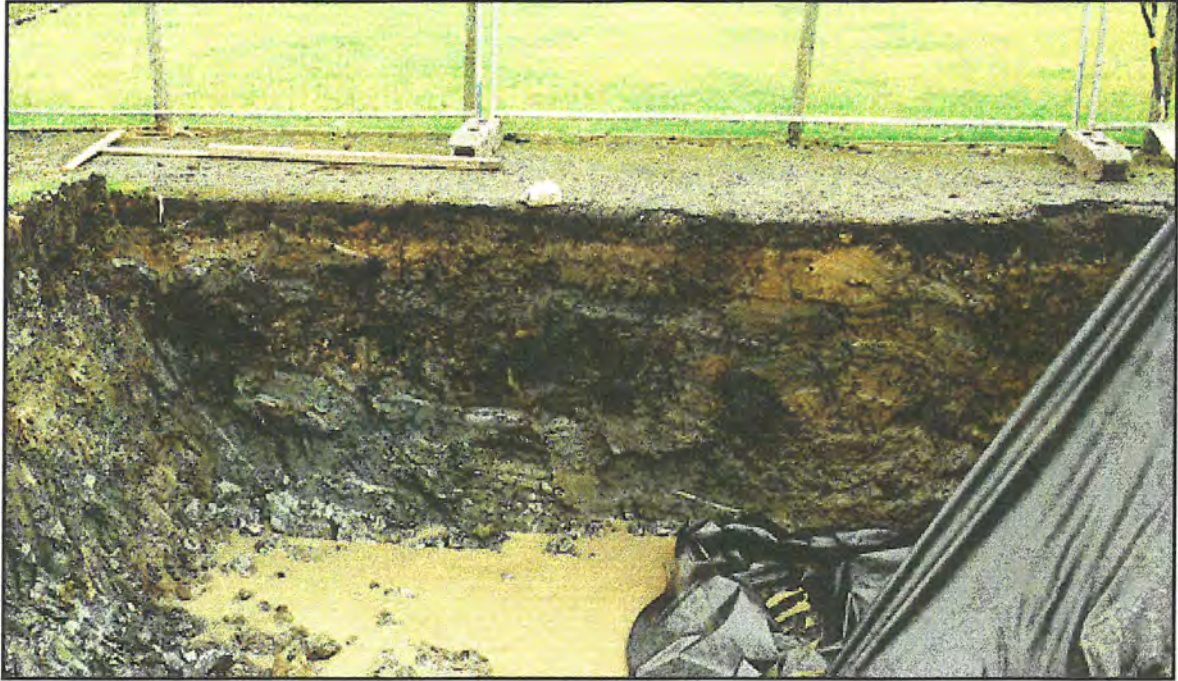
The area to the south of Bishop's Walk (the site of the car park) was found to consist of rubble infill to a depth of at least 1m. To the north of Bishop's Walk between the War Memorial and the Bowling Green the natural subsoil was exposed below a few centimetres of top soil. The subsoil consisted of an orangey clay with grey silt inclusions and lenses overlying pockets of grey river gravel. The subsoil was excavated to a depth of up to 1.8m and plastic Geotec Terram sheets were laid on the exposed surface. Slate waste was then spread on the Terram and the cavity was filled to the surrounding surface level with small stones. Beneath the retaining wall, running north south from the edge of Deiniol Road to the north side of the War Memorial, a water source was exposed during excavation which produced a constant flow of greyish water. This water source was presumed to be natural and was subsequently channelled into a drainage pipe running along Bishop's Walk.

Plate 3: Natural subsoil below path to the west of the Bowling Green

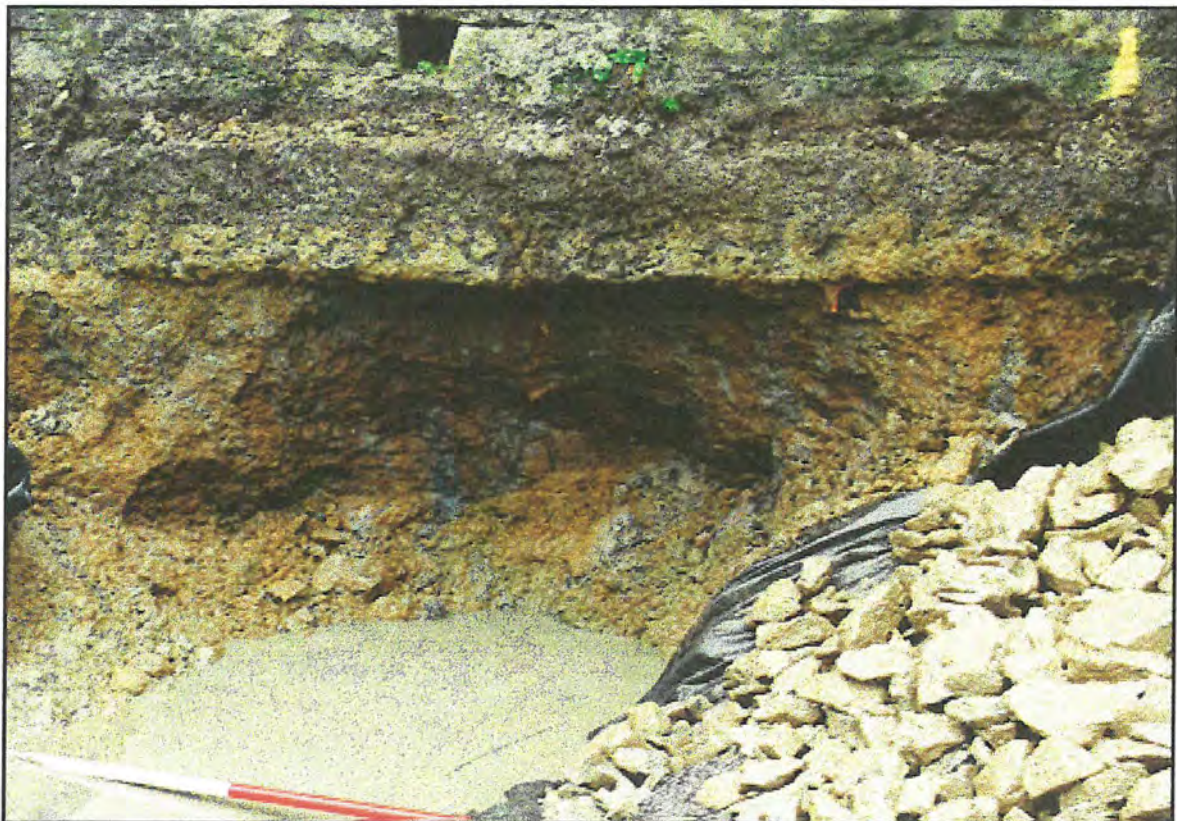
Plate 4: Natural subsoil and water ingress below the retaining wall to the north of the War Memorial
