TRE'R CEIRI MONITORING VISIT

20TH AUGUST 1999

Report number : 336

GWYNEDD COUNCIL

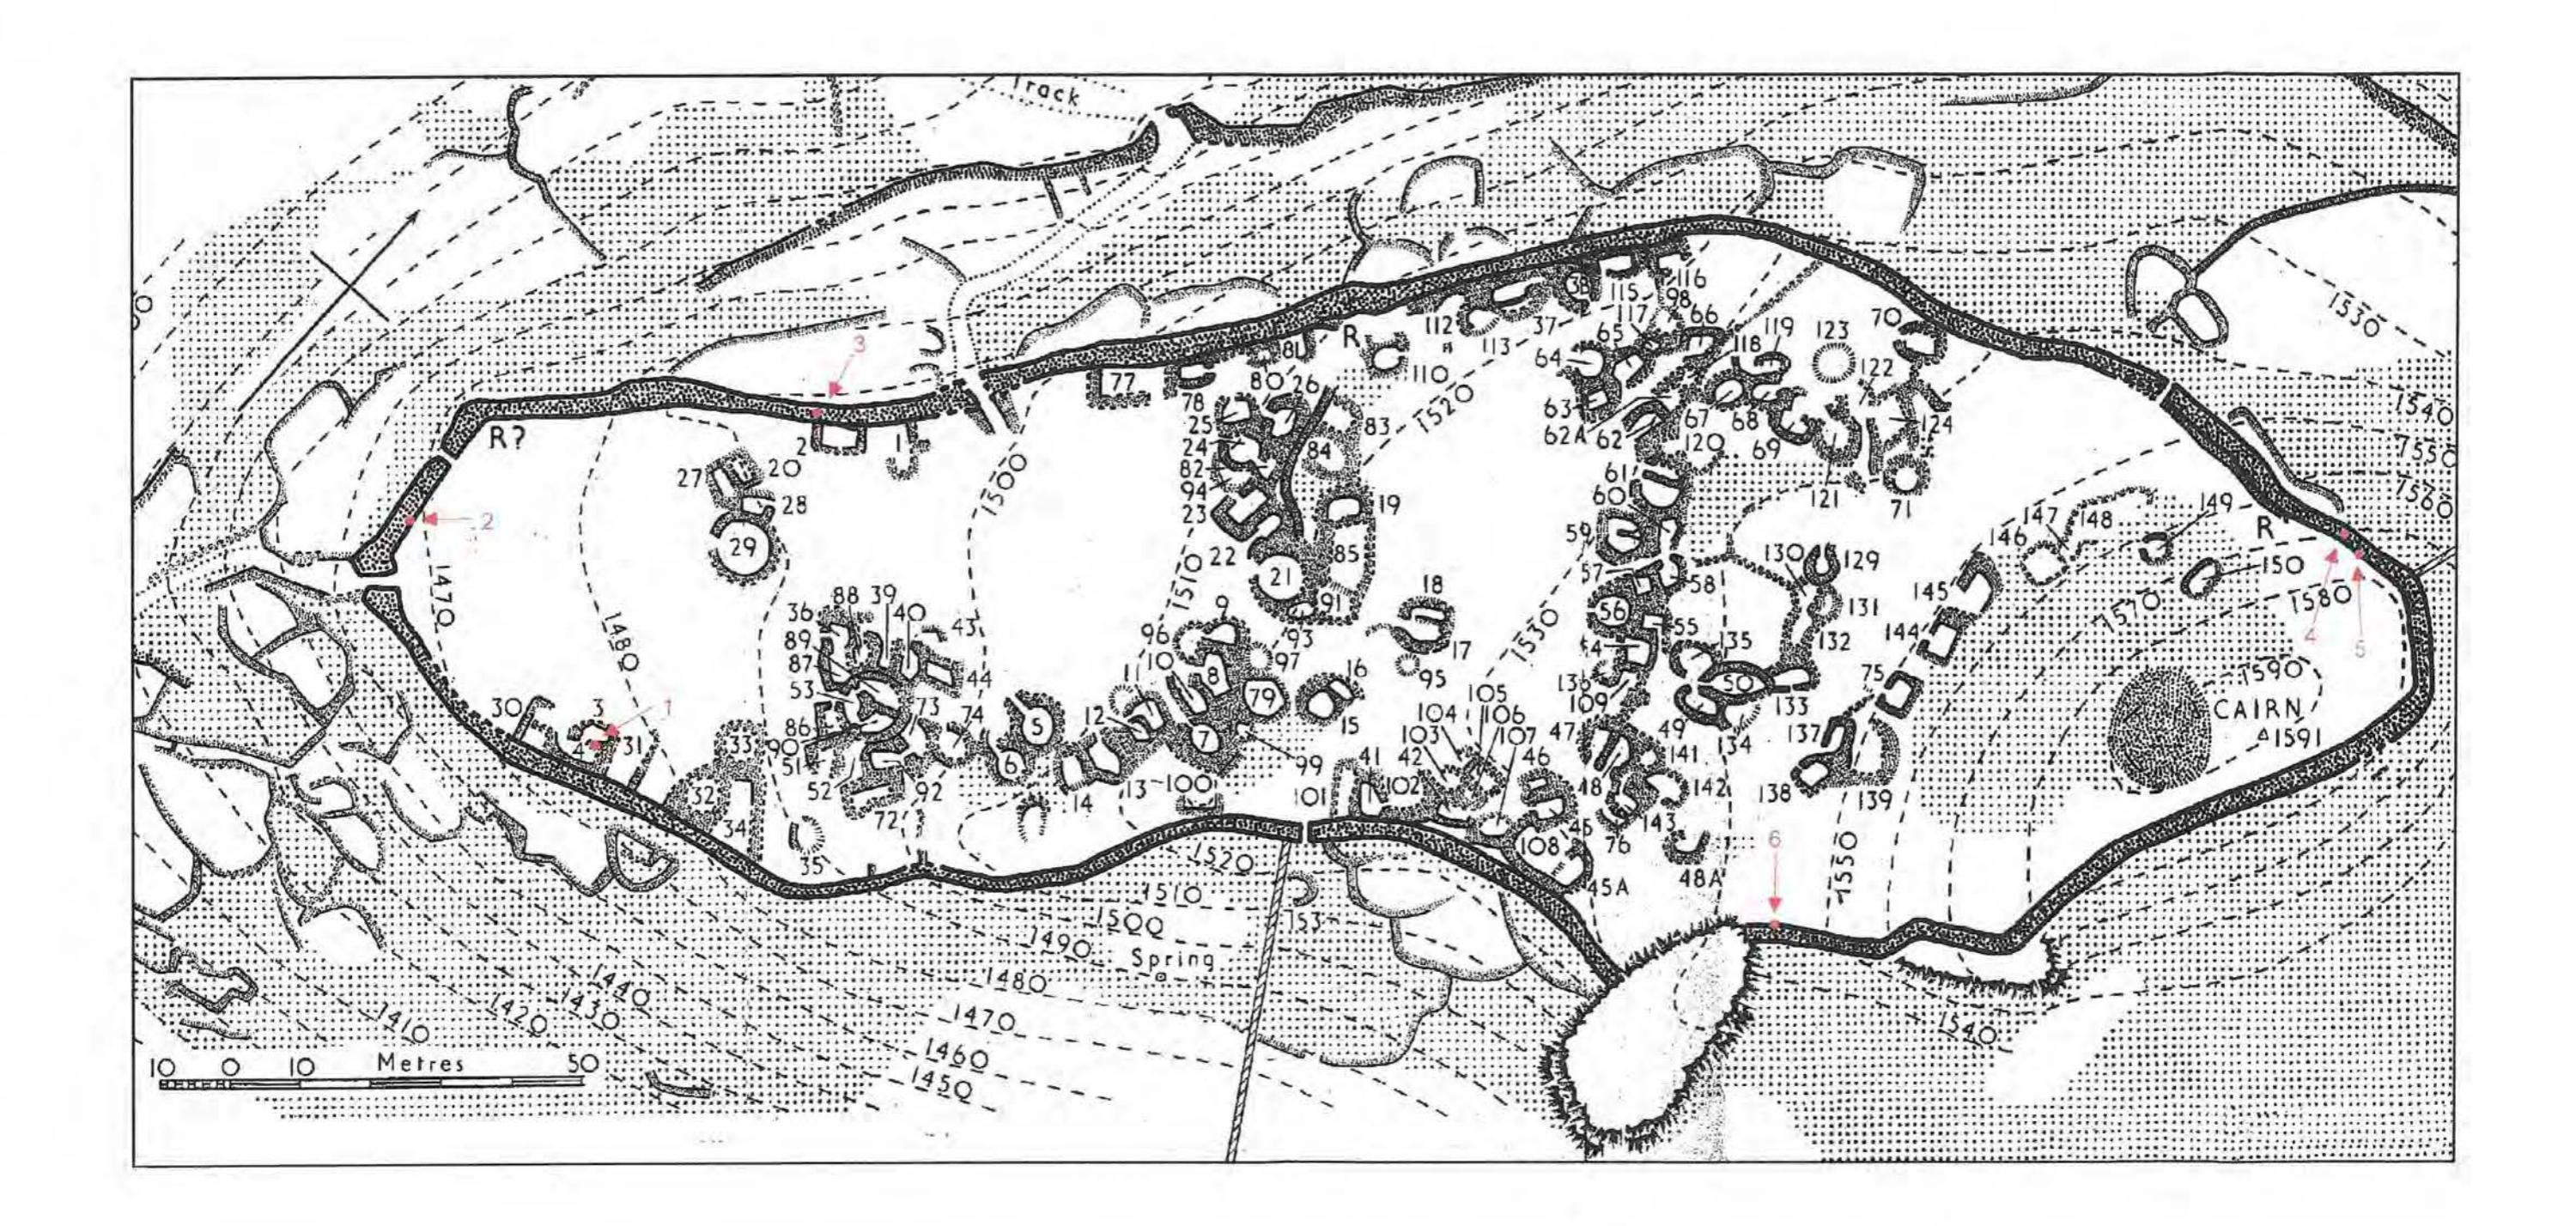
The following minor areas of damage were identified and were marked onto a plan of the site (Fig. 1). All were minor and in areas of reinstated masonry. No original masonry had been affected. Written records were kept of all works. No further recording was necessary as all but one of the areas of damage were stabilised by minor adjustments to the wall core.

1. A facing stone on the top of the dividing wall between huts 3 and 4 had become loose due to a small area of erosion in the core. This was an area of previously rebuilt masonry. The core was repacked thus stabilising the facing stone.

Five areas of instability were identified, all of which appeared to have been caused by visitors walking along the tops of the rampart.

2. A stone was beginning to work loose at the top of the inner facing 8m to the north of the south-west entrance. The stone was left in place and a few small packing stones were inserted into the core behind it.

3. The action of visitors walking along the wall top had caused a patch of wall core to become loose. A few loose stones that were causing the instability were repacked into the core.

4. The rampart travels up a steep slope at this point and the wall core was beginning to become unstable due to the affect of visitors scrambling up this vulnerable area of the rampart. This area had been stabilised during the site review at the end of season 10 of the conservation project.

5. A packing stone had fallen out of the wall at this point, causing a large stone on the edge of the wall to rock when trodden on. Loss of this stone would have led to instability in the upper facing, wall top and original parapet. The missing stone was lying in front of the wall and was reinserted into its original position thus stabilising the wall top.

6. A single stone had slipped forward from a previously conserved length of inner facing just to the northeast of the large outcrop that breaks the line of the rampart at its south-easternmost point. The stone was pushed back into its original position.

Fig.1 Tre'r Ceiri showing points of instability identified during the monitoring visit (after R.C.A.H.M.W. 1960)

The loose stones were packed back into the wall core. This section of the rampart will obviously have to be observed carefully during future monitoring visits.
