YMDDIRIEDOLAETH ARCHAEOLEGOL GWYNEDD GWYNEDD ARCHAEOLOGICAL TRUST

REPORT ON THE TENTH SEASON OF THE TRE'R CEIRI CONSERVATION PROJECT JUNE TO NOVEMBER 1998

D. HOPEWELL

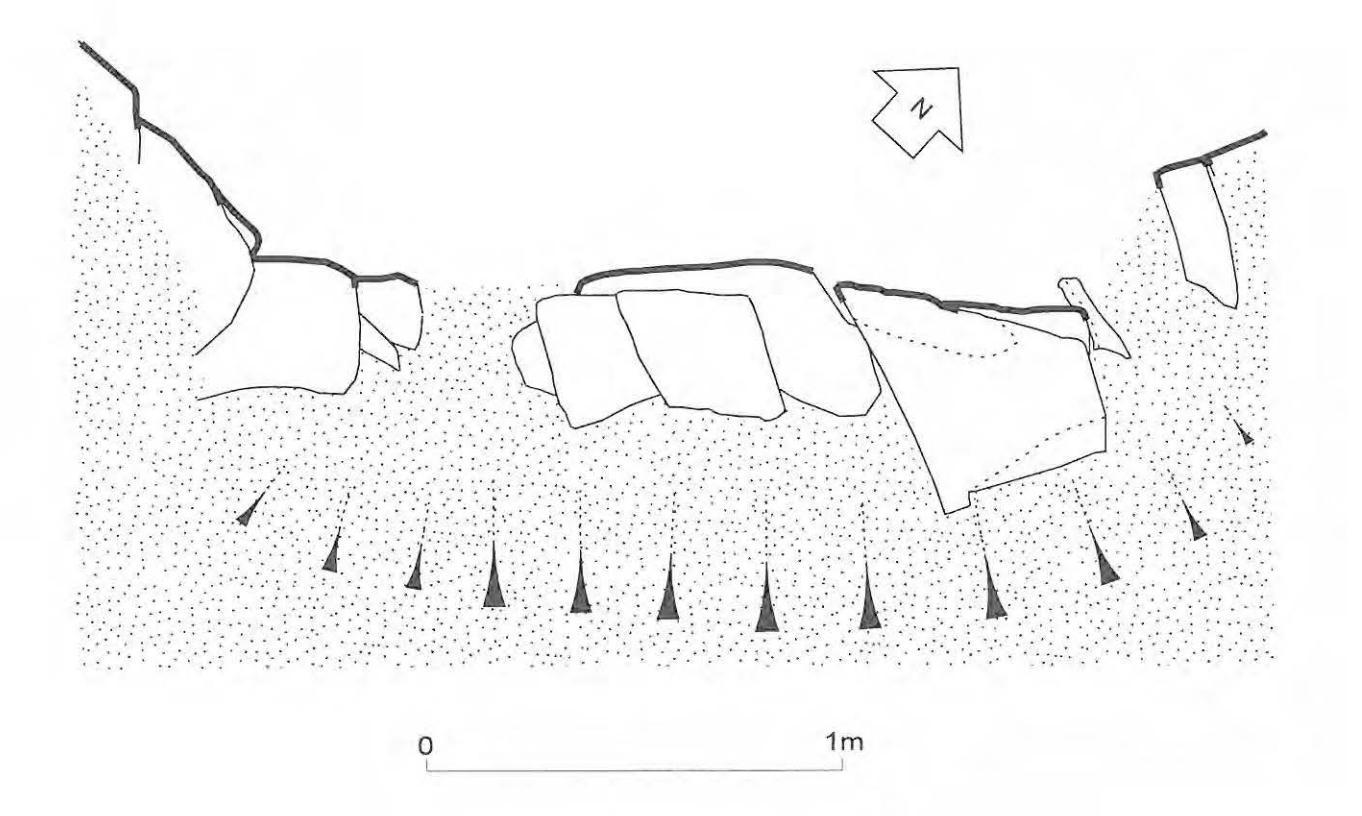
Fig. 5, Collapse 56c after clearance.

The rest of the collapse was cleared revealing a convincing basal course across most of the collapse (Fig. 5 and Plate 40). No reason for the collapse was discovered during clearance but the level masonry at the base of the wall showed that it had not been undermined. New masonry was added above the *in situ* basal course (Plates 41 and 42). The off-line facing at the northern end of 56c was not disturbed and was left as a bulge in the base of the wall.

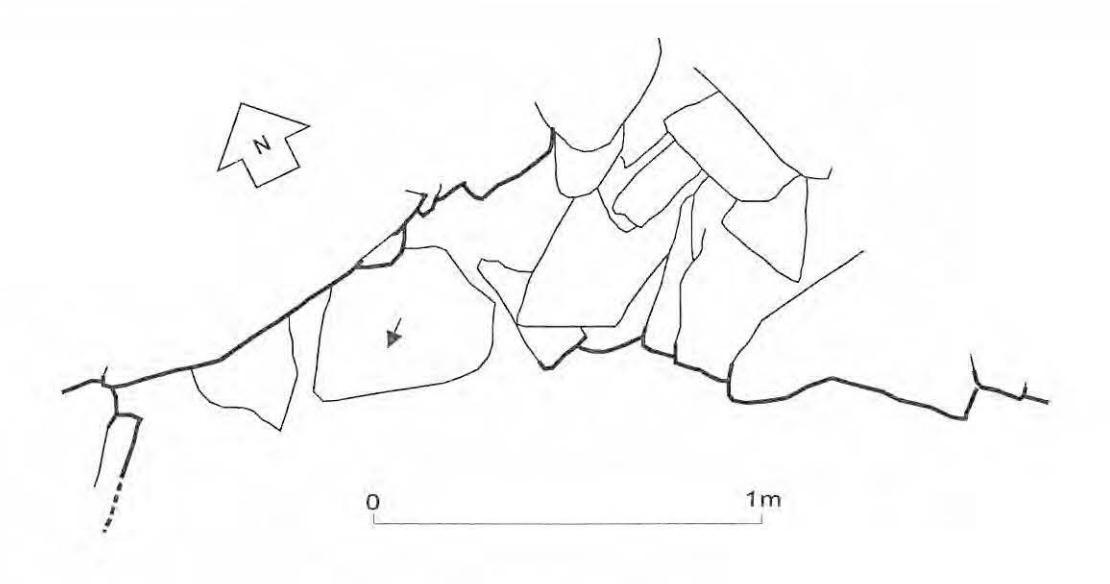
Fig. 11, Collapse 60b after clearance

A 0.6m length of facing had collapsed to close to ground level at the northern end of the hut (Plate 107). This appeared to have been caused by a failure at the base of the wall as an off line basal stone could be seen beneath the collapse.

The fallen masonry was cleared revealing the off-line and forward-sloping basal stone (beneath the lower scale, Plate 108). Behind this was a 1.0m length of reasonably well-defined facing running obliquely into the wall (Fig. 11). The upper 0.5m of this facing was quite clear but the base of the wall was jumbled and unconvincing. No further facing could be seen running into the wall beyond this point. The facing could be the remains of an earlier phase of building in this hut; the angular northern end of the hut suggests that modifications may have been made at some time in antiquity. The lack of a convincing basal course however must cast some doubt on this hypothesis. The lower part of the wall could have been lost due to the wall being undermined but it is also possible that the short length of surviving facing was originally a temporary revetment designed to retain the scree while the hut wall was being built (This type of detail has been observed in several other huts, see collapse 59b below). The fact that the facing is continuous with the main hut wall does suggest that the first hypothesis is correct as all other temporary revetments so far observed have been set back into the wall and separate from

The off-line basal stone was reset in a level position and a new panel of facing was built following the line of the extant hut wall (Plate 109).

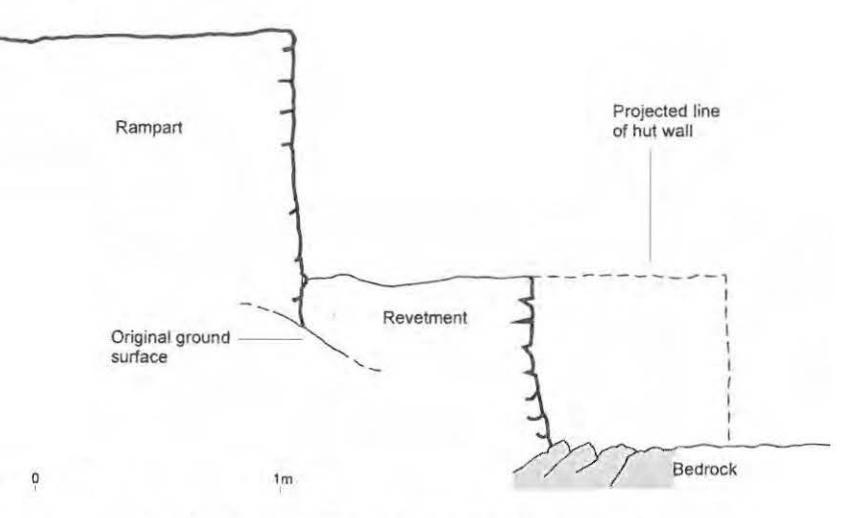
Fig. 31, Profile across hut 70 and the ramparts

A small amount of clearance was undertaken in front of the rampart behind the newly uncovered face exposing a 1.0m length of rampart and what appeared to be the original ground surface (Plate 363). The rampart did not continue down behind the facing for more than 0.25m. All of the stones in both the rampart and the ground surface were rounded and well weathered, showing that the rampart had been exposed to the elements for some time before the wall had been built in front of it. The characteristic rounded appearance of the stones was similar to that of the exposed rampart elsewhere in the fort except for the lack of grey crustose lichen that covers almost every exposed stone on the mountain. This lichen is the climax phase of vegetation on the scree and careful examination of areas that are known to have been disturbed by excavation show that it takes at least 70 to 100 years to become fully established. The lichen penetrates the surface of the stone which eventually breaks down (Syers and Iskandar, 1973).
