## **Dorothea Beam Engine House**

## **Archaeological Recording**

## Report No. 397

Prepared for Cyngor Gwynedd Council

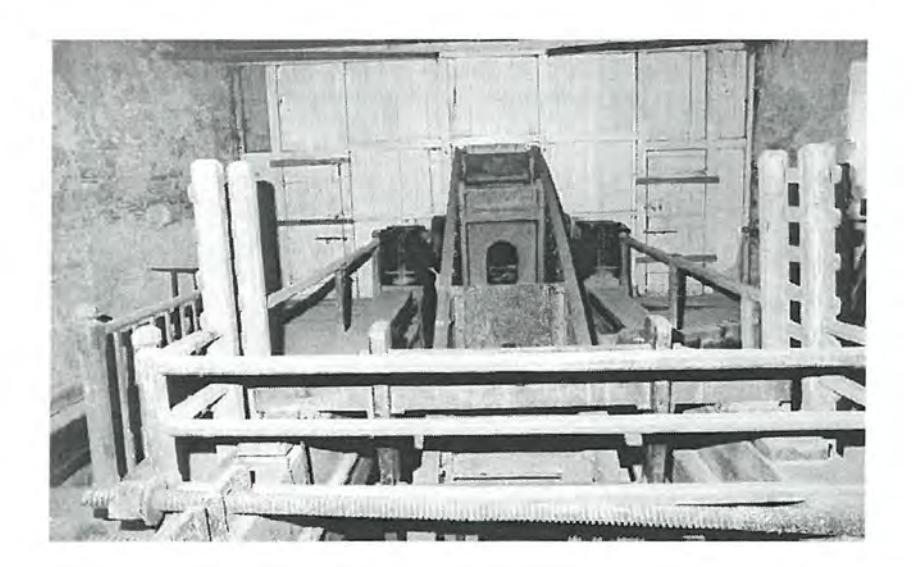
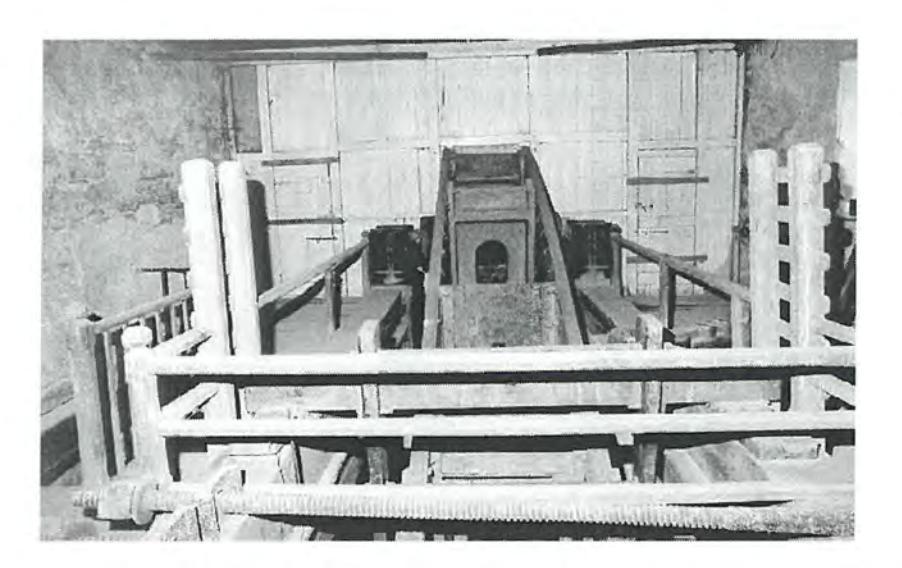
plate 1. The wrought iron beam. vie w from east

plate 1. The wrought iron beam. view from east

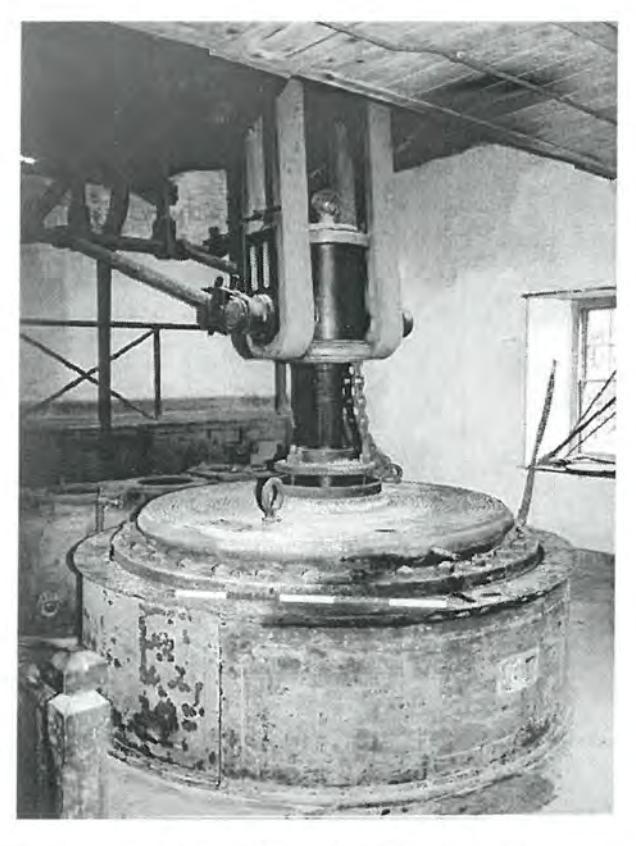
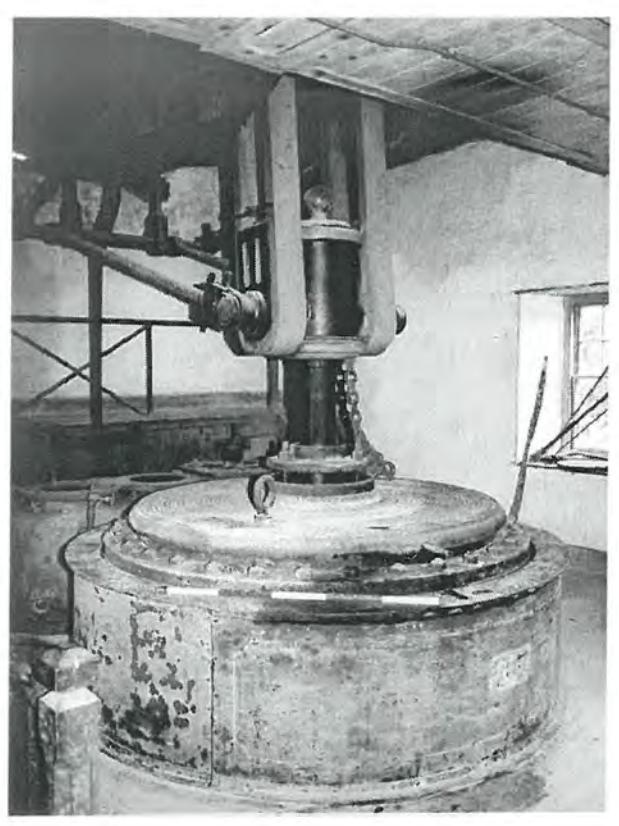
plate 2. The cylinder head, piston and linkage . Cylinder still enclosed. vie w from south east

plate 2. The cylinder head, piston and linkage. Cylinder still enclosed. view from south east

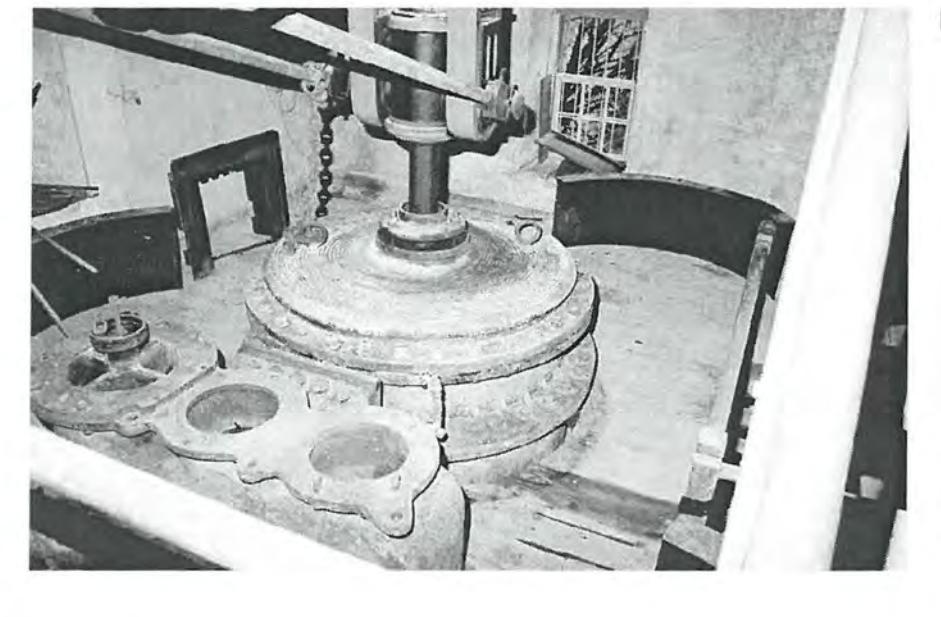
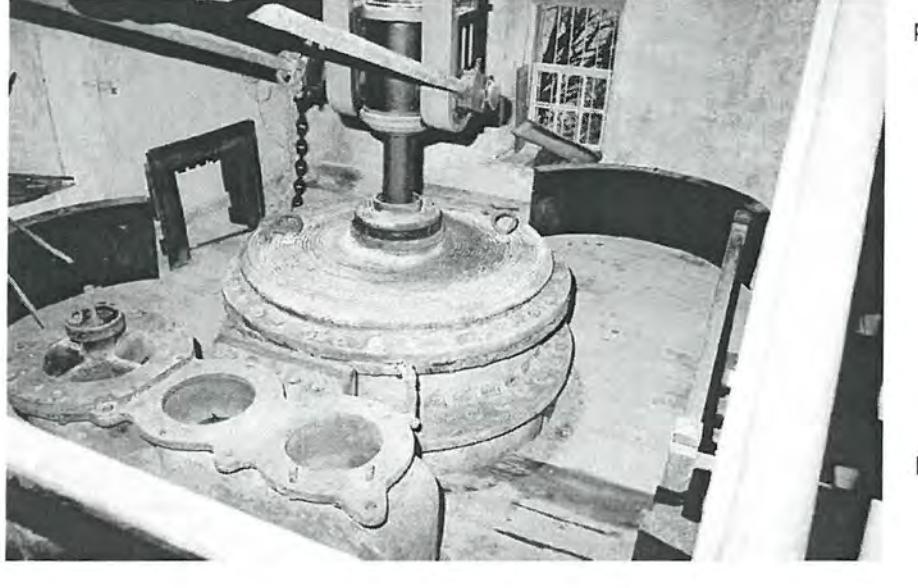
plate 3. The cylinder head, piston, linkage and v alve chamber, cladding remo ved. vie w from south east

plate 3. The cylinder head, piston, linkage and valve chamber, cladding removed. view from south east

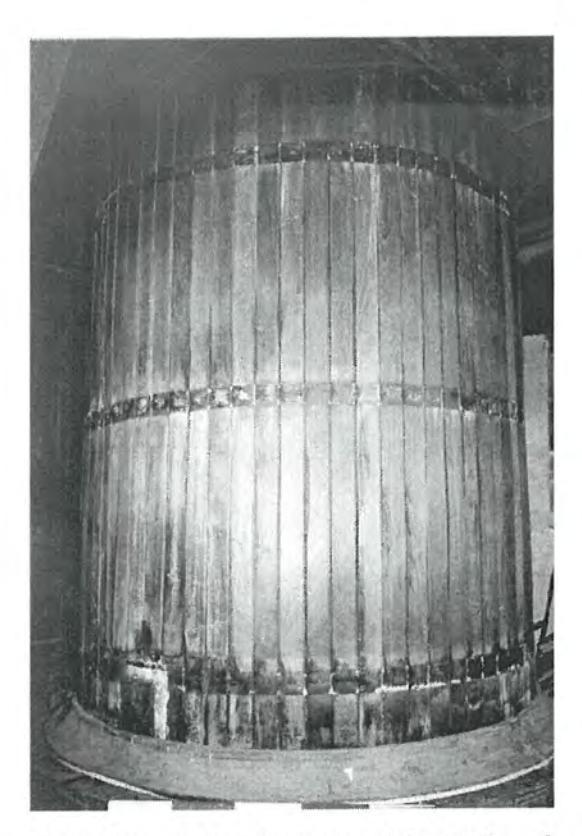
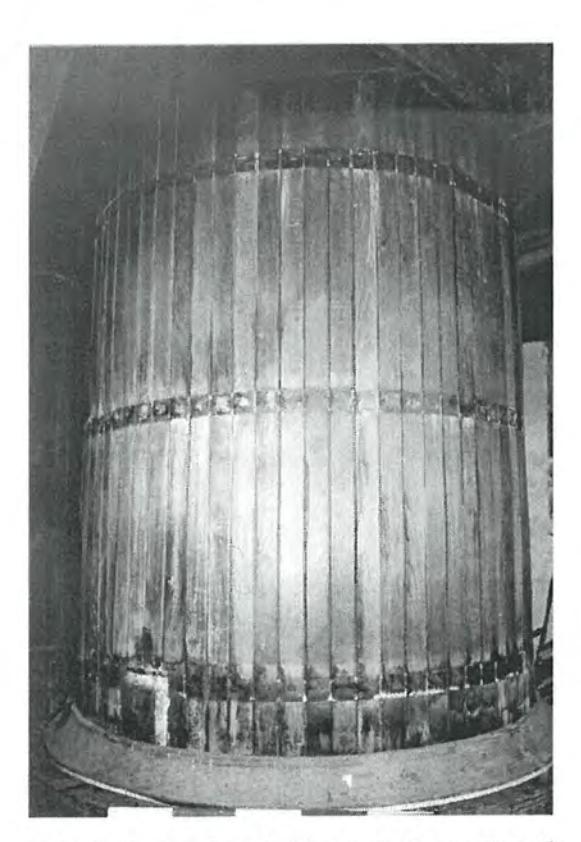
The lower floor casing (which is the main subject of this report) comprised three curving sections of lapping equal sized steel plate, with a shorter section of flat plate completing the circuit adjacent to the adjoining pipes to the rear of the cylinder. Attached around the periphery were five covers for the cylinder anchors in the floor. The main body of the cylinder was clad by vertically set wooden staves that interlocked by means of a steel tongue set into grooves running the length of the edge of the staves. These had been held in place by three metal bands that had encircled the cylinder but were now missing.

plate 4. The enclosed cylinder. Note location of missing bands . View from east.

plate 4. The enclosed cylinder. Note location of missing bands. View from east.

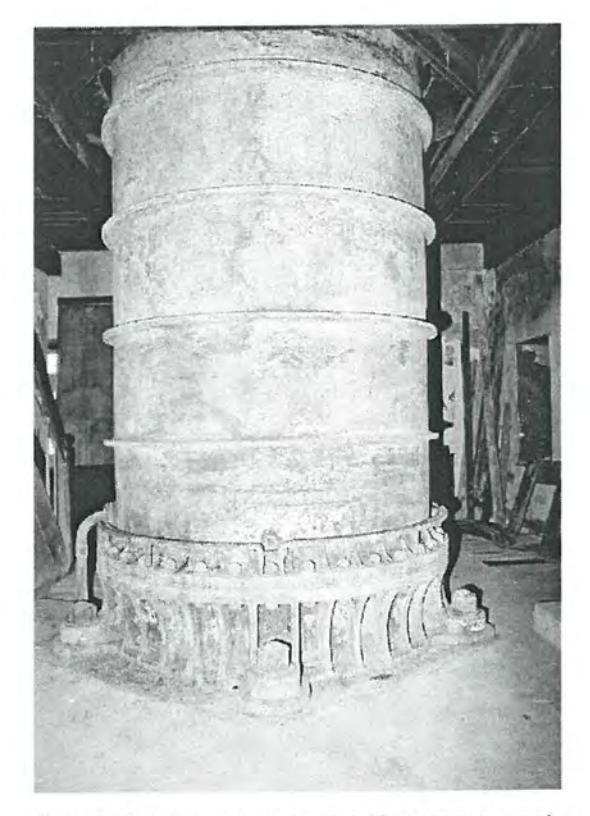
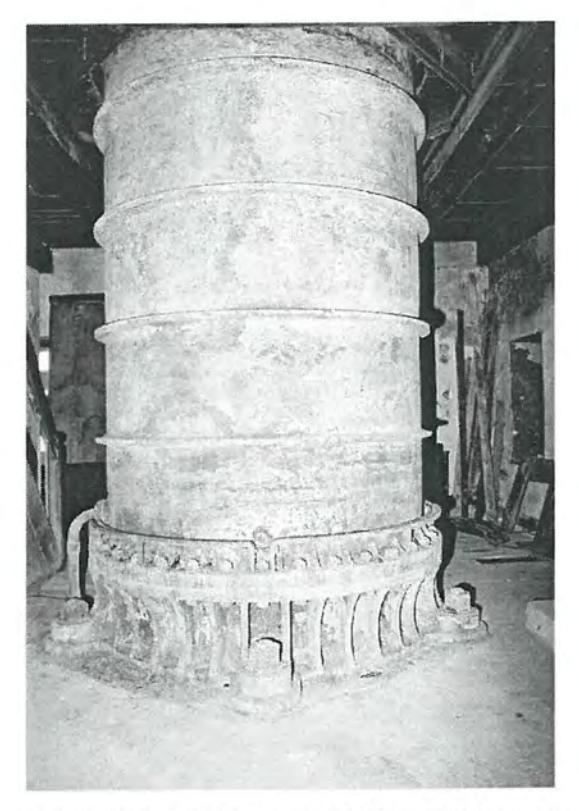
plate 5. The cylinder revealed. Note trap to cockpit at centre r ight. View from east.

plate 5. The cylinder revealed. Note trap to cockpit at centre right. View from east.

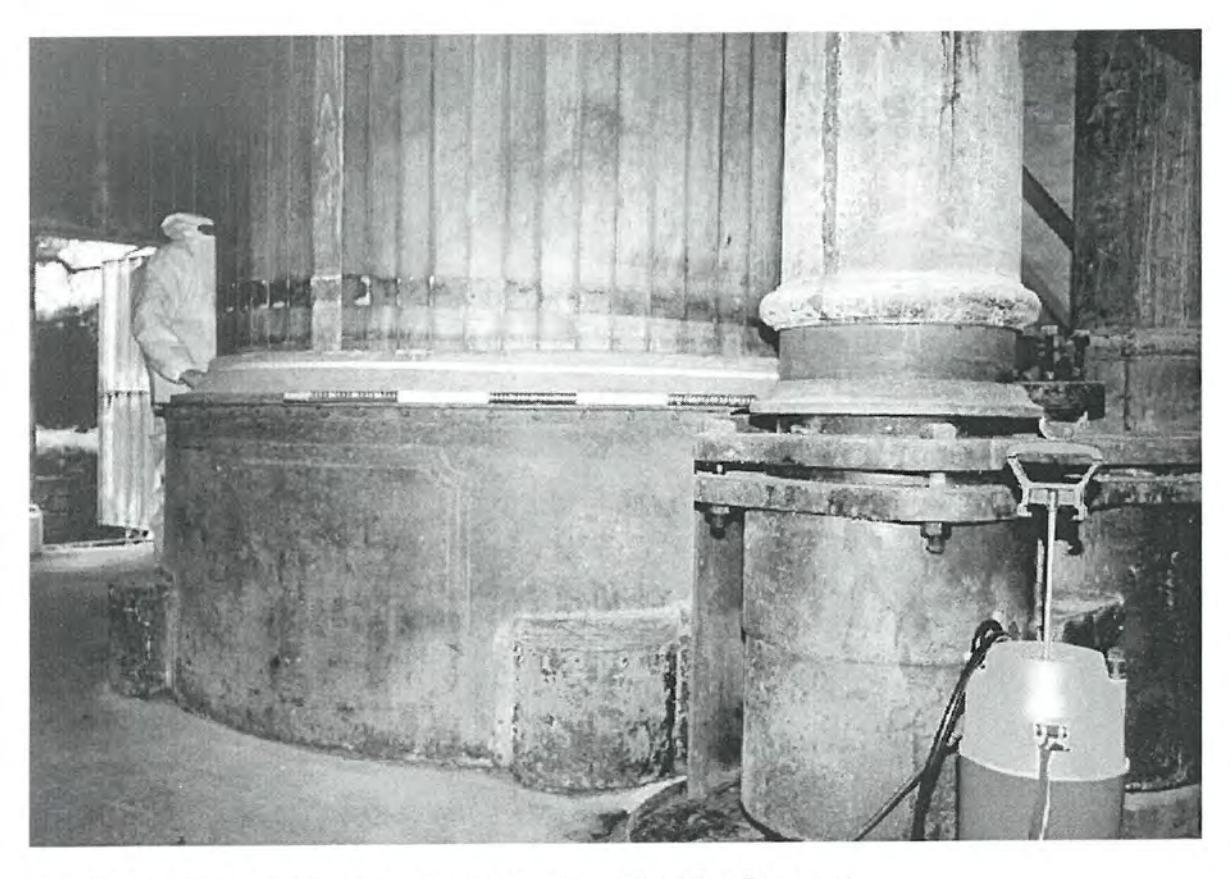
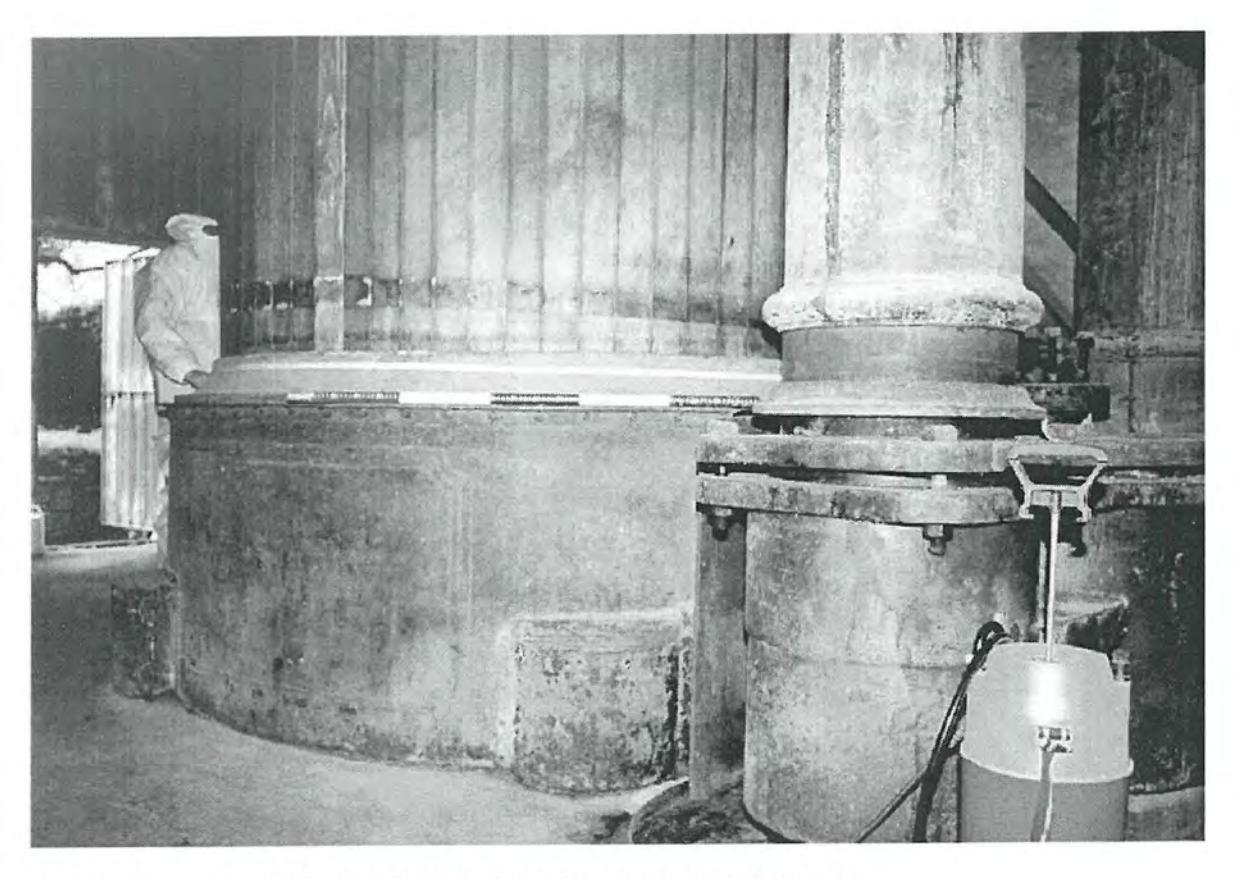
The staves had originally been varnished. The whole was bound together by a three-section iron collar that formed a junction between the staves and the lower steel panelling. Decoration on the panels and the anchor covers was still discernible and comprised of red and gold piping on a mid-green background.

plate 6. The lower cylinder casing. Note decorative piping. View from west.

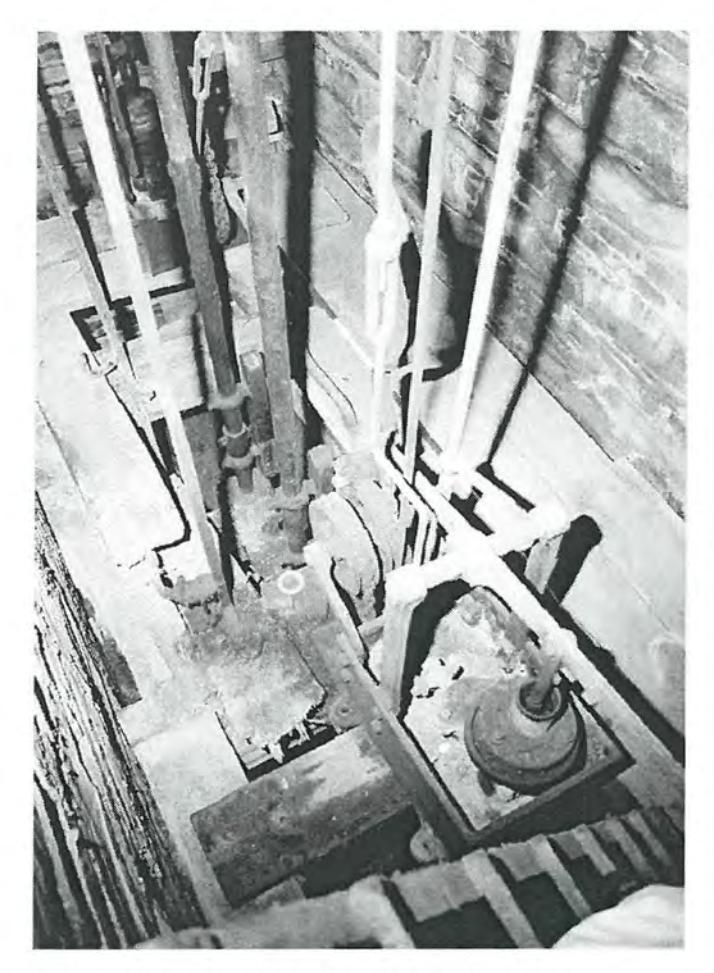
plate 7. View into cockpit from trap , view north.

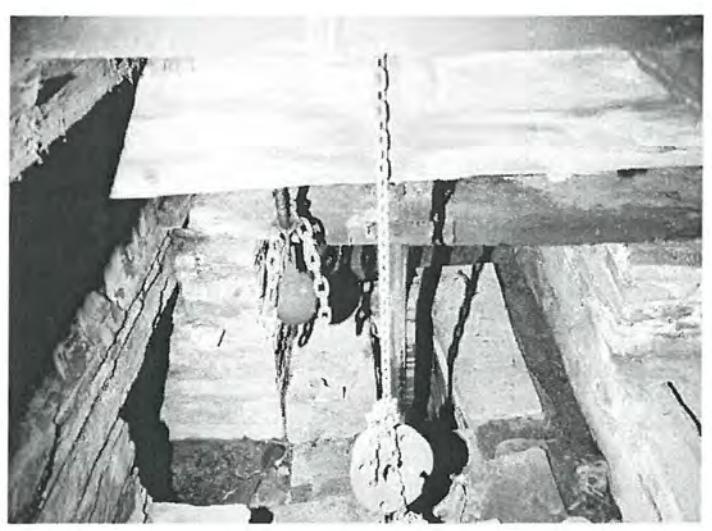
plate 8. View into crow pit looking south.

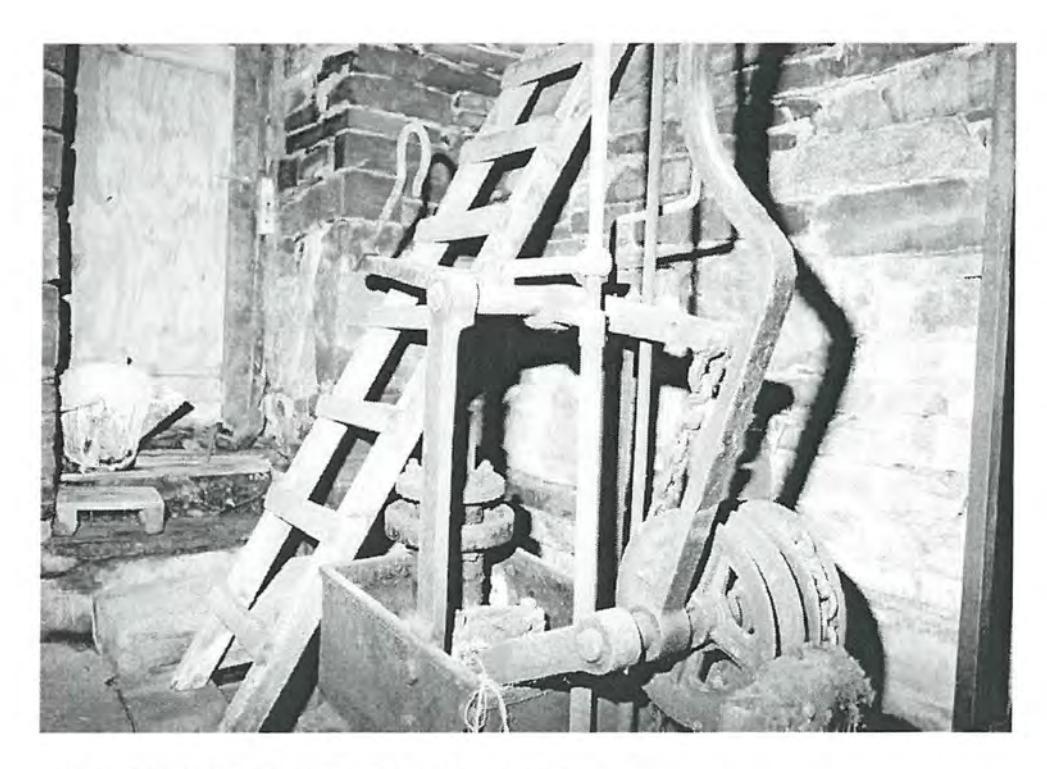
plate 9. Cock pit, view to trap and external door.
