## A470 (T) DOLWYDDELAN TO PONT-YR-AFANC IMPROVEMENT : SITE 74

# WATCHING BRIEF

## Report No. 418

## A470 (T) DOLWYDDELAN TO PONT-YR-AFANC IMPROVEMENT: SITE 74 (G1583)

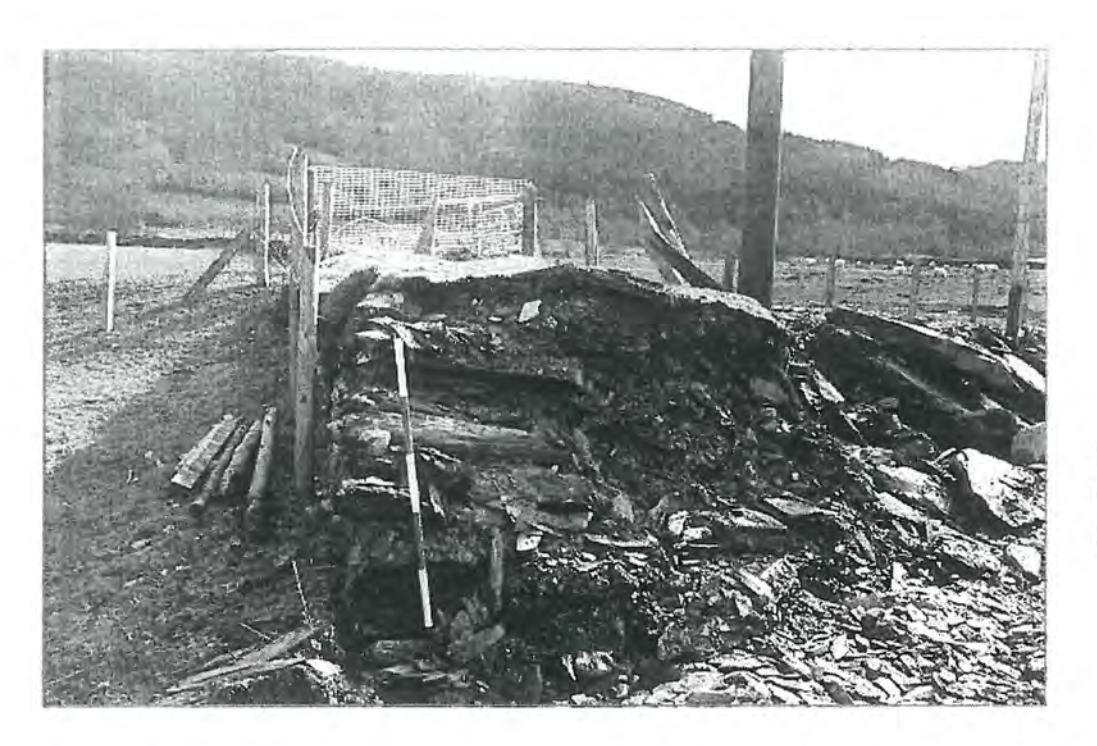
The tramway was constructed with large slate slabs as facing stones and slate rubble as a core. Some of the original surface layers of the tramway could also be seen, but nothing else of interest was visible. No sections of track, or other ironwork, were discovered during demolition; the site manager, Stephen Williams, had undertaken to put aside any such items if they were found. Some large slate slabs, up to 1.9 x 0.7m in size, were salvaged from the demolition and stored adjacent to the access road. However, most of the original stone was extremely rotten, and did not survive demolition. This was clearly due to the condition of the stone, and not the nature of the demolition work. New stone used in the reconstruction will be appropriate slate from Blaenau Ffestiniog.

Plate 1: profile through tramway. Looking south-east

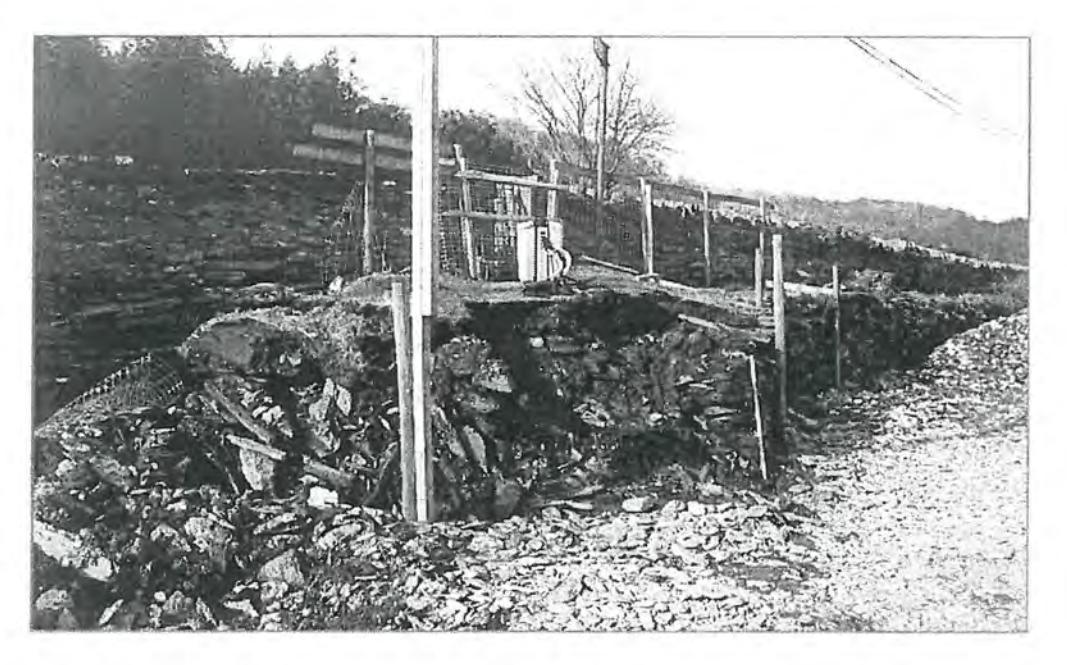
Plate 2: profile through tramway. Looking north-west

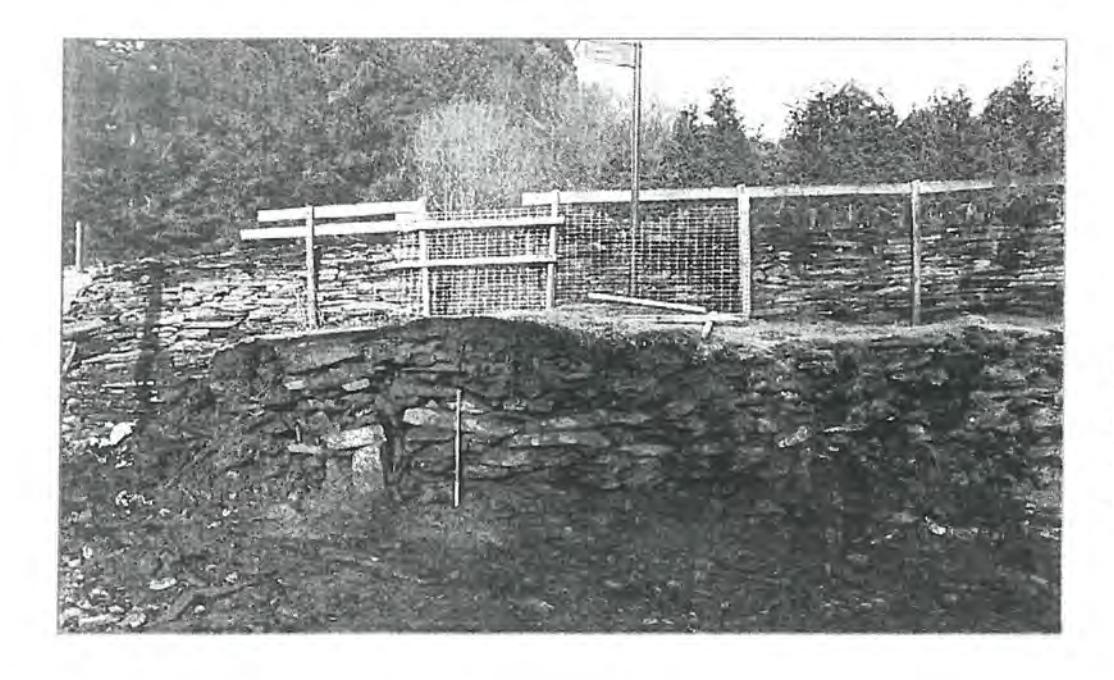
end revealed the face of the revetment wall continuing behind it, and proved that the tramway had been built up against the earlier wall, without being bonded into it.

The revetment wall originally ended at this point, as the facing continued round the south-western end. There was also a buttress-like structure added, presumably to support the end of the wall, and this had also been buried beneath the tramway (see plates 3 and 4). The 'buttress' was not an effective support as it had slumped more than the revetment wall, so it may have had another function, not immediately clear from the visible section.

Plate 3: South-west end of revetment wall revealed after removal of tramway

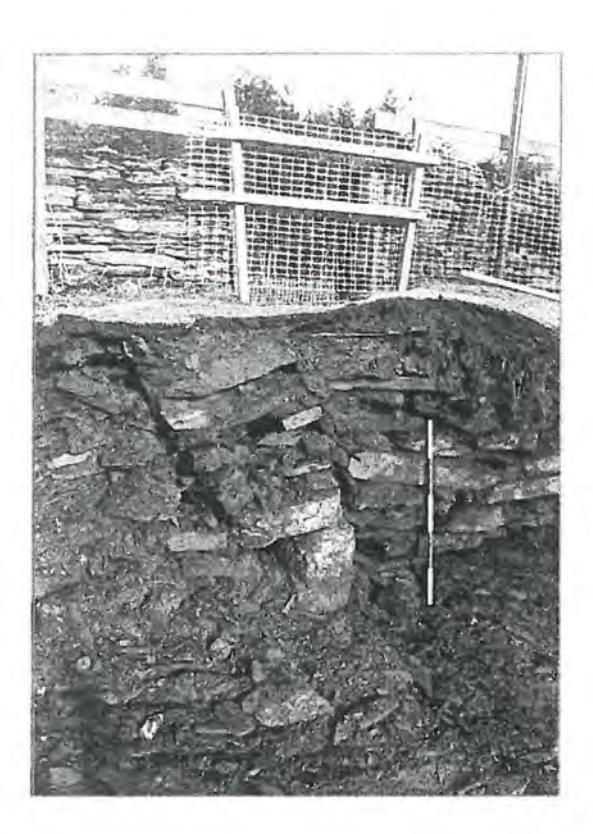
Plate 4: End of revetment showing buttress and remains of tramway built up against south-western end.

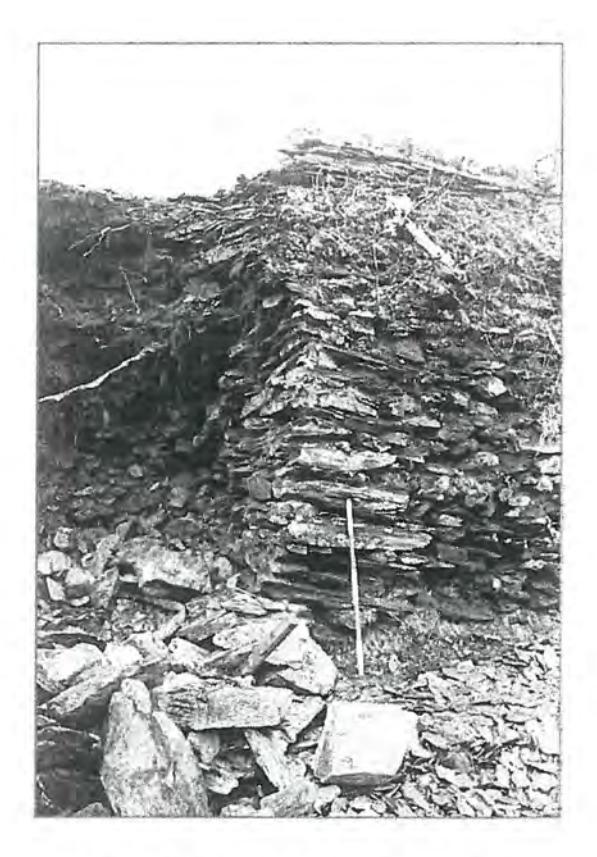
In the vertical joints large slabs had been used to construct substantial, relatively well-built corners (plates 5 and 6). This well constructed part of the south-western face was c.1m wide. The face did continue further into the revetment, towards the north-west, but it was very roughly built. Similar roughly coursed sections of stone work also occurred in places within the slate rubble behind the faces.

Plate 5: Vertical joint, feature 3 Looking north-west

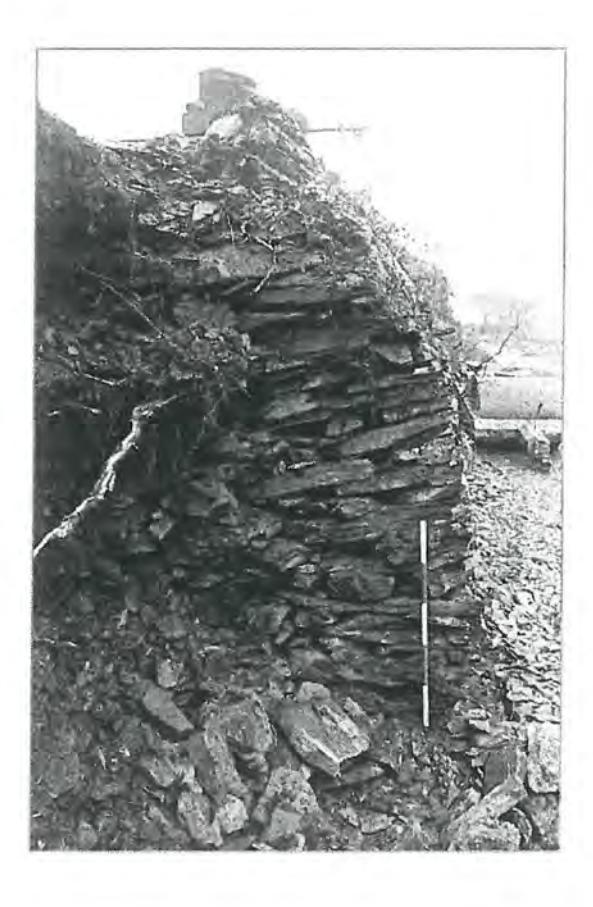
Plate 6: Vertical joint, feature 3 Looking north-east
