A470 DOLWYDDELAN TO PONT-YR-AFANC IMPROVEMENT

ARCHAEOLOGICAL WATCHING BRIEF AND RECORDING

REPORT No 531

Revision 1a, 29/11/2004

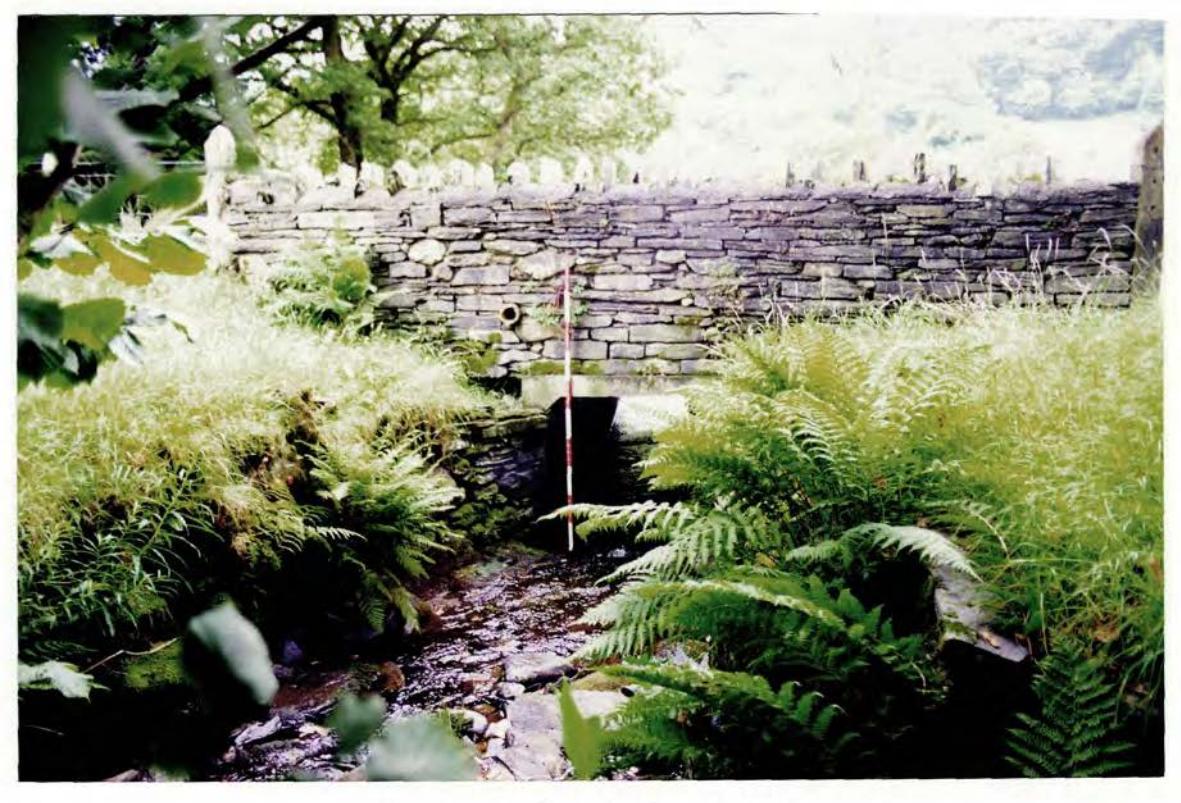
Plate 1 Site 79 from the east, in 1999

A watercourse or leat runs from the remains of Rhiw Gôch slate quarry to the Afon Lledr and passes under the road via a culvert (Plate 1 and Fig. 5). The majority of the edge of the leat is flanked by drystone revetment walls suggesting that it is entirely artificial as opposed to a modified natural stream. The culvert under the road had been replaced by a recent pre-cast concrete construction. The leat walls adjacent to the culvert appeared to have been rebuilt when the culvert was constructed. A concrete slab and the remains of a gabion were also visible in the bed of the leat in this area. Elsewhere the original masonry could be seen to stand to a height of around 0.9m. The area to the north-west of the road had been extensively landscaped and an incline from Rhiw Goch quarry had been converted into a track.

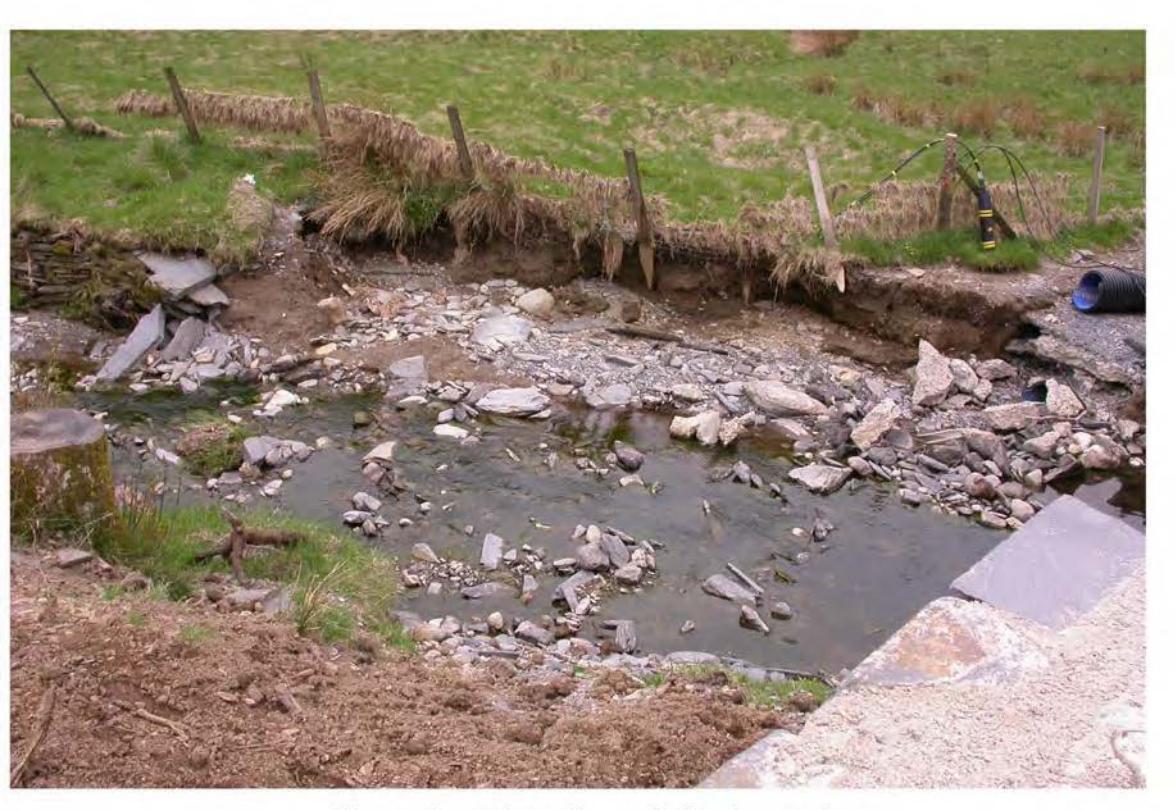
The leat walls to the south-east of the road had been badly eroded in places resulting in several serious collapses. Part of a raised slate pathway can be seen adjacent to the leat 24m to the east of the road. This is standing to a height of 0.5m and is 1.6m wide. It is flagged with large slate slabs running the entire width of the path. This can be traced for 16m at which point it appears that the path was carried towards and presumably over the river on stone piers. A bridge called Pont Carreg-y-bŵch (Fig. 6), leading to Pont-y-pant railway station, is shown on the OS 1:2500 map of 1913 (Carnarvonshire XXIII.7)

Plate 2 Site 79 from the north showing erosion

The southern leat wall was reinstated using slate masonry. Its line was slightly modified in order to lessen the scouring effect of the discharge from the culvert. The wing wall (i.e. the leat wall running at 90 degrees to the road) was lengthened, thus dissipating some of the energy from the outfall. The leat wall connecting the wing wall and the original masonry was reconstructed at a slightly different angle to its original line in order to tie in with the new wing wall. The modern leat walls adjacent to the roadside revetment were rebuilt and re-aligned in order accommodate the new culvert.

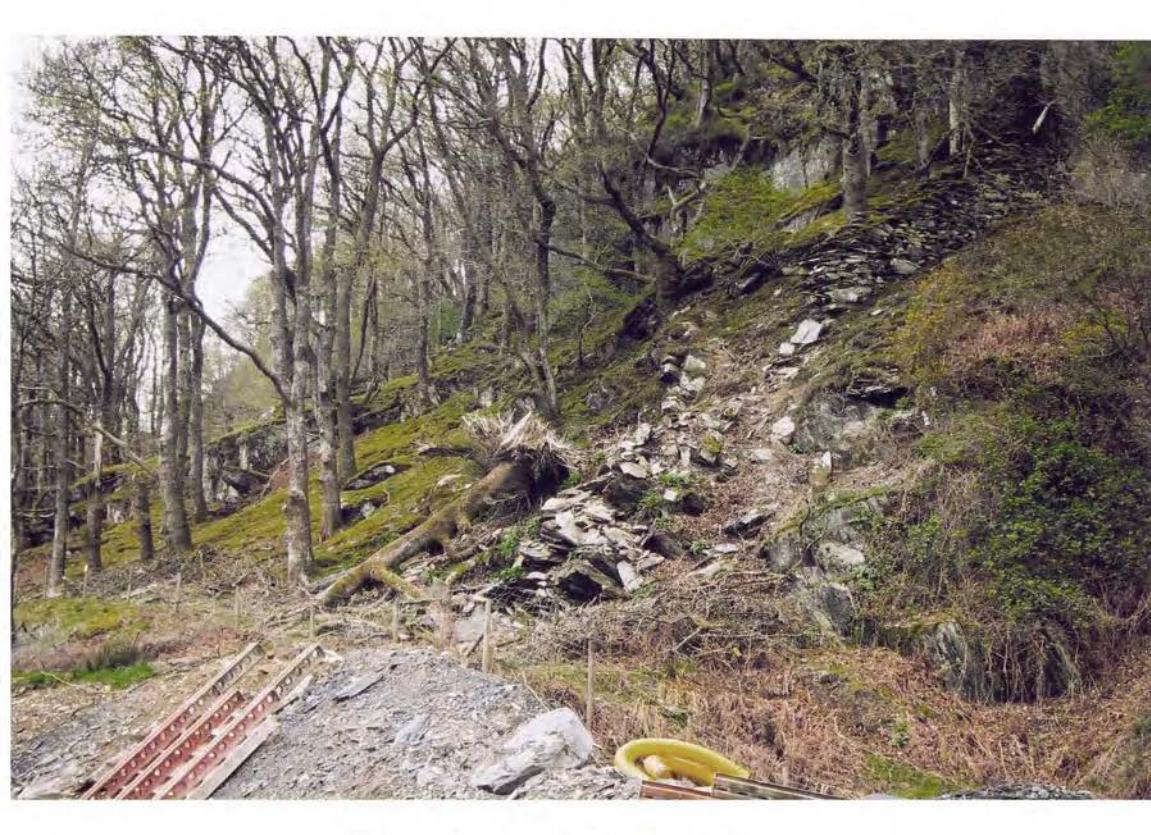
The are was inspected during a site visit in May 2004 and it was noted that the lower half of the northern wall had collapsed (Plate 4). This appears to have been caused by a wind-blown tree and was probably not a direct result of the improvement works.

Plate 4 Site 84 in 2004 after collapse

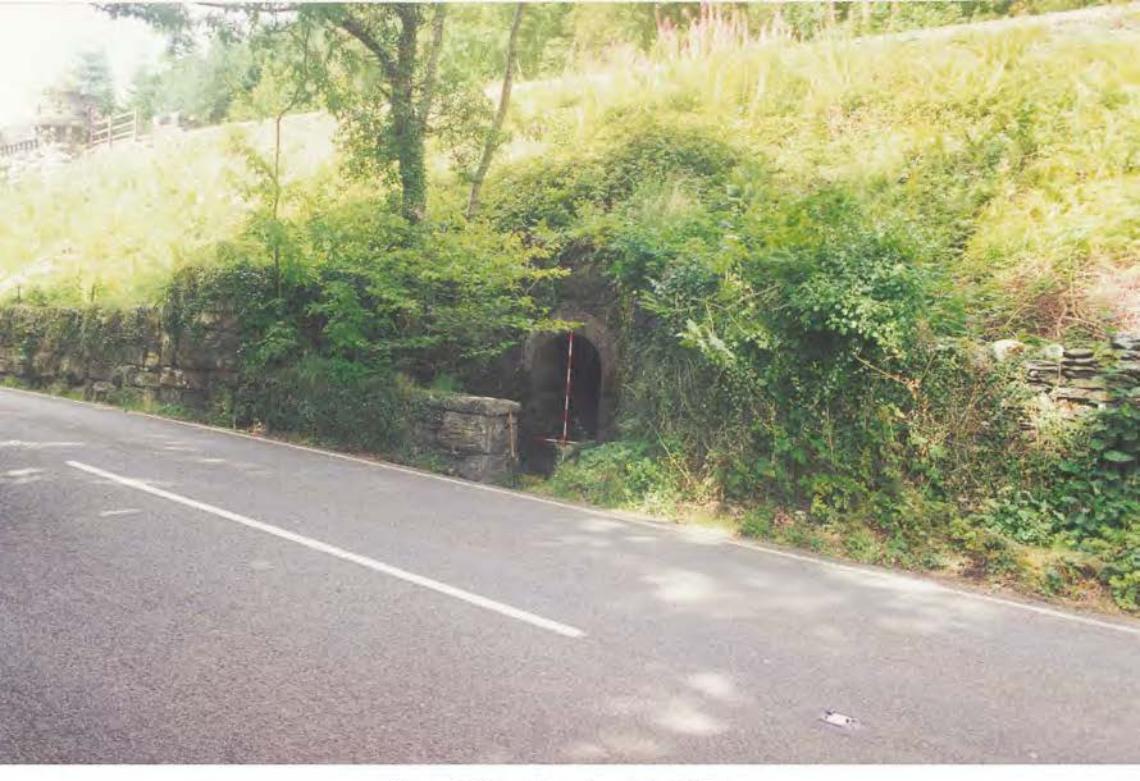
Plate 7 Site 93, culvert in 1999

The wingwall and headwall of the culvert alongside the road were constructed in the same distinctive masonry style as the viaduct (Plate 7). The new road carriageway impinges on this masonry as well as the roadside wall. The wingwall and headwall were therefore moved back by a small amount to accommodate the new road. All of the major stones were numbered and the wall was dismantled. New concrete footings were laid and the walls were reconstructed with the stones being replaced as close to their original arrangement as possible (Plate 8).

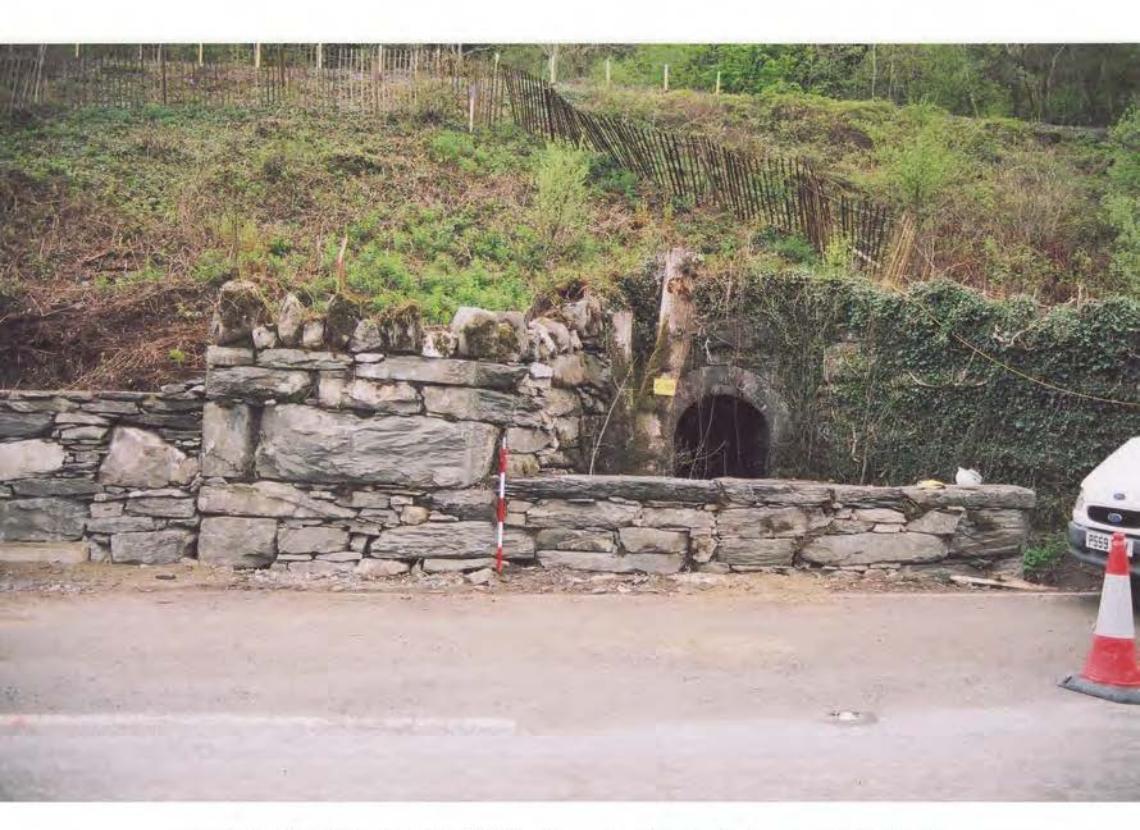
Plate 8 Site 93 culvert in 2004 after rebulding of wing and headwalls

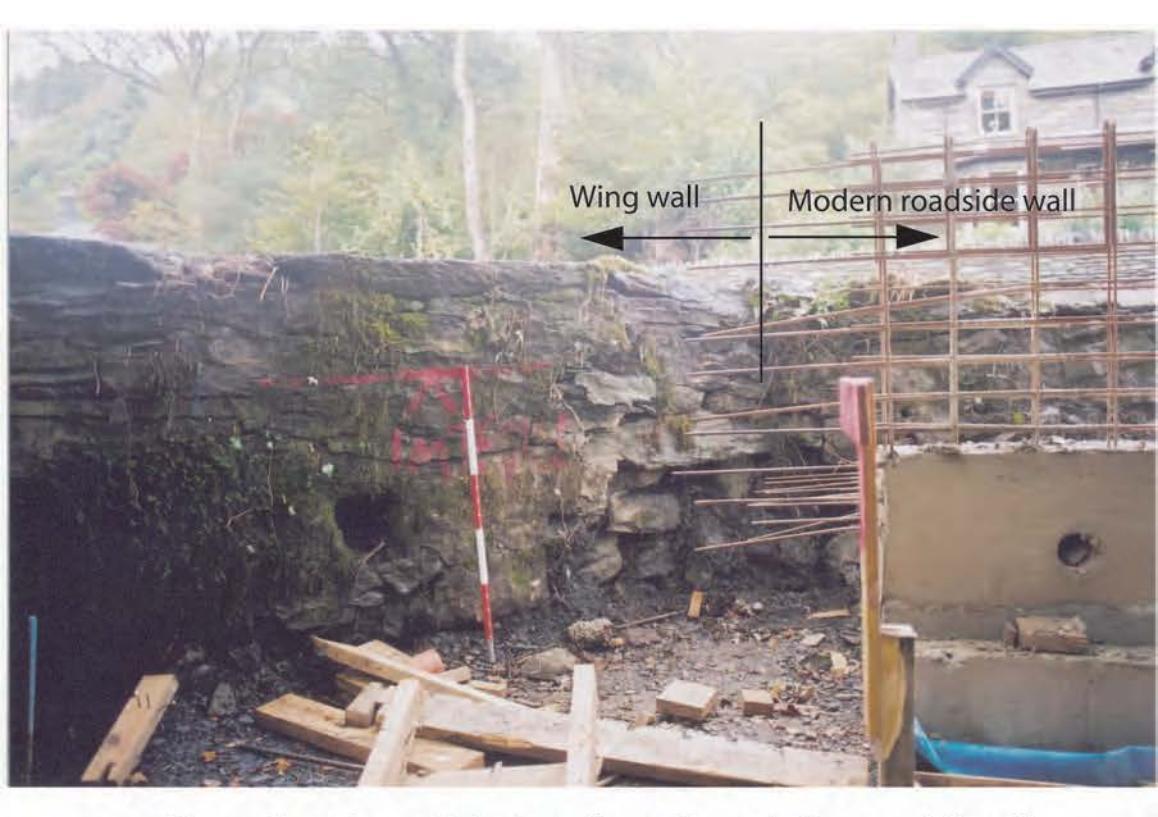
There were clearly two phases of masonry here. The end of the bridge wing wall had partially collapsed but could be seen to differ in several respects from the adjacent roadside wall although both phases were superficially of a similar construction. The wing wall was found to be of rough local slate slabs and retained traces of lime mortar. The outer face was standing between 1.4 and 1.6m from the current ground level. The basal courses were of local field stone (not slate). The wall was capped with flat slate coping stones with dimensions of 1.4m x 0.5m x 0.2m. Part of the upper part of the wall had been rebuilt using cement mortar presumably after being damaged by traffic. Two openings in the lower part of the outer face (indicated on Plate 9) acted as drains from the road. The drain on the right hand side was carefully constructed with a slate base and cap. The drain on the left was roughly built and could possibly be the result of a stone falling out of the wall facing. It was however still channelling water. It was noted that much of the eastern wing wall and bridge parapet was in a poor condition. The roadside wall contained some reused local slate but also contained field stone and quarried Anglesey black limestone. This was roughly bound using a coarse cement mortar. Flat coping was also used but the stones were irregular and smaller. This phase of the wall probably dates from the last time the road was upgraded, possibly in the 1970s. The flat coping stones and use of some slate suggests that this was a previous attempt to reconstruct the end of the wing wall.

Plate 10 Site 99 Pont-ar-Lledr wing wall, outer face and adjacent roadside wall

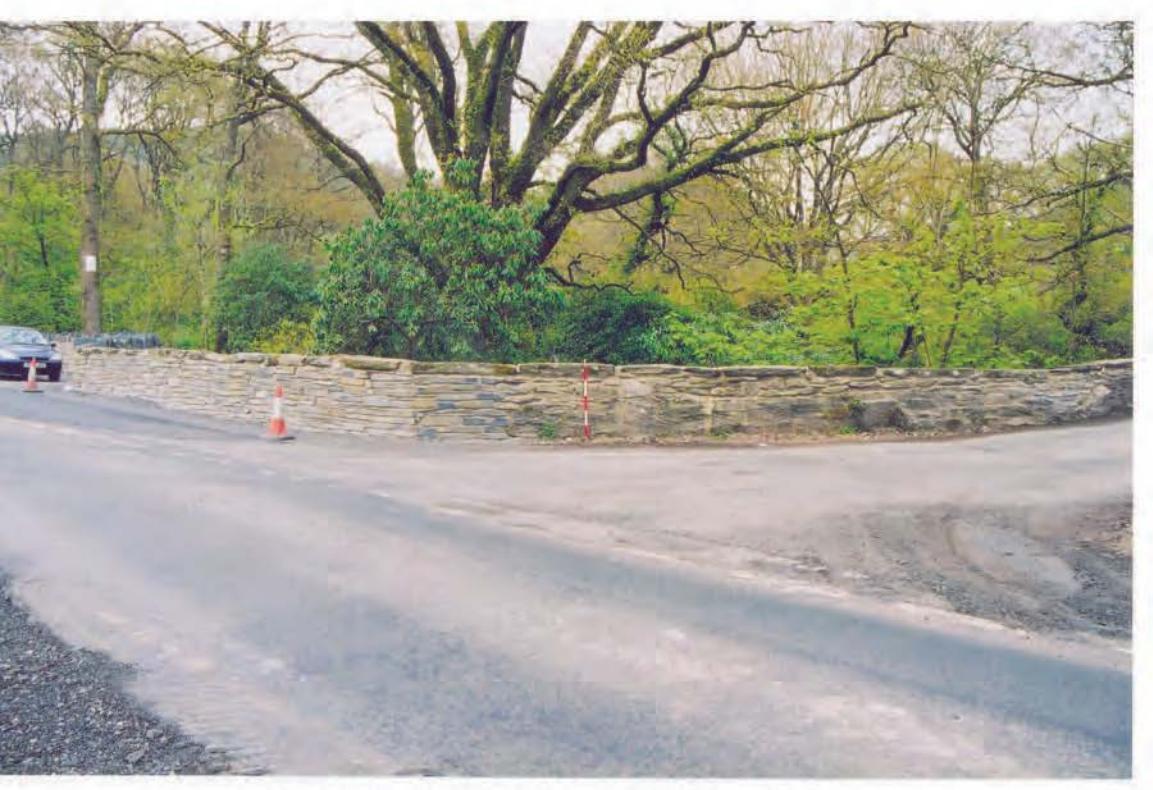
Plate 12 Site 99, Pont-ar-Lledr wing wall, inner face 2004

The wing wall was rebuilt on a different alignment in order to tie in with the new retaining wall (Plate 12). As much of the original stone was reused as possible but it was noted that some of the slate had degraded and was very friable and would have to be discarded. Irregular slate blocks were used as a replacement. The original masonry style was emulated in all but the last metre of the original wingwall but the roadside wall was constructed with a shuttered reinforced concrete core with slate cladding. A straight joint was incorporated in the masonry marking the junction between the reconstructed wing wall and the reconstructed roadside wall in order to indicate the position of the original different phases of masonry. The flat coping stones were reused on both the wing wall and the roadside wall. It should be noted that it was necessary to raise the height of the end of the wingwall from 0.7m to 1.0m in order to tie it in with the roadside wall.
