> GAT Project No. 1872 Report No. 596 January 2005

Archaeological Watching Brief

Archaeological Watching Brief: St Deiniol's Cathedral, Bangor (G1872)

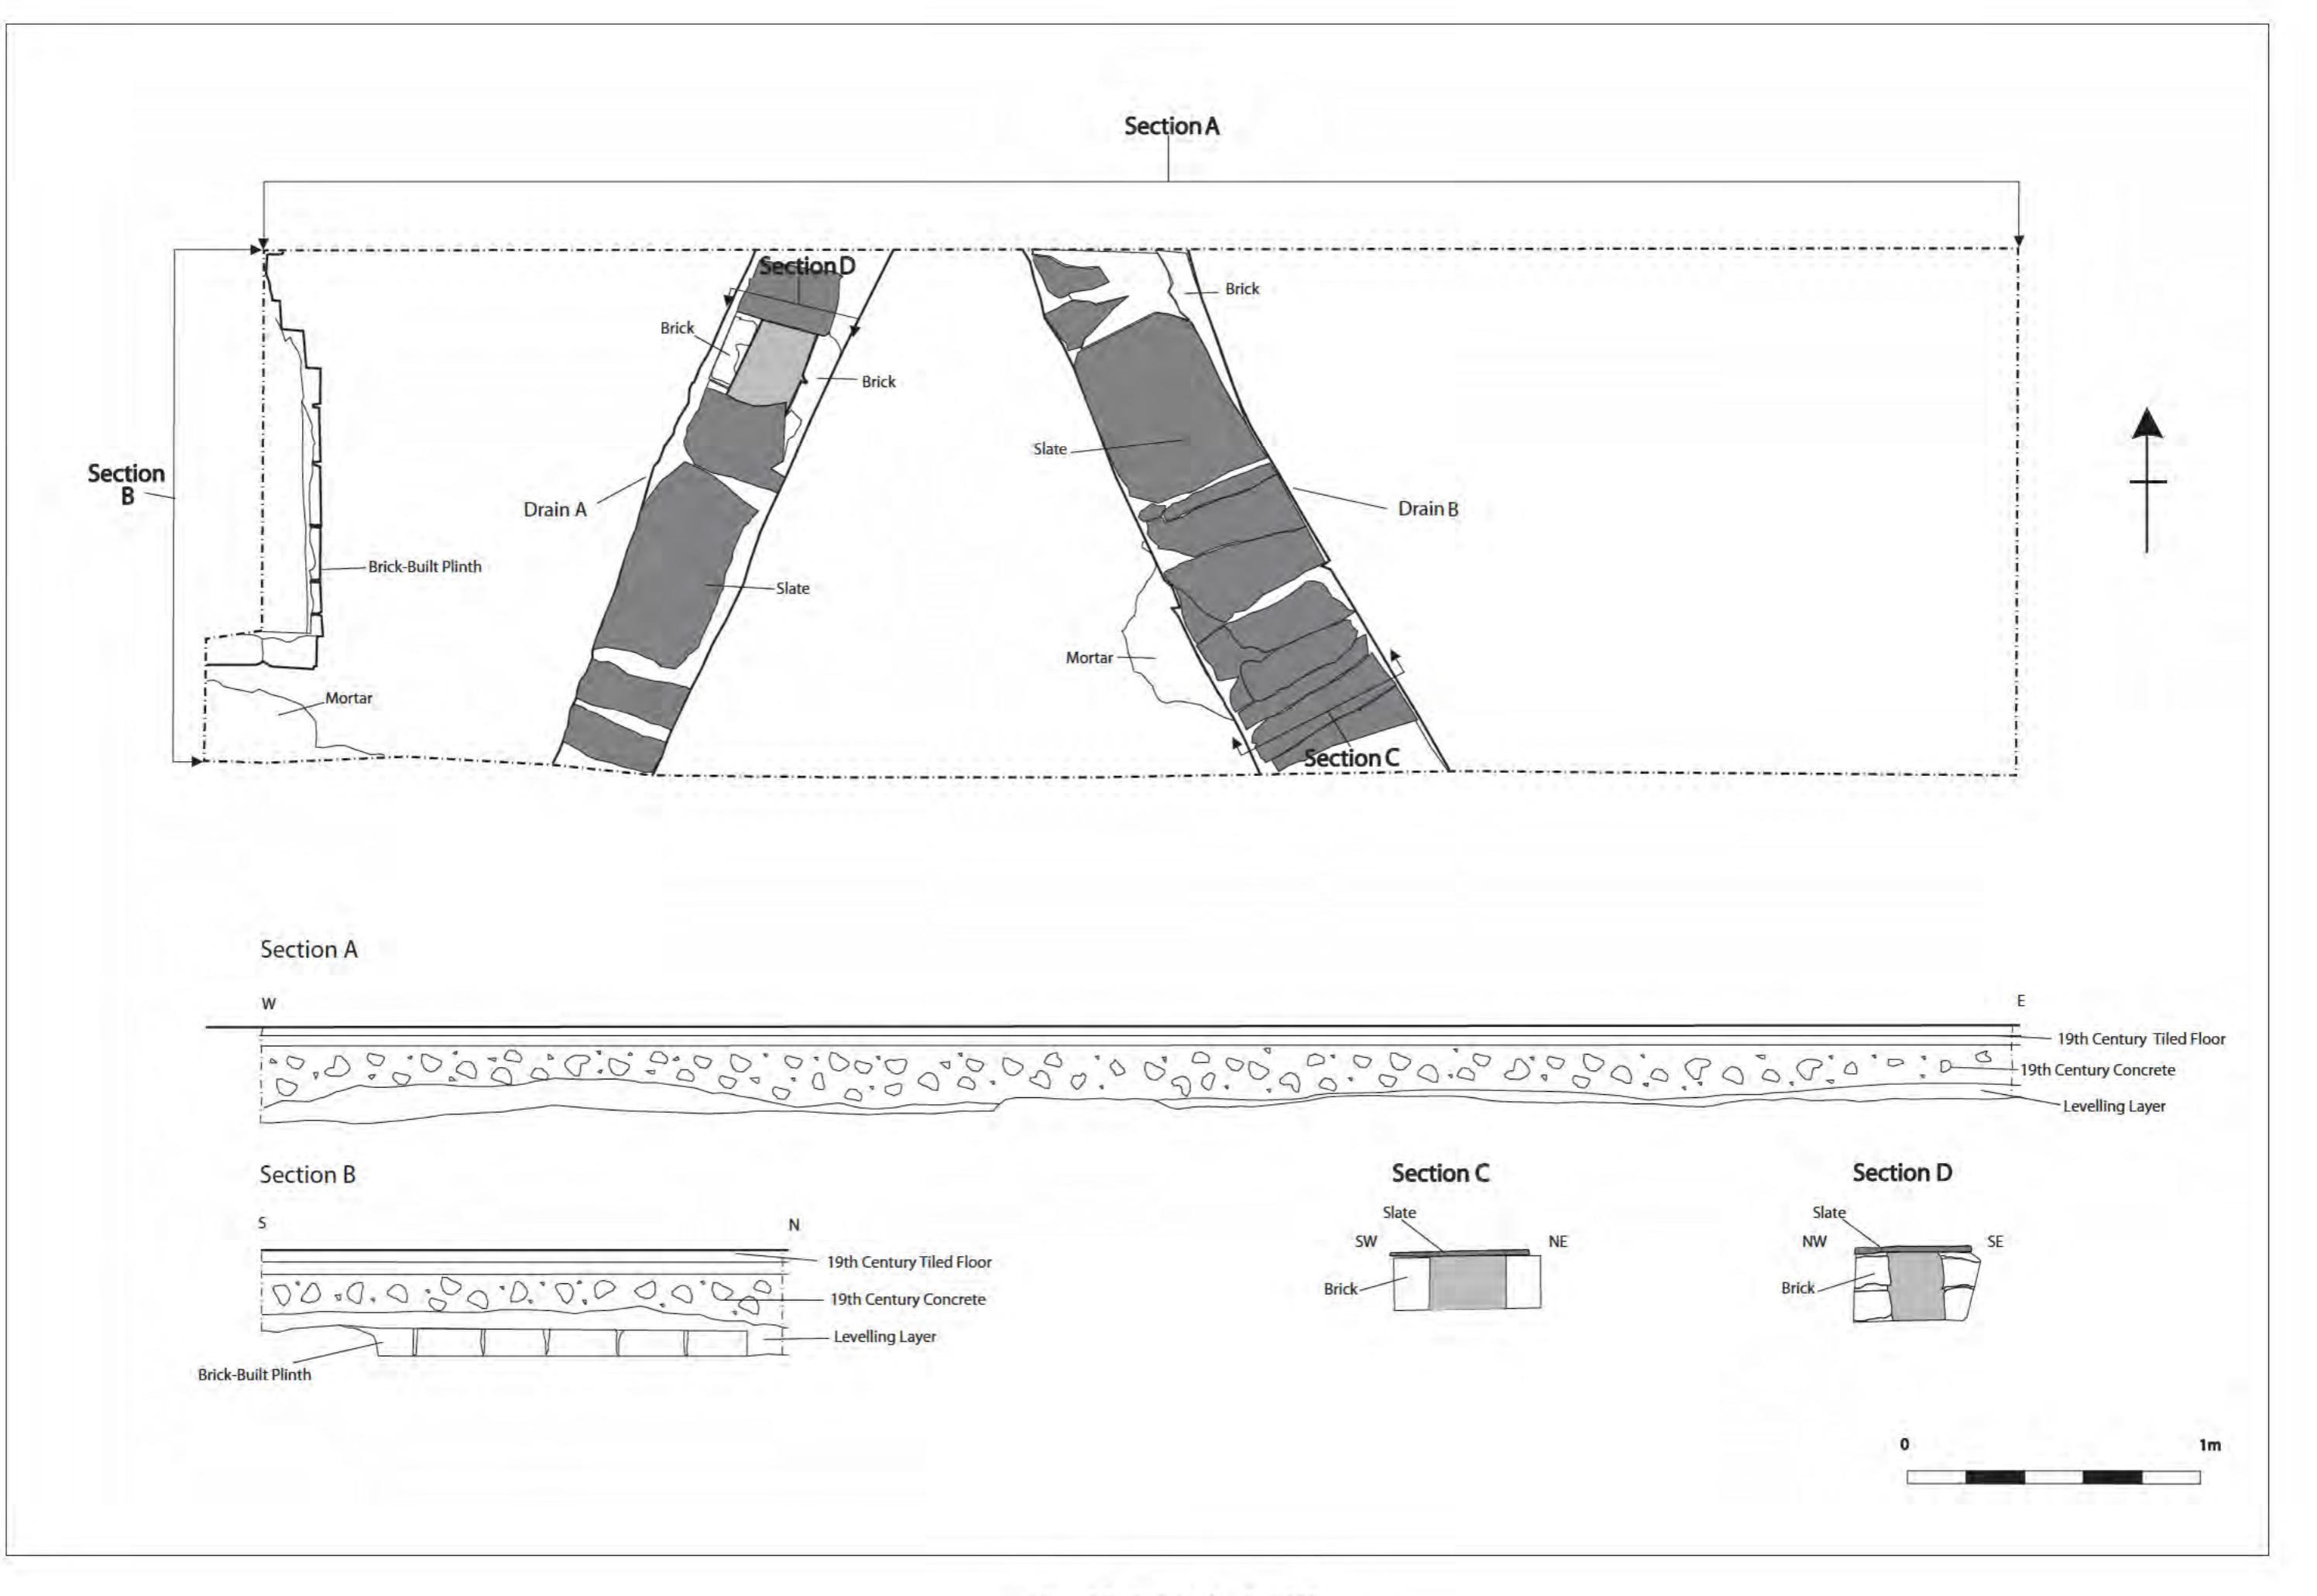
Figure 2: The Presbytery

There was another brick-built structure at the western end of the trench (Figure 2). The structure was only partially extant in the trench making an interpretation difficult, but it was a 1.20m long structure, one course high with the bricks laid on their side. The bricks were very narrow, only 0.05m wide (almost half the width of the bricks used in the drains), and were composed of an orange fabric similar to that used in domestic firebricks (Plate 8). Fragments of this brick were found in the grano-concrete layer, suggesting that the structure may have been higher but was partly demolished during the renovation work. There were fragments of mortar bonding attached to the brickwork, which was a reddish colour.

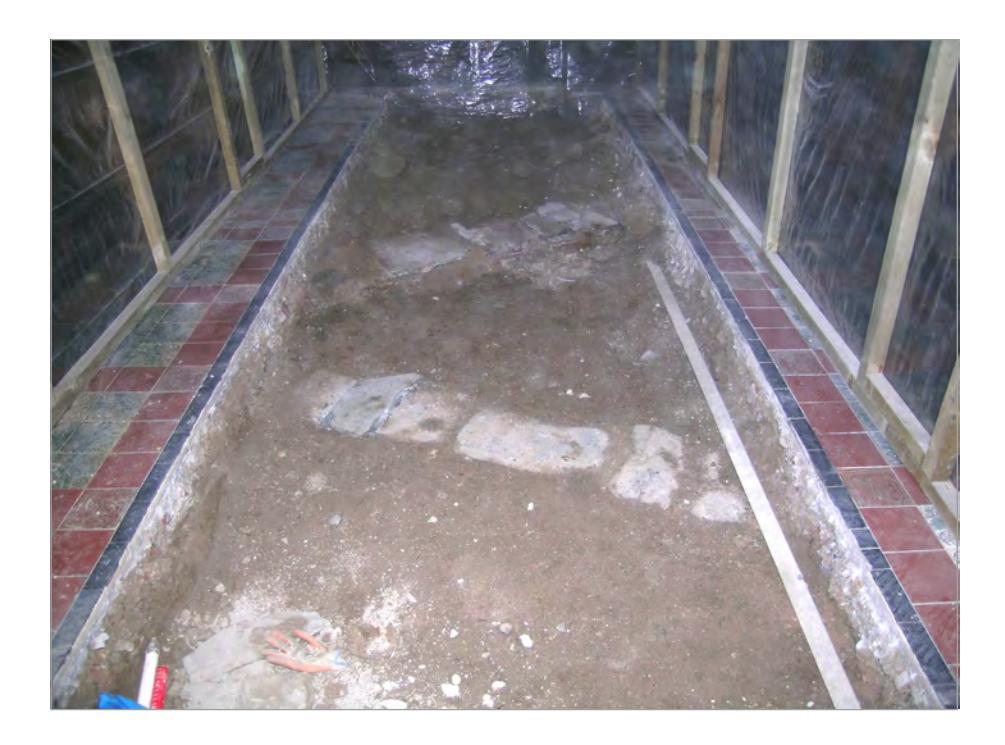
A trench measuring 6.20m x 1.80m x 0.30m (1 x w x d) was excavated by hand within the presbytery at the eastern end of the Cathedral (see Figure 1). The trench was orientated east to west and was excavated to investigate the cause of the presbytery tiles rising up in the centre (Plate 1). The floor tiles had been removed in advance of the watching brief, exposing a layer of Victorian concrete. The concrete was c.0.25m thick and comprised a mixture of brick fragments, red sandstone and slate (Figure 2). The concrete had been laid as part of the 1866 renovation programme to provide a solid base for the floor tiles. Below the concrete was a 0.02 to 0.14m thick demolition/levelling layer that comprised building fragments (including flecks of limestone mortar) mixed into a sand/silt deposit, which contained three heavily oxidised iron nails and a fragment of clay pipe stem. This deposit was interpreted as the primary levelling layer for the concrete. The material may have been imported so the nails and pipe stem could have come from outside the Cathedral. The primary levelling layer sealed a silty brown deposit that was cut by two drainage culverts both constructed using brick and slate. Drain A (Figure 2) was orientated southwest to northeast and measured c.2.0m in length and 0.40m in width. The top of the culvert was built from slabs of slate 0.02m thick laid either across or along the length of the drain (Plate 2). The slabs were generally rectangular in shape but varied in size, with the largest example measuring 0.70m in length and the smallest, 0.30m in length. The sides of the culvert were built from brick with each side standing two courses high (0.24m in total). The bricks were handmade and bonded using limestone mortar (Plate 3). The slate was bonded to the bricks in a similar fashion. The materials used, especially the brick, suggested a 19th century date, but whether this work was part of the 1866 renovation or the previous stages of renovation in 1822 or 1770 was unclear. The second drain, Drain B, was orientated southeast to northwest and measured 2.10m in length and 0.50m in width (Plate 4). This drain was constructed in a similar fashion to Drain A, suggesting they were contemporary. The only difference was the greater width of Drain B, with slightly longer and wider slate slabs being used. It appeared that the drains were fed from outside the Cathedral, presumably channelling rainwater off the valley side into a soakaway and would have discharged onto the slopes below.

Plate 1 View Looking East of the Nineteenth Century Drains

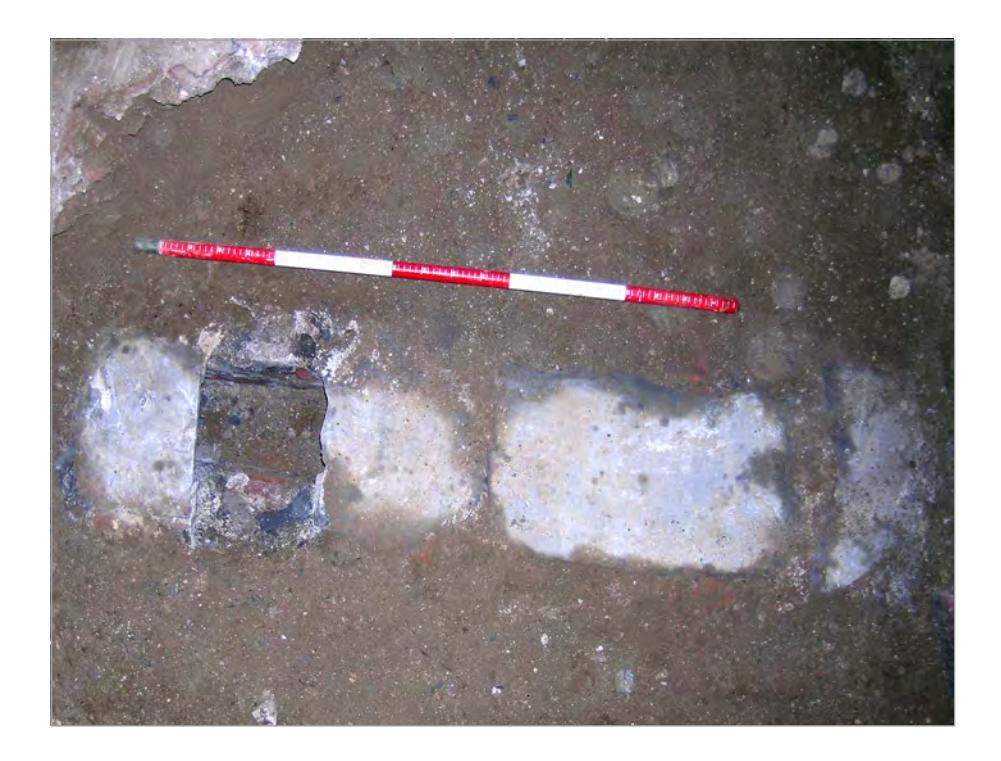
Plate 2 Birds' Eye View of Drain A

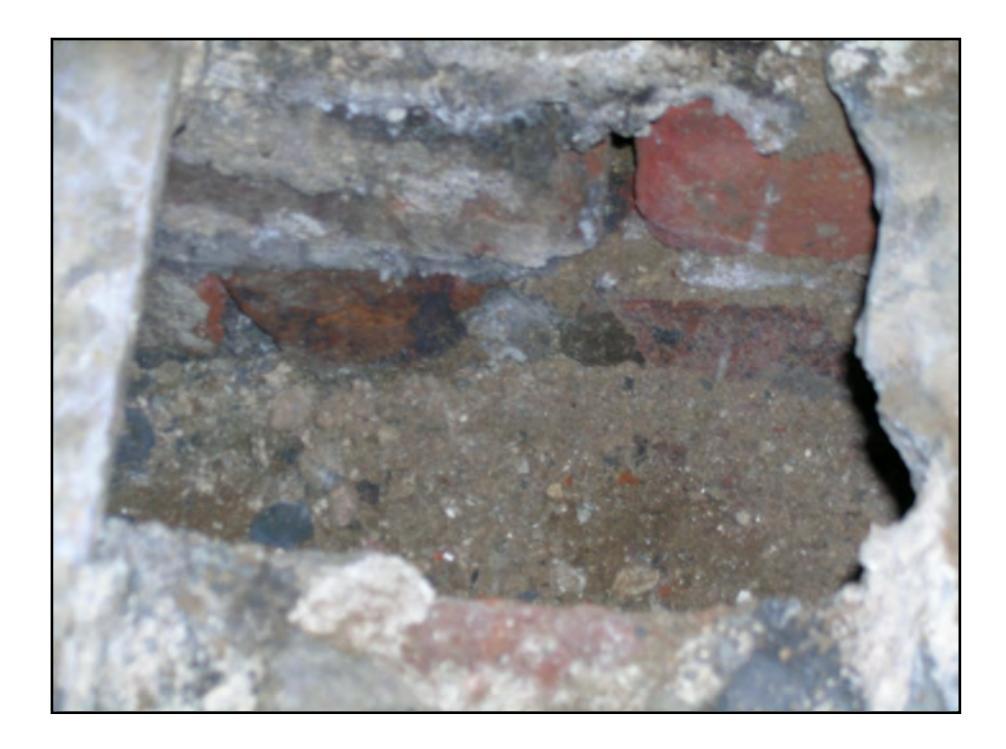
Plate 3 Close-up of Drain A

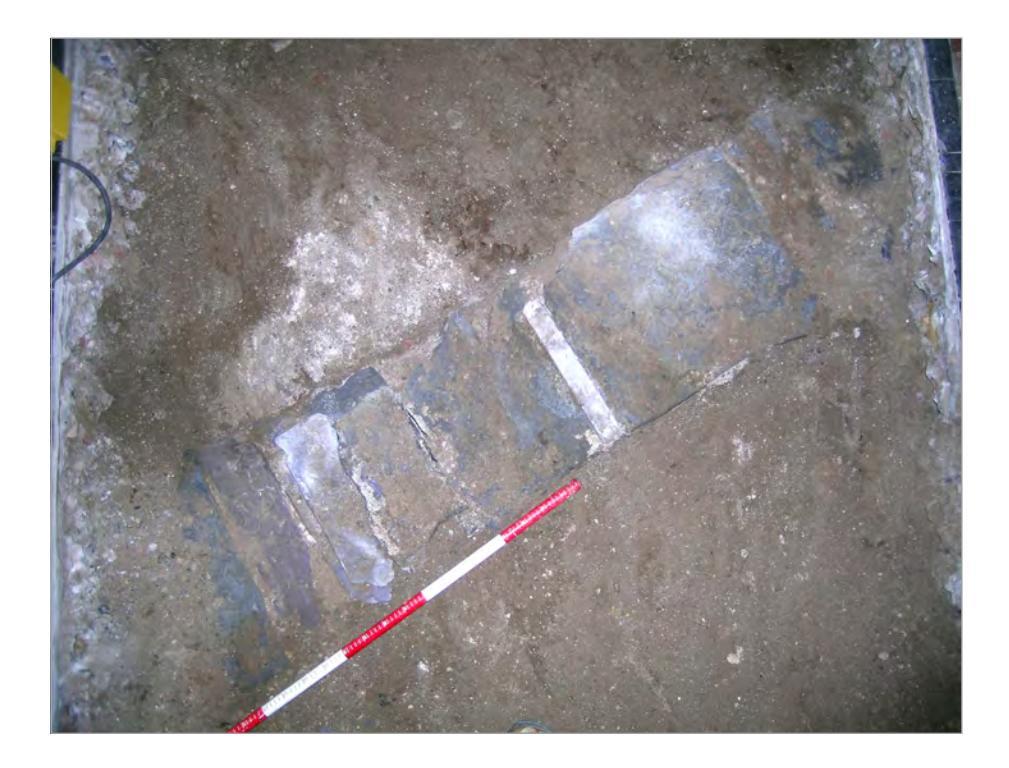
Plate 4 Birds' Eye View of Drain B

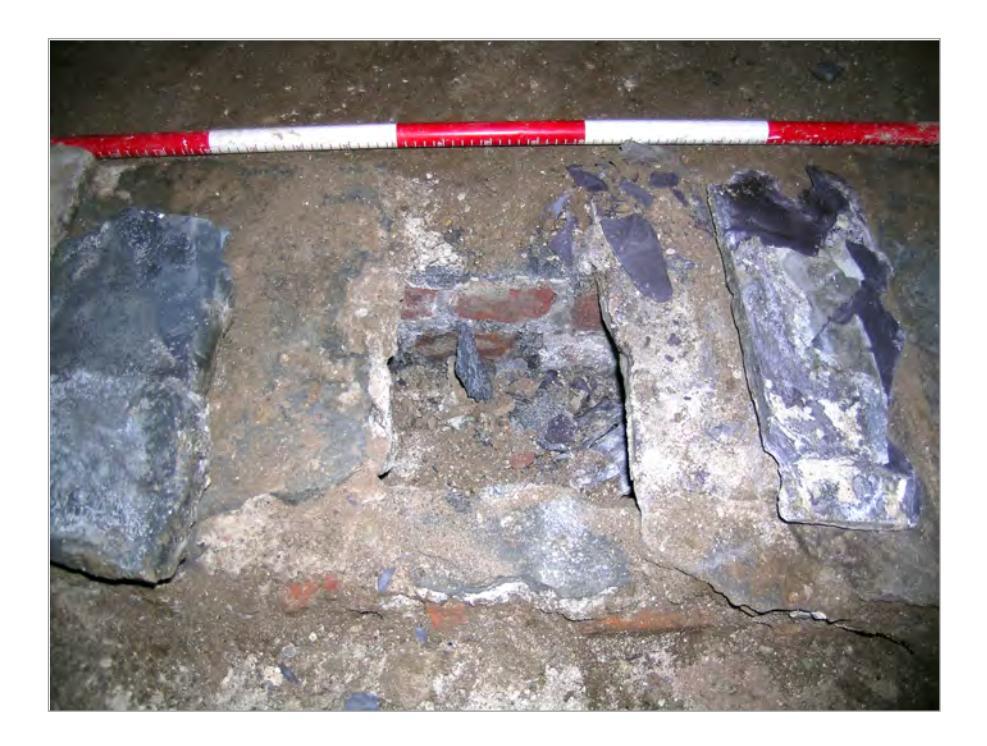
Plate 5 Internal View of Drain B

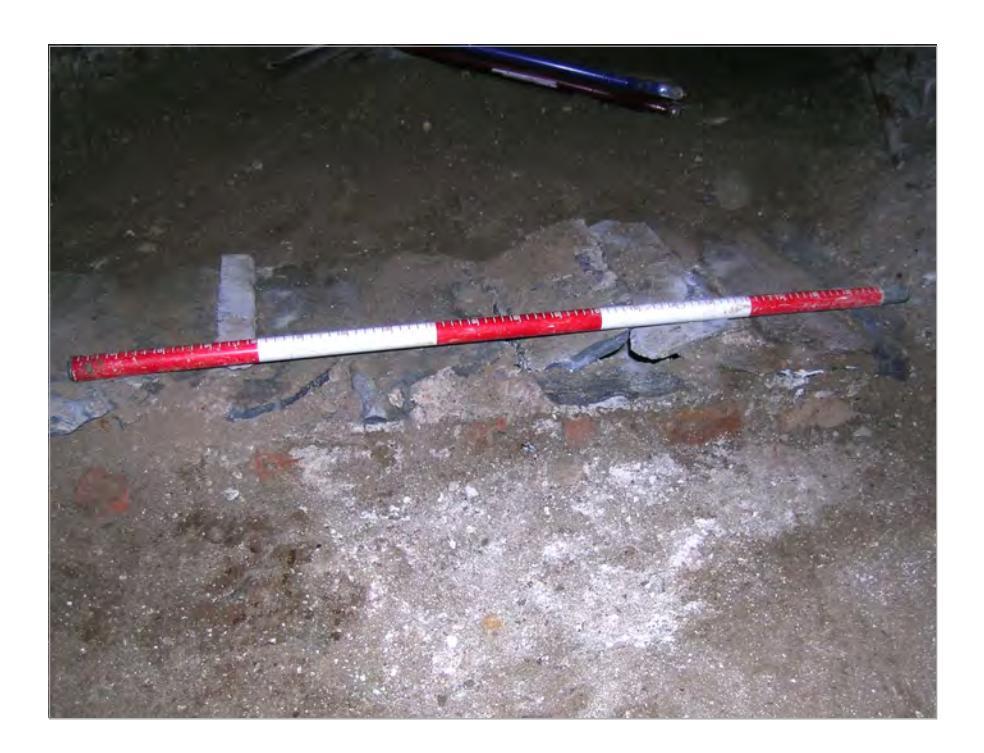
Plate 6 Side View of Drain B Detailing Brickwork

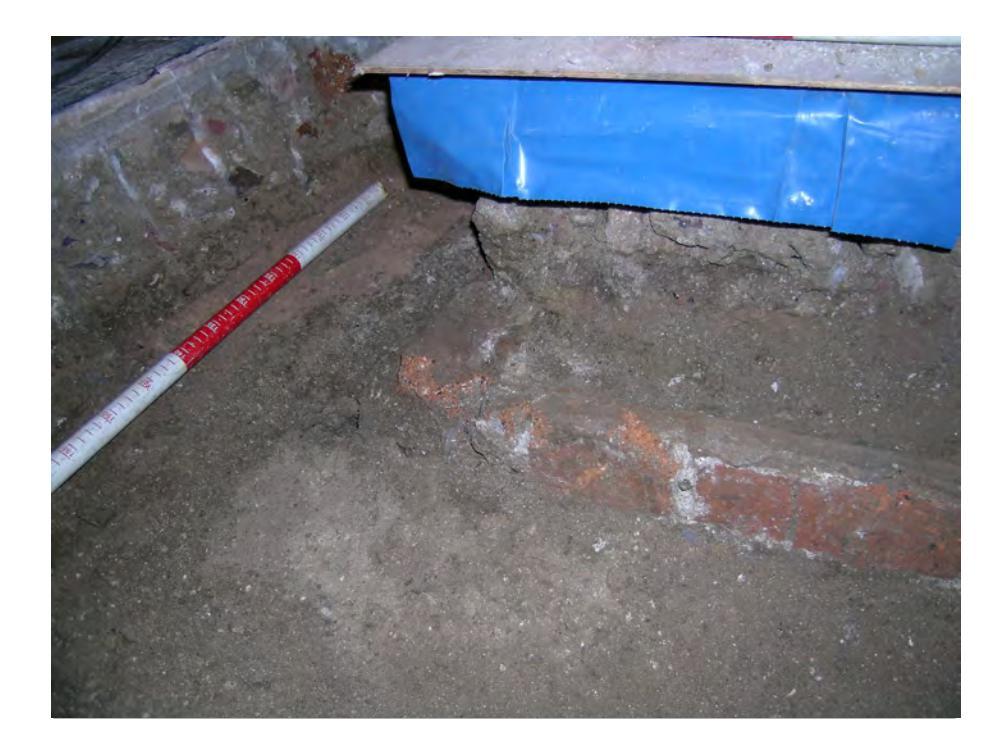
The structure was placed onto the silty brown deposit cut by the drains. No foundation cut was visible. The function of the structure was unclear but it was interpreted as a plinth.

Plate 7 Close-up of Brick-Built Plinth

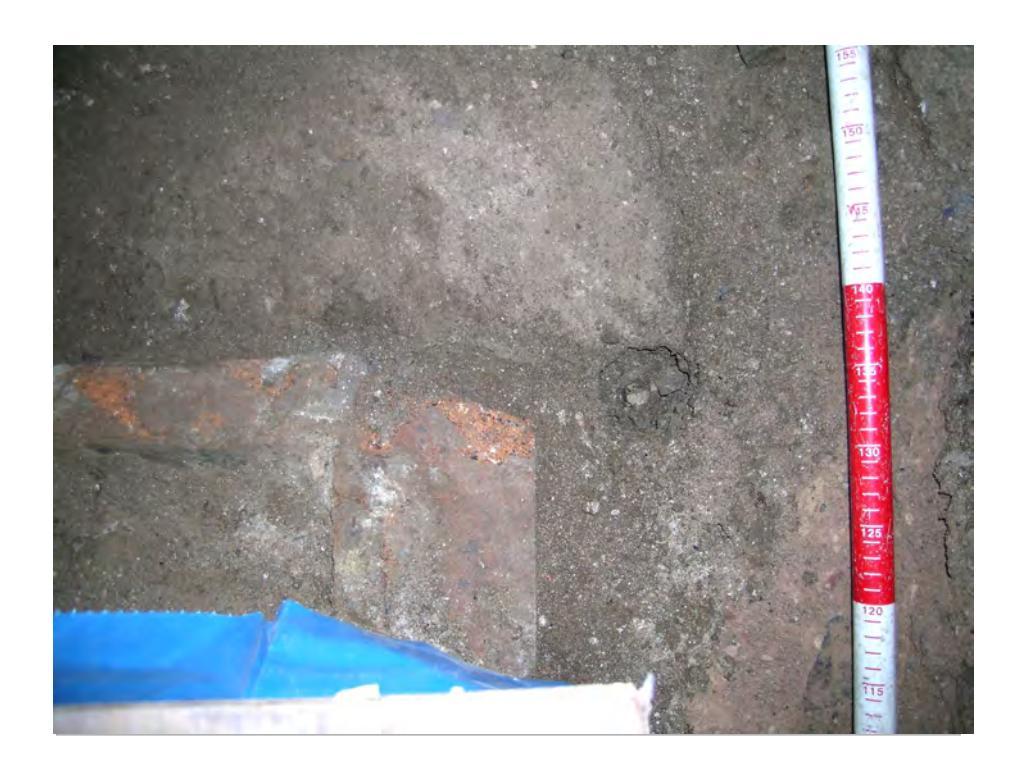
Plate 8 Birds' Eye View of Brick-Built Plinth

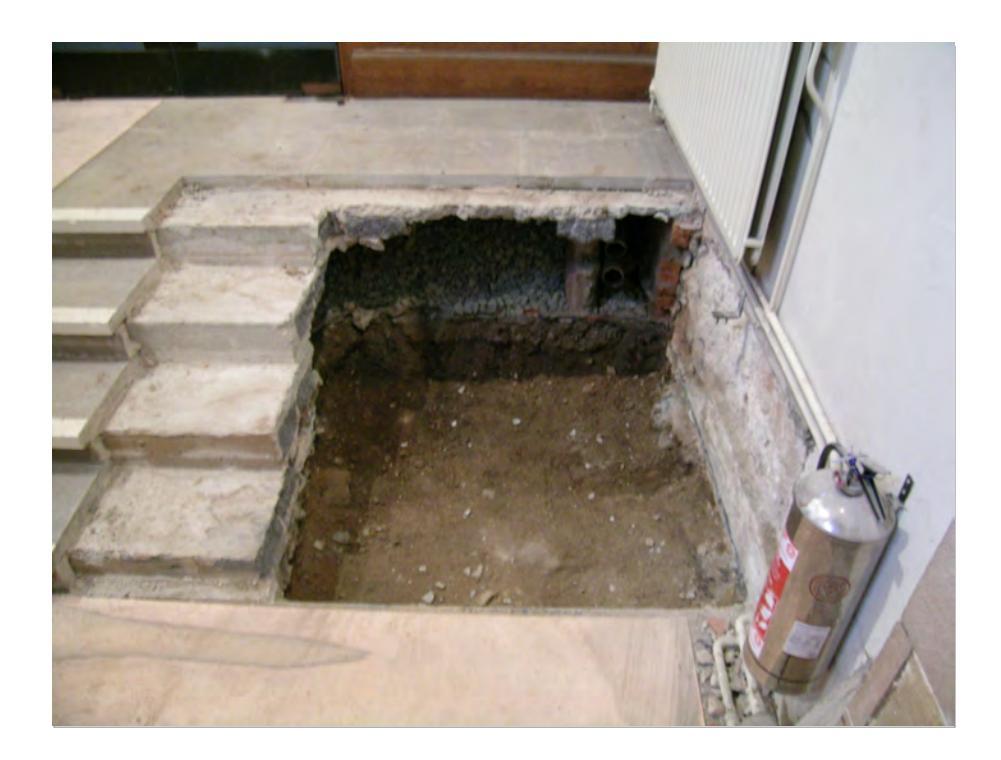
A 2.25m square trench was dug to a mean depth of 1.15m at the eastern end of the tower to facilitate disabled access into the Cathedral (Plates 9 and 14). A late twentieth century concrete staircase (comprising four steps) was partly removed exposing a pipe duct on the northern side of the trench, which contained two metal pipes (modern) that were removed. Modern concrete and breezeblock stairs (four steps and a landing) have been removed for disabled access. It appears the steps may have been closer to the entrance as there is a tiled surface below the steps (possibly nineteenth century). Three elevations were exposed:

Plate 9 View Looking West of Trench within the Tower

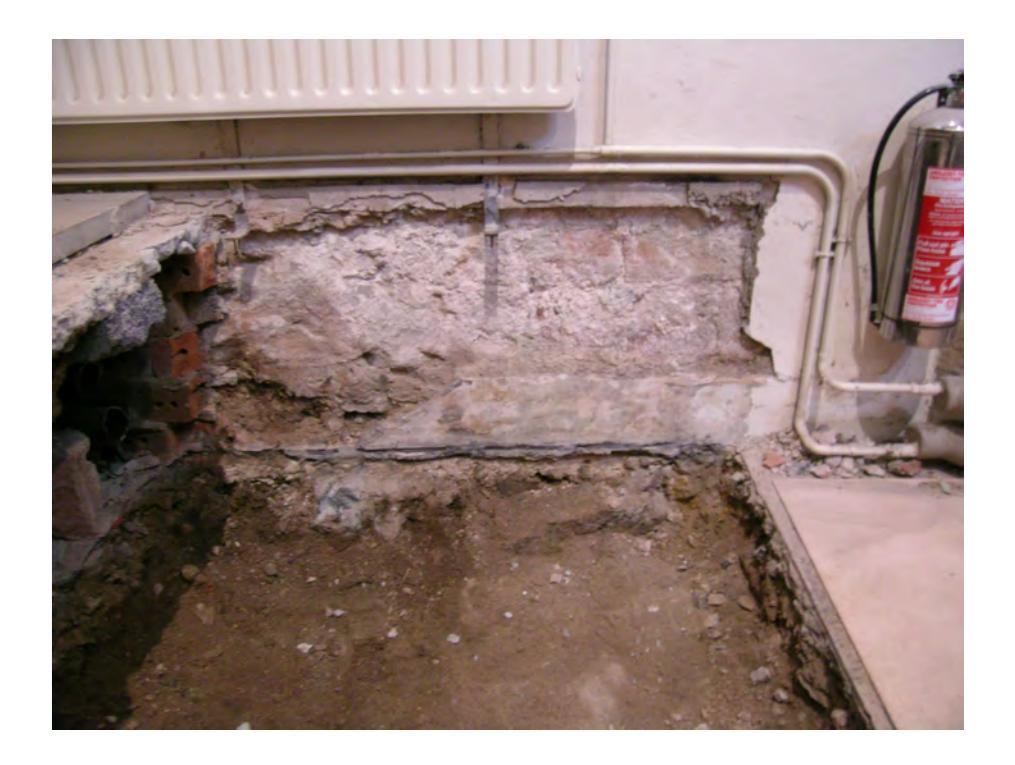
Southern Elevation (Plate 10)

This elevation has exposed stone and sandstone block-work with partly disturbed render; below the tiled surface is a layer of soft white lime-rich mortar atop a 0.30m thick layer of stone and sandstone, sitting atop a layer of silt with fragments of stone and sandstone and flecks of mortar. The block-work represents the structural material from the 14th century tower.

Plate 10 South-Facing Elevation

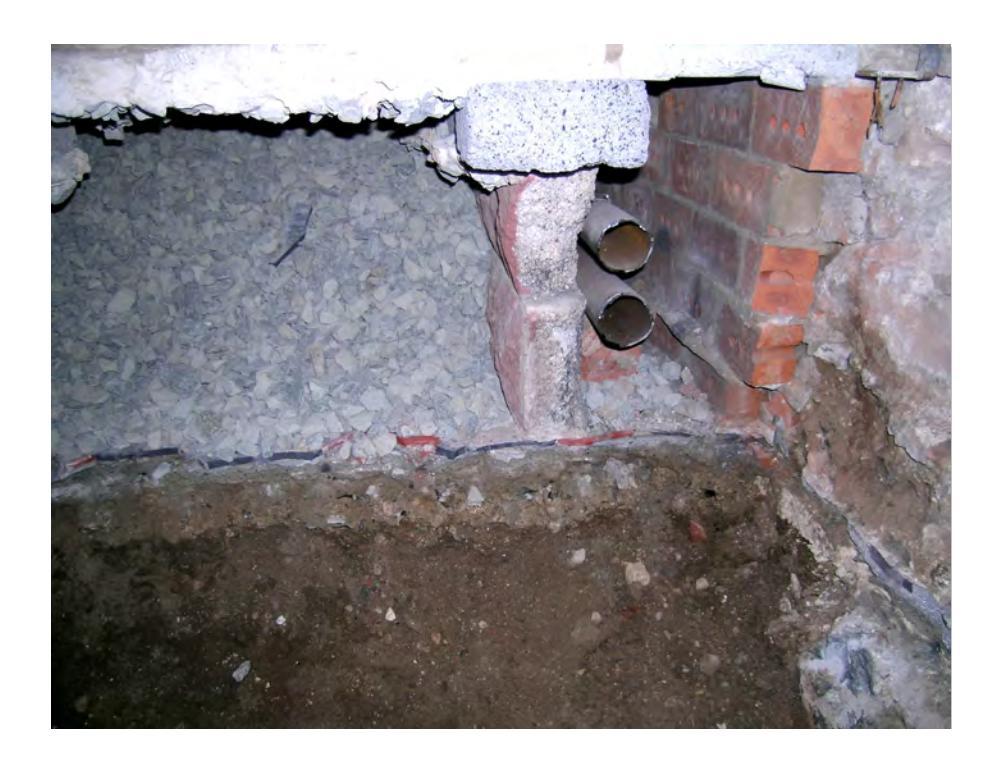
East Elevation (Plate 11)

Below the modern surface of concrete breezeblock is a 0.60m void filled with stone chippings (late twentieth century), covering the 19th century tiled surface. A pipe duct was visible on the right side, containing two metal pipes that had been truncated during the removal of the staircase. The duct was built from brick and breezeblock: the side closest to the southern elevation was built from modern aerated brick, whilst the opposite site was built from breezeblock. Rather curiously, a thin "skin" of sandstone block-work was attached to the breezeblock courses (Plate). This sandstone did not appear to serve any function and may have been decorative, and was probably used to disguise the pipe duct before the staircase was built.

Plate 11 East Facing Elevation

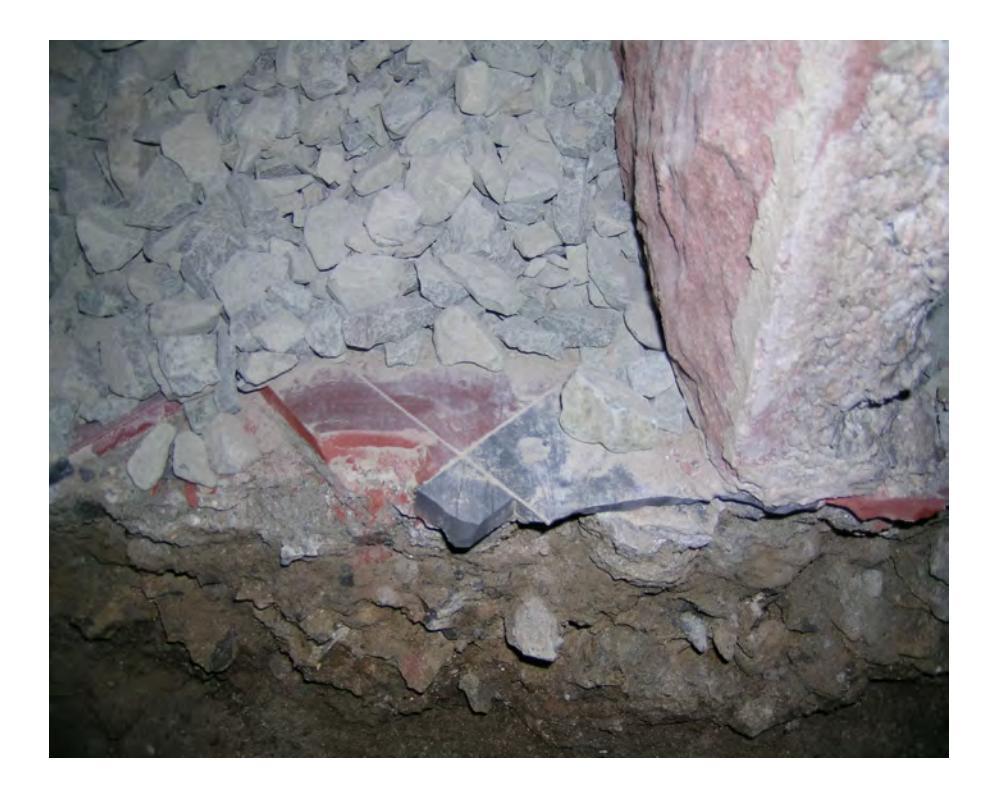
Plate 12 Close-up of East Elevation Detailing Sandstone/Breezeblock Wall and Redundant Floor Surface

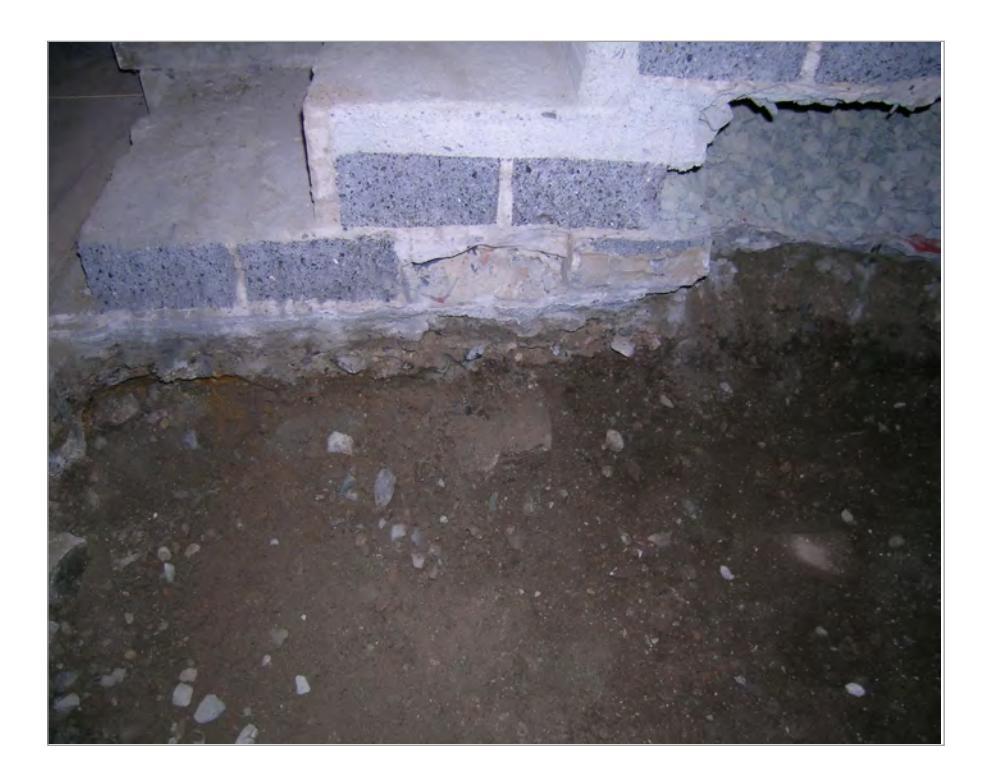
North Elevation (Plate 13)

The north-facing elevation comprised the concrete and breezeblock steps. The tiled floor surface was not visible suggesting it was removed, but the layer of fragmented stone and slate was visible atop the brown silty layer.

Plate 13 North Elevation

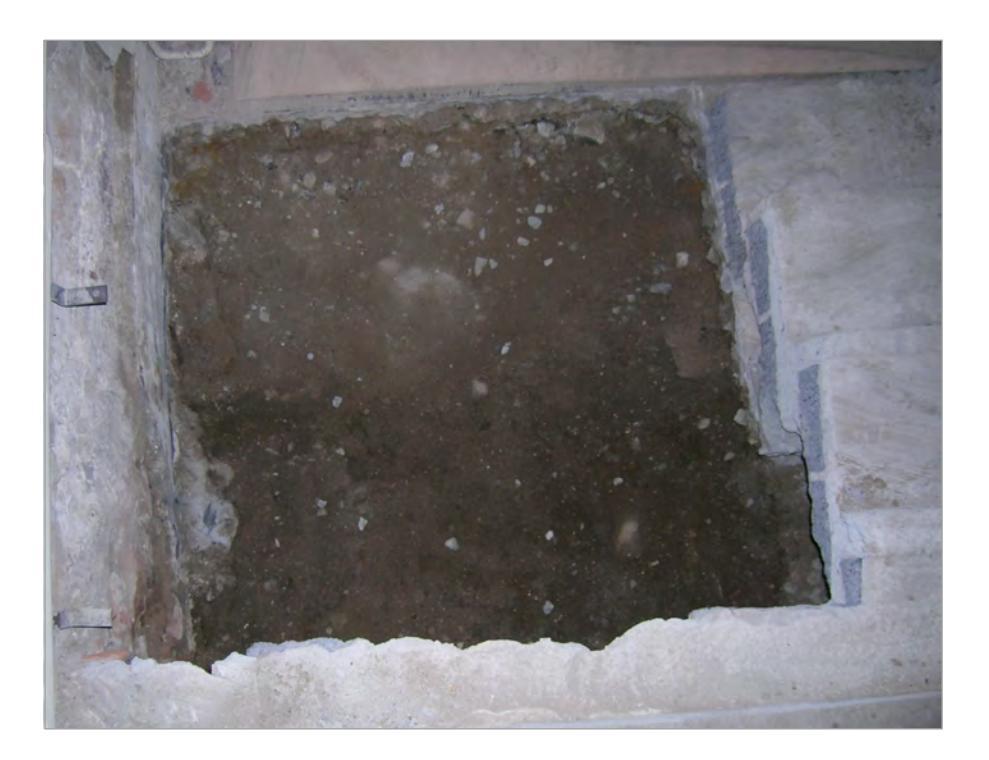
Plate 14 Birds' Eye View of Trench
