Seiont Brickworks, Caernarfon

Archaeological Watching Brief 2007

GAT Project No. G1952

Report No. 687

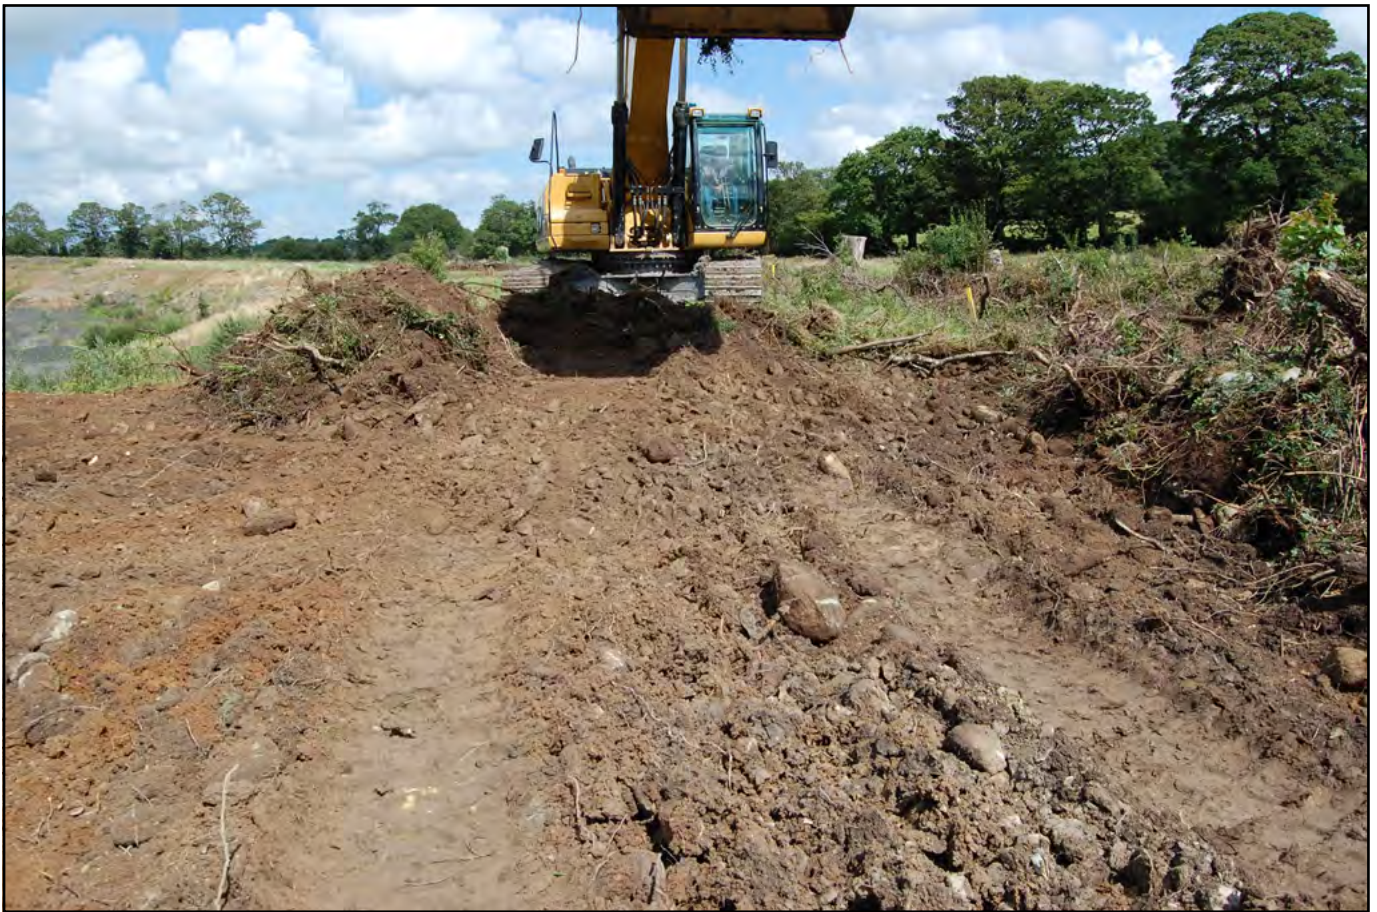
The topsoil strip revealed a thin spread of topsoil atop a glacial deposit of boulder clay and isolated patches of morrainic drift geology. The boulder clay included extensive spreads of sub-rounded stones. They were not distributed in any structural fashion and were interpreted as glacial boulders. The shallow depth of the topsoil, coupled with the frequency of large glacial stones and boulders, suggested that the area saw limited agricultural use and was used mainly for pasture.

Plate 3: View East of Quarry Extension. Note distinct Morrainic Drift Geology Below Topsoil
