Rhiwgoch Raw Water Main Replacement Works Near Harlech

**RHIWGOCH RAW WATER MAIN REPLACEMENT WORKS
AN ARCHAEOLOGICAL ASSESSMENT**

GAT Project no. G2055

GAT Report No. 775

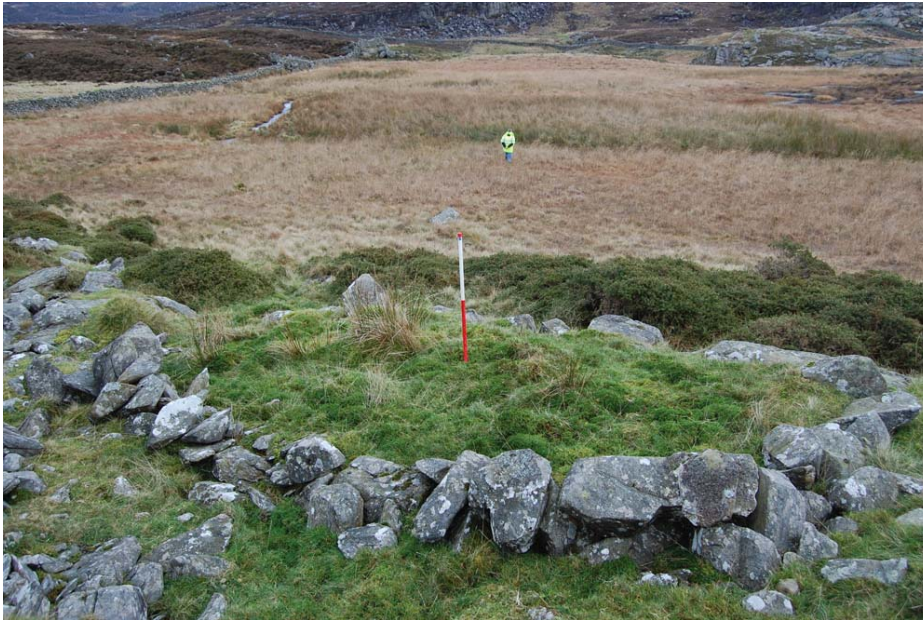
Plate 1: Feature 7, a peat stack platform, from the west

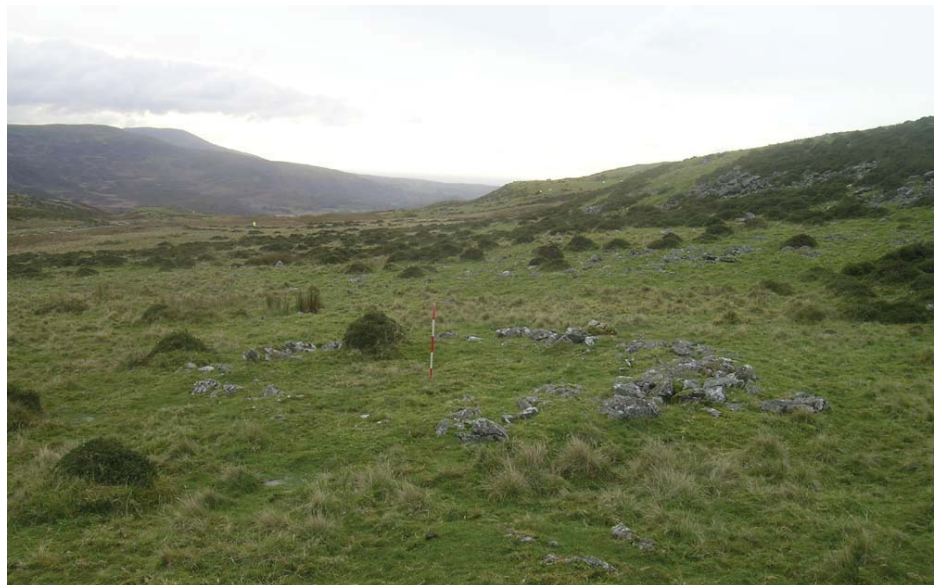
Plate 2: Feature 8, a hut circle, from the north

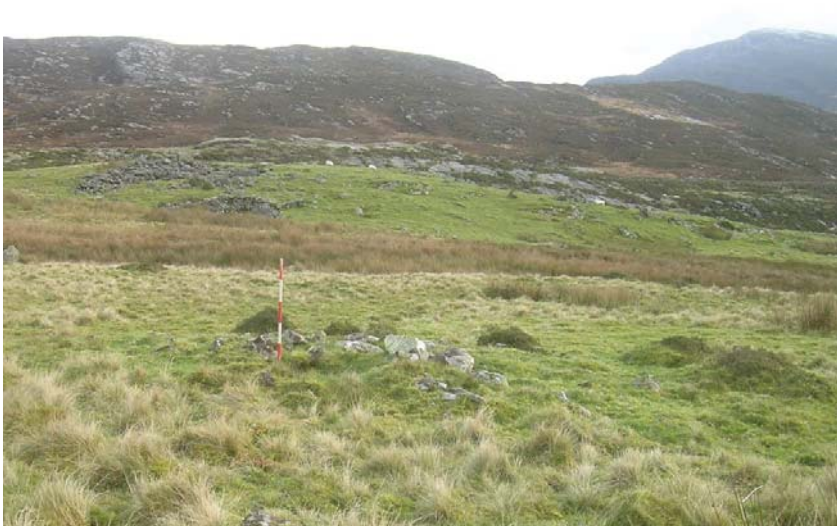
Plate 3: Feature 15, one of four cairns, from the north-west

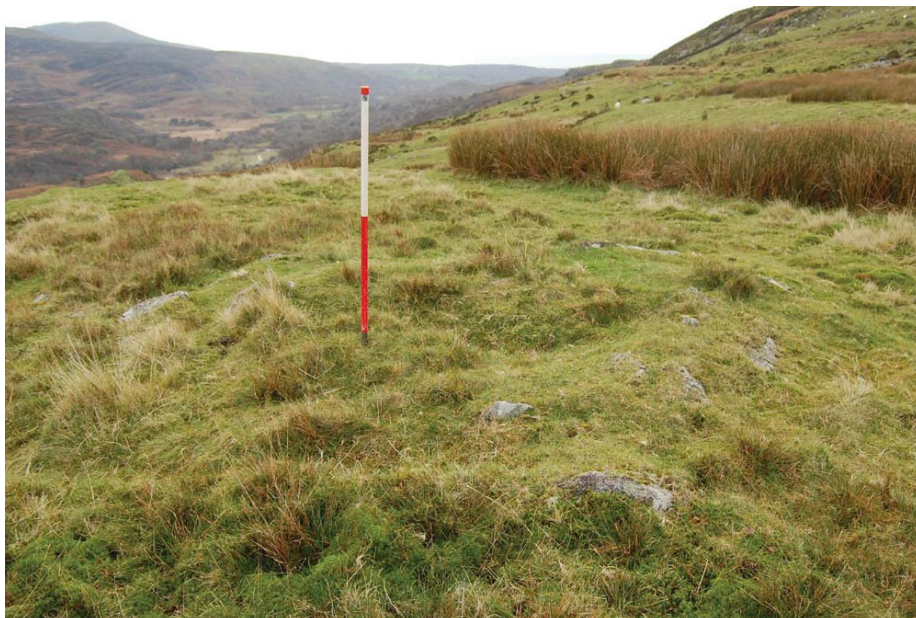
Plate 4: Feature 18, a possible burial cairn, from the north

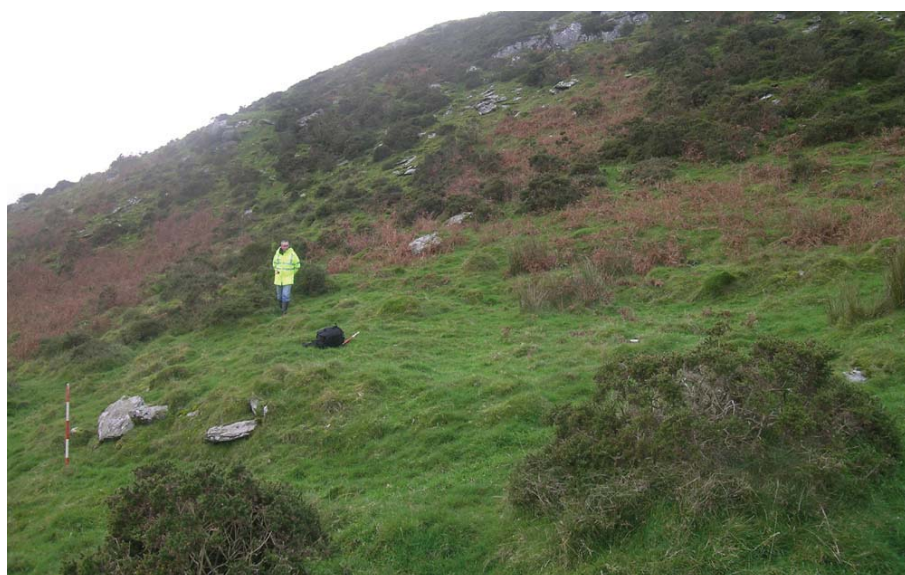
Plate 5: Feature 34, a Medieval long hut platform, from the east

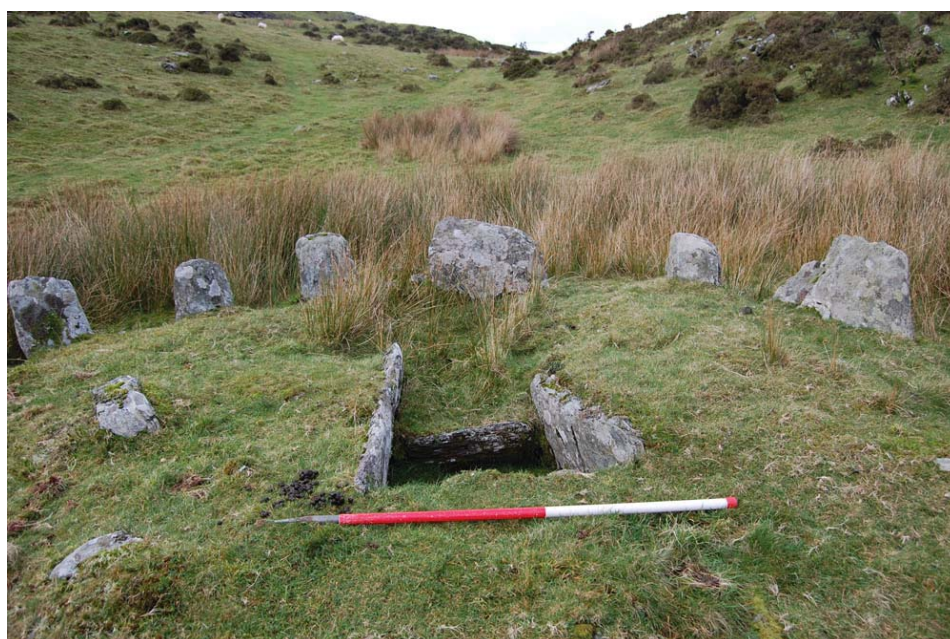
Plate 6: Feature 35, Ffridd Fron kerb cairn, from the south-east

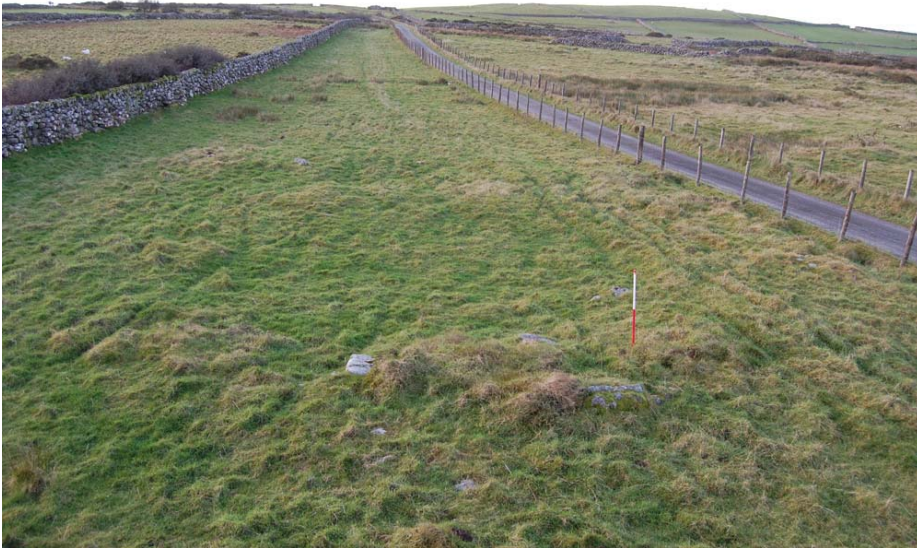
Plate 7: Feature 50, a possible ring cairn,
from the north-east

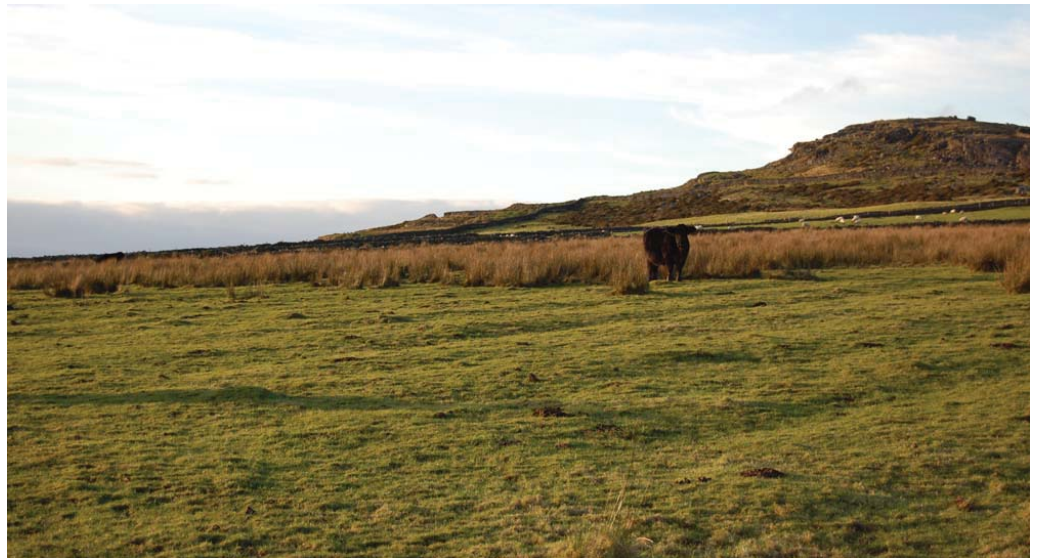
Narrow, straight ridge and furrow visible both on APs and on ground. Ridges 3m wide, no more than 0.1m high and parallel to NE boundary of field. Pipe trench will cut through the ridges just near the road, but easement will cause the loss of a 12m wide strip. Use of the road instead of creation of an easement should be considered. Record during strip, map and sample process.

Plate 8: Feature 60, ridge and
furrow, from south-east

Recommendations for mitigatory measures: Strip, map and sample.

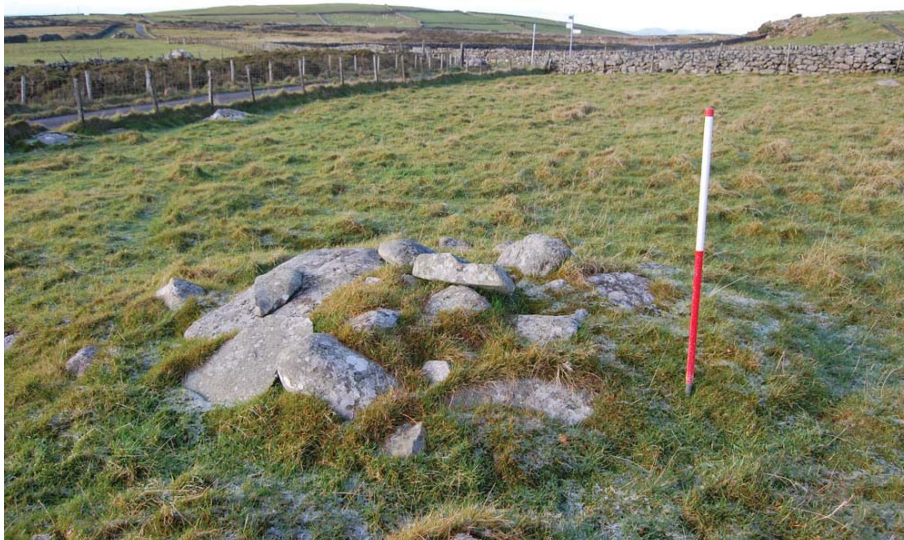
Plate 9: Feature 84, a clearance cairn,
from the east
