# Aberdaron, Meillionydd Bach Water Mains Renewal Scheme: Ground Investigation Programme

## Archaeological Watching Brief

GAT Project No. 2151

Report No. 902

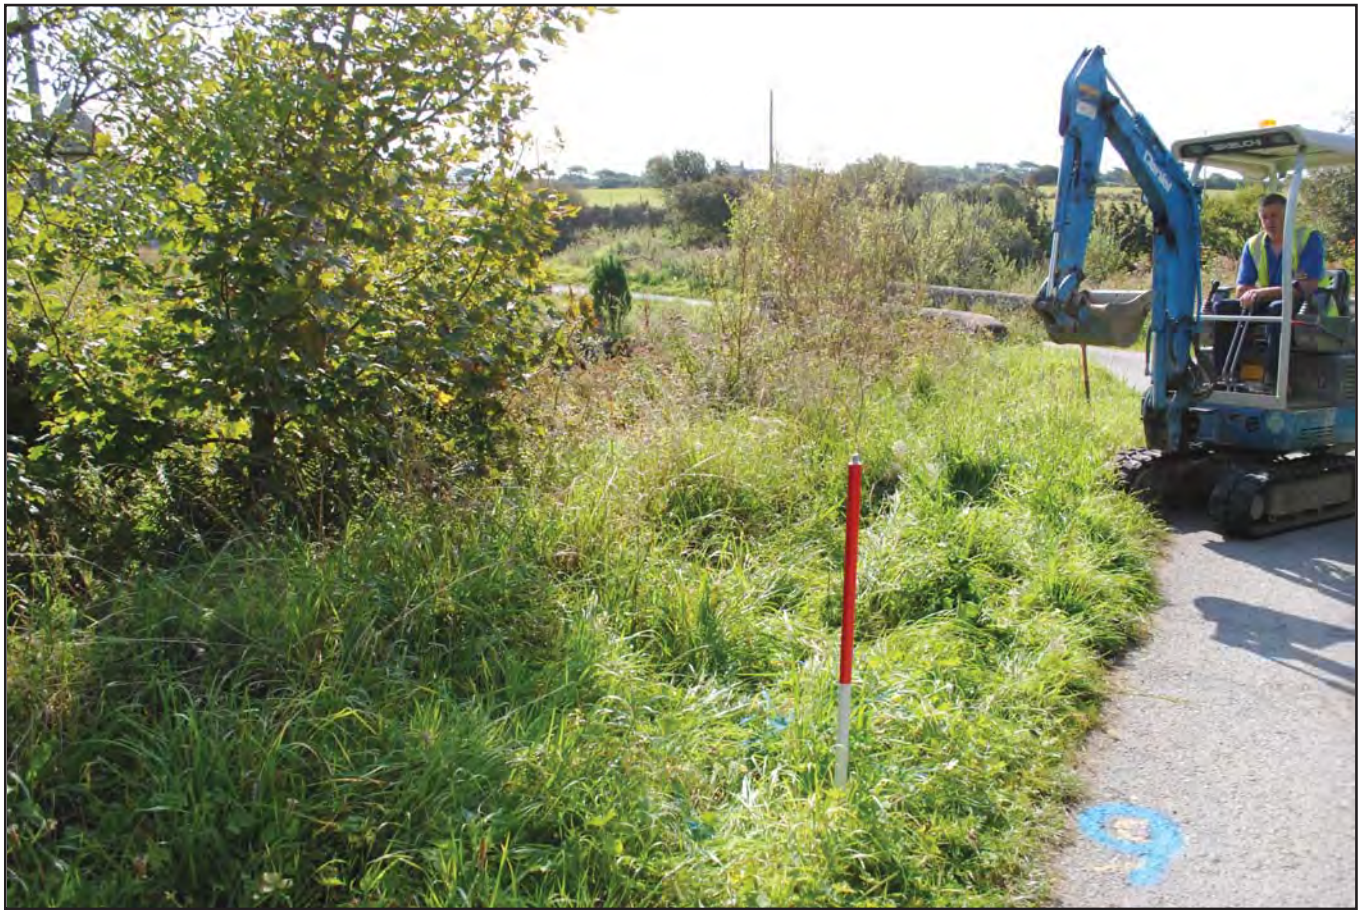
**Plate 1: Pre excavation shot showing location of Test Hole 6, view from the North-West**

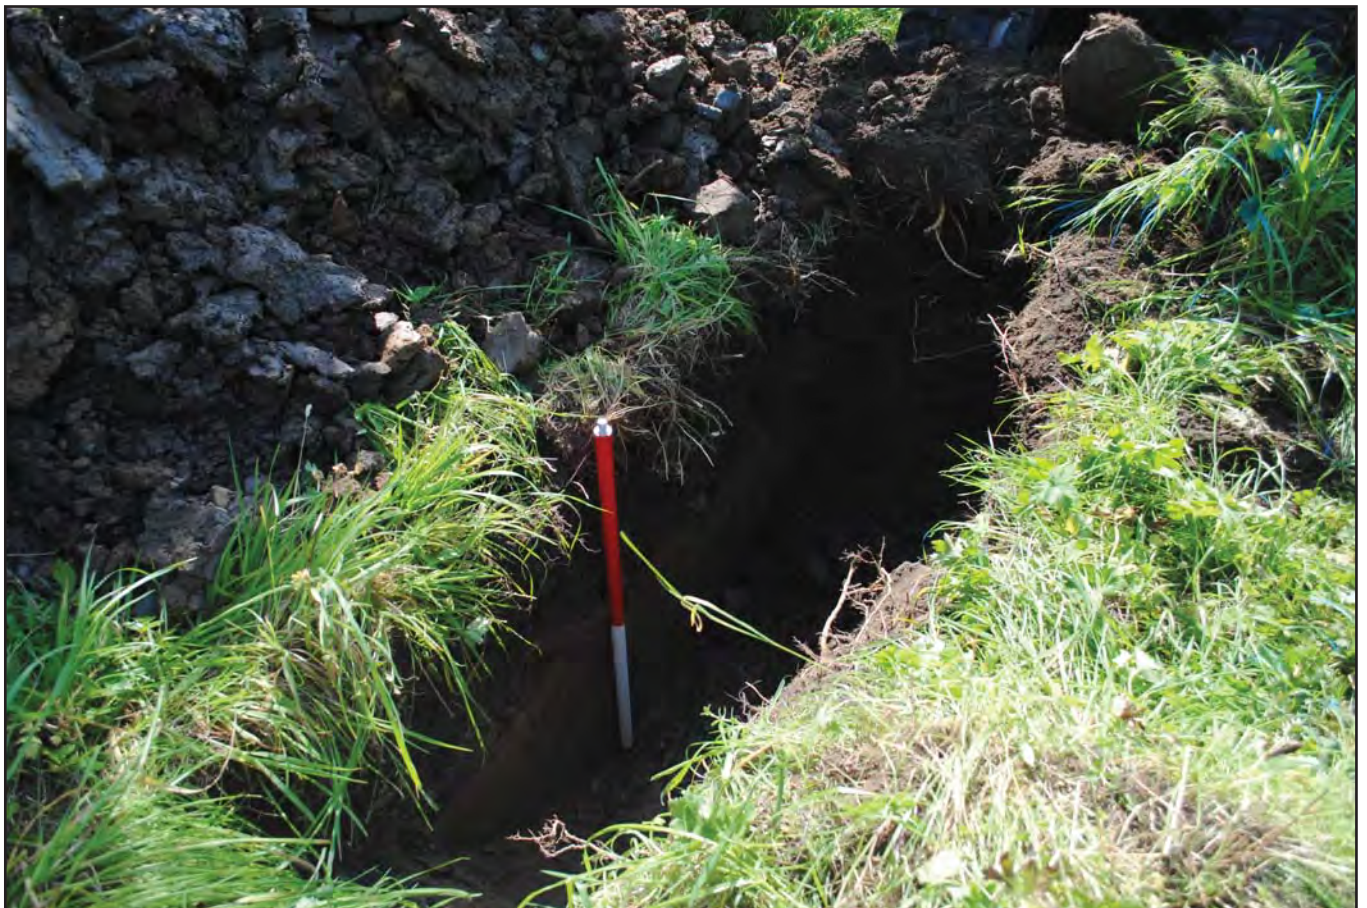
Test hole excavated to test ground conditions. 0.4m of dark orange-brown clay rich silt topsoil overlay 0.8m of yellow-orange natural clay. A number of larger stones which may have been natural were clipped at the southern end of the trench.

**Plate 2: Test Hole 6 post excavation, view from the North-West**

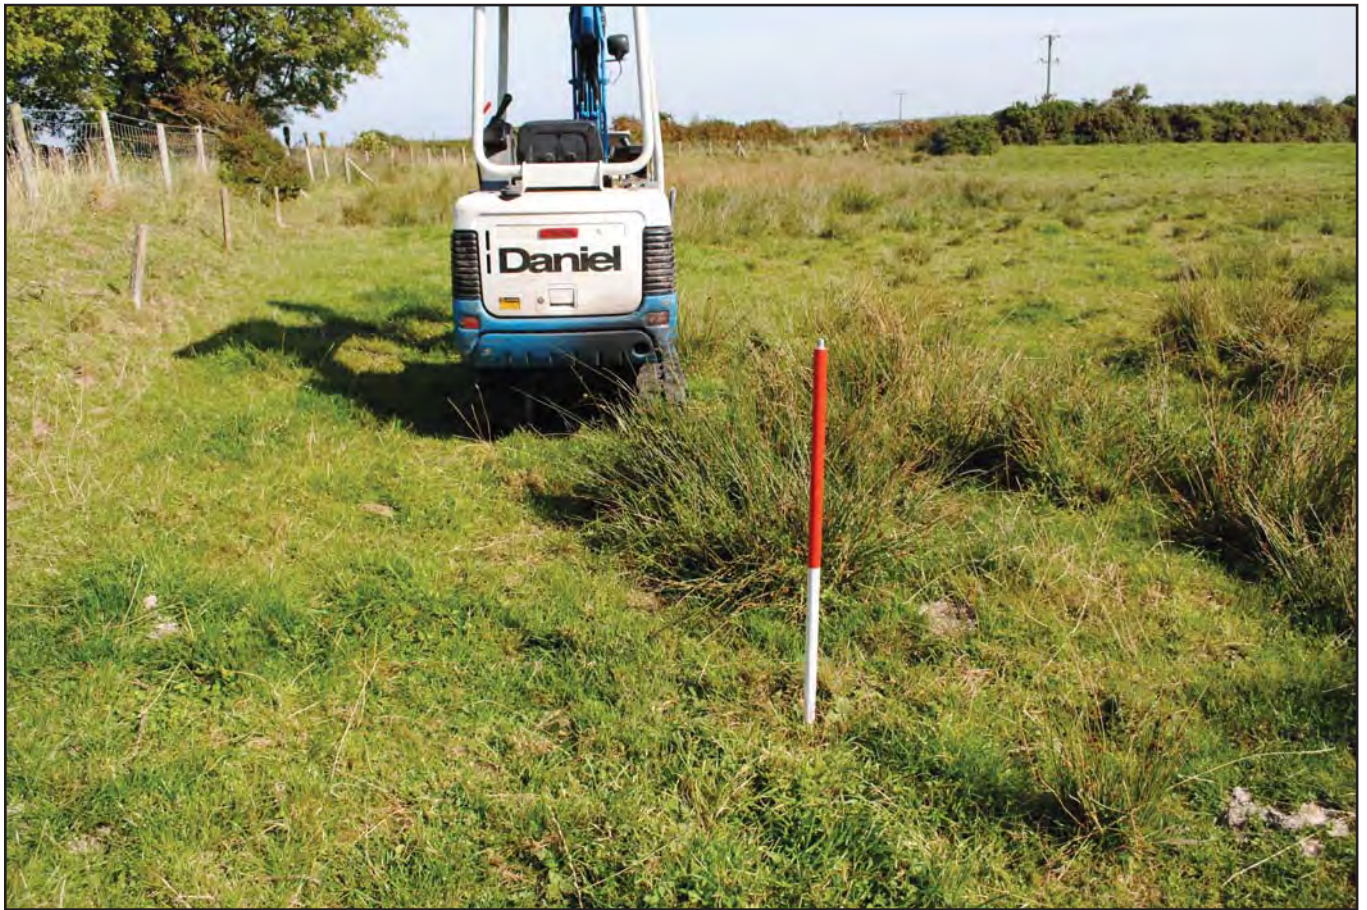
**Plate 3: Pre excavation shot showing the location of Test Hole 8, view from the South**

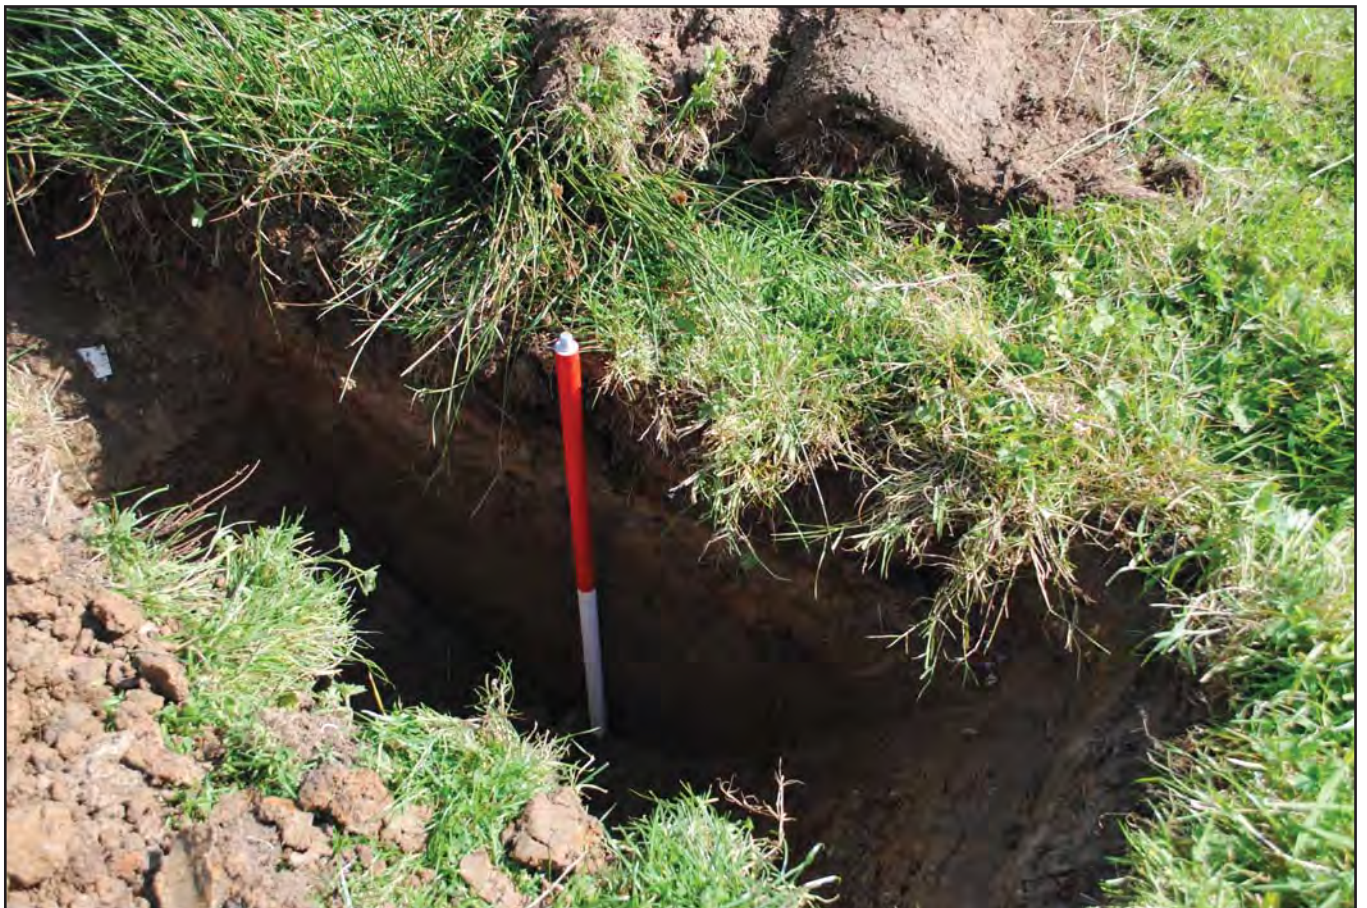
Test hole was located in a fairly wet field across the road from Tynllyn cottage and was excavated to test ground conditions. A layer of topsoil 0.25m thick consisting of mid grey-brown clay rich silt overlay 0.1m of grey-yellow sand. Both of these layers contained a fairly large amount of post medieval domestic material, probably rubbish from the nearby cottage. 0.65m of brown-orange clay underlay the upper deposits. Iron panning could be seen between the deposits.

**Plate 4: Test Hole 8 post excavation, view from the West-South-West**

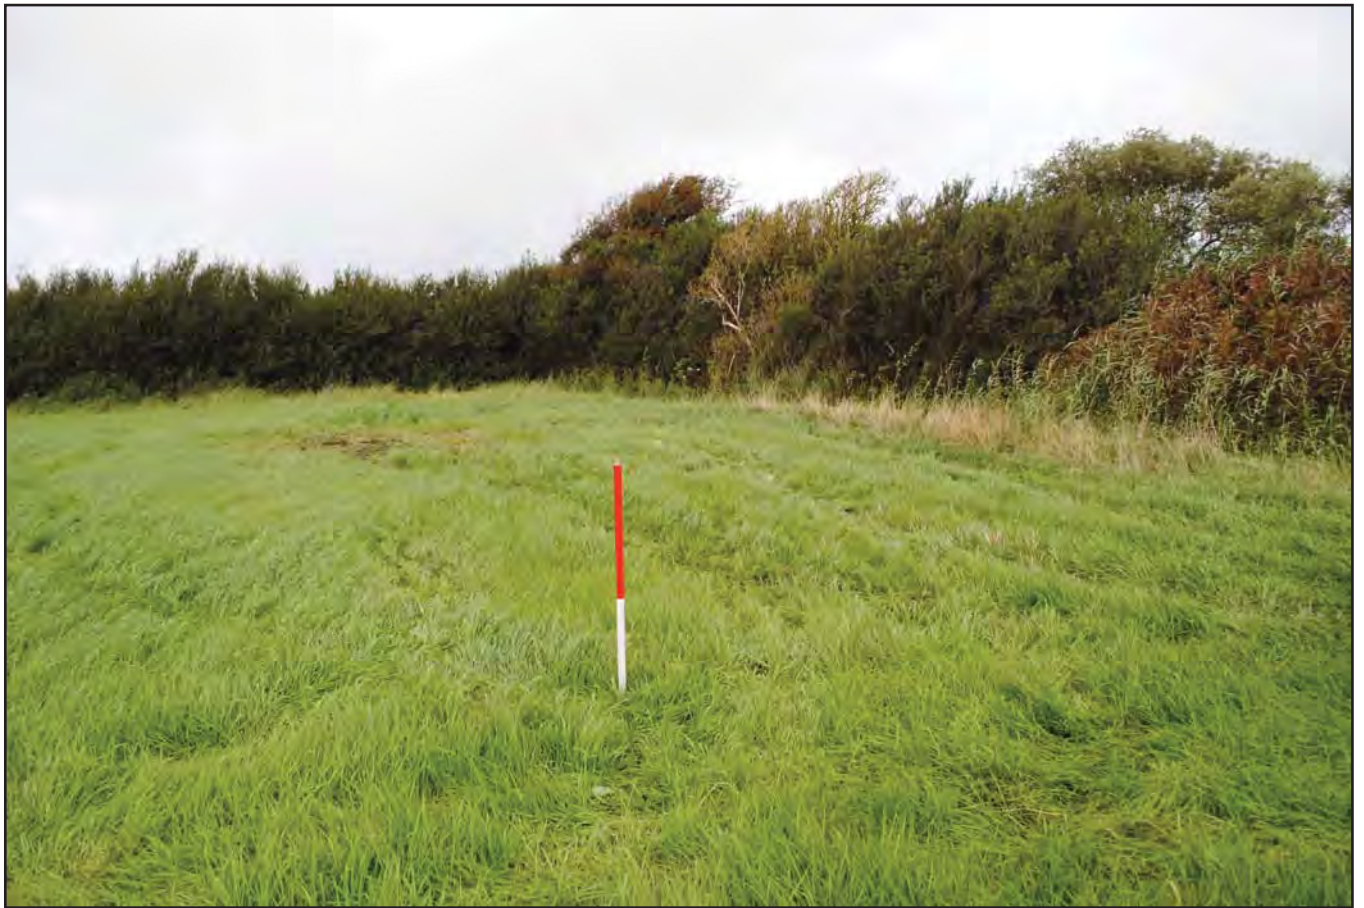
**Plate 5: Pre excavation shot showing the location of Test Hole 13, view from the South-East**

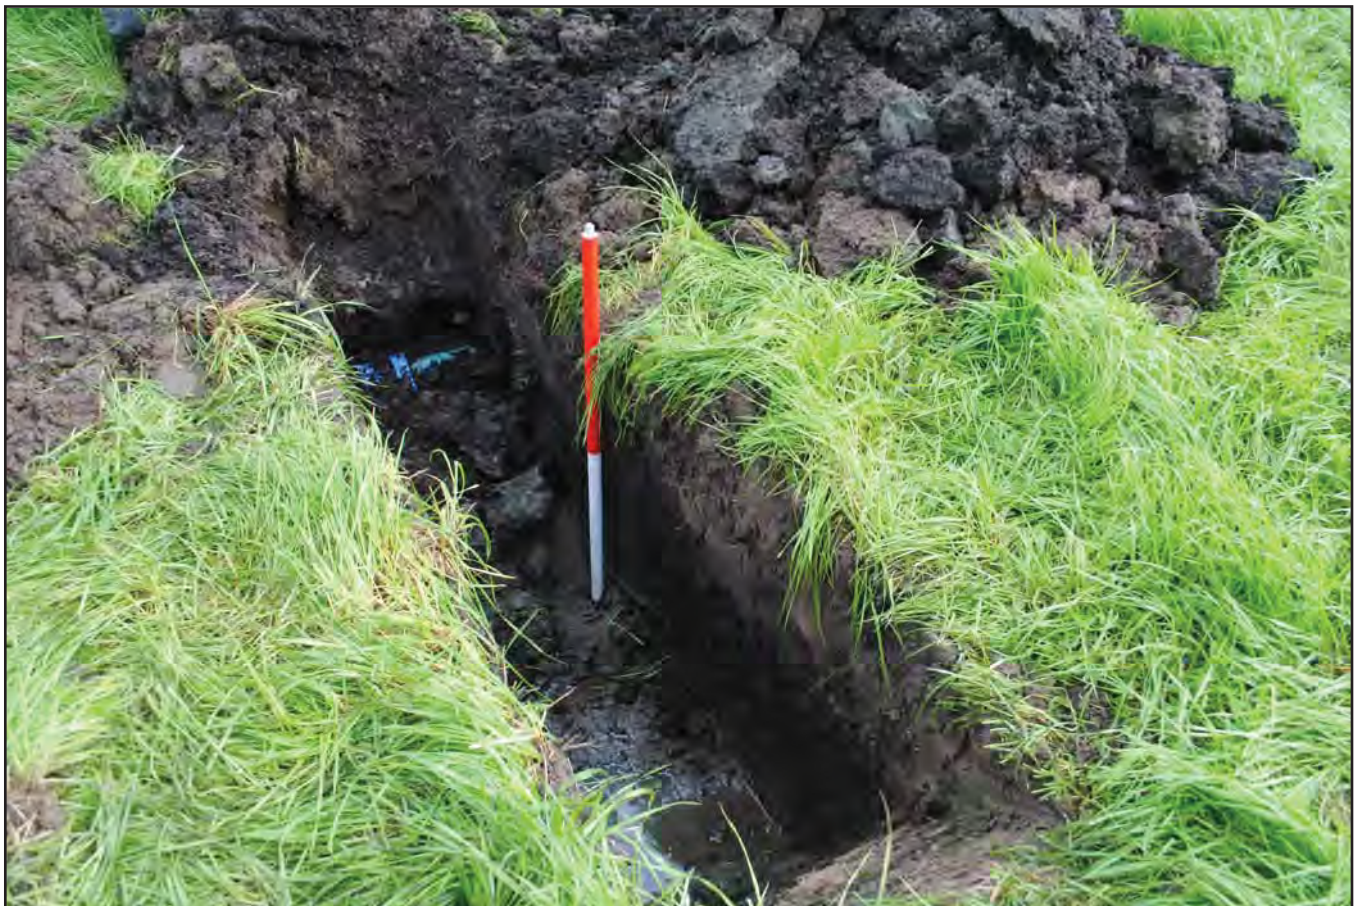
The test hole was located in a low point of a silage field at the base of a gradual slope, and was excavated to locate the existing water main. 0.3m of mid brown-gray silt-clay topsoil overlay 0.5m of dark brown-black peat. Below the peat was a mid grey clay. The existing main was located at a depth of 0.6m.

A second test hole, TH 13, revealed significant peat deposits which can provide valuable paeleoenvironmental information through preserved floral and faunal remains.

**Plate 6: Test Hole 13 post excavation, view from the West**

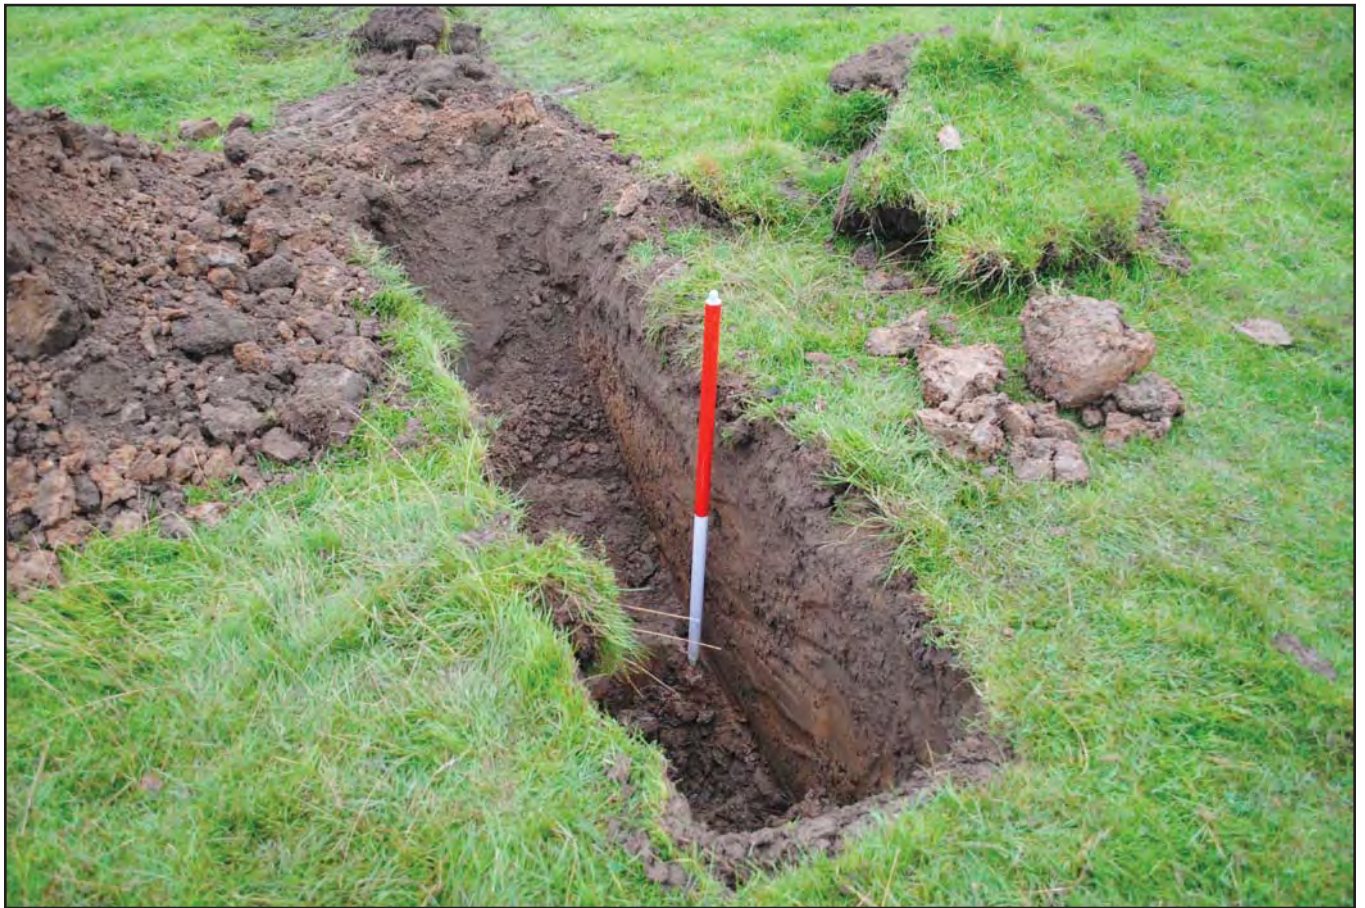
- TH 19I (*Plate 07*) was 2.3m x 0.5m and 1.05m deep, and orientated E-W. Deposits encountered consisted of 0.3m of mid orange-brown clay rich silt topsoil overlying 0.2m of mid brown-orange silt-clay subsoil. The natural was light orange-yellow clay. The existing main was located at a depth of 1m.

**Plate 7: Test Hole 19I post excavation, view from the North-West**

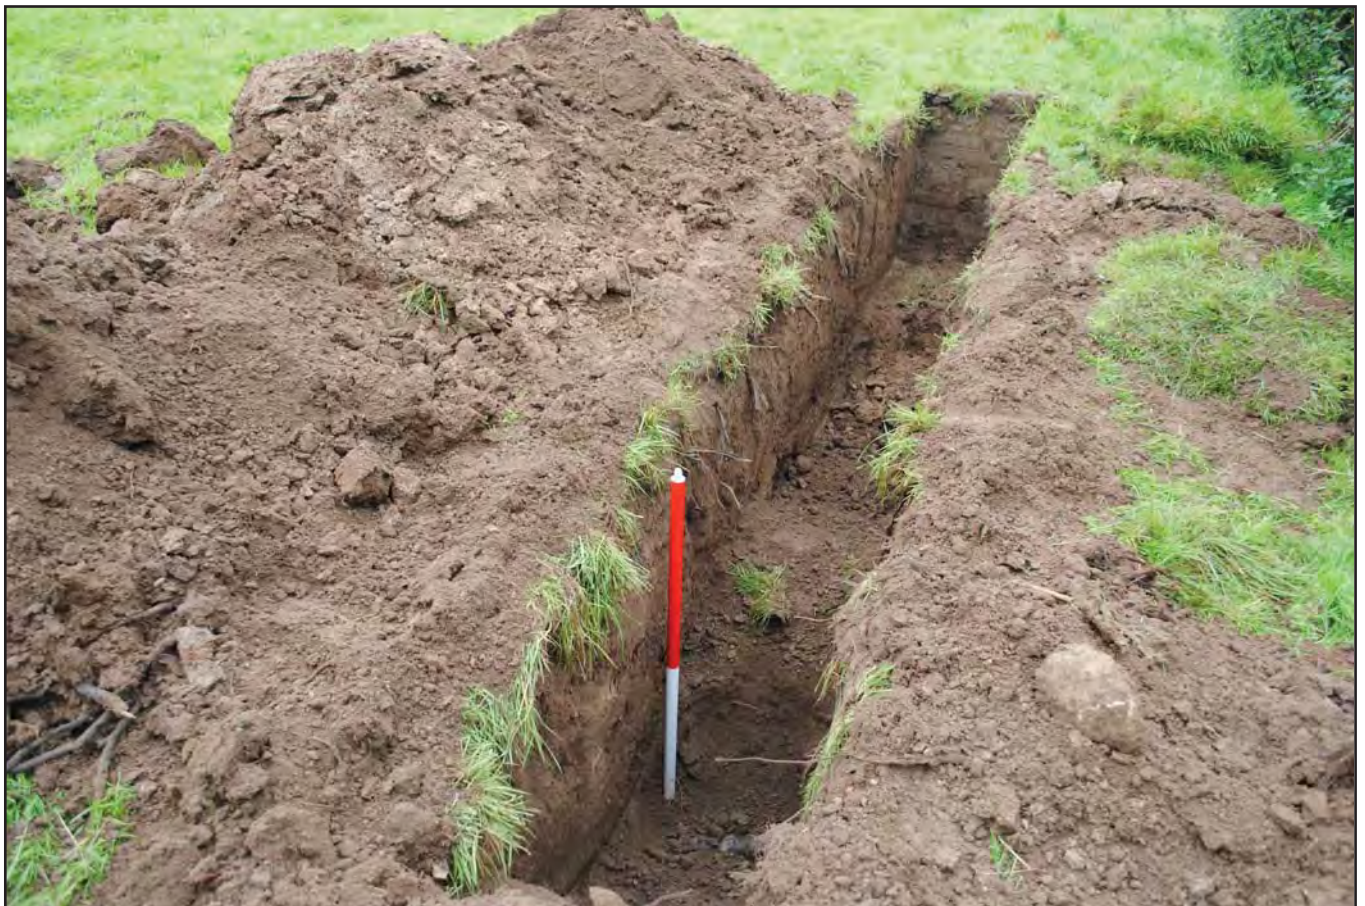
- TH 19K (*Plate 08*) was 4.9m x 0.5m and 1m deep, and orientated N-S. Deposits encountered consisted of 0.3m of mid orange-brown clay rich silt topsoil overlying 0.2m of mid brown-orange silt-clay subsoil. The natural was light orange-yellow clay. The existing main was located at a depth of 1m.

**Plate 8: Test Hole 19K post excavation, view from the North-West**

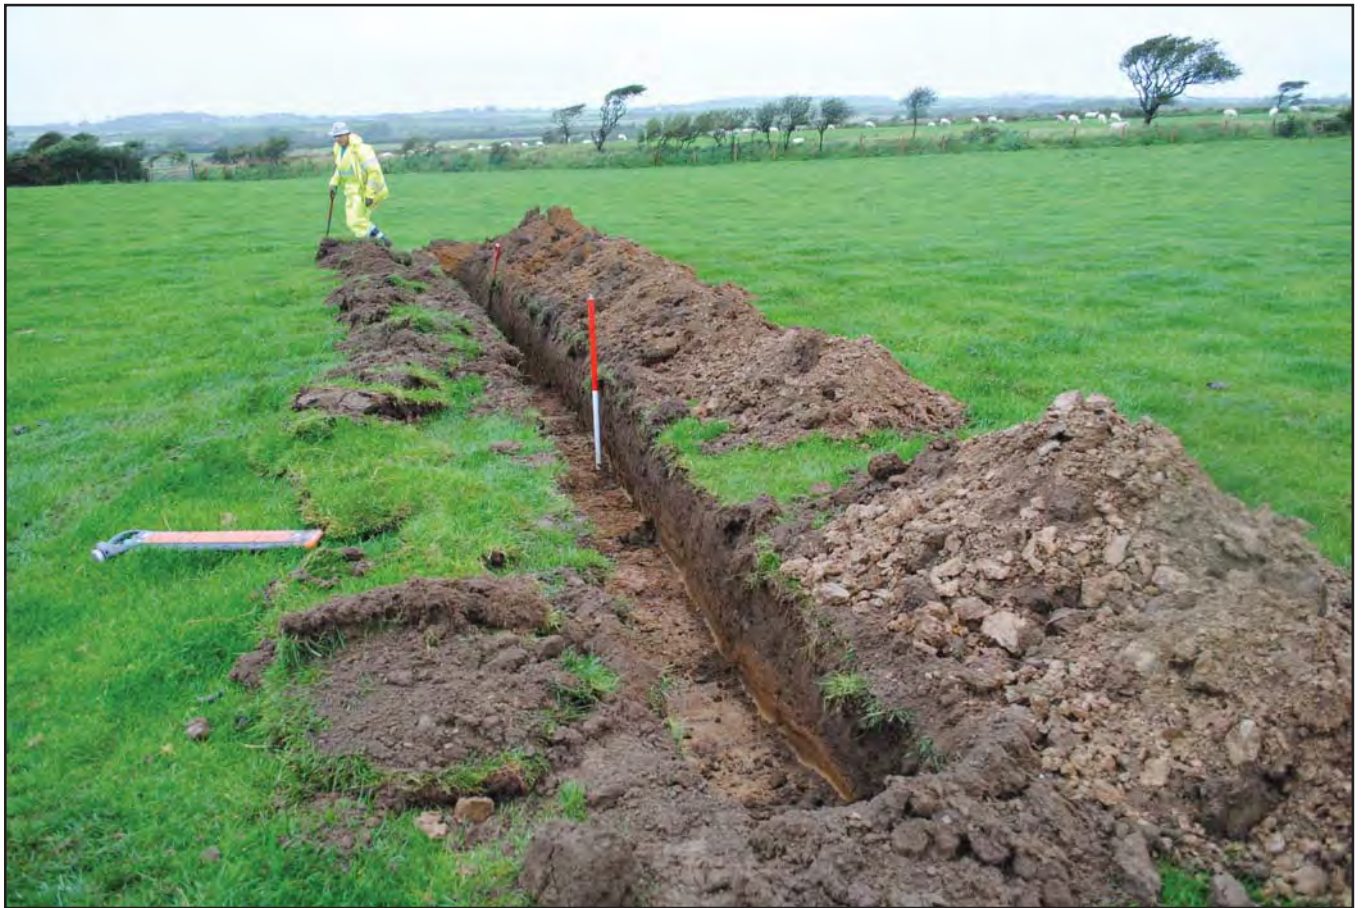
The test hole was initially excavated to identify ground conditions and later extended to locate the existing water main. Deposits encountered consisted of 0.4m of mid orange-brown clay rich silt topsoil overlying 0.1m of mid brown-orange silt-clay subsoil. The natural was orange-yellow sand rich clay containing a fair amount of small stones. Existing main was encountered at a depth of 0.9m.

**Plate 9: Test Hole 21 post excavation, view from the South-East**

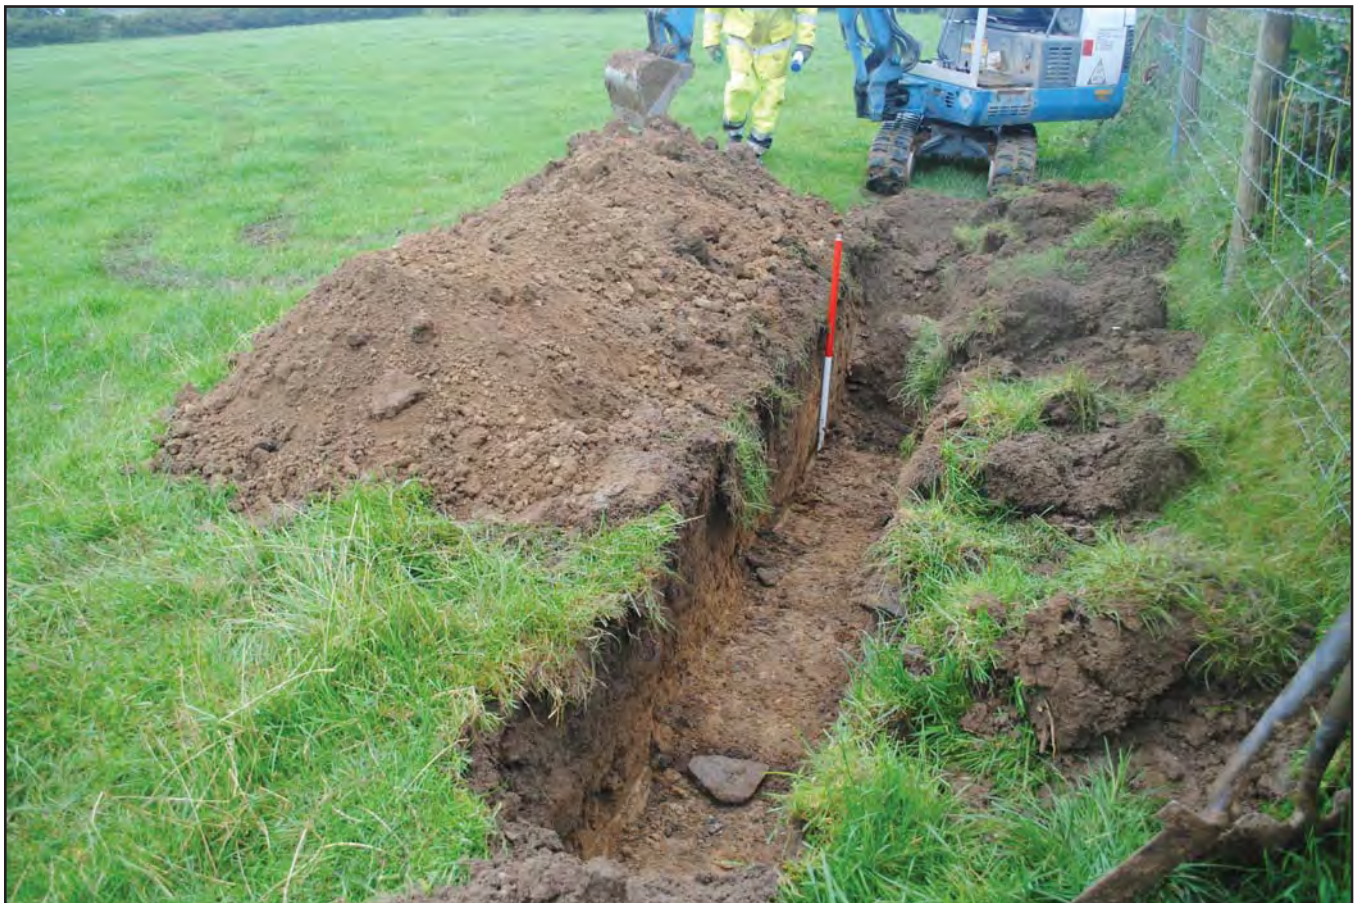
This additional test hole was excavated in the same field as TH 20 and TH 21 so that the line of the existing main could be traced. 0.5m of mid orange-brown clay rich silt topsoil overlay 0.2m of mid brown-orange silt-clay subsoil. The natural was orange-yellow stone rich sandy clay. The existing main was located at a depth of 0.9m.

**Plate 10: Test Hole 27 post excavation, view from the West-South-West**

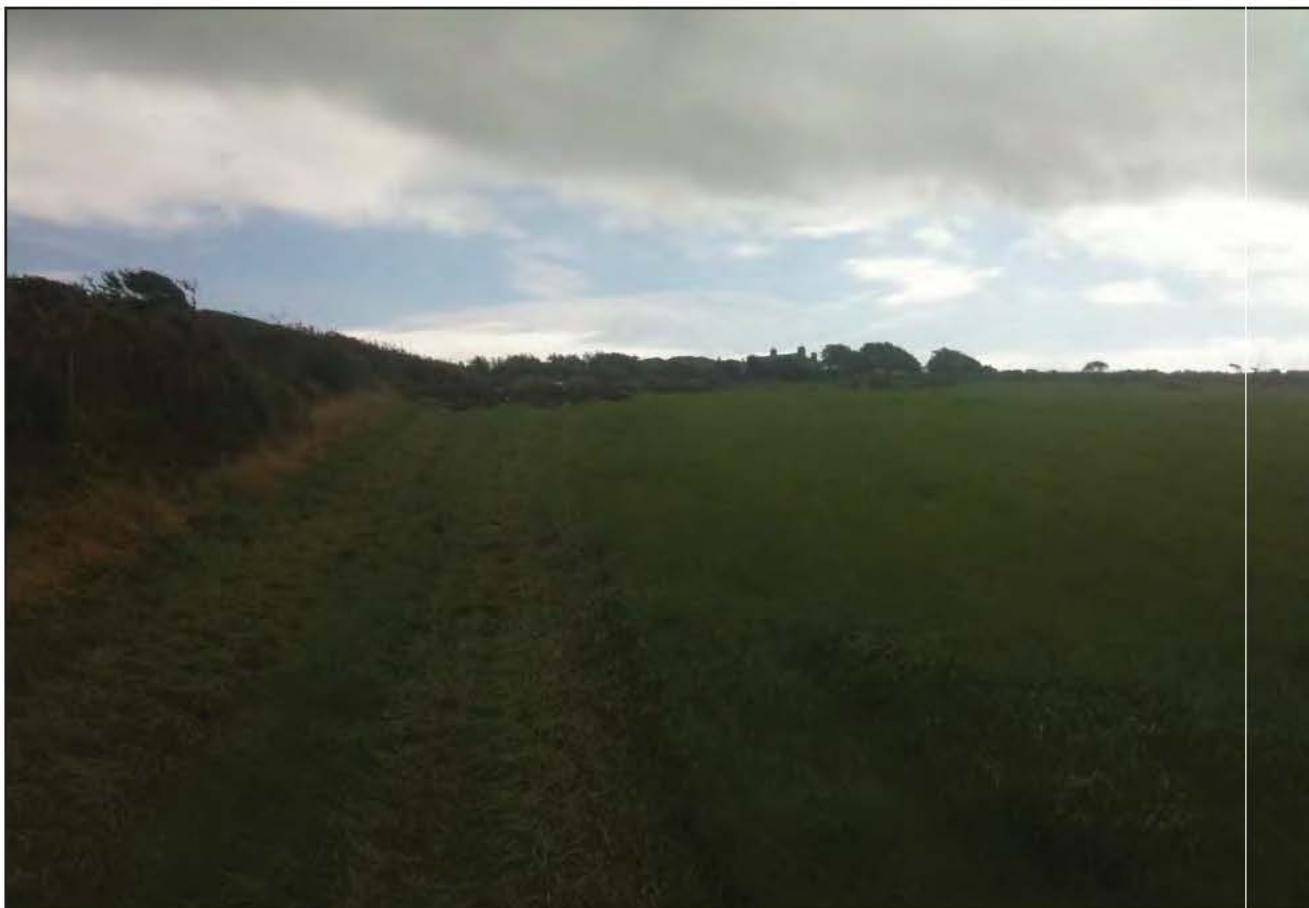
**Plate 11: General view of field where Test Hole 14E was located, view from the North-West**

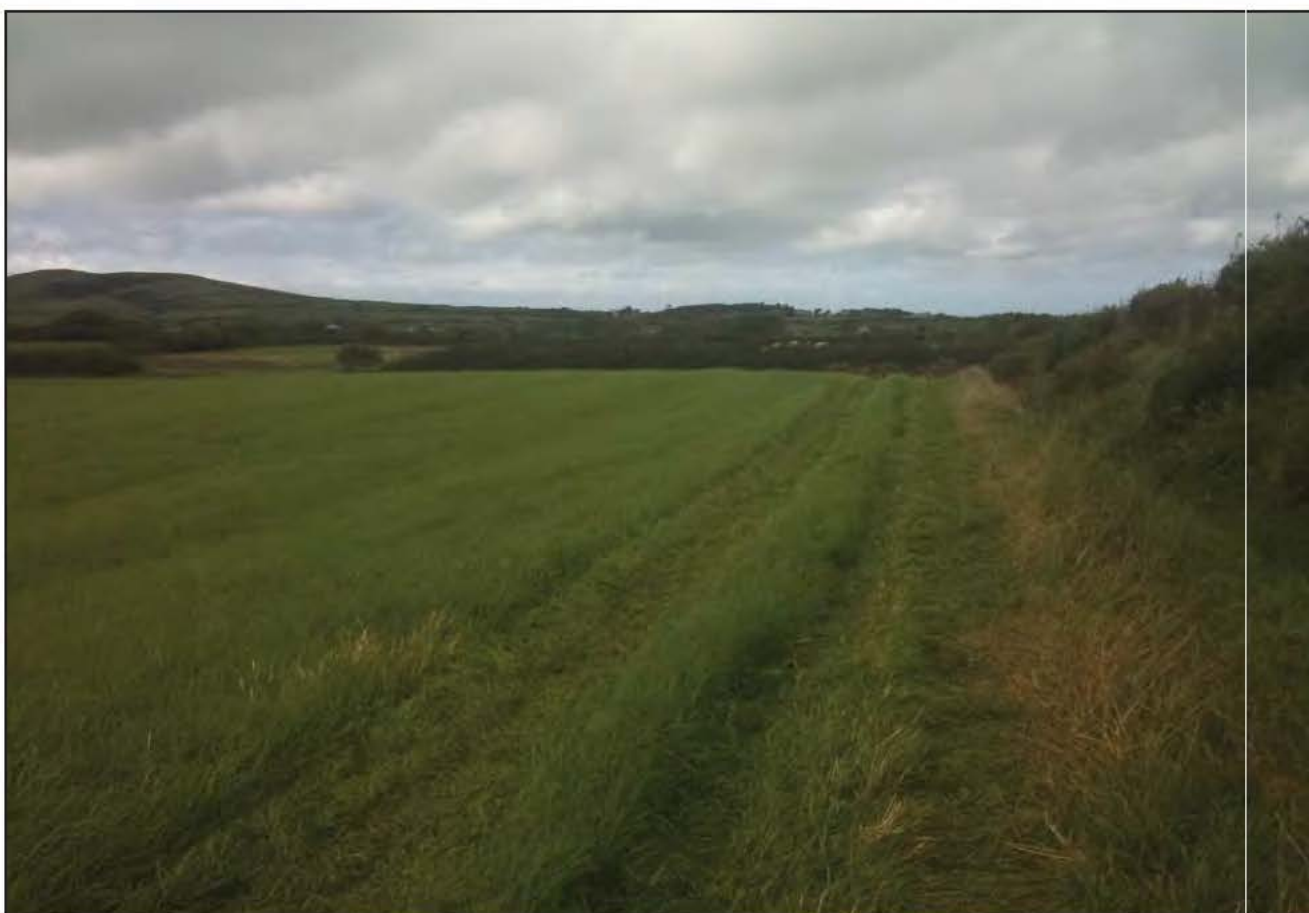
**Plate 12: General view of field where Test Hole 14E was located, view from the North-East**

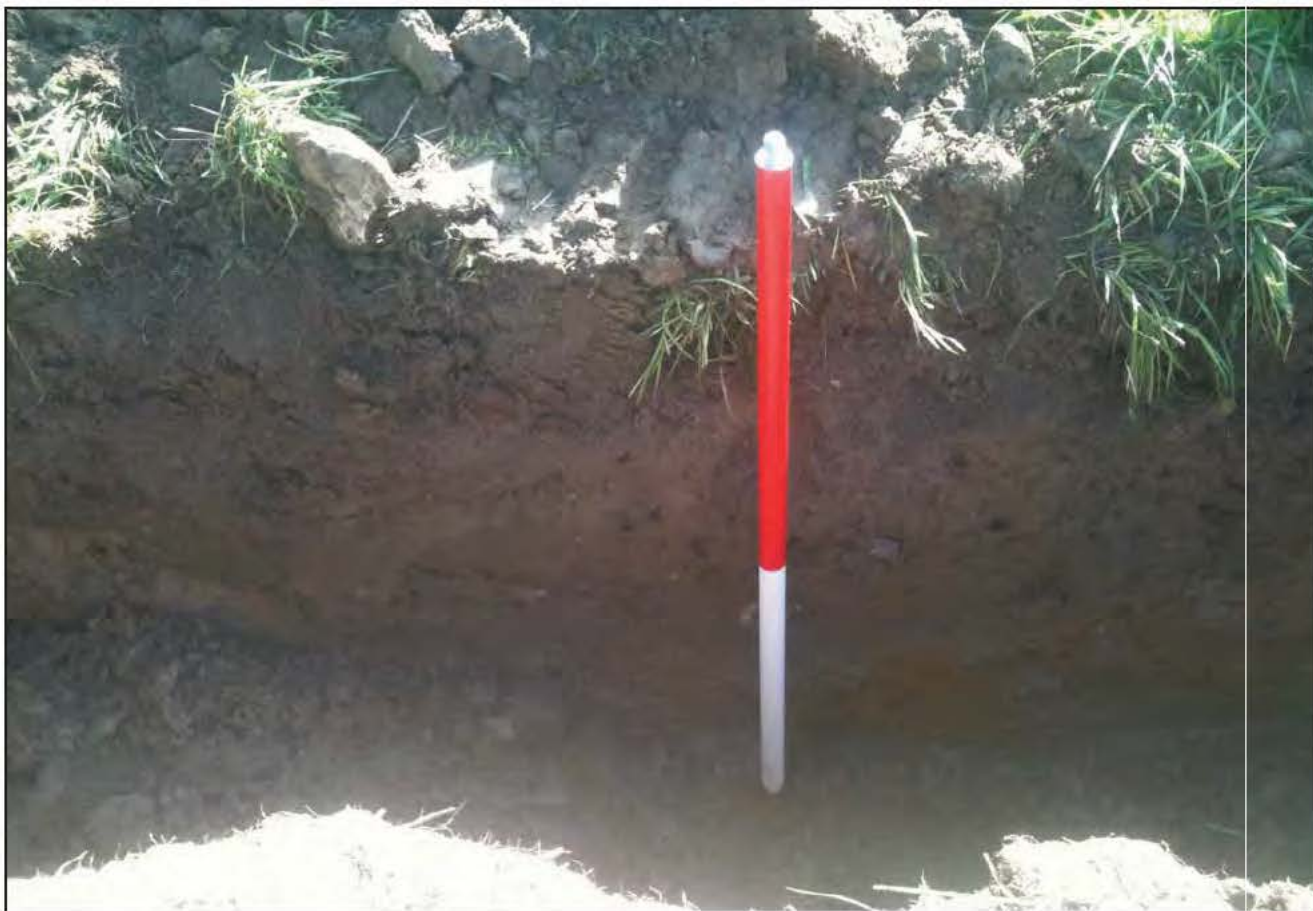
- E1401 – Topsoil, 0.25m of mid grey-brown silt rich clay.
- E1402 – Subsoil, 0.4m of mottled brown-orange clay.
- E1403 – Cut of pit, fairly shallow sides with a rounded base, 0.35m deep and 1.5m wide.
- E1404 – Upper fill of pit, 0.15m deep, mid grey-brown silt rich clay, similar to the topsoil.
- E1405 – Lower fill of pit, 0.2m deep, mid grey clay containing charcoal and flint.

The feature encountered was almost certainly prehistoric in date as a worked flint fragment was recovered from the lower deposit. Other worked flint fragments found in the spoil heap produced during the excavation of the test hole are likely to have come from the same feature as it was clearly truncated during excavation. In all 5 pieces of flint were recovered. One of these had been struck from a blade core and had been utilised as a cutting tool, blade technology of this kind is generally late Mesolithic to early Neolithic in date (*pers. comm.* George Smith). Another fragment is likely to have been produced during core rejuvenation and is also likely to date from a similar period. The remaining fragments were not diagnostic but could be said to be debitage from tool making.

**Plate 13: Section of Test Hole 14E showing prehistoric cut feature, view from the West-South-West**

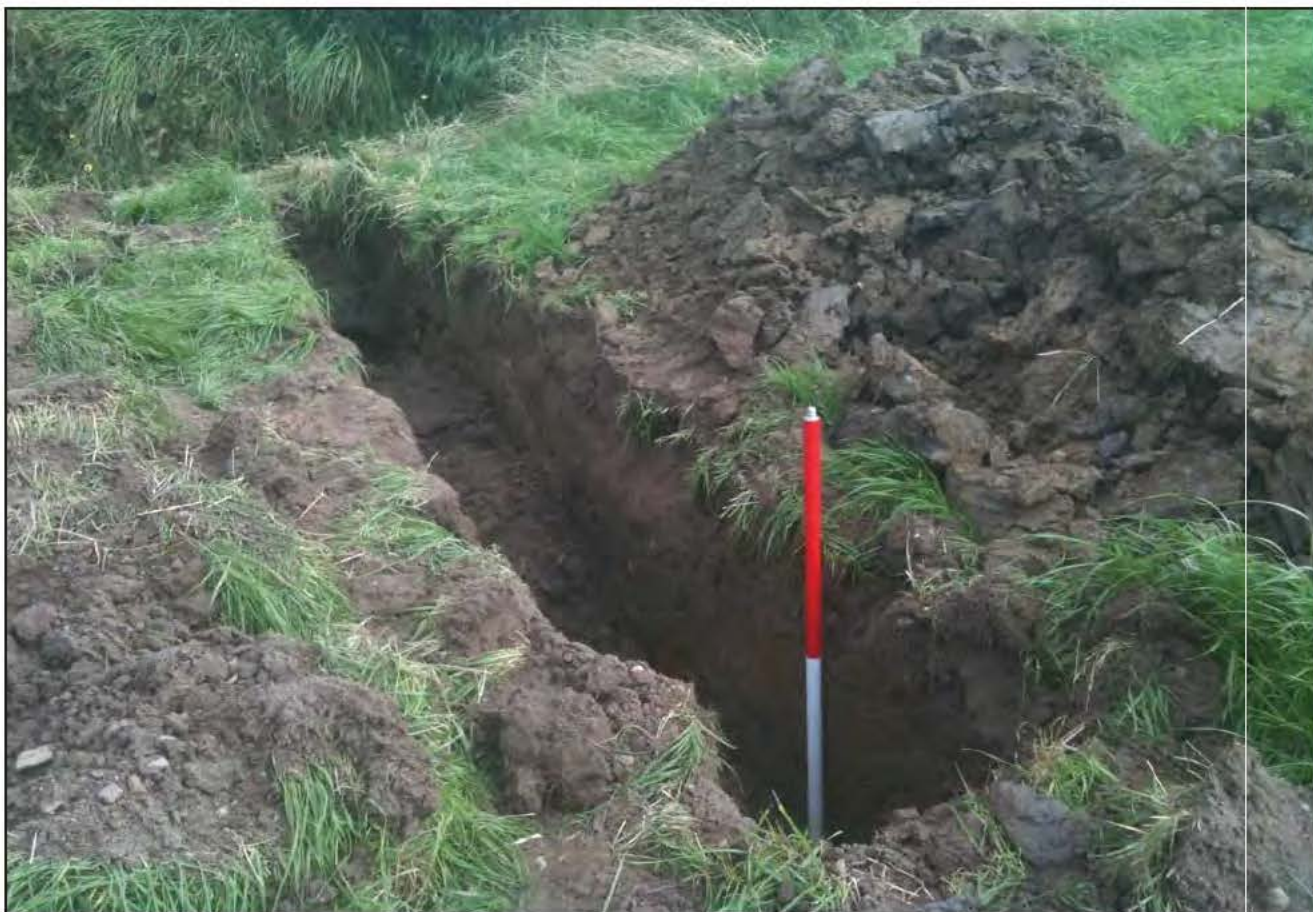
- TH 14E (*Plates 11-14*) was the only test hole which contained archaeological deposits. The test hole measured 4.5m x 0.5m and 1m deep, and was orientated NNE-SSW. It was located on a flat plateau which overlooked the location of TH 13.

**Plate 14: Test Hole 14E post excavation, view from the South-West**
