Pen yr Orsedd Slate Quarry, Nantlle

Archaeological Assesment

GAT Project No. G2035 Report No. 910 December 2010

Prepared for Welsh Slate

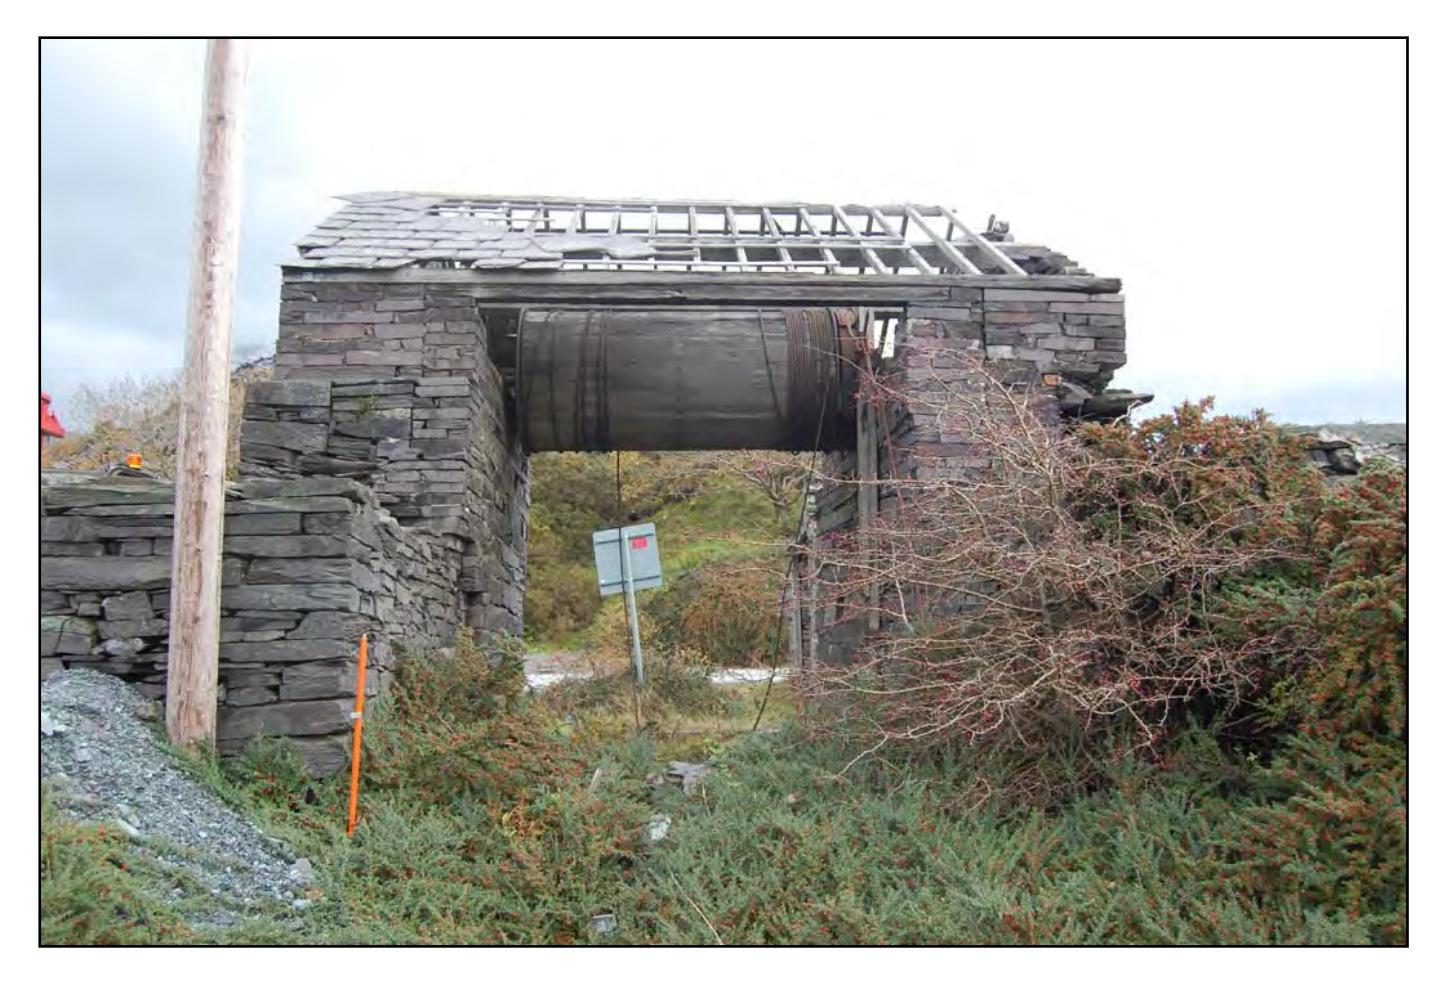
Plate 01: Incline and drumhouse feature 06 from the west

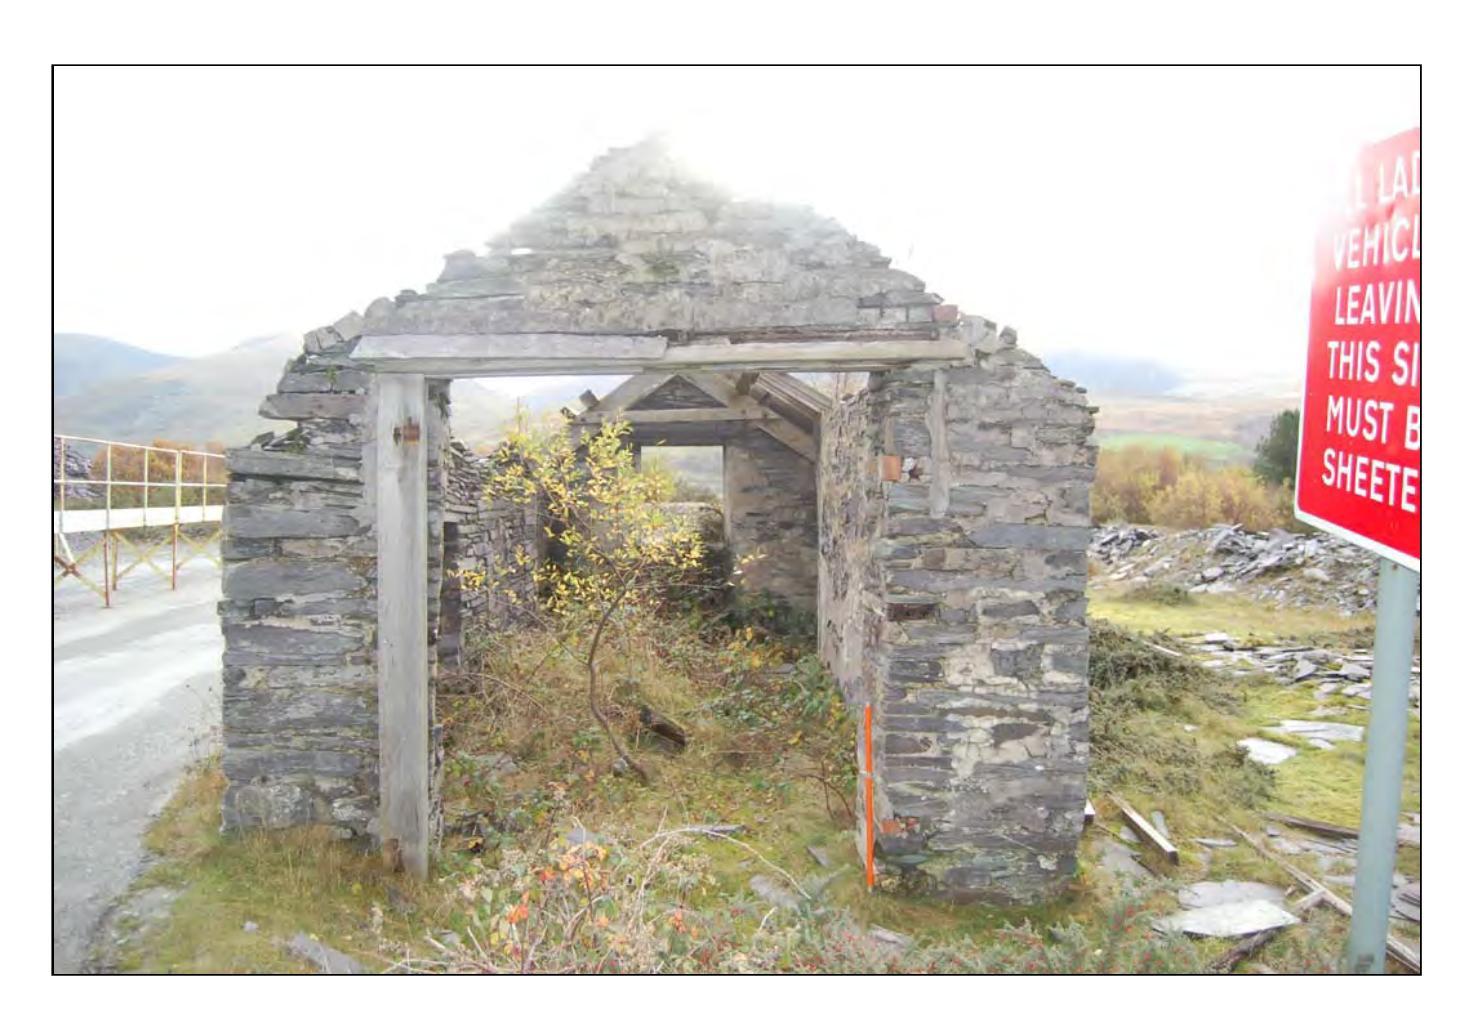
Plate 02: Locomotive shed feature 07 from the northwest

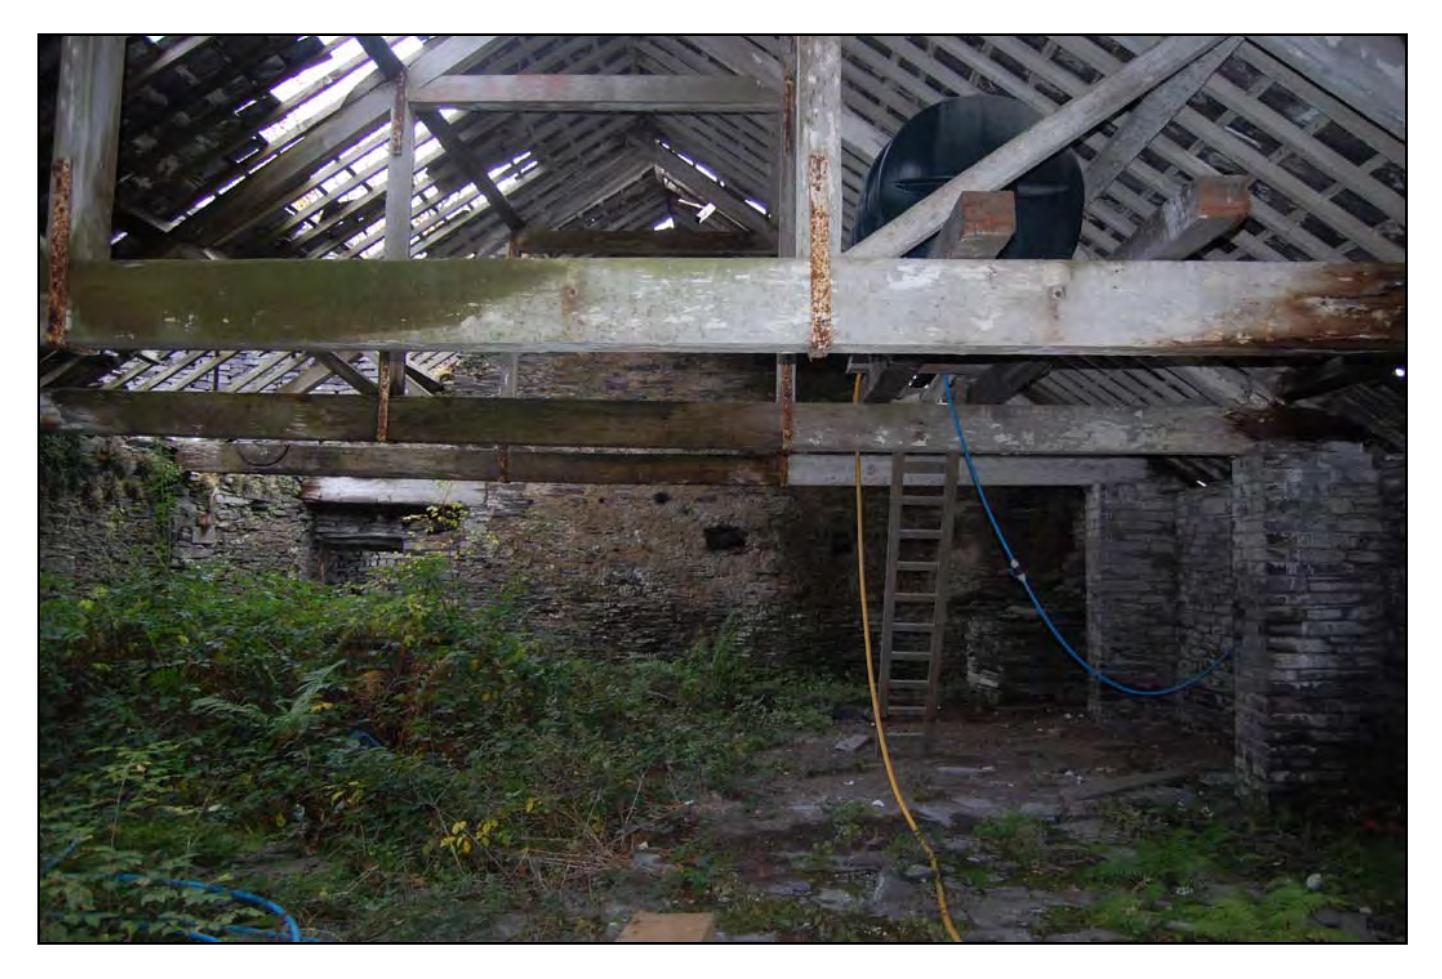
10 **Slab Mill** (see plate 03) Processing Statutory protection: LB II 23734 Category of Importance (A-E): A Site condition (1-5): Site Vulnerability (L, M, H): Medium/High 2/3Management recommendation: Level 4 Record Site description in 1997

The floor 4 slab mill, roofed and substantially complete, containing a smithing hearth and the base of what may have been a crusher. It is the oldest surviving mill in Dyffryn Nantlle, and was built to house the planer which now survives in a lean-to on the large Bonc yr Offis mill as well as a Hunter patent saw. The mill exemplifies the experimental stage of mechanical slab processing in Nantlle. The building is intact and in good condition. There are some slipped slates on the roof, and part of the crusher base is becoming dilapidated. It was recorded by students on a Plas Tan y Bwlch/Hull University course in August 1996.

Plate 03: Slab mill feature 10 interior showing queen-post roof trusses, from the northwest

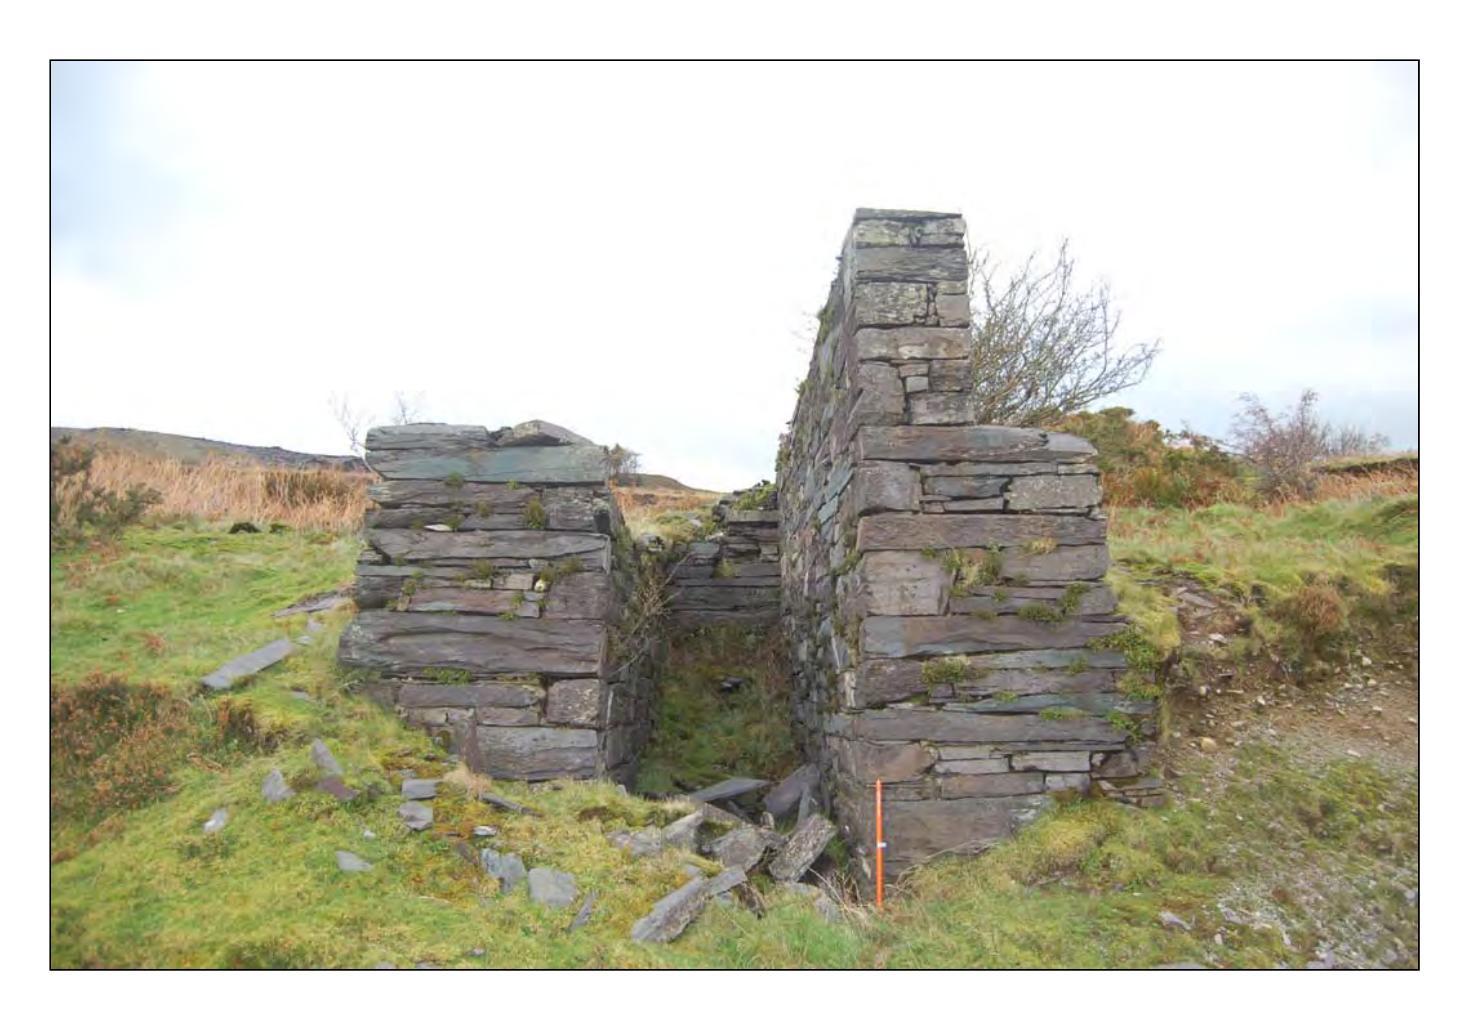
Plate 04: Water-wheel pit feature 22 from the south

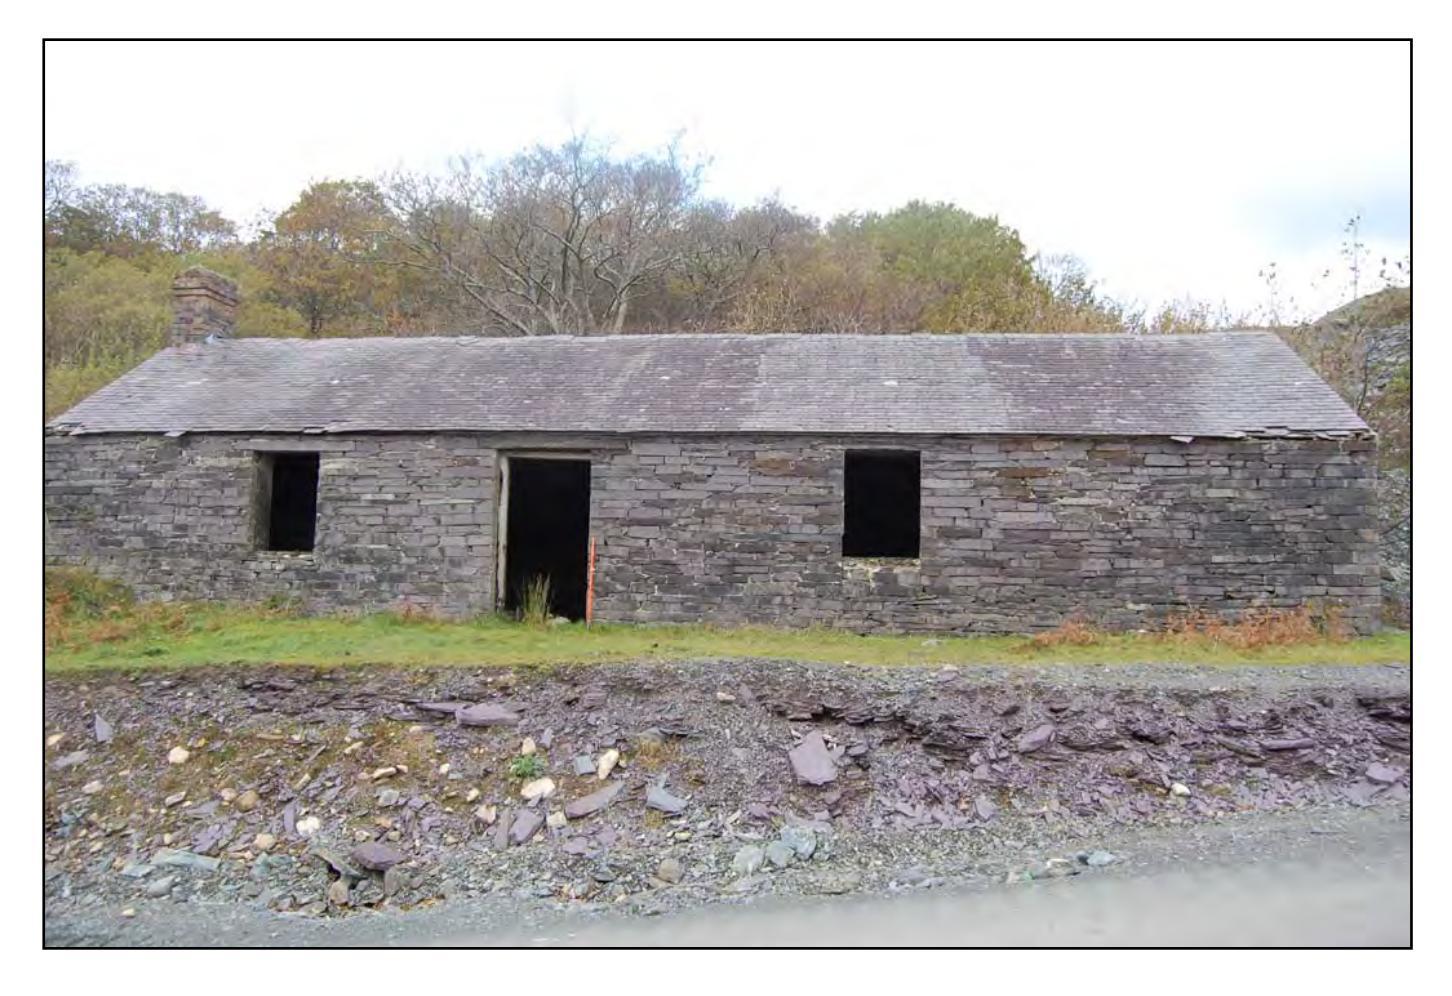
30 Compressor House (see plate 05)ProcessingCategory of Importance (A-E):BStatutory protection:LB II 23741Site condition (1-5):2Site Vulnerability (L, M, H):MediumManagement recommendation:Level 3 Record

A compressor house dating from the 1920s, formerly used to supply air to William and Ellen, in good condition, with an intact roof. The concrete bases for a prime mover and the compressor itself survive, but the only ironwork to survive is the air receiving cylinder.

The building lies immediately alongside the quarry road. It remains in good condition as described. The roof is of four bays on A frame trusses.

Plate 05: Compressor house feature 30 from the south

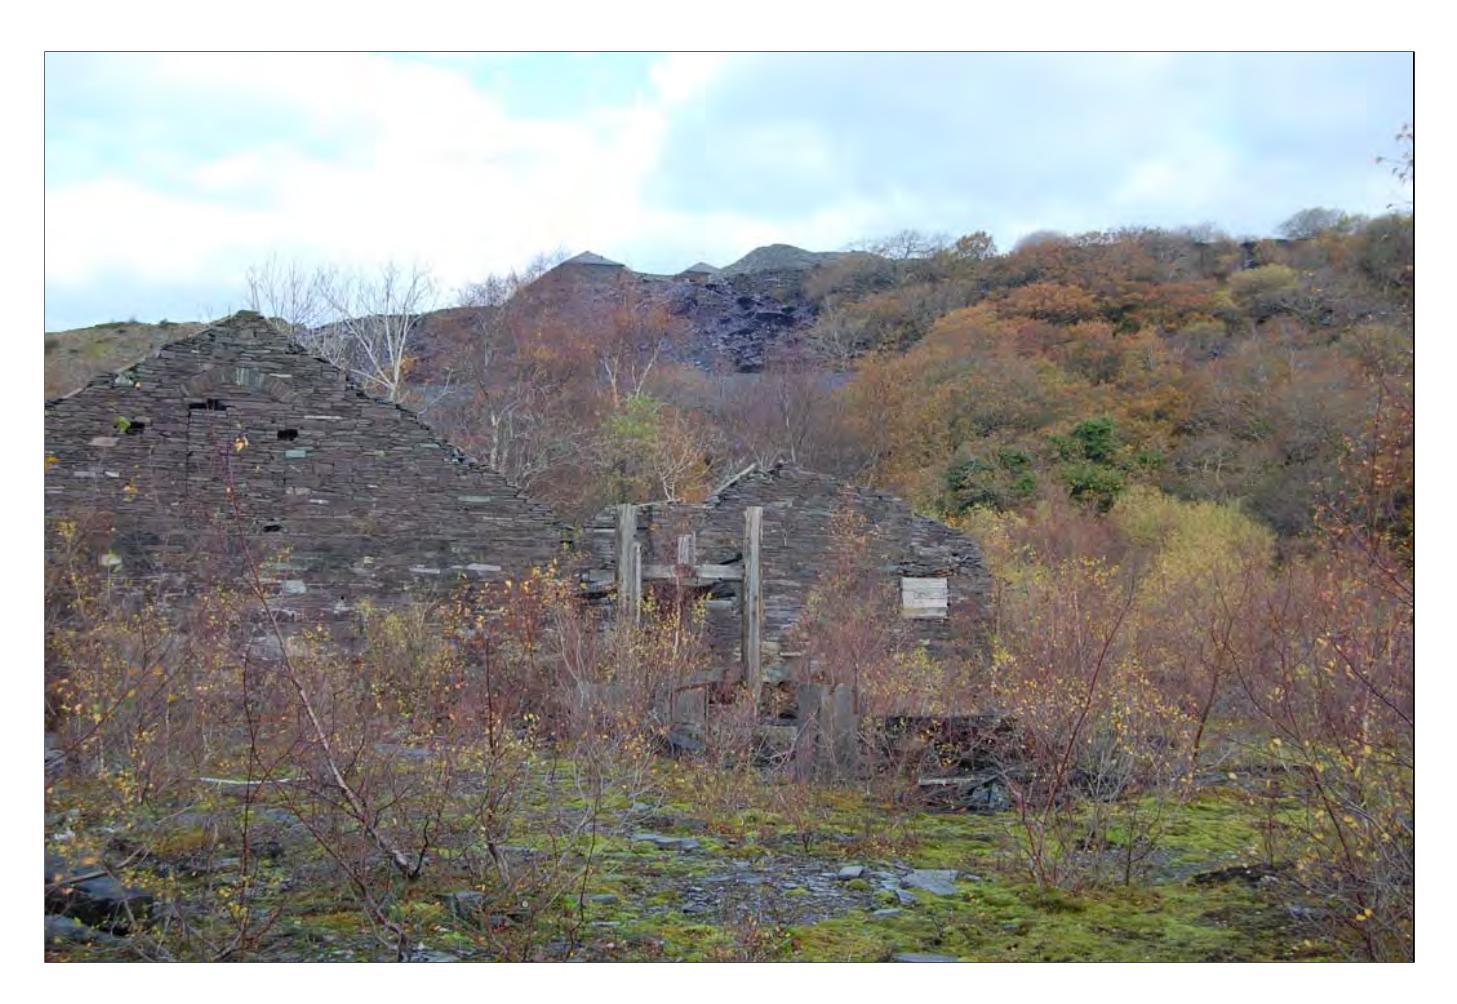
32 **Slate Mill** (see plate 06) Processing Category of Importance (A-E): A Statutory protection: None Site Vulnerability (L, M, H): Site condition (1-5): 3/4High Management recommendation: Level 4 Record

An integrated slate mill built in stages from 1874, roofless and partly dilapidated, containing a waterwheel-pit, a mounting for a succession of steam engines and an electric motor, the remains of a hydraulic accumulator, a Caernarfon-made slate planer of 1867 in a lean-to, and a number of dressing-machine frames. Two of the mill's original hydraulic feed tables constructed by De Winton of Caernarfon in the 1870s have been removed very recently. These were left in situ when the mill equipment was scrapped in the 1970s. The north-western part of the mill has been demolished above foundation level. The south-eastern part stands partly up to eaves height, but there has been substantial collapse in the gable wall and in the north-east longitudinal wall, with the possibility of further deterioration. The lean-to which houses the planer has lost most of its roofing slates but otherwise the condition of the planer and of the other machinery appears stable. The trusses have been stacked against the longitudinal wall. A measured survey was carried out by students on a Snowdonia National Park/Hull University course in August 1996. Site description in 2008

The masonry is in poor condition, though survives as previously described. The slate planer survives in a lean-to on the south gable of the mill, but no other machinery could be located. Site description in 2010 The interior of the mill is becoming heavily overgrown with saplings. OS NGR: 251003 353822

Plate 06: Slate mill feature 32 interior, from the south

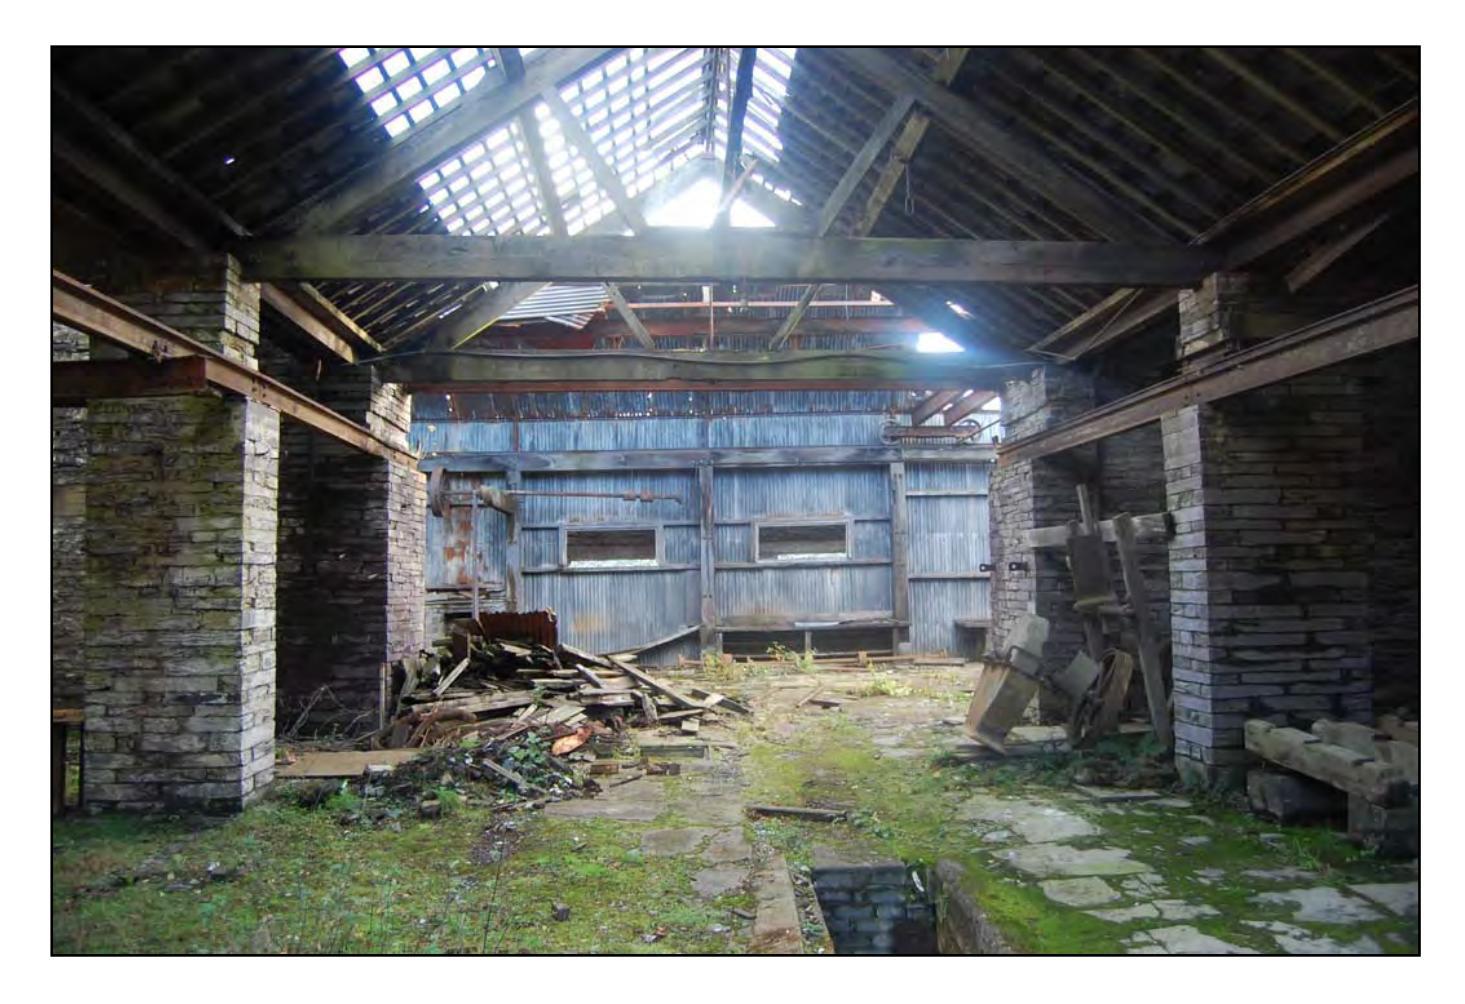
Plate 07: Workshops feature 37 interior, from the west

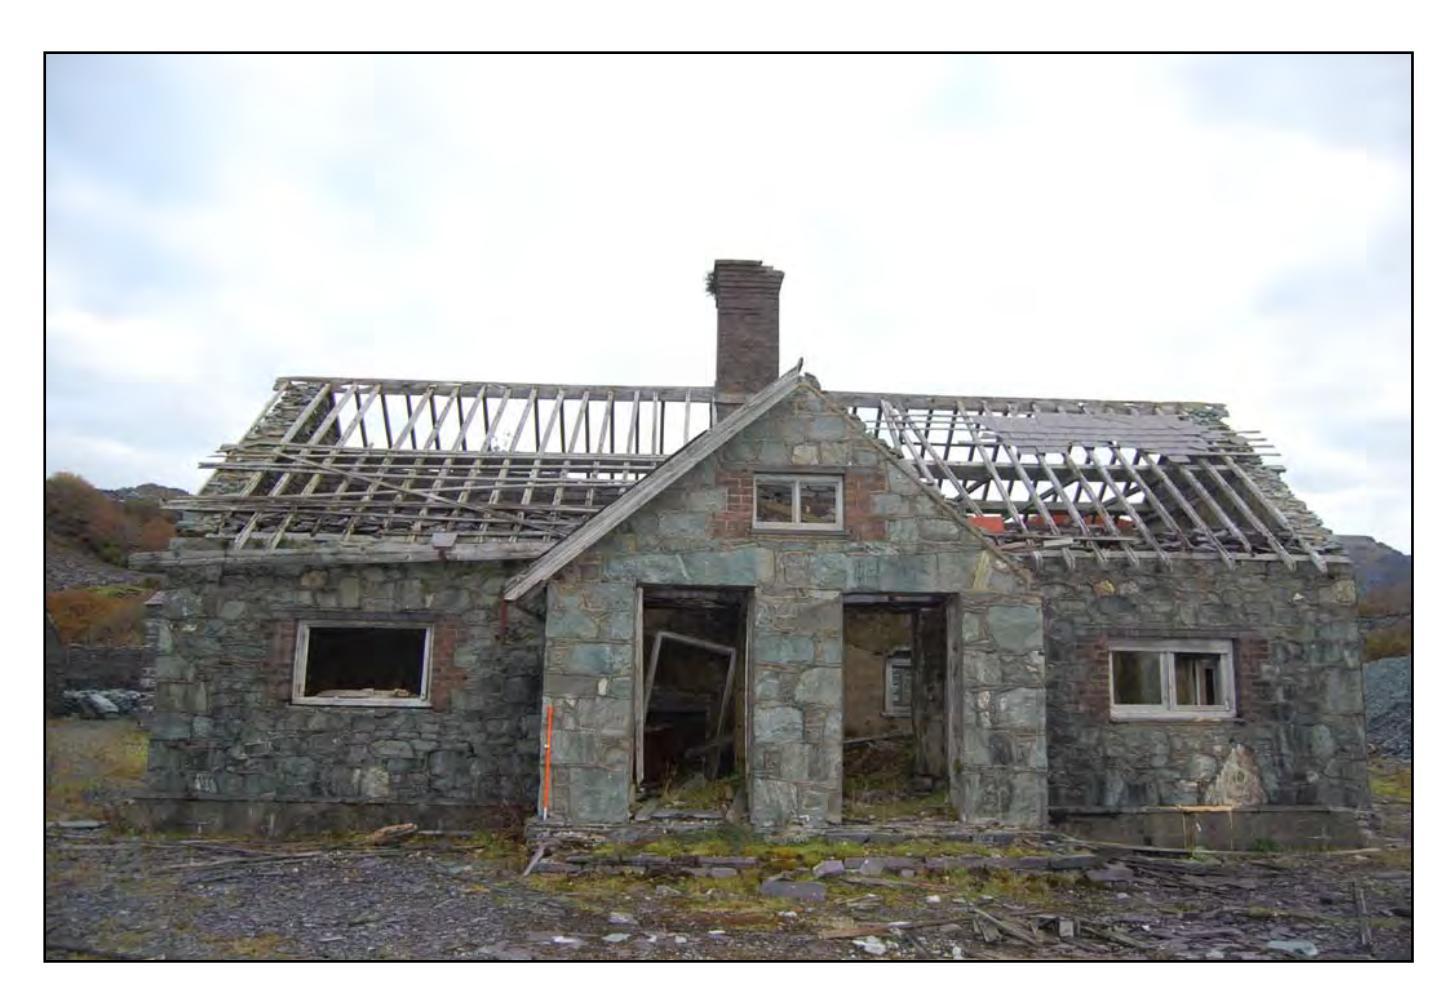
38 Hospital (see plate 08) Ancillary Category of Importance (A-E): B Statutory protection: LB II 23740 Site condition (1-5): 3 Site Vulnerability (L, M, H): Medium Management recommendation: Level 3 Record Site description in 1997 The late-nineteenth century quarry hospital, built on the main processing level. Constructed out of country rock with a brick chimney stack. This building is substantially complete but is losing its window frames and doors, and slates are slipping off the roof. Much of the internal plaster-work is intact. It has suffered recent damage from New Age Travellers. A measured survey was carried
 In the sufficient damage from New Age Traveners. A measured survey was carried out by students on a Snowdonia National Park/Hull University course in August 1996. The quarry war memorial formerly stood outside the hospital before its removal to Capel Baladeulyn. This is a particularly fine sculpture which includes carved scenes of the quarry at work. <i>Site description in 2008</i> No slates remain on the roof, otherwise the building is as described. <i>Site description in 2010</i> The structure survives as described. OS NGR: 250983 353749

Plate 08: Hospital feature 38 from the southwest

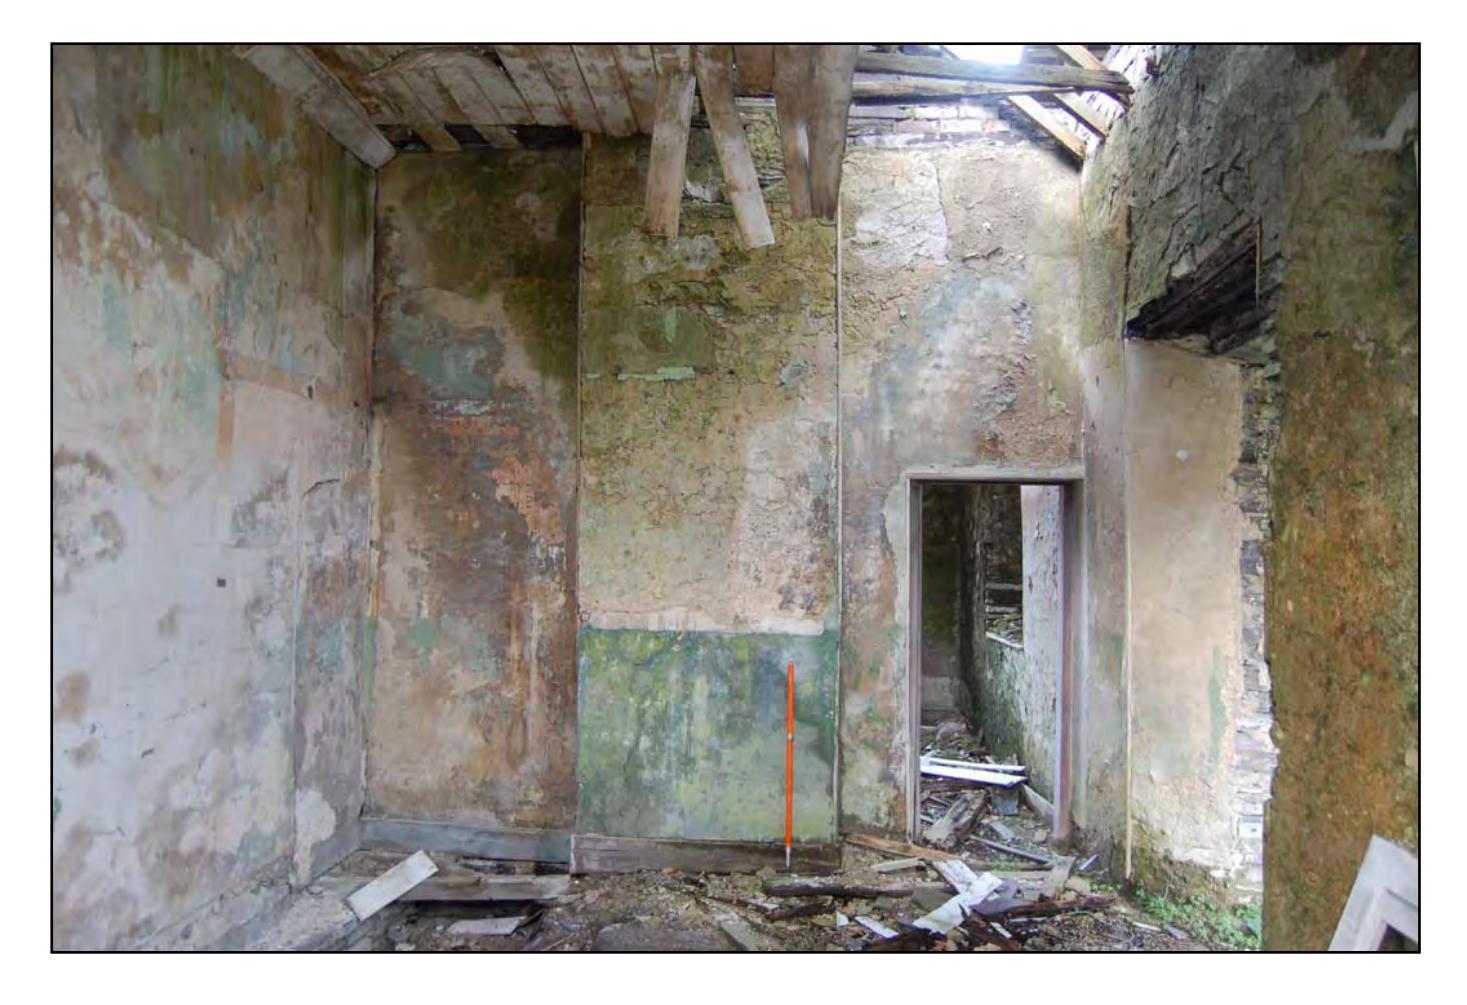
Plate 09: Office feature 40 interior showing roof damage, from the southeast

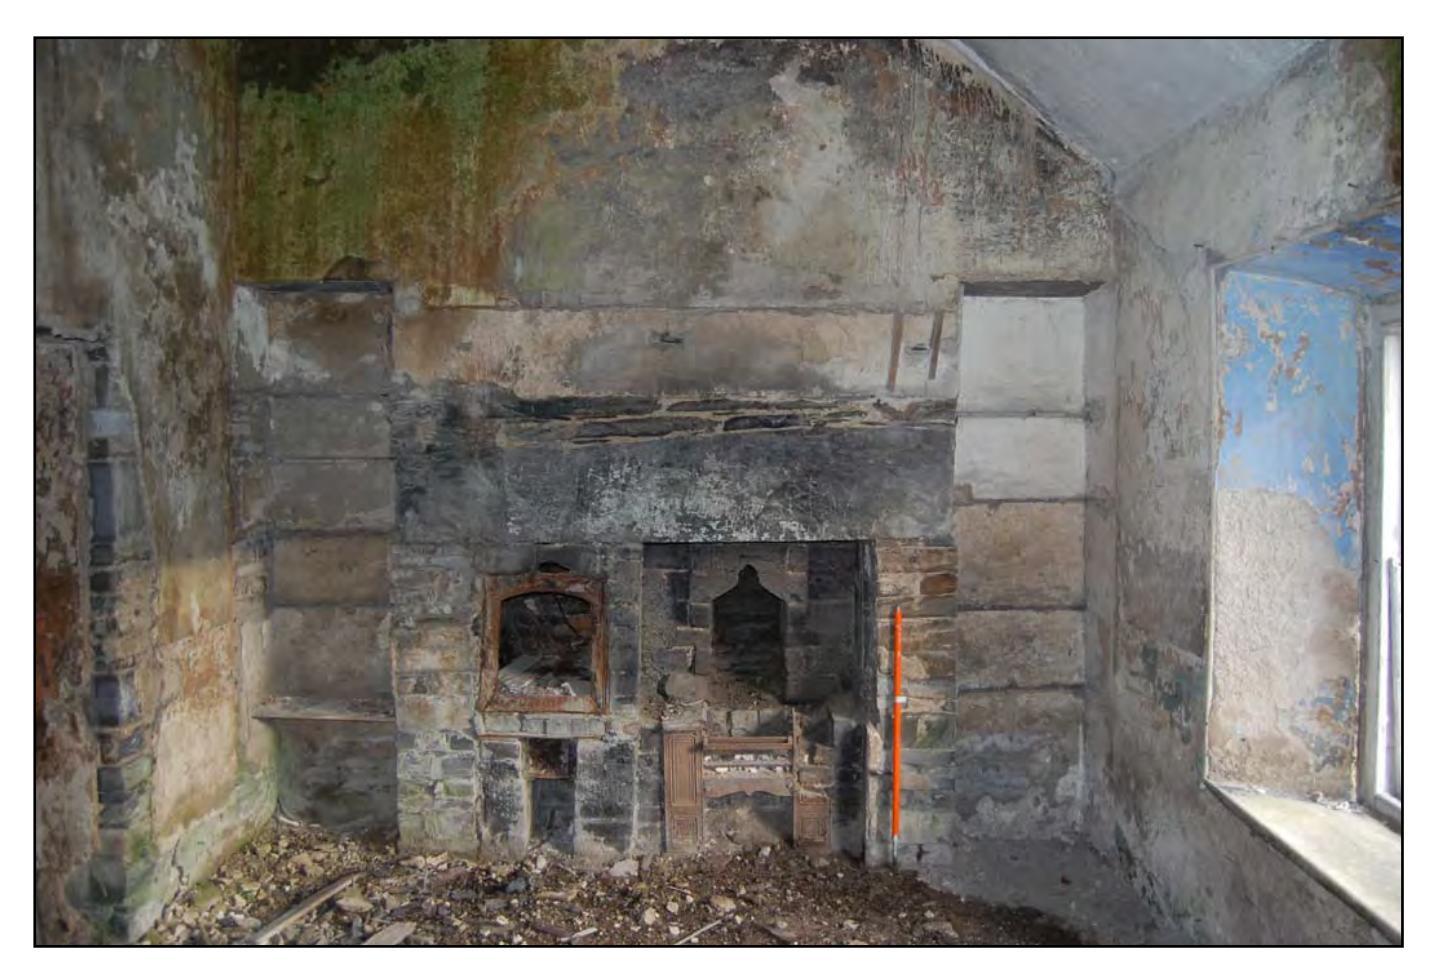
Plate 10: Barracks feature 41 interior showing cooking range, from the southwest

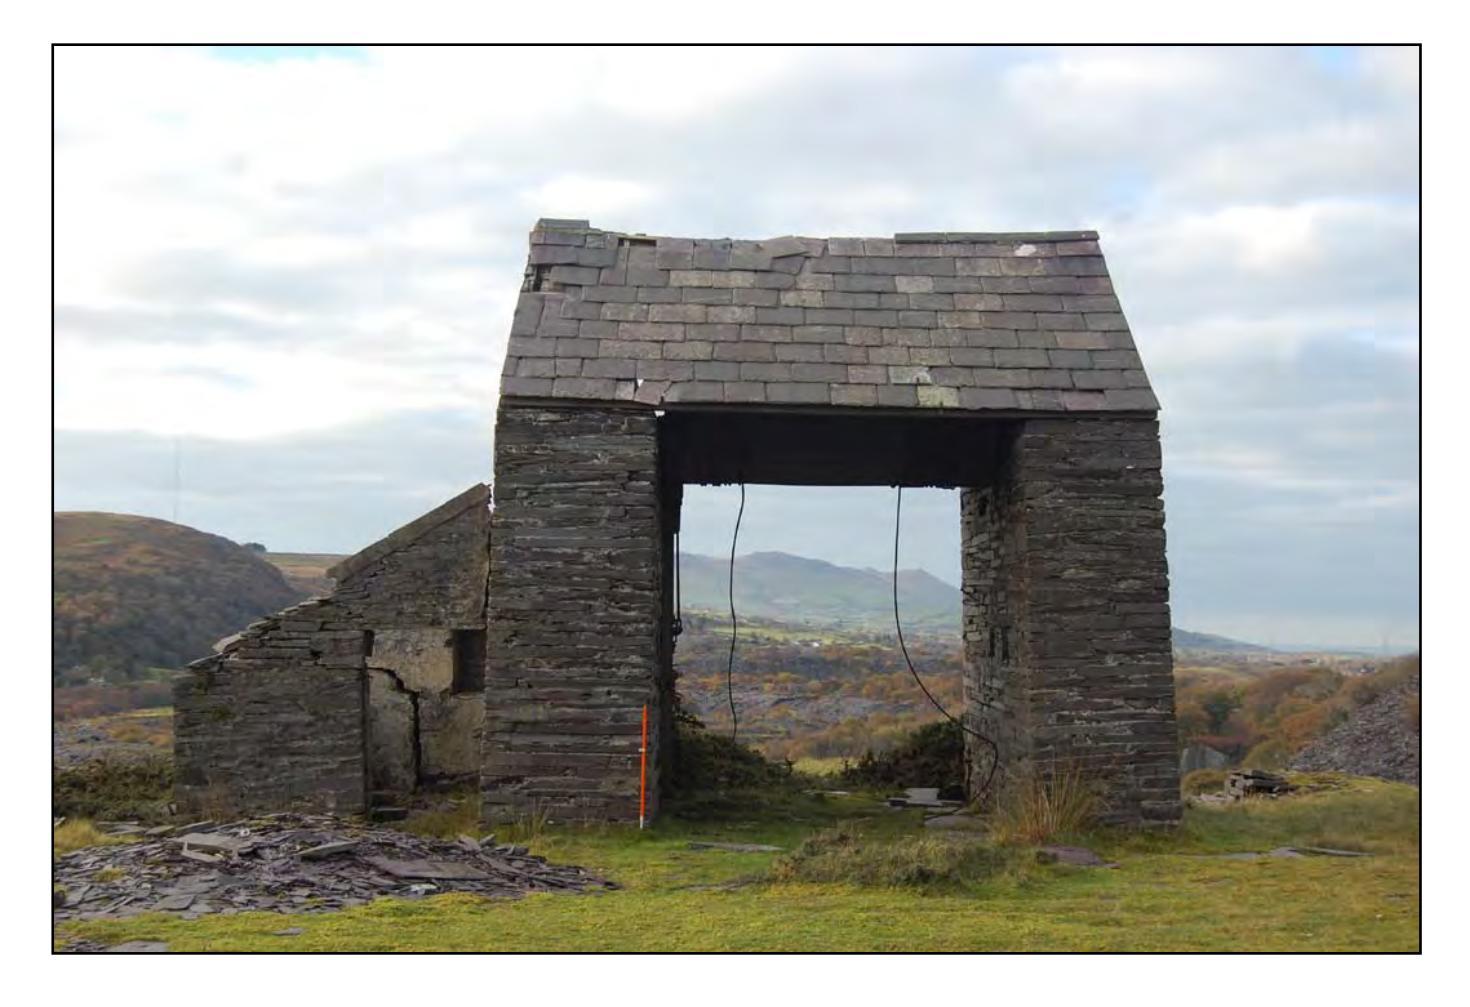
44 **Incline and Drumhouse** (see plate 11) Transport Category of Importance (A-E): B Statutory protection: LB II 23733 Site condition (1-5): Site Vulnerability (L, M, H): Medium 2/3Management recommendation: Level 3 Record Site description in 1997 The intermediate exit incline on the 3'6 gauge system, constructed in the late 1860s or early 1870s, replacing an earlier axis. The drumhouse survives in excellent condition with the drum and the brake in tact, and the course of the incline has been little damaged. Some rails survive in situ. Site description in 2008 The site remains as described, though the roof is deteriorating. Tip processing to the south has removed part of the tip on which the drum house stands. Site description in 2010 The incline is becoming overgrown with cotoneaster, and the lean-to appears precarious. OS NGR: 250933 353694 45 Locomotive Shed Transport Category of Importance (A-E): С Statutory protection: None Site condition (1-5): Site Vulnerability (L, M, H): 3 High Management recommendation: Level 2 Record Site description in 1997 Built between 1899 and 1907, and adapted for use as a gwal for tip contractors in the 1950s. Built out of slate rubble, the walls survive up to eaves height, but the roofing slates have gone, leaving only some roof timbers. There is danger of collapse in the south wall. Site description in 2008 The east wall has collapsed, and so have the roof timbers. End gable walls and west wall survive to eaves height. Site description in 2010 The structure survives as described. OS NGR: 251047 353728 46 Caban Domestic Statutory protection: None Category of Importance (A-E): В Site condition (1-5): 2 Site Vulnerability (L, M, H): Medium Management recommendation: Level 2 Record Site description in 1997 Built between 1899 and 1907, adjacent to (44). Built of slate rubble with a pitched roof. Site description in 2008 This structure survives with slate roof in tact. There is a fireplace in the south gable, and the entrance is in the north gable. The roof is of three bays divided by king-post trusses. The masonry is cracking slightly, and the condition of the slate roof is deteriorating. Site description in 2010 The structure survives as described. OS NGR: 251040 353729 47 Shaft-head Transport Category of Importance (A-E): C Statutory protection: None Site condition (1-5): 3/4 Site Vulnerability (L, M, H): Low Management recommendation: Level 2 Record Site description in 1997 A water-balance shaft constructed by DeWinton's Union Ironworks, Caernarfon, for the quarry in

Plate 11: Drumhouse feature 44 from the northeast

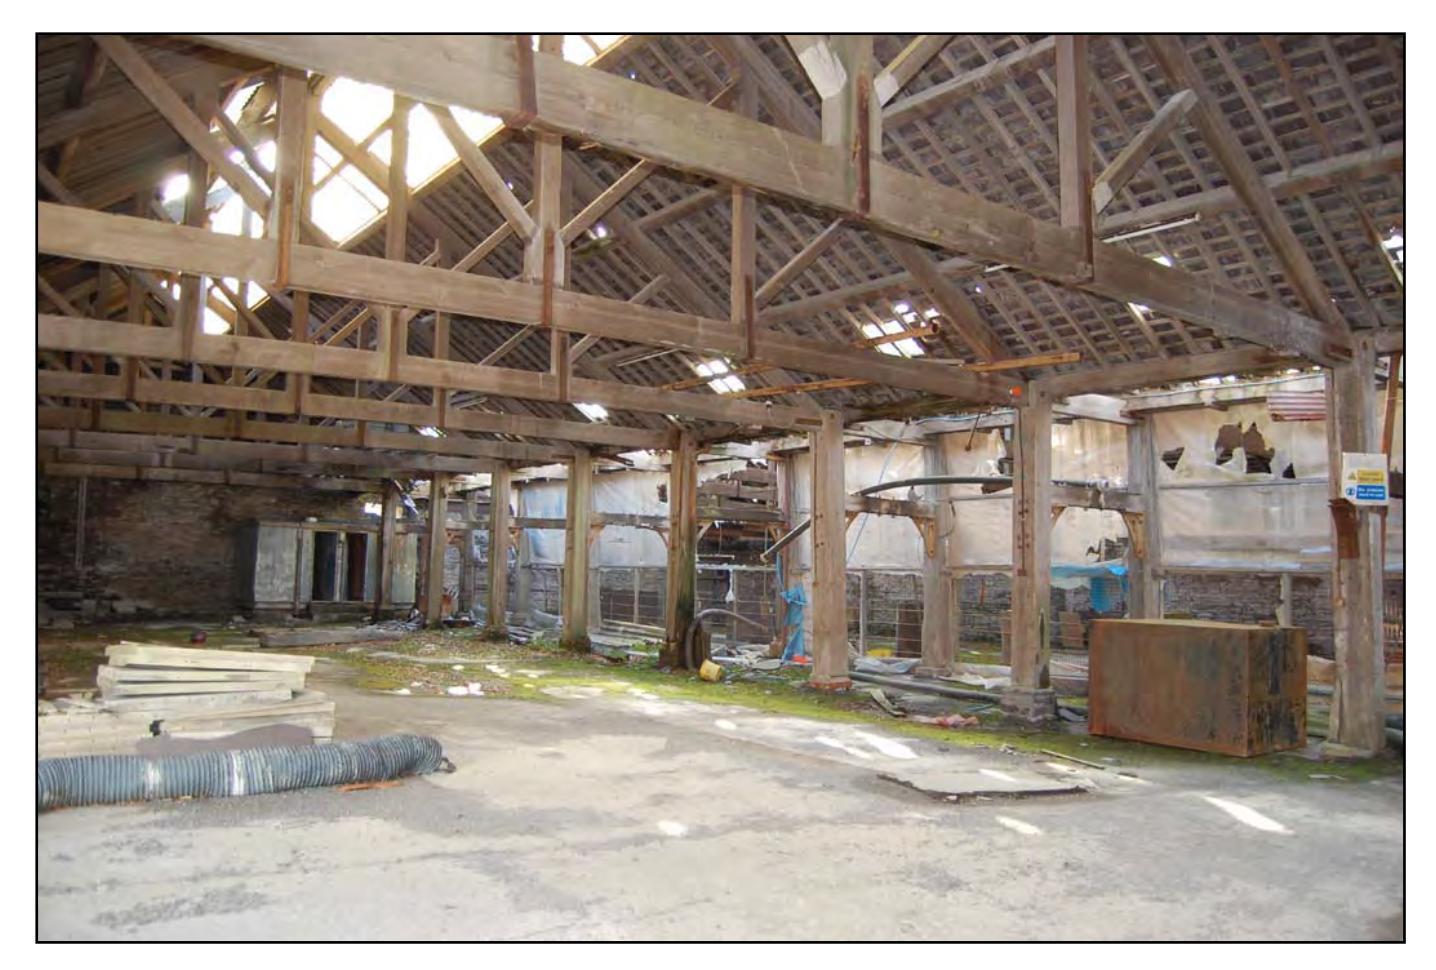
Plate 12: Slate mill feature 53 interior, from the north

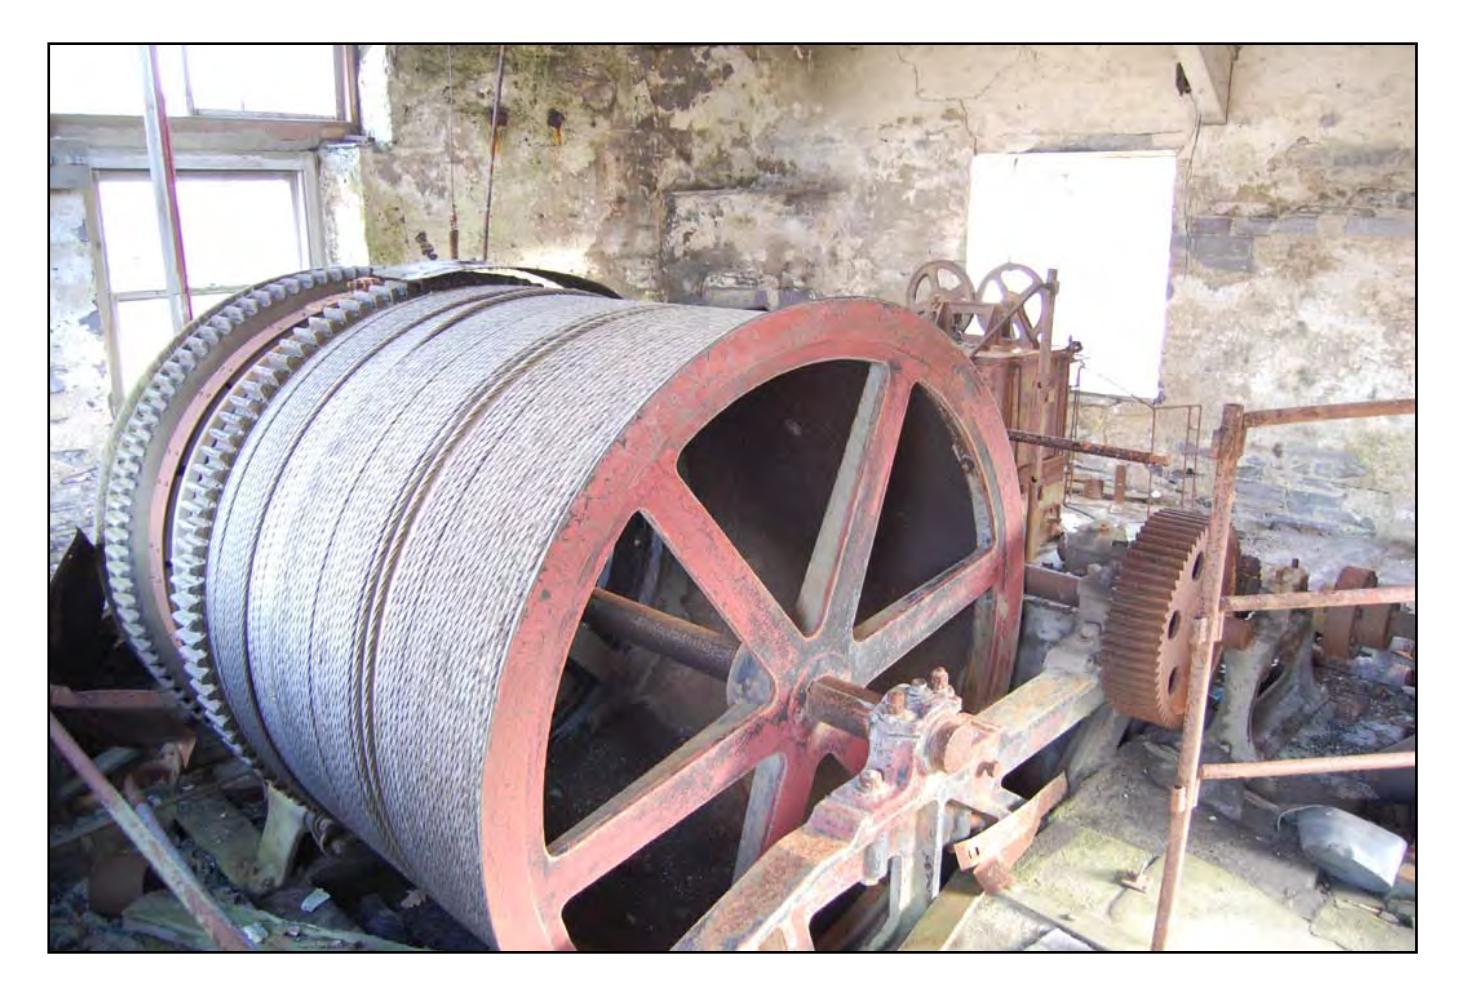
Plate 13: Engine house feature 55 interior showing winding drum, from the northwest

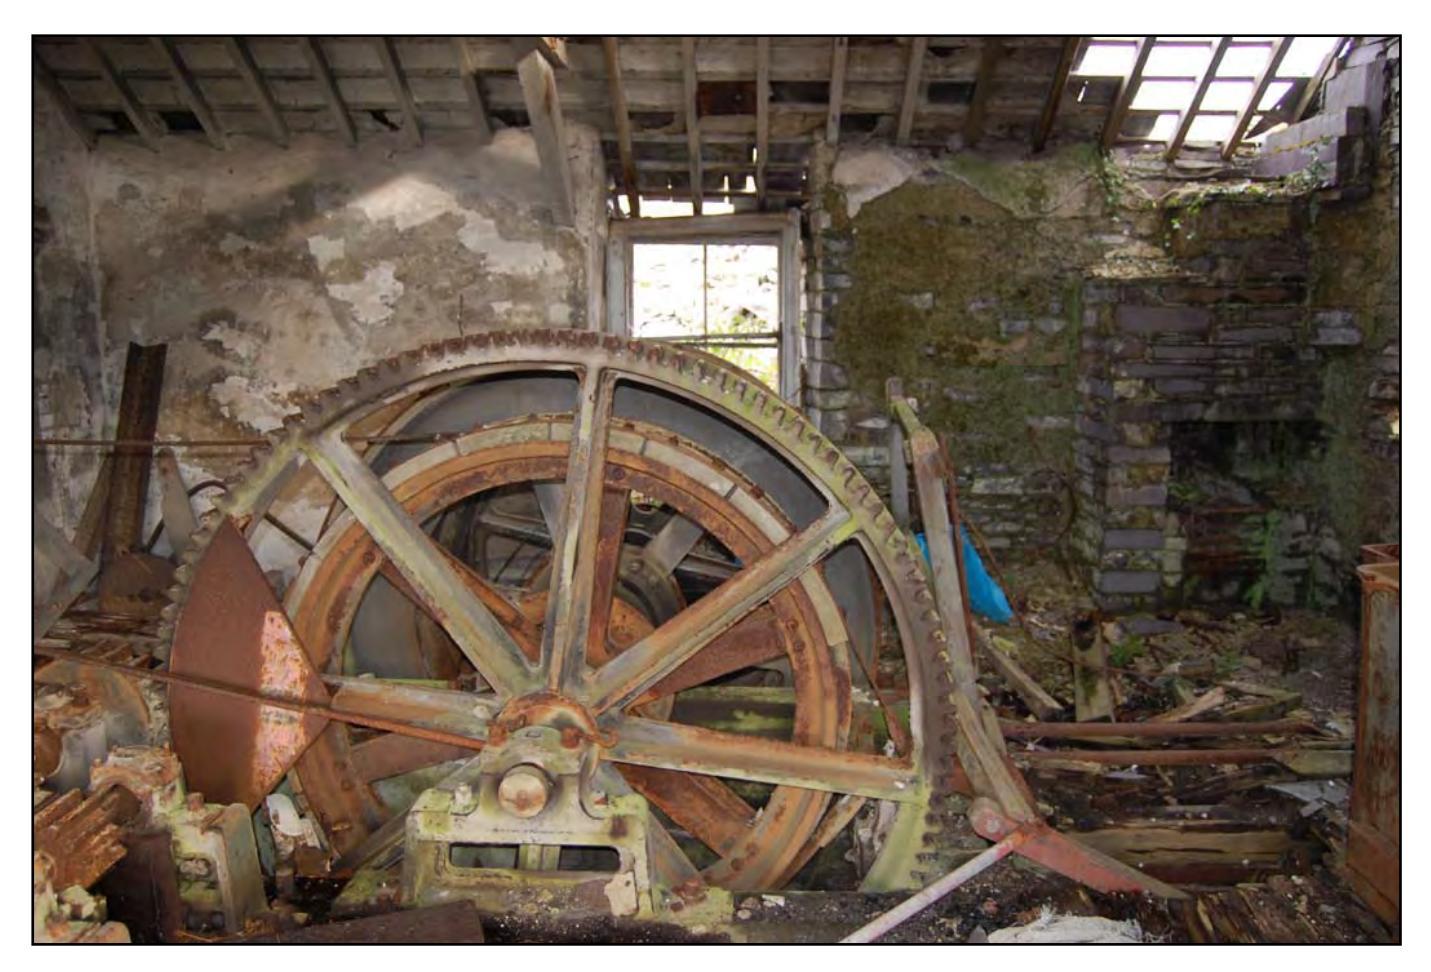
Plate 14: Engine house feature 58 interior showing the winding drum, from the south
