Pen yr Orsedd Slate Quarry, Nantlle

Archaeological Assesment

GAT Project No. G2035 Report No. 910 December 2010

Prepared for Welsh Slate

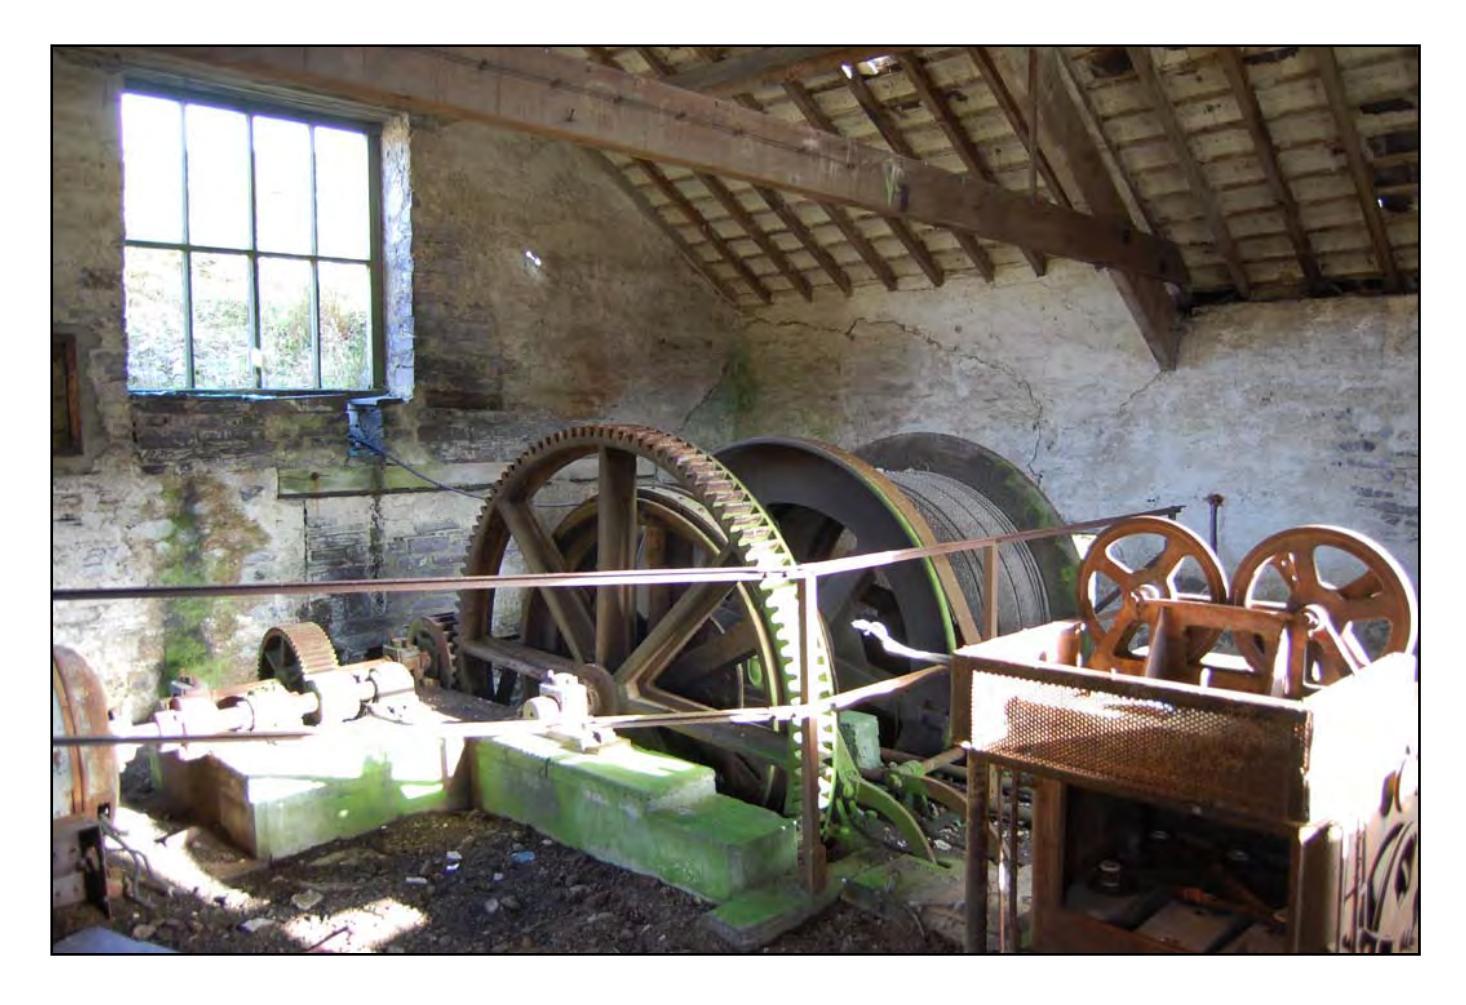
Plate 15: Engine house feature 59 interior showing winding drum, from the southeast

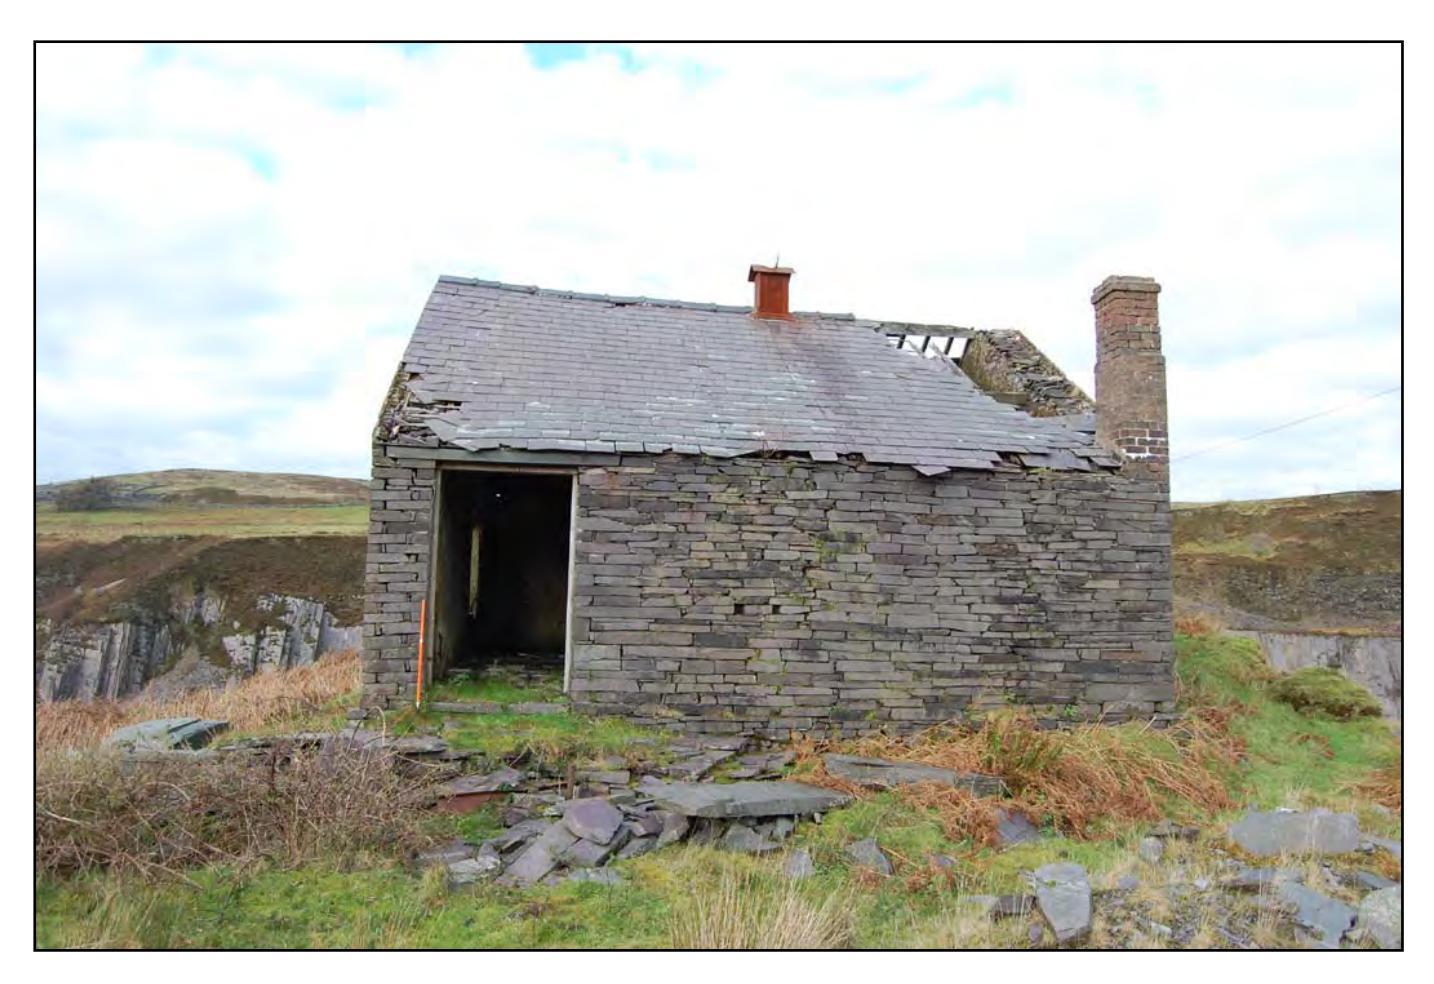
Plate 16: Drying house feature 60 from the southeast

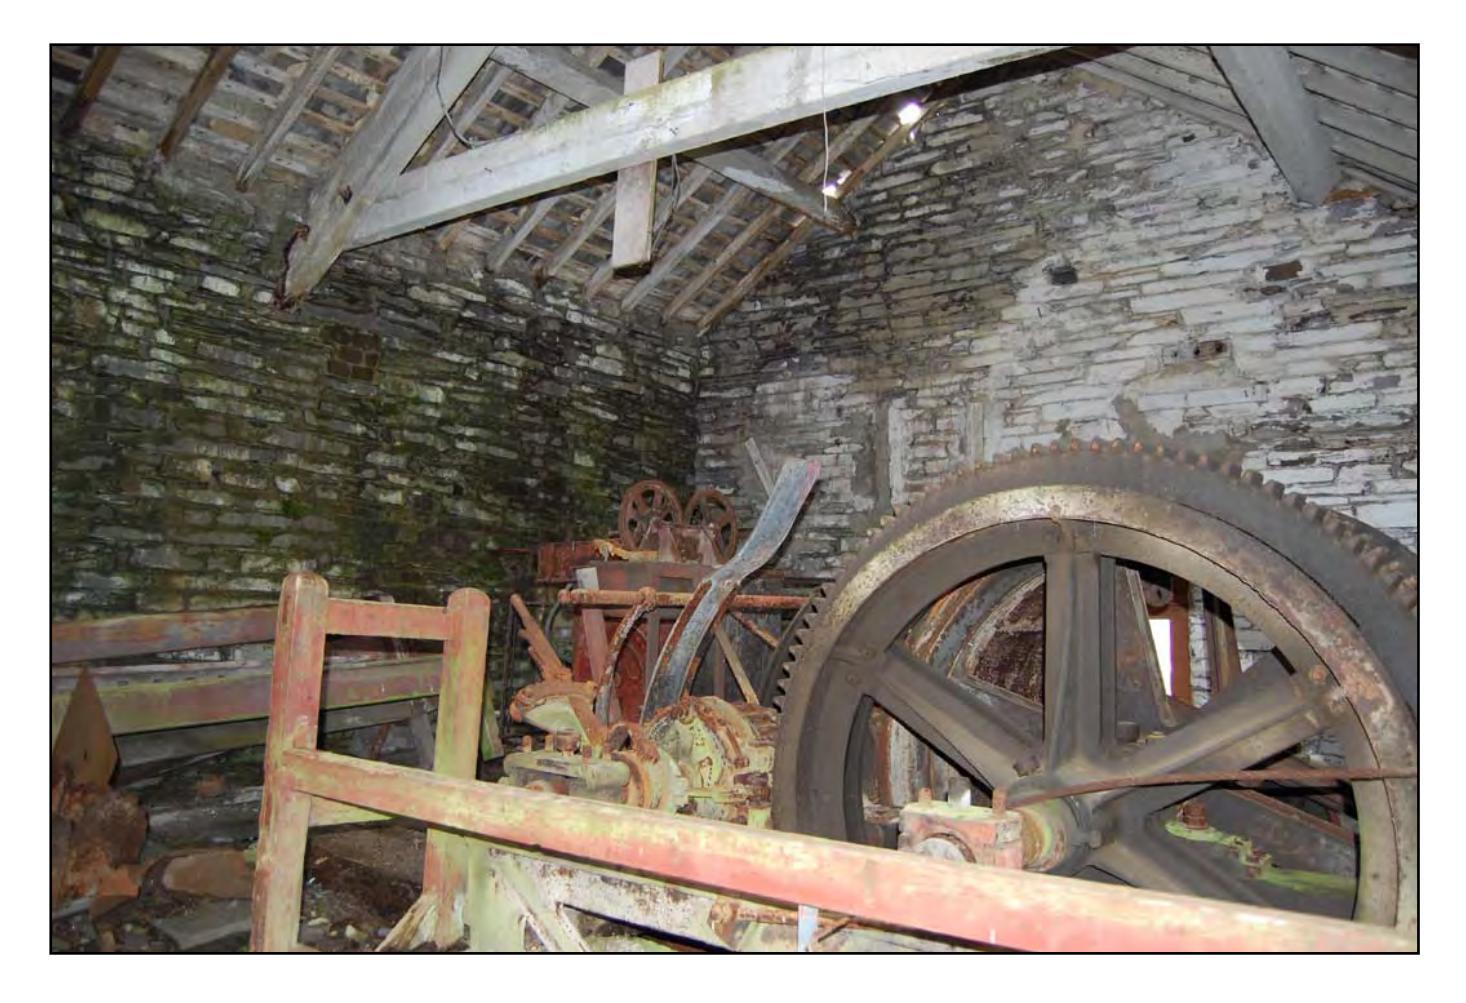
Plate 17: Engine house feature 62 interior showing winding drum, from the east

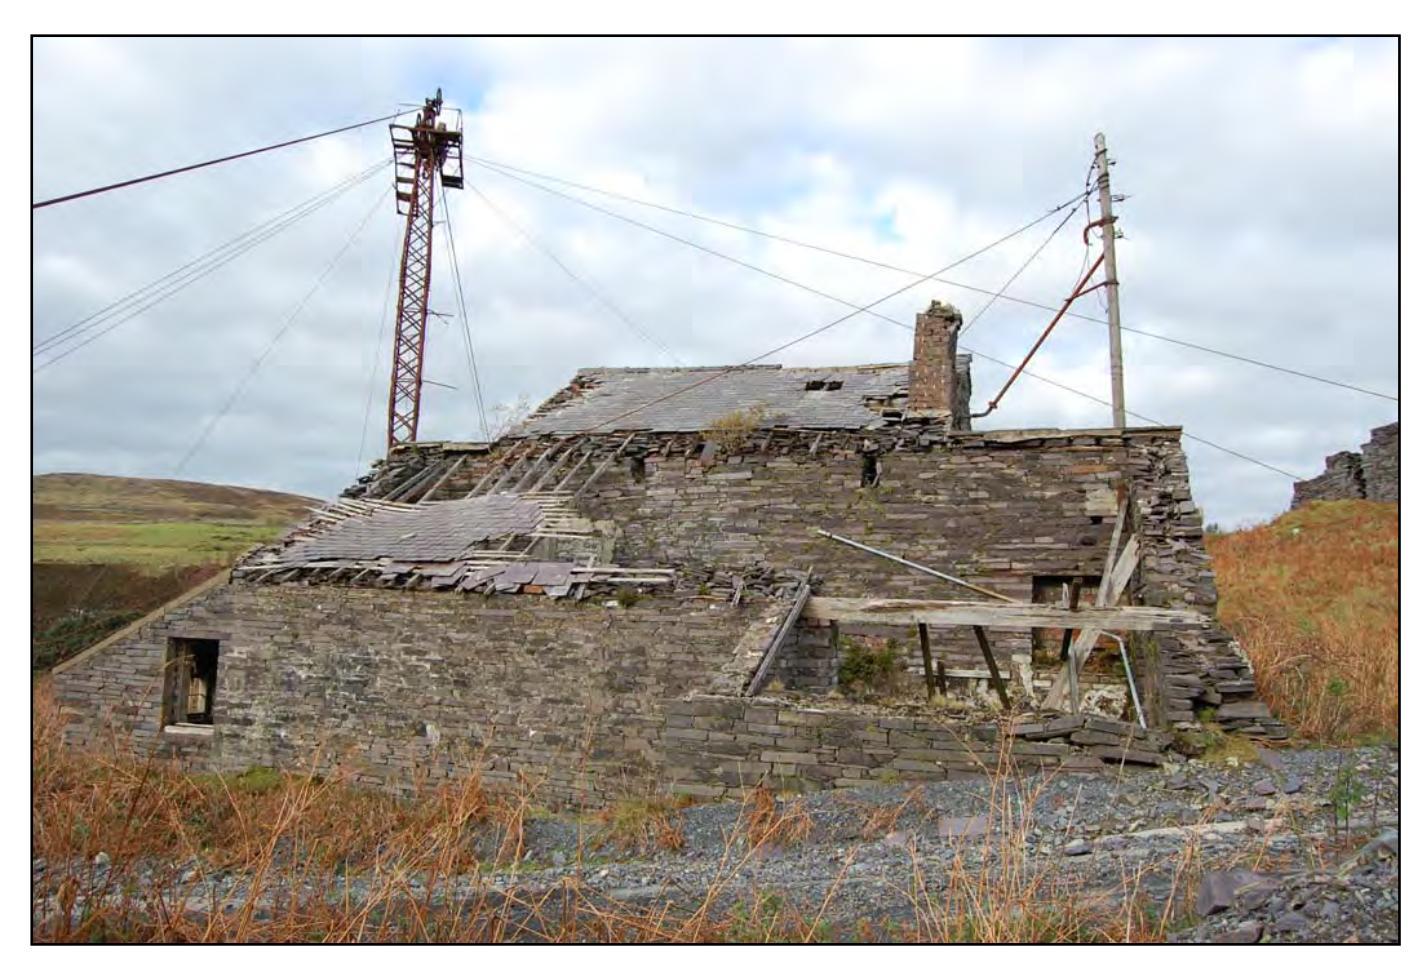
Plate 18: Compressor house feature 63 showing roof collapse, from the southeast

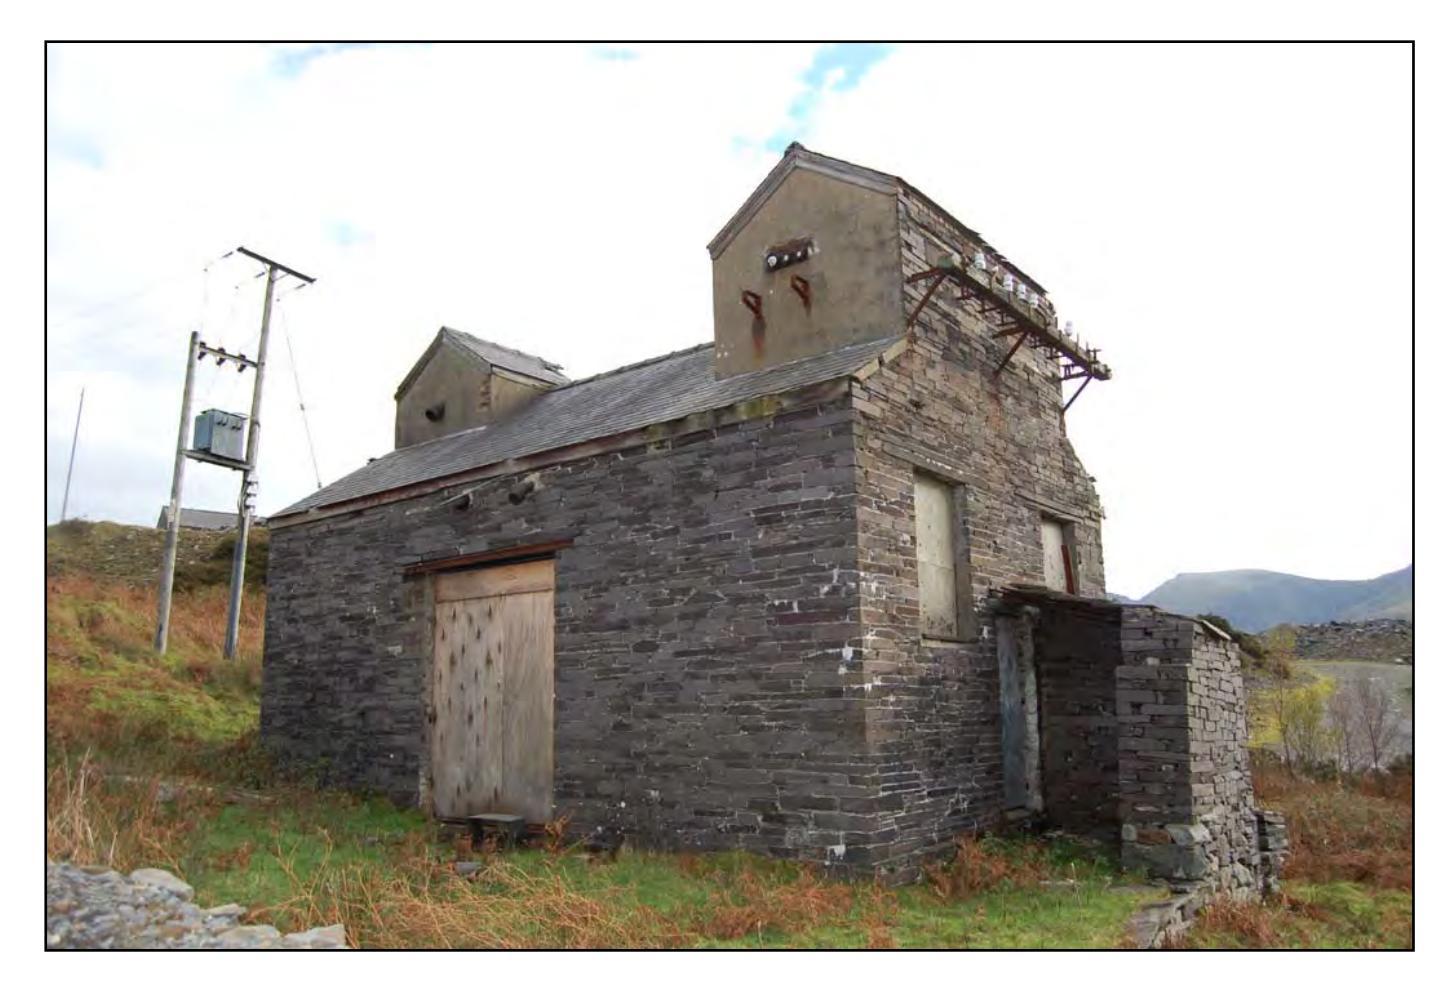
Plate 19: Transformer house feature 64 from the northwest

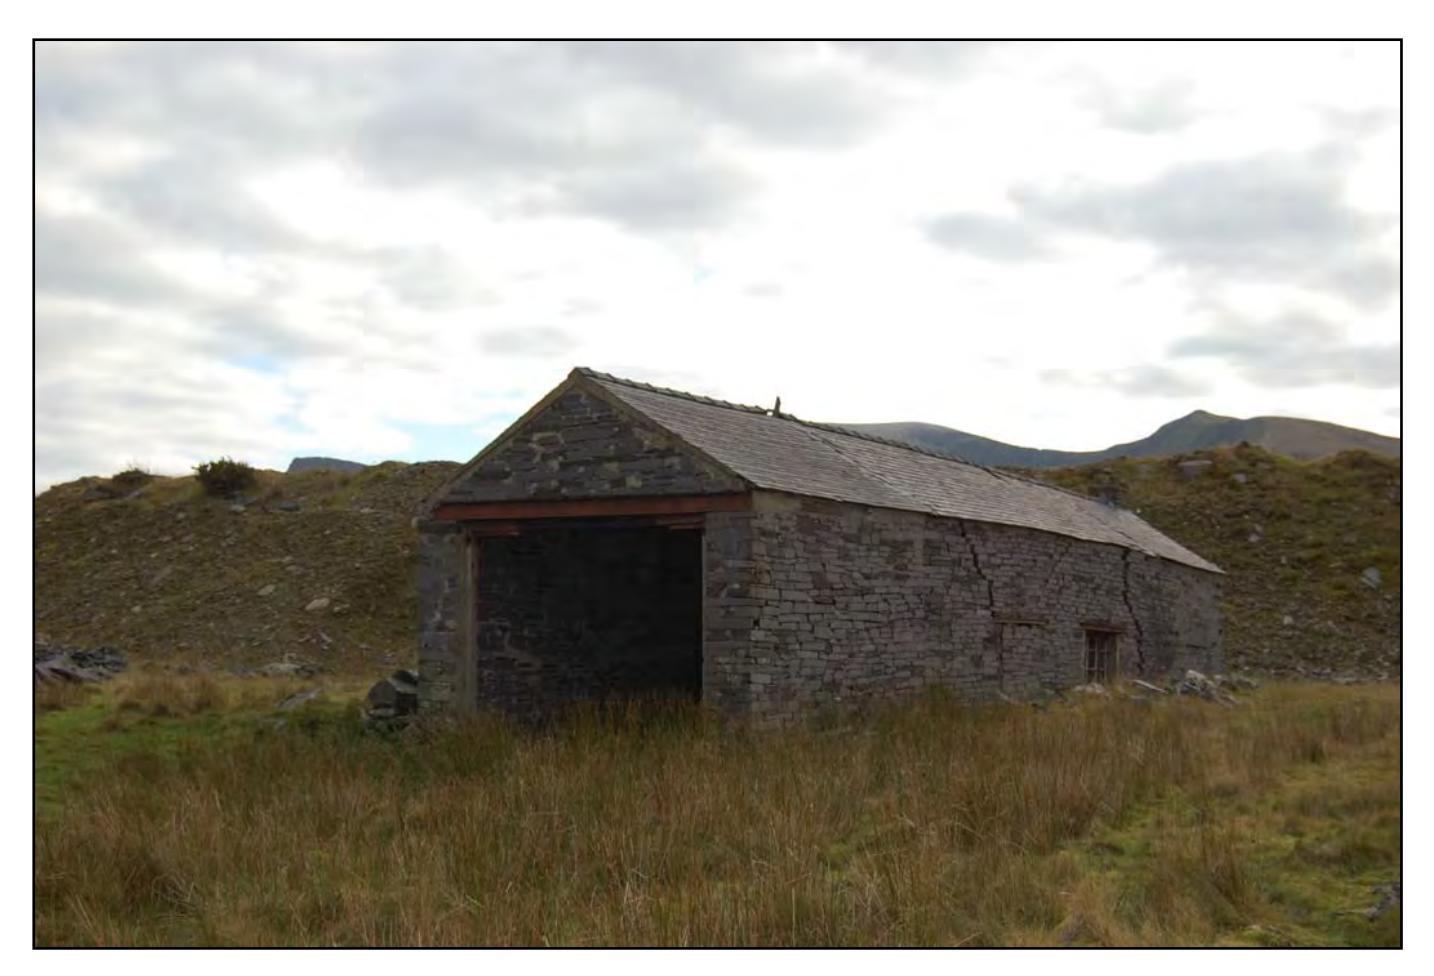
Plate 20: Locomotive shed feature 65 showing subsidence, from the northwest

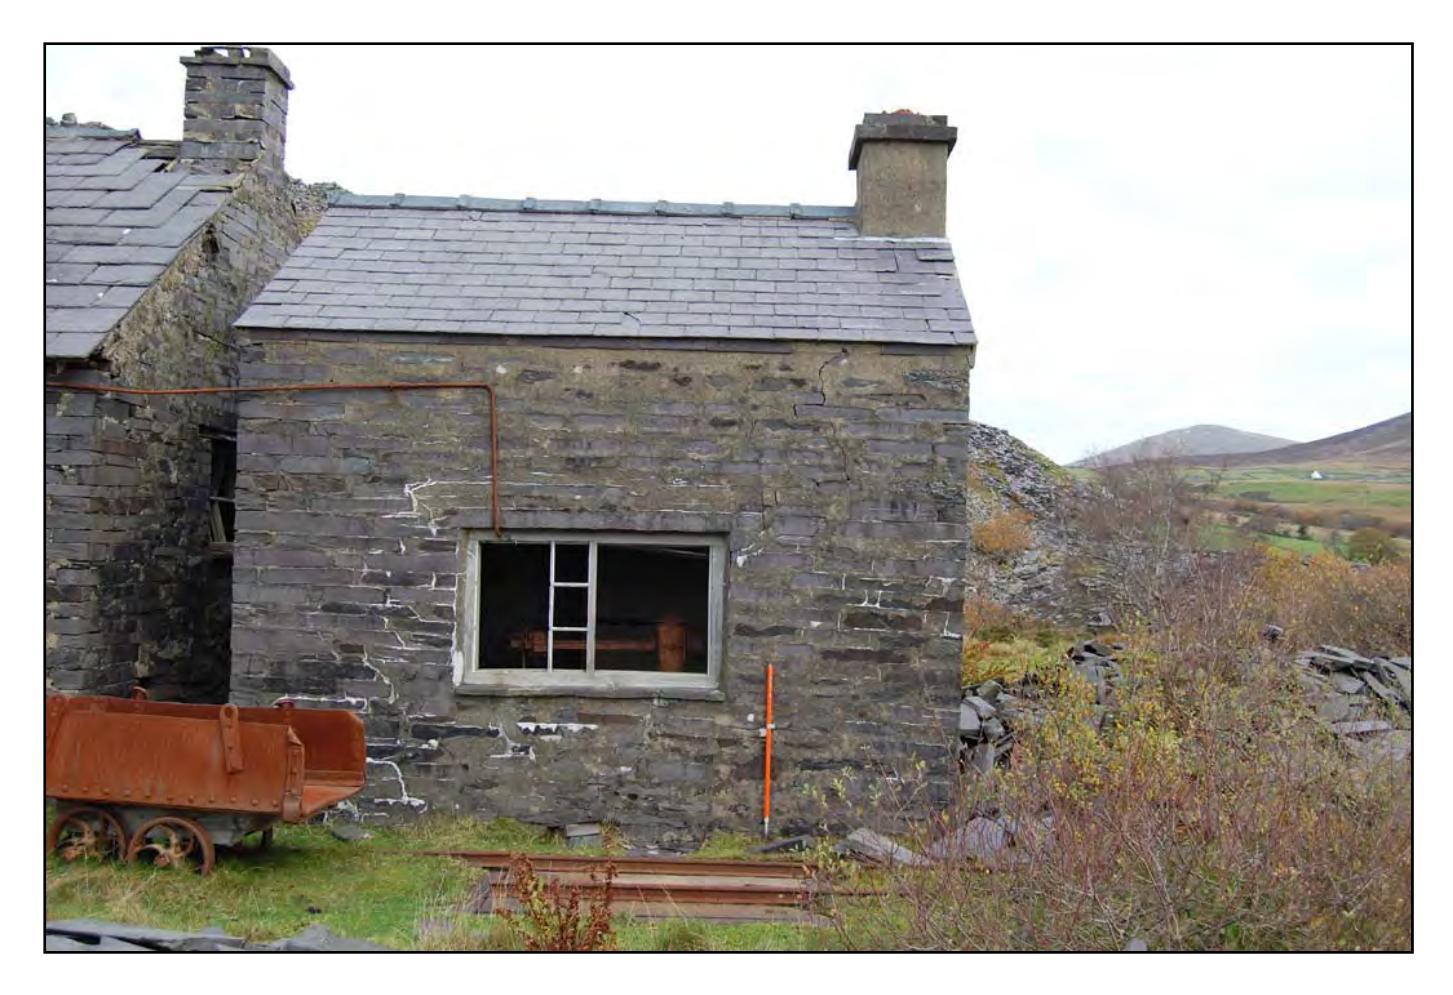
Plate 21: Weighbridge house feature 68 from the west

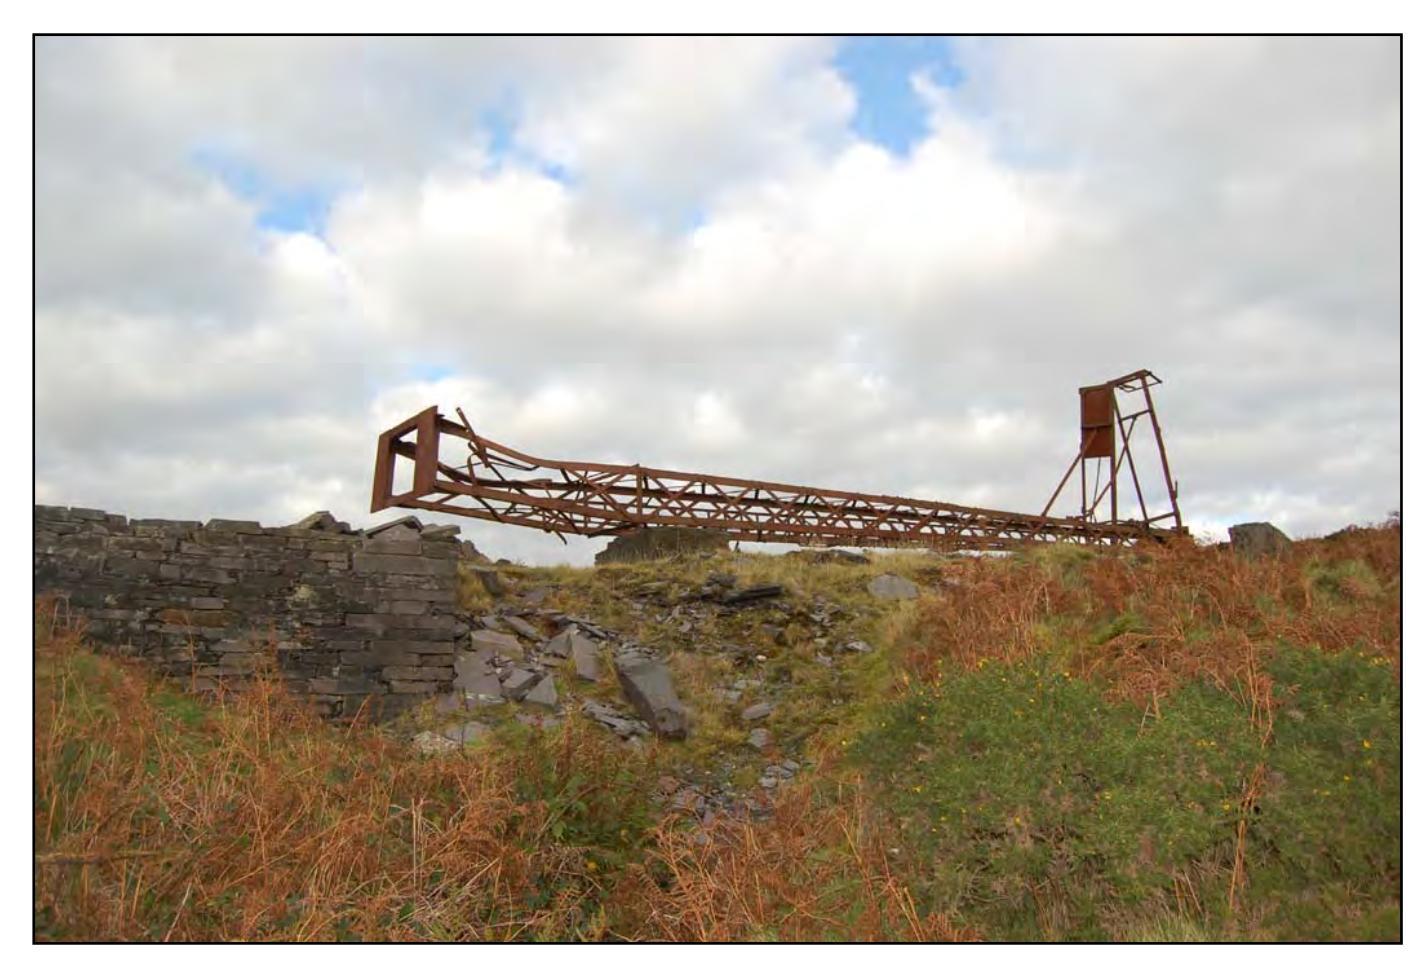
Plate 22: Collapsed ropeway system feature 70, from the south
