Fieldwork Report for  
Archaeological Watching Brief  
Water Main Repairs, Northgate Street, Caernarfon  
Document Number B1601.02

Northgate Street, Caernarfon

Fieldwork Report for  
Archaeological Watching Brief

Prepared for Dŵr Cymru Welsh Water

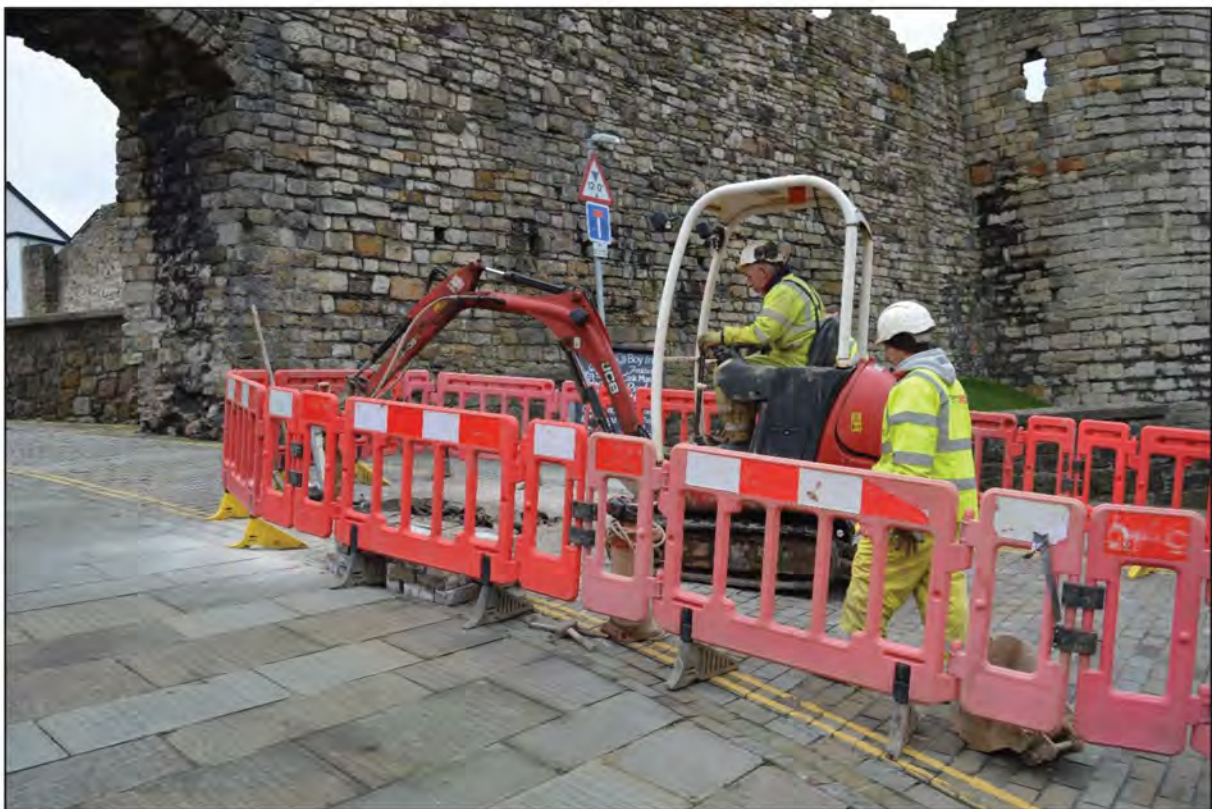
1. General view of works in progress, from the North-East

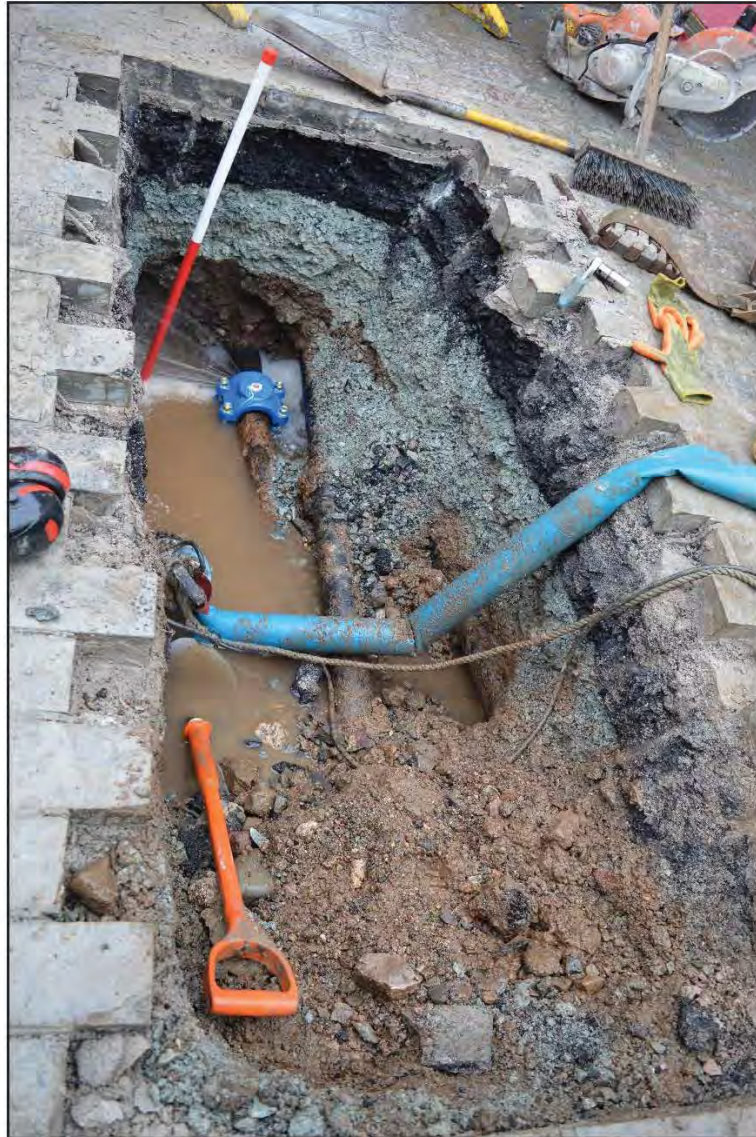
A single trench measuring 1m x 1.5m was opened over the probable location of the leak, in order to improve access to the leak the trench was extended to the south, the final dimensions of the trench were 1m x 2.5m.

The current road surface consisted of grey bricks laid into grey cement which overlay the former road surface consisting of a 0.18m thick layer of black tarmacadam. Below the tarmacadam was a 0.23m thick layer of crushed slate hardcore which overlay the backfill of the original pipe trench which consisted of orange-brown gravel rich silt which contained general building rubble. The maximum depth of the trench was 0.87m.

No archaeological deposits or features were encountered within the trench.

2. Trench following completion of excavation, showing identified leak (scale 1m, view from the North-Northeast)
