Watching Brief Commissioned by The National Trust Wales

Hafod y Llan Hydro Scheme Watching Brief October 2013 EAS Client Report 2013/10

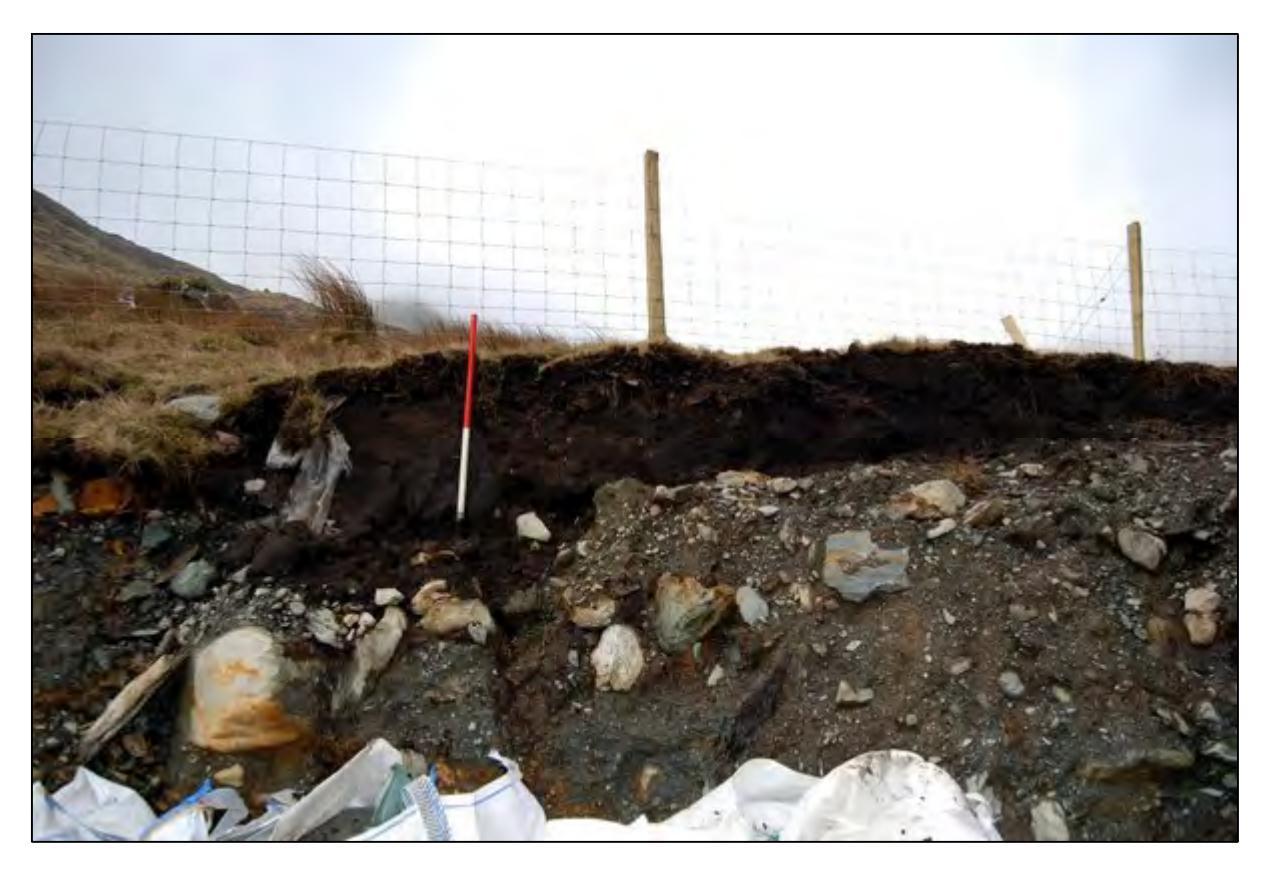
At the north western end of the development the Watkin Path was temporarily breached in order to construct the inlet pond and dam. This revealed a peat deposit, approximately 800mm thick (Plate 1). This was sampled in two sections (Plate 2) using overlapping column samples, at SH 62115 52018. At the time of sampling there was no budget for the analysis of these samples, however it was an opportunity to take samples from a peat deposit with the ultimate aim of investigating the palaeoenvironmental development of this part of Snowdonia. The peat deposit would have been sealed by the construction of the Watkin Path in 1892 and therefore predate this point in history. A similar peat column studied near Blaenau Ffestiniog, for example, had deposits dated to 5805 ± 35 BP (Grant 2013, 22) at its base showing the potential for the sampled deposits. It is also possible that this core may give an indication for the earliest period of metal extraction, in the area, in the form of metal dust caught within the peat which could be indicated using X-ray fluorescence analysis.

Plate 1: Location of the peat deposits

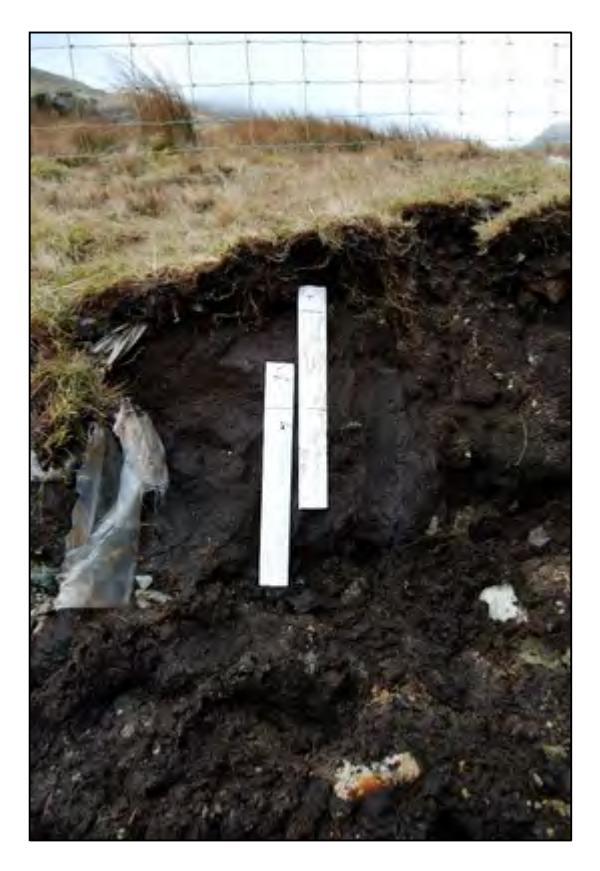
Plate 2: Sampling the peat

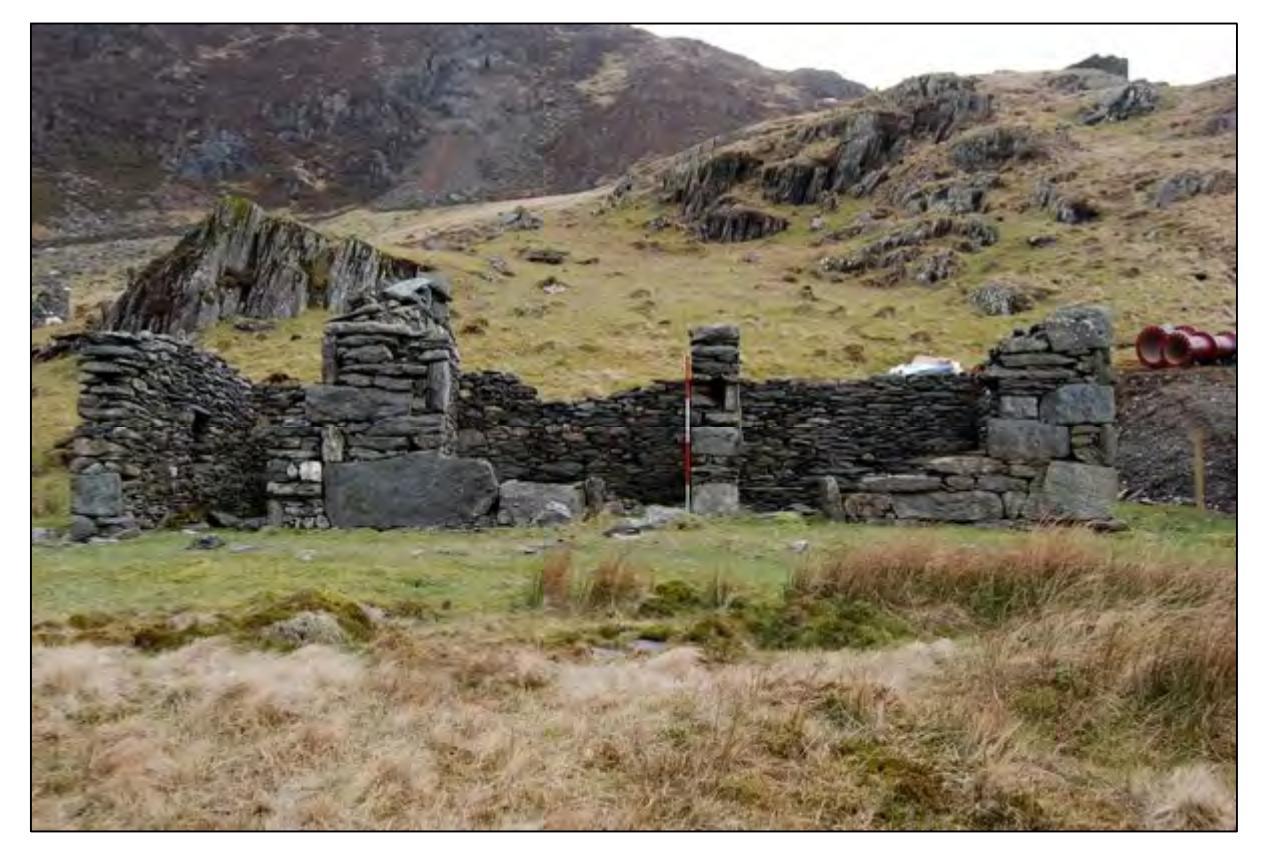
Slightly to the east of the dam site is the office for the Hafod y Llan copper mill (NT PRN 44829, Plate 8). This is an essentially two celled building which was extended to the north and which faced to the west overlooking the point where the tramway from Braich-yroen would have crossed the Afon Cwm Llan. Outside this building, at SH 62140 52049, is a stone, partly buried, which has four holes drilled into its upper surface (Plate 9). Whilst it is possible that these holes held the posts for a fence line, the relatively close spacing between the holes suggest this may have been a simple rock cannon.

Plate 8: Hafod y Llan office

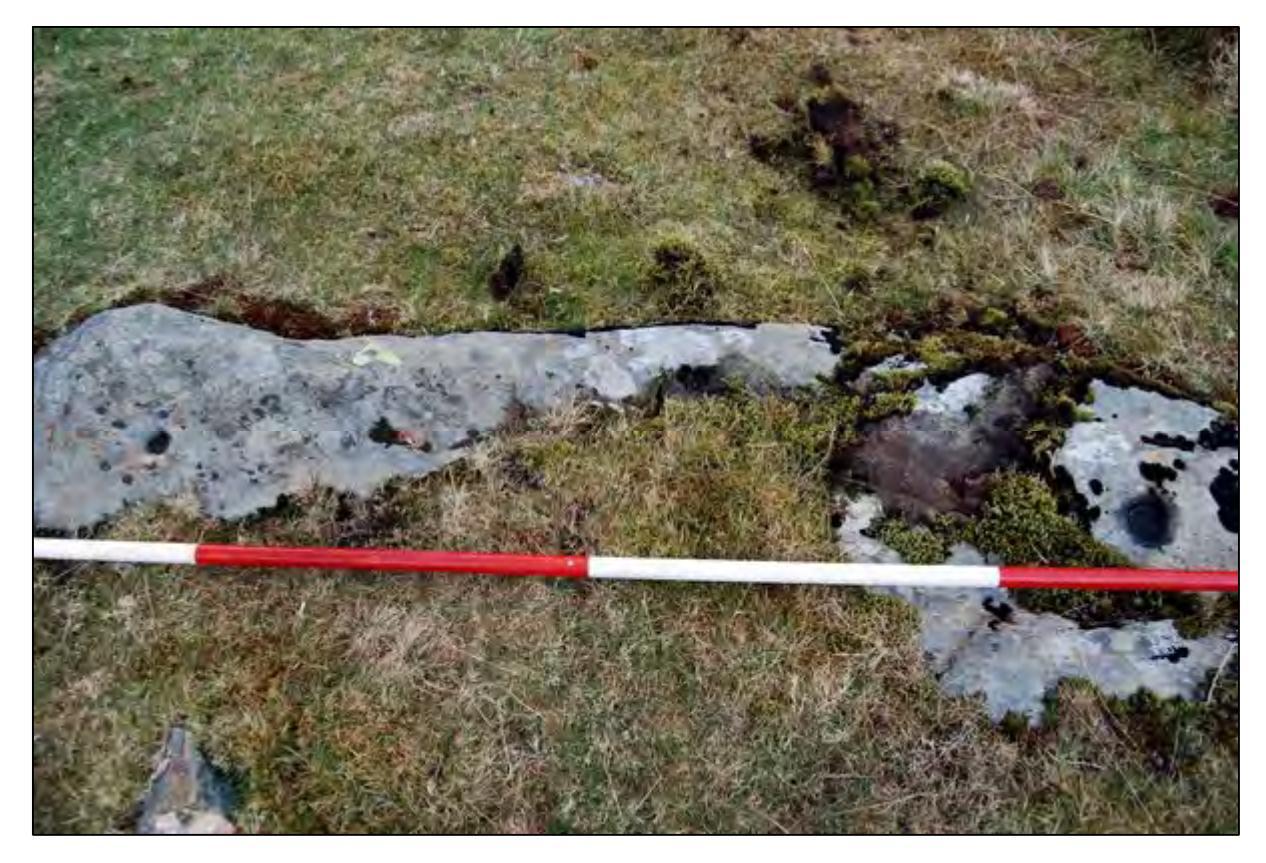
Plate 9: Block with drill holes in front of the Hafod y Llan office

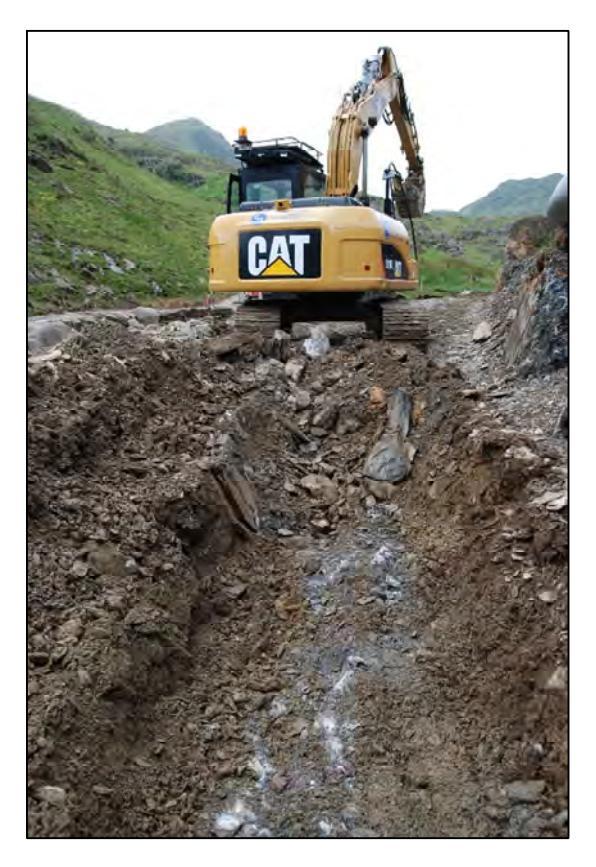
Whilst the Office building (NT PRN 44829) and an open shaft (NT PRN 44857) at SH 62130 52023 were protected during the course of the construction works, the space between the office and an adit (NT PRN 44857) at SH 62146 52023 was used as a temporary construction compound for storing materials and the turning vehicles causing disruption to this area. The main copper mill (NT PRN 44858, Plate 10) was also avoided with both the haul road and the pipeline skirting the eastern side of the buildings and associated platforms. However this required both of these to run along the line of the tramway (NT PRN 44856, Plate 11) which originally ran from the river crossing to the hoppers which fed the crusher within the copper mill. The tramway would appear to have been a two phase construction with a lower tramway being replace by a higher level route, presumably to allow ore to be tipped into the top of the ore bin. Both of these routes had dry stone revetting along their south western sides and were terraced into the hillside to the north and east. During construction, the surface of the upper tramway was buried with debris from pecking the rock so that the tramway could be widened to allow access by mechanical excavators to the dam site. The pipe trench was then dug through this debris (Plate 12). This trench was very shallow, such that the majority of the pipe was above the level of the trench. On reinstatement little attempt was made to follow the original contours of the tramway, however this resulted in the tramway being protected with the layer of spoil which also covered the pipe (Plate 13).

Plate 12: The pipe trench over the tramway

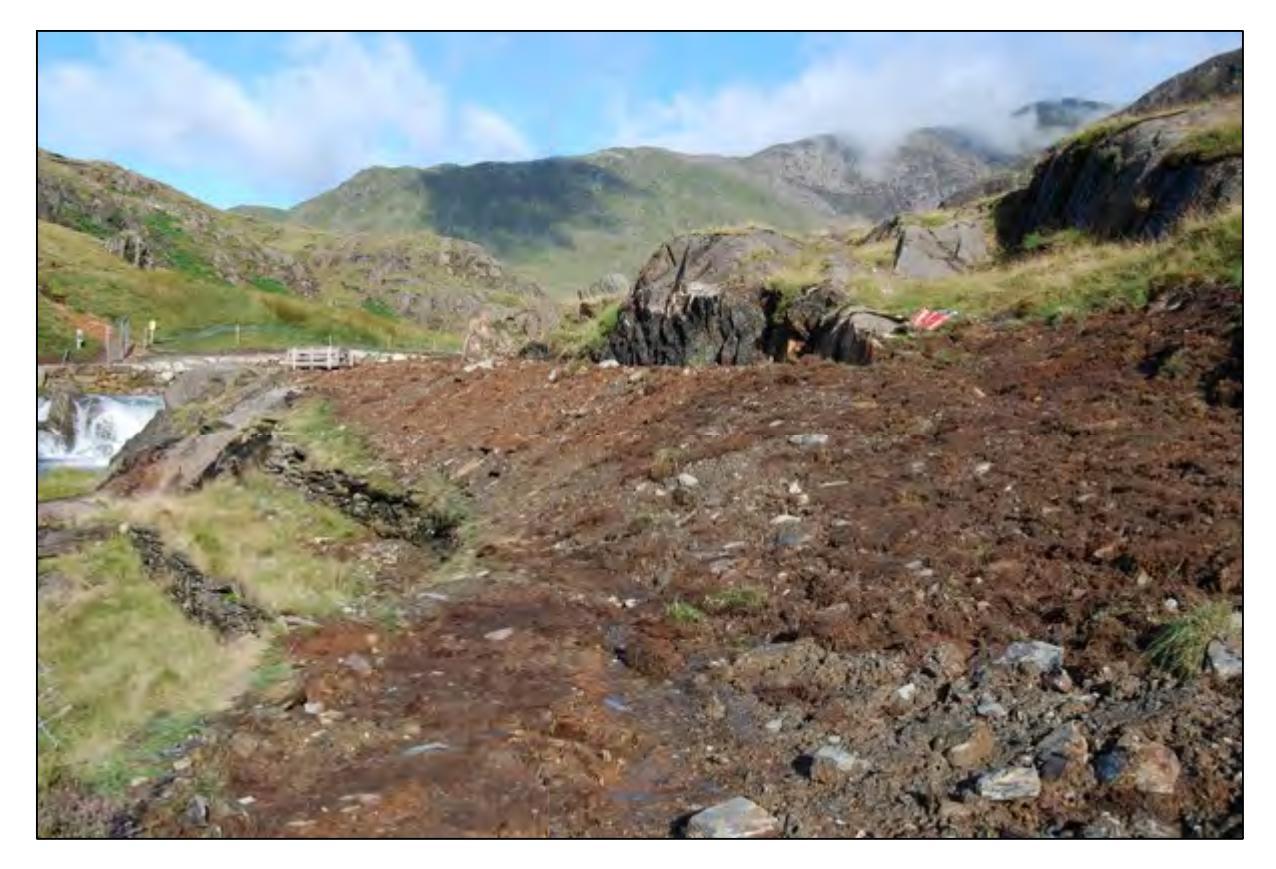
Plate 13: The tramway after reinstatement

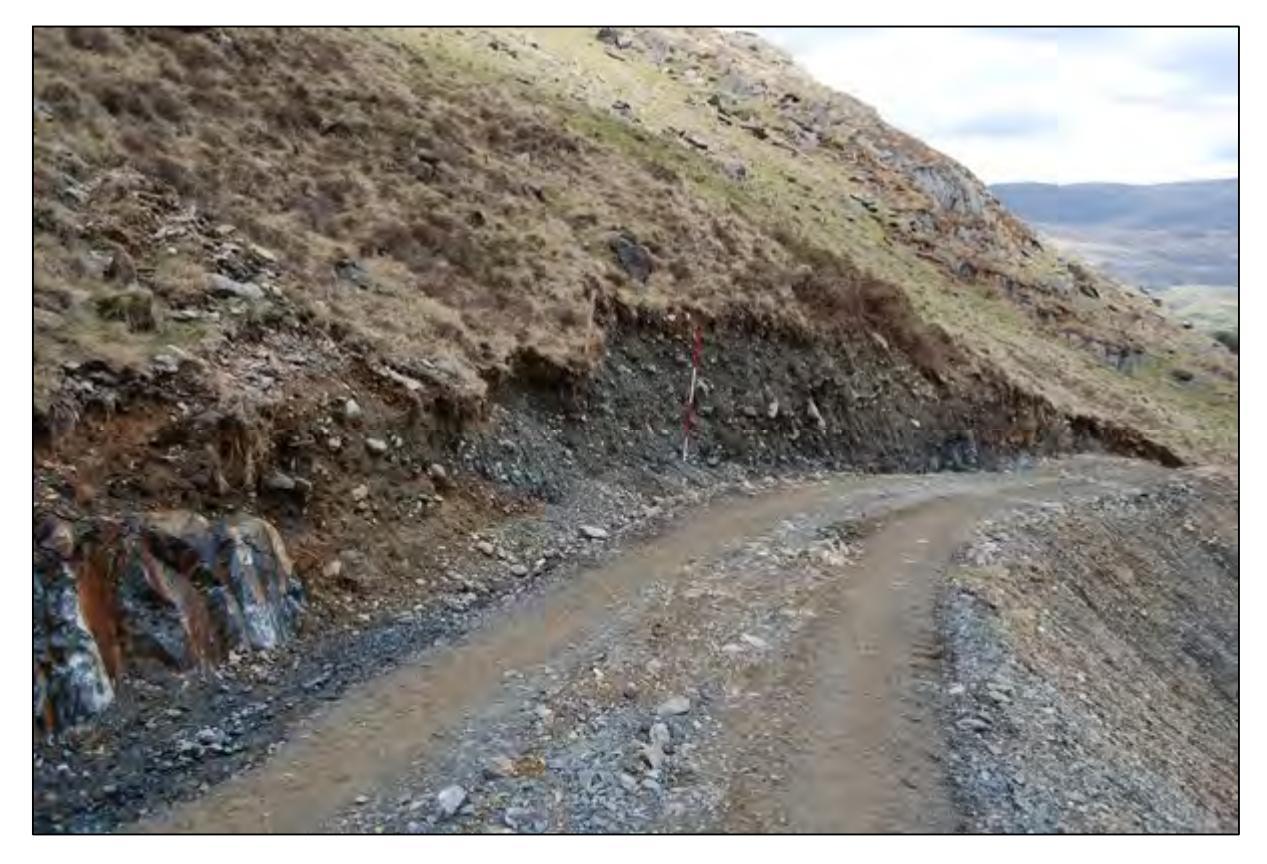
Between SH 62220 51982 and SH 62146 52023 the pipeline and the haul road cut through the tail of a large spoil heap (Plate 14). The digging of the haul road exposed a section approximately 32 m long and up to 2.2 m high of angular stone block in a matrix of dark brown clayey silt. Originally this spoil heap had a smooth profile with its tail resting against the rear wall of the building in the south eastern corner of the working platform associated with the copper mill. This building contained the presumed terminus for a cableway marked by a drum house on the skyline (Plate 15). It would seem likely that the build-up of spoil may be related to this method of transporting ore from the mountainside and Hafod v Llan mine itself to the works. Other possible interpretations are that the spoil heap may be the result of the dumping of the excess spoil from the creation of the working platform or the remains of a denuded incline feeding the copper mill from the mine high on the hillside.

Plate 14: The spoil heap, looking SE

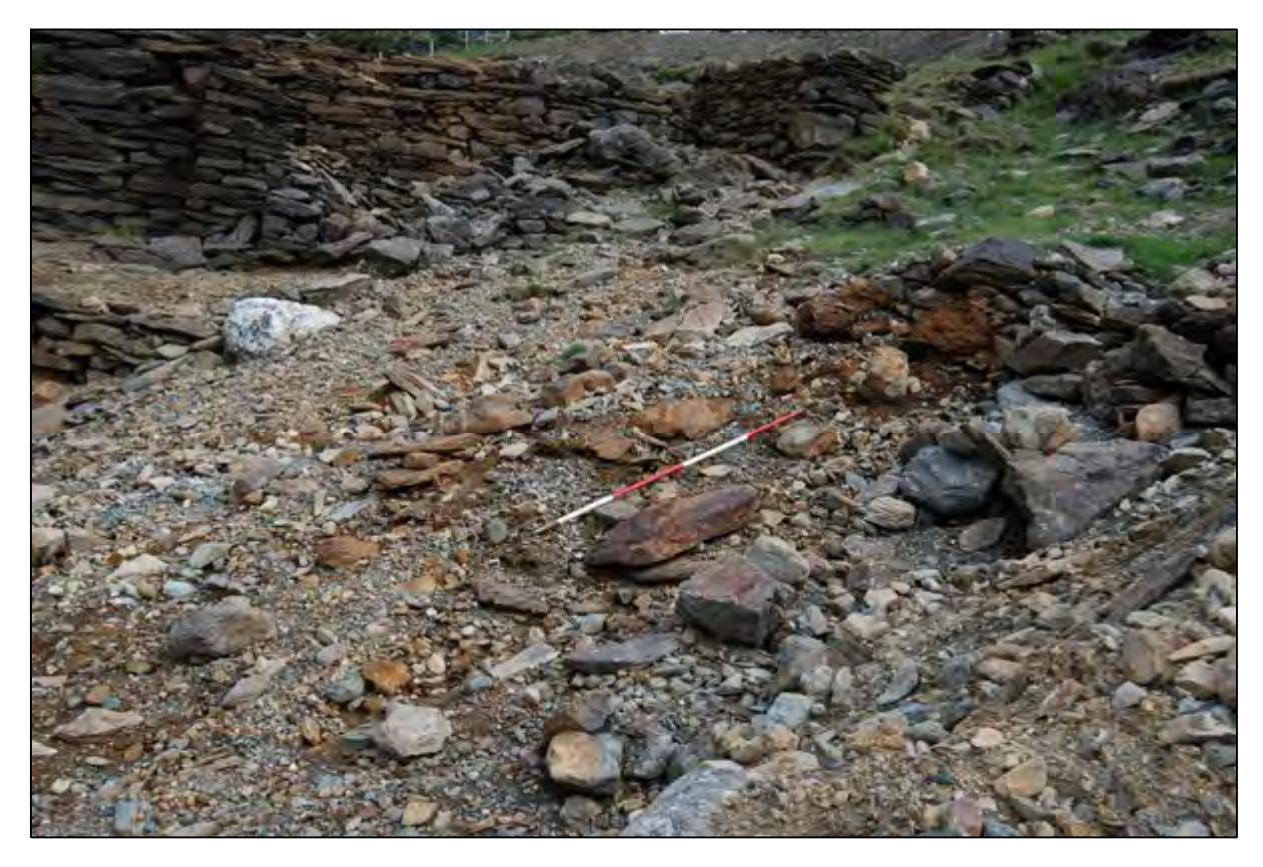
The construction of the haul road required the inclusion of drains in order to keep the road dry. Unfortunately these drains had their outfalls on the downhill side onto the working platform and waste tips associated with the copper mill. Some attempts were made to disperse the water by the use of straw bale filters, however some damage was done to the site by erosion. This was particularly noticeable within the waste tips to the south east of the working platform (Plate 16) where the fine deposits probably derived from the buddle (Plate 17) were remobilised. Also at the bottom of this slope the deposits were disturbed by turning a vehicle around leaving tracks across the deposits.

Plate 16: Damage caused to the spoil heaps by the drainage to the haul road

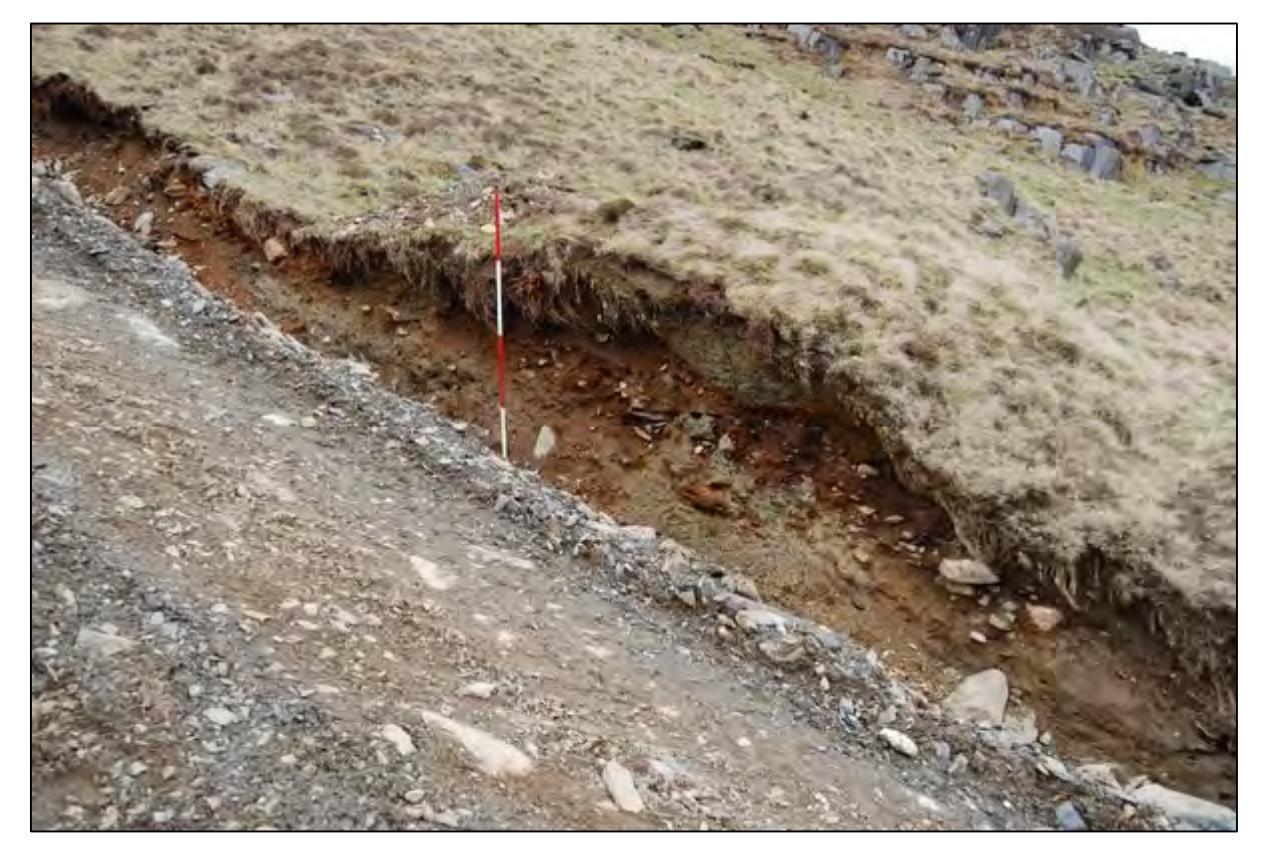
The natural instability of the slopes to the south and east of the copper mill are demonstrated by the rotational slumping at SH 62223 51918 (Plate 18). Here the rotation is such that the underlying natural clay has been brought to the surface and the iron pan rich soils have been at least partly buried. This demonstrates both the relatively high slopes and the generally wet condition of these slopes.

Plate 18: Rotational slump

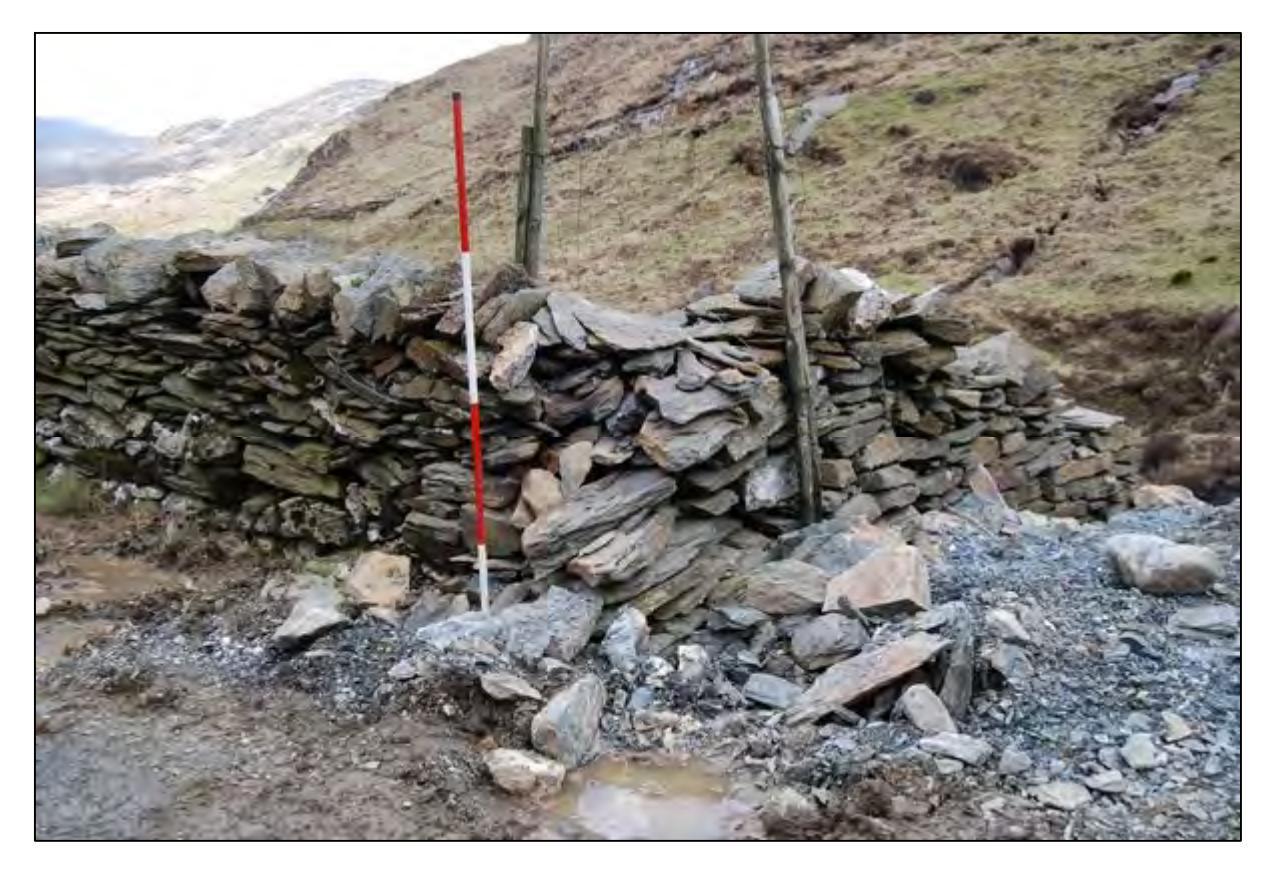
The haul road cut through and ran alongside a series of stone walls (Figure 2). Walls 1 and 2 (Plates 19 and 20) were of a similar character, approximately 1.5 m high with pitched stone capping, however Walls 3 and 4 (Plates 21 and 22) are of different characters. It is likely that Walls 1 and 2 are contemporary and were recorded as NT PRN 45869 by the Gwynedd Archaeological Trust (Cooke and Evans 2011,

Plate 19: Wall crossing 1

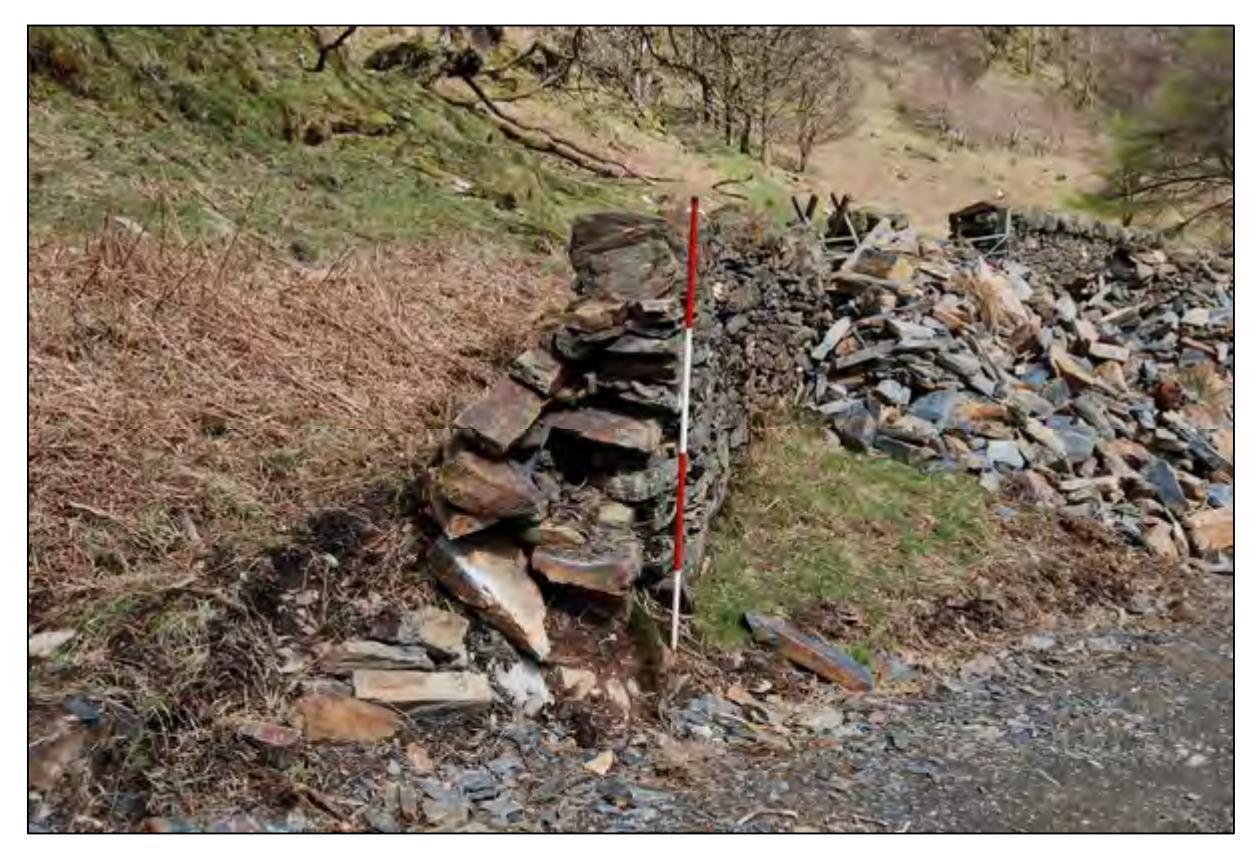
Plate 20: Wall crossing 2

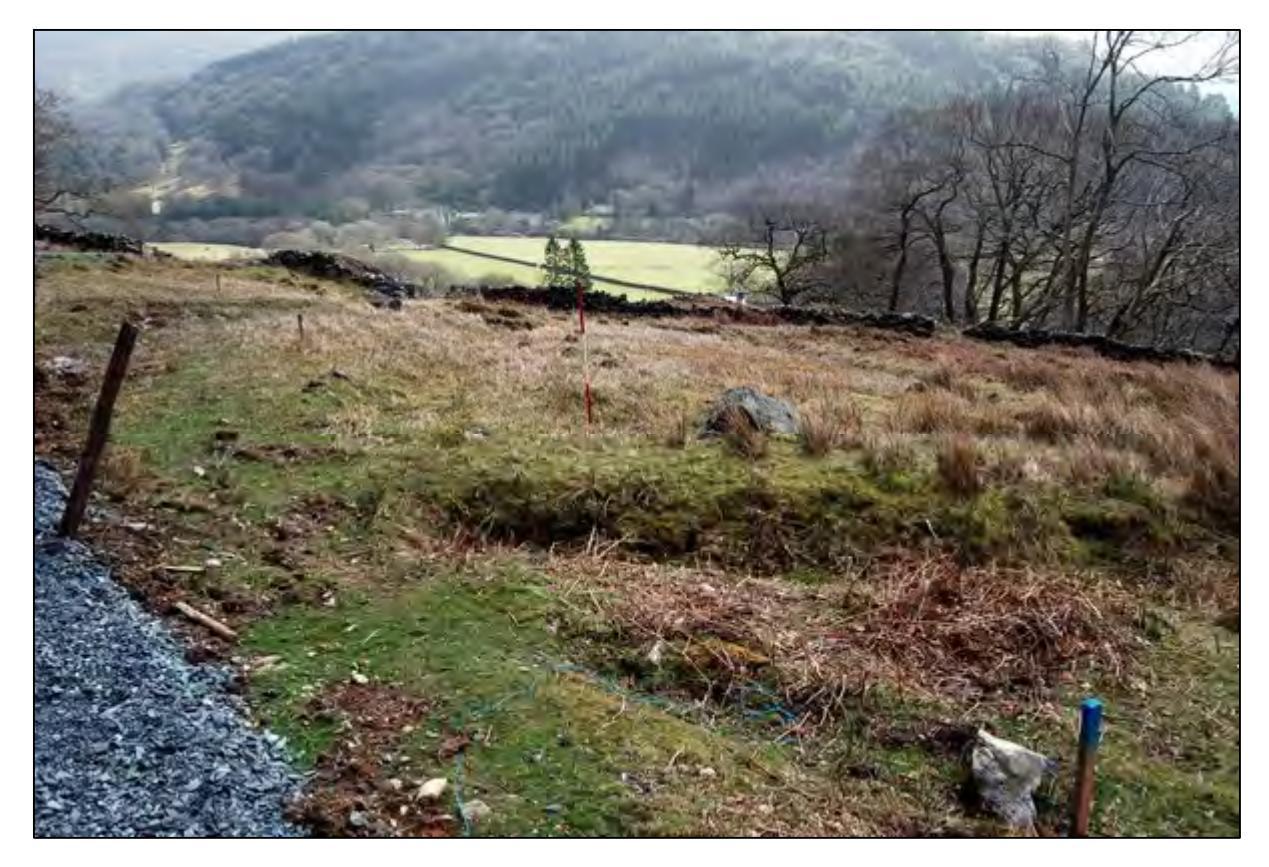
Slightly to the west of Wall 4 is an area of peat cutting (Plate 23) that was not recognised in the initial surveys of the pipeline. Extending over an area of 45 x 65 m there are a network of drainage ditches (Figure 4) cutting across an area of soft sediments (Plate 23). Each of the ditches (Plates 24-26) was up to 1.2 m wide and 0.4 m deep. They were cut through a layer of degraded peat up to 0.4 m thick (Context 1) which formed slight hummocks between each of the ditches (Plate 27). This layer sealed a layer of angular stones in a grey, slightly sandy, clay matrix up to 0.2 m thick (Context 2) which appear to be water lain, possibly an out wash layer. This in turn sealed a layer of amorphous peat up to 0.5 m thick (Context 3). These layers would suggest there has been at least two phases of peat cutting on the site. The top of Context 3 appears to have been truncated, however there was then a period of run off depositing Context 2 over the area. This period must have included considerable water flow with an area of exposed gravels above the area of the peat cutting. Peat, or at least organic rich soils, then regenerated on the site and it was these deposits which were

Plate 23: Area of peat cutting

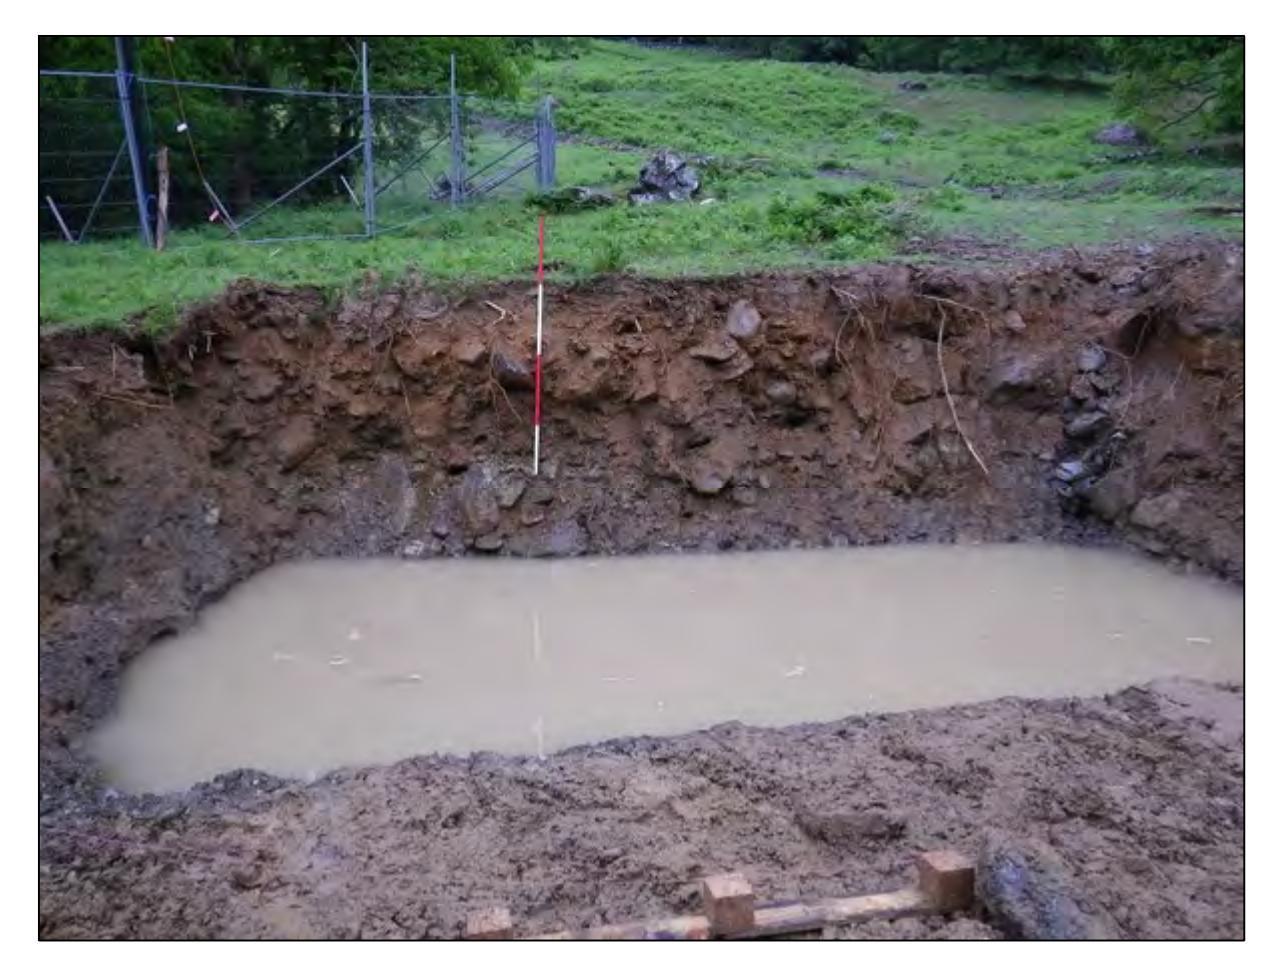
The location of the excavations for the turbine house were of some archaeological interest given their proximity to the bridge abutment located by K. Laws in her site visit of May 2012 (Plate 28). No signs of a formal track way leading from the bridge abutment was located, however, the pipe trench leading into the north western side of the turbine house was dug and backfilled without archaeological monitoring. The excavation for the Turbine House, however did give an opportunity to inspect the Pleistocene deposits in this part of the valley. There would appear to be a mixture of till and outwash gravels within the sections (Appendix 1, Plate 29). Given the large size of the water worn boulders within these deposits (up to $1.5 \ge 1.5 \ge 1.5 = 1.5$ relatively high energy regime occurred to move the stones whilst the clays associated with the till would suggest a much quieter period of deposition.

Plate 29: The excavation for the turbine house
