Field Barn - Isgaer, Llanfair Hall, Caernarfon

> I.P. Brooks EAS Client report 2019/04

Project Commissioned by Adrian Williamson on behalf of Robin and Anwen Jones

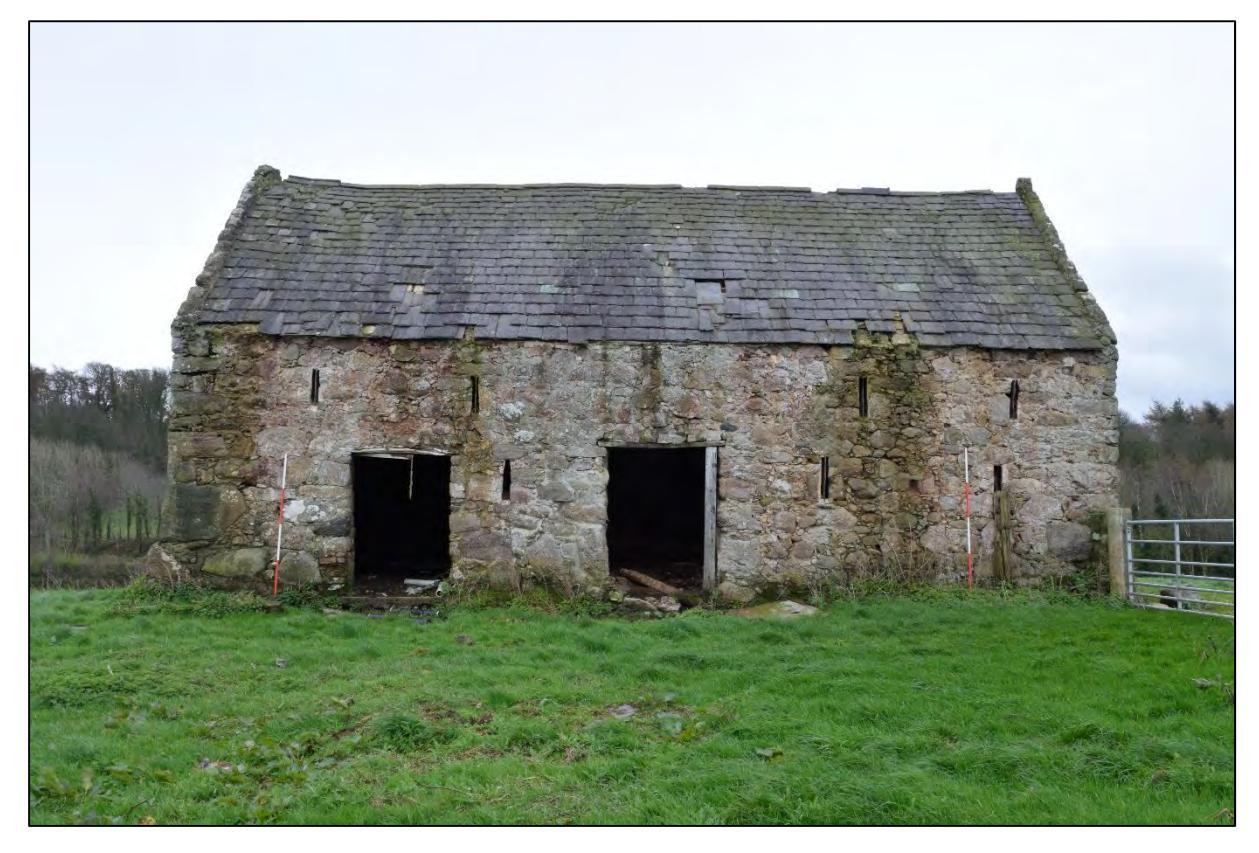
Currently the main openings are on the north western elevation of the building (Plate 2, Figure 5) with two doorways within the northern half of this elevation. The southern doorway (Plate 3) has a wooden lintel and one surviving, wooden jamb. The northern doorway, however, (Plate 4) has a slightly arched wooden lintel on the outers face, although the rest of the opening has flat top with a series of wooden lintels supporting the wall. Both of these doors are set slightly above the surrounding landscape so that there is a step up of approximately 0.2 m into the building. There are a series of ventilation slits within this elevation which are set at two distinct levels. The lower slits are approximately 1.4 m above the local ground level, whilst the upper slits are set at a level of 2.4 m (Plate 5). Six of seven ventilation slits in this elevation are unusual in having a slate "baffle" (Plate 6) dividing the opening. These "baffles" only run back through approximately half of the thickness of the wall (Plate 7) whilst the general opening is typically splayed.

Plate 2: Northern elevation

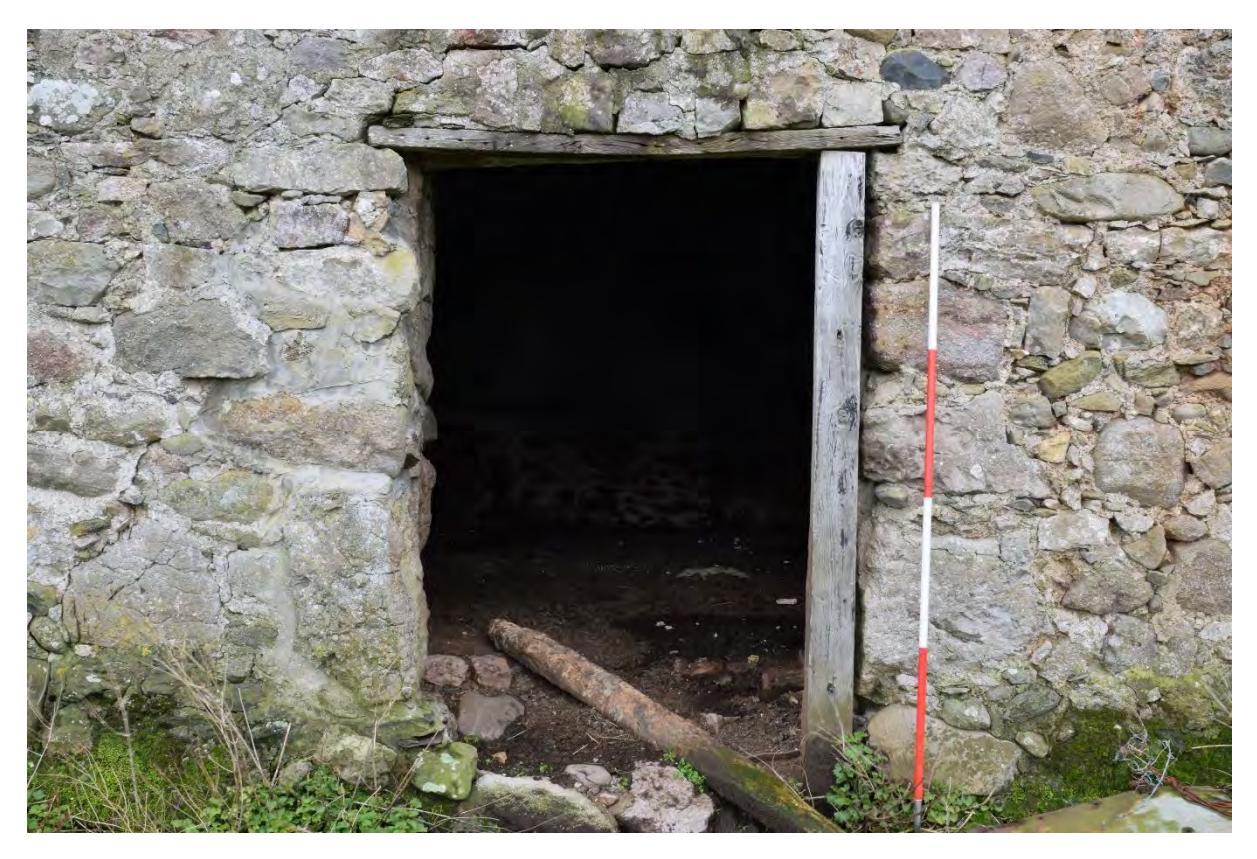
Plate 3: The western doorway in the northern elevation

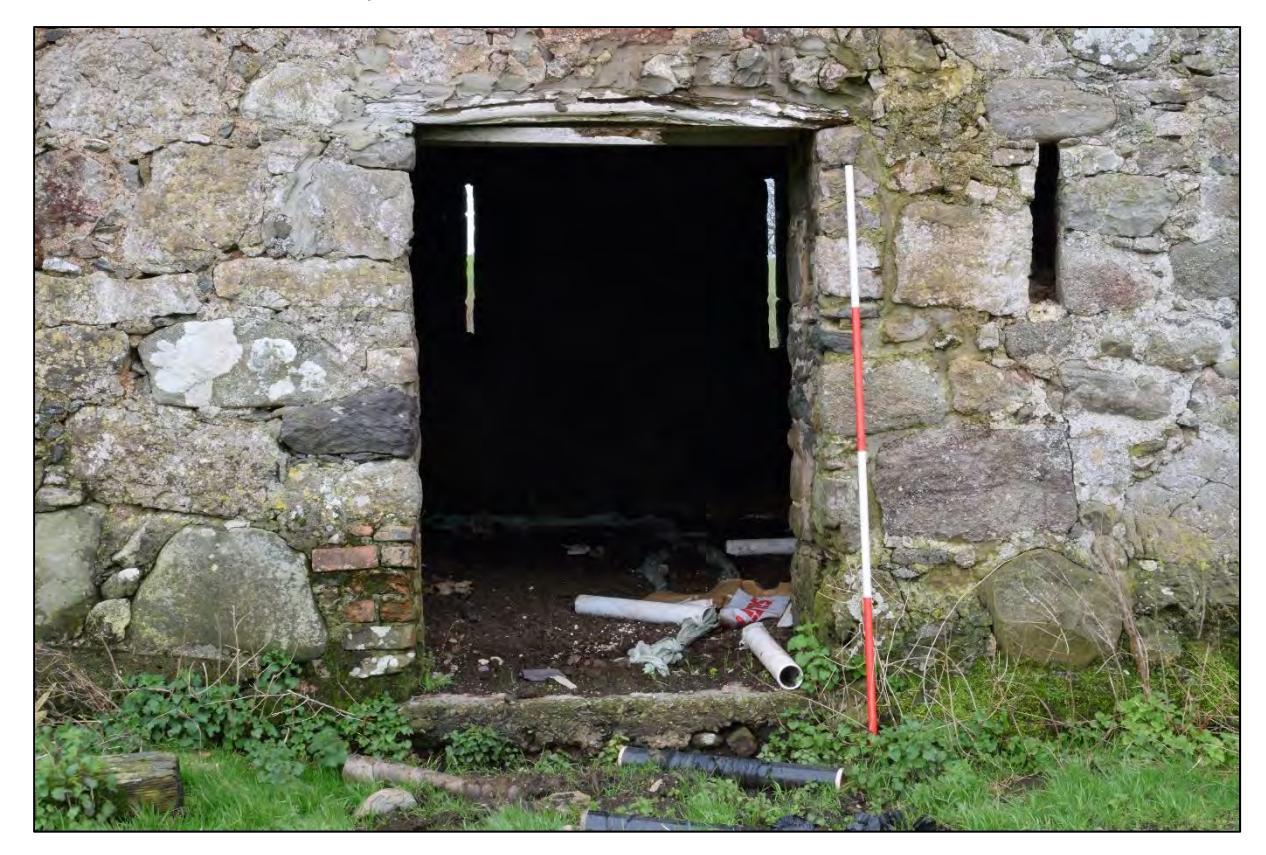
Plate 4: The eastern doorway in the northern elevation

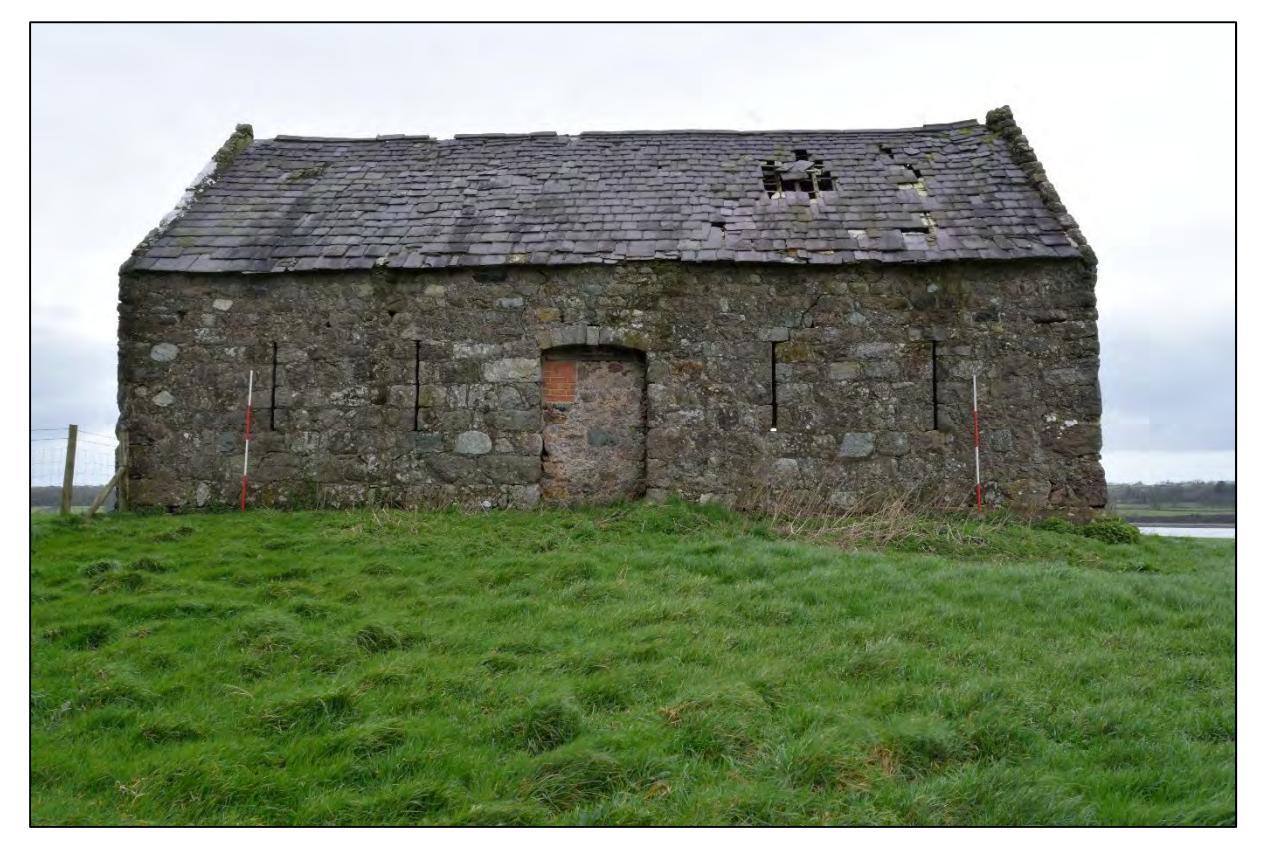
The south eastern elevation (Plate 8, Figure 6) is distinctly better built, of roughly coursed boulders many of which appear to have been roughly squares. There is a centrally placed doorway, now blocked, with stone voussoirs forming a segmental arch (Plate 9). This opening has been blocked with at least two phases of blocking being evident. The majority of the blocking is of rough, mortared, stonework whilst there is a later, brick blocking in the upper left corner of the opening. These bricks are relatively modern, machine made, bricks with a cementous mortar. On either side of the door are two ventilation slits which are well made with stone block, jambs (Plate 10). These are longer than those in the northern elevation being 1.23 m long whereas those in the north western elevation are typically 0.56 m high.

Plate 8: Southern elevation

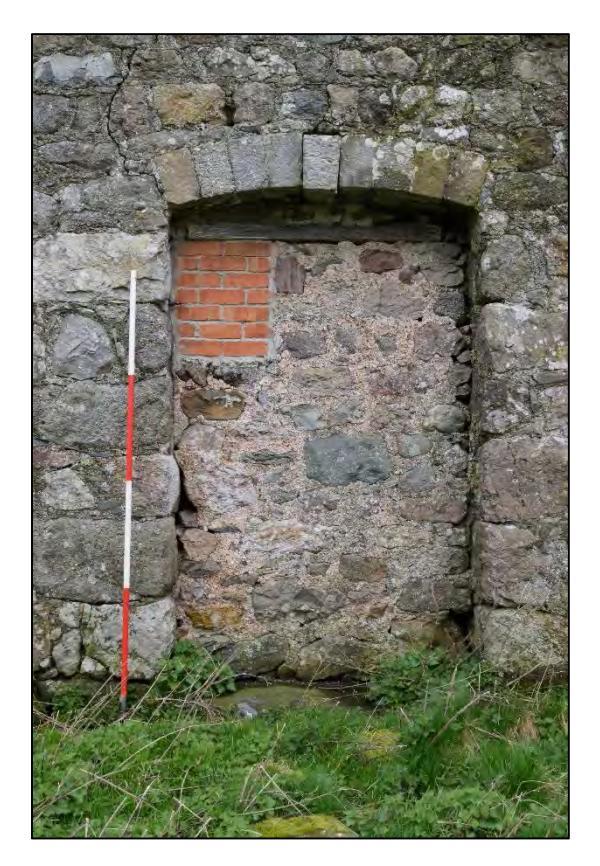
Plate 9: Blocked doorway in the southern elevation

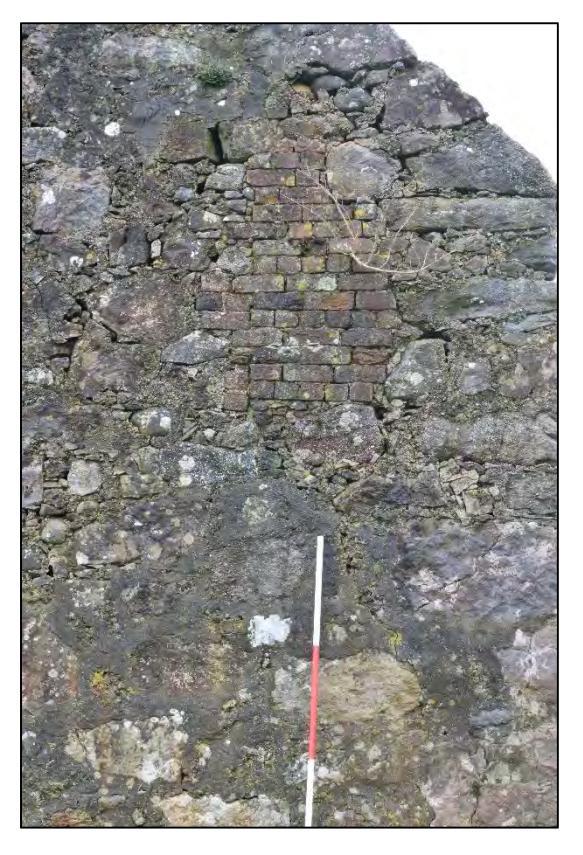
The south western gable (Plate 11, Figure 7) has no distinct features except for a brick patch (Plate 12) which appears to have been made with, possibly re-used, hand made bricks. The north eastern gable, (Plate 13) however, has a tracery window frame placed high in the gable with a rectilinear

Plate 12: Detail of the brick repair to the western gable

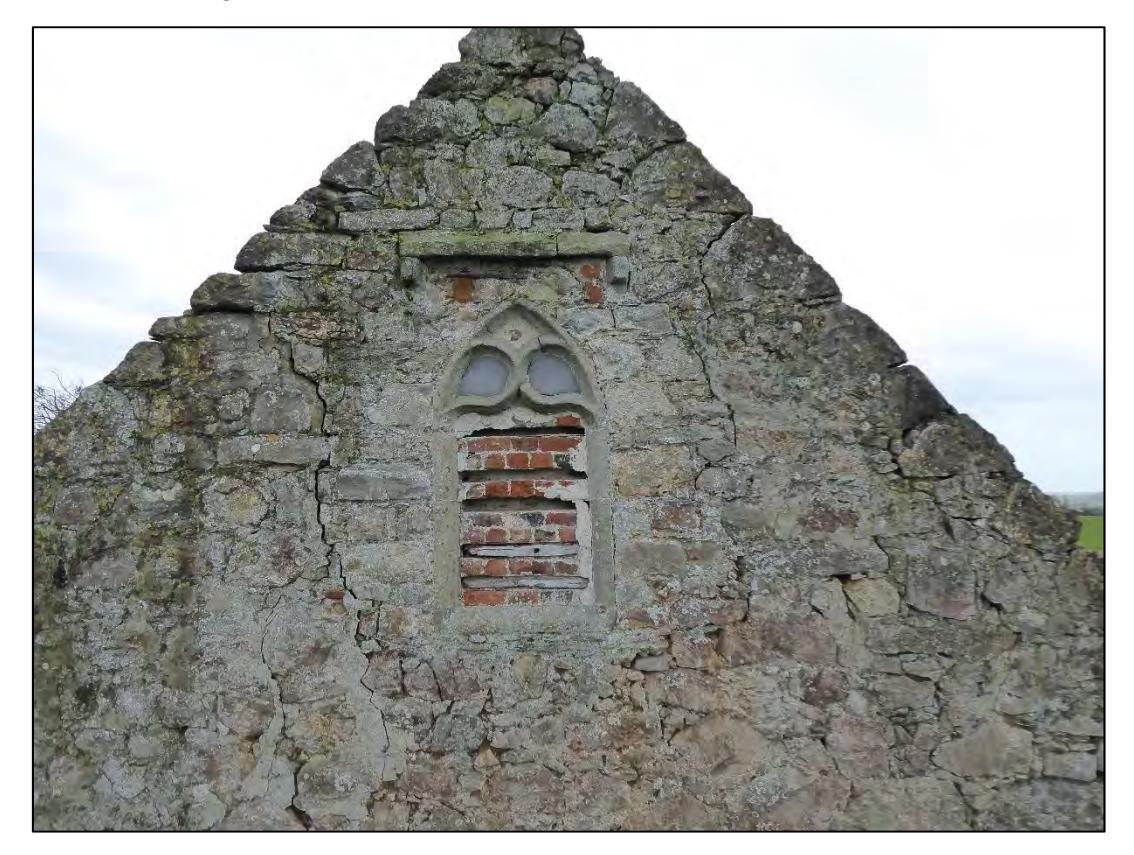
stone hood above (Plate 14). This is blind window with a backing of hand-made bricks and timber rails. The window is of pointed form with flowing ogee tracery which is also found within the 14th century on Anglesey (Haslam *et al* 2009, 441). Inside the barn there is only a small blocking (Plate 15) suggesting there may have been a ventilation slit in this gable and that the tracery "window" is only a surface decoration.

Plate 14: Detail of the tracery in the eastern gable

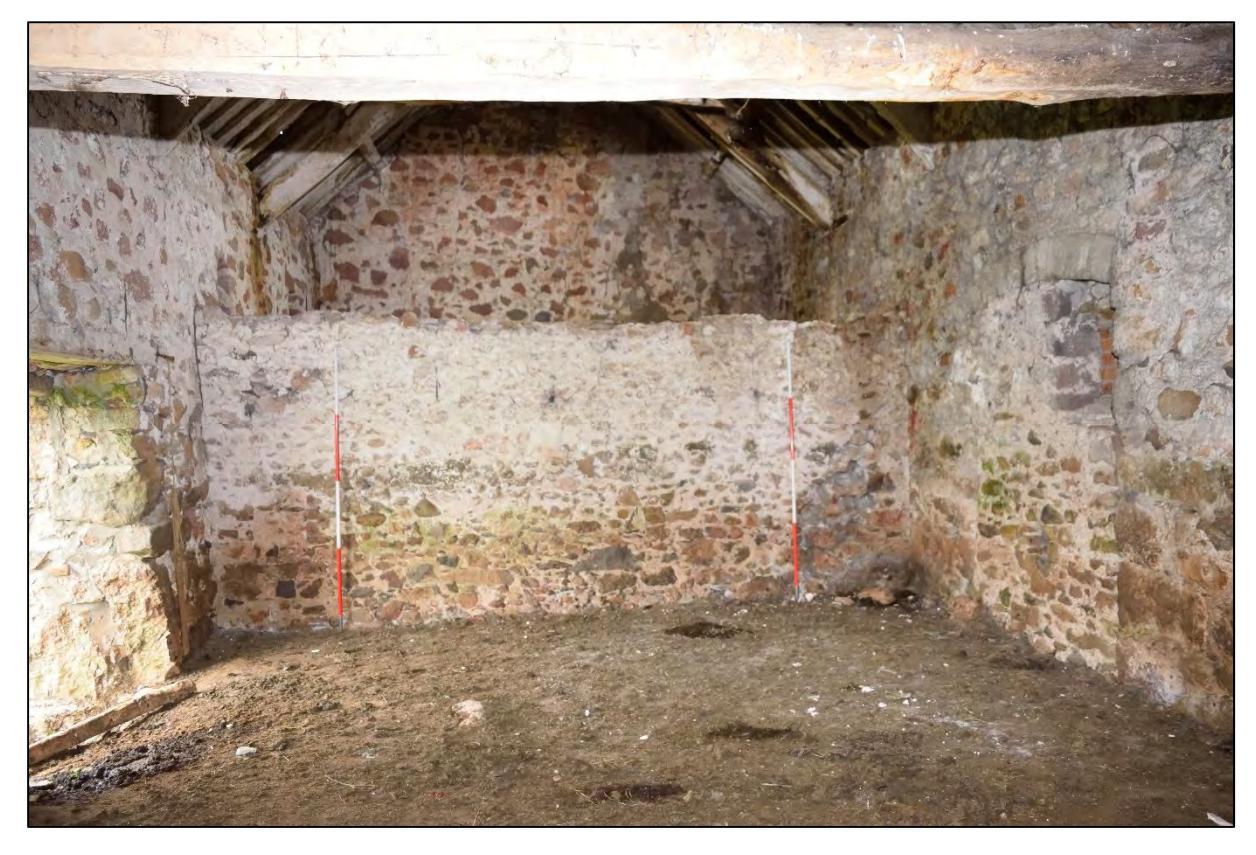
Internally the building is divided into two "rooms" by a low wall, approximately 2.4 m high which is clearly a late modification as it has straight joints with the walls at both ends (Plate 16). This wall is probably contemporary with the beams crossing the building which are assumed to have supported two raised platforms. The south eastern platform occupied all of the south eastern "room" and is clearly a later insertion the beams having their north western ends lodged in the splayed openings of the ventilation slots (Plate 17). Similarly, the beams for the second platform are also lodged in the splays of the ventilation slots on the north western side (Plate 18). All of the beams are set in the south eastern wall of the barn.

Plate 16: Dividing wall within the barn, looking NE.

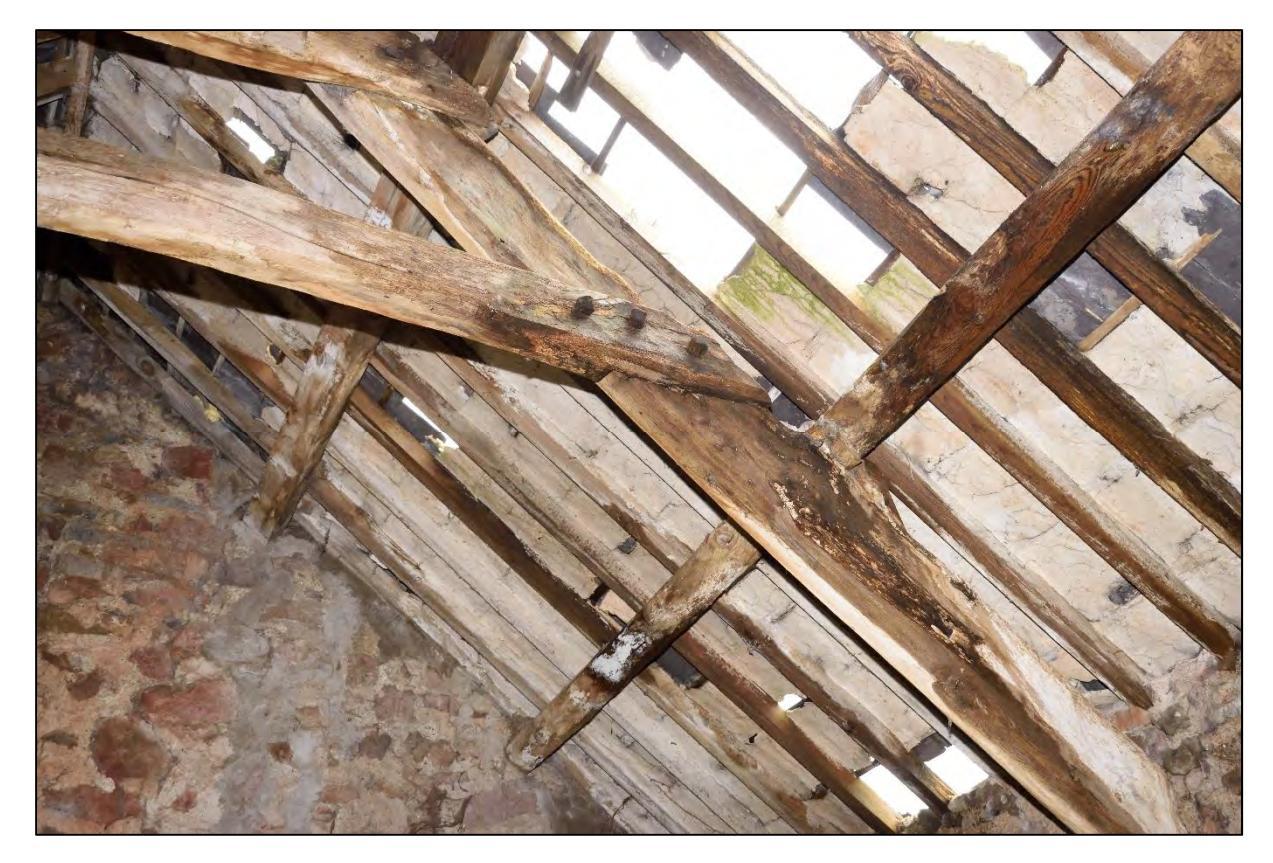
There are four trusses supporting the roof (Figures 9 - 12) which fall into two broad types. The two outer trusses (Trusses 1 and 4, Figures 9 and 12, Plates 25 and 26) are relatively simple trusses with slightly cambered tie beams which have pegged, half lap, joints (Plate 27). The peak of both of these trusses also have half lap joints which are also pegged. Truss 1, however has an additional wooden plate nailed on the surface of the truss which extends above the truss and has a slot in its top to hold the ridge piece. This would suggest either; a re-roofing of the barn with the addition of this plate to level out the ridge of the roof, or that this truss is re-used and needed to be modified to make it fit into the roof. Truss 4 also has an additional timber trenched into the end of the south eastern principal rafter (Plate 28) modifying the position of the ridge piece at this point. In general, the purlins on these trusses rest on the top of the principal rafters, however some of them have been supported with wooden cleats.

Plate 27: Half lapped joint between the principal rafter and the tie beam on Truss 4

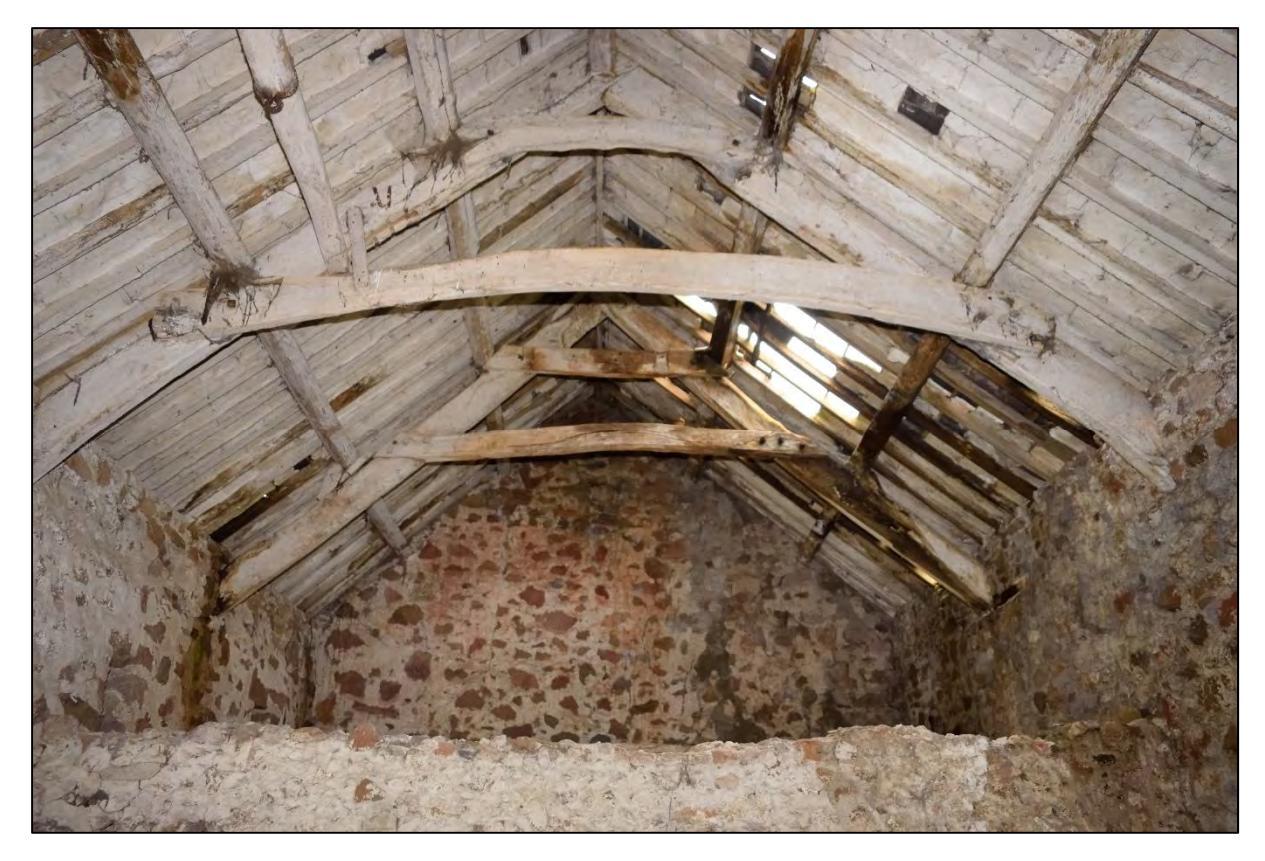
The middle trusses (Trusses 2 and 3, Figures 10 and 11, Plates 29 and 30) also have slightly canted tie beams, however, these have simple lap joints which were originally pegged, but later were reinforced with metal bolts. The tie beams replaced an earlier tie beams which had been morticed into the principal rafters and pegged in place (Plate 31). The peak of both of these trusses have half lap joints which are pegged. Truss 3, however also has a similar wooden plate nailed to its surface and supported by two short timbers attached to the top surface of the truss. Once again, the majority of the purlins rest on the principal rafters, however, on both trusses the lower eastern purlin has been slightly trenched into the principal rafters.

Plate 29: Truss 2, looking SW

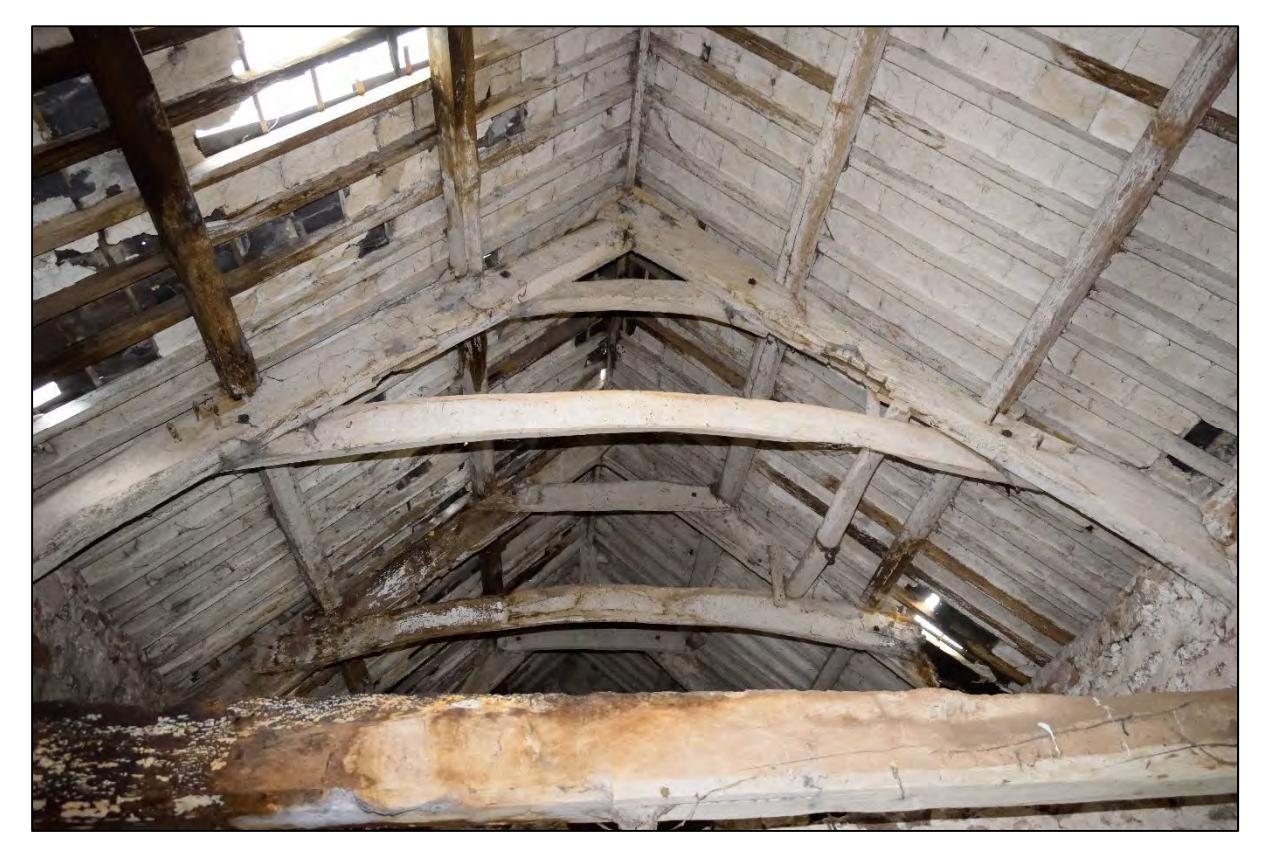
Plate 30: Truss 3, looking SW

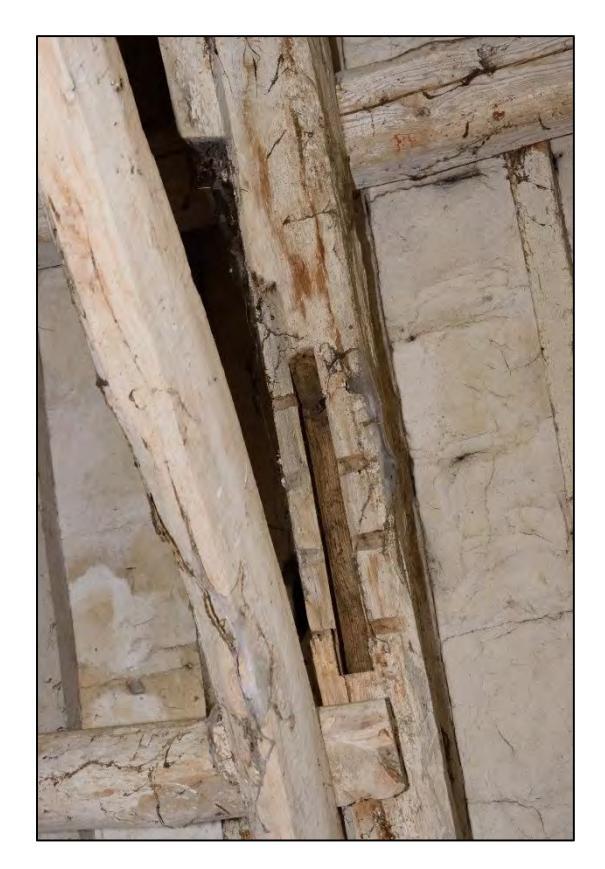
Plate 31: Mortice and broken peg hole in Truss 2

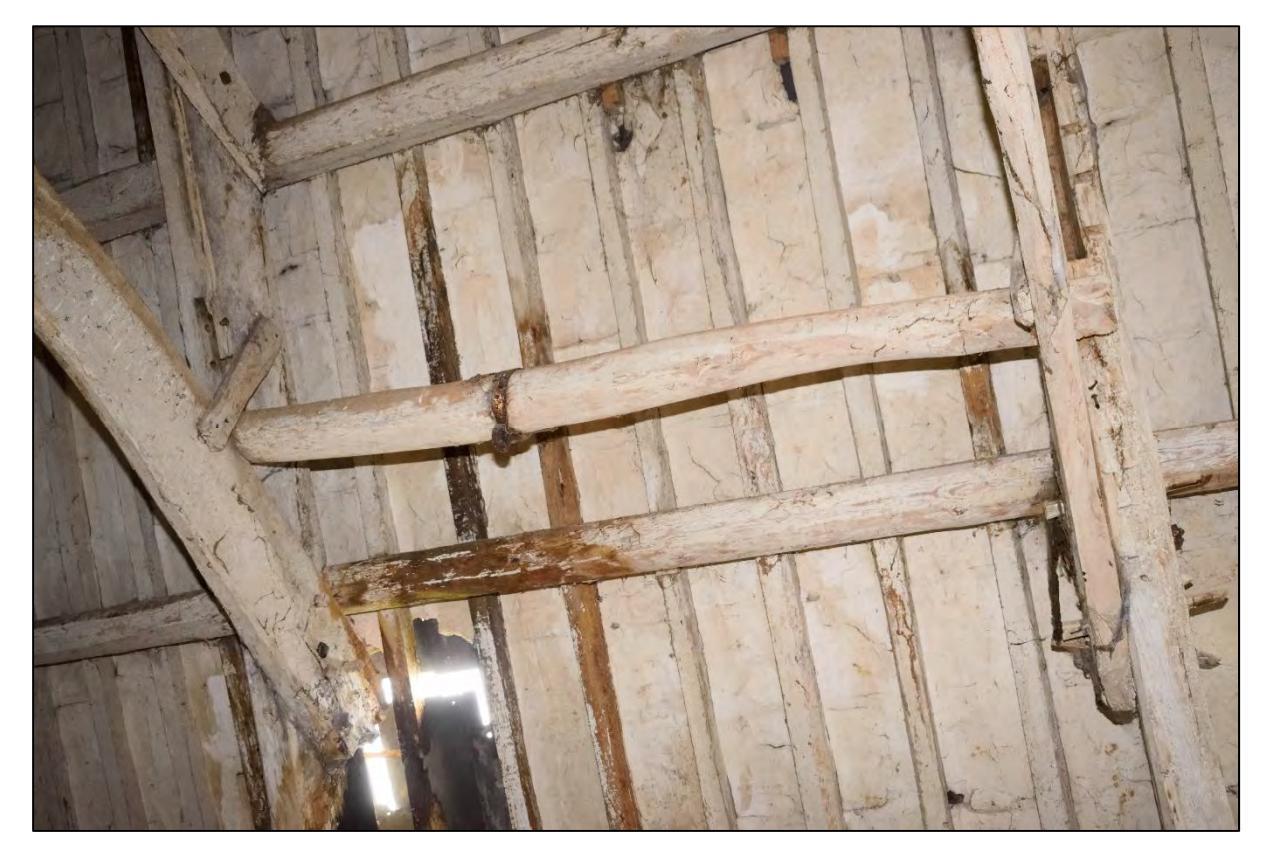
Between Trusses 2 and 3, and above the south western door is a timber resting on to of the truss and held in place by short structs between the principal rafters and the tie beams. There is the remains of rope attached to this beam, possibly suggesting that this beam was the support for winch.

Plate 32: Possible winch support between Trusses 2 and 3
