Harbwr Y Felinheli Archaeological Assessment November 2001

Archaeological Assessment Commissioned by Sedgwick Associates

Kathy Laws Engineering Archaeological Services Ltd.

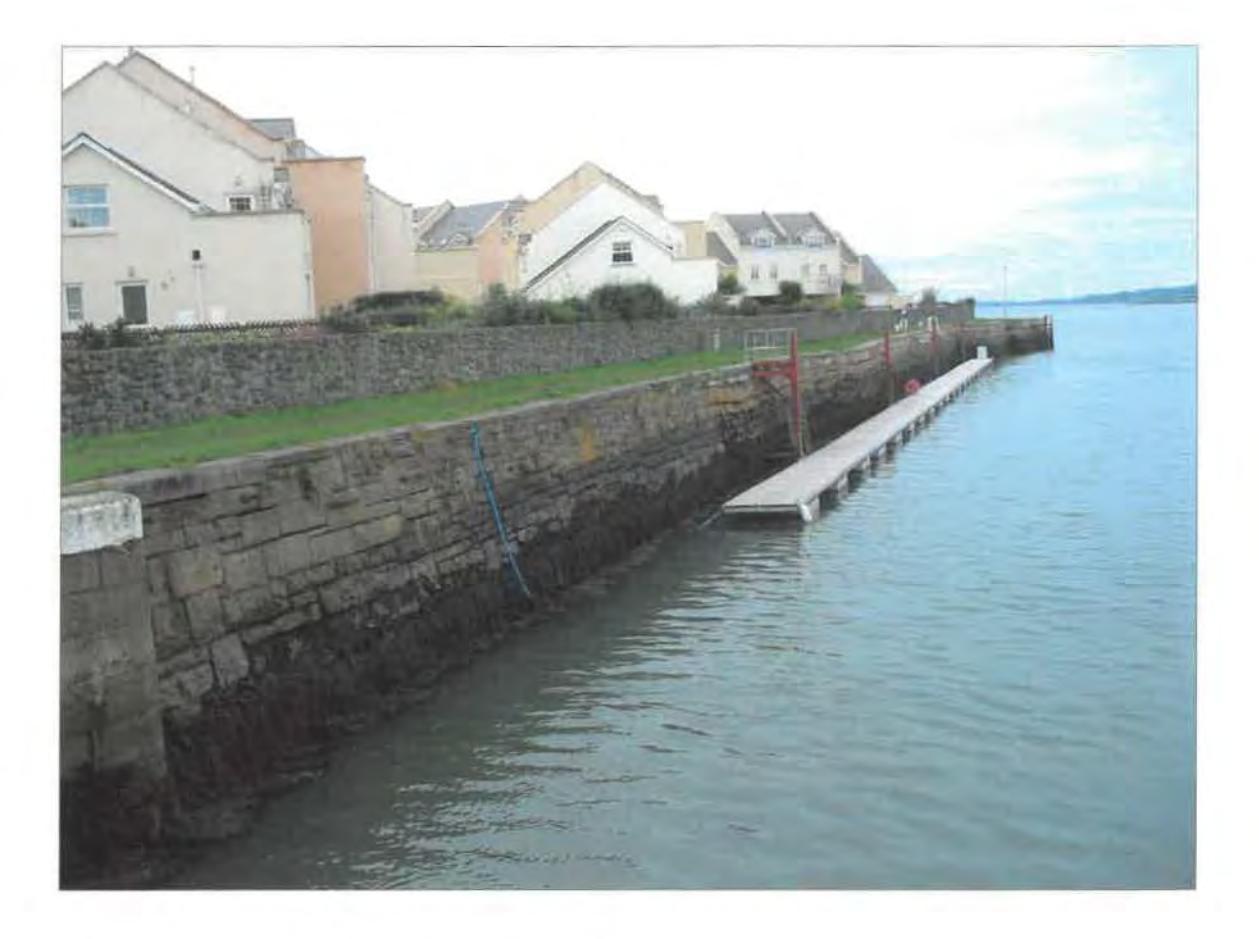
Figure 17. Outer tidal quay. (PRN 15880)

Condition: Moderate. In places the wall is bulging. Slumps in the ground surface above coincide with bulges in the wall. The mortar is being eroded due to wave action. Action has been taken to stabilise the wall at the most seaward point where concrete and wire meshing have been applied to the wall face. Iron mooring points on the quay side are in good condition. Iron ladders and fixings attached to the wall face are corroding.

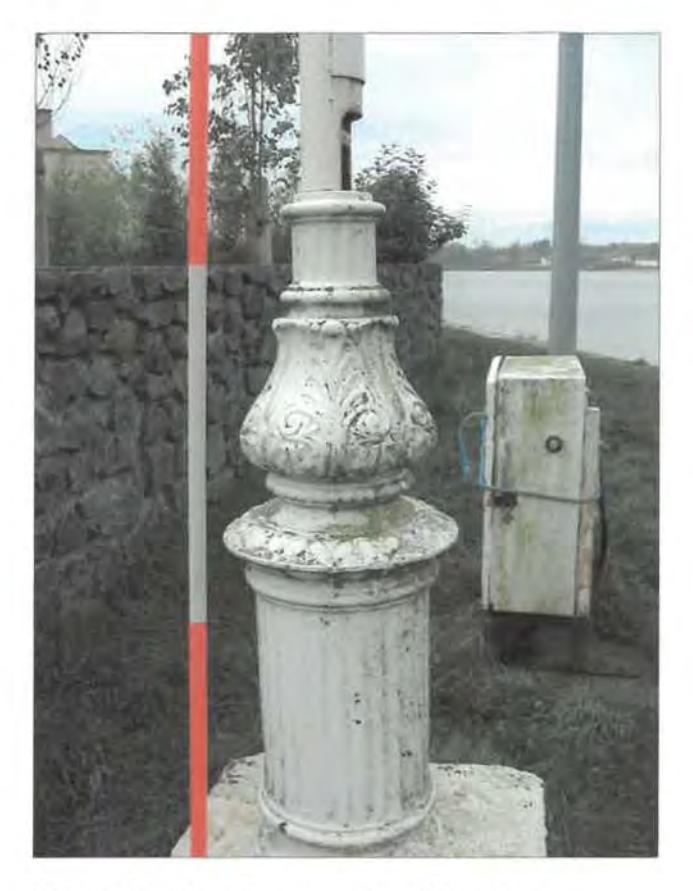
Figure 21. Iron Lamp post adjacent to PRN 15883

Description: A cast iron lamp post set in a square concrete base. The lower stand exhibits a decorative Acanthus leaf design above a mock Corinthian column while the upper shaft which accommodated two lamps is much plainer and is probably a replacement. It is possible that this was originally powered by gas and subsequently converted to electrical power. **Condition:** Moderate, showing signs of corrosion.

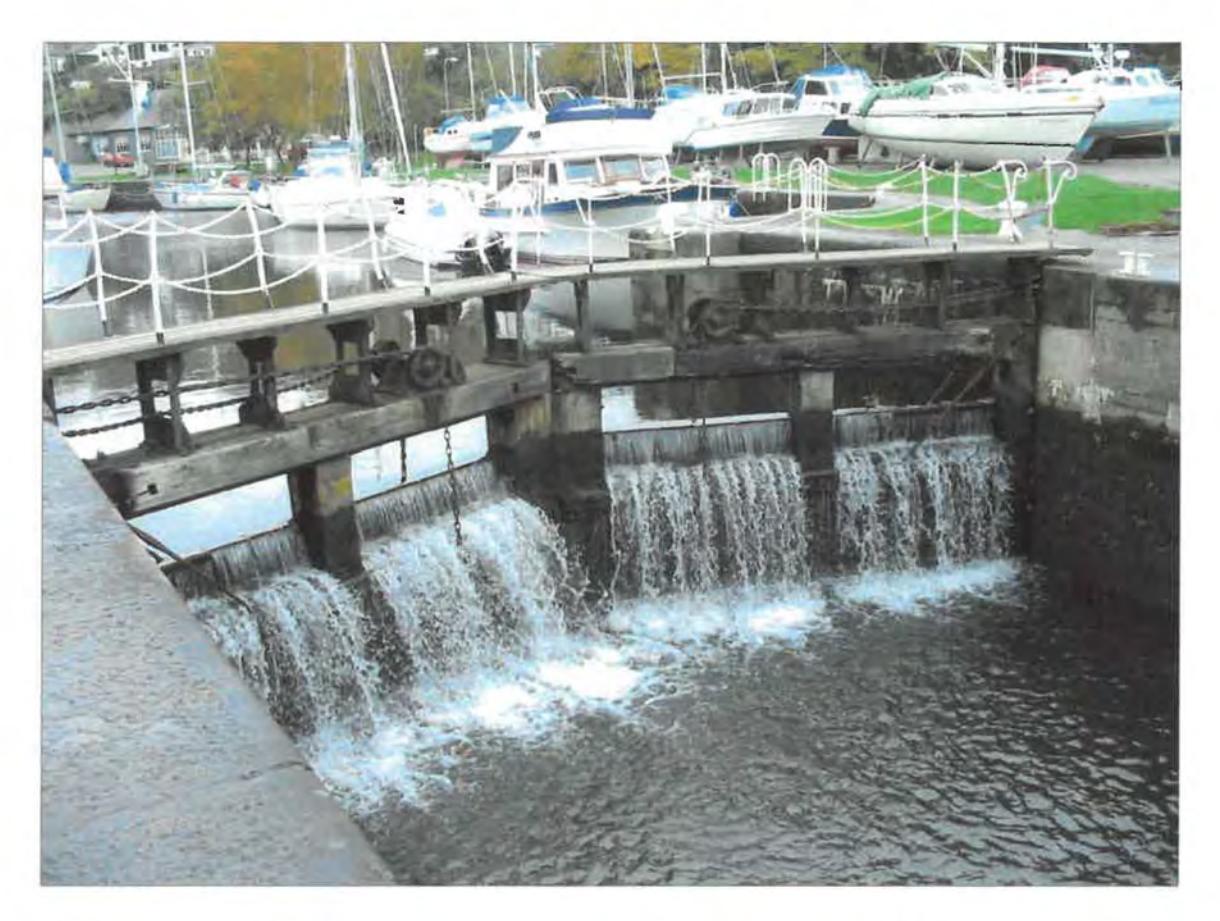
Figure 24. Inner lock gate. (PRN 15885)

NGR: SH 52616 67855 Type: Inner lock gate Date: c.1900 Description: As for PRN 15883 Condition: Working order. Vulnerability: None due to current development. Category: B Figure nos: 24

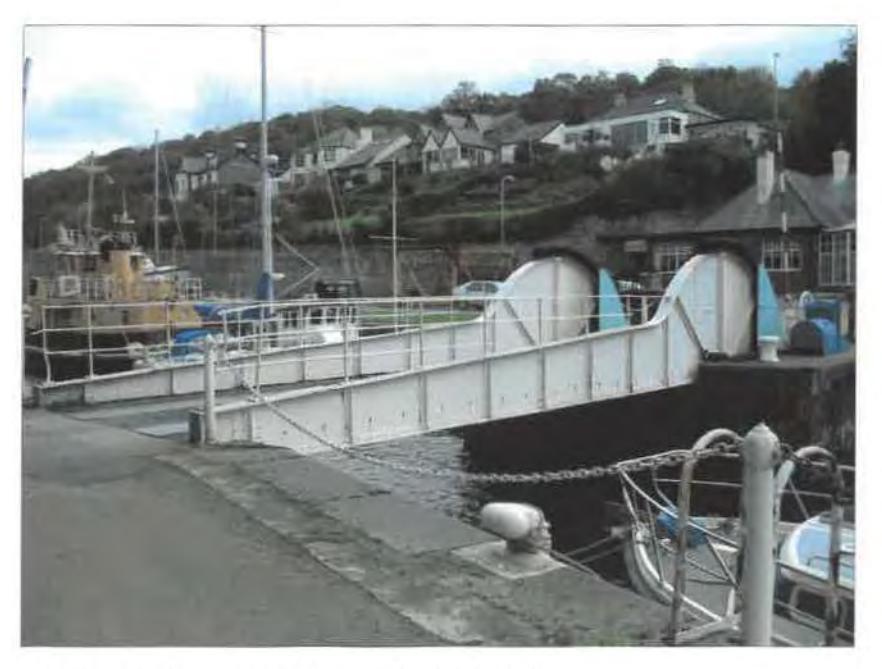
Figure 27. Swing Bridge. (PRN 15888)

PRN: 15888
NGR: SH 52709 67871
Type: Swing bridge
Date: c. 1900
Description: Iron swing bridge, 20m in length, pivots at the southern end. The original manually powered mechanism is still in place but now powered electrically. The bridge is raised to vertical position by means of a below ground cog system.
Condition: Working order
Vulnerability: Non due to current development.
Category: B
Figure nos: 27

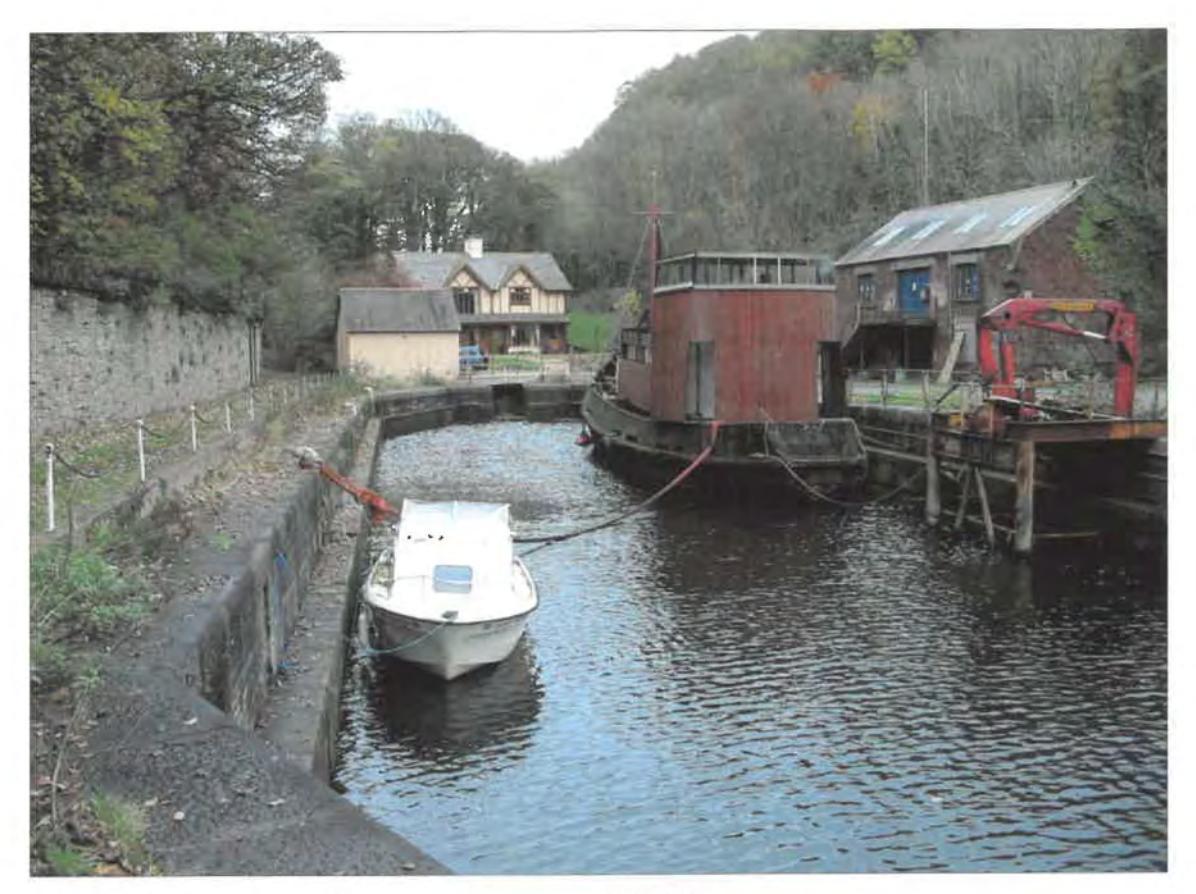
Figure 28. General view of dry dock. (PRN 15889)

Condition: Has unused and unmaintained appearance. Silting is preventing use for large vessels. Brickwork appears sound, gate not evident, metalwork not up to same standard as the rest of the lock system.

Vulnerability: Due to be brought into working condition as part of current development Category: B

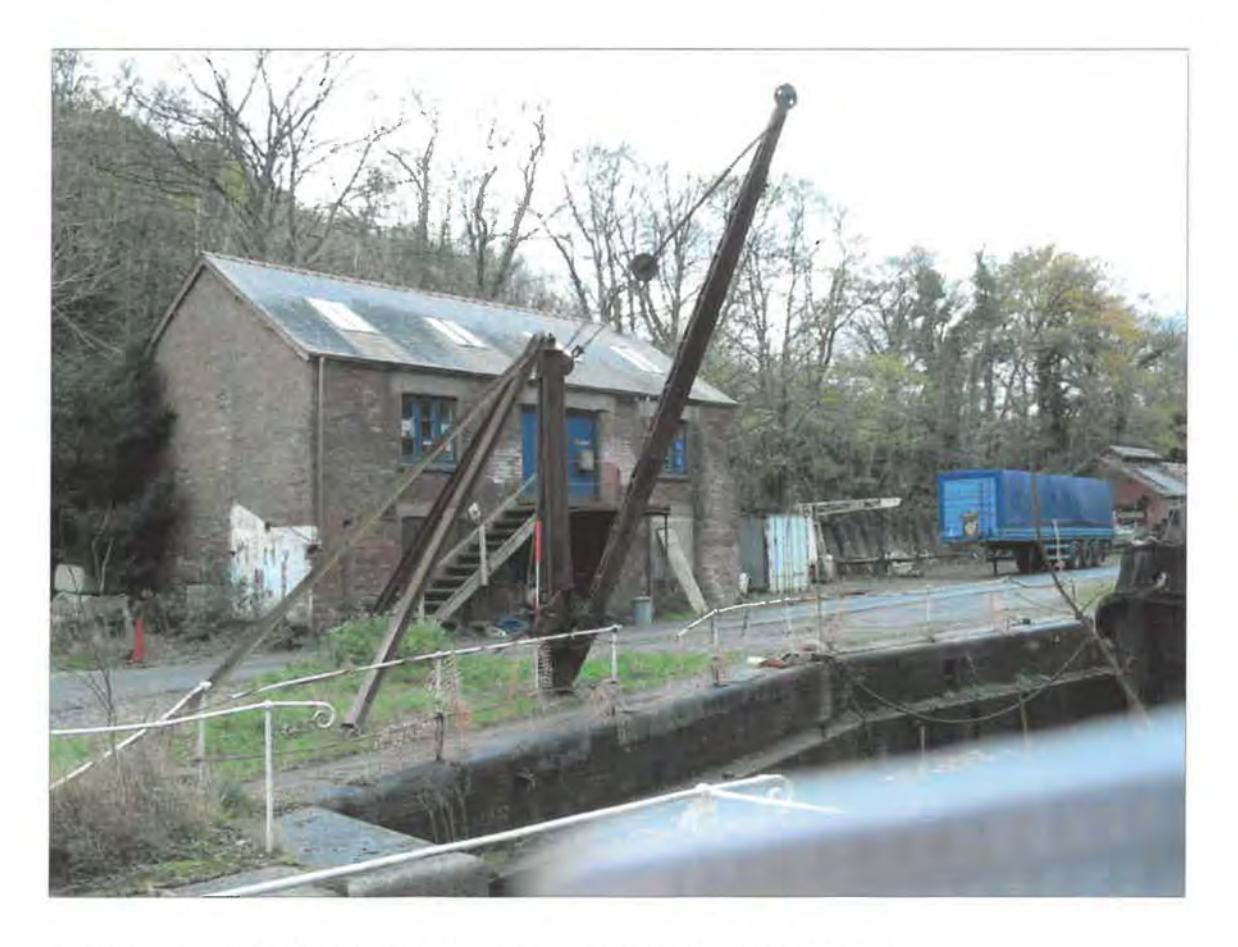
Figure 31. Crane (PRN 15891) and sail makers loft (PRN 15890)

Condition: Moderate, in need of some repair work. Four cast iron tie beams suggest that the building has suffered from subsidence in the past.

PRN: 15891 NGR: SH 52993 67871 Type: Dock side crane Date: Post 1900. Description: Cast iron stationary pivoting crane. Manual winch system based on an "A" frame with lowerable jib. Condition: Reasonable. Modern winching wire suggest that it may have been working recently. Does not appear to be in use currently. Vulnerability: May be affected due to current development. Category: C Figure nos: 31 PRN: 15892 NGR: SH 52941 67969 Type: Dry dock gate mechanism hut Date: c. 1902 Description: Small hut situated to the south of the dry dock entrance probably contained the controls for the dry dock gates. The hut is 4.7m wide and 3.2m wide. The walls of the hut were possibly originally constructed with wood but are now of modern brick. The roof is of wooden planks covered with roofing felt with a skirt of riveted iron sheet between the roof and brick wall. A small staircase near the hut leads to a small door directly below it which is presumed to give access to the gate mechanism itself. Condition: Good, recently repaired. Vulnerability: May be affected due to current development. Category: C

Vulnerability: Due to be repaired as part of the current development. Category: C

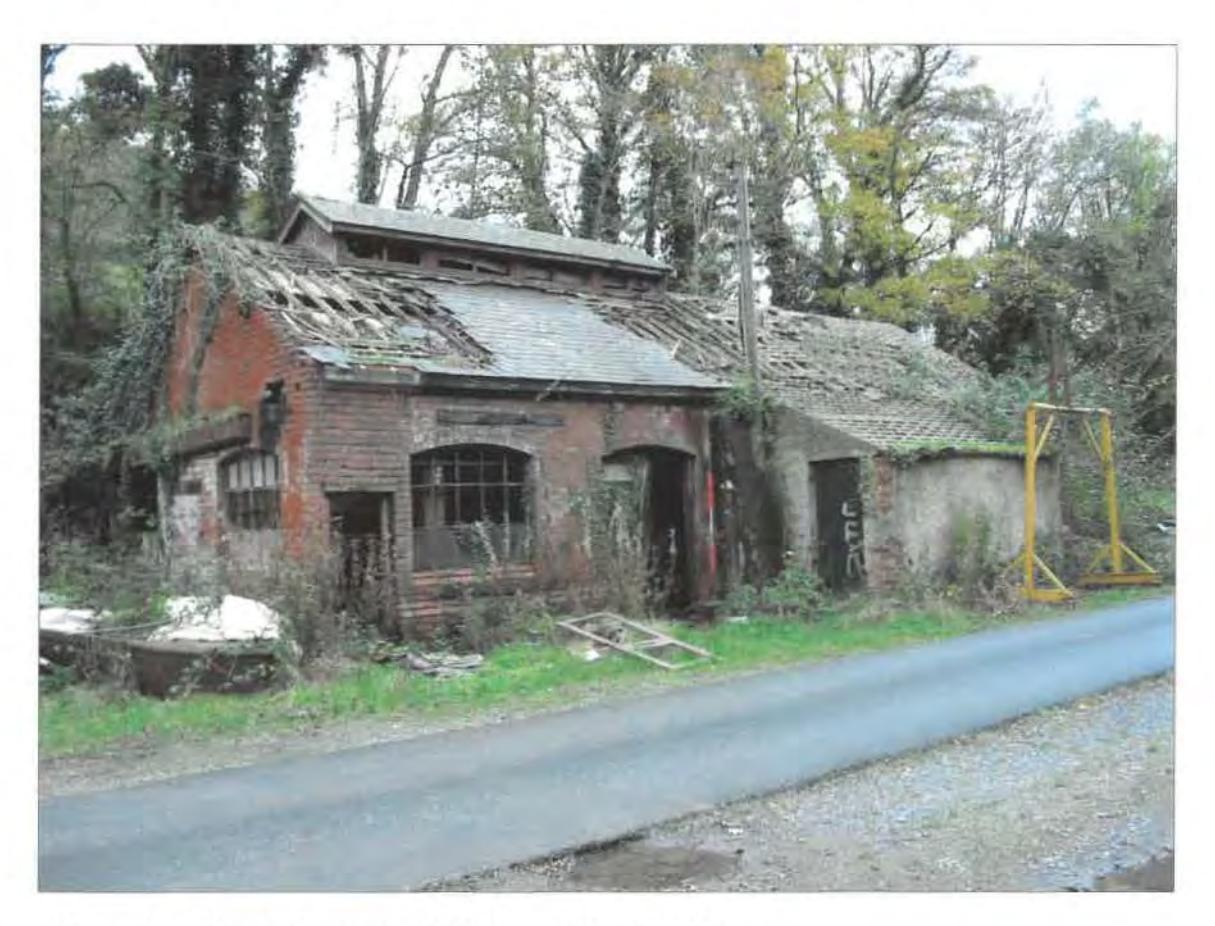
Figure 33. Electricity supply building. (PRN 15893)

Condition: Derelict, unstable. Concrete butresses and a possible tie beam indicate long term stability problems with this structure possibly as a result of it being partly constructed on top of the infilled 1800's harbour. Internal features are in a poor condition.

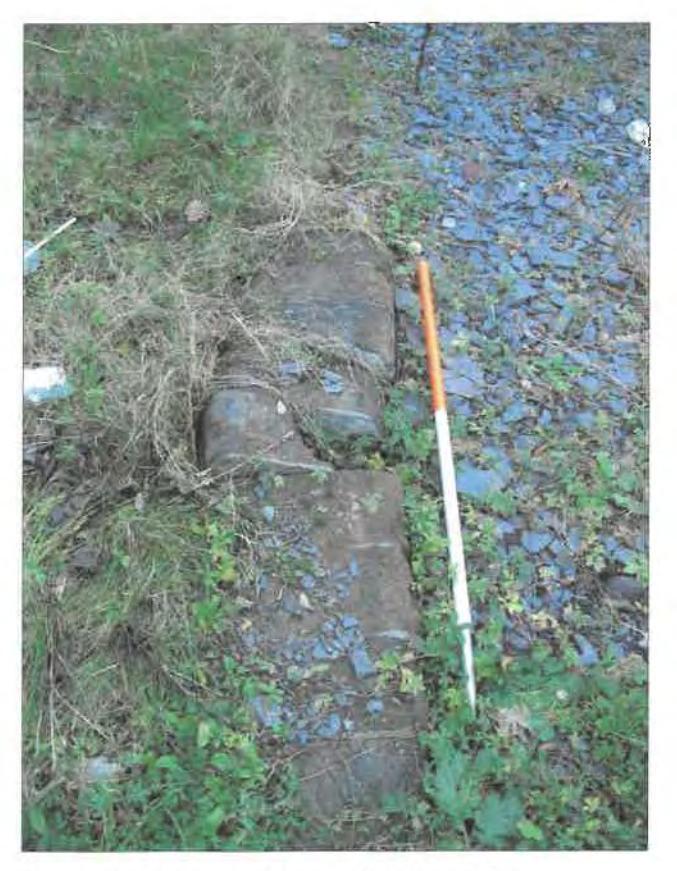
Figure 37. Brick edging. (PRN 15895)

PRN: 15895
NGR: SH 52787 67888 - 52820 67904
Type: Brick edging line
Date: Uncertain
Description: A line of purply red moulded bricks with a diamond pattern presumably for grip on the upper surfaces may represent the edge of the Carnarfon to Bangor branch line where it ran along the quay side.
Condition: Only visible intermittently, bricks dislodged in places.
Vulnerability: Likely to be affected by development.
Category: C
Figure nos: 37

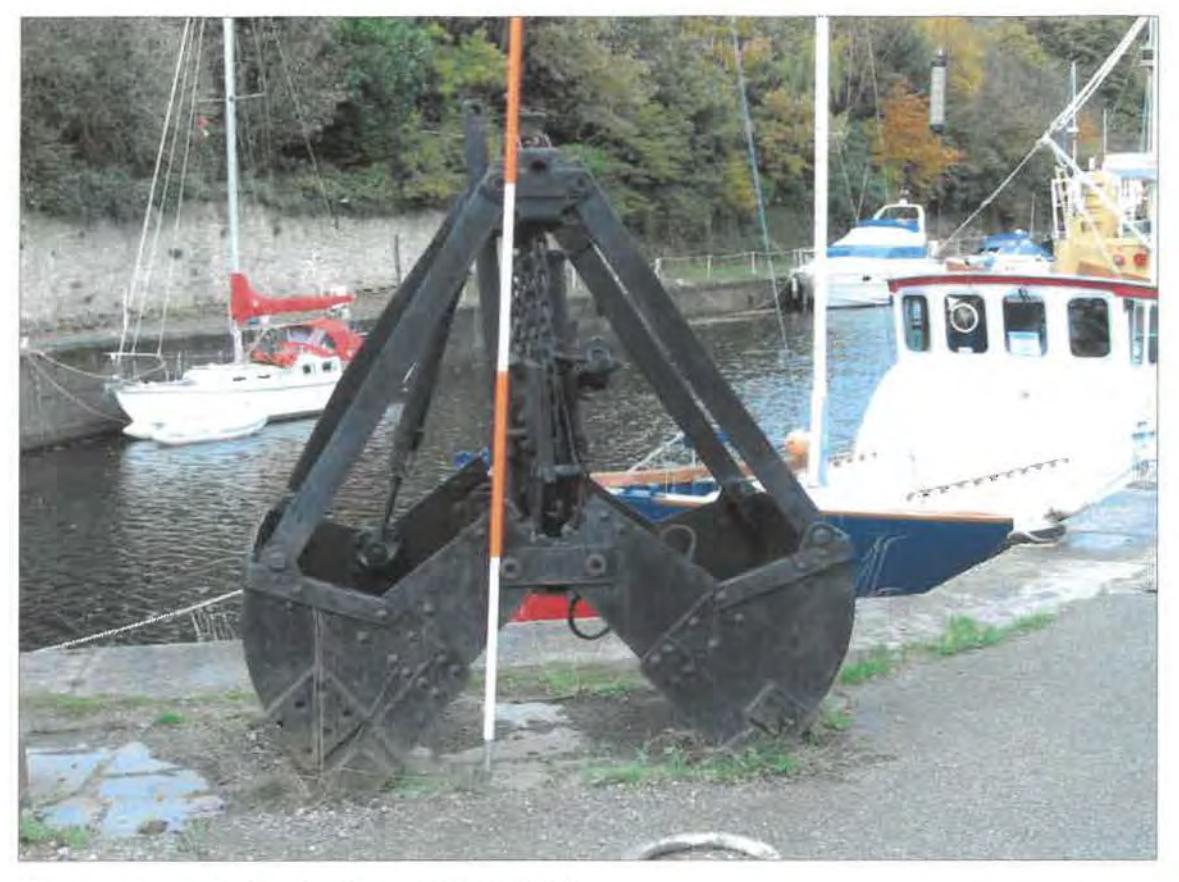
Figure 38. Dredging bucket. (PRN 15894)

PRN: 15894
NGR: SH 52725 67862
Type: Dredging bucket (decorative feature)
Date: Post 1900
Description: Old iron dredging bucket which has been salvaged and positioned close to the bridge (PRN 15888). Painted black.
Condition: Reasonable.
Vulnerability: None due to current development.
Category: C
Figure nos: 38
