CAMBRIAN MOUNTAINS ESA, HISTORIC MONITORING

BASELINE 1995

CAMBRIAN MOUNTAINS ESA HISTORIC MONITORING RESURVEY 1999

| PRN: 1367 SITE NAME: Foel Welly Morfydd Longhouse | | | |

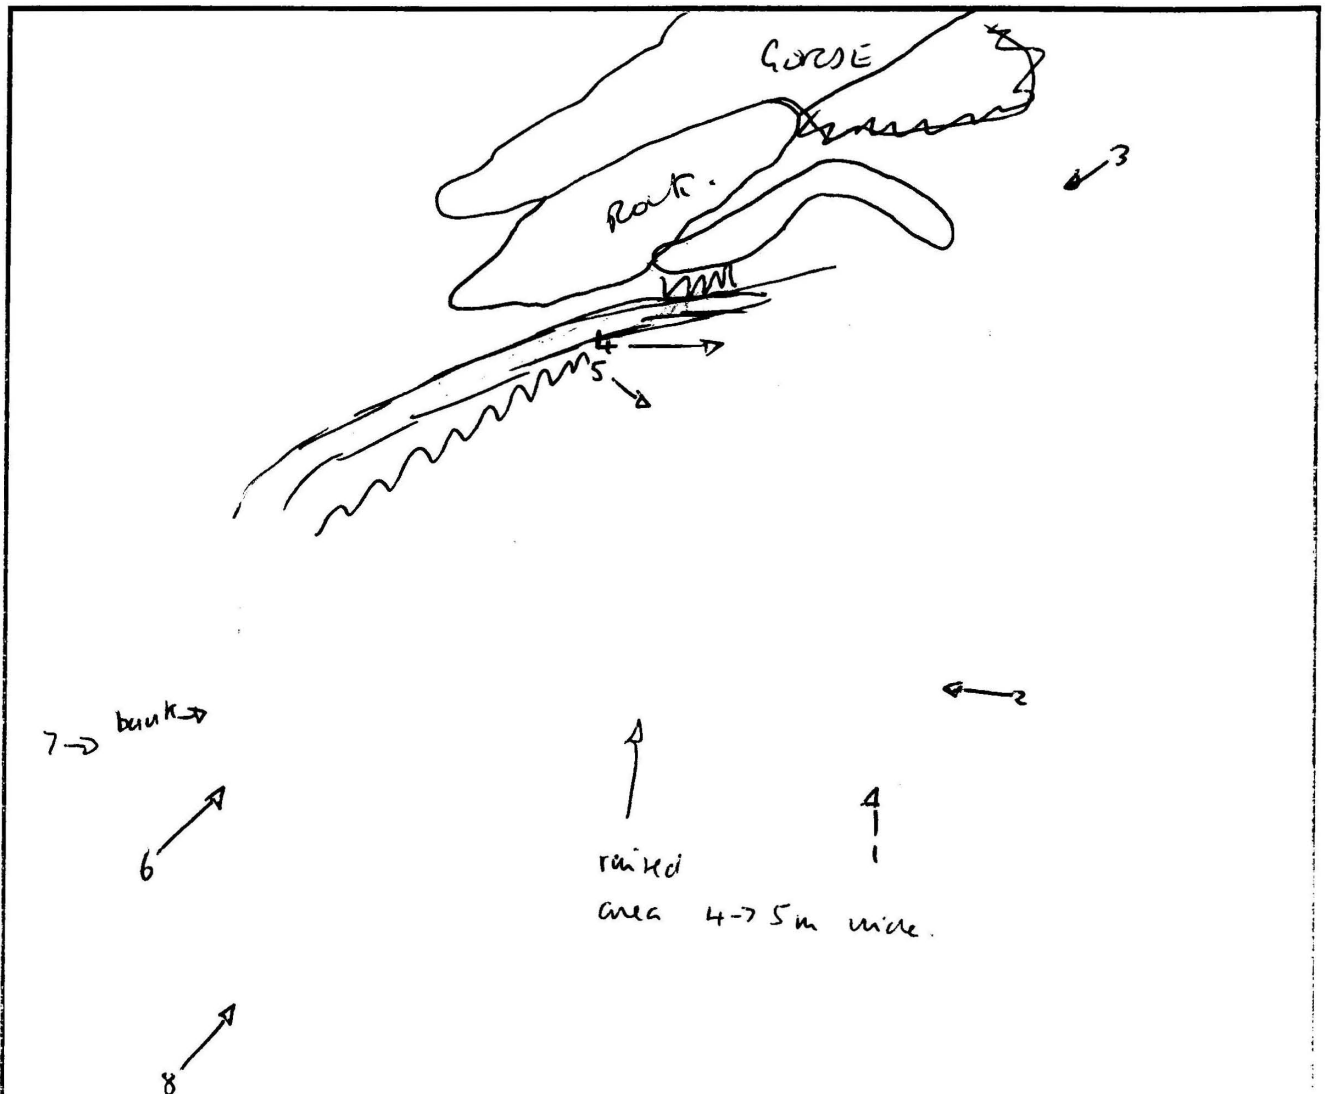
SUPPLEMENTARY NOTES TO FIELD SURVEYS

D/ bottom of slope not very obvious. Approx dimensions 15m x 12 m.

2nd feature next to (part of?) enclosure, later mining addition?, remains of field boundary?. Raised bank 4-5 m wide with bank on right hand edge + ditch? on left (looking down slope). No bank at top but vague bank at bottom.
